Uruti Wetland Management System

URUTI COMPOSTING FACILITY

WETLAND TREATMENT SYTEM

MANAGEMENT PLAN

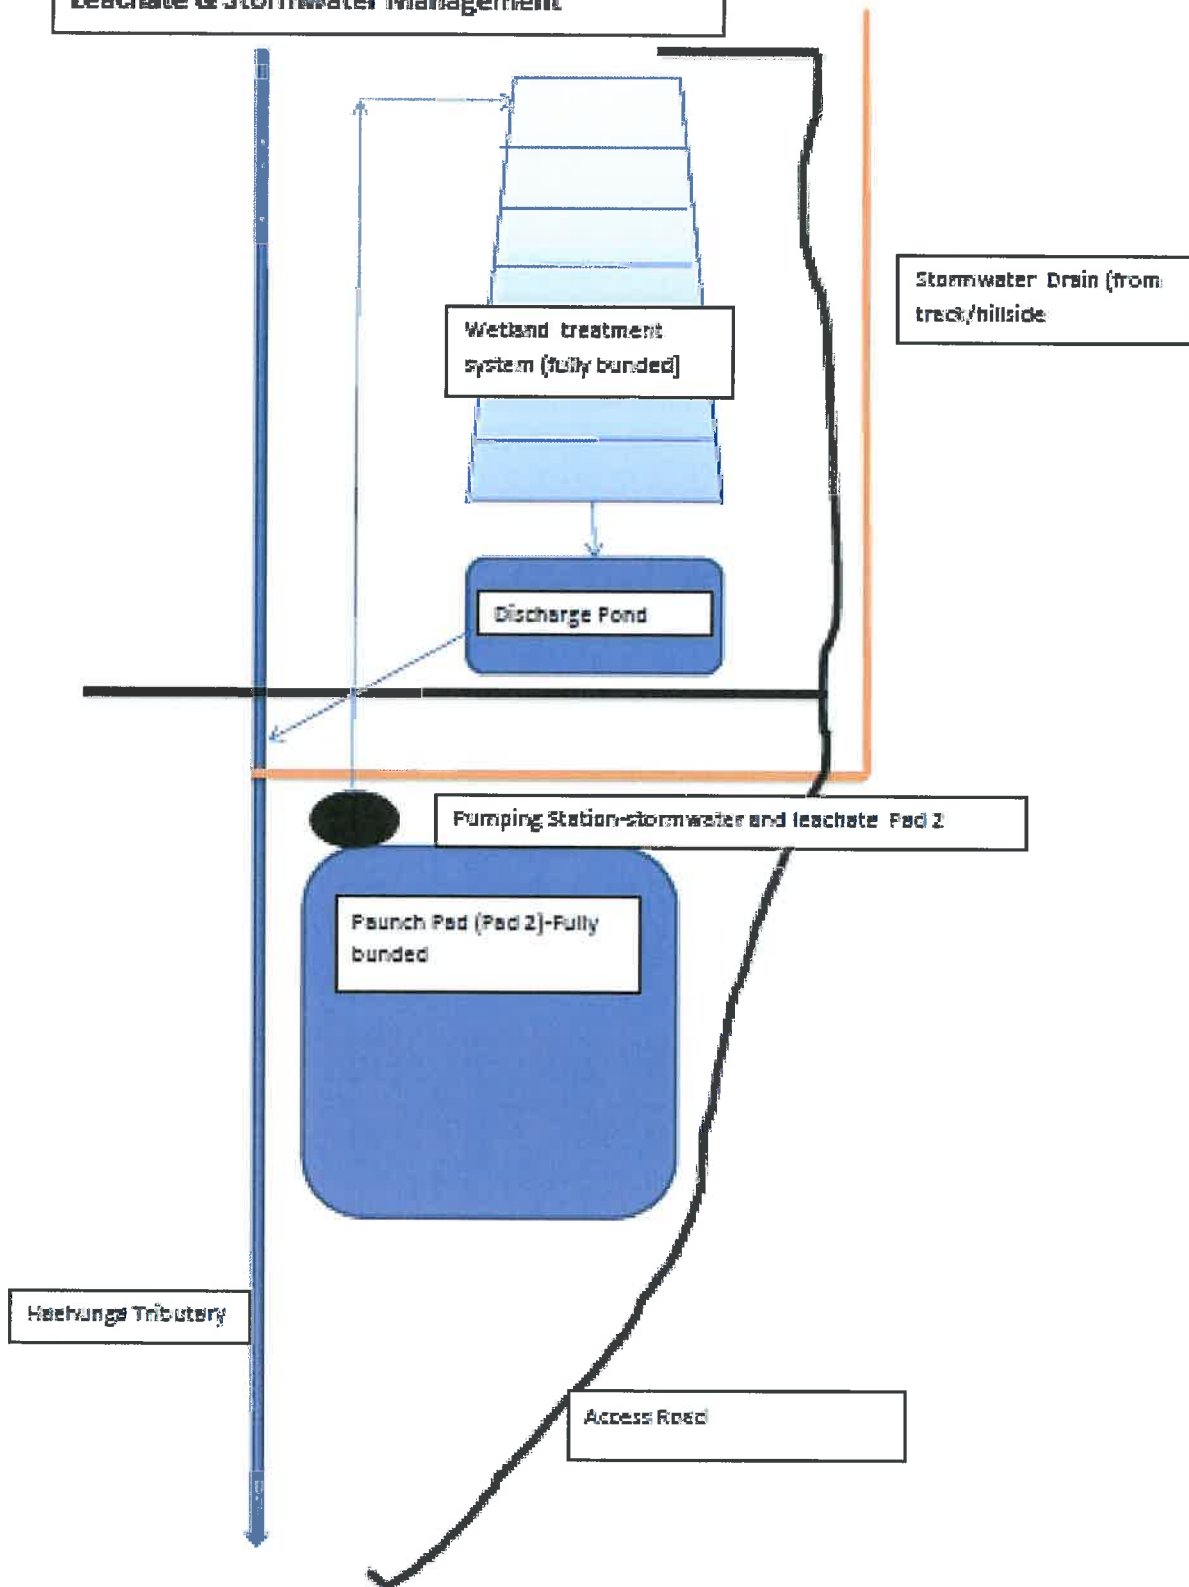
Appendix 2

Uruti Compost Pad 2

Leachate & Stormwater Management

Paunch Grass is received (approximately 5-6,000 tonnes per annum) on a 4,000m² pad, where it is pre composted for up to six months before being feed to worms at various sites in Taranaki.

A diagram of Pad 2 is attached as Appendix 2.

Leachate form Pad 2 is collected in 400m³ capacity pond on Pad 2, from there it is pumped to the Wetland on a as required bases, this allows solids from Pad 2 to settle out before pumping.

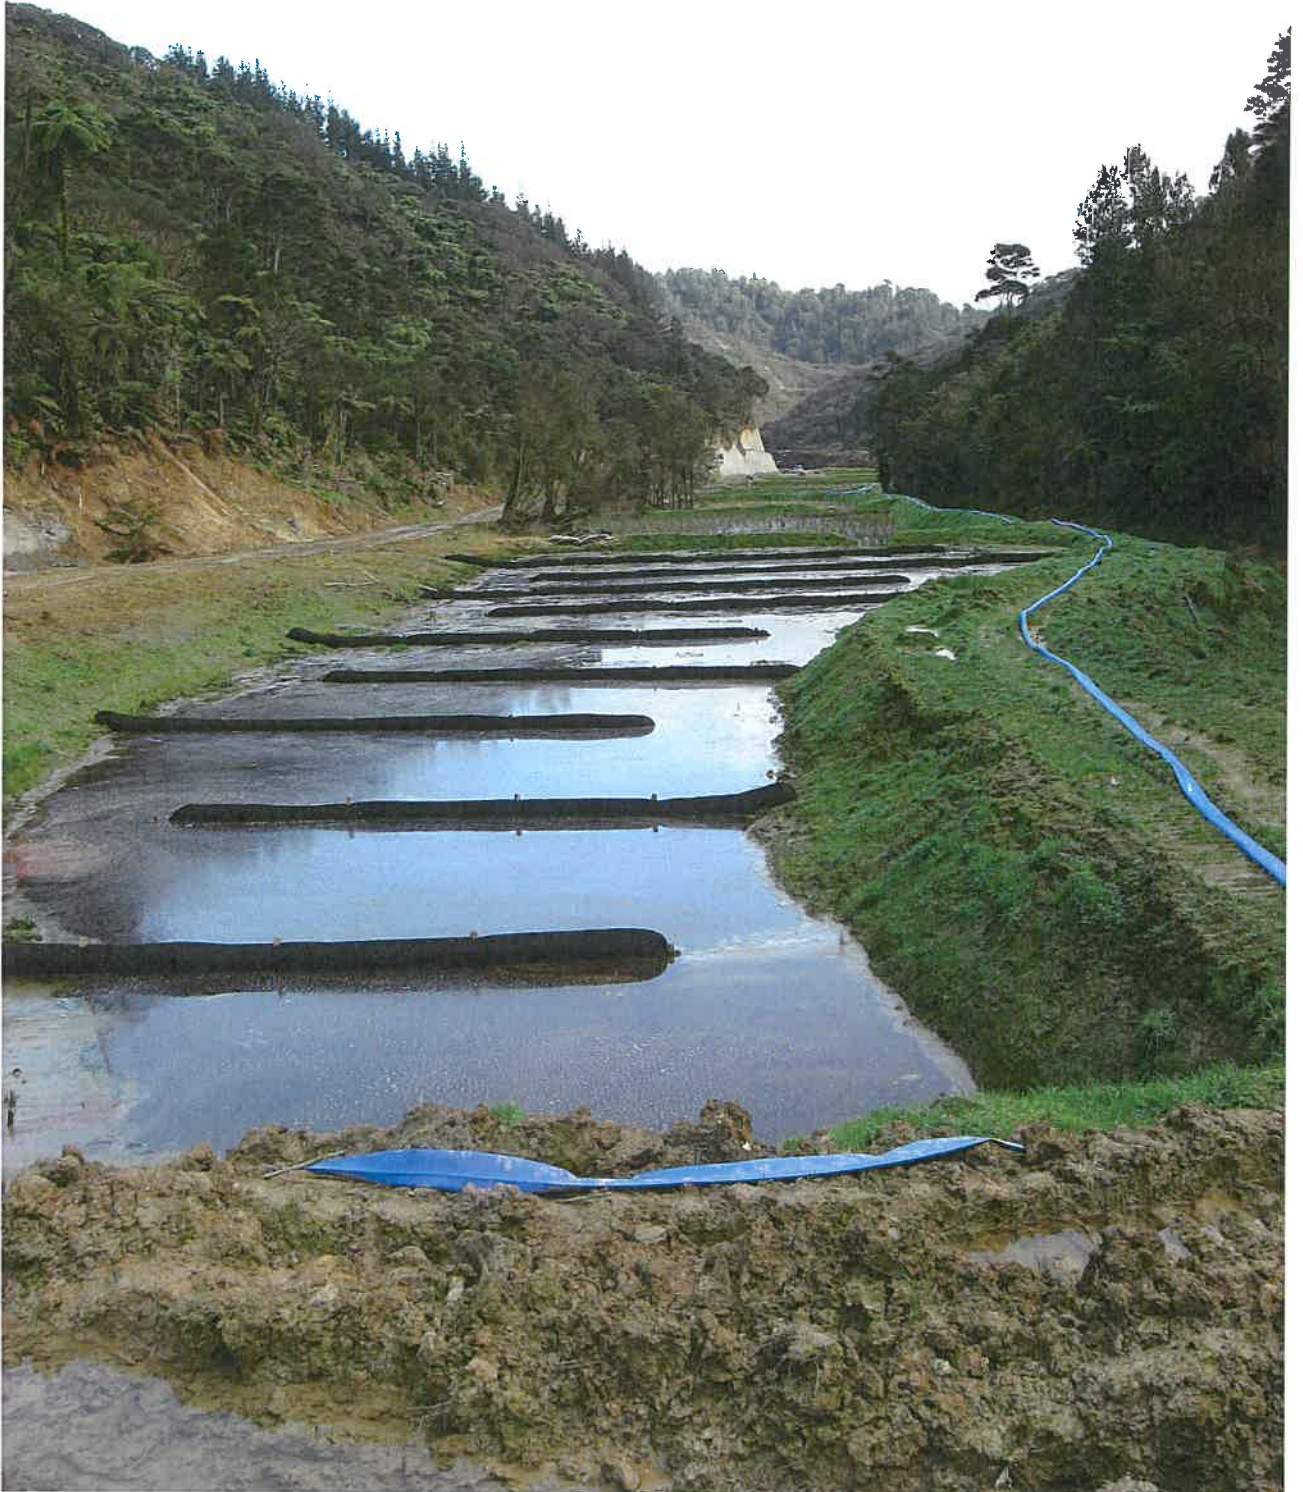
Appendix 5

Section One contains a series of filter sox which are designed to remove solids before they enter the planted sections of the wetland (refer to appendix 5).

Solids that have accumulated in section one (filter sox) and the exit weirs of the wetland system are monitored weekly and cleaned out and on a 20% base. A long reach digger is used.

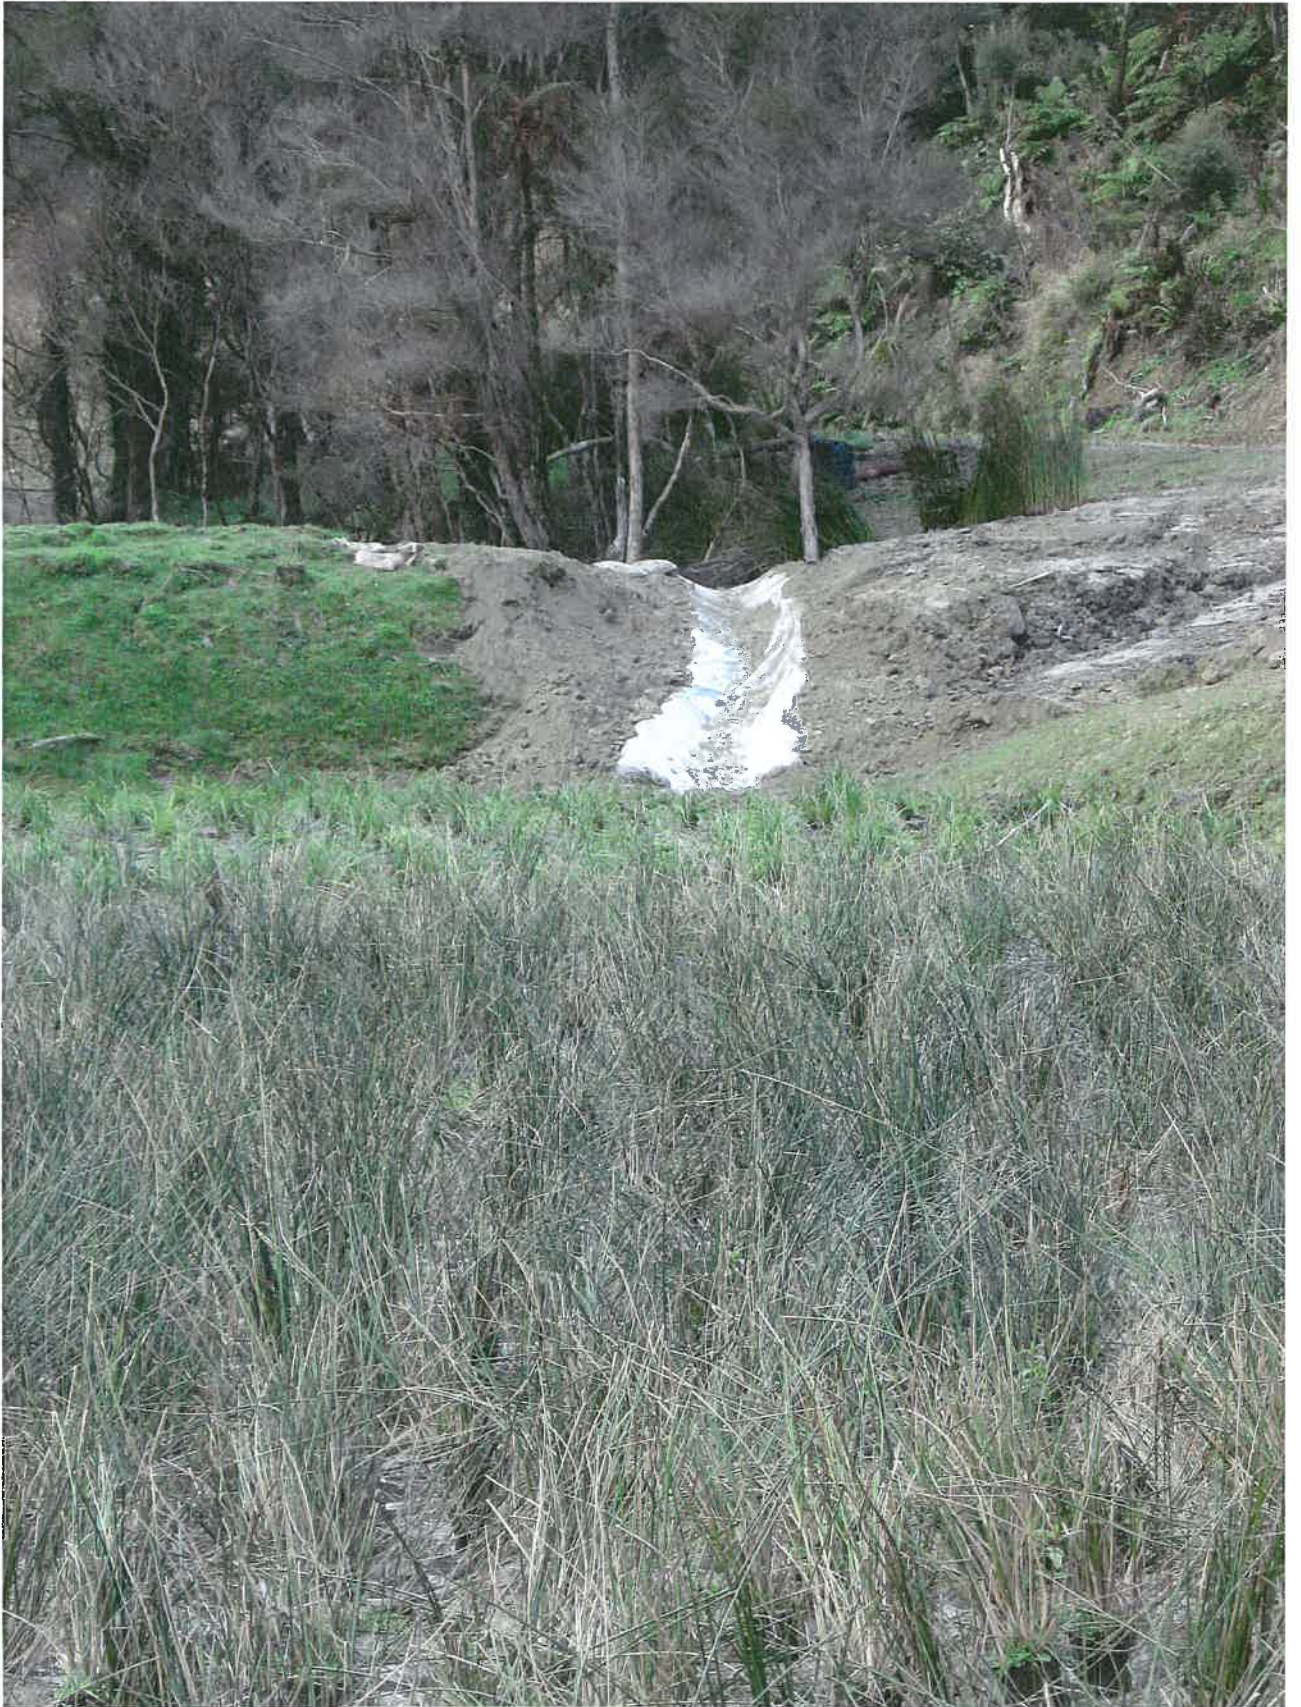
Appendix 6

Sections 2 to 7 are planted with species appropriate to nutrient loadings as leachate passes through the system. Each terrace has a filter sox before the exit weir (refer to appendix 6).
