**BEFORE THE TARANAKI REGIONAL COUNCIL**

of an application by Remediation (NZ) Limited for resource consents under Part 5 of the Resource Management Act 1991

**STATEMENT OF EVIDENCE OF  
DAVID PAUL GIBSON  
DATED 9 March 2021**

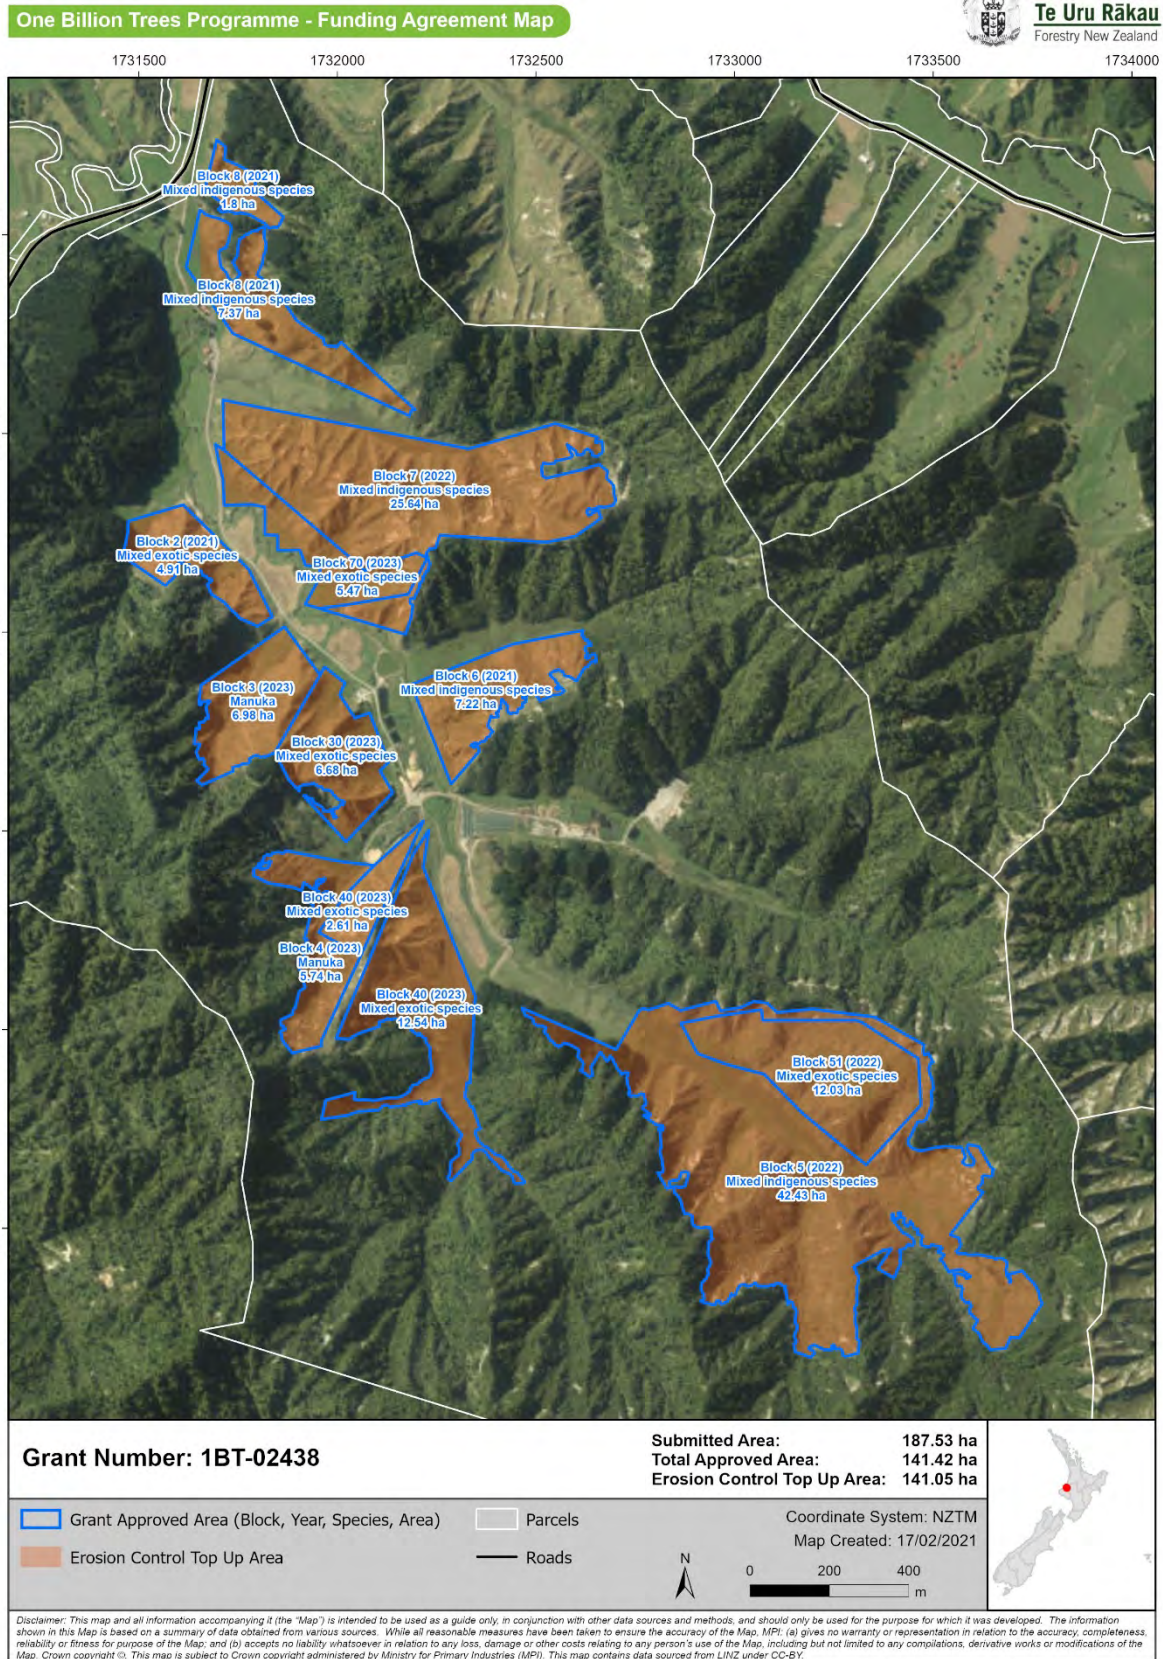
# Appendix 1-One Billion Tree Programme-Funding Agreement Map

28. Riparian planting is ongoing along the Haehanga stream banks. A plan has been developed with the help of the TRC, and each year further planting is undertaken. RNZ intends to continue this planting up the catchment beyond our operational areas. All site riparian planting is expected to be complete by the end of 2024.
29. Remediation (NZ) Ltd has applied to the 1BT fund for assistance in planting indigenous, mixed indigenous, and exotic (redwood, eucalyptus, tasmania blackwood and cyprus) on land that has been previously grazed (140ha). A site plan is attached that shows the areas to be planted out-see Appendix 1 'One Billion Tree Programme-Funding Agreement Map.
