To Nathan Crook, Job Manager
From Bart Jansma; Environmental Scientist
Report No BJ308
Document No 2049001
Date 7 May 2018

Biomonitoring of the Haehanga Stream in relation to discharges from the Remediation (NZ) Limited composting site at Uruti, January 2018

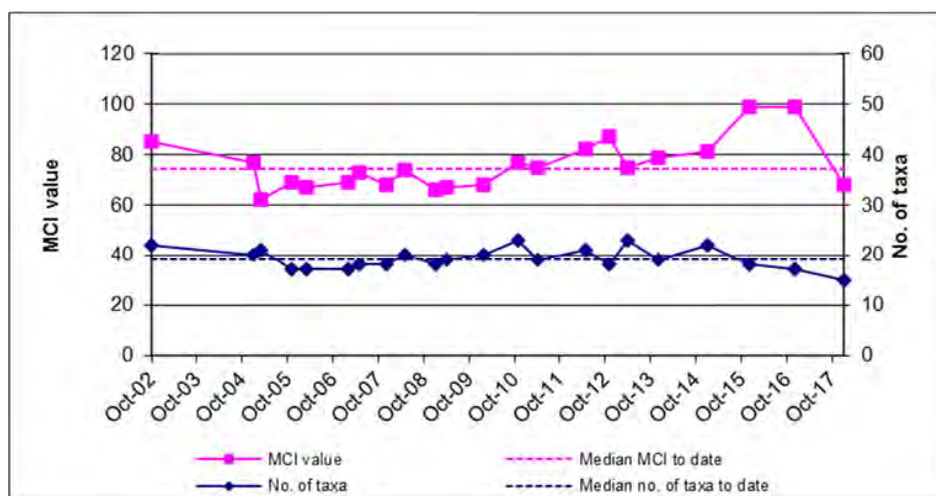
Figure 5 Taxa numbers and MCI recorded to date at site 2

The MCI value of 68 units reflected a low proportion of sensitive taxa in the community at this site (33%). This score is more than thirty units less than that recorded in the previous survey, but not significantly different to the median score for this site, and is within the range of previous results (Stark 1998) (Table 2, Figure 3). The SQMCI_s value at this site (4.1) was similar to the median value, and similar to that recorded in the previous survey, and reflecting the overall numerical dominance of the 'extremely abundant' *Potamopyrgus* snails.

Although this suggests that water quality at this site has deteriorated from the previous survey, it should be noted that the sampling technique differed to the two previous surveys. Historically, this site was sampled using the vegetation sweep technique, as it was in the current survey. However, the December 2015 and 2016 surveys used the kick sample technique, due to a lack of macrophyte habitat. The vegetation sweep technique samples habitat that tends to support more 'tolerant' taxa and therefore produces lower MCI and SQMCI₅ scores. This also explains the similarity in MCI score between sites 1 and 2.

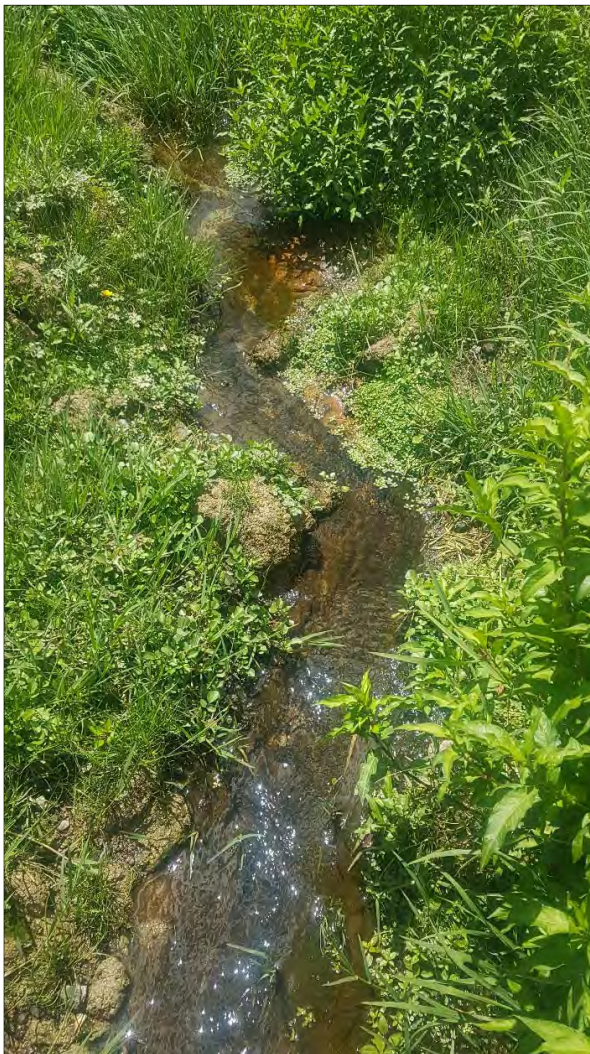
Photo 1 Haehanga Stream at site 6, 16 January 2018

A richness of nine taxa was recorded at this site, located downstream of the effluent irrigation area (Table 2, Figure 7). This represents a reduction on that recorded in the previous survey when sixteen taxa were recorded, which is considered a direct reflection of the habitat limitation caused by low flows and algal growth on the streambed (Photo 1).

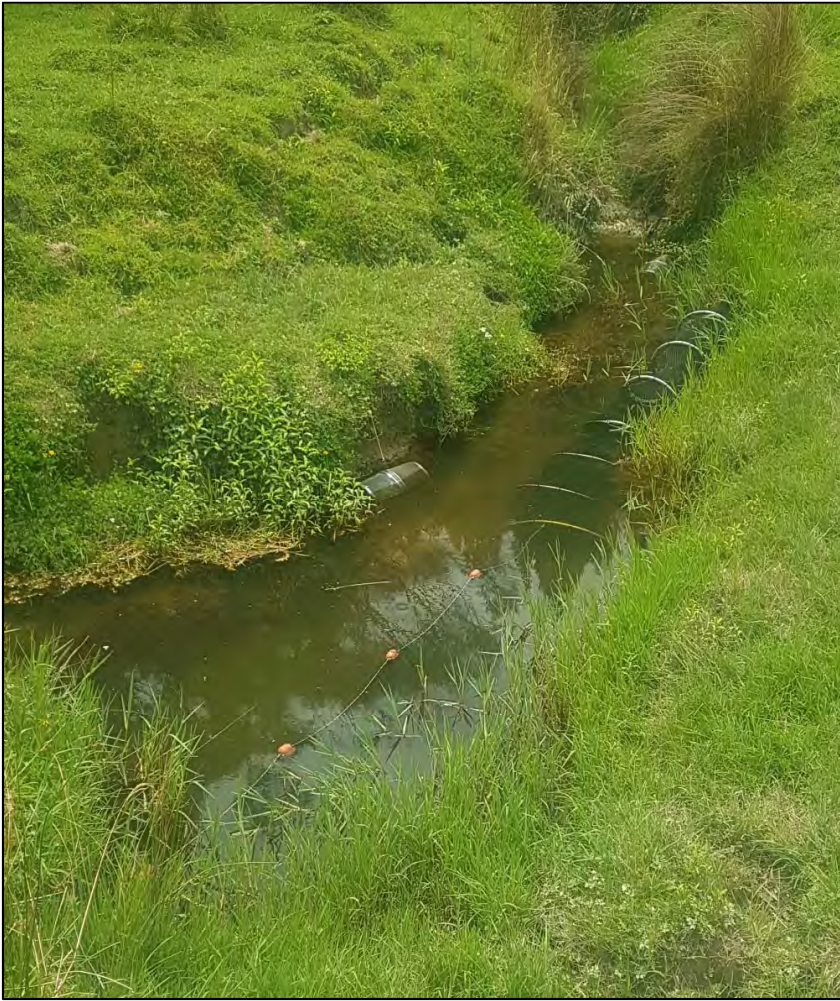
Photo 1 A fyke net and gee minnow trap, set at site 1, Haehanga Stream. 16 January 2018

The fish populations were sampled using fyke nets (Photo 1) and gee minnow traps. At each site, five gee minnow traps were set, and baited with Marmite. They were set overnight, among macrophytes or alongside woody debris. Two fyke nets were also set at each site, a standard mesh (25mm) net and a fine mesh (13mm). The standard mesh net was set downstream, in attempt to intercept any large eels moving up from downstream. Both fyke nets were baited with fish food pellets. These nets were also set overnight. All fish caught were identified, counted and measured, and any eels longer than 300mm were weighed, using electronic scales that measured to the nearest 20 grams. All nets and traps were deployed on the afternoon of 16 January 2018, and retrieved midmorning the following day.

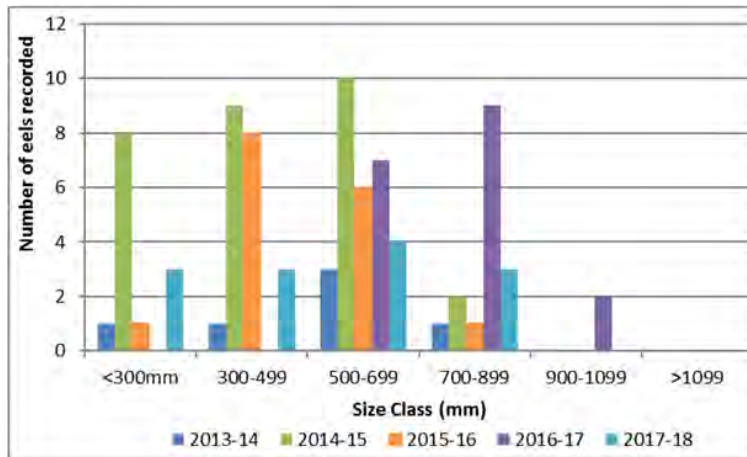
Figure 2 Size class distribution of all eels recorded at site 2 over the four surveys completed to date

Thirteen eels were captured, of which two were longfin eels, none of which were particularly large, with the largest being 570mm and 0.46kg. This is a reduction from the number of eels recorded in the previous survey, which recorded eighteen eels. Unlike in the more recent surveys, there was little difference in size class distribution, similar to that recorded in the 2013-2014 survey, which was also undertaken in low flows (Figure 2). There were more smaller eels recorded at this site than in the previous survey, which is likely

related to the smaller number of large eels, and a consequent reduction in predation within the nets.

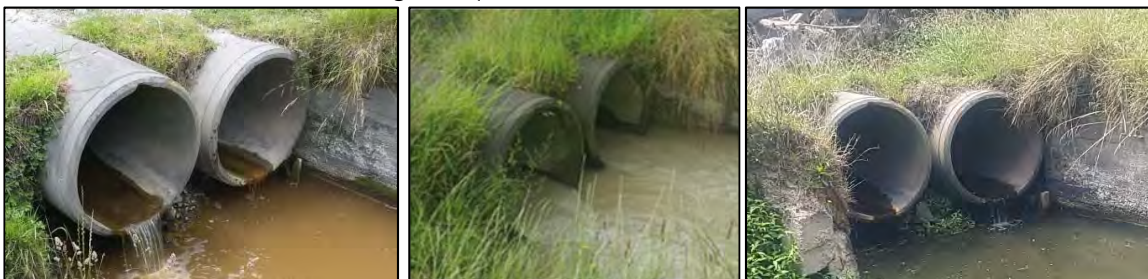
Photo 2 The access culvert immediately upstream of site 2, December 2015 (left), December 2016 (middle) and January 2018 (right).

It is apparent that site 2 still had a much higher abundance than that recorded upstream at site 1. This suggests that the access culvert immediately upstream of this site may still be posing a barrier to fish passage (Photo 2). Some remedial works had been undertaken in the past, with gravel being used to build up the bed level at the outlet of the first pool downstream of the culvert prior to the 2016-2017

survey. While this was an appropriate approach, as it lifted the water level and resolved the perched nature of the culverts, the material used was too fine and had already begun scouring away. During the current survey, it was apparent that the material had indeed washed away, and the culverts were again perched. Remedial works are therefore once again required.

Three access culverts were assessed for fish passage during this survey, and all were found to present a barrier to fish passage at most if not all flows. Even in higher flows, it is likely that these culverts severely restrict the passage of swimming species such as inanga. The culvert located immediately above site 2 was perched, as the remedial works completed prior to the previous survey had scoured away. Remedial works are required on this culvert, and on the remaining two culverts, which have been identified as a barrier for a number of years.

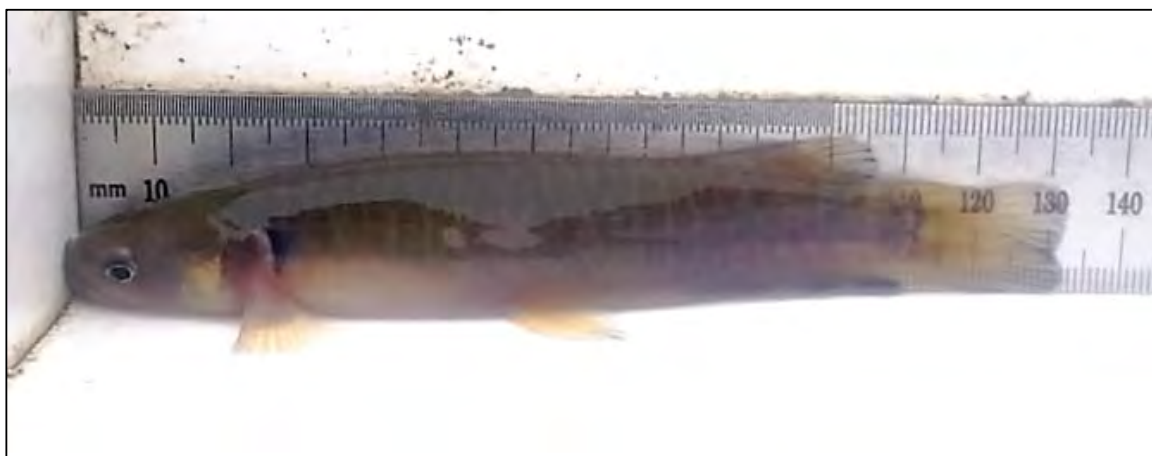
Photo 3 Banded kokopu (*Galaxias fasciatus*) captured in the unnamed tributary upstream of the wetland discharge, December 2016.

This tributary was surveyed for the second time in this survey, with the current survey being the first occasion when both sites T1 and T2 were trapped. It should be noted that previous macroinvertebrate surveys have incidentally recorded fish, including banded kokopu and longfin eel, with larger unidentified eels observed below the wetland discharge. Unfortunately, no fish were recorded at either site in the current survey, which is a reflection of the relatively low intensity trapping, but also the low flows present at the time. In the previous (2016-2017) survey, one banded kokopu was captured (Photo 3), being an individual 130mm in length, likely to be between two and three years old (Hopkins, 1979). Banded kokopu are considered a regionally distinctive species in Taranaki, and as such, their presence in this unnamed tributary shows the significant values such small streams can have.

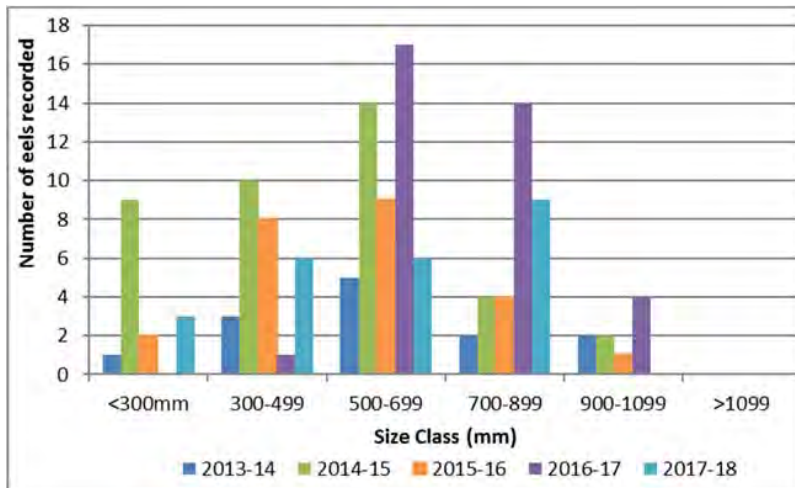
Figure 4 The size class distribution of all eels captured at all sites over the three surveys undertaken to date.

Figure 3 Figure 4 shows that a lower number of eels were recorded in the current survey than in the 2015-2016 survey, but similar to that recorded in the 2015-16 survey. The size class distribution was quite different however, with no size category clearly dominating the community. This differs to the previous surveys, which have recorded the most eels in the 500 to 700 mm size class. The most abundant size category in the current survey (albeit by only two eels) was the 700-899 mm size category.

This difference in the number of eels and the size class distribution can be attributed to the reduced flow conditions during the current survey. This lower flow meant that the bait scent was not carried as far downstream, with fish attracted from a smaller area than during higher flows. This will have contributed to the reduced number of large eels in the nets, reducing the likelihood of predation in the nets. This allowed for an increased survival of smaller eels.

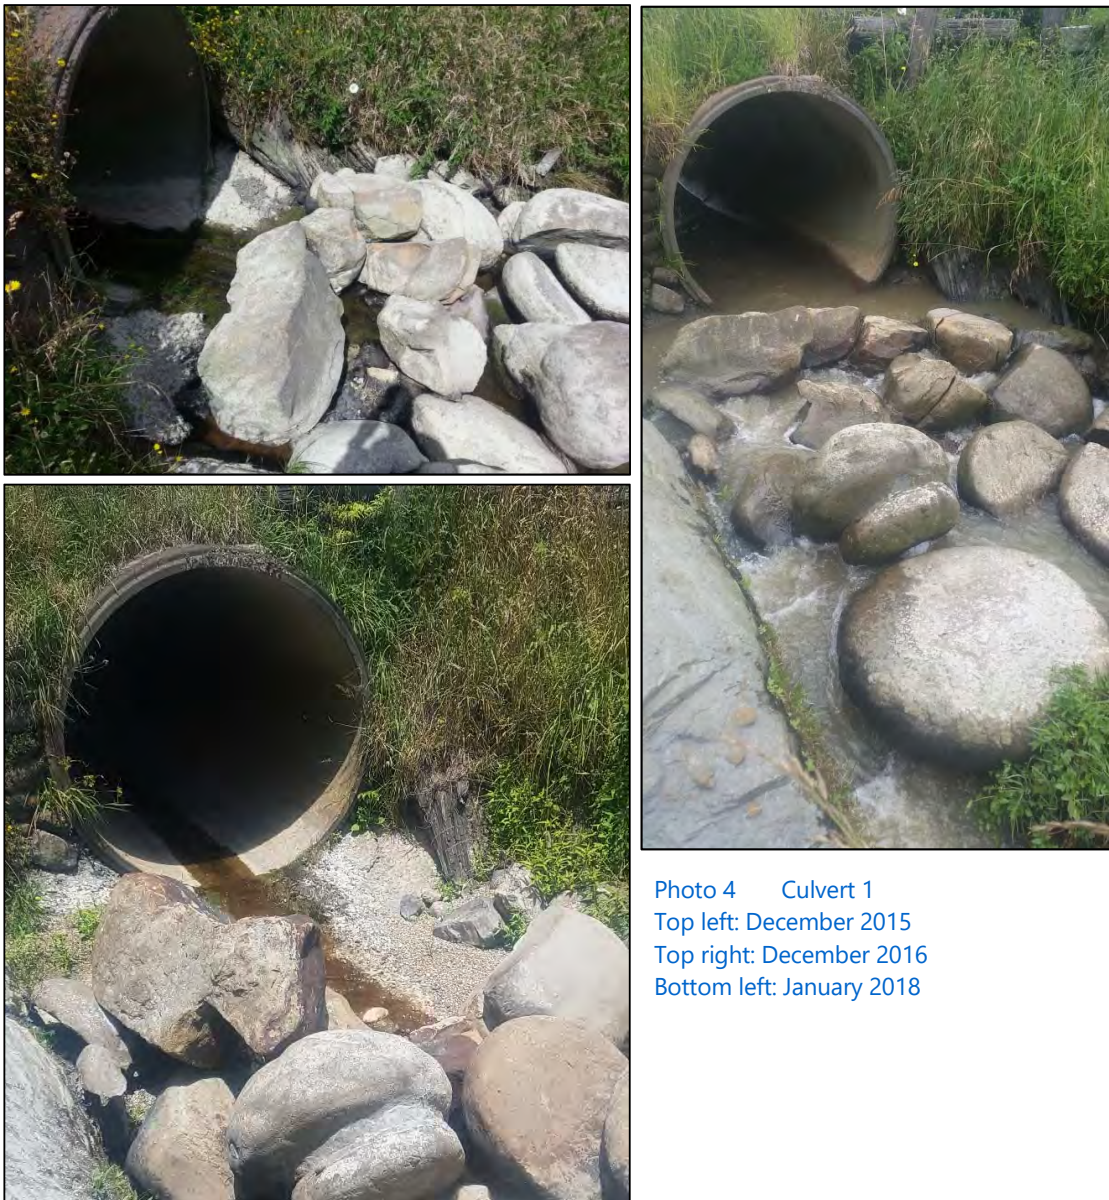
Photo 4 Culvert 1
Top left: December 2015
Top right: December 2016
Bottom left: January 2018

During this and previous surveys, three access culverts were inspected, and assessed for fish passage. The locations of these culverts are summarised in Table 4. It was noted that each of the three culverts impeded fish passage in some way.

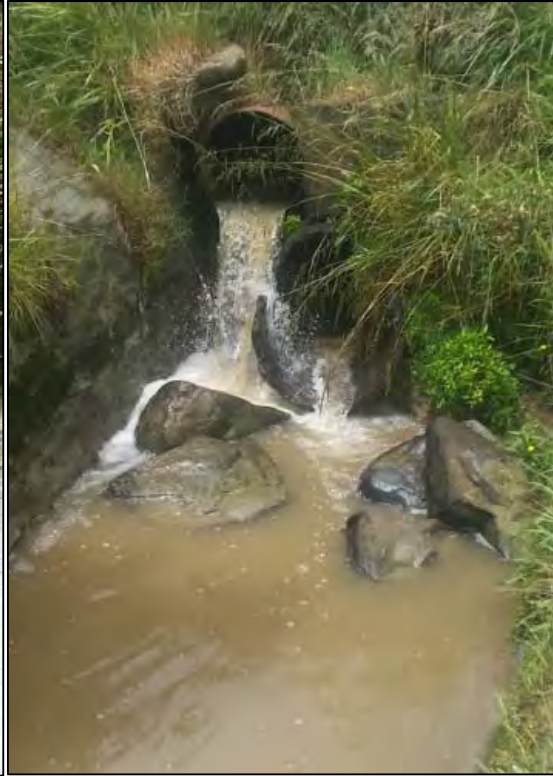
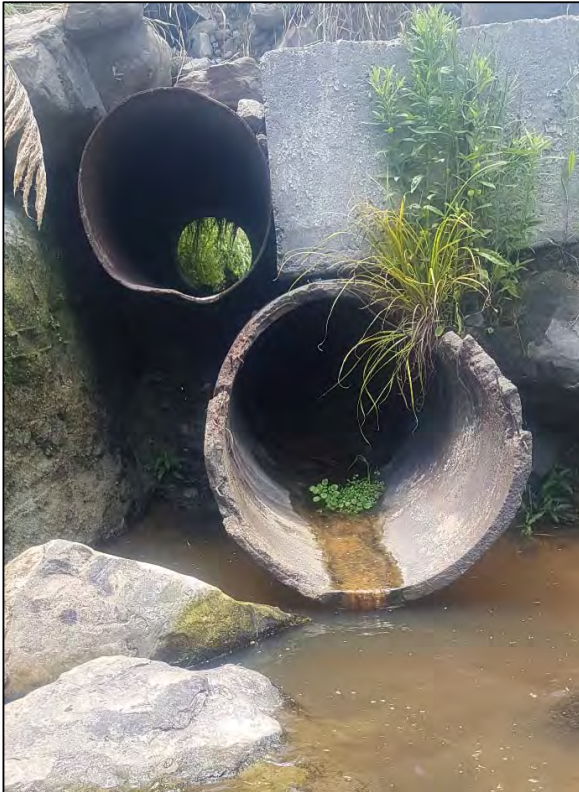
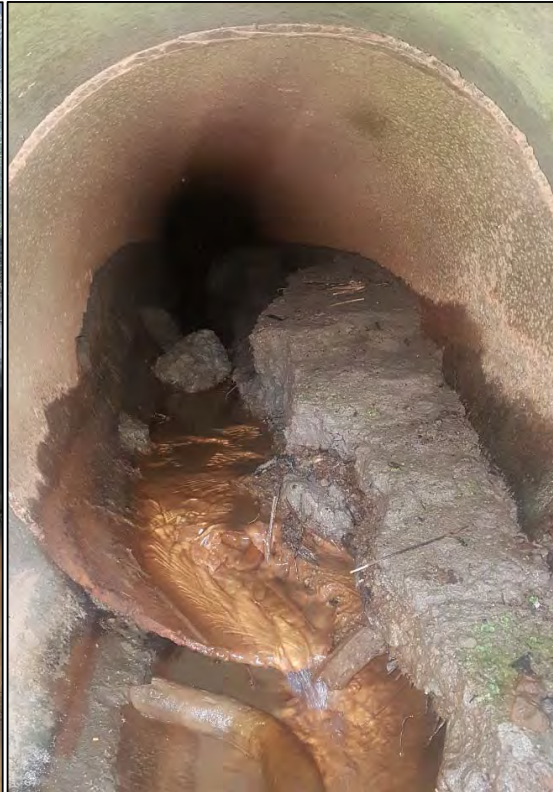
Photo 5 Culvert 2

Bottom left: January 2018

Bottom right: Interior, January 2018
