# Waitotara Scheme Management Plan

March 2017

Document No: 1794900

## 1. Introduction

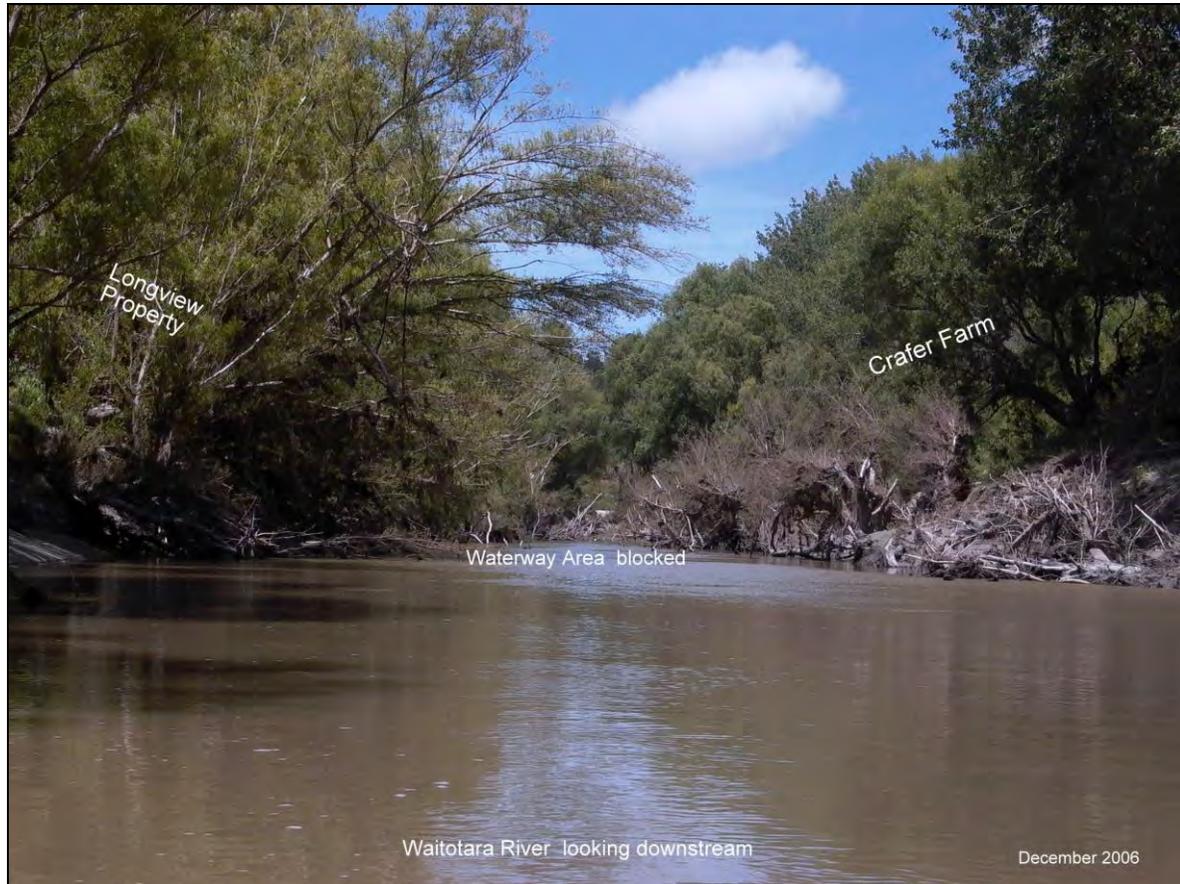
*Figure 1: Willow congestion adjacent to Waitotara Township prior to clearing works – refer to Figure 3 for location*

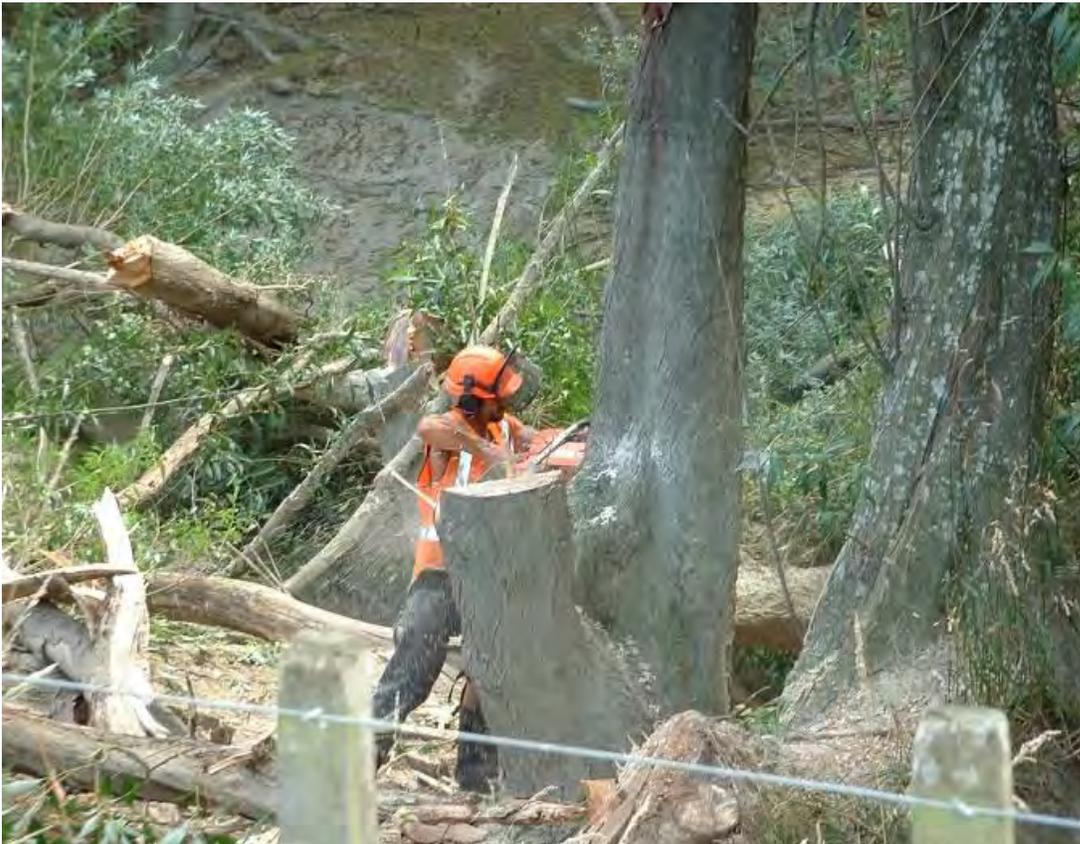
*Figure 2: Willow removal showing how large some of the trees were*

Figure 2 shows the size of some of the willow that was removed from the channel as part of the initial clearing works.

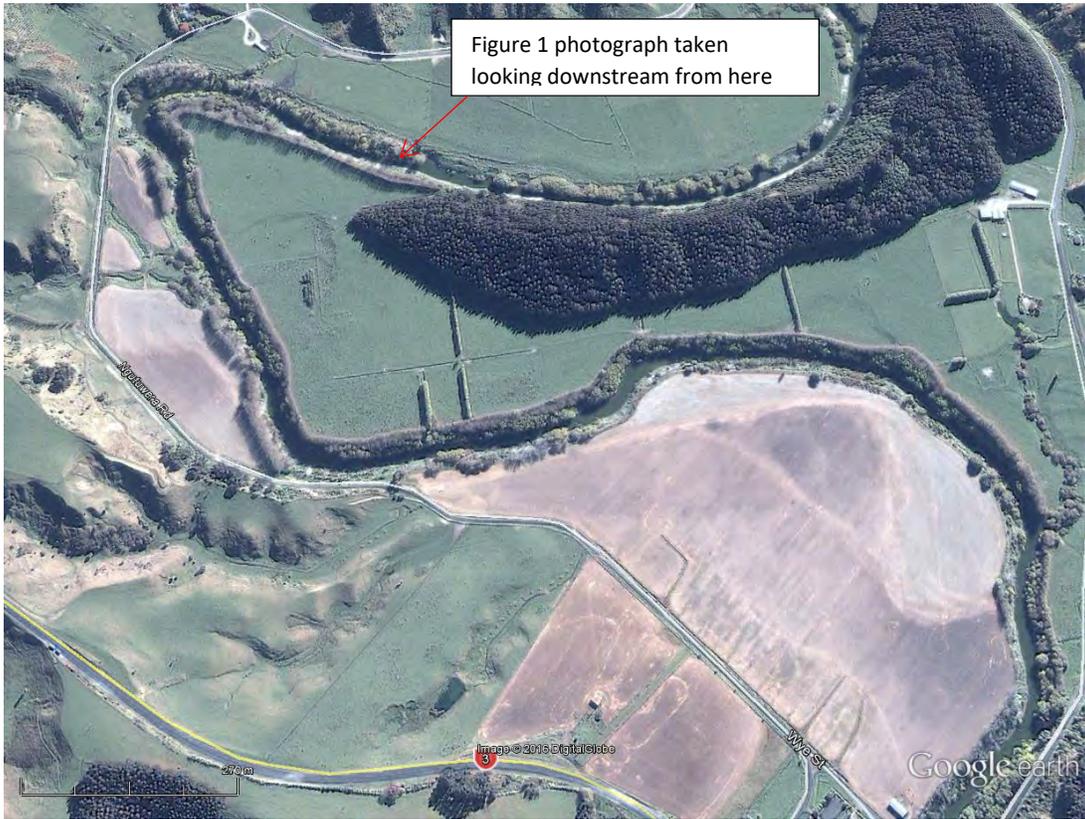
Figure 3: Upstream of SH3 - 2002 - Prior to willow clearing

Figures 3 to 6 show the river channel in the vicinity and upstream of Waitotara in 2002 and in 2013 being before and after the significant willow clearing works were undertaken on the river.

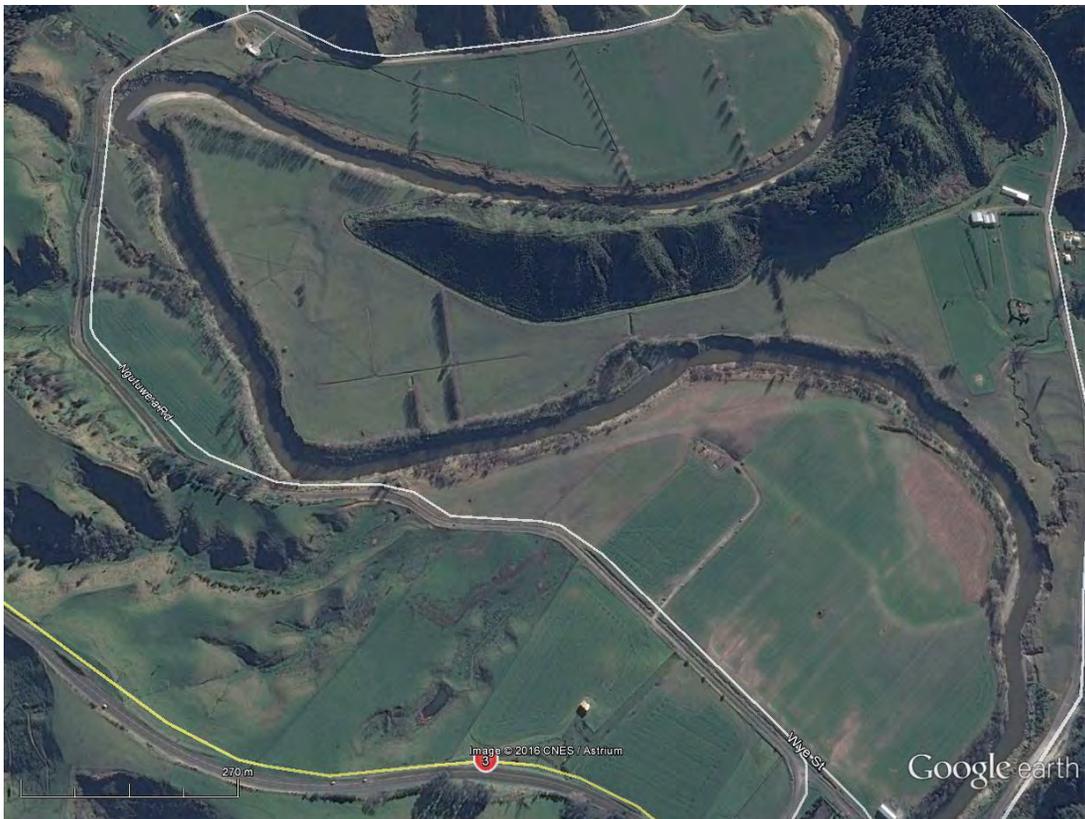
Figure 4: Upstream of SH3 - 2013 - After willow clearing

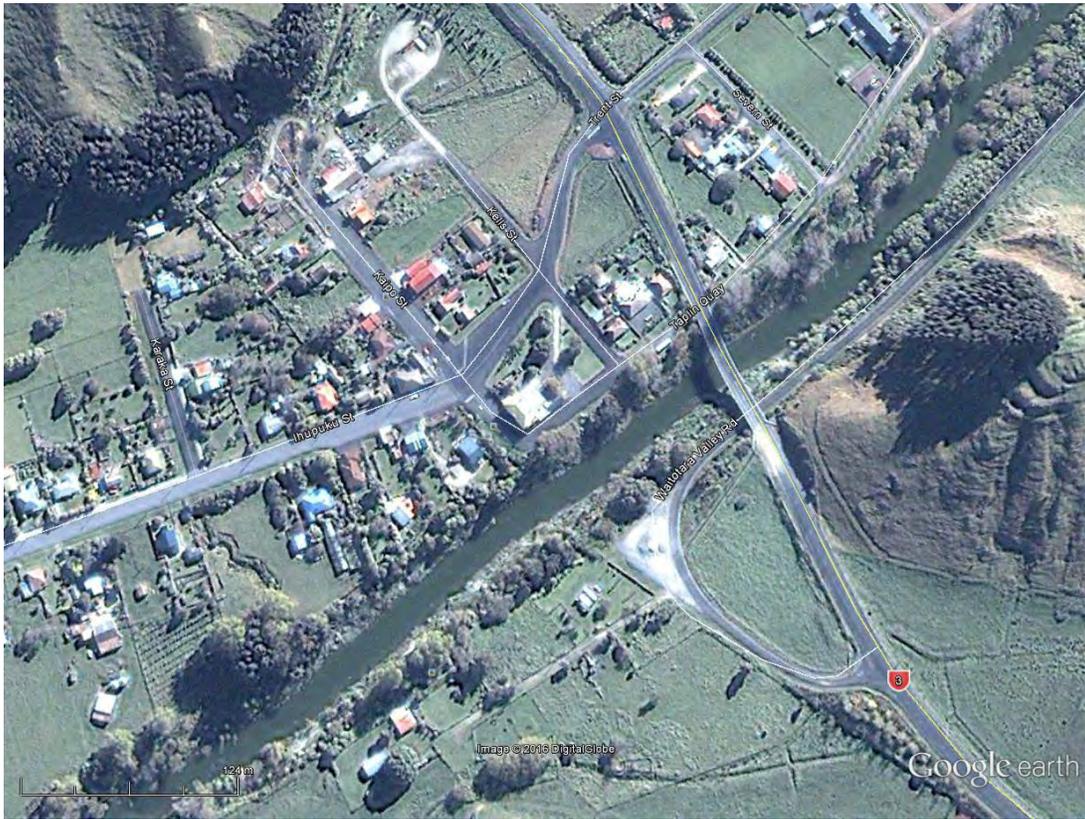
Figure 5: At Waitotara - 2002 - Prior to willow clearing

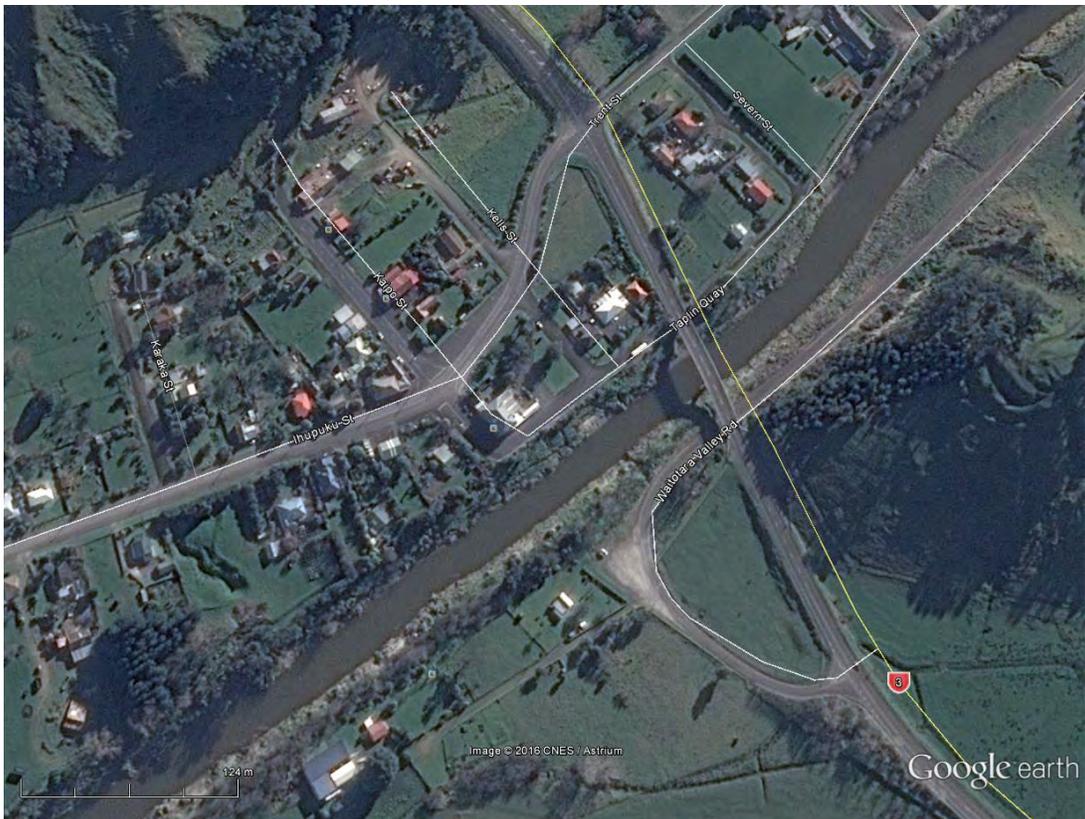
Figure 6: At Waitotara - 2013 -After willow clearing

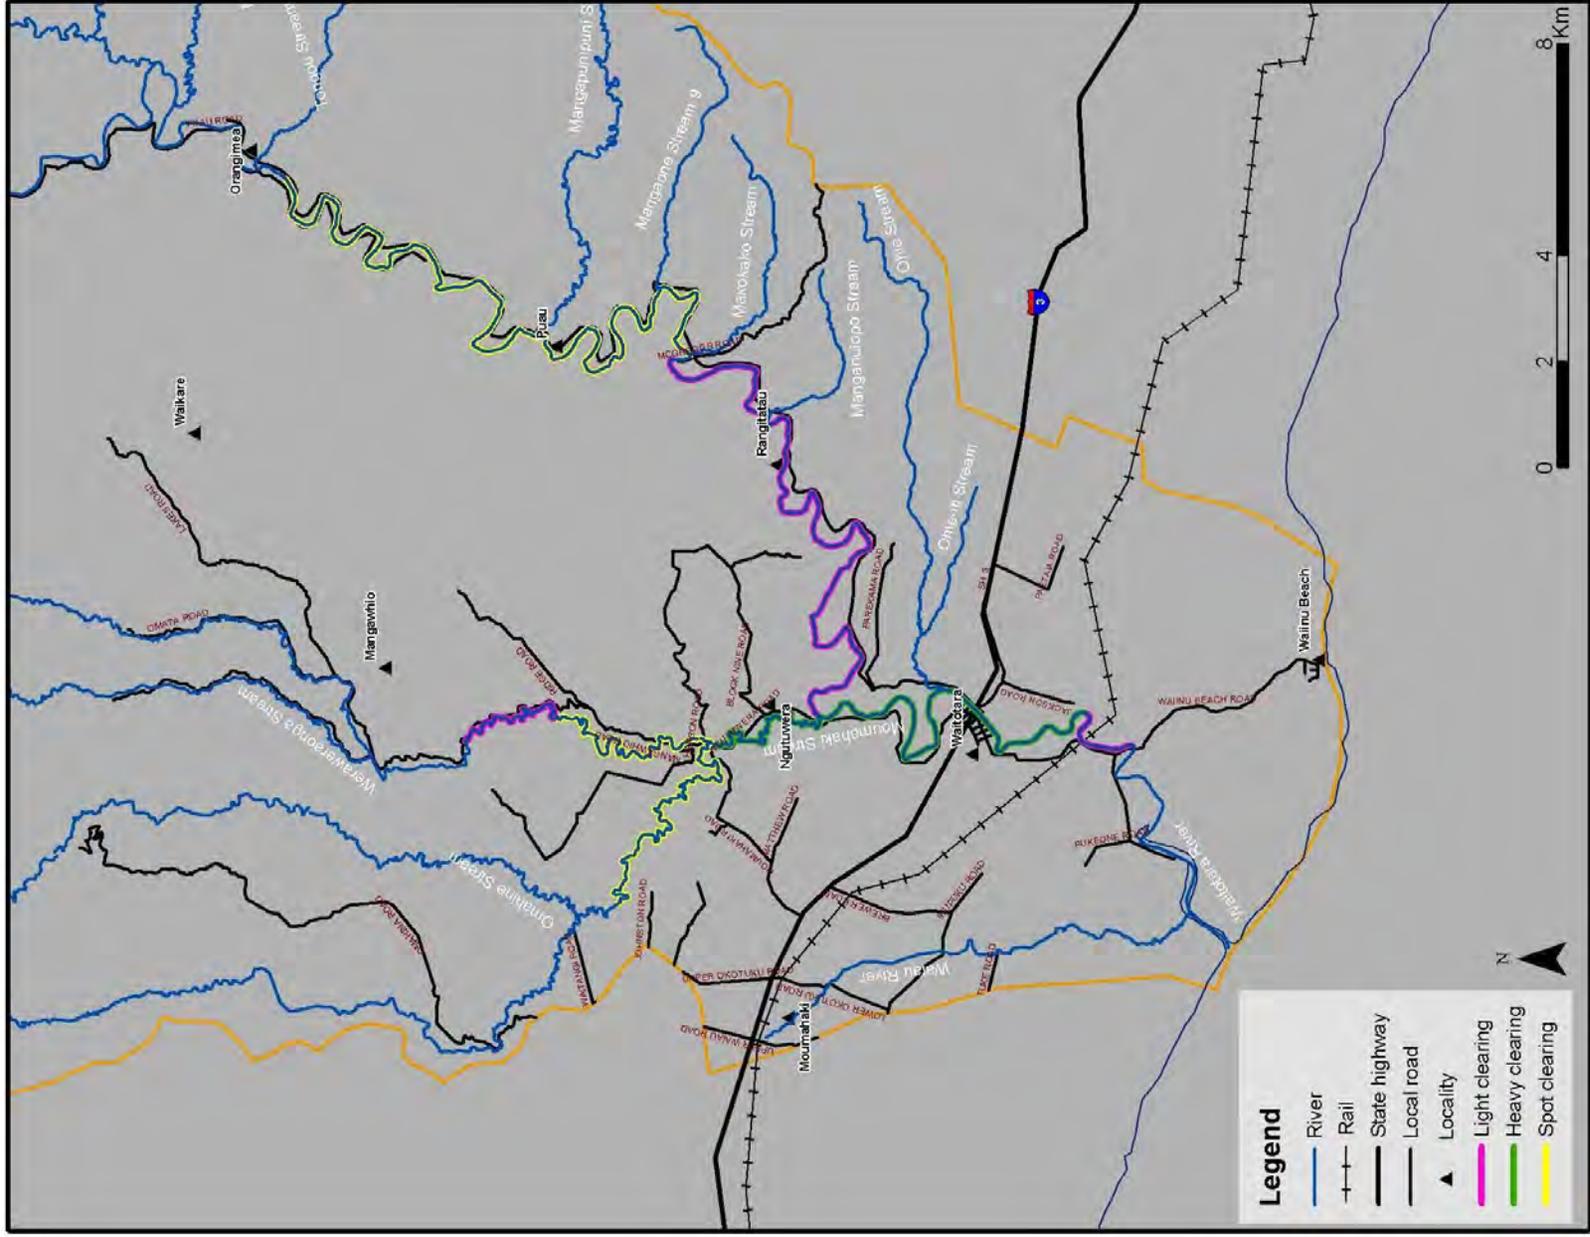
Figure 7 shows the extents of the Schemes Rivers which are included in the works area. Close examination of 2002 and 2016 aerial photographs however show that most of the clearing works on the Waitotara River occurred in the river between the Lime Works Bridge and the Moumahaki confluence and in the Moumahaki River up to Weraweraonga confluence

Figure 7 : Extent of Scheme Works Area

Refer to Figure 7 for the previously cleared reaches of the Waitotara River and the Moumahaki and Weraweraonga Streams.

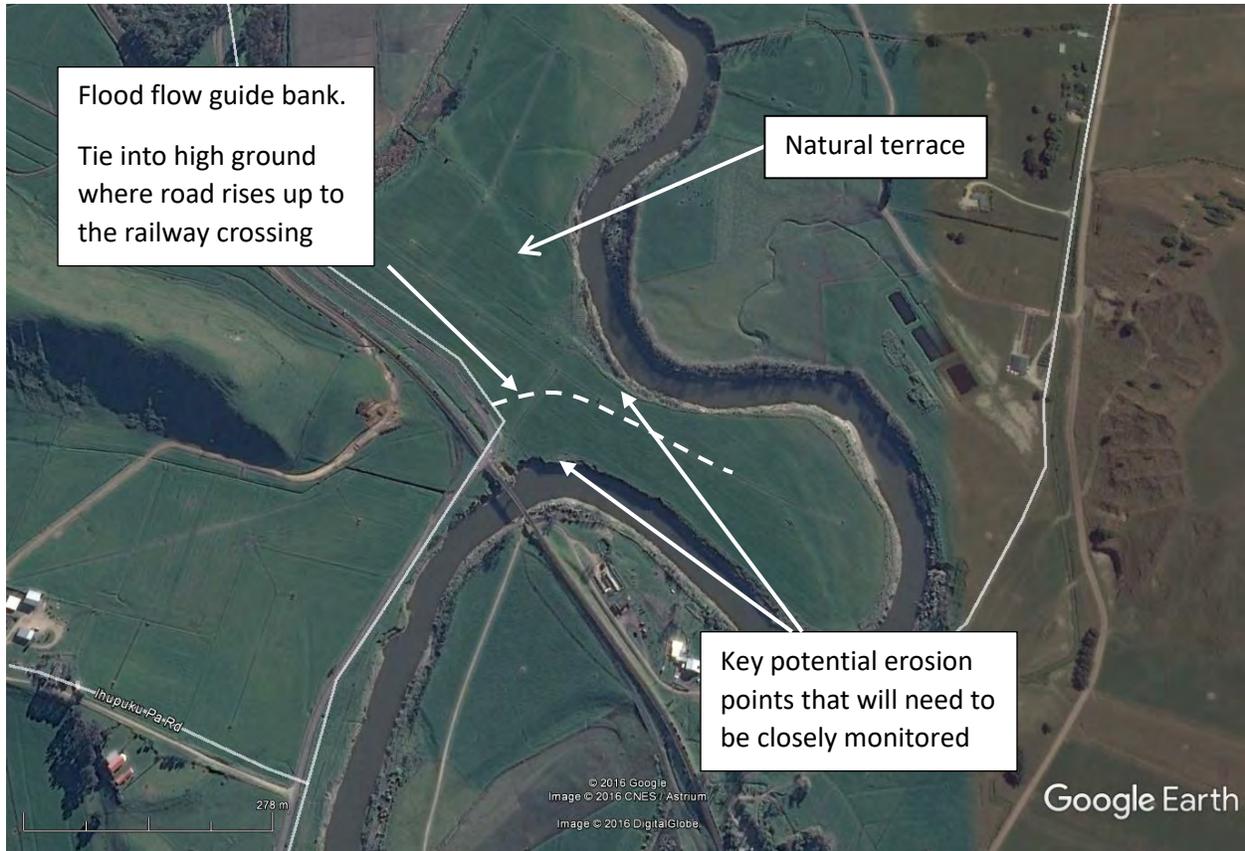
Figure 8

In the longer term, the 1.2km reach of the river directly upstream of the Railway bridge will need to be monitored closely to prevent the river trying to cut off that long bend by eroding the right bank at the upstream end of that bend. Refer to Figure 8. Also in relation to the stability of this bend, the right bank of the river directly upstream of the rail bridge needs to be monitored and protected if required as flood overflows from the upstream bend will cause erosion as they re-enter the river. Erosion at the upstream and the downstream end of this bend could over the long term cause the bend to be cut through.

One option available to manage this bend should erosion at the downstream point become a problem, would be to construct a guide bank along the dashed line or along the natural terrace shown in Figure 7 to prevent flood waters from taking the short steeper path, and forcing the flood flows to pass around the longer bend.
