**Osflo Fertiliser Ltd**  
Monitoring Programme  
Annual Report  
2020-2021

Technical Report 2021-22

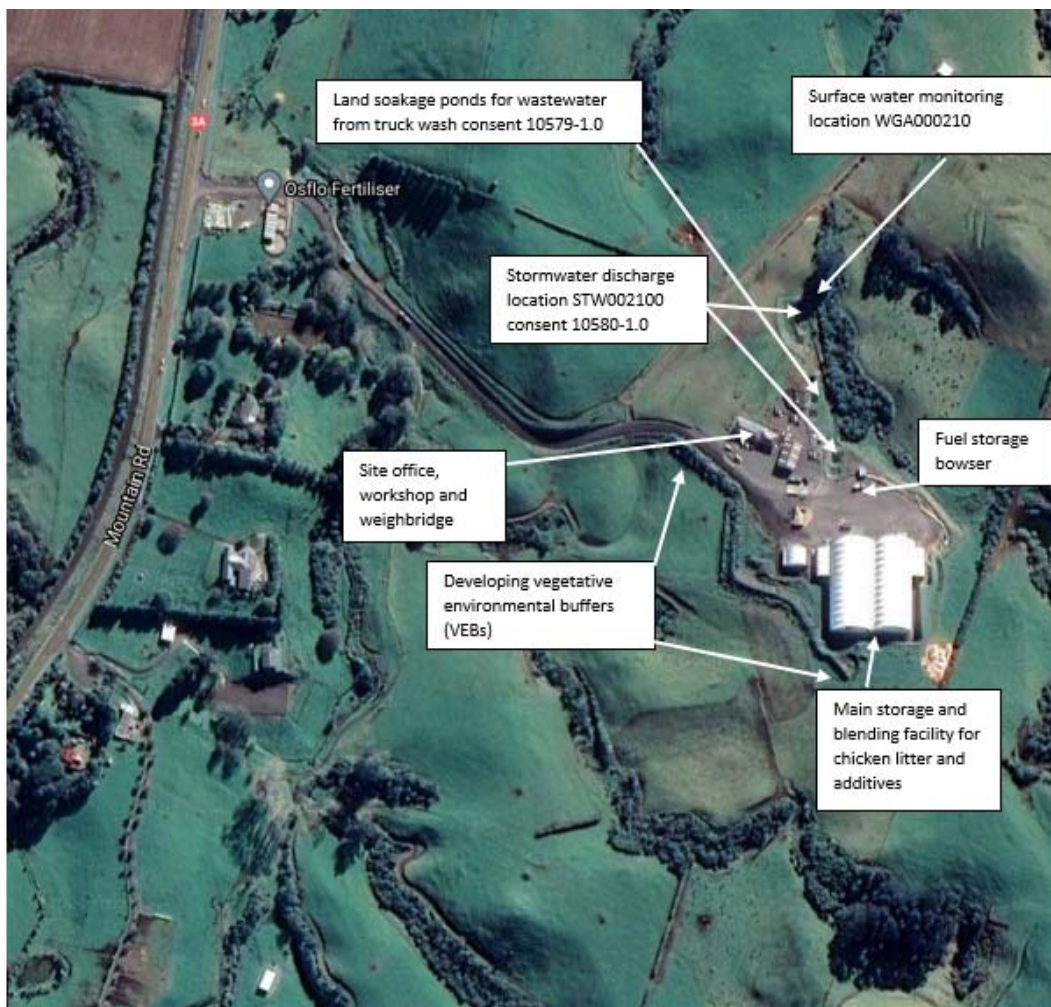
Figure 1 Company site layout 1319 Mountain Road

The Company operates a poultry litter storage, blending and distribution facility located at 1319 Mountain Road, Inglewood. The poultry litter is used as a general agricultural fertiliser. The site is a purpose built facility, operating on a three hectare site, however the overall site area is much larger at 46 hectares. It is situated in close proximity to an unnamed tributary of the Waiongana Stream on the eastern side of Mountain Road. The site is surrounded by grazing farm land, with the nearest neighbour located some 400 meters to the west of the facility. The predominant wind direction is from the south east and the lesser from the south west.

The poultry litter is collected from farms around the Taranaki region, and sold as a registered fertiliser which is spread on pasture. The site is the administration center for collection and distribution of the used litter, with the majority of the product being taken directly from the poultry farm and provided to the general farming customer. A total of 17 people are employed in the operation, utilising seven trucks.

- The five samples of the receiving waters (WGA000210) were compliant with condition 4 of consent 10580-1.0.
- A sample of the stormwater discharge (STW002100) was not collected due to the fact the Company was not discharging during inspection times.
- The only contaminated discharge occurs to land, by land soakage, via a multi soakage pond system (Figure 1).

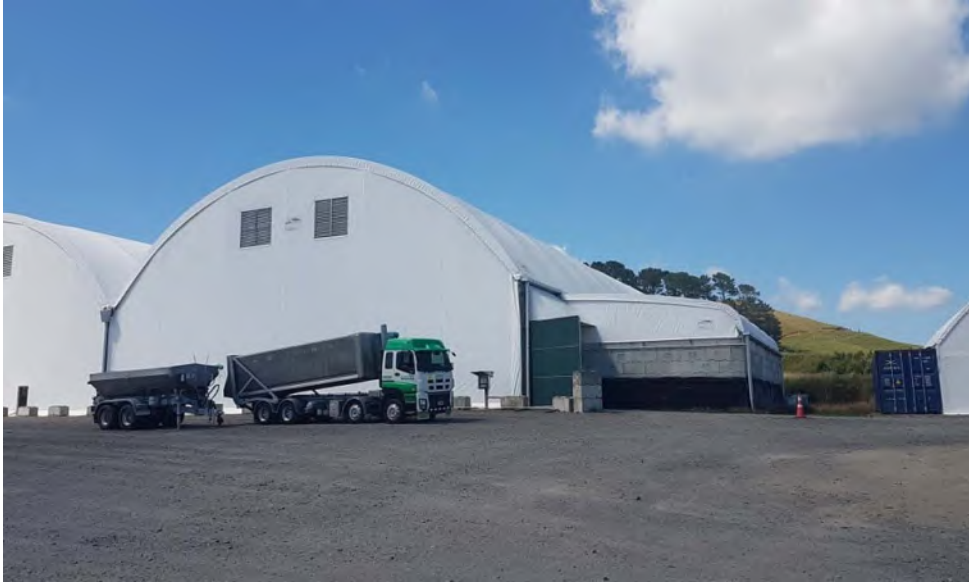
Photo 1 Osflo facility main storage facility

The main storage facility appeared to be about half full with drying chicken litter and a smaller portion of bio-char<sup>2</sup> on the eastern edge. It was noted that the additive bio-char was being used in a Company trial. The odour in this area was noted as constantly noticeable. The material was well stored and limited tracking of material was evident through the storage facility, which would indicate that the wash down bay was working as proposed. On exiting the storage barn the odour intensity quickly relented to barely noticeable.

storage facility was described as objectionable and ammonia was noted. The facility was about three quarters full.

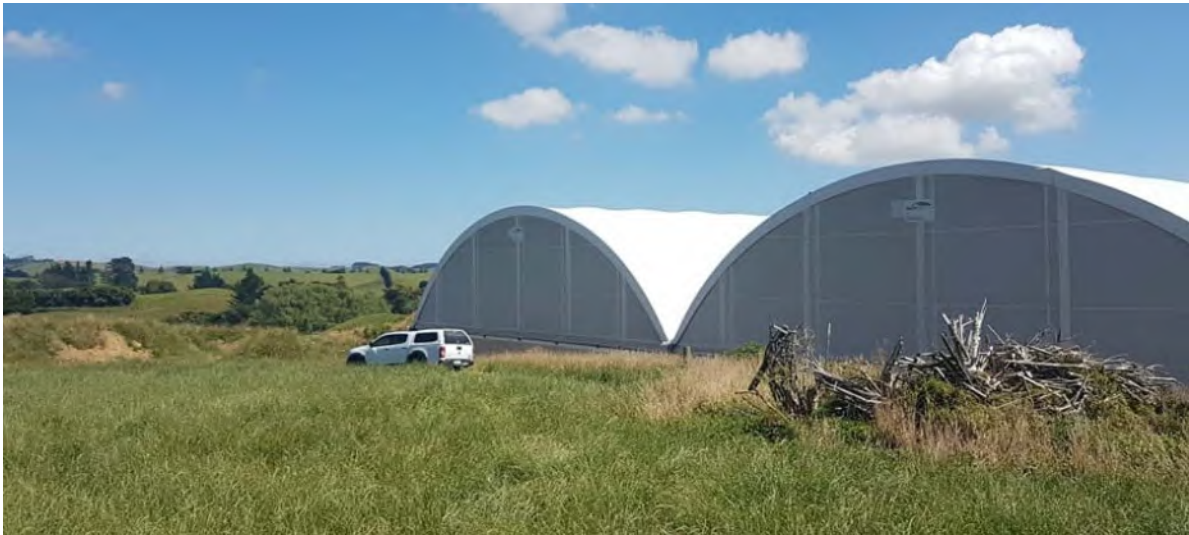
Photo 2 Rear of the Osflo main storage facility

The rear of the main storage facility was then observed. The main storage facility remained shut in, with minimal odour noted on the up wind side. The earlier established Japanese cedars were beginning to take shape in this area, as part of the vegetative environmental buffers

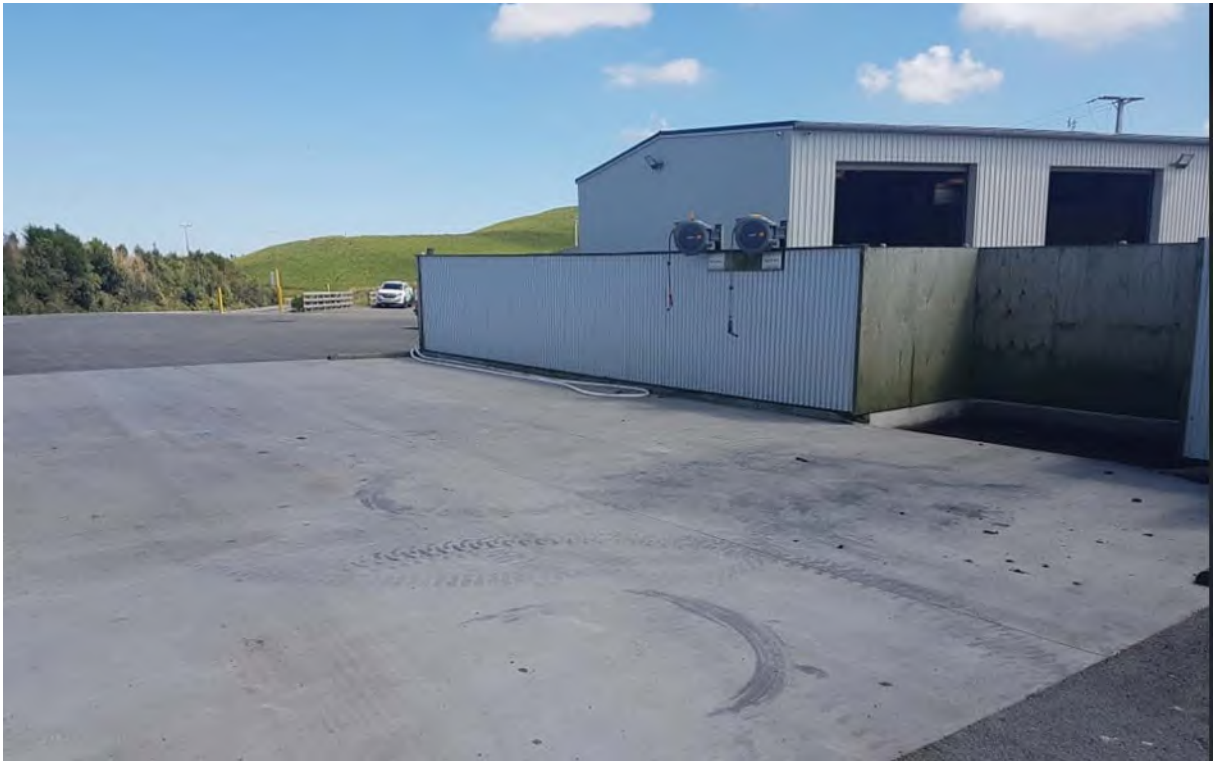
Photo 3 Truck wash area

Wastewater from the facility is strictly limited to the truck wash down area (Photo 3). This is a purpose built wash down bay, which is partially enclosed to prevent spray drift. The wastewater from the bay is treated in a series of soakage ponds which discharge to land.

The car park had been recently extended. The associated truck wash down area was assessed and found to be in good order. The first stage land soakage pond looked reasonably full, with a noticeable localised odour in this area. No seepage was observed.

This system appeared to be functioning as planned, in accordance with the submitted application. The partially enclosed truck wash reduces the potential for spray drift and the associated concentrate pad area was observed to clean during inspections, which demonstrates regular housekeeping.

The associated land soakage ponds are regularly cleaned out, with one pond noted to be cleaned out during inspections. There were no visible signs of the ponds overflowing and these are observed constantly by site staff.

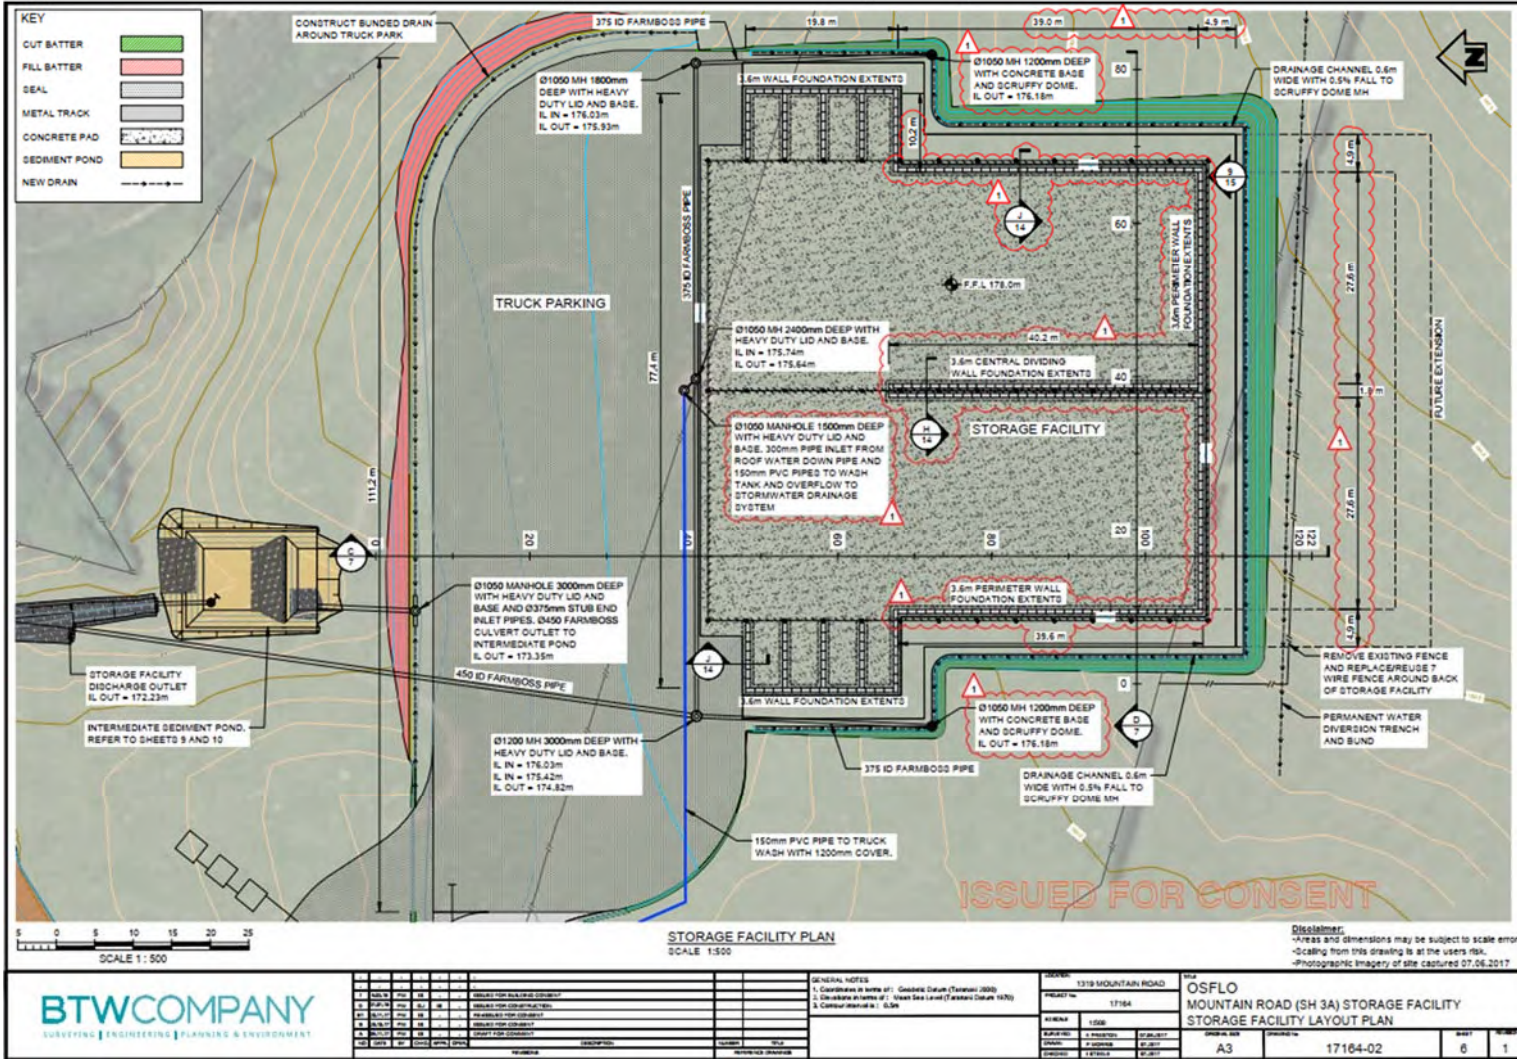
Appendix 2: Area of stormwater, including roof water and truck parking.

Clean stormwater from the roof of the storage facility and the associated workshop and office area is collected in onsite storage tanks and reused on site when required. Once these have been filled, the system discharges the remaining stormwater to land, via a cut stormwater channel. In extreme weather events stormwater may discharge at location STW002100 (Figure 1) into an unnamed tributary of the Waiongana Stream. This discharge point, after a set mixing zone, is where the main surface water monitoring location (WGA000210) site is located.
