South Taranaki District Council
Kaponga, Manaia, Patea, and Waverley WWTPs
Monitoring Programme
Annual Report
2017-2018

Technical Report 2018-99

Taranaki Regional Council
Private Bag 713
STRATFORD
March 2019

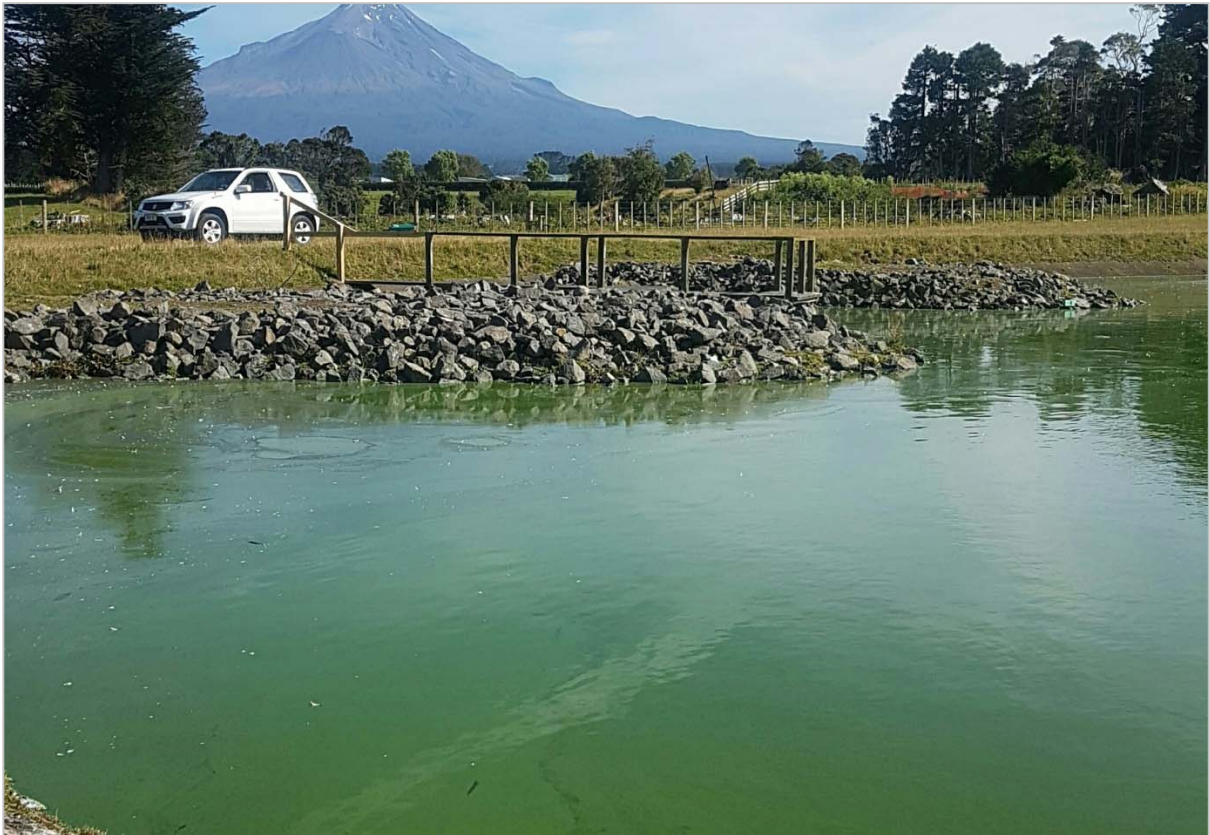
Photo 1 Kaponga WWTP

The Kaponga WWTP is a single oxidation pond system (constructed in 1971) that has been separated into two sections by a wooden dividing barrier. The pond is gravity-fed mainly domestic wastes from a population of about 370 people although it was designed for a population of 650. A sludge survey performed by consultants for the consent holder (MWH, 2005) found that there had been a slow rate of sludge accumulation and at such a rate, it was estimated that the system would not require desludging for another 17 years. Sludge surveys will be repeated at five-yearly intervals (STDC, 2015). Issues of stormwater infiltration, improved mixing within the ponds' system, and reduction of the microfloral component of the treated wastewater discharge, were identified in consideration of upgrading the treatment system during the consent renewal process in the 2007-2008 period (CH2M Beca Ltd, 2006). Upgrades to the system were completed by late May 2008. Infiltration remedial work has a lesser priority for the Kaponga system than elsewhere in South Taranaki although house inspections and smoke testing to identify faulty/illegal connections are planned for the 2018-2019 period (STDC, 2018).

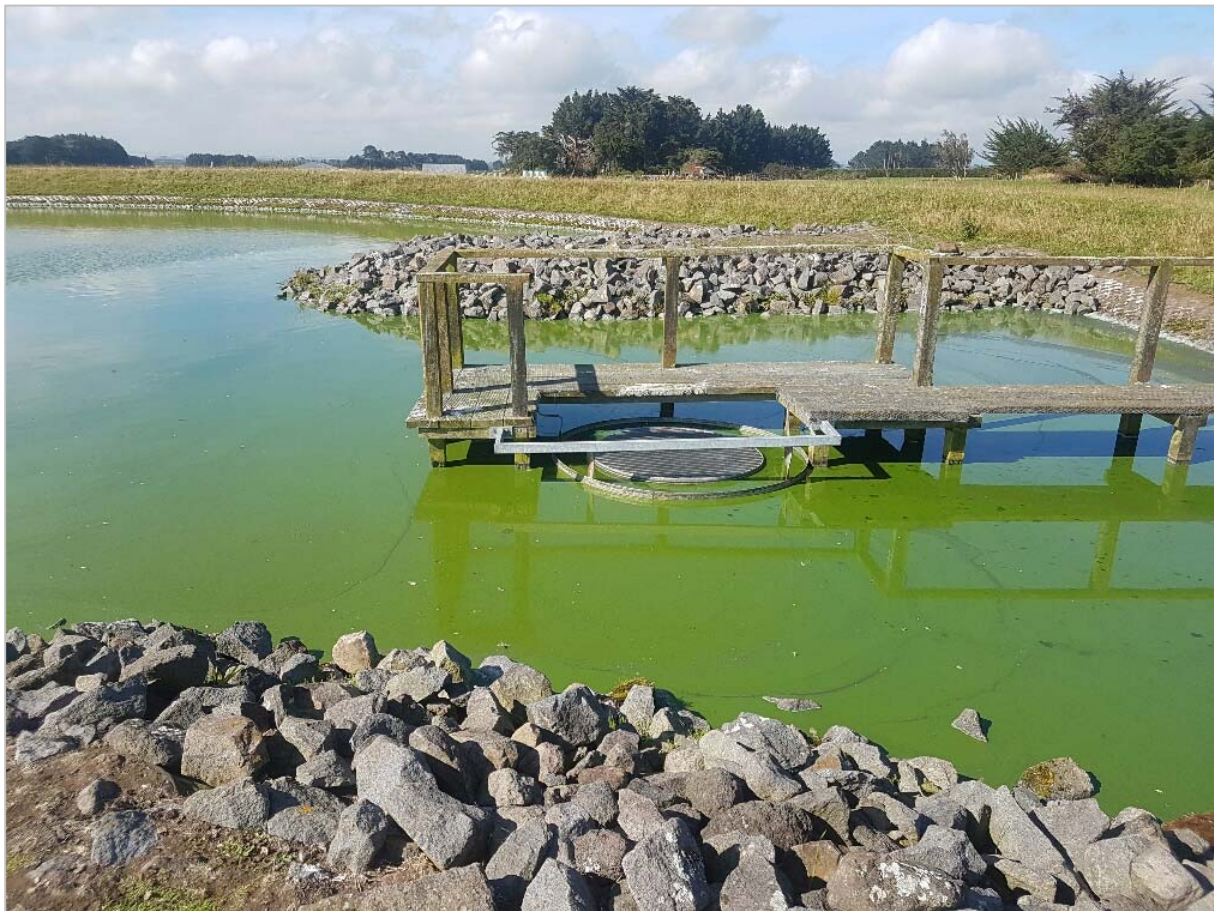
Despite the wide range of concentrations of chlorophyll-a in the primary pond, most samples showed low concentrations including a new minimum for this pond since records began, observed on 12 June 2018. The lowest algal concentration occurred while dissolved oxygen concentrations were also low (5.4 mg/L), and indicates high stormwater loadings on the pond. The highest levels, recorded during the summer survey, indicated a significant phytoplankton component in the pond.

Photo 2 Algal bloom on the surface of the pond caused by high microfloral levels.

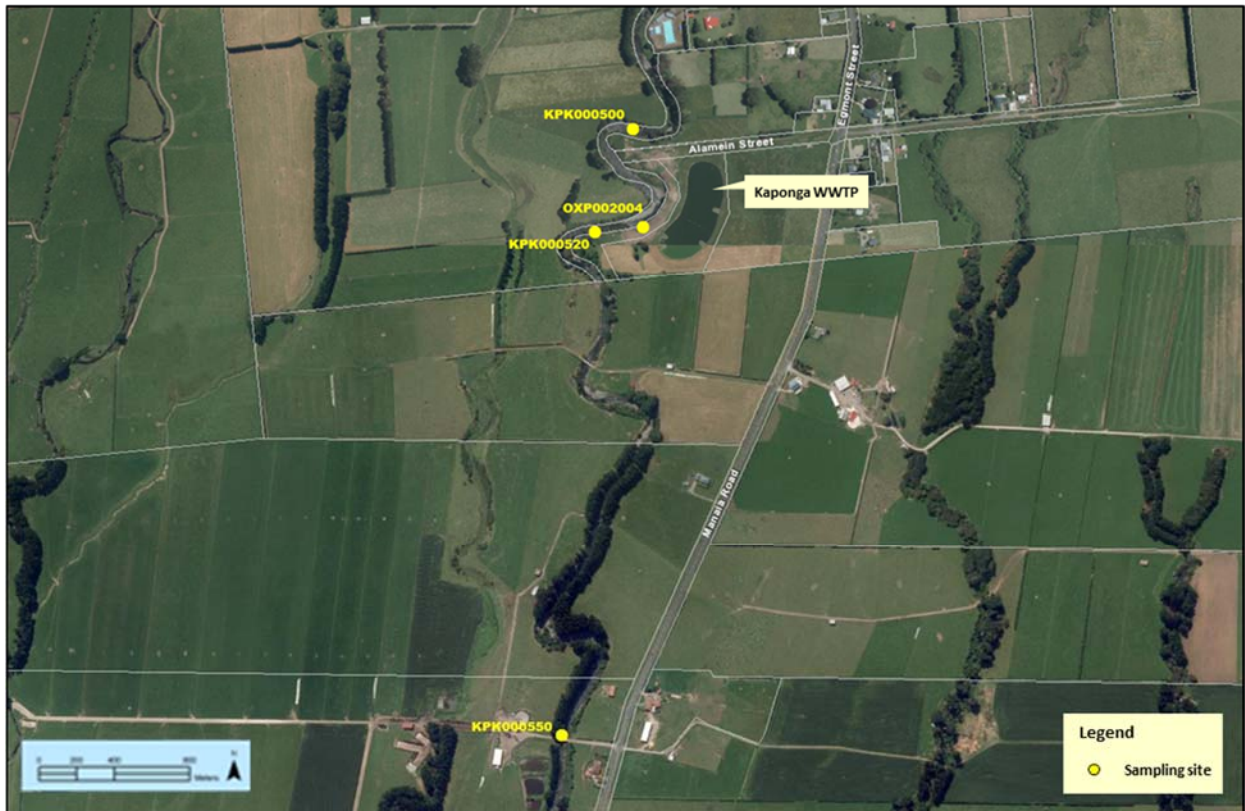
Figure 1 Aerial location map of sampling sites in relation to Kaponga WWTP

summer 2018 (Section 2.1.3.2). The locations of sampling sites are listed in Table 4 and displayed in Figure 1 below.

No.	Location	Description	GPS Reference	Site Code
U	Kaupokonui River	Approximately 250 m upstream of the WWTP discharge	1698609 E 5634423 N	KPK000500
OP	Effluent	Adjacent to outlet of second section of the oxidation pond	1698629 E 5634266 N	OXF002004
D1	Kaupokonui River	50 m downstream of the WWTP discharge	1698548 E 5634263 N	KPK000520
D2	Kaupokonui River	Approximately 1 km downstream of the WWTP discharge	1698497 E 5633456 N	KPK000550

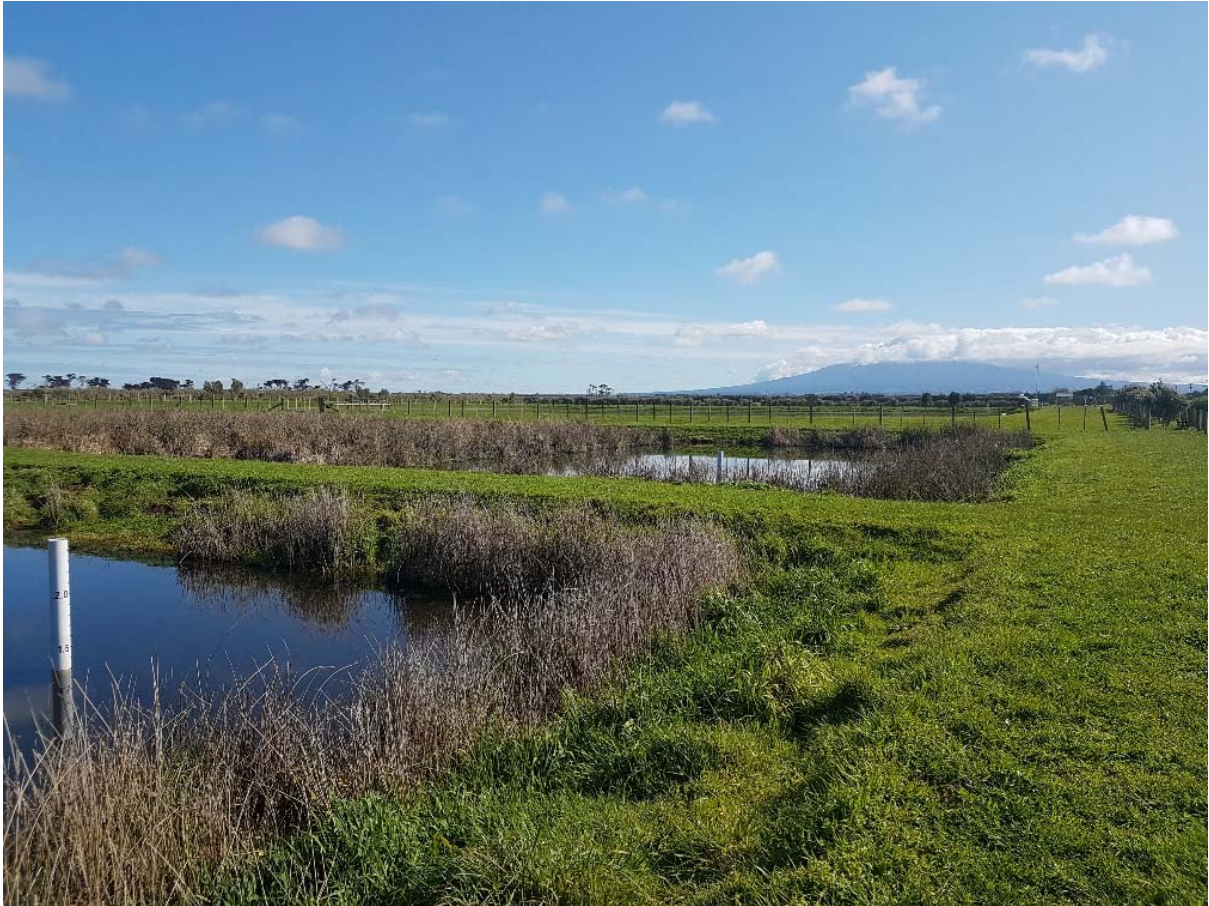
Photo 3 Manaia WWTP showing view of wetlands

The Manaia WWTP is a single treatment oxidation pond (constructed in 1984), followed by twin wetlands (in parallel) receiving mainly domestic sewage together with trade wastes from the bakery industry. These trade wastes are currently un-regulated but with the proposed introduction of a planned trade waste by-law, restrictions and standards are intended to be imposed by the consent holder (STDC, 2013).

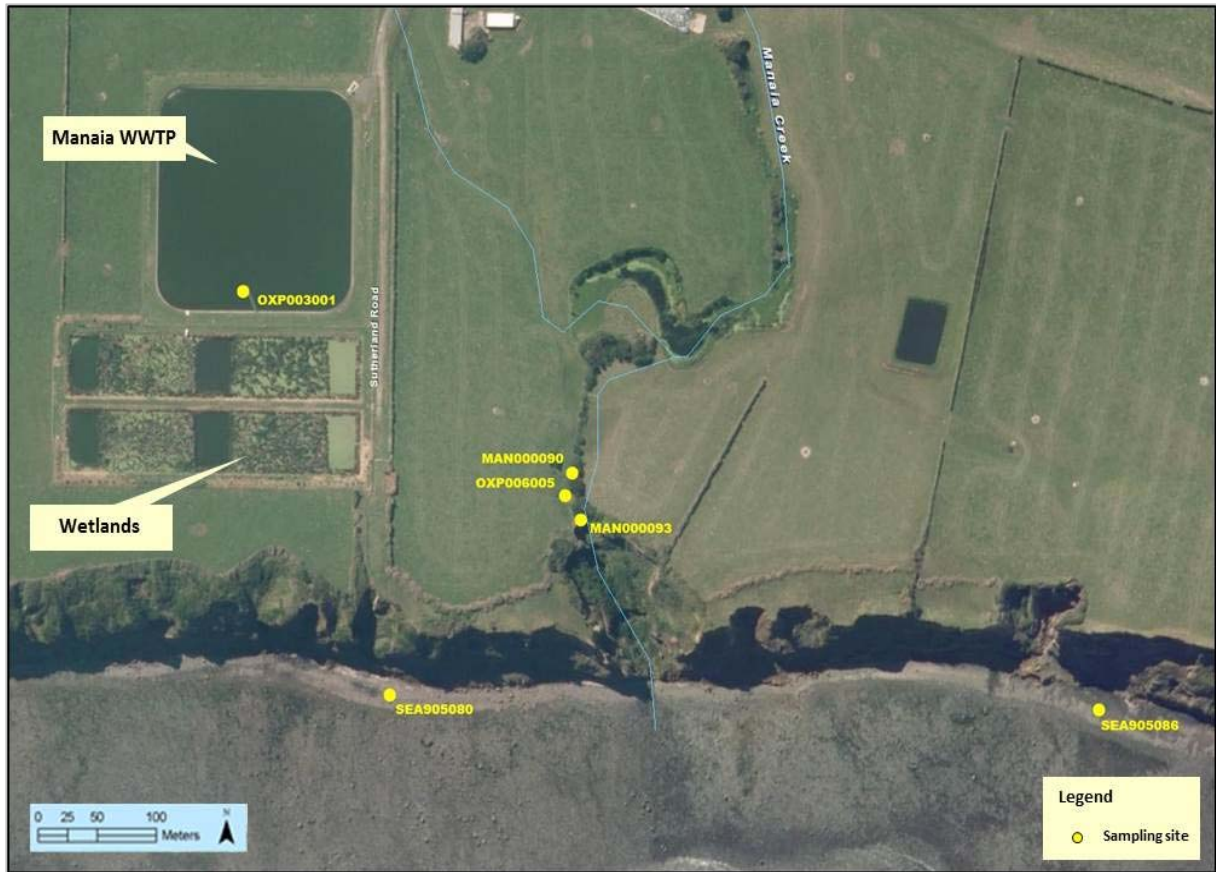
Figure 2 Aerial location map of sampling sites in relation to Manaia WWTP

No	Site	Location	GPS Reference	Site code
U	Manaia Creek	5 m upstream of the WWTP discharge	1696373 E 5618563 N	MNA000090
OP	Effluent	WWTP oxidation pond effluent at outfall	1696197 E 5618609 N	EXP003001
WET	Outlet	WWTP wetland at outfall	1696368 E 5618551 N	EXP006005
D1	Manaia Creek	10 m downstream of the WWTP discharge	1696369 E 5618539 N	MNA000093
SE	Tasman Sea	200 m east of mouth of Manaia Creek	1696641 E 5618404 N	SEA905086
SW	Tasman Sea	200 m west of mouth of Manaia Creek	1696255 E 5618419 N	SEA905080

Monitoring of the impacts of the Manaia WWTP on receiving waters is measured using chemical analyses of the Manaia Creek upstream and downstream of the final wetlands discharge, and beyond the boundary of the mixing zone with the receiving waters of the Tasman Sea. An annual biological inspection is also carried out on the intertidal zone at the boundary of the mixing zone. Chemical sampling was attempted on three occasions during the 2017-2018 period (Section 2.1.3.1), and successfully carried out during two of these. One biomonitoring inspection was conducted during winter 2018 (Section 2.1.3.2). The locations of sampling sites are listed in the previous section, in Table 9 and Figure 2.

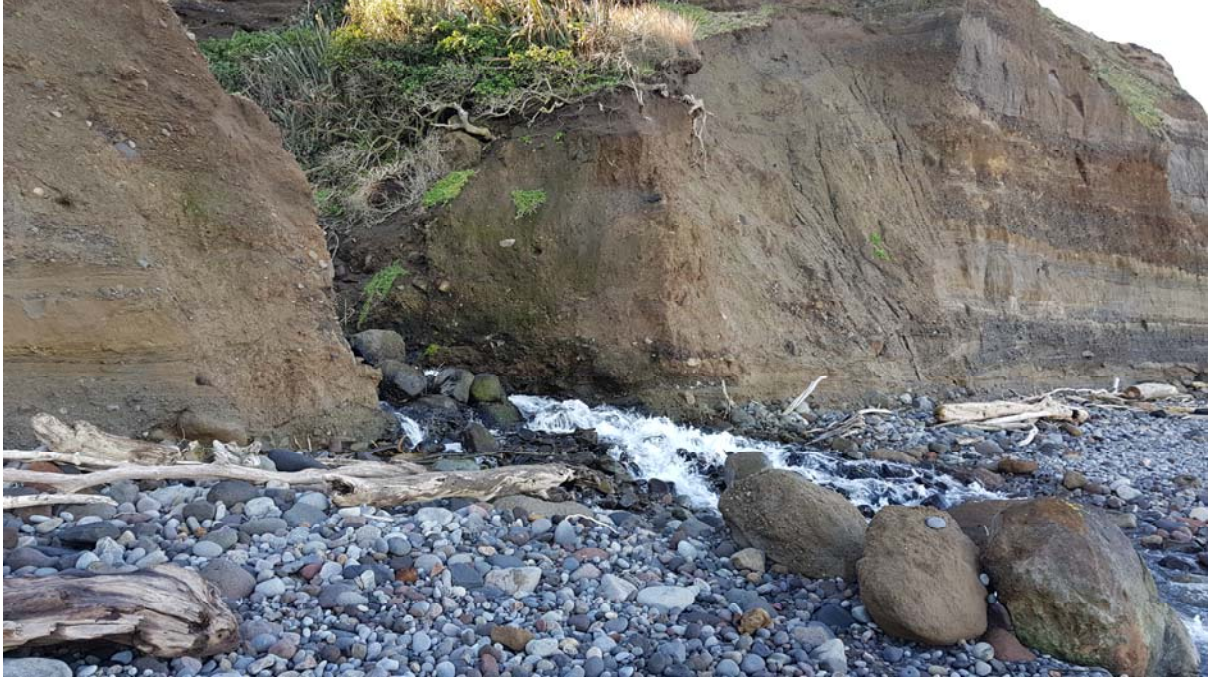
Photo 4 Manaia Creek flowing over the intertidal reef at Manaia

A marine ecological inspection of the foreshore, in the vicinity of the discharge from the Manaia oxidation pond system (Photo 4), was carried out on 27 June 2018 at 1430 (NZST). Low tide on this day was at 1521 (NZST), at a height of 0.6 m above chart datum. At the time of the inspection, there was a north easterly breeze, and weather conditions were overcast. Inshore waters were very turbid during the inspection.

The stream appeared to have a significant effect on nearby intertidal organisms, most likely as a result of freshwater influence. *Ulva* spp. were evident along the length of the stream, although the cover was notably less dense than observed during previous surveys, and was not abundant beyond the 50 m mixing zone extending either side of the stream. Prolific growth of *Ulva* spp. is typical of nutrient enrichment. The diversity and abundance of intertidal communities, both within the influence of and away from the stream, was typical of that found at other reef sites around Taranaki (Photo 5). Species diversity appeared to have improved considerably at the Manaia Reef since the previous reef inspection, although the abundance and health of organisms were limited in the direct influence of the stream.

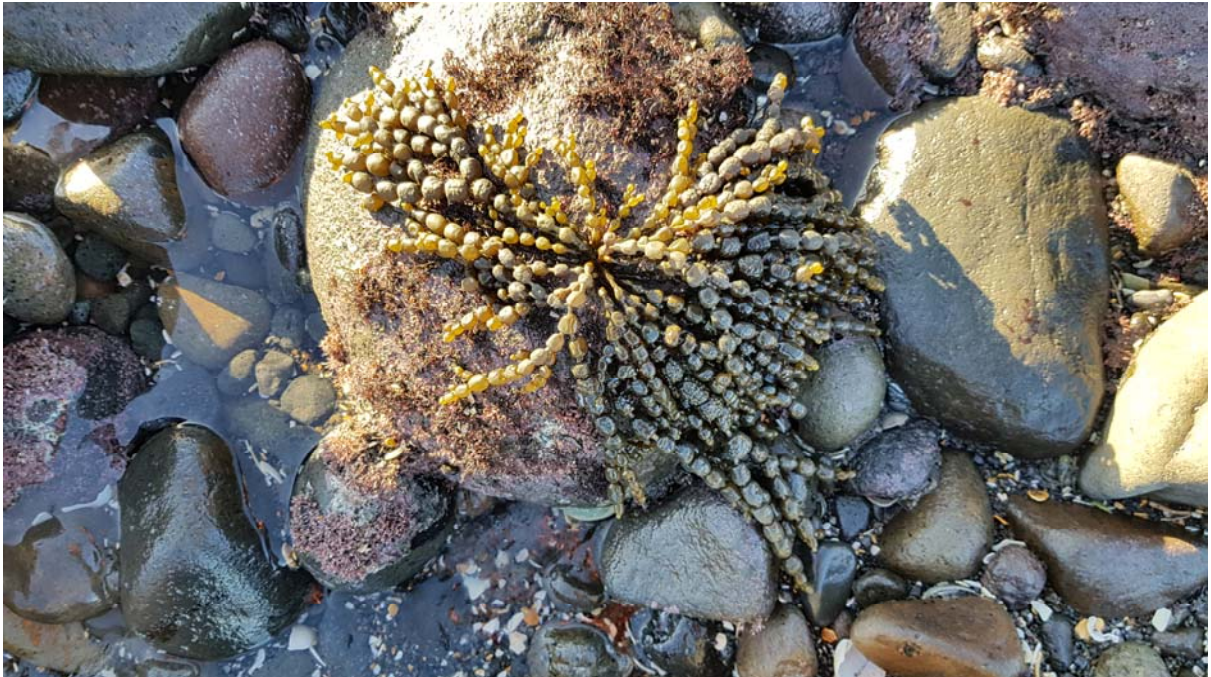
Photo 5 *Hormosira banksi*, in the vicinity of Manaia Creek, in the lower reaches of the shore

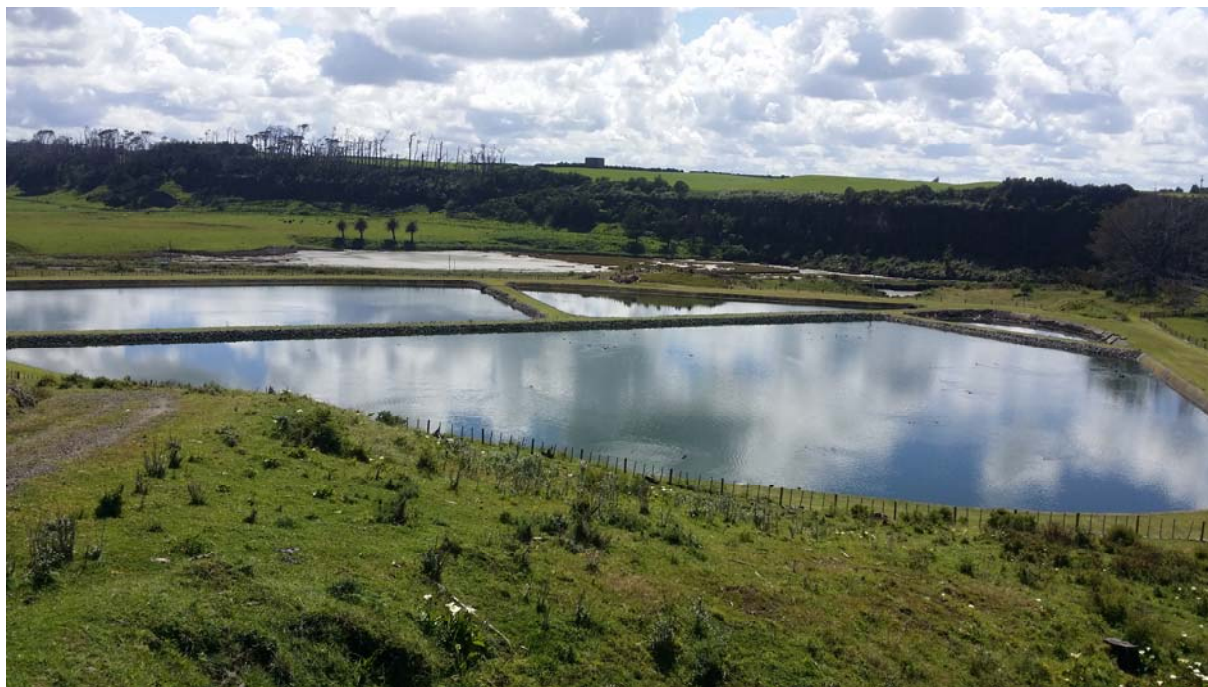
Photo 6 View of Patea WWTP

The Patea WWTP (constructed in 1973 for a population of 2,400) was originally comprised of a single large oxidation pond which was upgraded to a three cell system in 2008 (Photo 6). There are currently no significant industrial wastes being discharged into this system, which services a population of 1,098 (measured in 2013). The nearby York Street pumping station has provision for river overflow via a separate outfall in the event of emergencies.

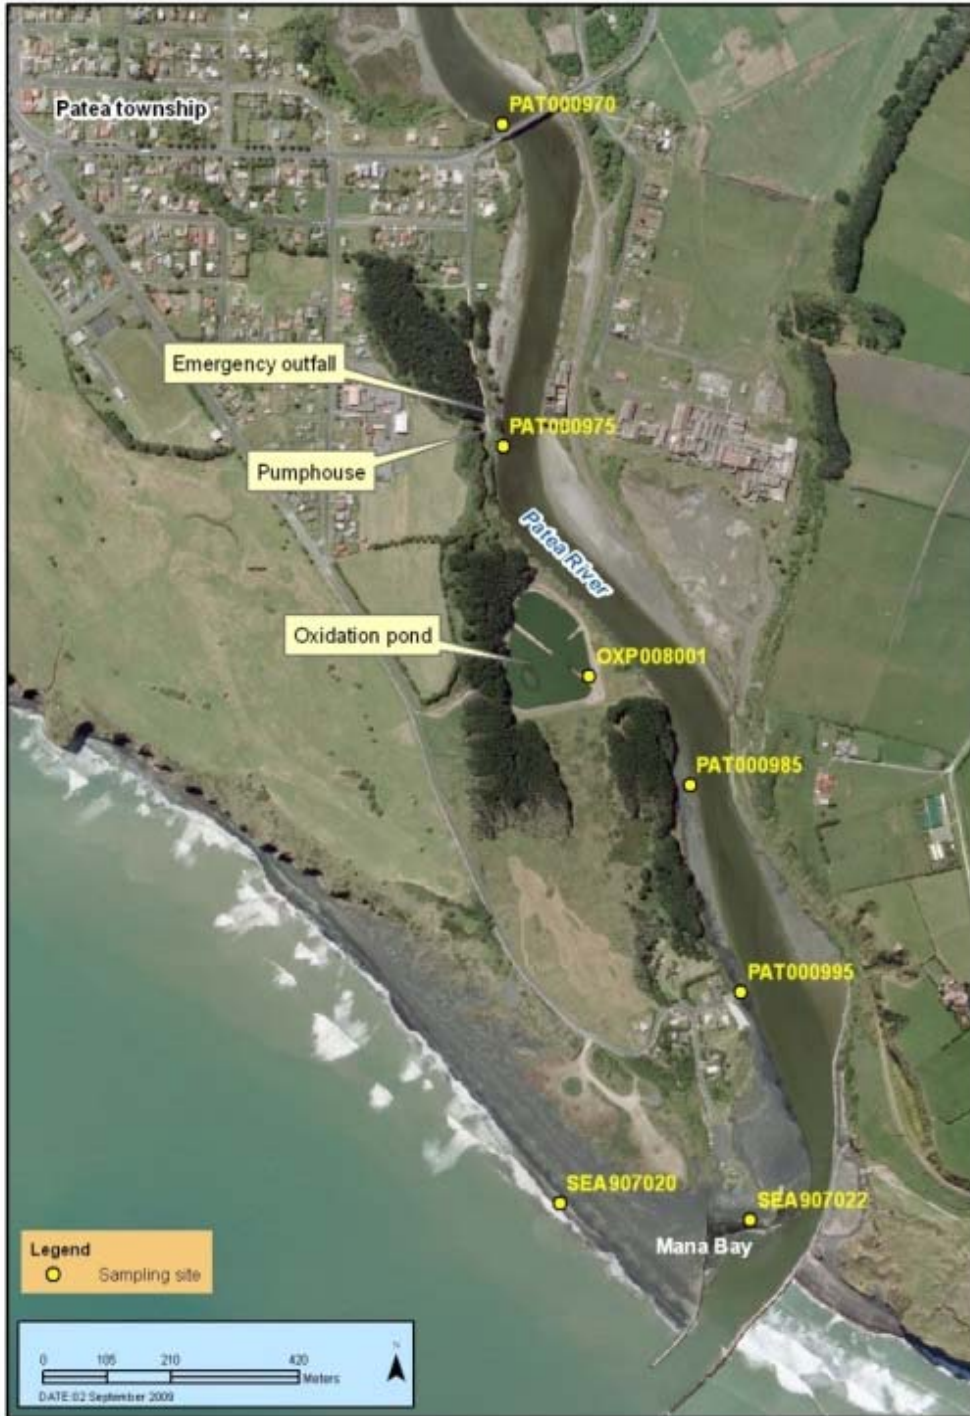
Figure 3 Map showing sampling sites in relation to Patea WWTP

Monitoring of the impacts on receiving waters is measured using both chemical analyses of the Lower Patea River, and contact recreational bacteriological quality surveys of the coastal marine area at the Patea Boat Ramp and the Tasman Sea at Mana Bay (Figure 3). Chemical sampling was carried out on two occasions during the 2017-2018 period (Section 4.4.1). Contact recreational bacteriological water quality monitoring (section 4.4.2) at the Patea Boat Ramp and Mana Bay was carried out by the Council on 22 separate occasions between early November 2017 and early April 2018 (TRC, 2018). The sampling sites are detailed in Table 19.

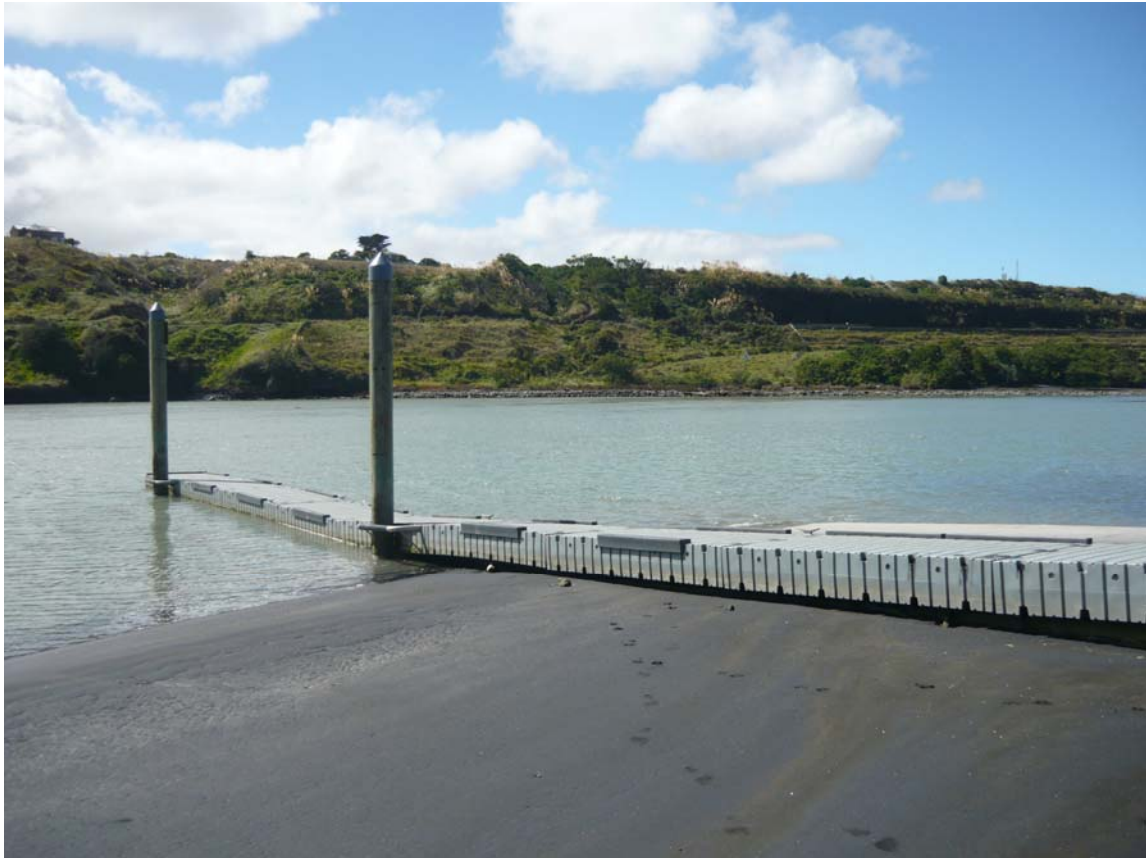
Photo 7 View of Patea boat ramp sampling site

Sampling at the first two sites during the summer monitoring period occurred between early November 2017 and early April 2018. It was concentrated on high tide conditions (15 samples), but also included low tide conditions on seven other occasions. The results are summarised in Tables 21 and 22, and illustrated in Figures 5 and 6.

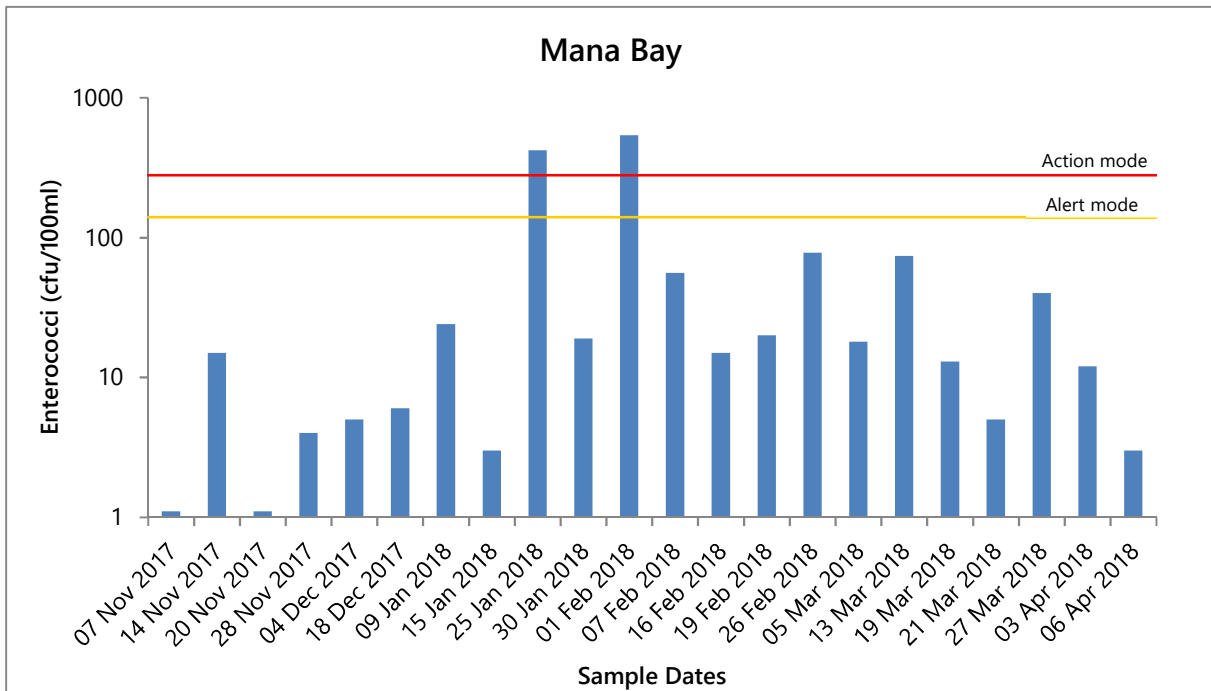
Figure 5 Enterococci numbers for Mana Bay

Water quality at Mana Bay remained relatively high throughout the season, with only two exceedances of the 'Action' level guideline. (Figure 5). The first occurred during a low flow sampling run, and the second during high tide but while the river was approaching its lowest recorded level for the bathing season. All results were within the historical range of values for this site.

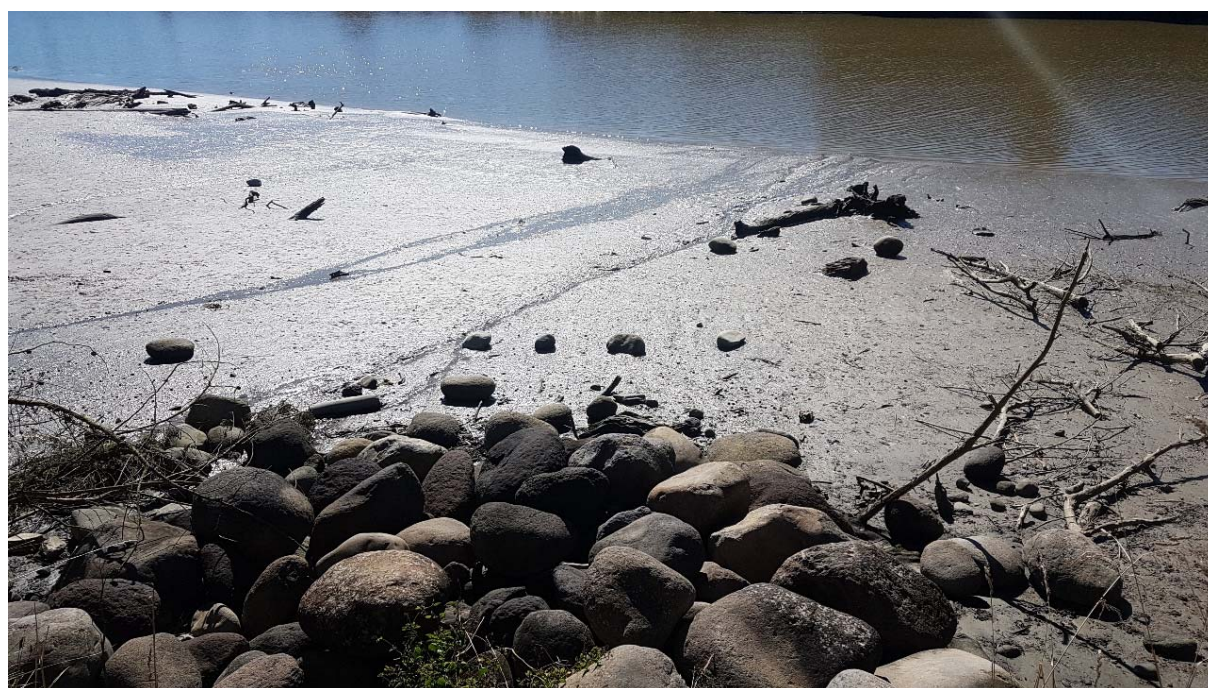
Photo 8 View of the discharge point from the Patea WWTP emergency overflow structure, February 2018

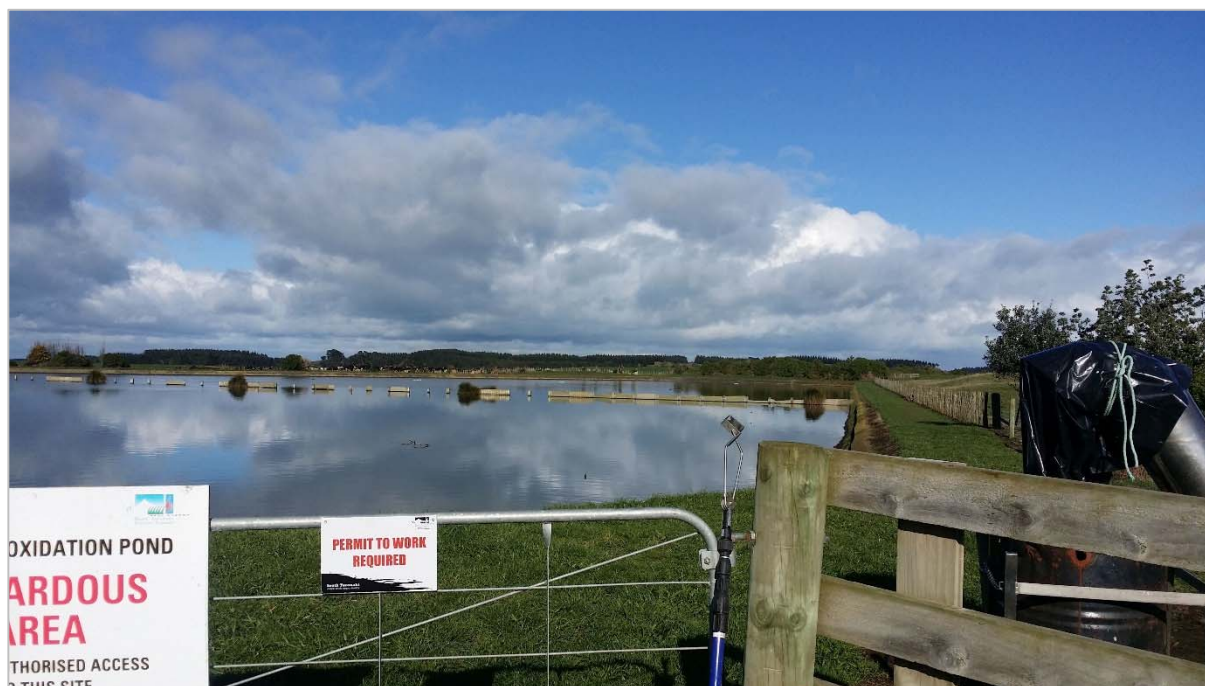
Photo 9 Waverley WWTP

The WWTP system was reconfigured during the 2008-2009 period with the existing outfall abandoned, the secondary pond converted to a primary pond with a new inlet design, repairs made to the dividing wall, and the primary pond converted to a secondary pond with a repositioned outlet connected into the original outfall to the Wairoa Stream (Photo 9). 'Sludge-bugs' were introduced into the system for the purpose of microbial sludge digestion in September 2013 and this was completed by December 2014 with more than 5000 cubic metres of sludge removed (STDC, 2015). Inlet flow monitoring was added in 2010. Mechanical screening of the incoming wastes was installed at the inlet during the latter half of the 2012-2013 period, which has associated telemetry alarming.

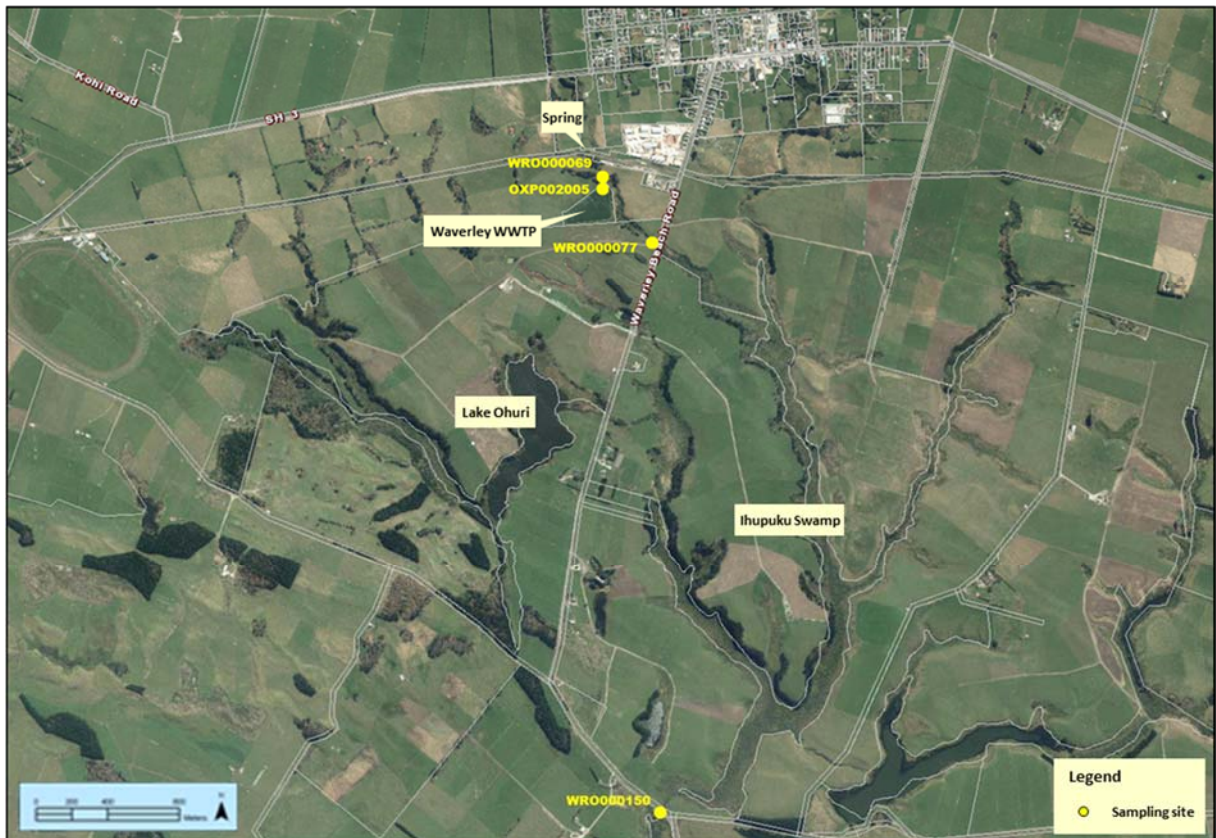
Figure 6 Aerial location map of sampling sites in relation to Waverley WWTP

Monitoring of the impacts of the Waverley WWTP on the receiving waters was measured using chemical analyses of the receiving waters of the unnamed tributary of the Wairoa Stream. Sampling was carried out on one occasion during the summer period, when stream flows were at a seasonal low. The locations of sampling sites are listed in Table 30 and displayed in Figure 6 below.

No.	Site	Location	GPS reference	Site code
2	Unnamed trib. of Wairoa Stream	Upstream of confluence with WWTP discharge	1739148E 5596620N	WRO000069
OP	Effluent	At outfall to stream	1739140E 5596588N	EXP002005
4	Unnamed trib. of Wairoa Stream	Approx. 400 m downstream of WWTP discharge (Waverley Beach Rd)	1739367E 5596322N	WRO000077
5	Wairoa Stream	Outlet of Ihupuku Swap, approx. 3 km d/s of WWTP discharge (Beach Rd)	1739402E 5593780N	WRO000150

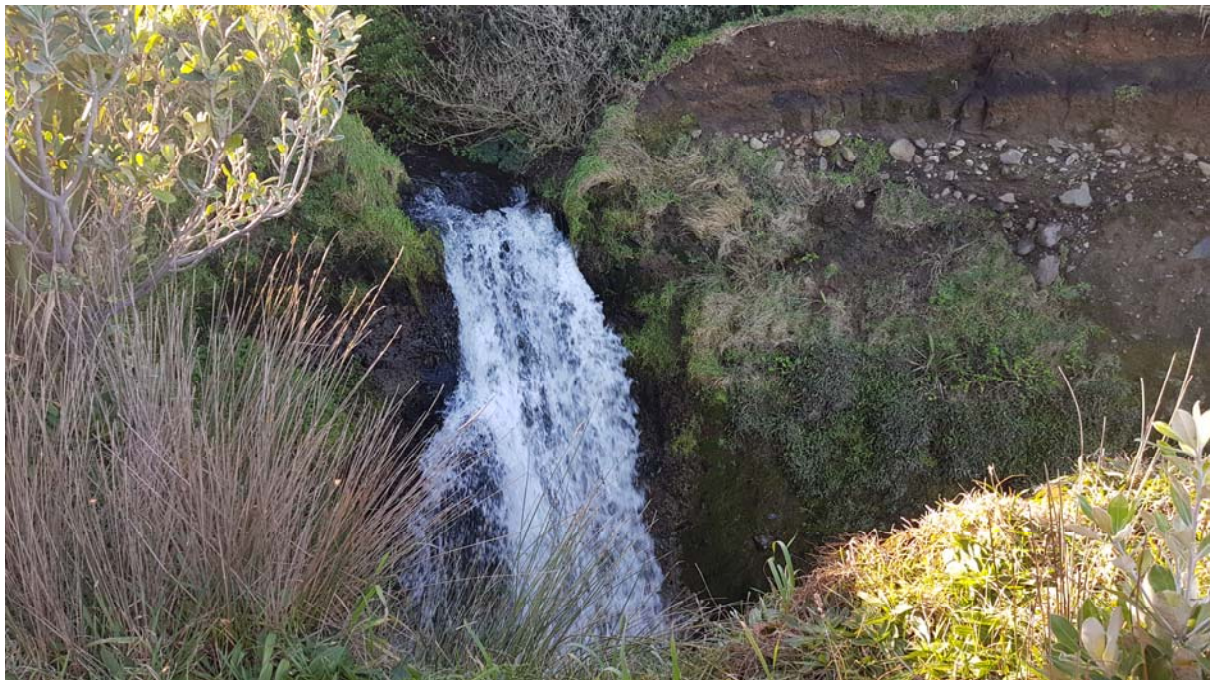
The Manaia Creek (Unnamed Stream 27, Consent 1204-4) was in moderate flow during the inspection (Photo 1).

Photo 1 Waterfall in the Manaia Creek, in moderate flow (27 June 2018)

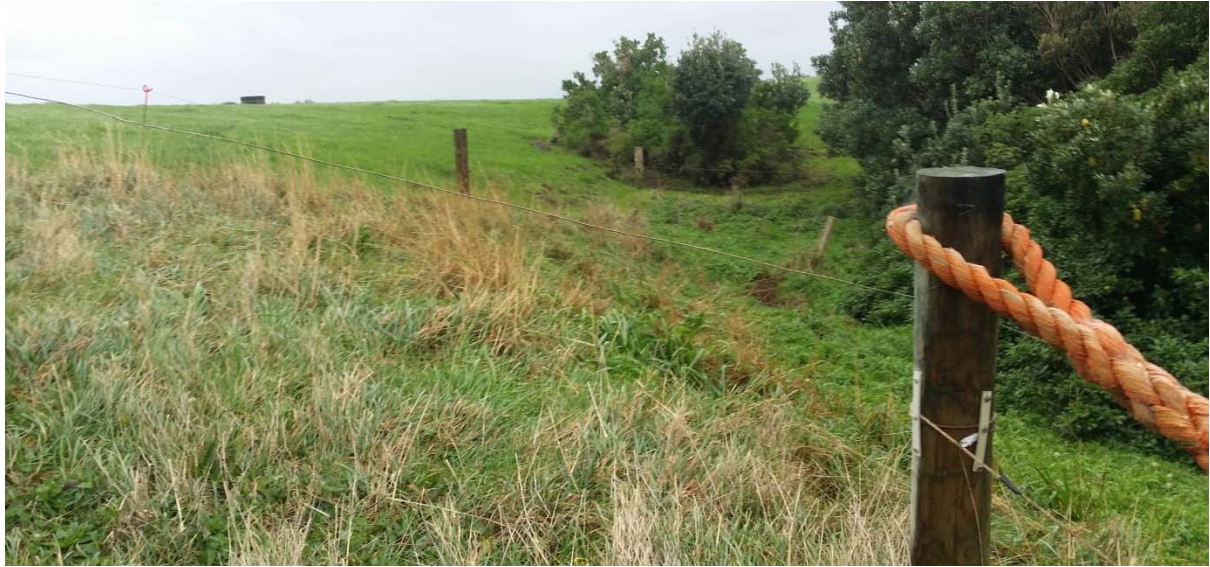
As noted in the previous inspection, the area surrounding the discharge channel had been fenced (Photo 2).

Photo 2 Fencing around the discharge channel from the oxidation ponds

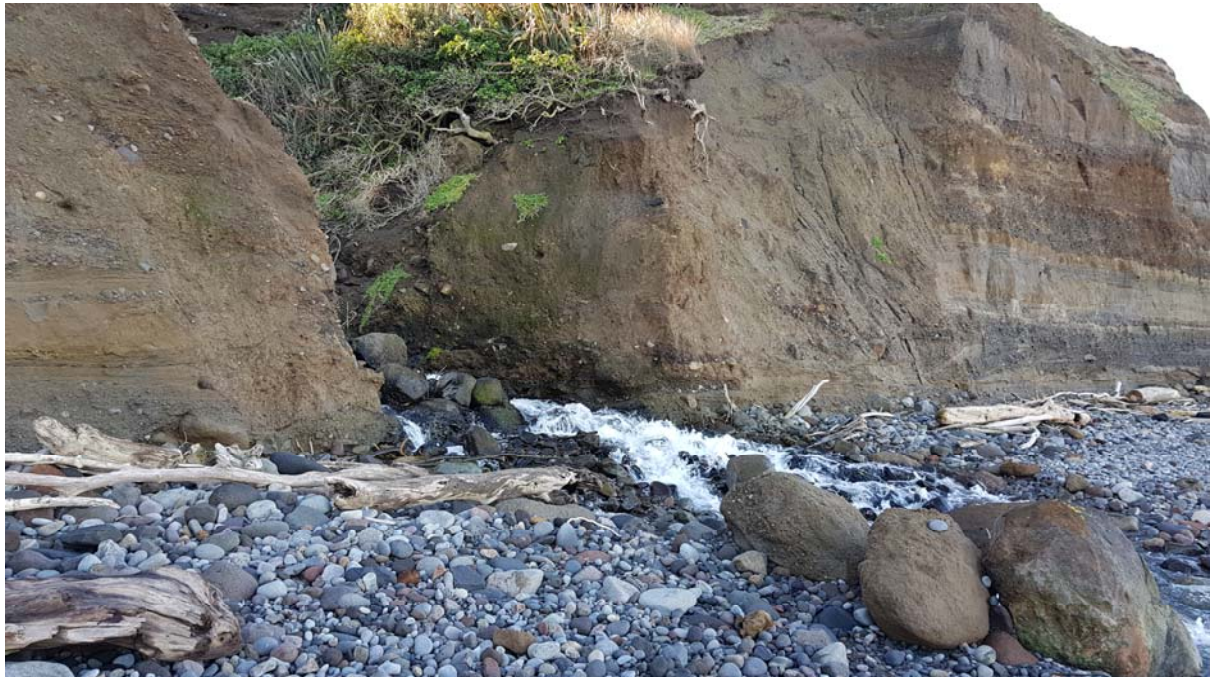
Photo 3 Manaia Creek flowing over the intertidal reef at Manaia

The intertidal inspection consisted of a qualitative assessment of the species present on the reef. The inspection covered the area where the stream flowed across the reef (Photo 3), and an area up to approximately 50 m northwest of the stream, and included high, middle and low shore. The stream was approximately 10 m wide at the coast, and had a slight yellow-brown colouration. The water was turbid, with no surface foam present. Orange deposits coating cobbles and boulders within the influence of the stream were noted in the midshore intertidal region (Photo 4). A mild sewage odour was detected downwind of the water flow.

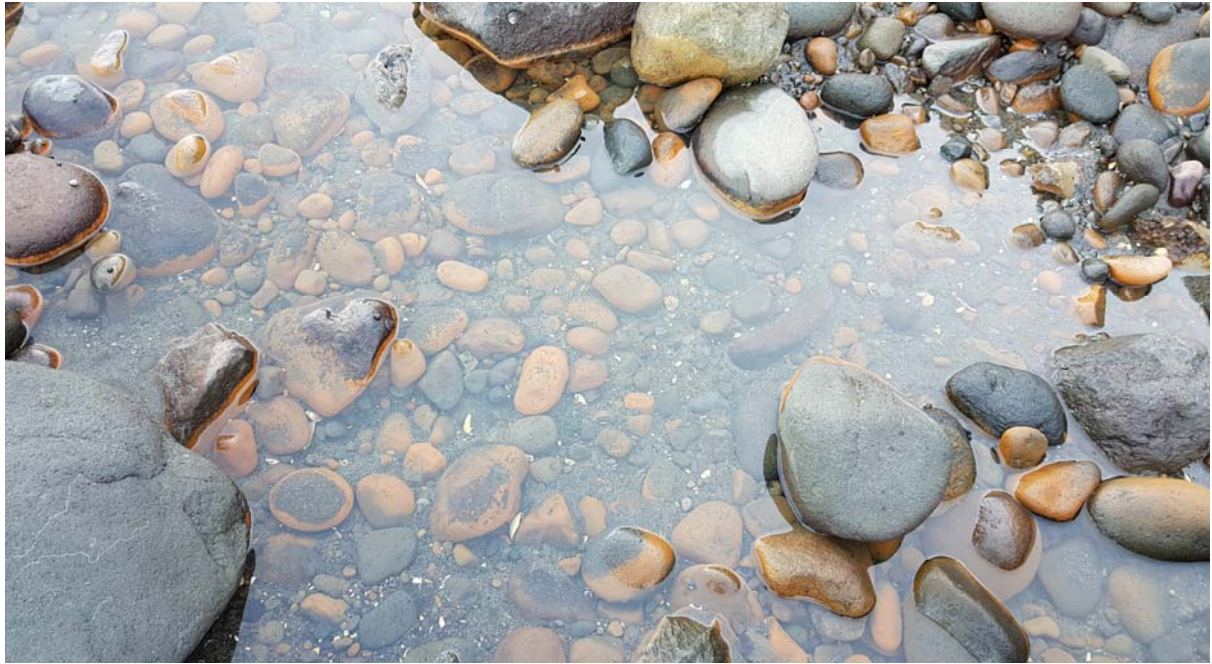
Photo 4 Cobbles and boulders within the influence of the stream, coated with yellow-orange deposits

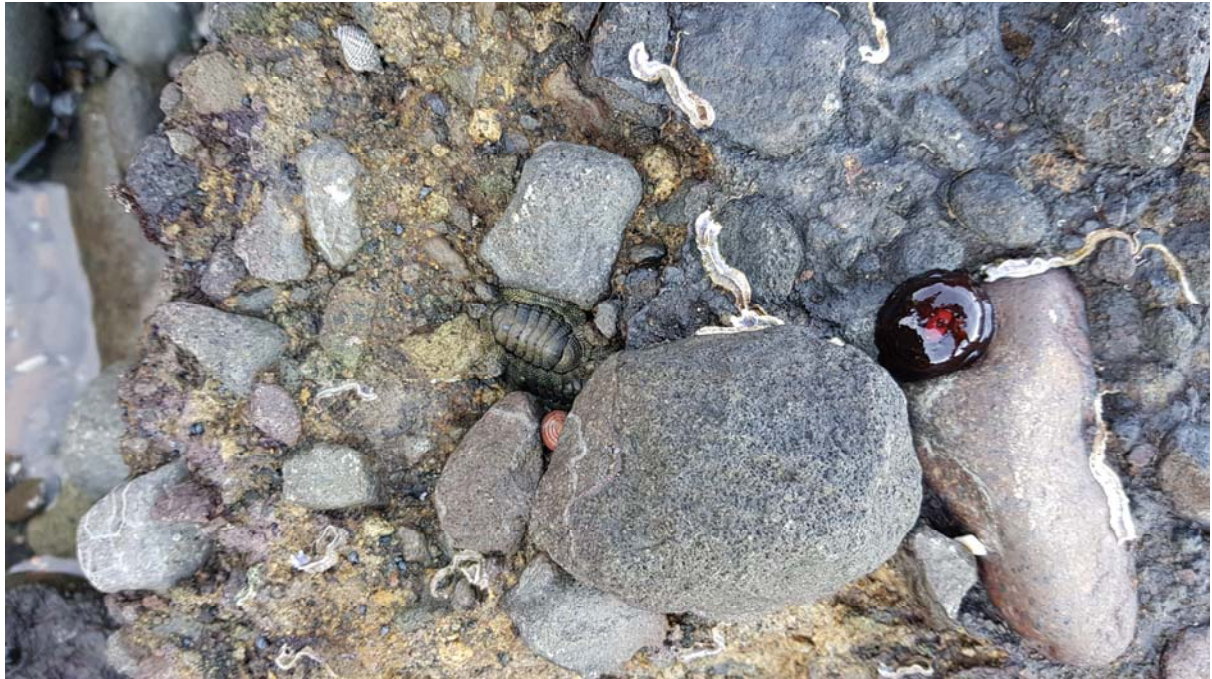
Photo 6 A range of species identified in the vicinity of the stream, in the upper intertidal region

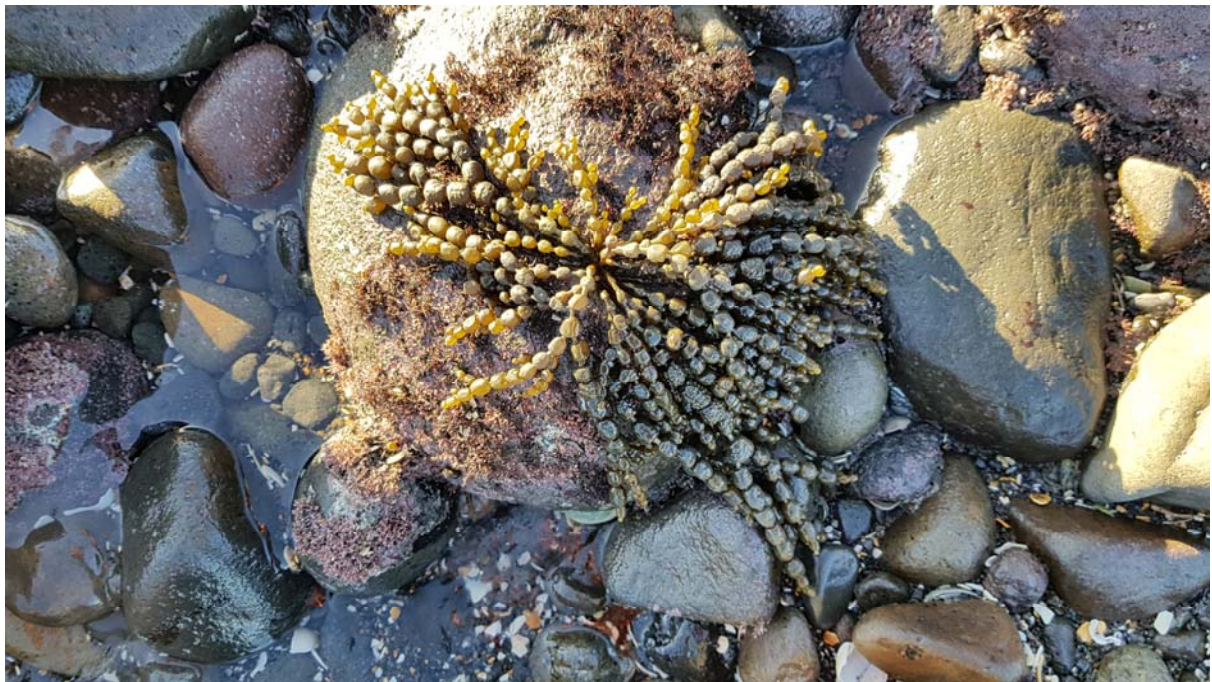
A greater diversity and abundance of algal and animal species occurred at the mid and low tidal regions, as typical of intertidal marine communities, and expected with the diminishing influence of the stream. At the mid and low shore elevations, 33 animal and algal species occurred within the vicinity of the stream. *Ulva intestinalis* was present within the direct influence of the stream. The algal species *Corallina officinalis*, encrusting *Corallina* spp., *Gelidium caulacanthum*, *Ralfsia* sp. and *Hormosira banksii* were present on boulders within the stream, becoming more abundant lower down the shore (Photo 7). As with the upper shore, some animals found within the immediate vicinity of the stream in the mid and low tidal regions appeared to be unhealthy and desiccated, including specimens of *Diloma aethiops* and *Patiriella regularis*.

Photo 7 The brown alga *Hormosira banksii*, in the vicinity of the Manaia Creek, in the lower reaches of the shore
