Osflo Fertiliser Ltd
Monitoring Programme
Annual Report
2016-2017

Technical Report 2017-65

Taranaki Regional Council

August 2017

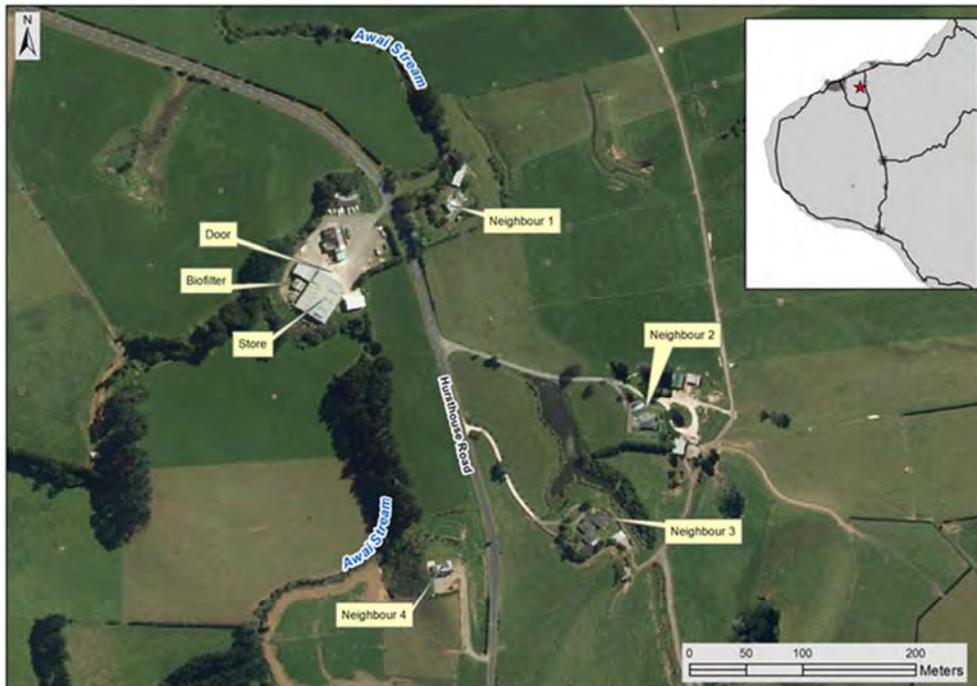
Figure 1 Osflo site on the Hursthouse Road

Osflo operates a storage, blending and distribution facility for agricultural fertiliser based on poultry litter at the site of the old Tarurutangi dairy factory on Hursthouse Road, near Lepperton (Figure 1). The poultry waste is collected from farms around the Taranaki region, and sold as a registered fertiliser to be spread on pasture. The depot is the administration centre for collection and distribution of the used litter, with the majority of the product being taken directly from the poultry farm to the general farming customer. Some blending in of additional ingredients occurs at the depot. A total of 17 persons are employed in the operation, utilising seven trucks.

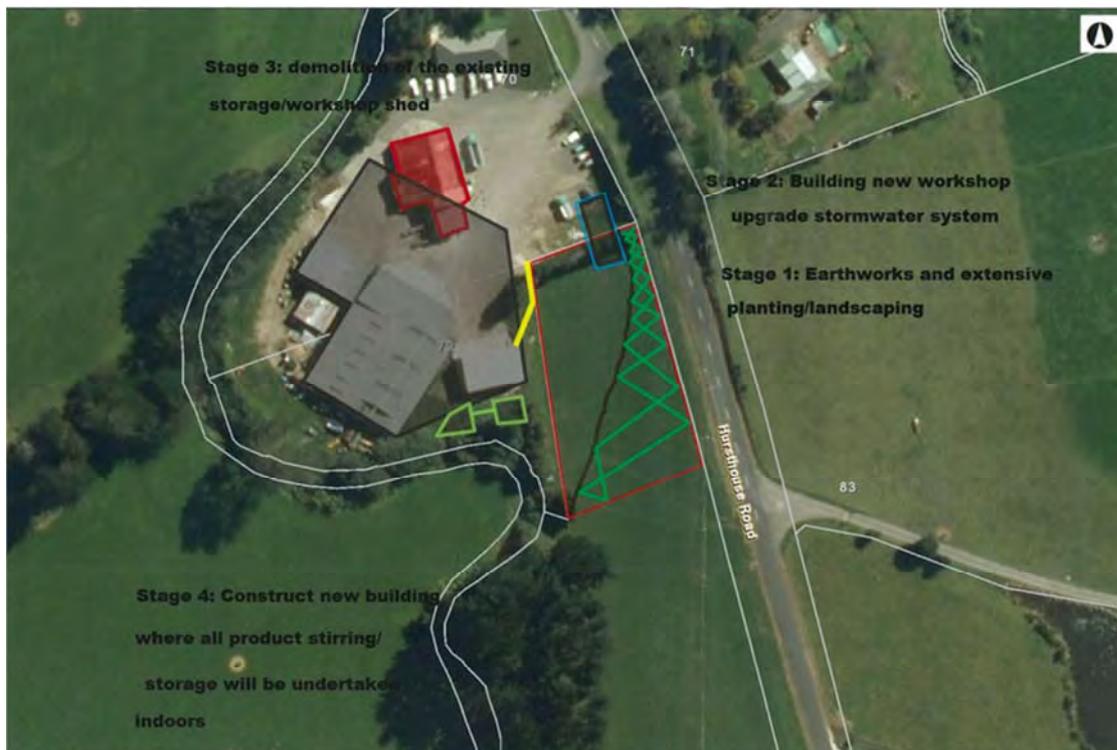
Figure 2 Staging of site development

At the time that this report was composed 24 months had past since the consent 5918-2 was granted. Osflo has undertaken Task 1, though no demolition work had been actioned for Stage 2.

Additional plans have been discussed with the Council and Osflo intend to continue with the consented progress, and accept that they have not met their commitment time line for development in terms of Stage 2. But they remain firm in their commitment to the final date of June 2019.

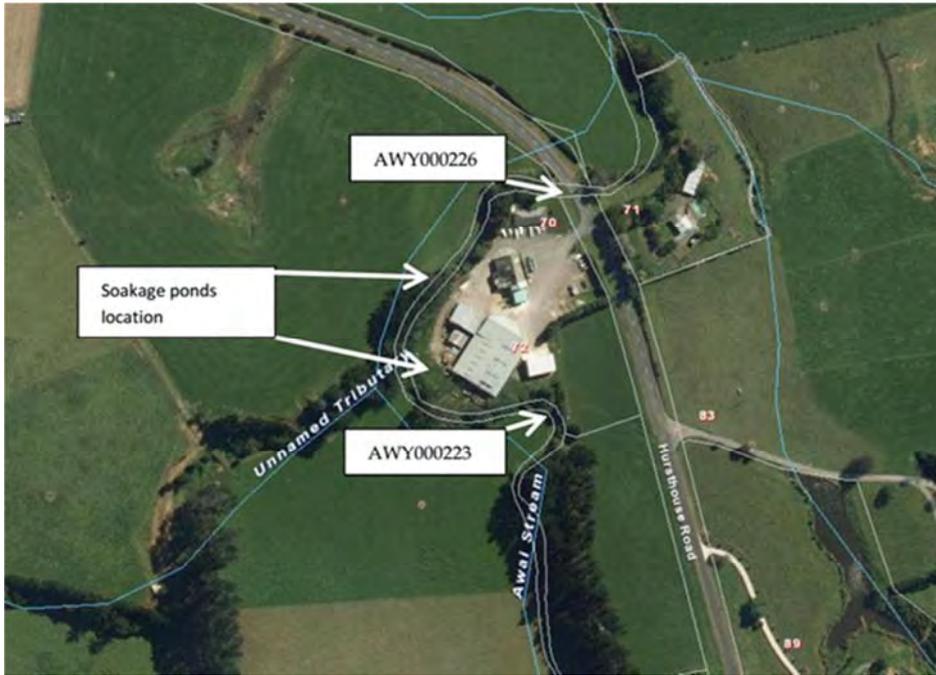
Figure 3 Aerial view of Osflo site with associated sample collection points

Sample locations AWY000223 and AWY000226 were set up as monitoring locations on the Awai Stream (Figure 4). AWY000223 is the upstream location, to determine the quality of the preceding stream conditions, whilst AWY000226 is the downstream location which will assess for any potential additional inputs to the stream as it flows around the Osflo facility.

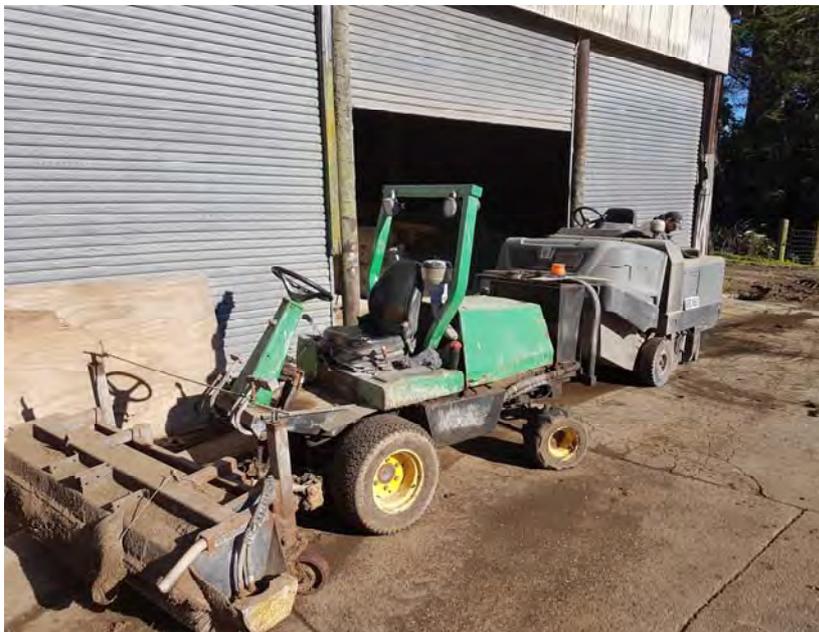
Photo 1 Osflo yard cleaning machinery

Following on from the issuance of the abatement notice, Osflo purchased additional machinery (Photo 1 and 2) to aid them in better managing the odour related issues which have been apparent this monitoring period. The machinery, aimed at keeping the outside blending area clean and clear when not in use appeared to be mitigating diffuse odour at the facility.

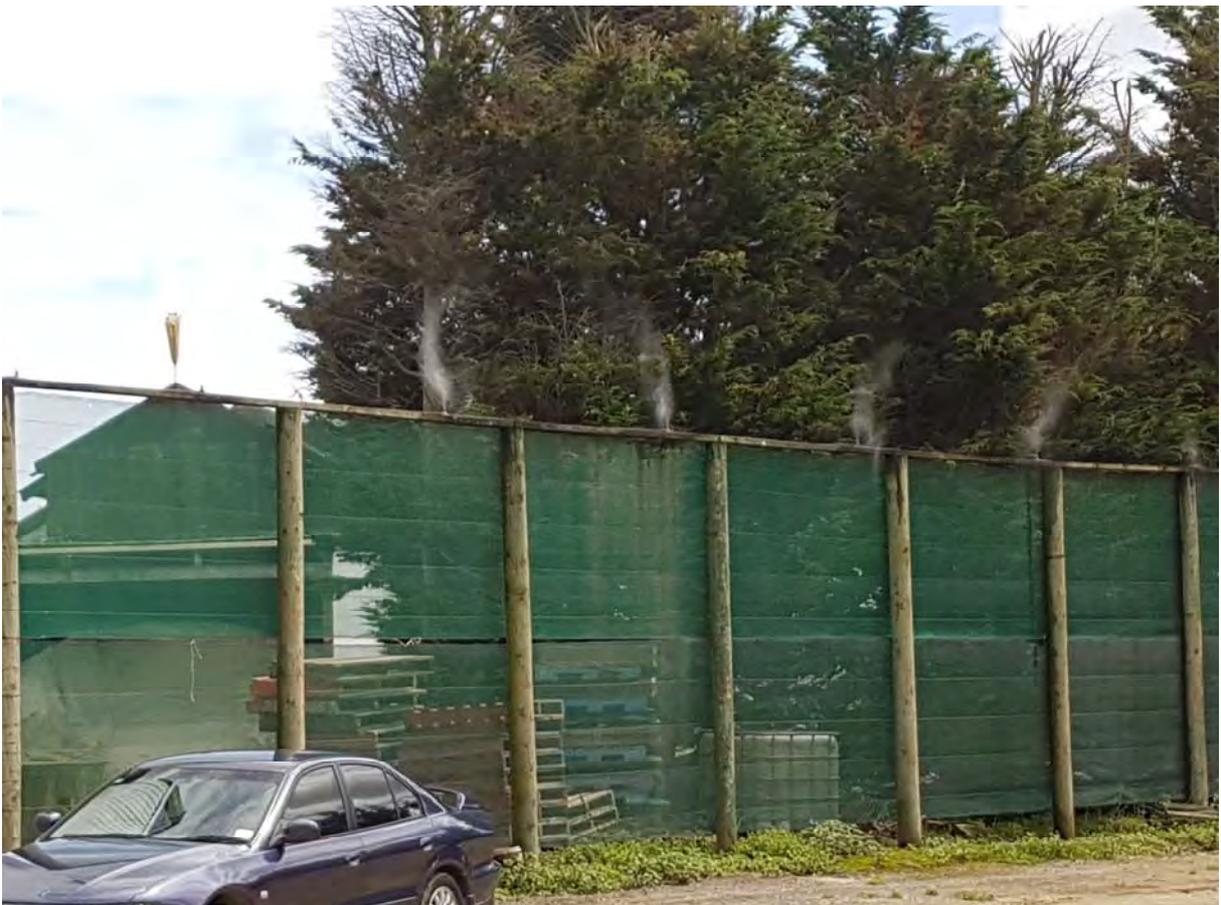
Photo 3 Osflo odourisers

More recently, the finding and fixing of a leaking water pipe directly under the blending area has further reduced the odour apparent on site. Since these two undertakings there have been no odour complaints. These additional engineering controls are aimed to lessen the impacts from odour generation. Additional odourisers have been added to the site, an example of which is provided in Photo 3.

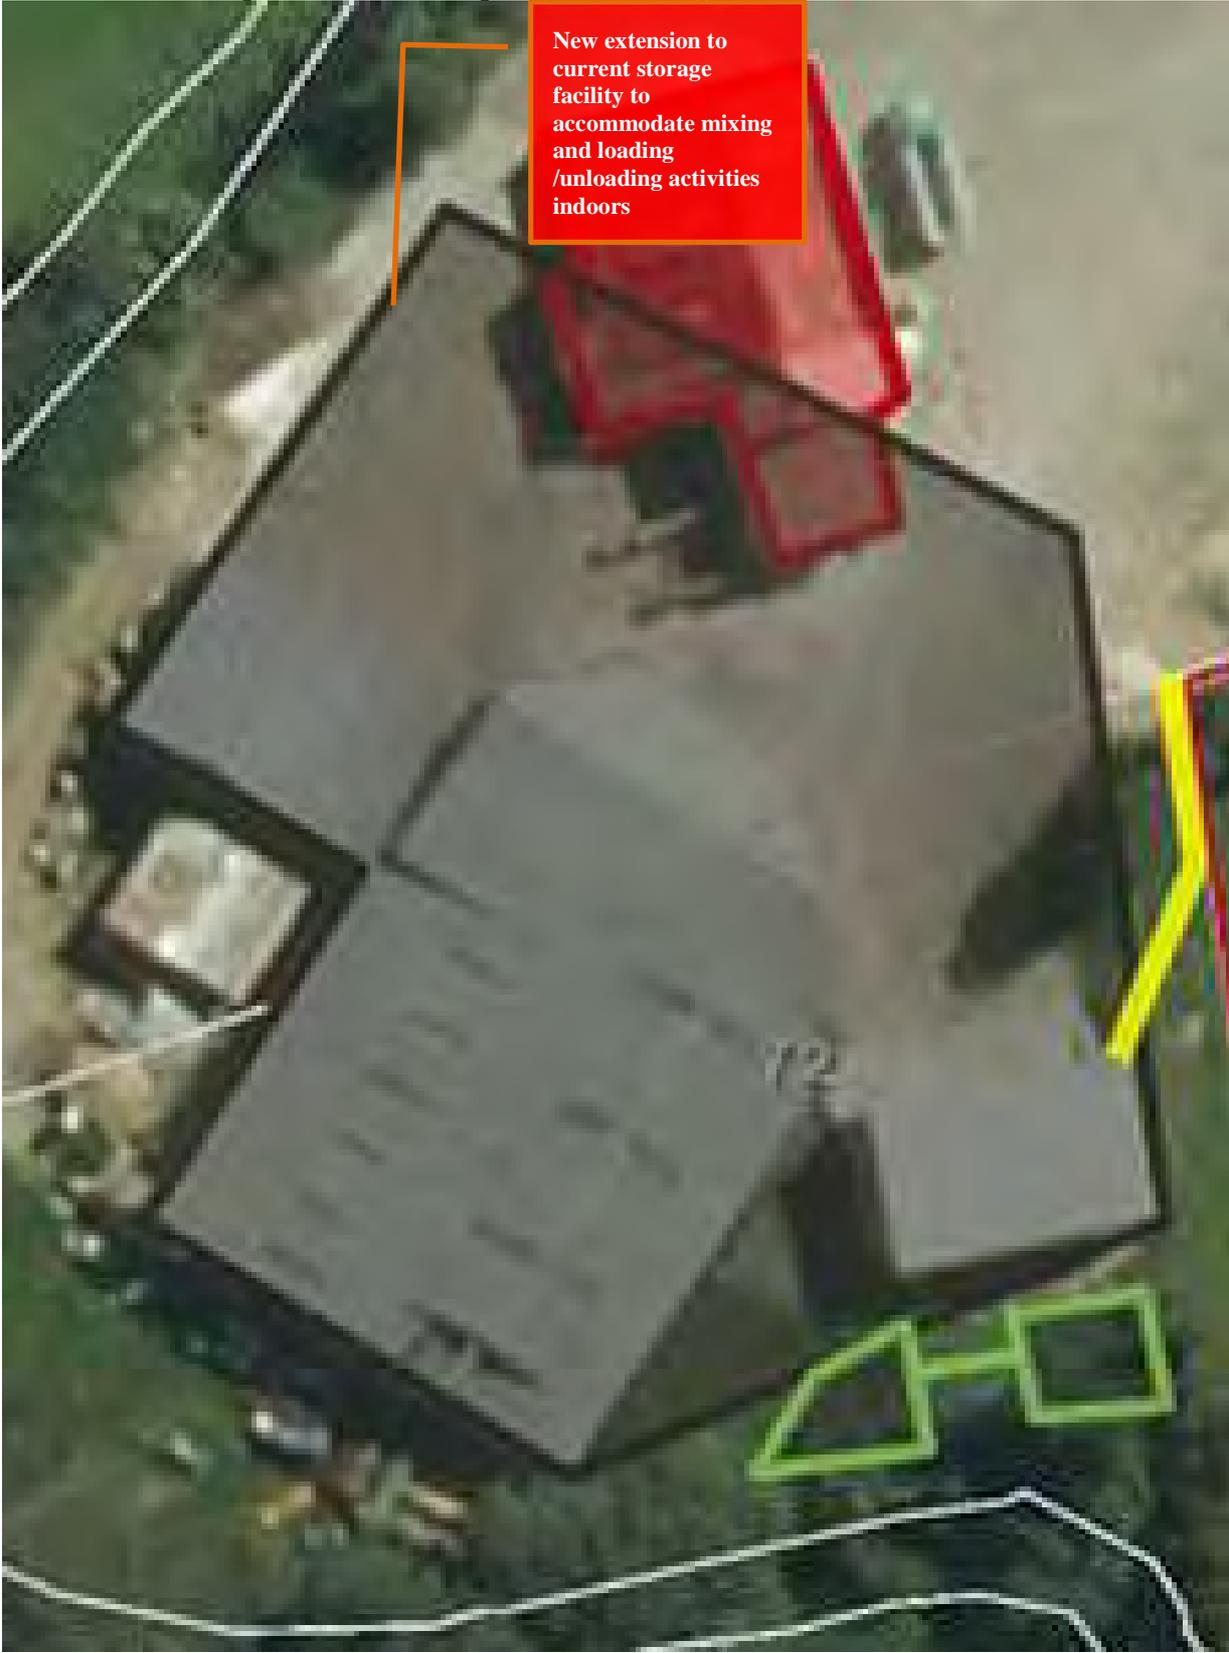
Attachment 4: Proposed Odour Mitigation Plan – Stage 3

New extension to current storage facility to accommodate mixing and loading /unloading activities indoors
