Osflo Fertiliser Limited
Monitoring Programme
Annual Report
2018-2019

Technical Report 2019-15

Taranaki Regional Council
Private Bag 713
STRATFORD
November 2019

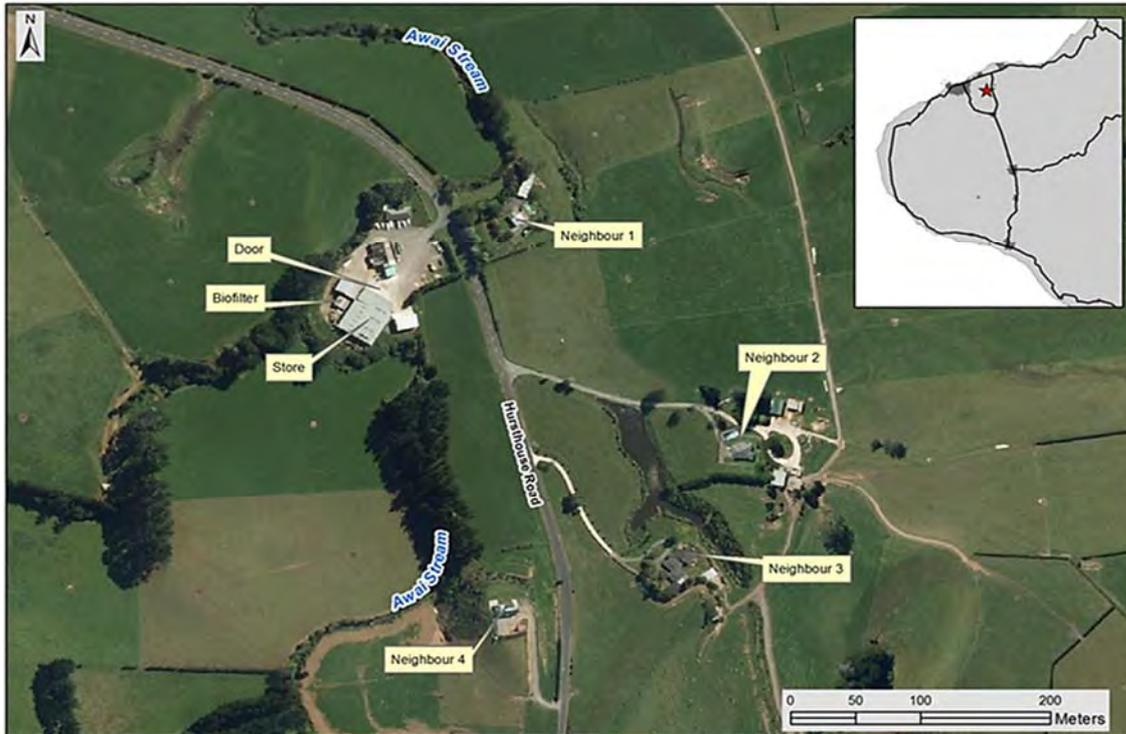
Figure 1 Osflo Fertiliser Ltd (former) site on the Hursthouse Road

The Company historically operated a storage, blending and distribution facility for agricultural fertiliser based on poultry litter at the site of the old Tarurutangi dairy factory on Hursthouse Road, near Lepperton (Figure 1).

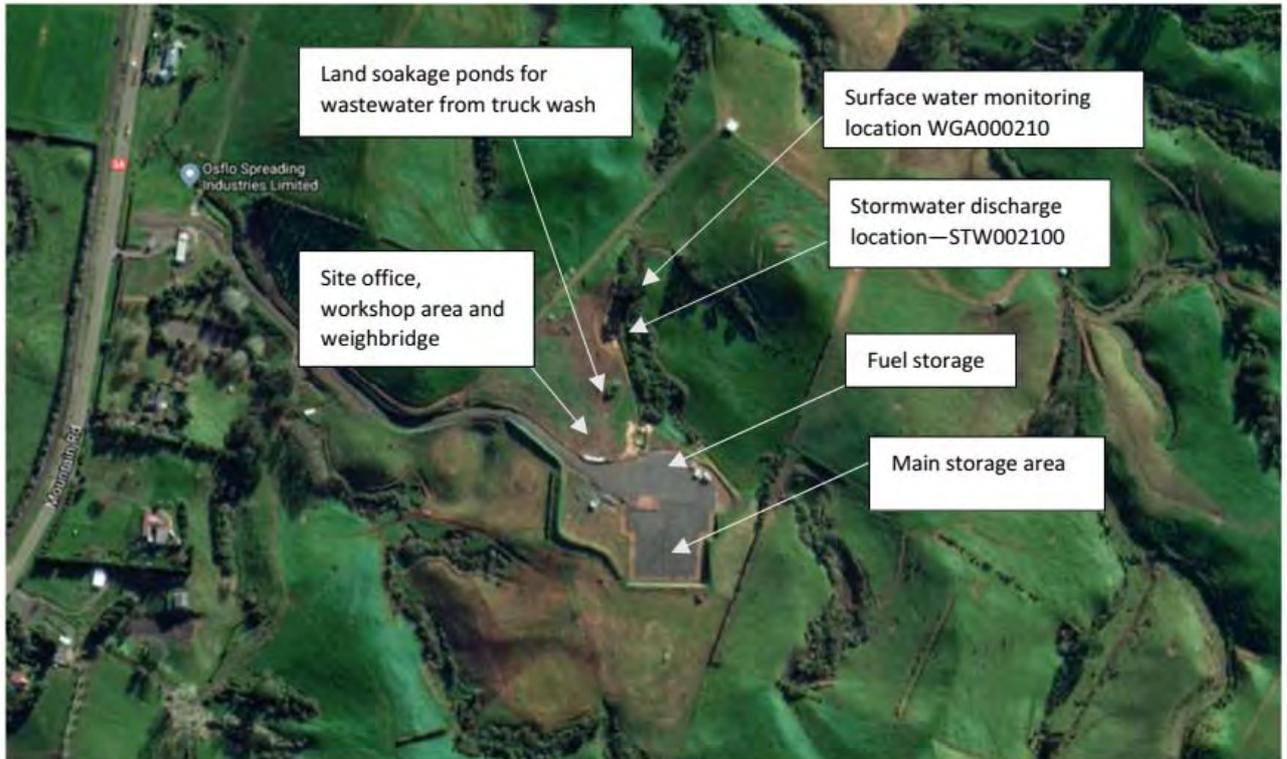
Figure 2 Osflo Fertiliser Ltd (current) site on Mountain Road

The current Mountain Road depot is a purpose built facility, the active site land area is just over three hectares. However the overall site area is much larger at 46 hectares. The site is located within its own valley in close proximity to an unnamed tributary of the Waiongana Stream. It is situated on the eastern side of Mountain Road. The site is surrounded by grazing farm land. The nearest neighbour is located some 400 meters to the west of the facility. The predominant wind direction is from the south east and the lesser from the south west.

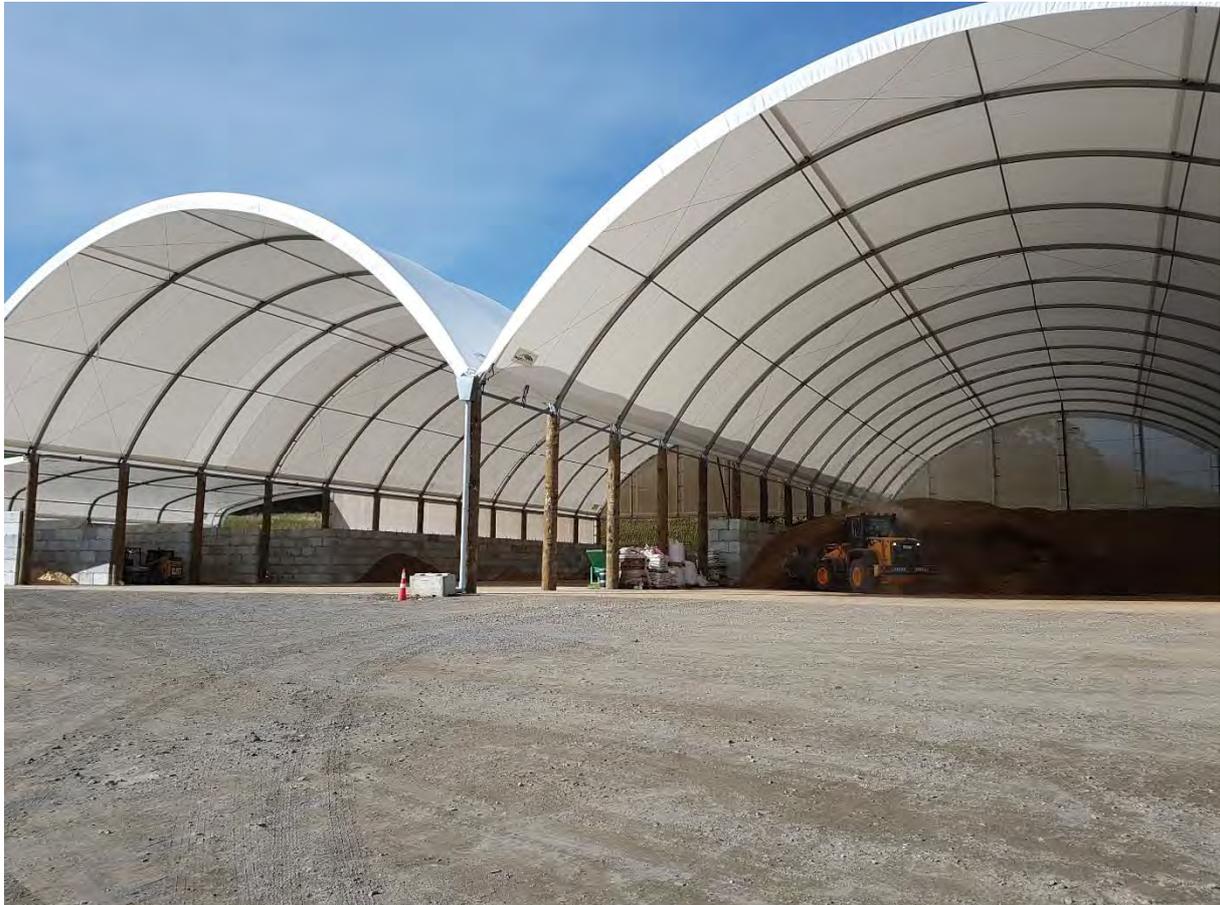
Figure 3 Osflo new site facility storage area 1319 Mountain Road

The new fully covered storage depot comprises two large, stockpiling areas. The fresh litter is deposited on one side of the storage area, where it is composted in this area with sawdust. Older more mature litter is stockpiled on the other side. In this area the more mature litter can be mixed with additional components as required, prior to being loaded for customers.

Odours at the facility are controlled with good air flow through the specially designed roof of the facility (Figure 3), this actively dries the material. A separate odour assessment of the project was undertaken by the consultant's Golder Associates to confirm this prior to the granting of the consents.

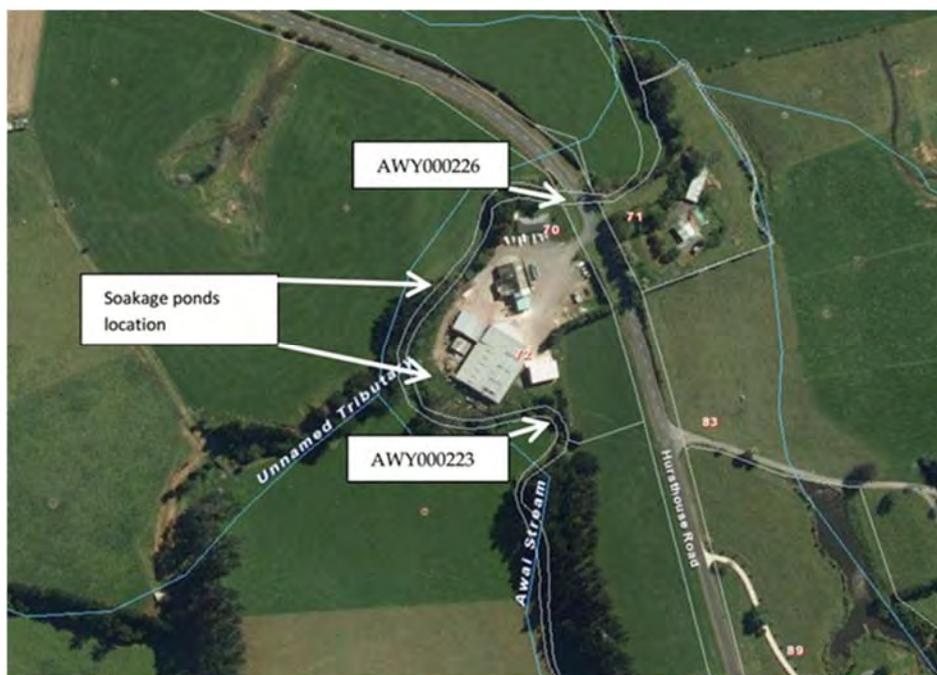
Figure 4 Aerial view of the former Osflo site on Hursthouse Road with sample locations denoted

Sample locations AWY000223 and AWY000226 were set up as monitoring locations on the Awai Stream (Figure 4). AWY000223 is the upstream location, to determine the quality of the preceding stream conditions, whilst AWY000226 is the downstream location which will assess for any potential additional inputs to the stream as it flows around the Osflo facility.

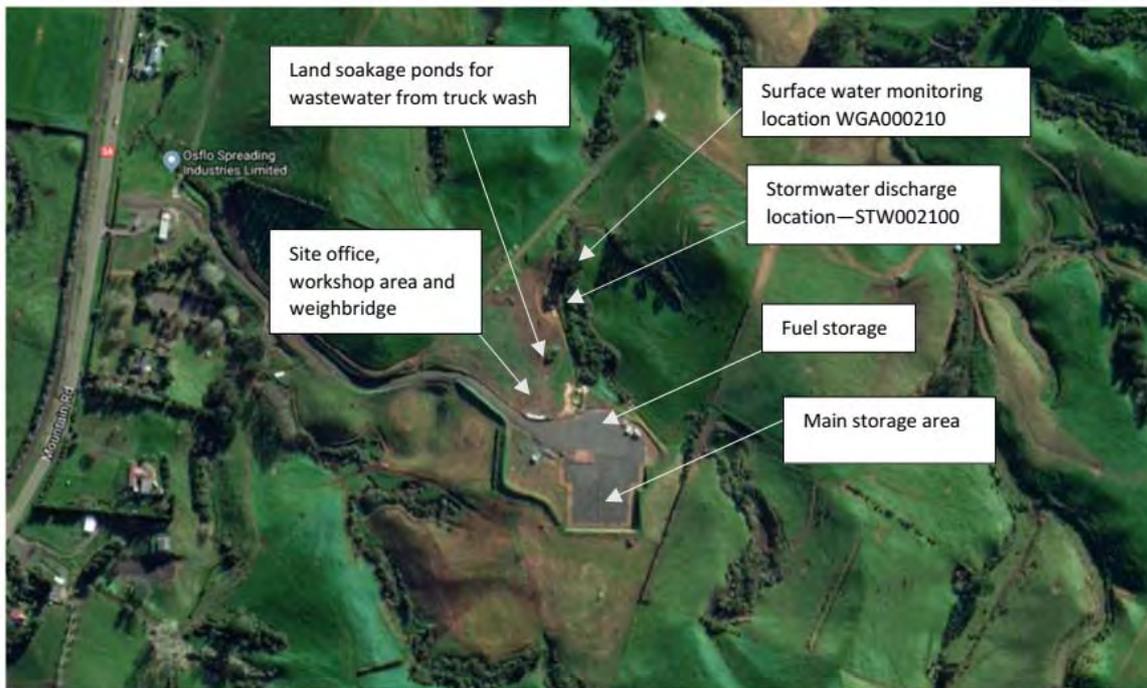
Figure 5 Aerial view of New Osflo site with associated labelling

One surface water monitoring round was undertaken at the new company facility located on Mountain Road. This marked the inception of surface water monitoring at the new company facility. As previously discussed, the facilities' only discharge to surface water is stormwater which is composed of the roof surfaces only at the facility. The only wastewater discharge is through ground soakage as defined in the following Figure 5.
