NPDC Coastal Structures

Monitoring Programme

Biennial Report

Technical Report 2022-84

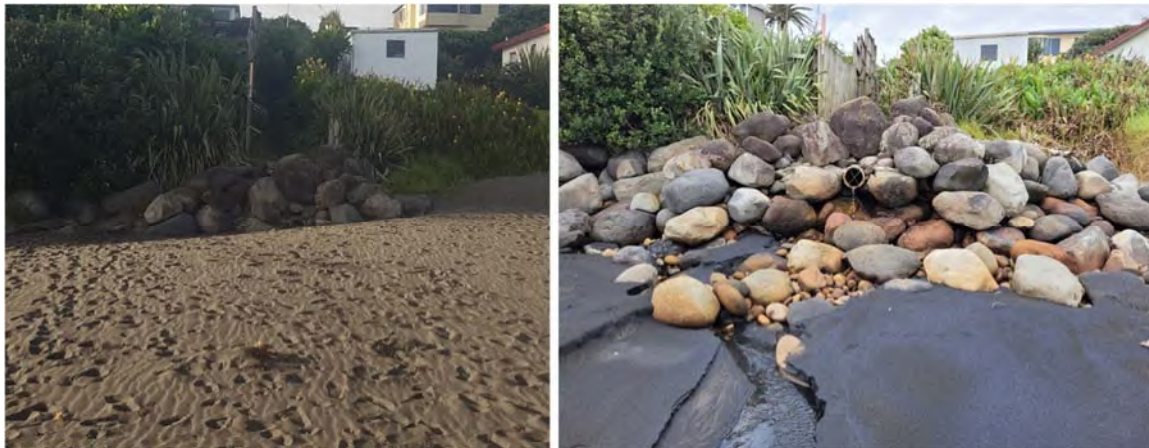
The stormwater outfall located at the end of the Messenger Terrace beach access way in Oakura (5223-3), had become more exposed after big seas had removed a significant volume of sand from the beach in front of it (Photo 1). The structure was assessed to be stable and at no additional risk of collapse. NPDC are continuing to monitoring this outlet to ensure the structure and surrounding rock work protection do not deteriorate.

Photo 1 Beach level significantly higher in April 2020 (left), compared to June 2022 (right) at the Messenger Terrace stormwater outfall

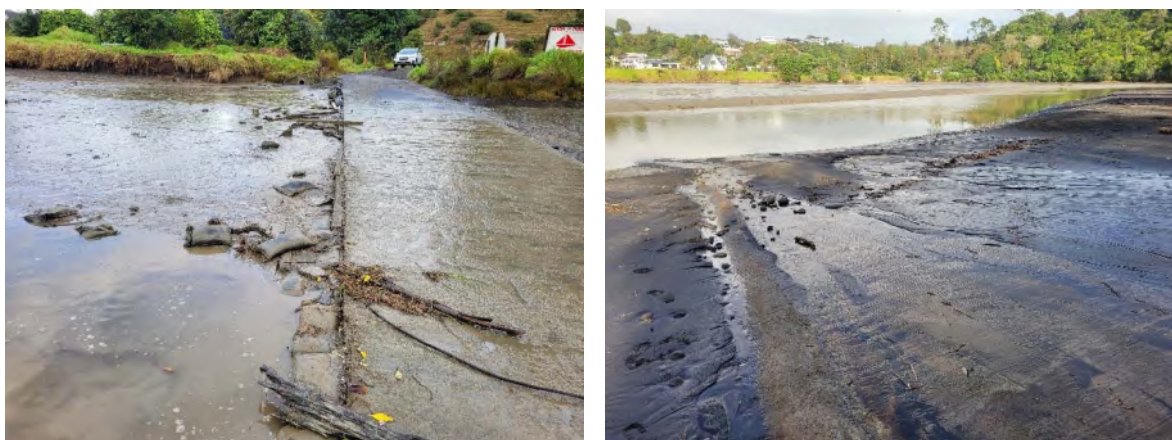
inspections. It was noted that the Tongaporutu boat ramp (4004-3) required some minor maintenance, as some of the sand bags along the upstream edge had been shifted out of place. Only one of the three bridges that are included in this monitoring programme was found to be in need of maintenance. Assessments carried out during both years found that the Onaero camp bridge (4590-2) is in very poor condition and is now scheduled for renewal works in the 2023-2024 financial year.

During the same period, Council inspections were carried out across two dates, in June 2022. The boat ramps all appeared to be in a satisfactory condition, with only minor issues noted. At Tongaporutu (4004-3), minor maintenance was required to reinstate some of the sand bags that had been washed out of place (Photo 2). At Urenui (4065-3), there was a significant volume of sand covering the boat ramp which could potentially limit the use of the structure (Photo 2). At Back Beach (6553-1), bank scouring was identified adjacent to the boat ramp. No issues were identified with the Te Rewa Rewa bridge, or the Waiwhakaiho footbridge structures. Although not likely to be related to the structure, substantial bank scouring and undercutting was identified in the vicinity of the Waiwhakaiho footbridge (4603-2).

Photo 2 Displaced sand bags at the Tongaporutu boat ramp (left), and sand deposition on the Urenui boat ramp (right), 8 June 2022

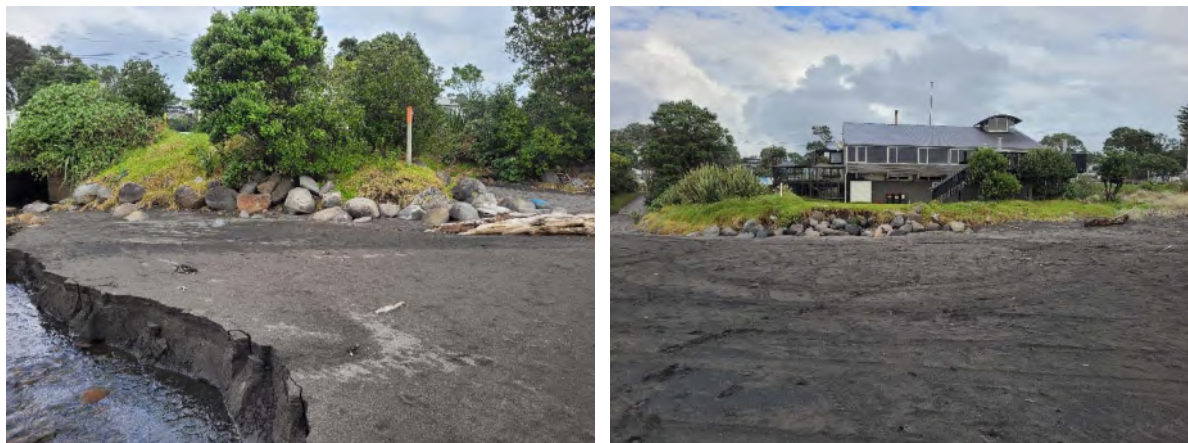
During the same period, Council inspections were carried out across two dates, in June 2022. For the most part, these structures were found in a satisfactory condition and were not presenting any additional safety concerns or other impacts on the surrounding environment. Some localised bank scouring was observed in a number of areas, including Tongaporutu, Waiwhakaiho, Te Henui and Oakura; though this was not clearly attributable to the presence of associated structures. The (non-urgent) need for maintenance of the structures identified by NPDC was confirmed during the Council inspection round. Additionally, the condition of the rock protection structure in front of the Oakura Surf Club Building was found to have

deteriorated (4584-2). This was more apparent during the June 2022 inspection due to the recent loss of sand that had been covering the structure in recent years (Photo 3).

Photo 3 Oakura Beach rock protection structures 5523 (left) and 4584 (right), 8 June 2022

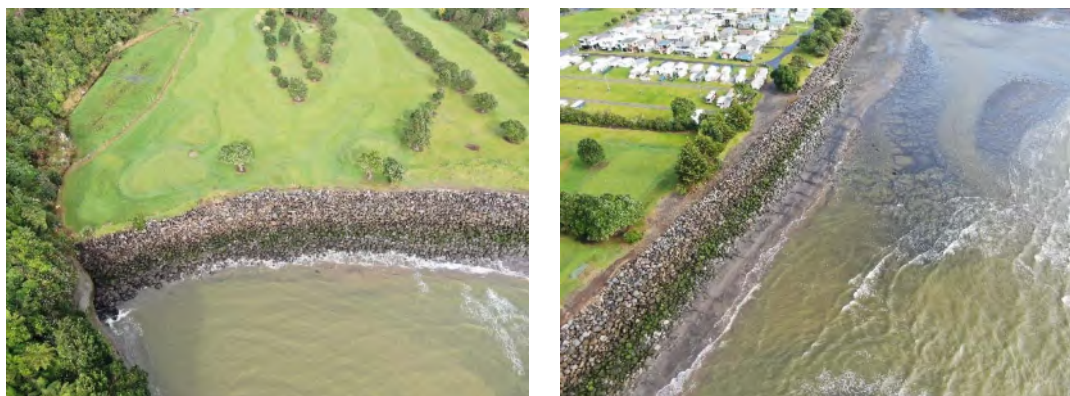
No issues were identified during NPDC's initial inspection in July 2020. However, another inspection was carried out in September to assess the impact of the king tides and high winds that had subsequently occurred. It was found that the mid-eastern section of the wall had been overtopped, which led to slumping of the wall and erosion of the track behind it. Repairs were completed in February 2021, adding 220 tonnes of rock to the wall.

NPDC inspections carried out the following year confirmed the need for additional, preventative maintenance works to re-profile the structure and restore its 'as-built' dimensions. These works were carried out between March and April 2022, adding 1,500 tonnes of rock to the wall.

Council inspections did not identify any issues with the seawall additional to those already identified and addressed by NPDC. Aerial photographs were captured during the June 2021 inspection (Photo 4). During the final inspection of the monitoring period, carried out on 8 June 2022, the seawall appeared to be in good condition, with the profile restored and no further erosion behind the crest.

Photo 4 Urenui Beach rock rip rap seawall, June 2021

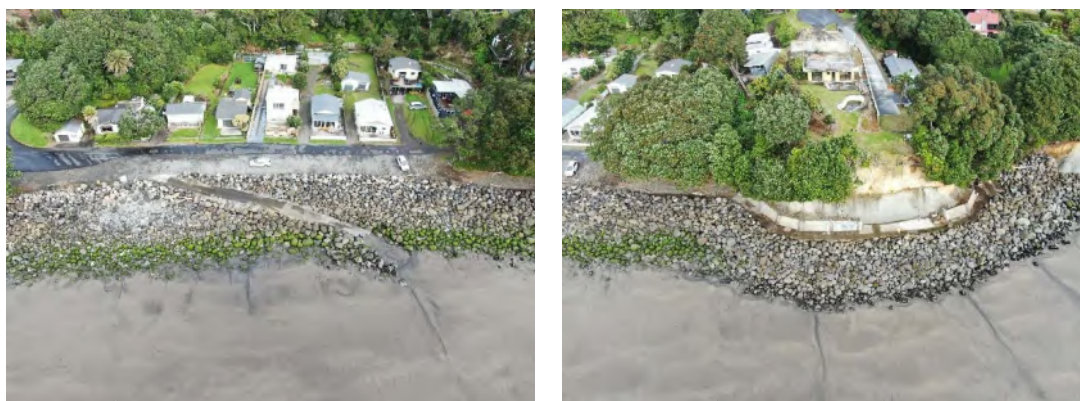
No issues were identified during NPDC's initial inspection in July 2020. Similarly, the structure was found in a sound condition during the next inspection. However, preventative maintenance was scheduled for 2022 in order to re-profile the hollow/slumped sections of the wall that were beginning to appear. The maintenance was carried out in March 2022, adding 400 tonnes of rock to restore the profile of the structure.

No further issues were discovered during either of the Council's two inspections carried out in the monitoring period. Aerial photographs were captured during the June 2021 inspection (Photo 5). The structure was found in a satisfactory condition, and there were no impacts on the adjacent shoreline that were readily visible.

Photo 5 Onaero Beach rock rip rap seawall, June 2021

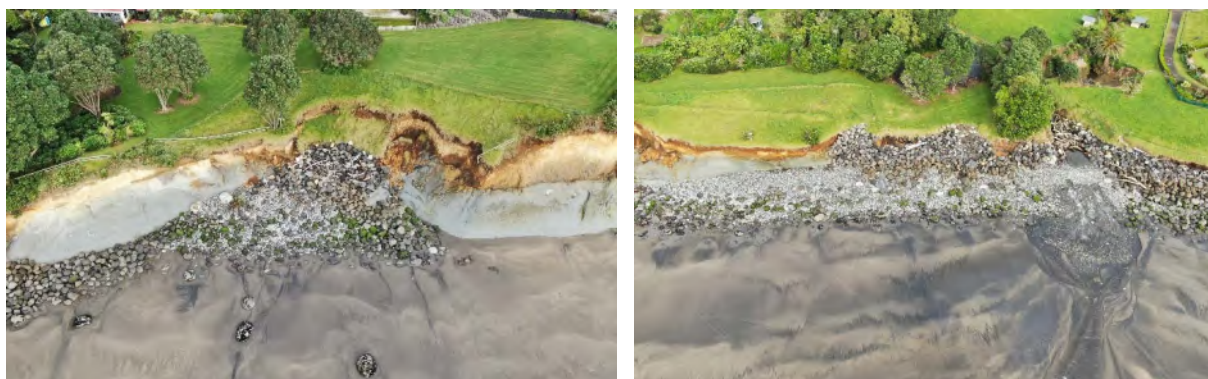
On 19 February 2021, Council determined that the structures themselves had not been maintained as originally designed and built. This assessment was based on the subsidence of boulders and their migration down the shore, and the associated erosion that was occurring on the western edge of the main incision repair. The structures themselves were intended as an interim solution to reduce erosion, and they had largely served this purpose since their construction. However, NPDC were still required to maintain the structures in an as-built condition so as to not impact the surrounding environment through loss of material, and to ensure that the structures would still remain as effective as possible at reducing the rates of erosion. Abatement Notice (EAC-23874) was issued to NPDC to undertake works to comply with the resource consent's maintenance requirement. However, in a subsequent meeting held in March 2021, it was agreed that the maintenance could wait until such a time that the beach volume had dropped to a level where the displaced boulders were exposed again. This would allow the works to be carried out with minimal beach disturbance, while increasing the recovery of boulders to be returned to the structure. While the sand volume on the beach was relatively high, there was reduced potential for ongoing erosion.

Photo 6 Onaero Beach rock rip rap incision repairs, June 2021

In June 2022, Council discovered that the volume of sand on the beach had reduced significantly following a storm, exposing much of the material that had migrated down the shore from its original position. NPDC were advised and the maintenance works were scheduled. As part of the maintenance planning process, a trained penguin detection dog survey was carried out at the Onaero incision repairs to identify potential burrows in May 2022. NPDC worked cooperatively with Council to carry out the maintenance works, which were completed after the period under review, in November 2022. Following completion of the maintenance, the structures were assessed as being compliant with consent conditions, and the requirements of the Abatement Notice had been addressed.

The Onaero Beach rock rip rap incision repairs were non-compliant during the monitoring period, which resulted in an Abatement Notice being issued. Ultimately, NPDC worked cooperatively with Council to address the maintenance issues; restoring compliance with the resource consent and Abatement Notice.

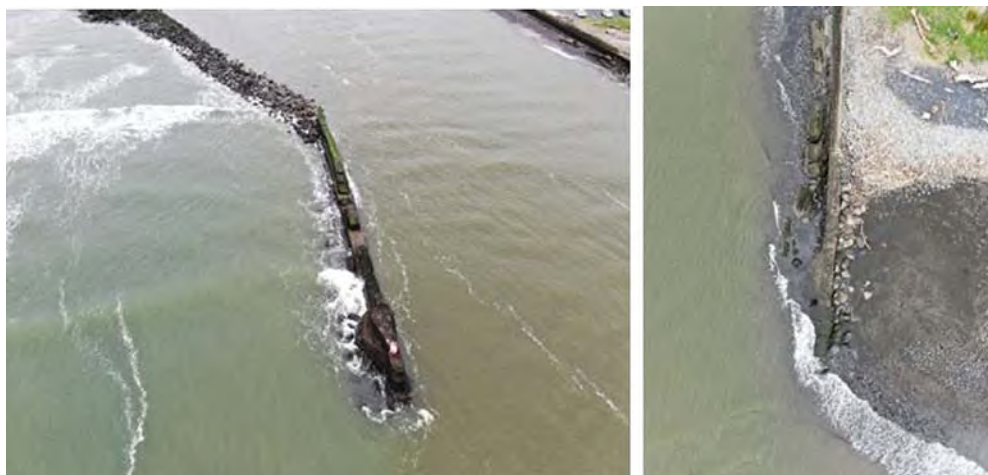
NPDC's inspections during the monitoring period found that the structures were generally performing as designed. The main issues that were identified included degradation and cracking of the concrete on the inside of the western training wall (4600-2.1), and the slumping of middle section of the eastern training wall (9328-1.1). No maintenance was carried out during the monitoring period, however, there was no noticeable degradation of the structures during this time. NPDC have implemented more regular monitoring to assess any further degradation of the concrete on the inside of the western wall.

Photo 7 Waitara River mouth training wall structures, June 2021

Aerial photographs were captured by Council during the June 2021 inspection (Photo 7). No further structural issues were identified by Council during either inspection. However, as discussed in the previous monitoring report (TRC, 2020), there were ongoing concerns regarding the erosion of the eastern shoreline adjacent to these structures. This issue is discussed further in section 3.2.

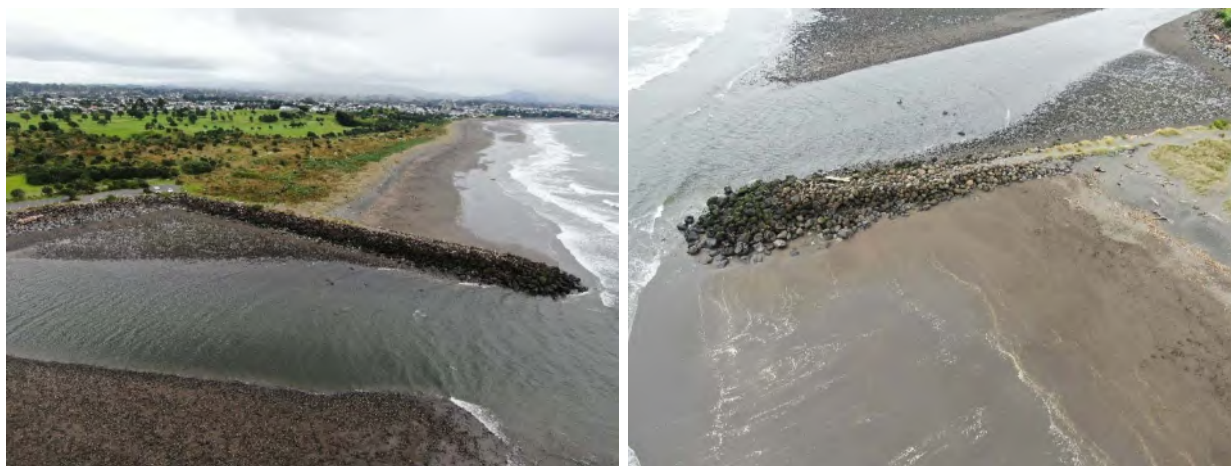
NPDC's inspections during the monitoring period found that the structure was in satisfactory condition and was performing as designed. A hollow was discovered at the top of the groyne, due to the movement of rocks further down the structure. The issue was addressed by placing a small number of boulders within the hollow, in order to eliminate the risk of anyone falling in. This minor maintenance task was carried out in accordance with Rule 38 in the Interim Coastal Plan for Taranaki, and the associated Coastal Structure Maintenance Guidelines (TRC, 2022). As part of the maintenance planning phase, a trained penguin detection dog survey was carried out along the groyne to identify potential burrows in November 2020.

No further structural issues were identified during Council inspections. Aerial photographs were captured during the June 2021 inspection (Photo 8). When the groyne was visited in June 2022, a significant volume of sand had been removed from the beach on the updrift side of the structure following a recent storm event. The beach had also changed from sand to cobble-dominated. It is unclear whether these changes were related to, or exacerbated by the presence of the groyne. However, the newly commenced beach profile monitoring is intended to help measure these changes and provide evidence of driving factors in the future. The first round of beach profile monitoring was carried out in March 2022, as per the revised monitoring requirements set out in resource consent 4585-2.1.

Photo 8 Waiwhakaiho rock rip rap groyne, June 2021

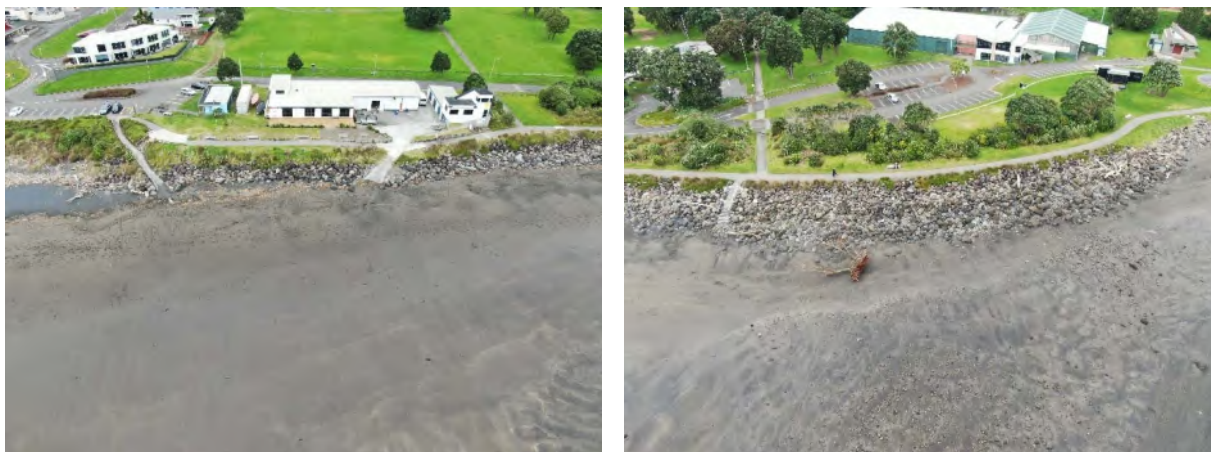
NPDC's inspections during the monitoring period found that the structure was in reasonable condition and was performing as designed. Some minor issues were noted, including some bank scour within the river mouth and the degraded condition of the boat ramp structure. The East End Surf Club Boat Ramp has been scheduled for replacement in the 2022-2023 financial year.

Photo 9 East End rock rip rap seawall, June 2021

No further issues were identified during Council inspections. The recessed shoreline at the north eastern end of the structure did not appear to have changed from previous inspections. Aerial photographs were captured during the June 2021 inspection (Photo 9). There was lots of evidence of penguins nesting within the wall during the June 2022 inspection.

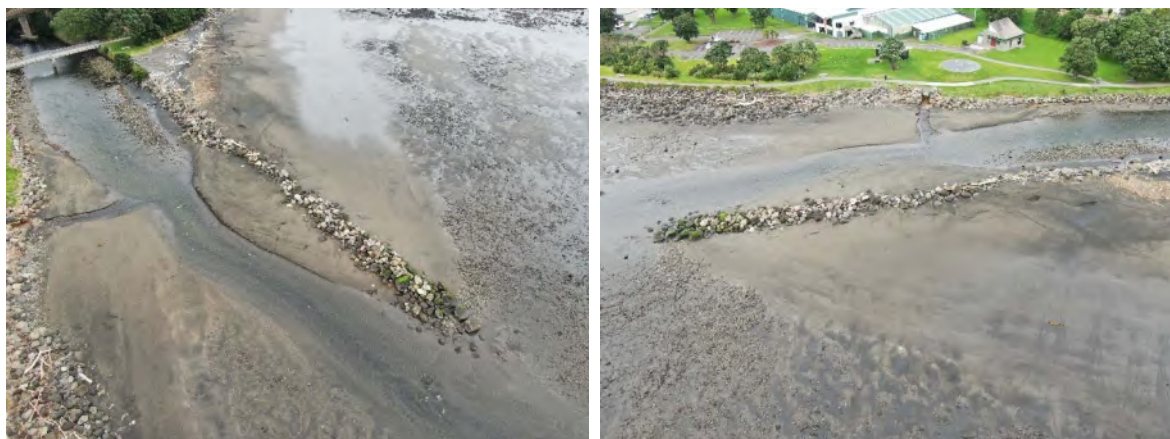
NPDC's inspection in August 2020 found that the groyne was in very poor condition, particularly in the mid to lower sections. Boulders and rocks had come apart, with the tide able to wash through the structure. Maintenance works were planned for the following summer to address the issue. In May 2021, 320 tonnes of rock were added to the structure, to reinstate the mid to lower sections. The repairs were highly effective and the structure was found to be in good condition during the next inspection carried out in September 2021.

Photo 10 Te Henui rock rip rap groyne, June 2021

No further issues were identified during Council inspections. Aerial photographs were captured during the June 2021 inspection (Photo 10). In June 2022, the beach in front of the Buller Street carpark appeared to have built up considerably; indicating that the groyne was effectively trapping sediment on that side of the structure.

The maintenance works were carried out in accordance with Rule 38 in the Interim Coastal Plan for Taranaki, and the associated Coastal Structure Maintenance Guidelines (TRC, 2022). As part of the maintenance planning phase, a trained penguin detection dog survey was carried out along the groyne to identify potential burrows in November 2020.
