STDC Coastal Structures
Monitoring Programme
Annual Report
2015-2016

Technical Report 2016-45

November 2016

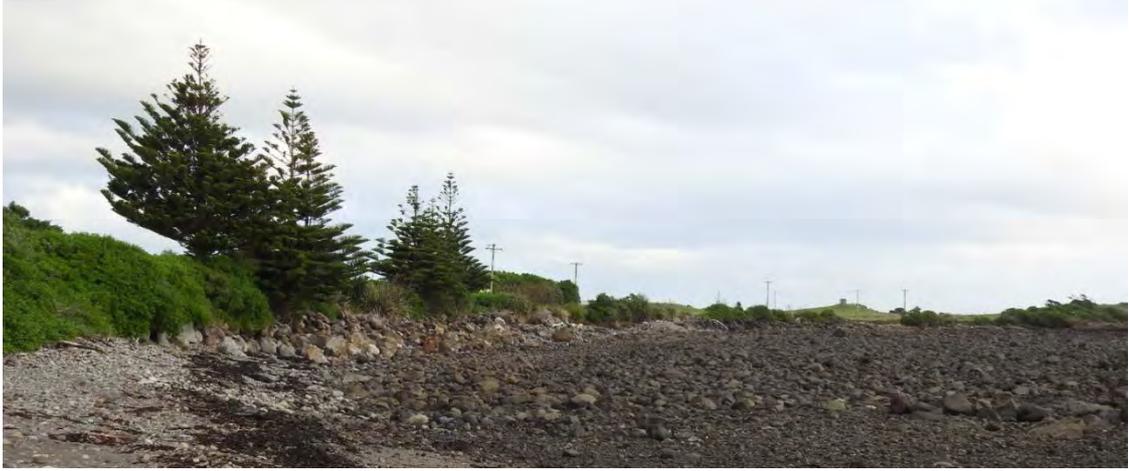
Photo 1 Bayly Road seawall (May, 2016)

As a result of the works, the boulder protection now extends from the boat ramp in the north to the pre-existing 40 m of boulder protection south of Bayly Road, with a total length of approximately 290 m (Photo 1).

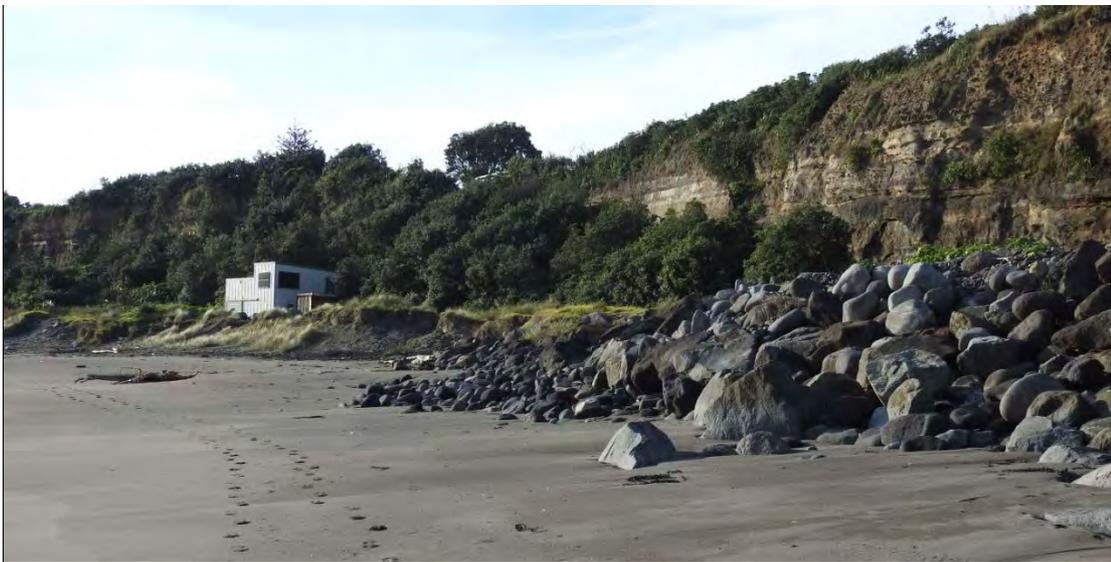
Photo 2 Rip rap seawall, Middleton Bay (May, 2015)

Subsequently, STDC applied to reconstruct, and maintain a boulder rip rap seawall on the foreshore at the southeast end of Middleton Bay for coastal erosion protection purposes. This application was granted as coastal permit **5504**.

Due to Middleton Bay being a pocket sand beach, and the location of the revetment being well forward towards the surf zone, there is a high potential for adverse effects to the soft shoreline at the north-western end and in front of the structure. Within a year of the structure being constructed, there was erosion of the foredune at the north-western end of the revetment, which may have been as a result of 'end effects' from the structure (Tonkin & Taylor, 2001).

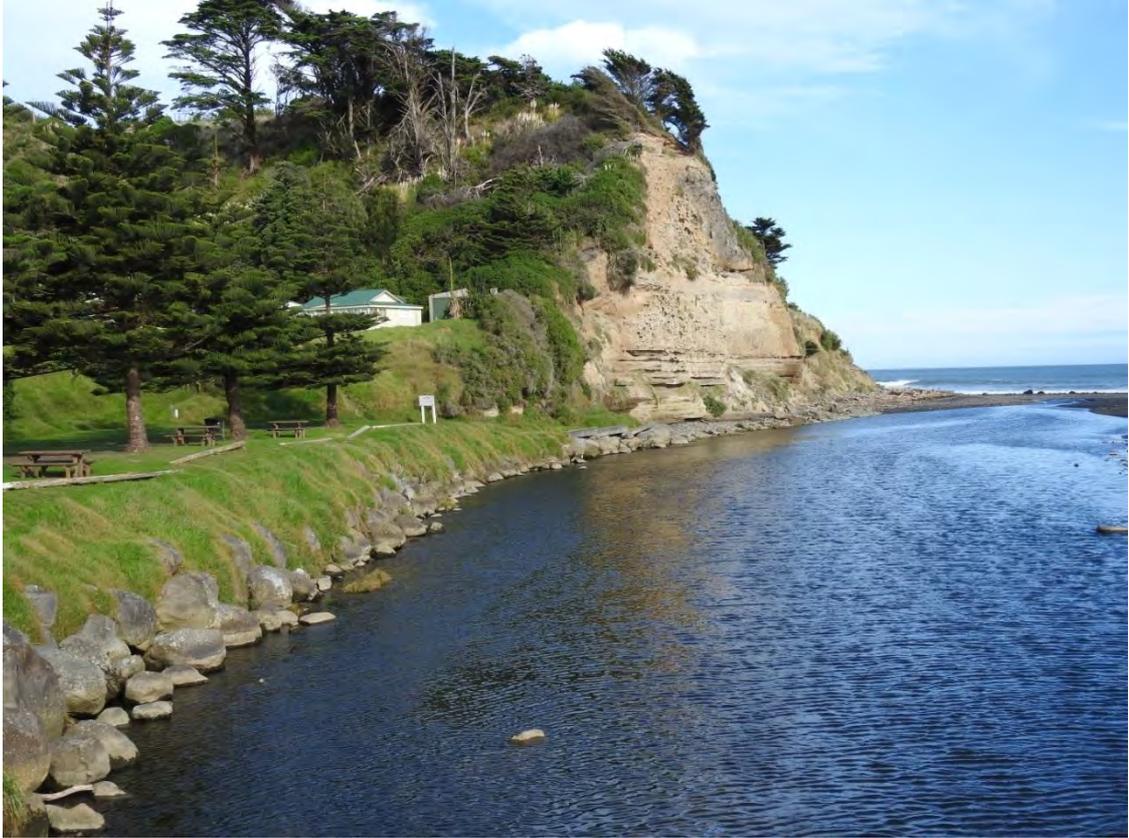
Photo 3 Looking upstream along rock protection works in the Kaupokonui Stream (May 2015)

Following receipt of a complaint regarding works in the Kaupokonui Stream in 2002, investigation by Council officers discovered that substantial boulder rock rip rap had been placed on the true left bank of the Kaupokonui Stream (Photo 3).

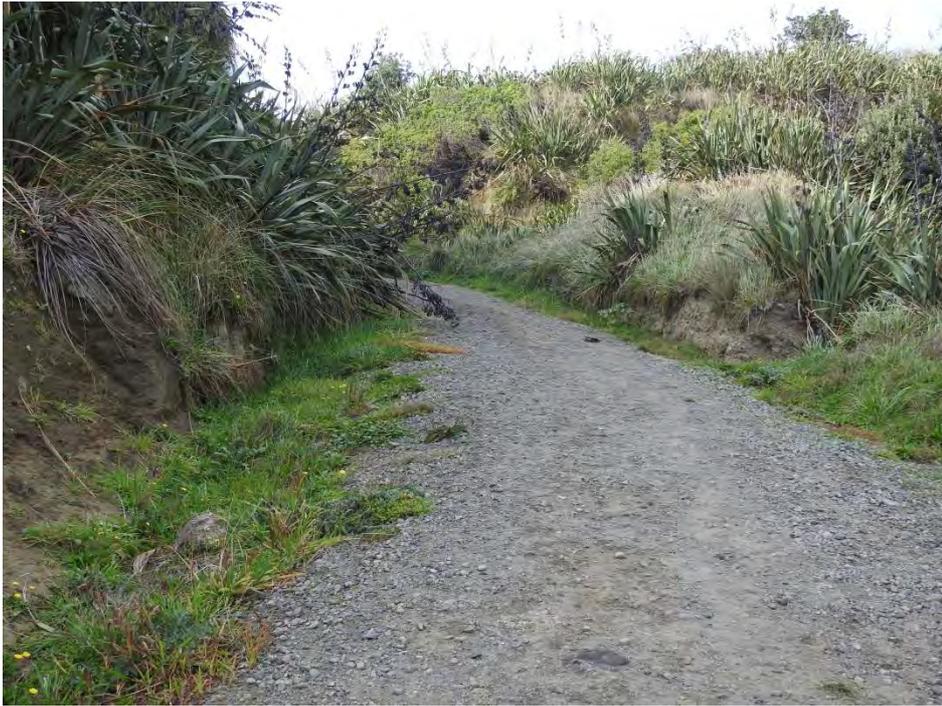
Photo 4 Beach track at the end of Denby Road leading to the gabion mattress consented under 6736.

STDC installed a gabion mattress at the bottom of the access track with the intention of improving access to the beach and helping control the erosion problems. This structure is authorised by coastal permit 6736. The gabion mattress measured 6 m x 2 m x 0.23 m in size and was placed on existing rocks. Surrounding the rocks a geo textile fabric was used to prevent the scouring of sand and to increase the longevity of the structure. Once completed, the structure was covered in concrete to further aid pedestrian access. The structure is authorised by coastal permit 6736.

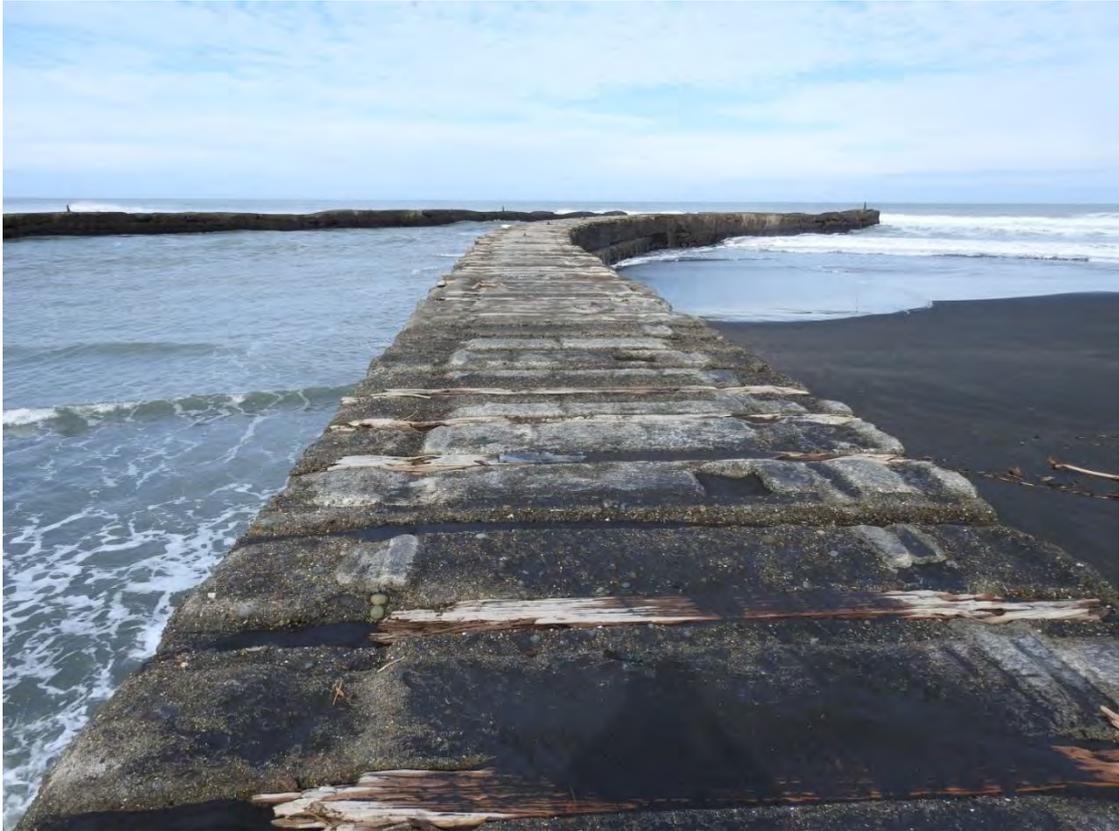
Photo 5 Patea groynes (May 2016)

this could result in the passage between the river and sea becoming no longer navigable. From the studies undertaken by Duffill Watts & King (2006), it was found that without some intervention process the Patea River will break through behind the southeast mole within 20 to 25 years which would prevent navigable access to the sea. It was proposed that the most effective method to maintain a navigable river entrance for small seagoing craft was to reconstruct the southeast seawall. Consent **6839** was granted by the Council authorising the works, which aimed to constrain the river channel to its existing alignment and prevent it from breaking through behind the left mole (Photo 5).

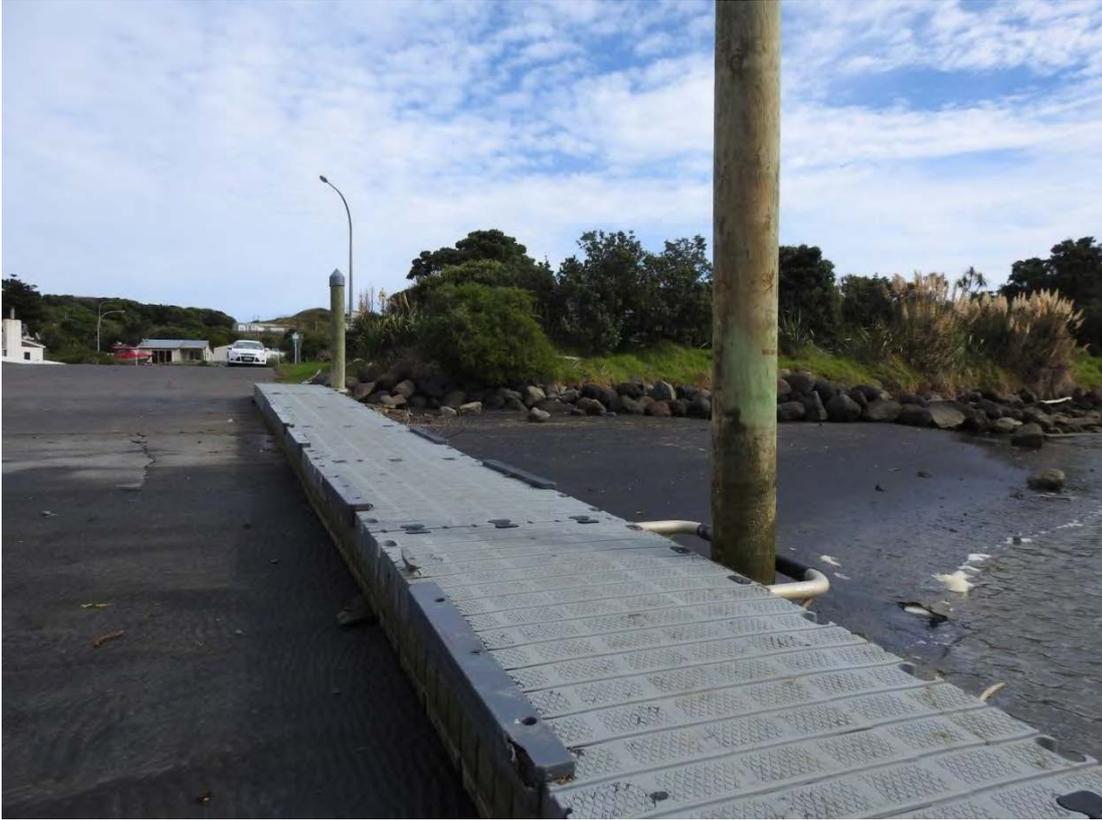
Photo 6 Patea boat ramp (May 2016)

The boat ramp at Patea has been in existence for many years, providing one of the few effective and safe boat launching facilities on the South Taranaki coast (Photo 6). The facilities are used extensively and are considered to be one of Patea's more important recreational facilities.

The launching ramp was an undular concrete pad which extended from the end of the formed roadway of Turi Street, down to approximately the low tide level of the river. Upon granting of coastal permit **4566**, the STDC strengthened the existing boat launching ramp by placing a concrete strengthening overlay over the existing ramp. The overlay is 7 m wide and extends a further 3 m down into the river than the previous ramp, improving the launching facility.

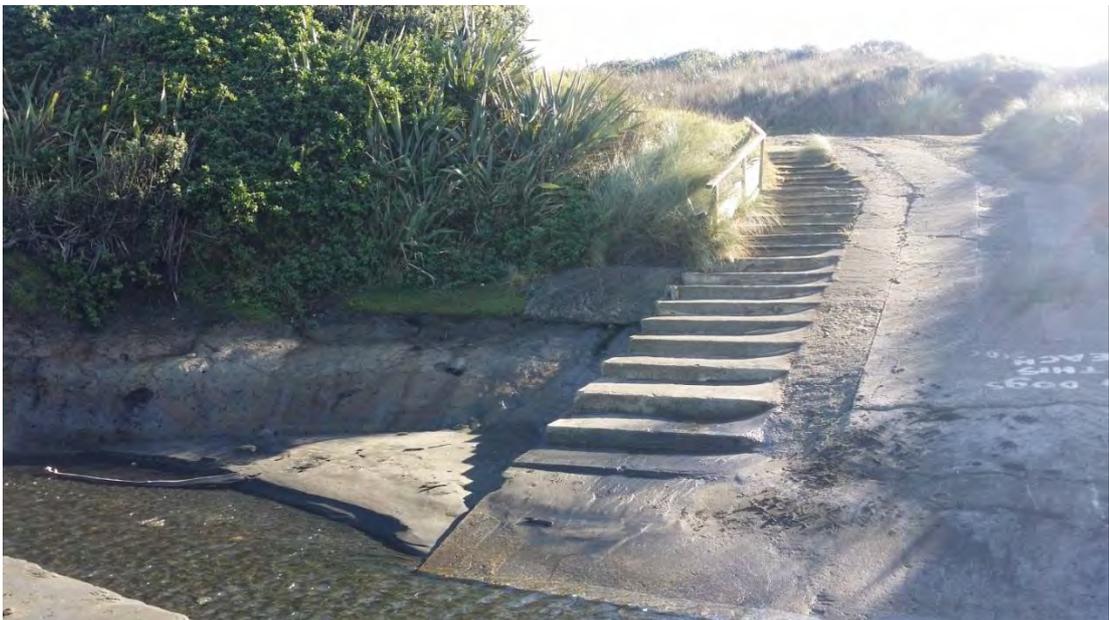
Photo 7 Access to Waverley Beach (May 2015)

The structure covered by consent **4579** consists of a concrete public access ramp way, 20 m in length and 3 m in width with an associated 2 m wide by 16 m long concrete step-way down the western edge of the ramp (Photo 7). The ramp extends down to the beach sands from the upper ground level of the mudstone coastal bluffs, providing access to Caves Beach, again reducing pedestrian damage of the fragile sand dunes.

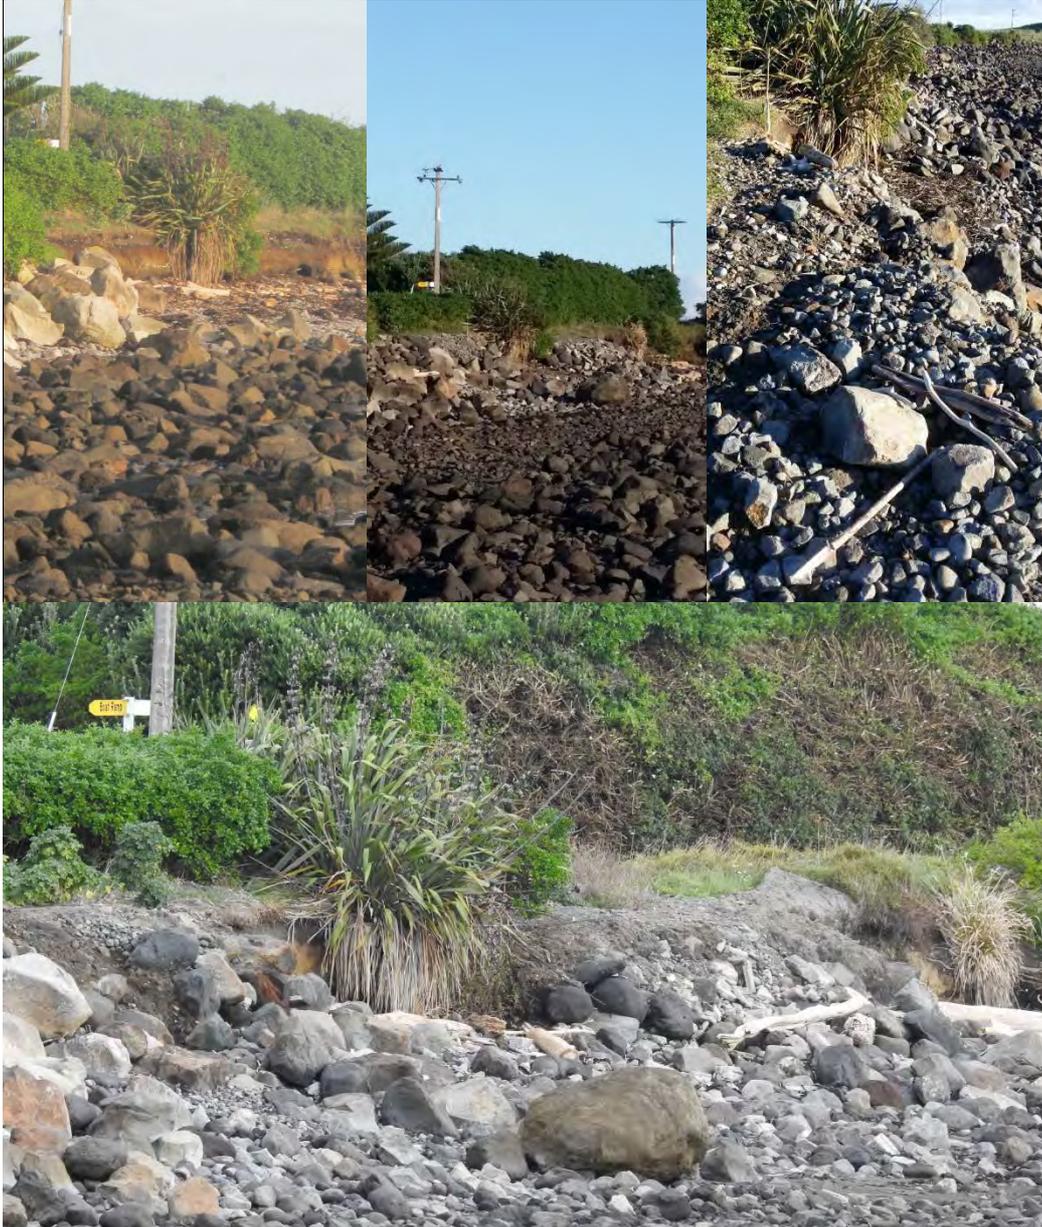
Photo 8 Bayly Road seawall (top left erosion on the south side of the seawall May 2014, top centre and right rubble used to prevent further erosion May 2015, bottom rubble remaining in place May 2016)

An inspection of the Bayly Road seawall was undertaken on 4 May 2016. The rip rap appeared satisfactory and areas of previous erosion at the south remained filled in with rubble (Photo 8).

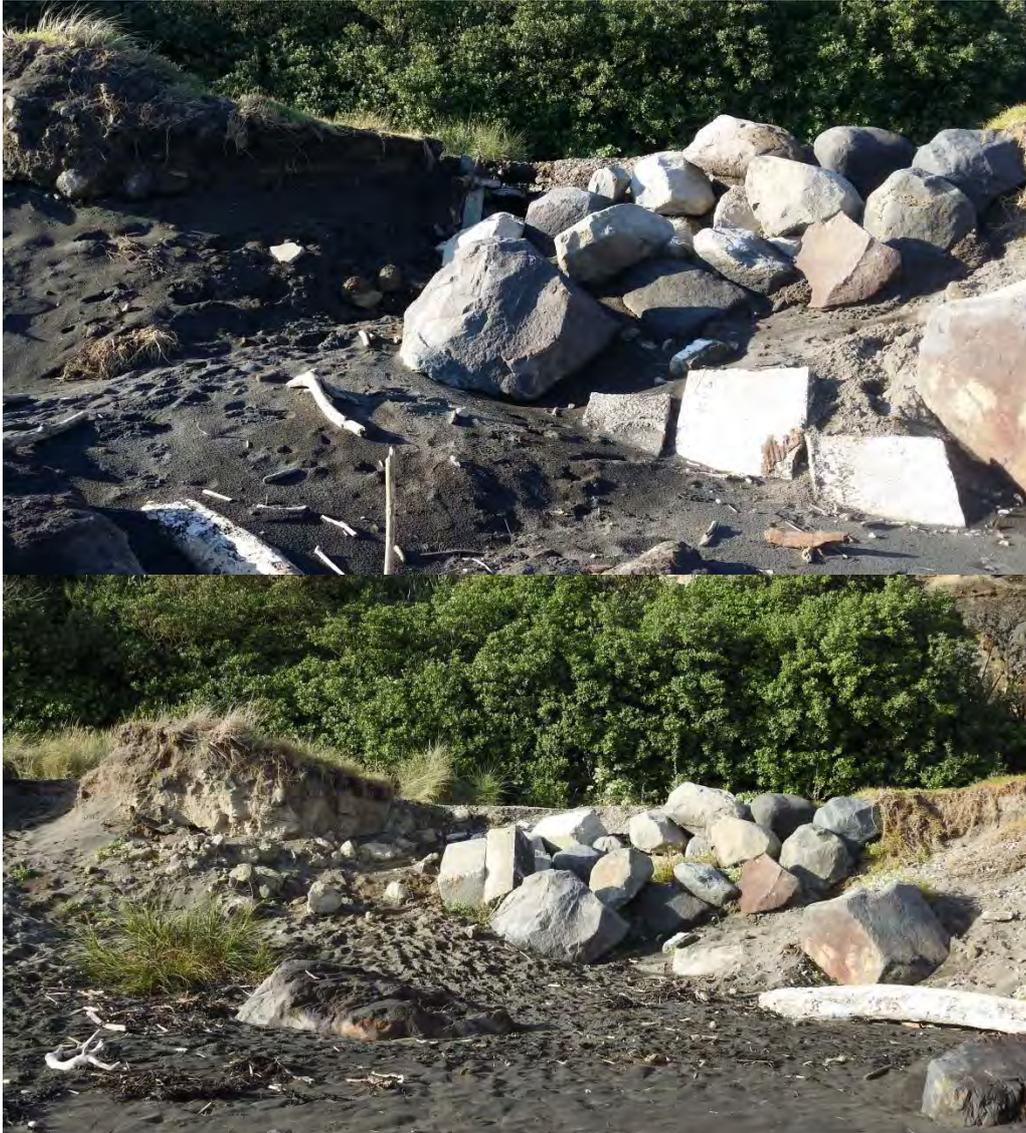
Photo 9 Erosion at the north-west end of the Middleton Bay seawall (top May 2015, bottom May 2016)

An inspection of the Middleton Bay seawall was undertaken on 4 May 2016. The seawall itself was in good condition (Photo 2). The area to the north west of the wall was checked for potential end effects. Erosion was evident off the north-west end of

the seawall where an area of the bank was being used as an access track to the beach (Photo 9). Use of this track appeared to be accelerating erosion of the bank.

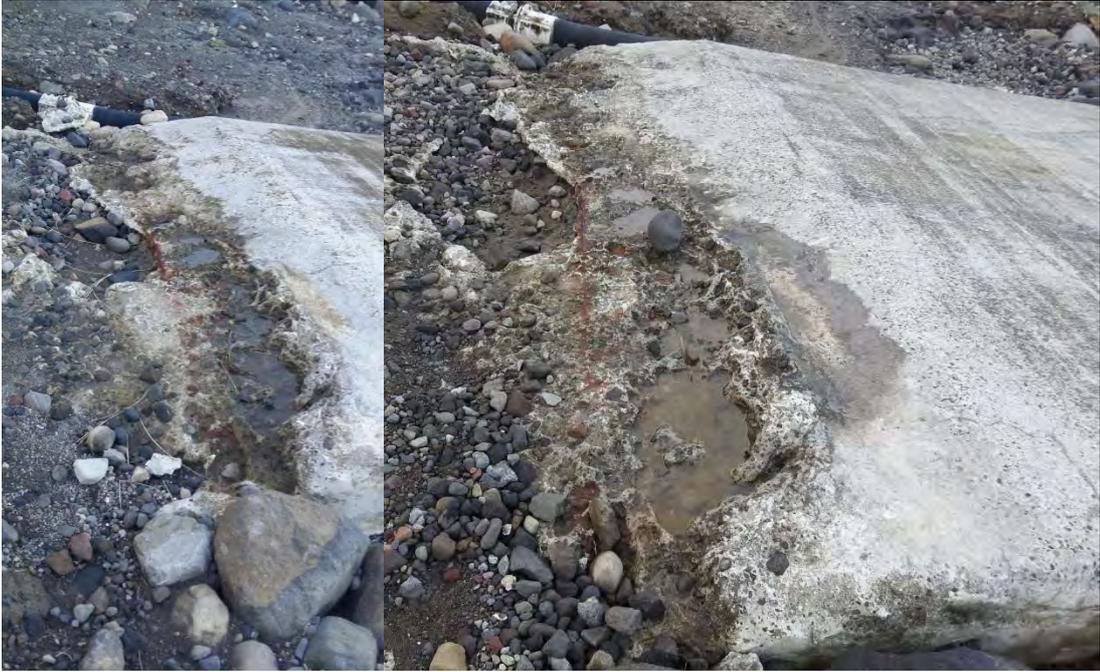
Photo 10 Top section of the Opunake Beach boat ramp (left May 2015, right May 2016)

An inspection of the Opunake Bay boat ramp was undertaken on 4 May 2016. The structure appeared to be in satisfactory condition. There was some erosion above the top end of the boat ramp which could potentially cause access difficulty for some vehicles (Photo 10).

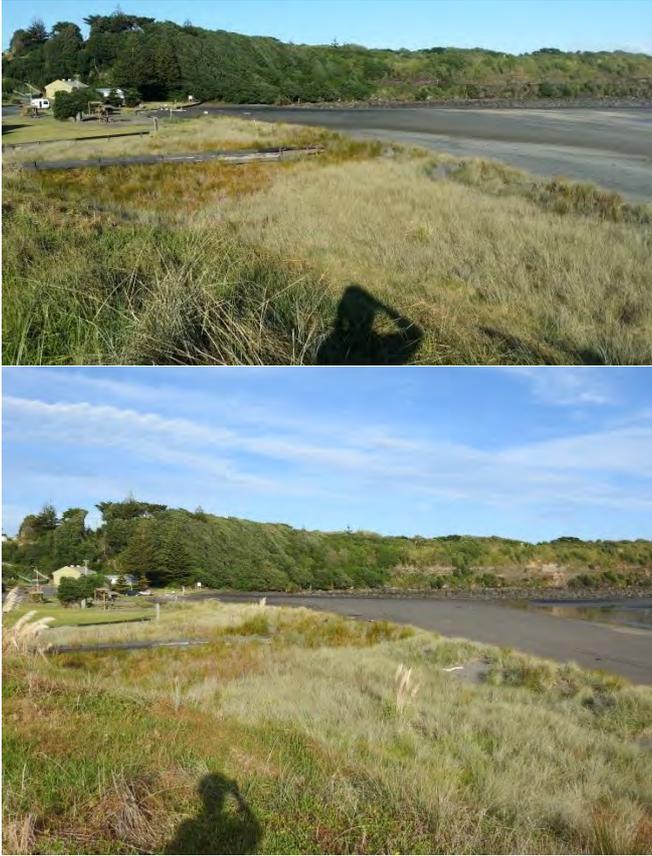
Photo 11 Dune planting at Opunake Beach (top May 2015, bottom May 2016)

The rip rap wall at the north-west end of Opunake Beach appeared to be sound when inspected on 4 May 2016. The retaining wall consented under 4578-2 is buried under the dunes therefore it is not possible to address the integrity of the structure during the inspection. The dune planting in front of the Surf Life Saving Club, carried out early in 2011, appeared to have been effective as there was no obvious erosion of the dunes at the time of inspection (Photo 11).

During the 2013-2014 period STDC had undertaken works to remove the build-up of sand from the top of the retaining wall. No additional work was required over the period under review (2015-2016).

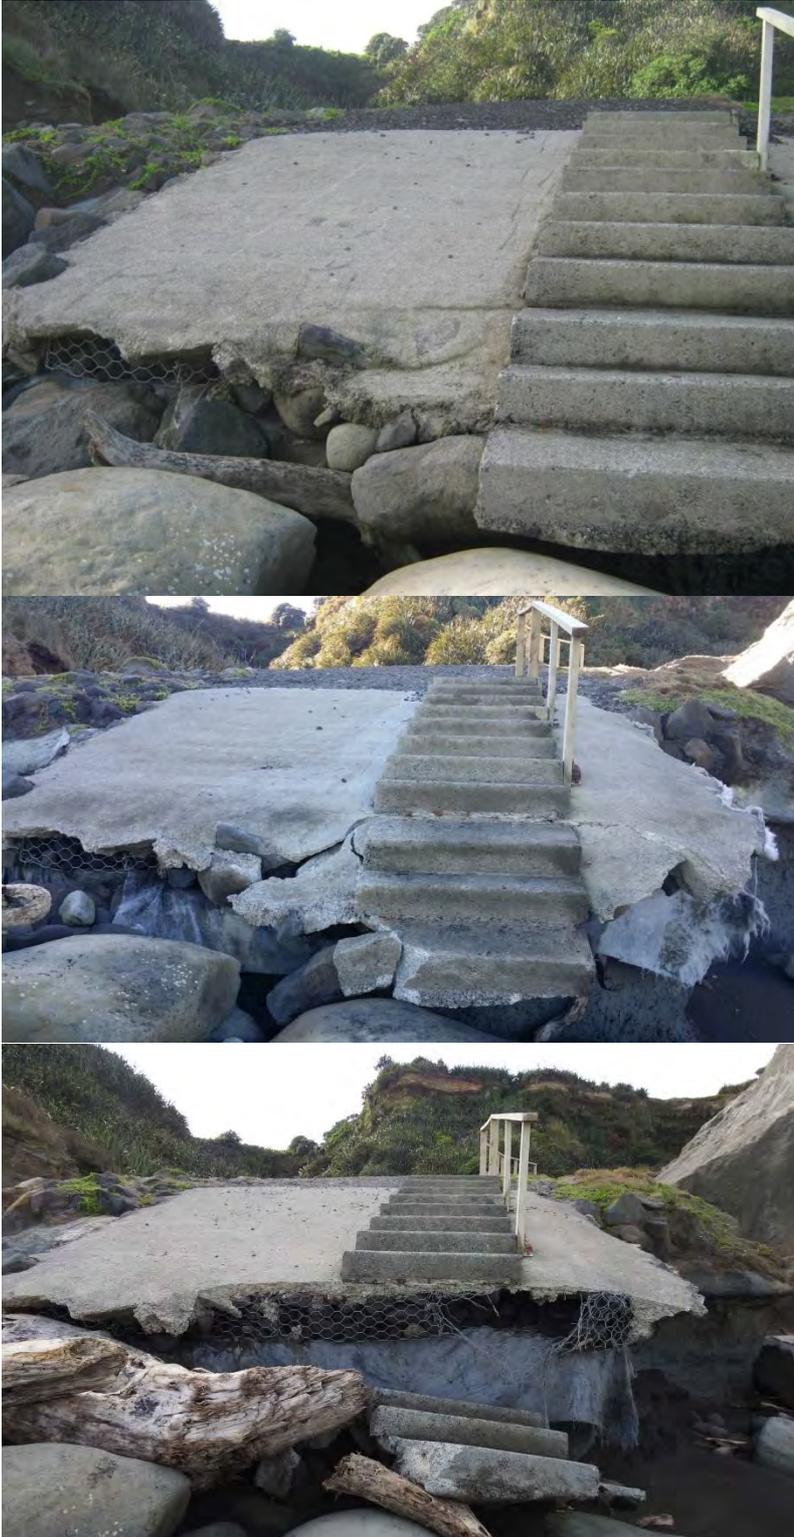
Photo 12 Access way to Waihi Beach, Hawera (above May 2014, middle May 2015, below May 2016)

Wave and weather damage at the base of the structure appeared to have worsened over the 2015-2016 period (Photo 12). At the time of inspections it was questionable whether the ramp was fit for purpose (Consent 6736) i.e. to allow emergency access to the beach. The three lower steps had been separated from the rest of the structure.

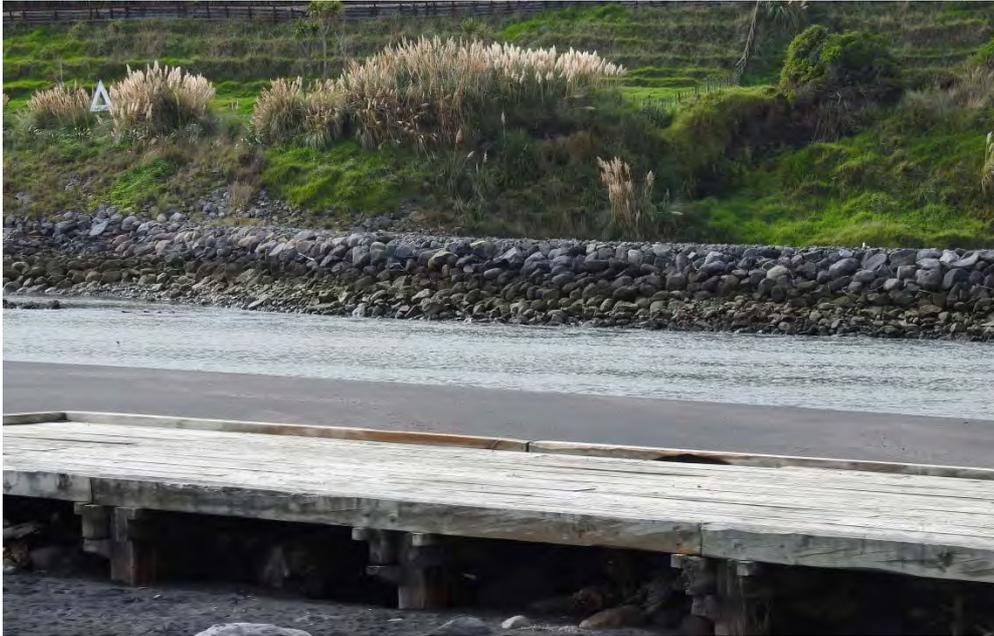
Photo 13 Training wall at Patea shown on the far side of the river (May 2016)

without divers. Areas of damage on the training wall noted in previous inspections had been repaired and were not evident during the March 2013, May 2014, May 2015 or May 2016 inspections (Photo 13). Mana Bay seawall and Carlyle Beach rock protections were also inspected and photographs are available on request.

STDC have been undertaking significant repairs in this area, since works began in 2006. STDC continued repair works to the Patea groynes and training walls over the 2013-2014 period with an expenditure of approximately \$40,000 associated with repairs to the eastern training wall in 2013.

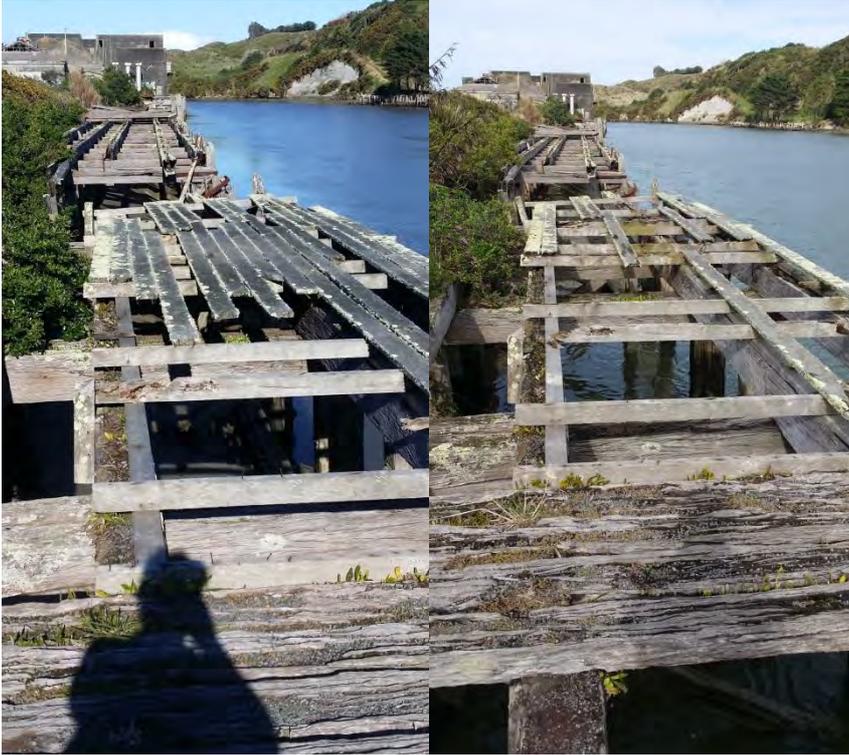
Photo 14 Old Patea wharf (left May 2015, right May 2016)

As noted in previous inspections, the wharf was in a dilapidated state and had been so for some time. No improvements were noted during the inspections carried out on 4 May 2016 (Photo 14).

The consent for this structure was renewed on 23 June 2010 with reduced maintenance requirements. This allows STDC to continue to occupy the space provided the derelict wharf does not pose a navigational hazard. No warning signs had been erected to warn the public of the unsafe structure.

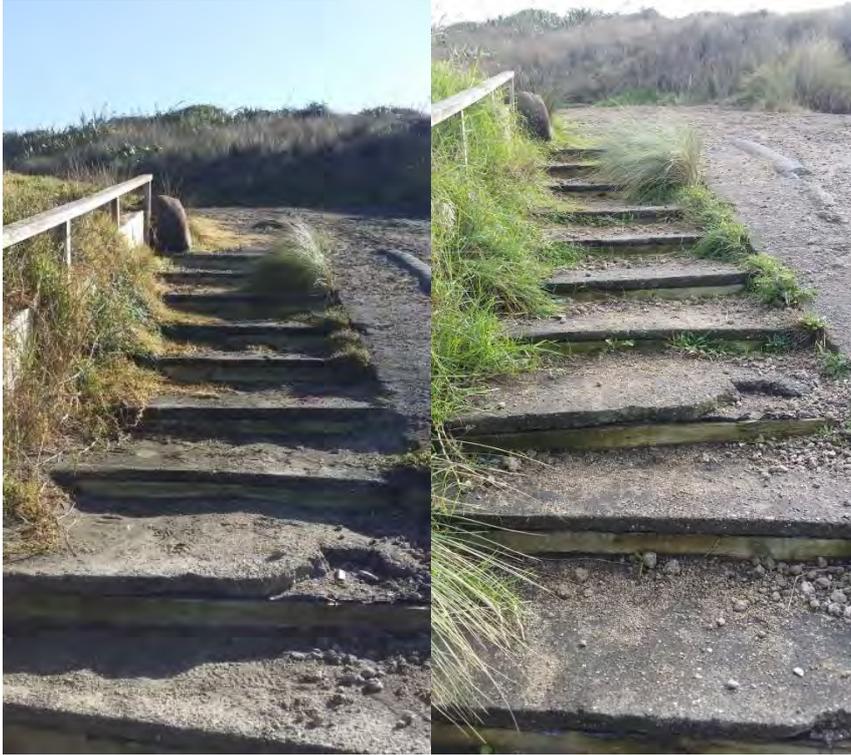
Photo 15 Access to Caves Beach, Waverley (right May 2015, left May 2016)

Waverley Beach was visited on 4 May 2016. In general, the access ramp down to Waverley Beach was in a satisfactory condition. The access to Caves Beach had sections of concrete missing from the middle steps (Photo 15). This area of damage showed no significant deterioration since the previous inspection in May 2015. During the March 2013 inspection the top steps were overgrown with vegetation. This had been cleared by the May 2014 inspection. During the 2015 and 2016 inspections, although there was some grass growing onto the steps, this did not impinge access to the beach.
