STDC Coastal Structures  
Monitoring Programme  
Annual Report  
2018-2019

Technical Report 2019-27

Taranaki Regional Council  
Private Bag 713  
STRATFORD  
September 2019

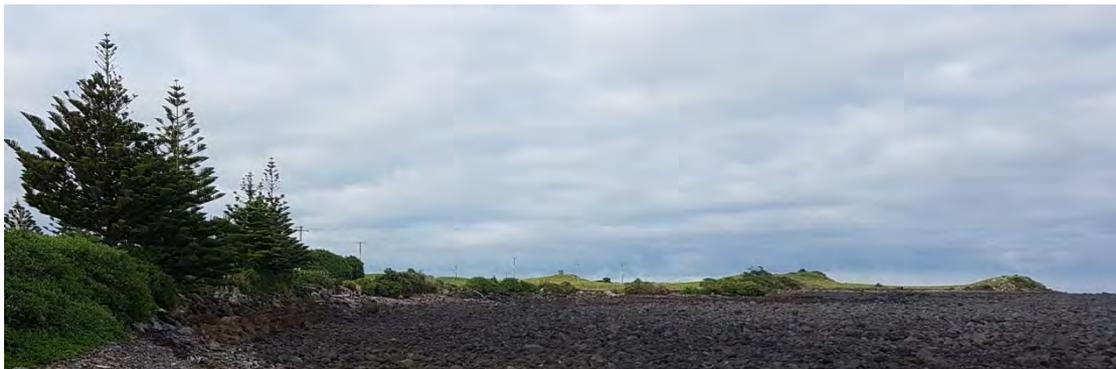
Photo 1 Bayly Road seawall (April 2017)

As a result of the works, the boulder protection now extends from the boat ramp in the north to the pre-existing 40 m of boulder protection south of Bayly Road, with a total length of approximately 290 m (Photo 1).

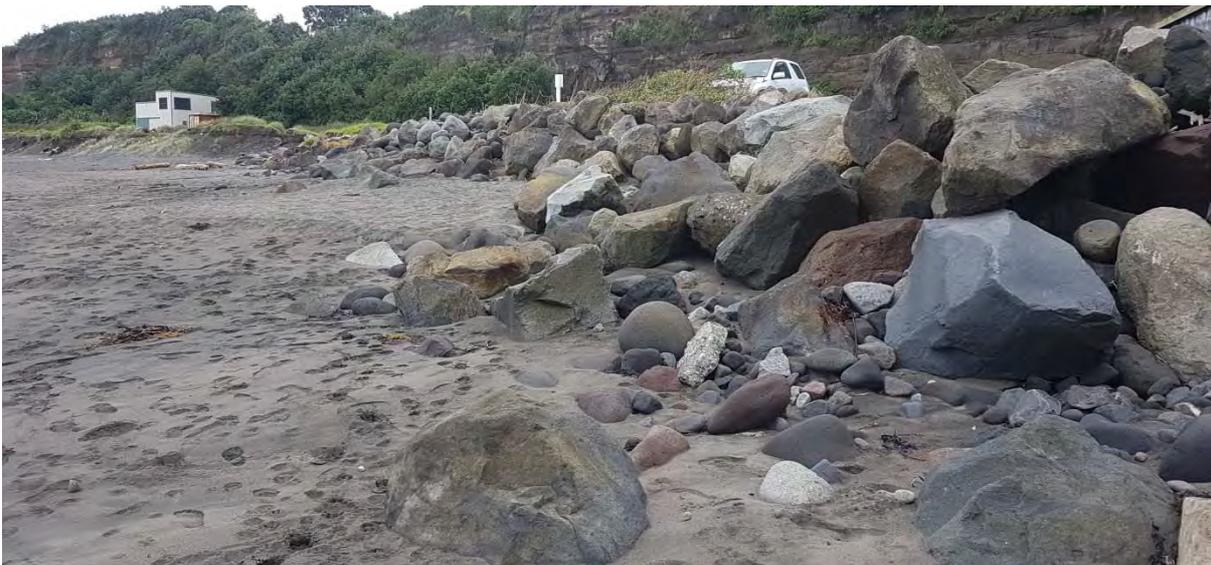
Photo 2 Rip-rap seawall, Middleton Bay (April 2017)

Due to Middleton Bay being a pocket sand beach, and the location of the revetment being well forward towards the surf zone, there is a high potential for adverse effects to the soft shoreline at the north-western end and in front of the structure. Within a year of the structure being constructed, there was erosion of the foredune at the north-western end of the revetment, which may have been as a result of 'end effects' from the structure (Tonkin & Taylor, 2001).

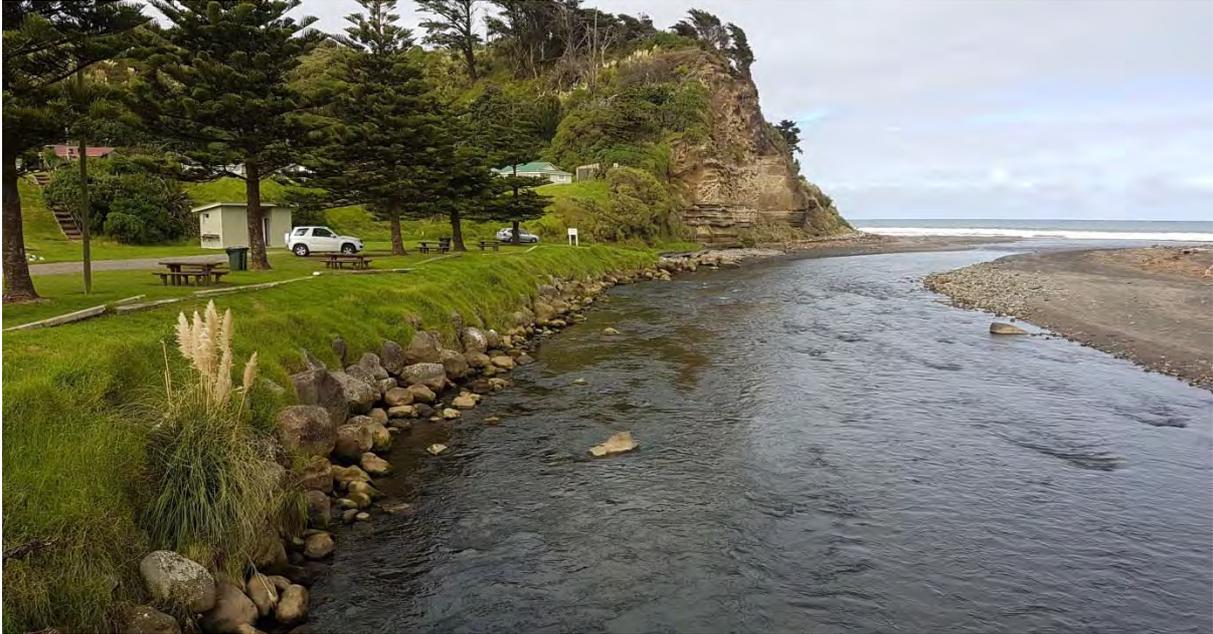
Photo 3 Looking downstream along rock protection works in the Kaupokonui Stream (April 2017)

Following receipt of a complaint regarding works in the Kaupokonui Stream in 2002, investigation by Council officers discovered that substantial boulder rock rip rap had been placed on the true left bank of the Kaupokonui Stream (Photo 3).

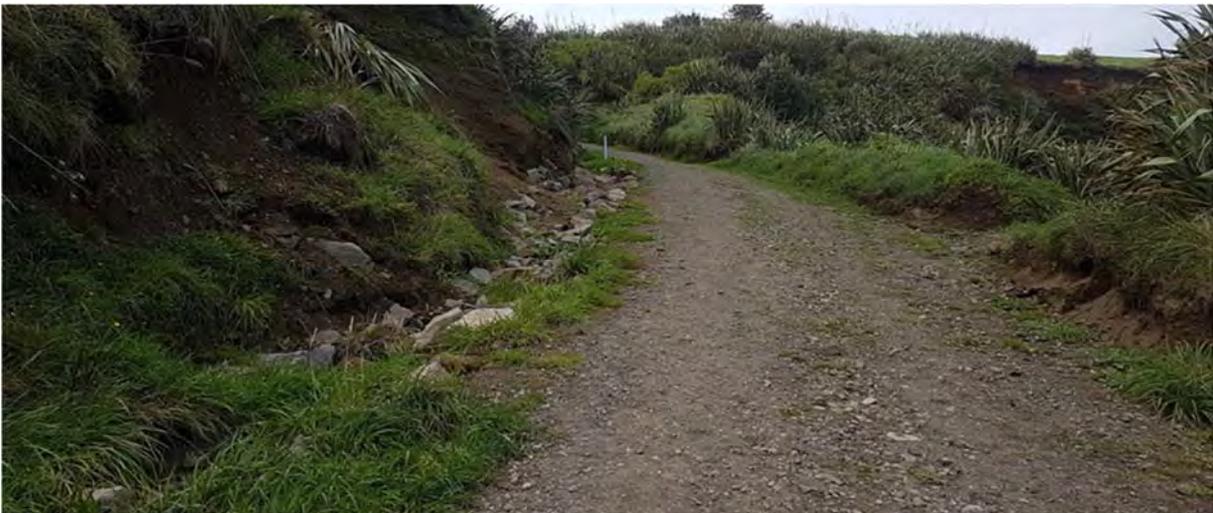
Photo 4 Beach track at the end of Denby Road leading to the gabion mattress consented under 6736 (April 2017)

STDC installed a gabion mattress at the bottom of the access track with the intention of improving access to the beach and helping control the erosion problems. The mattress measured 6 m x 2 m x 0.23 m in size and was placed on existing rocks. Surrounding the rocks a geo textile fabric was used to prevent the scouring of sand and to increase the longevity of the structure. Once completed, the structure was covered in concrete to further aid pedestrian access. The structure is authorised by coastal permit **6736**.

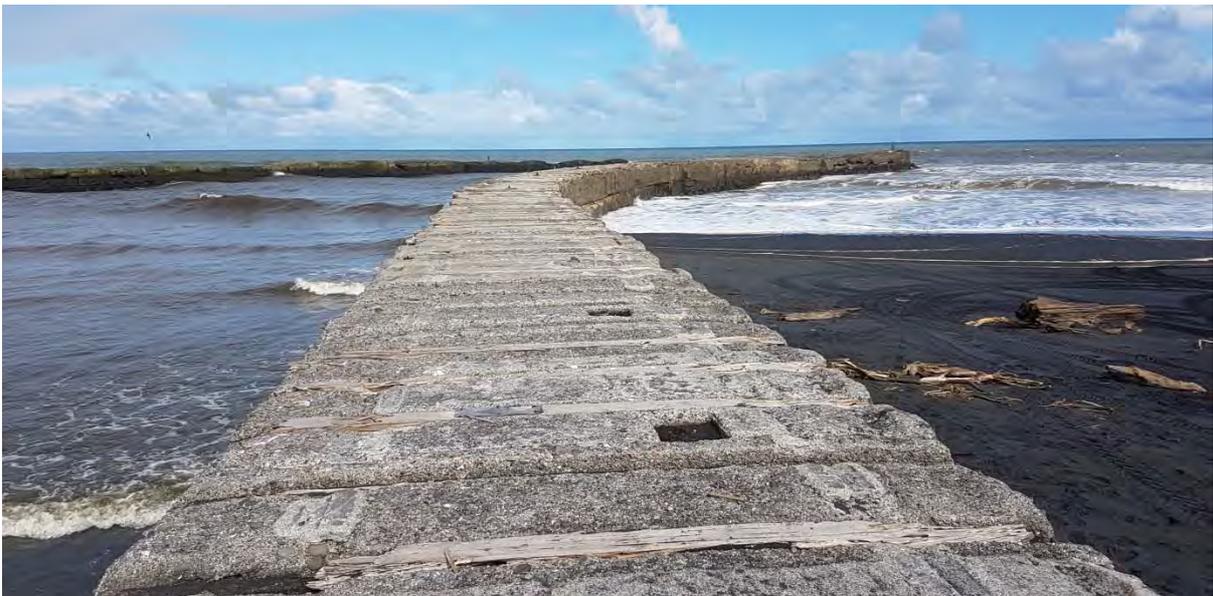
Photo 5 Patea groynes (April 2017)

Significant levels of erosion occurred along this coastline during the past 50 years which led to the river moles becoming seriously degraded. Studies undertaken by consultants (Duffill Watts & King, 2006) showed that with the condition of the moles and rate of shoreline change, the river moles could decay, threatening the overall stability of the river entrance. If the stability of the river entrance changed, this could result in the passage between the river and sea becoming no longer navigable. From the studies undertaken by Duffill, Watts & King (2006), it was found that without some intervention process the Patea River would break through behind the southeast mole within 20 to 25 years and prevent navigable access to the sea. It was proposed that the most effective method to maintain a navigable river entrance for small seagoing craft was to reconstruct the southeast seawall. Consent **6839** was granted by the Council authorising the works, which aimed to constrain the river channel to its existing alignment and prevent it from breaking through behind the left mole (Photo 5).

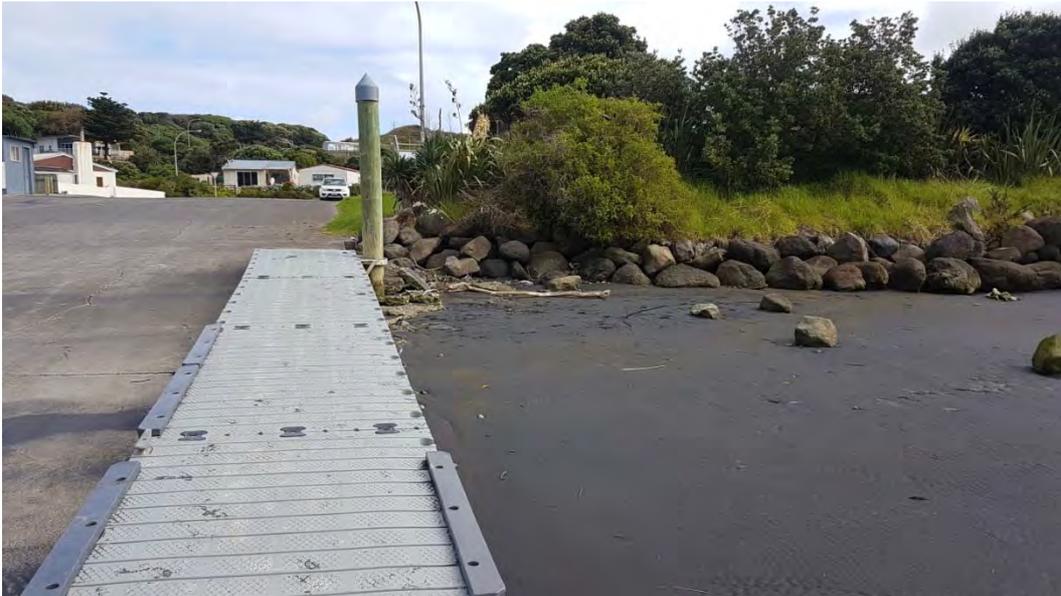
Photo 6 Patea boat ramp (April 2017)

The boat ramp at Patea has been in existence for many years, providing one of the few effective and safe boat launching facilities on the South Taranaki coast (Photo 6). The facilities are used extensively and are considered to be one of Patea's more important recreational facilities.

The launching ramp was an undular concrete pad which extended from the end of the formed roadway of Turi Street, down to approximately the low tide level of the river. Upon granting of coastal permit **4566**, the STDC strengthened the existing boat launching ramp by placing a concrete strengthening overlay over the existing ramp. The overlay is 7 m wide and extends a further 3 m down into the river than the previous ramp, improving the launching facility.

The overlay was contoured so it is more consistent with natural beach profiles than the previous ramp and is therefore expected to have less effect on riverbed/beach processes than the previous ramp. In association with expanding and strengthening the ramp, the STDC reinstated and rock protected the eroding riverbank both immediately upstream and downstream of the ramp. The bank protection was wrapped smoothly into the existing bank and aligned in a manner which is compatible with wave refraction/diffraction patterns and which will not adversely affect natural river processes.

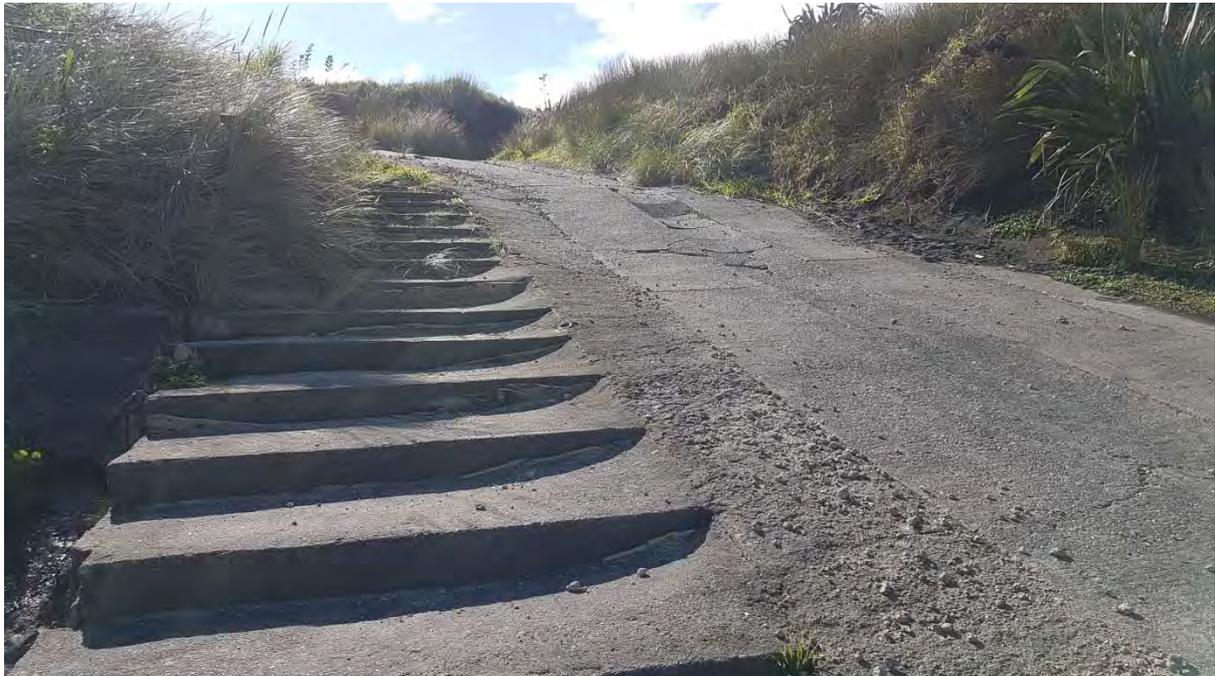
Photo 7 Access to Waverley Beach (April 2017)

The structure covered by consent **4579** consists of a concrete public access ramp way, 20 m in length and 3 m in width with an associated 2 m wide by 16 m long concrete step-way down the western edge of the ramp (Photo 7). The ramp extends down to the beach sands from the upper ground level of the mudstone coastal bluffs, providing access to Caves Beach, again reducing pedestrian damage of the fragile sand dunes.

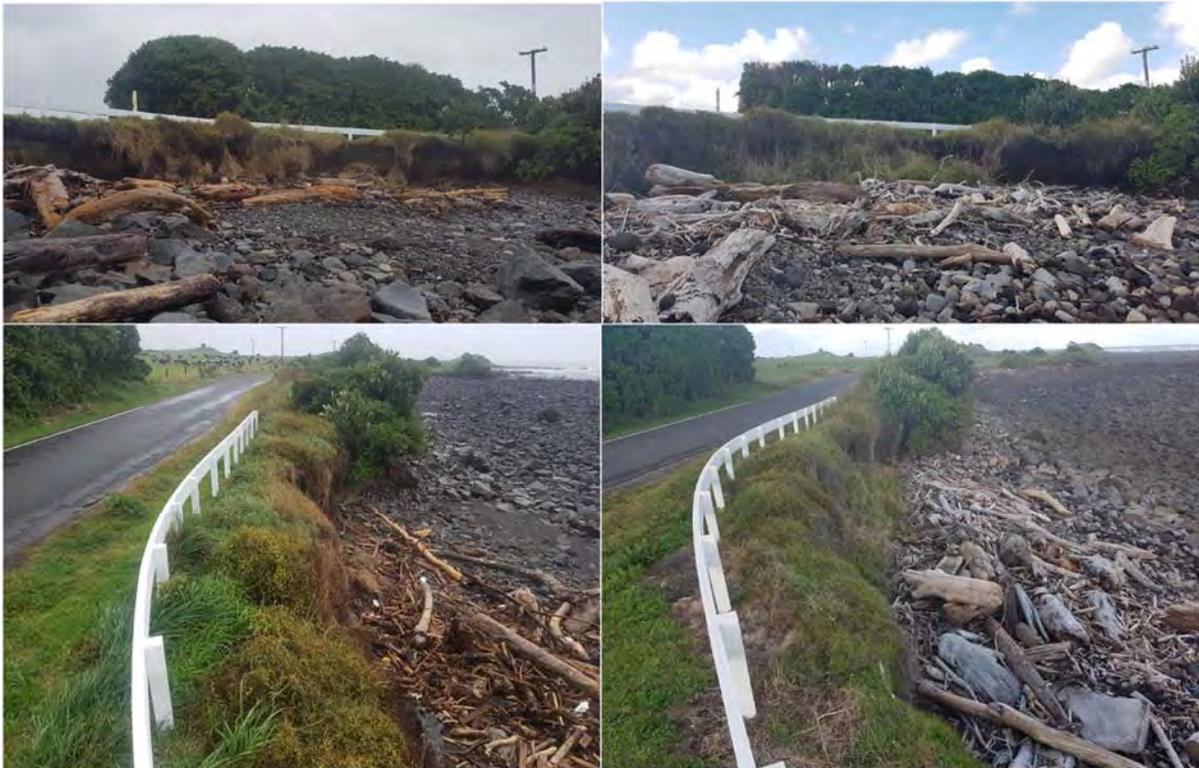
Photo 8 Bayly Road erosion, 11 May 2018 (left) and 12 April 2019 (right)

An inspection of the Bayly Road seawall was undertaken on 12 April 2019. As per the previous inspection, there were a number of sections along the scarp where scour and erosion were evident. This appeared to be a result of decreased wave protection due to slumping and/or loss of material from the seawall. Significant erosion at the intersection between Bayly and Coast Roads was still evident although the scarp was now covered with overgrown grass (Photo 8). The repair works which had been planned in the previous year had not been carried out. No wider environmental effects were apparent. The current state of this structure is non-compliant with resource consent 5512-2.

12/04/19	Bayly Road seawall (5512-2) found in a degraded condition (no wider environmental effects were noted).	N	14-day letter sent requesting explanation for non-compliance.	Designs for seawall reinstatement currently being prepared. Repair works to commence following tender process. No further enforcement action required.
12/04/19	Northern end of Middleton Bay seawall (5504-1) found in a degraded condition (possible end effects occurring).	N	Nil	Remedial works to be undertaken once renewed resource consent is granted.

The seawall at Bayly Road was found in the same state as it was in the previous year. That is, the slumped sections of the seawall and the eroded sections of the scarp had not been repaired. Very little distance remains between the eroding edge of the scarp and the intersection between Coast and Bayly Roads. The current state of this structure is non-compliant with resource consent 5512-2. No wider environmental effects were discovered.

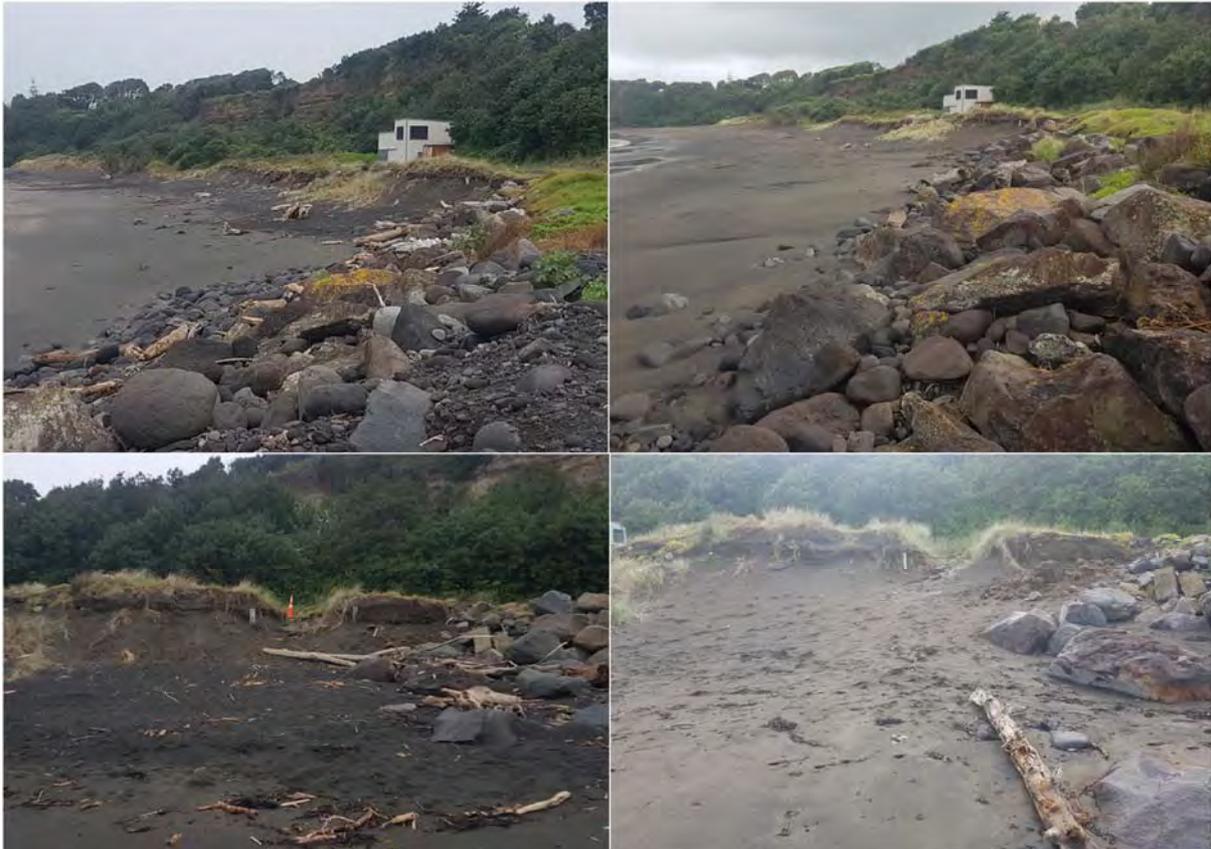
Photo 9 Northern end of Middleton Bay seawall, 11 May 2018 (left) and 12 April 2019 (right)

An inspection of the Middleton Bay seawall was undertaken on 12 April 2019. The structure and adjacent coast was found in similar condition to the previous inspection. Most of the seawall structure appeared to have remained in good condition, except for the northern end where it has deteriorated to a condition which is not compliant with resource consent 5504-1 (Photo 9). The obvious scouring adjacent to the northern end of the wall may be attributable to end effects, though it is likely accelerated by pedestrian beach access. Further around the bay, the dunes appeared to be in a similar condition to the previous year (Photo 9).

The northern end of the Middleton Bay seawall was found in a degraded condition, with boulders beginning to scatter across the beach. According to STDC, this end of the wall is set to be repaired following issue of the renewed consent. Currently, the structure is non-compliant with resource consent 5504-1.

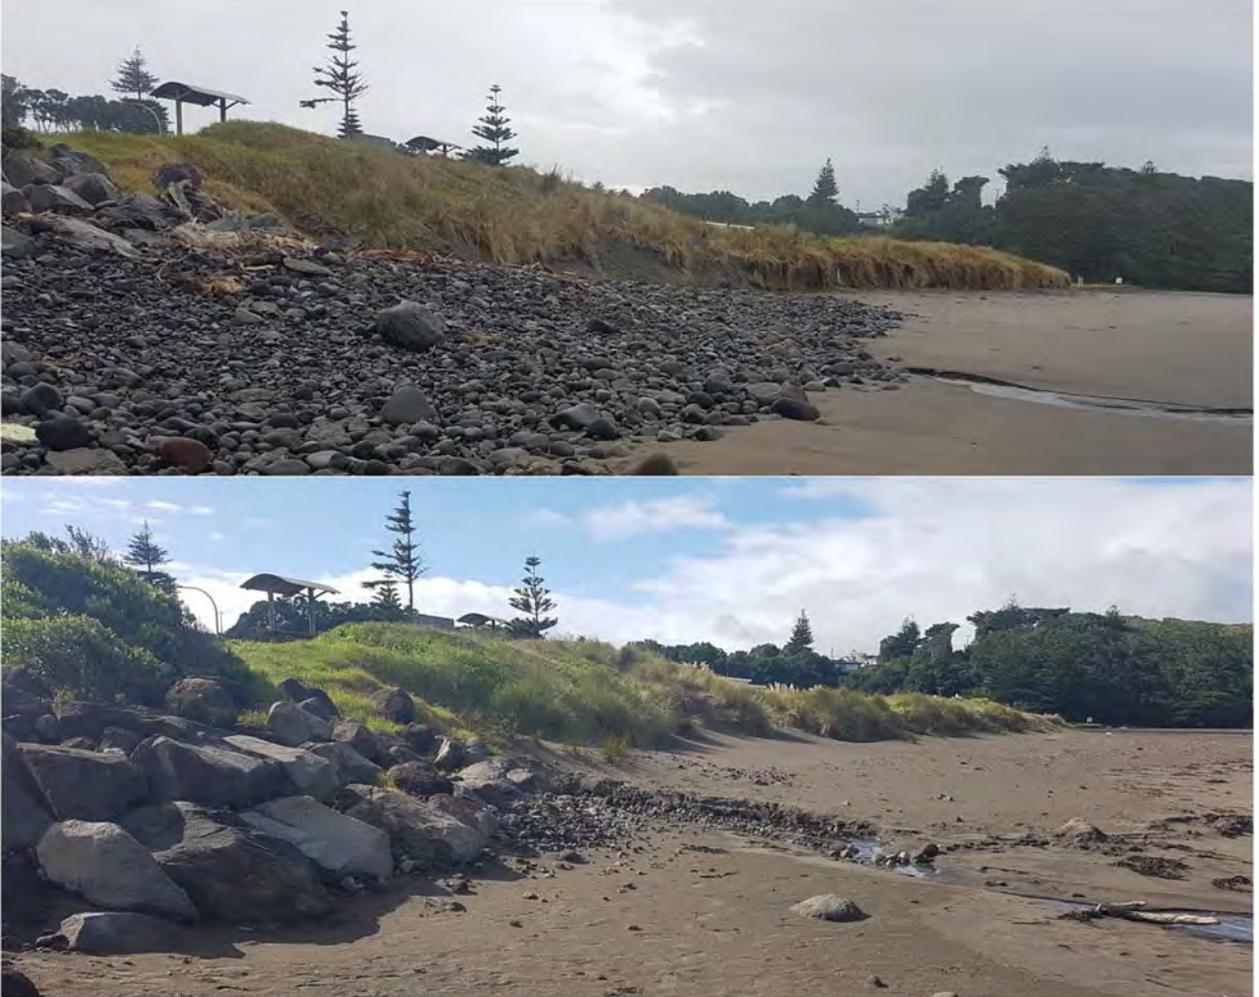
Photo 10 Dune toe recovery at Opunake Beach, May 2018 (top) and April 2019 (bottom)

There did not appear to be any structural issues with the seawall at the northern end of Opunake Beach when inspected on 12 April 2019. The cobble patch that was present high on the shore in 2018 had been shifted and/or buried by the increased volume of sand that was noted across the beach (Photo 10). A considerable length of retaining wall in front of the surf club remains buried under the dunes therefore it was not possible to assess the integrity of this structure. The associated access ramps appeared to be in good condition. The dune toe appeared to be recovering following the erosion event which occurred earlier

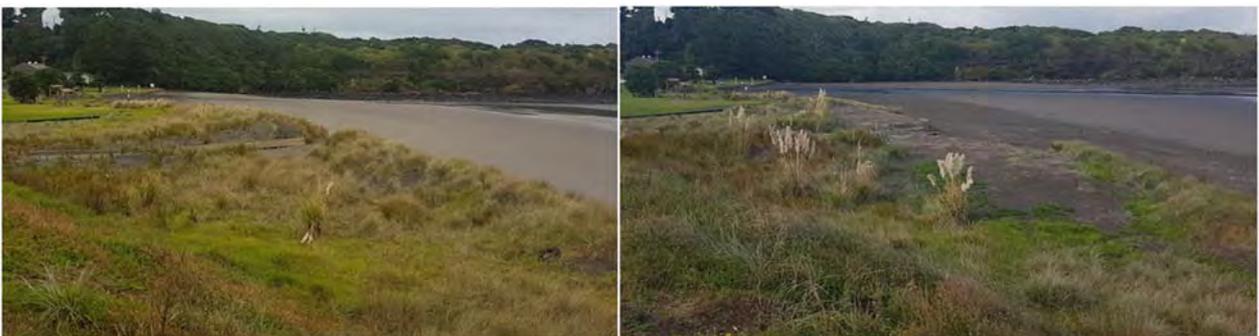
Photo 11 Fore dune in front of surf club at Opunake Beach, May 2018 (left) and April 2019 (right)

in 2018 (Photo 10). STDC's dune lowering work was also evident (Photo 11). Further south along the beach, the exposed sections of the pylon retaining wall showed signs of deterioration.

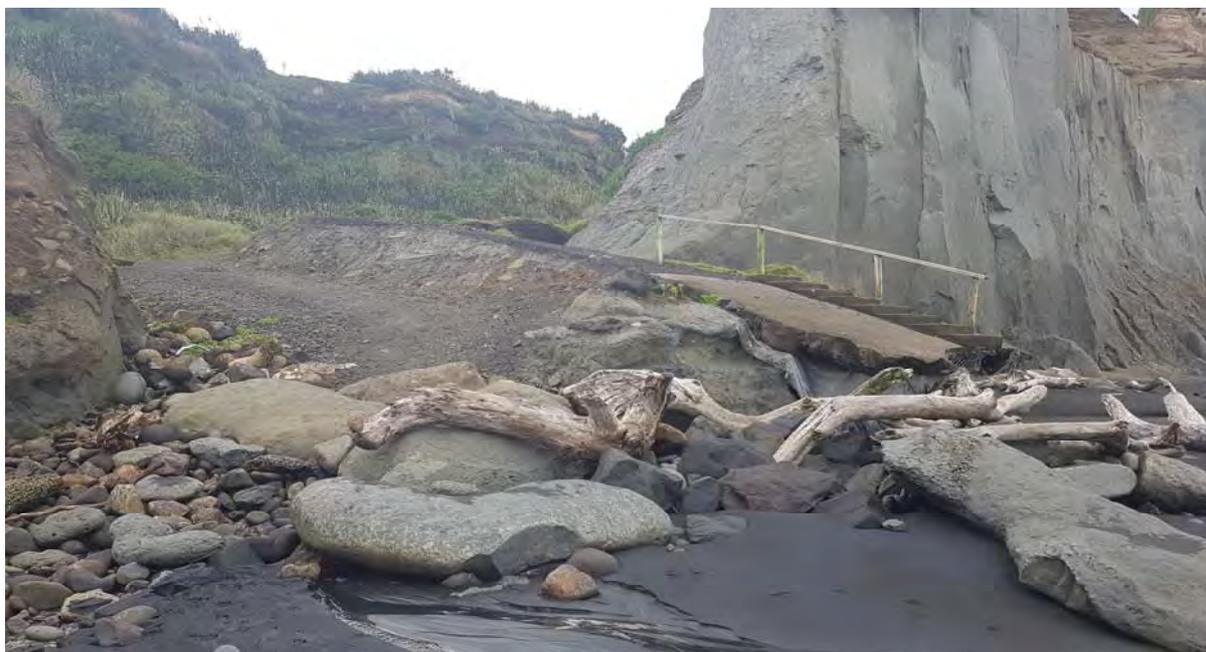
Photo 12 Denby Road access to Waihi Beach, 11 April 2019

The Waihi Beach access ramp was inspected on 11 April 2019. Since the previous inspection, an alternative access track had been excavated adjacent to the consented structure (Photo 12). All works were undertaken above mean high water springs and as such did not require a resource consent. This alternative track has improved beach accessibility. As per recent inspections, the remnant consented access structure is in a highly degraded state, and is continuing to be undermined by the tide. In this current state, the structure remains non-compliant with resource consent 6736-1.

Date	Details	Compliant (Y/N)	Enforcement Action Taken?	Outcome
11/04/19	Denby Road access structure (6736-1) found in a degraded condition (no wider environmental effects were noted).	N	14-day letter sent requesting explanation for non-compliance.	STDC have erected pedestrian barriers and signage to prevent further use of the degraded structure. Removal is being considered as part of a wider project planned for Waihi Beach. No further enforcement action required.
11/04/19	Eastern end of Mana Bay seawall (4573-2) found in a potentially dangerous condition (no wider environmental effects were noted).	N	Safety concerns raised with STDC shortly after inspection, 14-day letter subsequently sent requesting explanation for non-compliance.	STDC have engaged professional surveyors to assess the seawall and other structures at the river mouth. Following this, repair works will be undertaken as necessary (current likelihood of boulders shifting has been deemed low). No further enforcement action required.

An alternative access way had been excavated at Denby Road, ultimately improving beach access at this site. However, the original access structure is continuing to deteriorate, as the sea undermines the underlying substrate. In this current state, the structure remains non-compliant with resource consent 6736-1. No wider environmental effects were discovered.

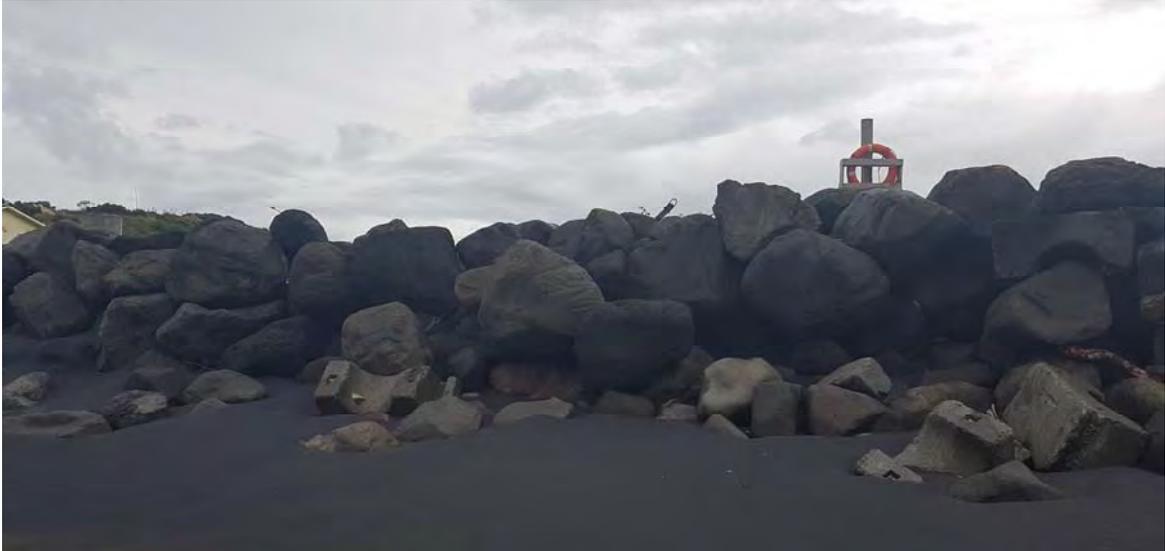
Photo 13 Perched boulders at the western end of the Mana Bay seawall, 11 April 2019

The high volume of sand in Mana Bay meant that the western end of the seawall was largely buried. The wall appeared to have been undermined by the tide at the eastern end, leaving some of the higher boulders perched in potentially dangerous positions (Photo 13). Given these safety concerns, the structure is currently non-compliant with resource consent 4573-2.

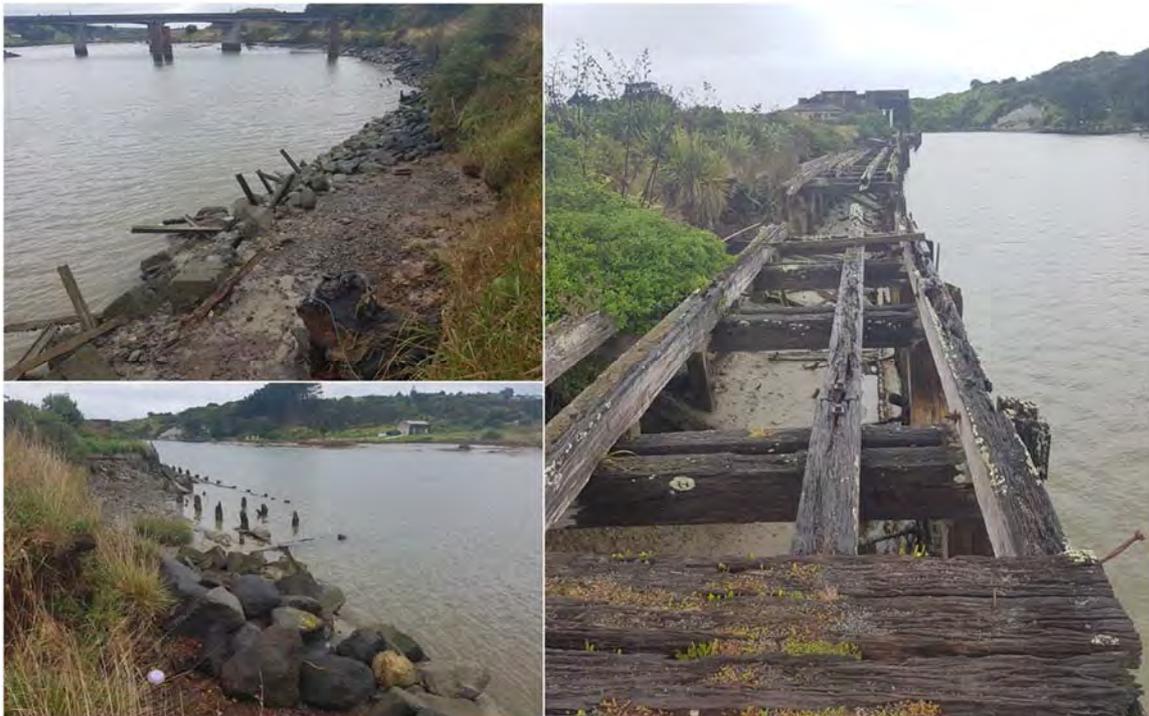
Photo 14 Patea wharf and rock wall, 11 April 2019

As noted in previous inspections, the wharf is in a dilapidated state and has been so for some time. The consent for this structure was renewed on 23 June 2010 with reduced maintenance requirements. This allows STDC to continue to occupy the space provided the derelict wharf does not pose a navigational hazard.

The wharf and rock wall were inspected on 11 April 2019 (Photo 14). Continued degradation of the wharf was evident, although its condition was largely similar to the previous inspection. Neither the wharf nor the rock wall appeared to be presenting any increased navigational hazards.

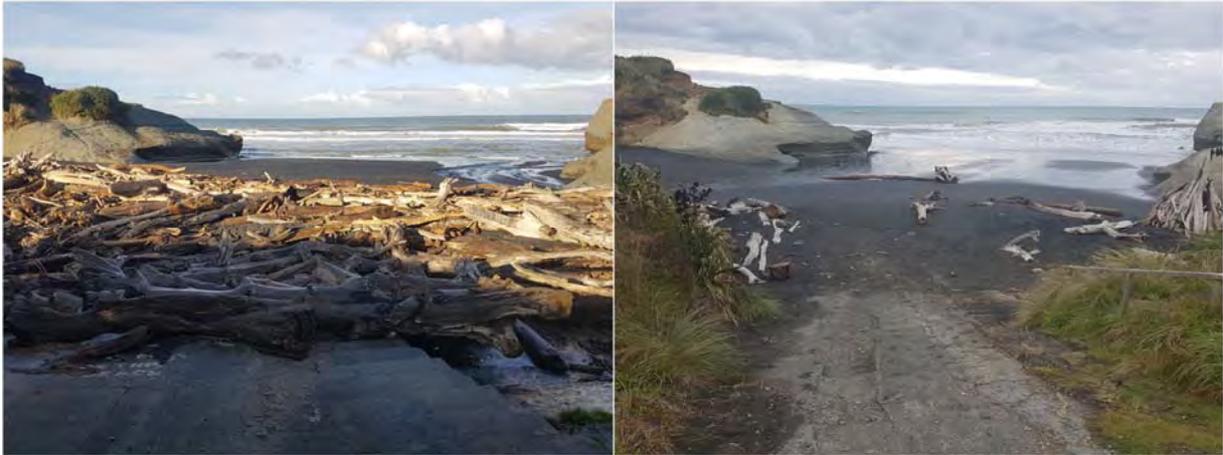
Photo 15 Caves Beach access ramp, May 2018 (left) and April 2019 (right)

Caves Beach was visited on 11 April 2019. The poor condition of the steps was comparable with previous inspections as they remained overgrown with grass in sections. However, the steps and ramp still provided access to the beach, as required by the resource consent. The beach itself had changed considerably since the previous inspection, with a greater volume of sand on the shore, and the driftwood pile having disappeared (Photo 15). Any scouring that had been previously noted at the base of the structure was now buried by sand.
