Methanex Motunui and Waitara Valley  
Combined Monitoring Programme  
Annual Report  
2019-2020

Technical Report 2020-44

Taranaki Regional Council  
Private Bag 713  
Stratford

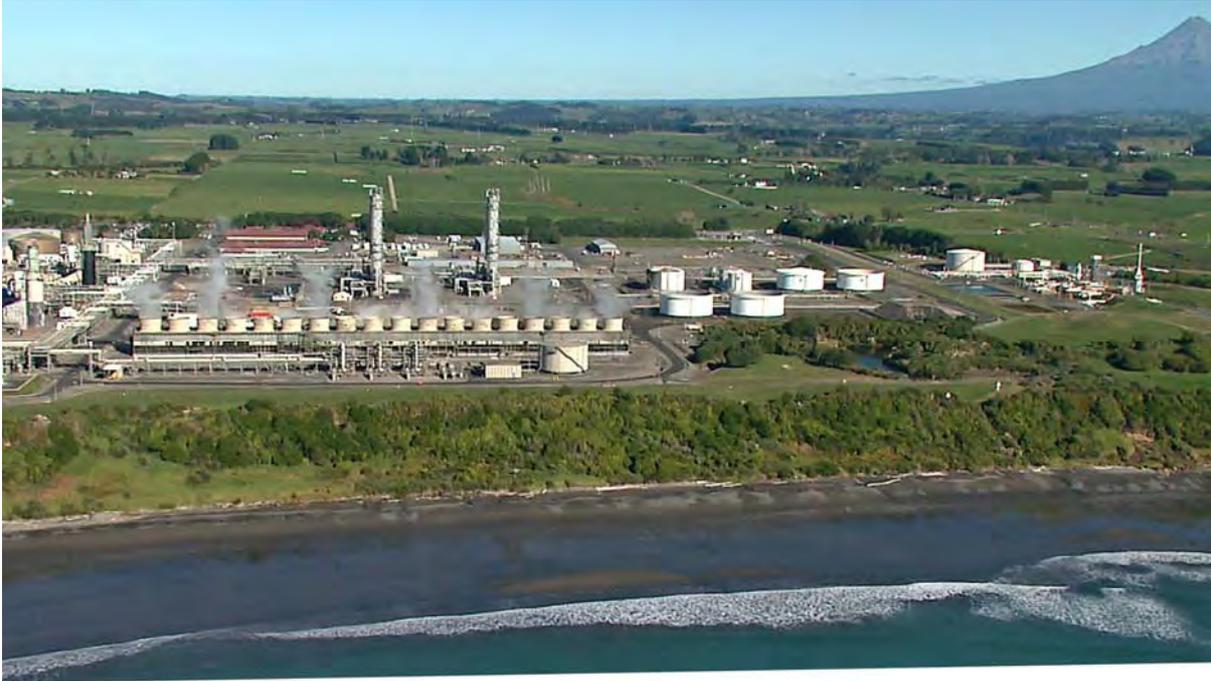
Photo 1 Cooling towers and distillation stacks at the Methanex Motunui site

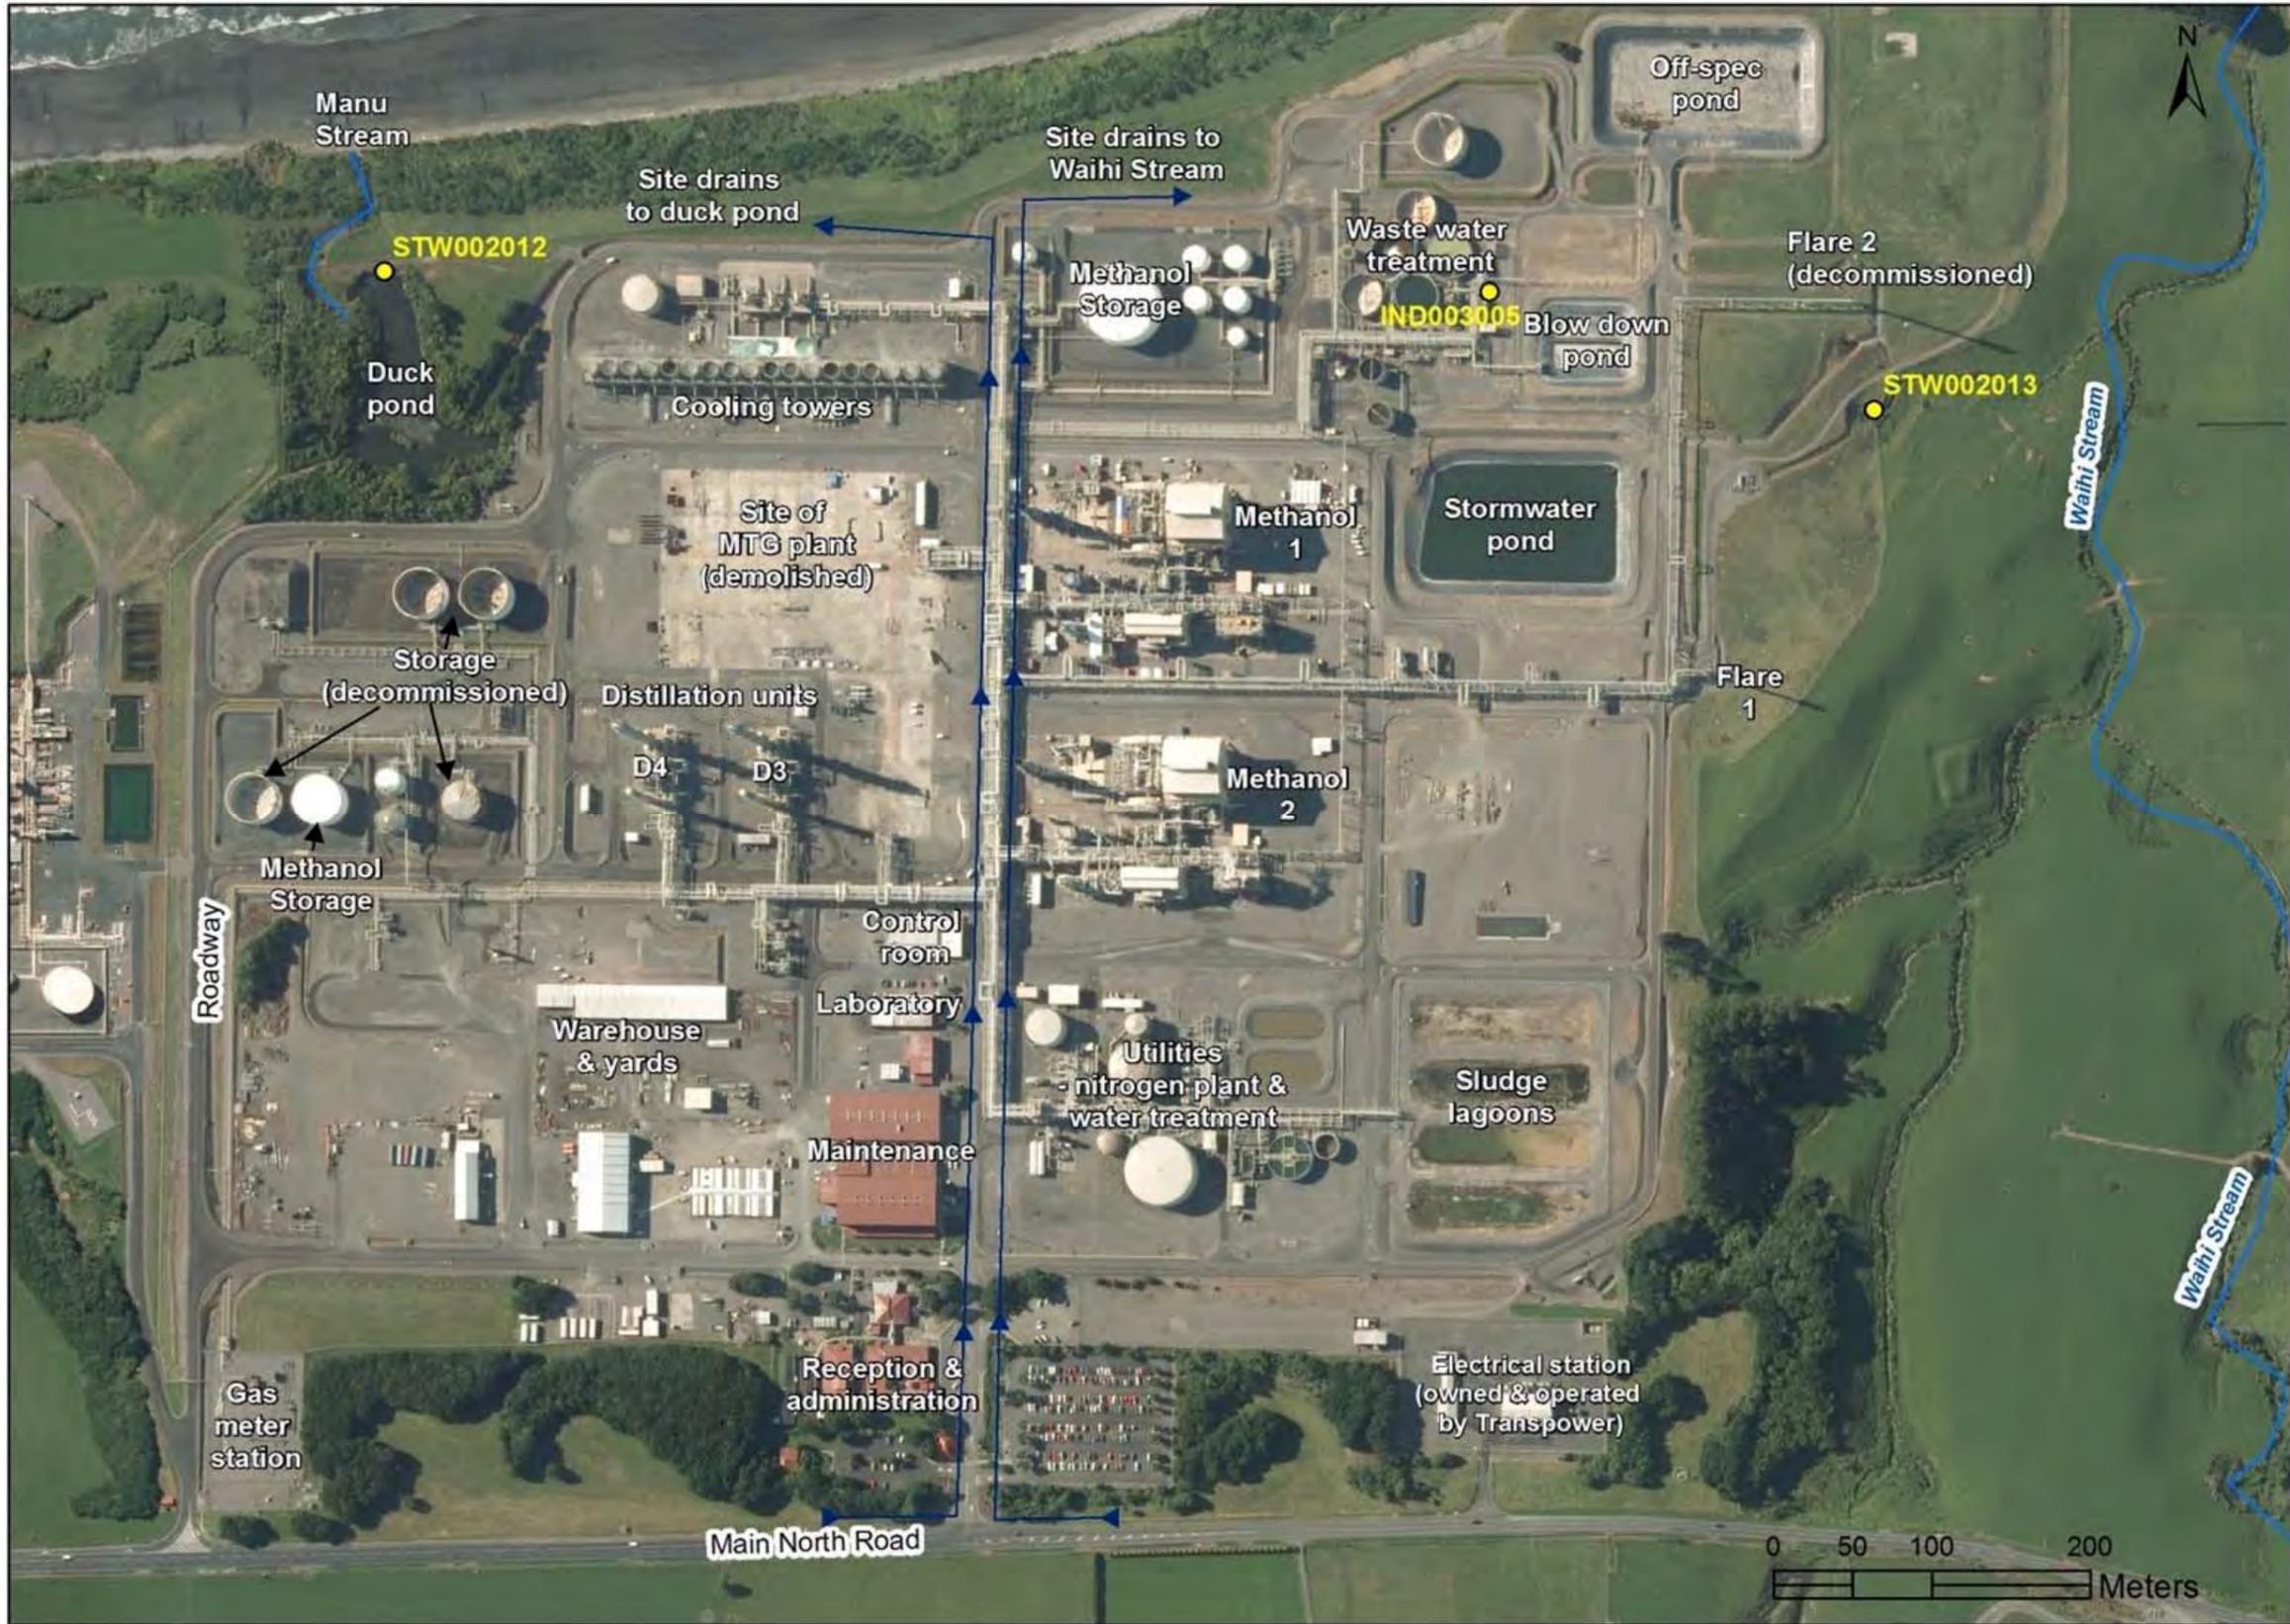
Figure 1 presents the layout of the site and references various components that will be referred to in this report.

Figure 1 Motunui site layout and water sampling site locations

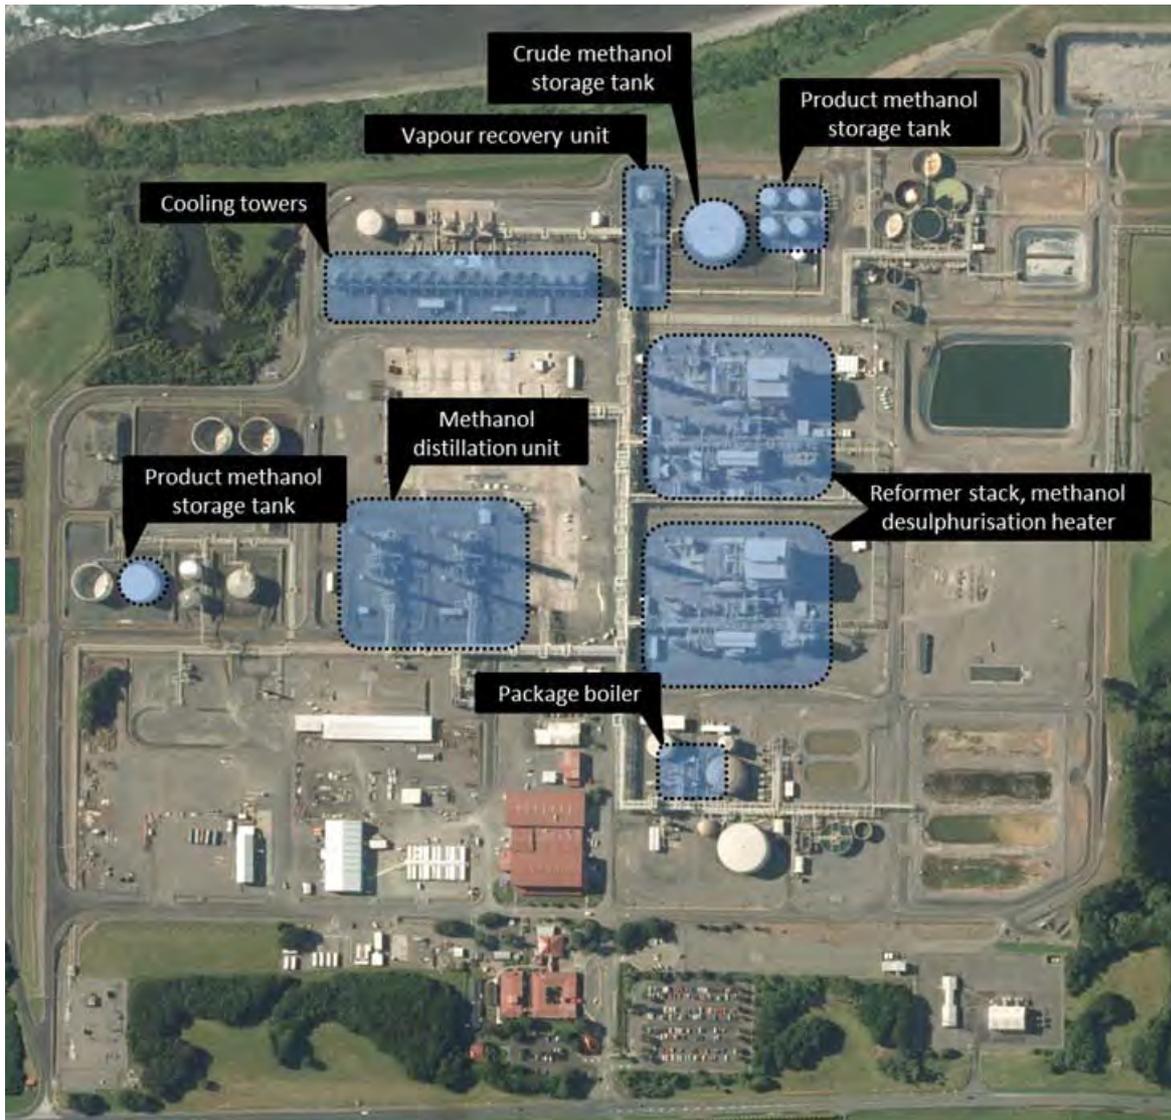
The major sources of emissions to air are shown in Figure 2. The greatest quantities of air discharges from the Methanex complex were emitted from the reformer stacks. The flue gases are the products of combustion reactions within the steam reformers. They comprise gases typical of any combustion processes based on natural gas i.e. nitrogen passing through the process unchanged from the atmospheric air drawn in to support combustion, water (from oxygen in the air reacting with hydrogen in natural gas), carbon dioxide (created similarly) and residual oxygen. There are also traces of nitrogen oxides due to atmospheric nitrogen oxidising in the heat of the reformers.

Figure 2 Major process air emission sources at Motunui

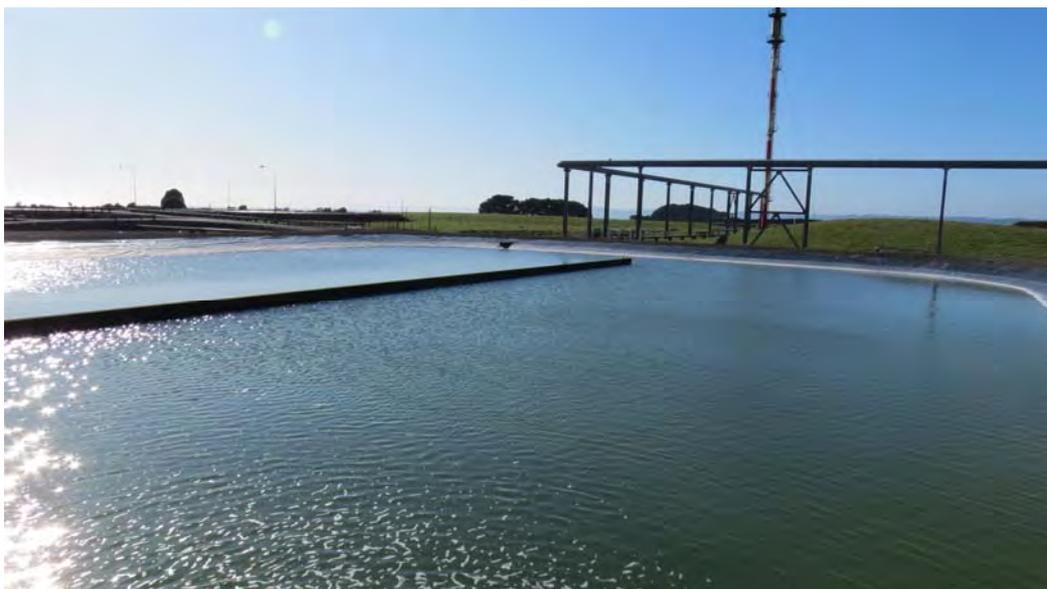
Photo 2 The Motunui site's blow down pond (decommissioned flare 2 can be seen in the background)

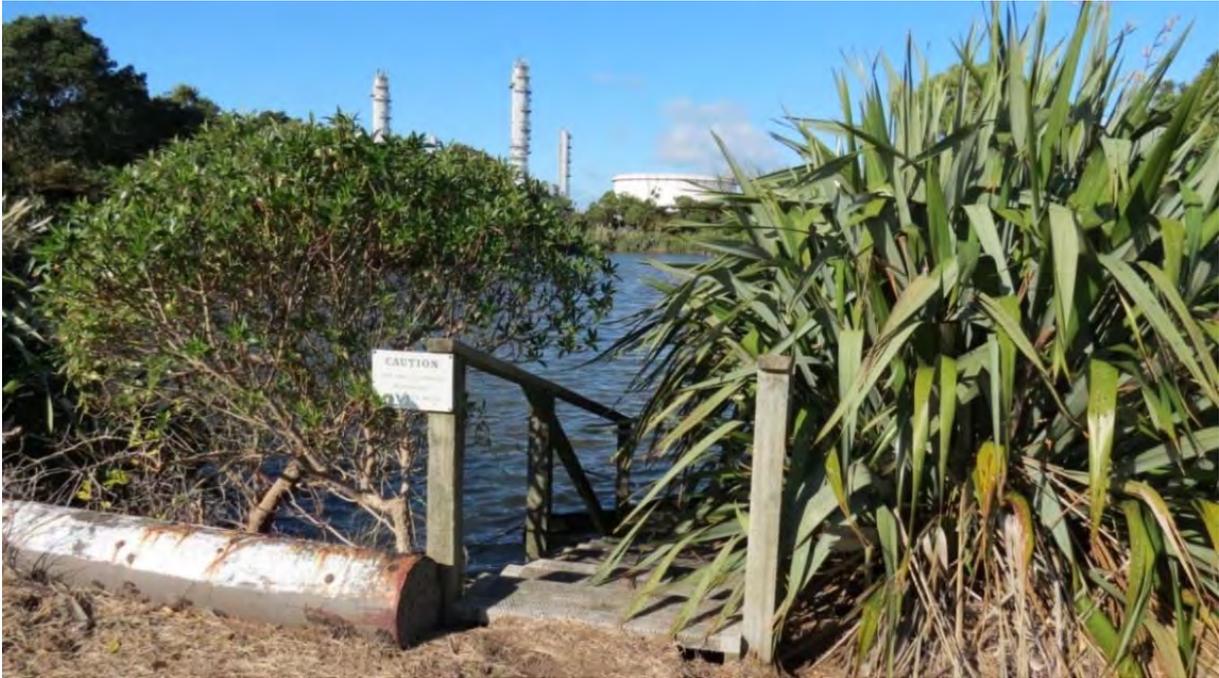
Photo 3 The Manu Stream sampling point at the Motunui site

The quality of the stormwater discharge from the pond was within the agreed guideline or consent limits for uncontaminated stormwater on each monitoring occasion except for the suspended solid results in two samples collected in February 2020 (440 and 210 g/m<sup>3</sup>). The reason for these exceedances was that the Manu Stream was not flowing at the time due to dry conditions and therefore sediment from the river bed was entrained with the sample as it was collected. This sample was therefore not representative as no discharge was occurring.

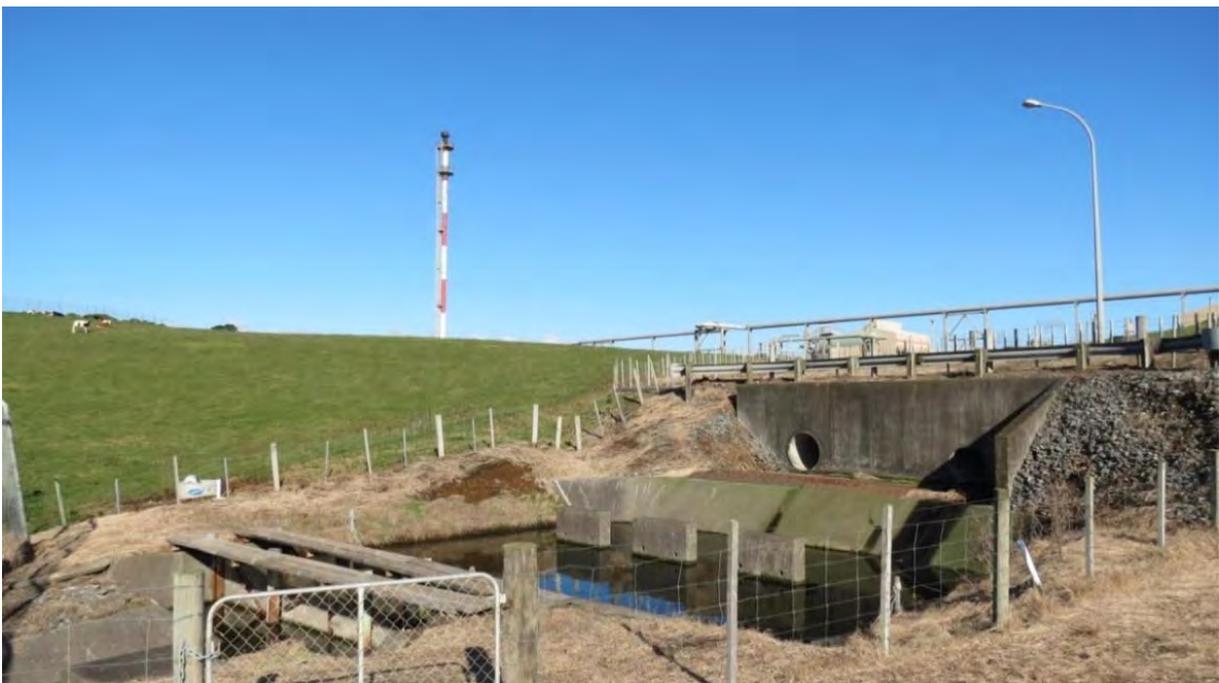
Photo 4 The Waihi Stream sampling point at the Motunui site

With the exception of total suspended solids and one pH result, the stormwater samples analysed from the Waihi Stream monitoring site were within agreed limits required by the consent. The two high suspended solids results (550 and 177 g/m<sup>3</sup>) were recorded in December and were associated with the entrainment of sediment in samples that were collected under low flow, stagnant conditions (there was no discharge occurring at the time of sampling) and therefore are not representative of the actual stormwater discharge quality. The low pH result (4.8) recorded in January was similarly related to dry conditions where there was no flow to the Waihi Stream. Methanex arranged for the vacuum emptying of the outlet and disposal of this to waste water to ensure that there was no subsequent impact on downstream areas. The stream was also sampled at three points downstream with all pH results being returned within the normal range.

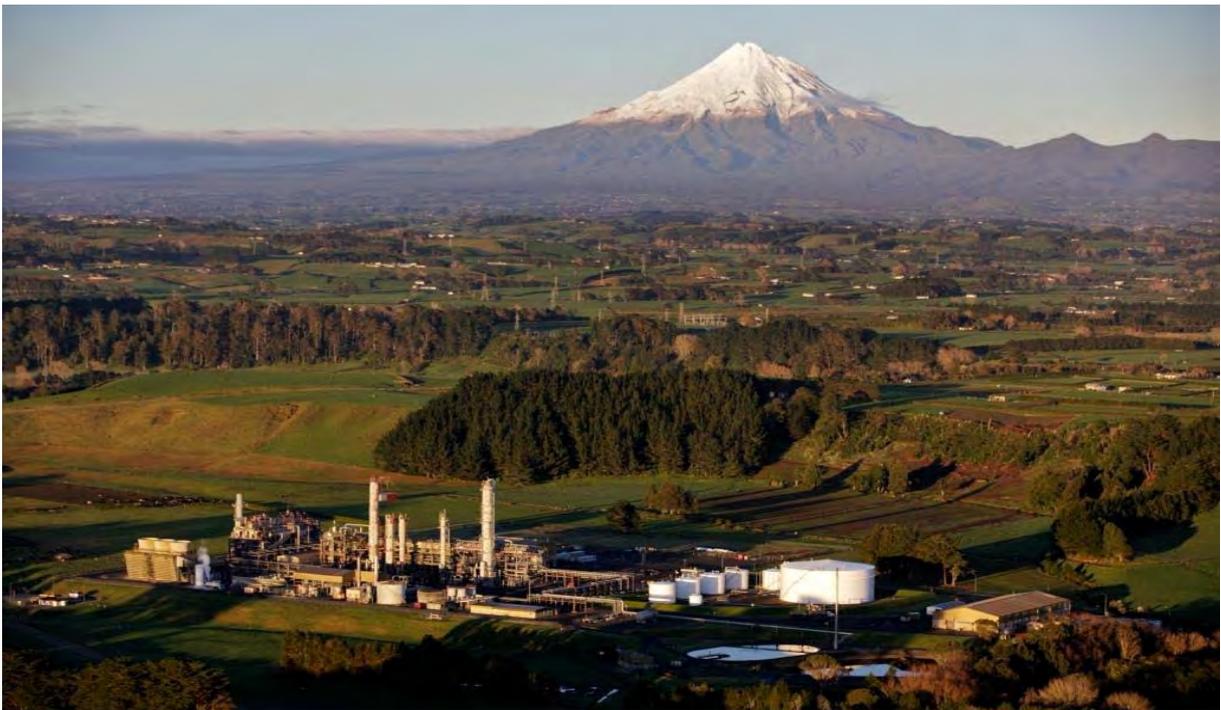
The processing area includes the reformer, main compressor, and the distillation units (D1 & D2). The distillation towers are the tallest structures on the site at 51.5 metres, followed by the reformer stack at 38 metres. Product storage area consists of one substantial storage tank and six smaller tanks. A cooling tower and the main servicing facilities are located in the utility area. It is noted that the cooling tower technology in place at the Waitara Valley site differs from the system used at Motunui and the cooling tower is considerably smaller in size.

Photo 5 Methanex Waitara Valley site

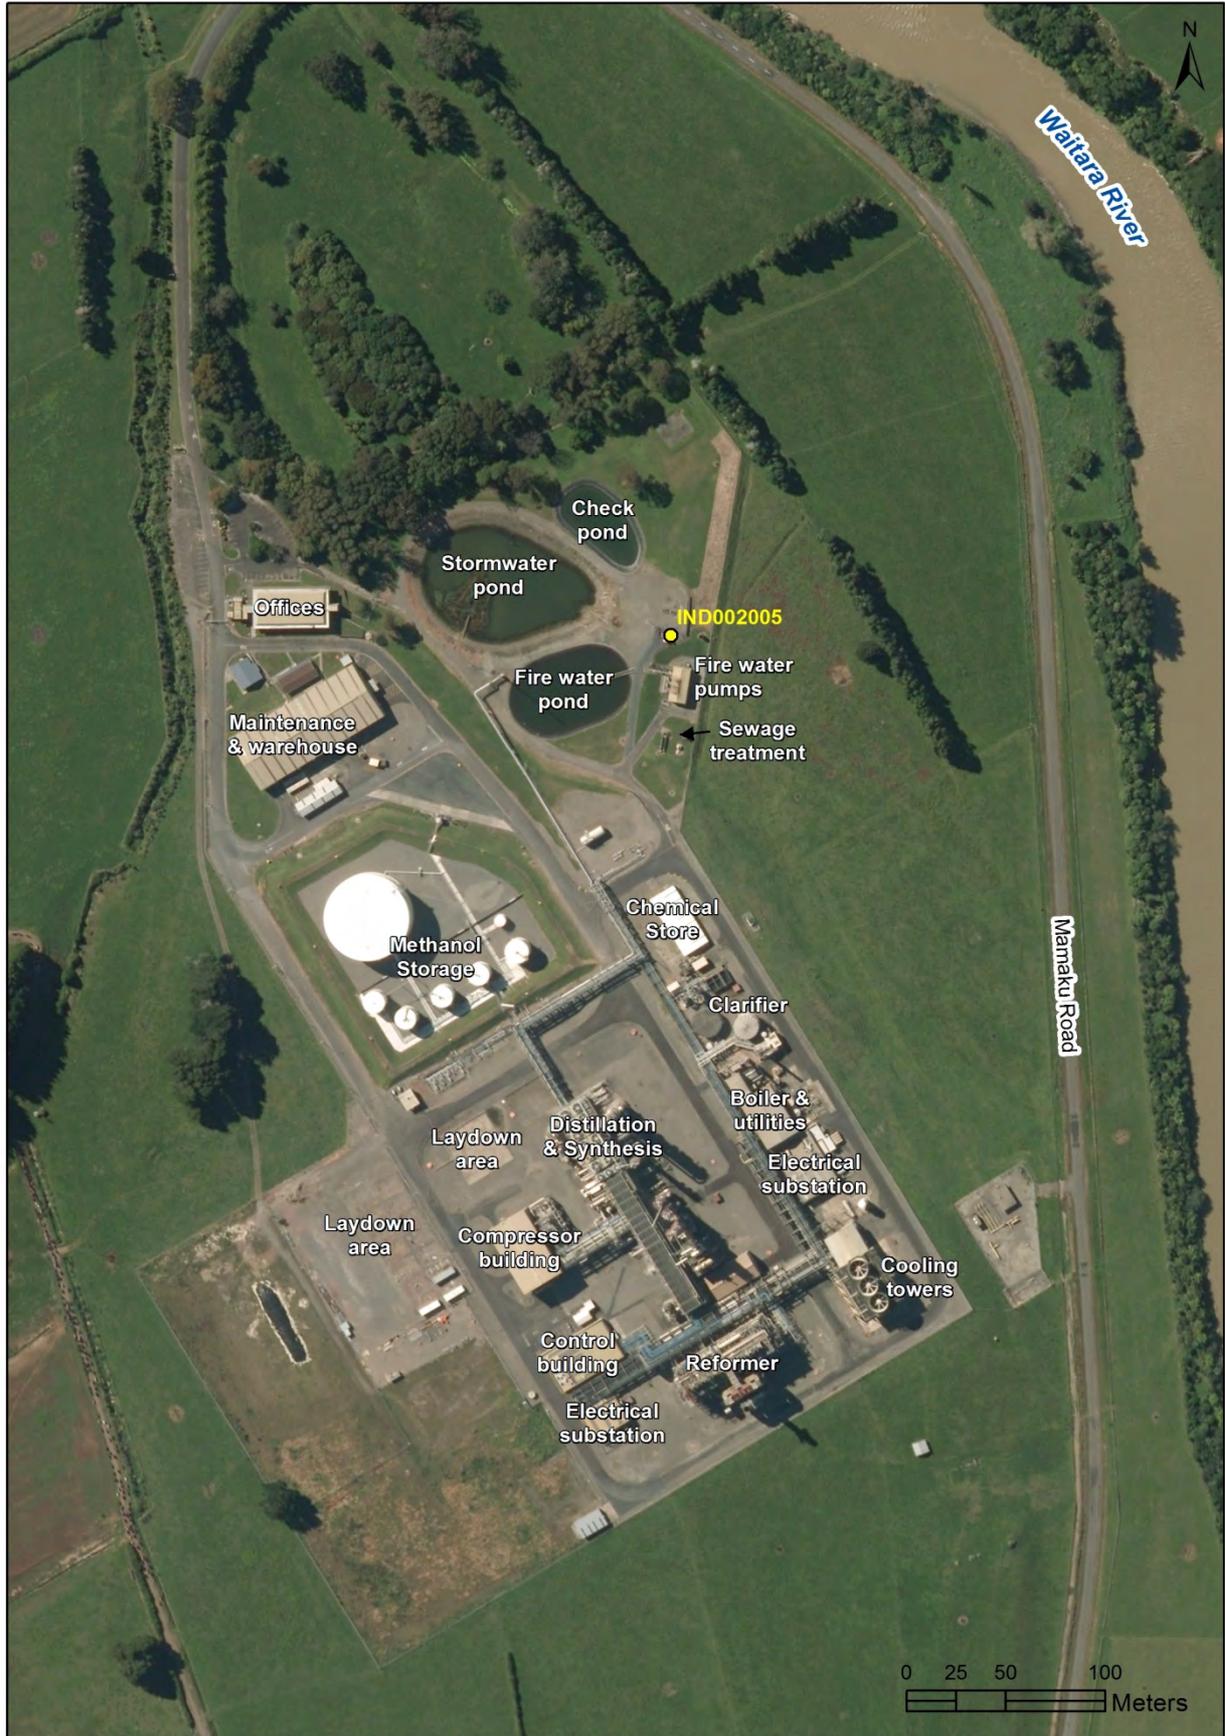
Methanex Waitara Valley site is divided into several discrete areas associated with the on-site production of methanol (Figure 3).

Figure 3 Waitara Valley site layout and water sampling site location

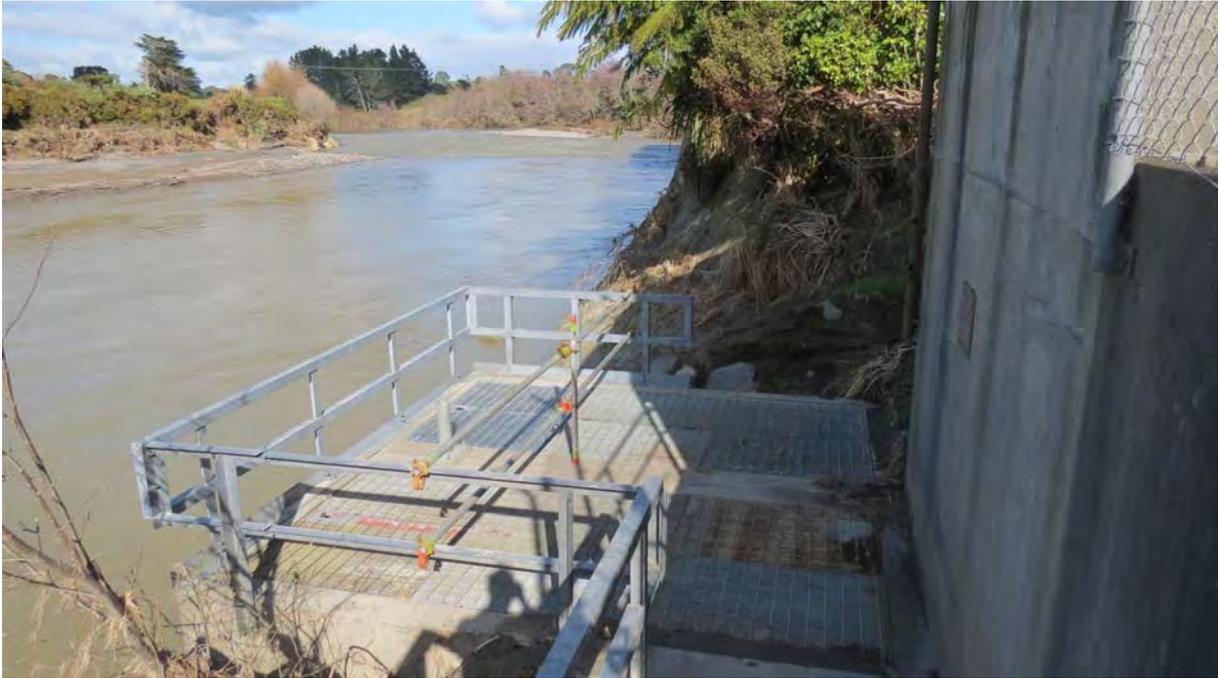
Consent 0801-2 allows Methanex to take up to 300 m<sup>3</sup>/hr from the Waitara River (Photo 6) when the river flow at the Bertrand Road gauging station is above 4,600 L/s (16,560 m<sup>3</sup>/hr). A hydrograph of river flows at the Bertrand Road gauging station based on data for calculated mean daily flows during the 2019–2020 monitoring period is attached to this report as Appendix II. The Waitara River flow fell for a short period below the consent limit of 4,600 L/s during February 2020. As discussed in Section 2 of this report, production continued through this period, with permission received from the Water Shortage Event Manager. The environmental effects of the continued abstraction were unlikely to have any significant additional impact on the river.

Photo 6 Waitara Valley water take

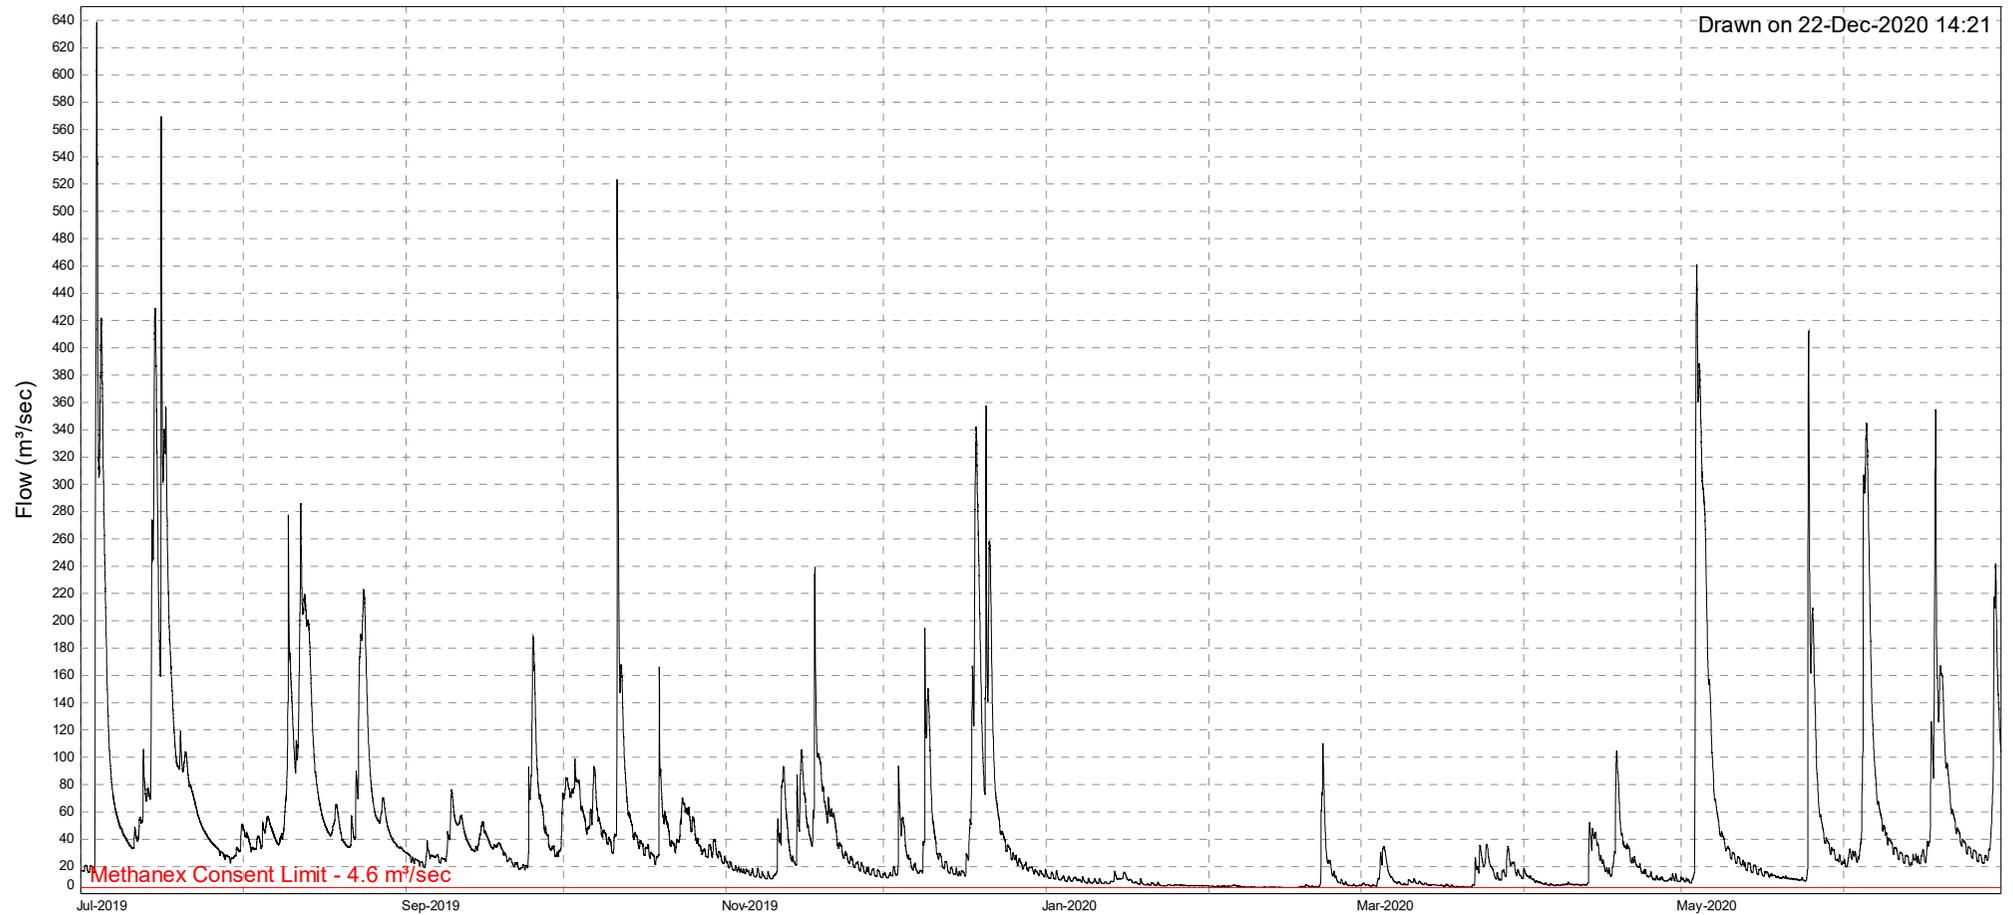
Hydrograph for the Waitara River at Bertrand Road  
for the monitoring period July 2019 to June 2020

— Waitara at Bertrand Rd from 1-Jul-2019 00:00:00 to 1-Jul-2020 00:00:00

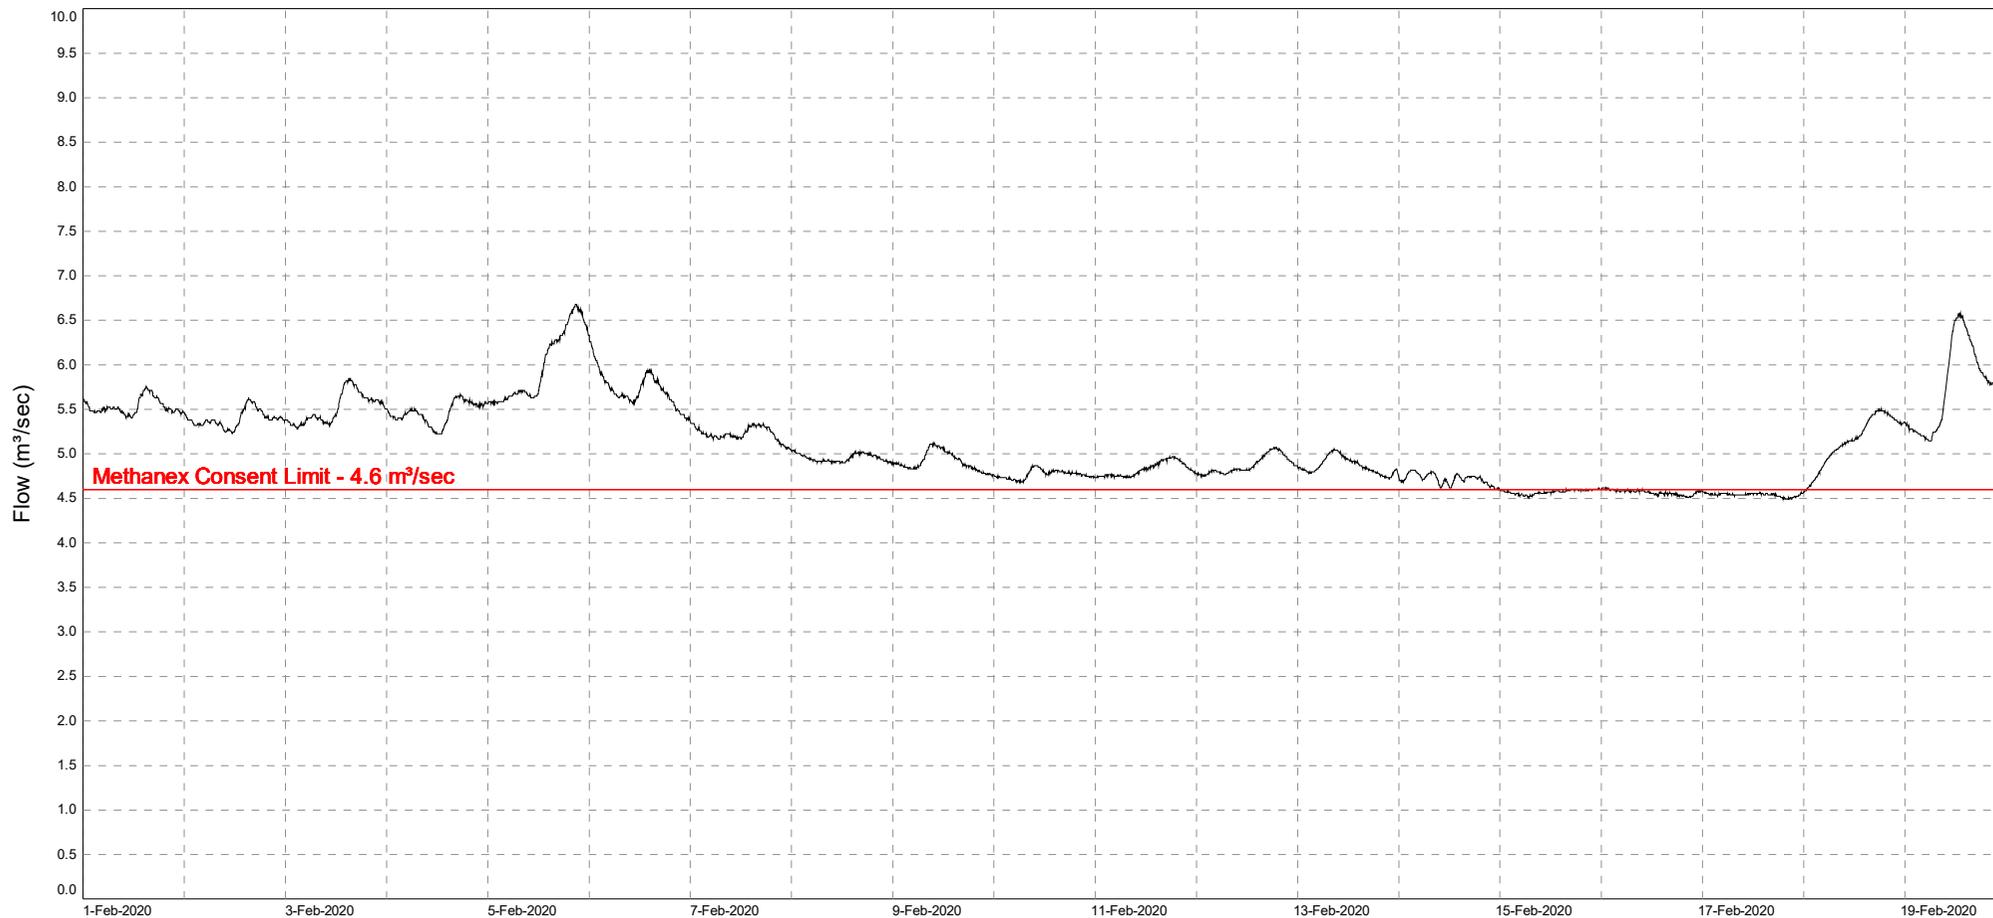
— Waitara at Bertrand Rd from 1-Feb-2020 00:00:00 to 20-Feb-2020 00:00:00

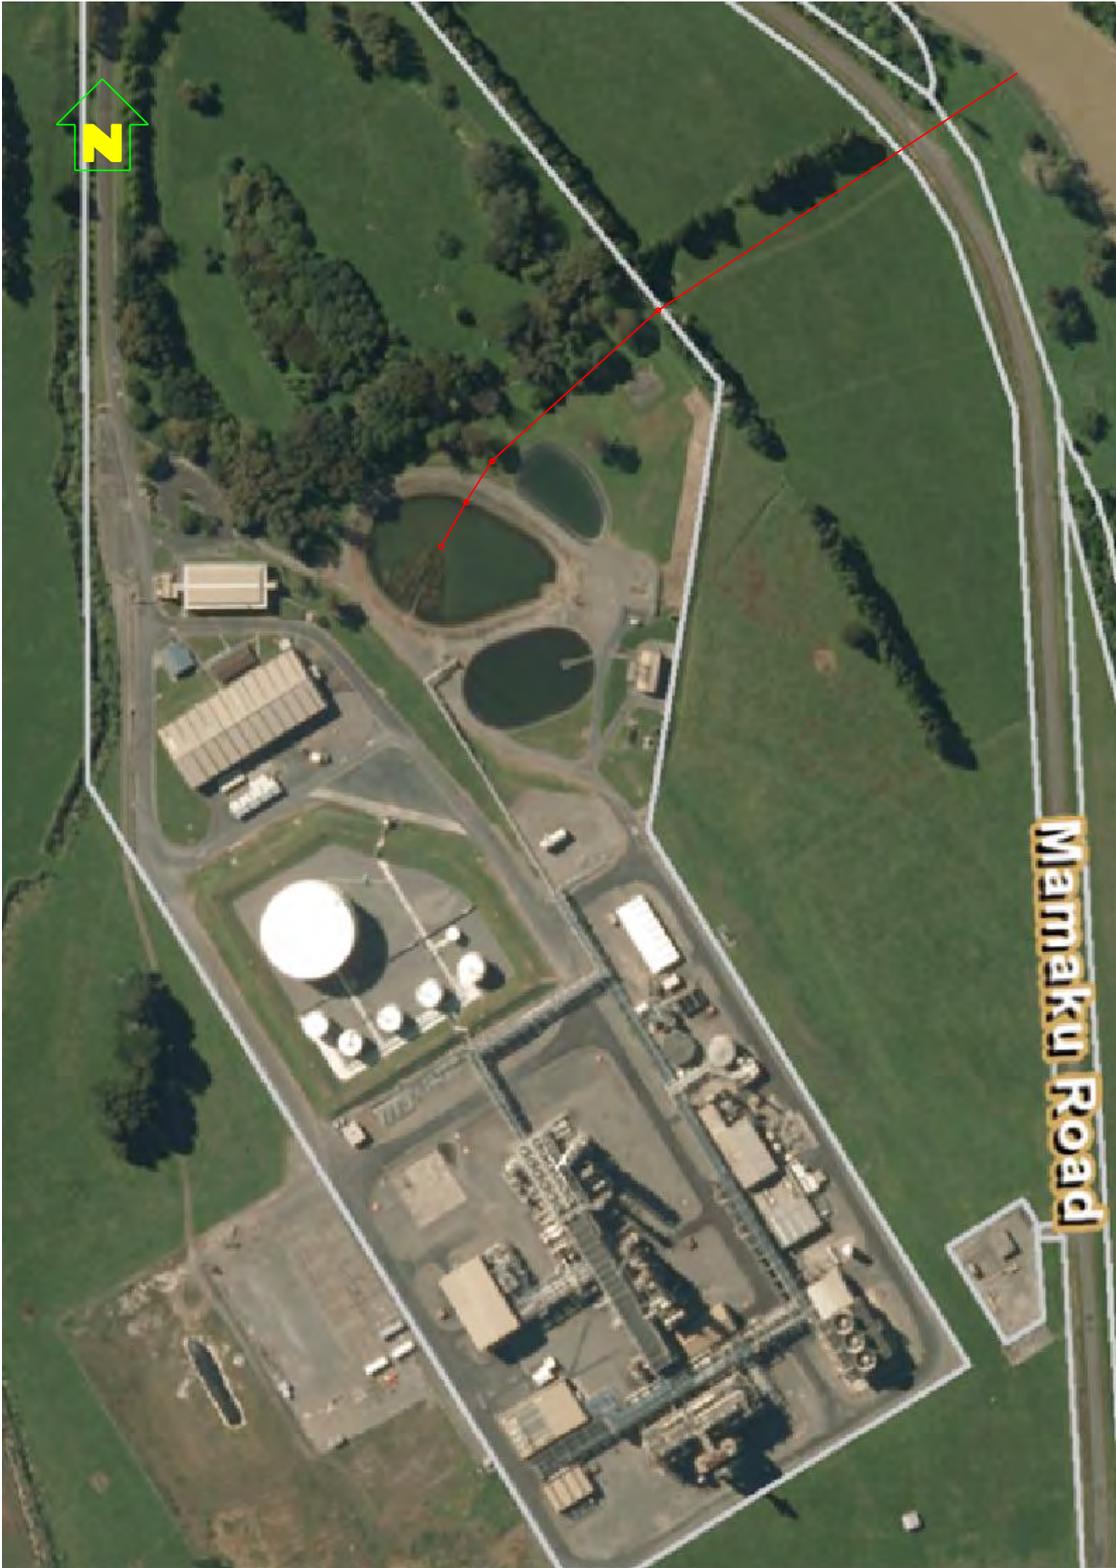
The leak of methanol to the stormpond resulted in an exceedance of the consented wastewater discharge methanol limit. Methanex notified this incident to the Taranaki Regional Council (TRC) and maintained communication as it occurred. This investigation report details the timeline of the event and the causal factors, with associated corrective actions to prevent a reoccurrence and ensure improvement.

Figure 1: Aerial image of the Waitara Valley Plant showing the pipeline from the stormpond to the Waitara River

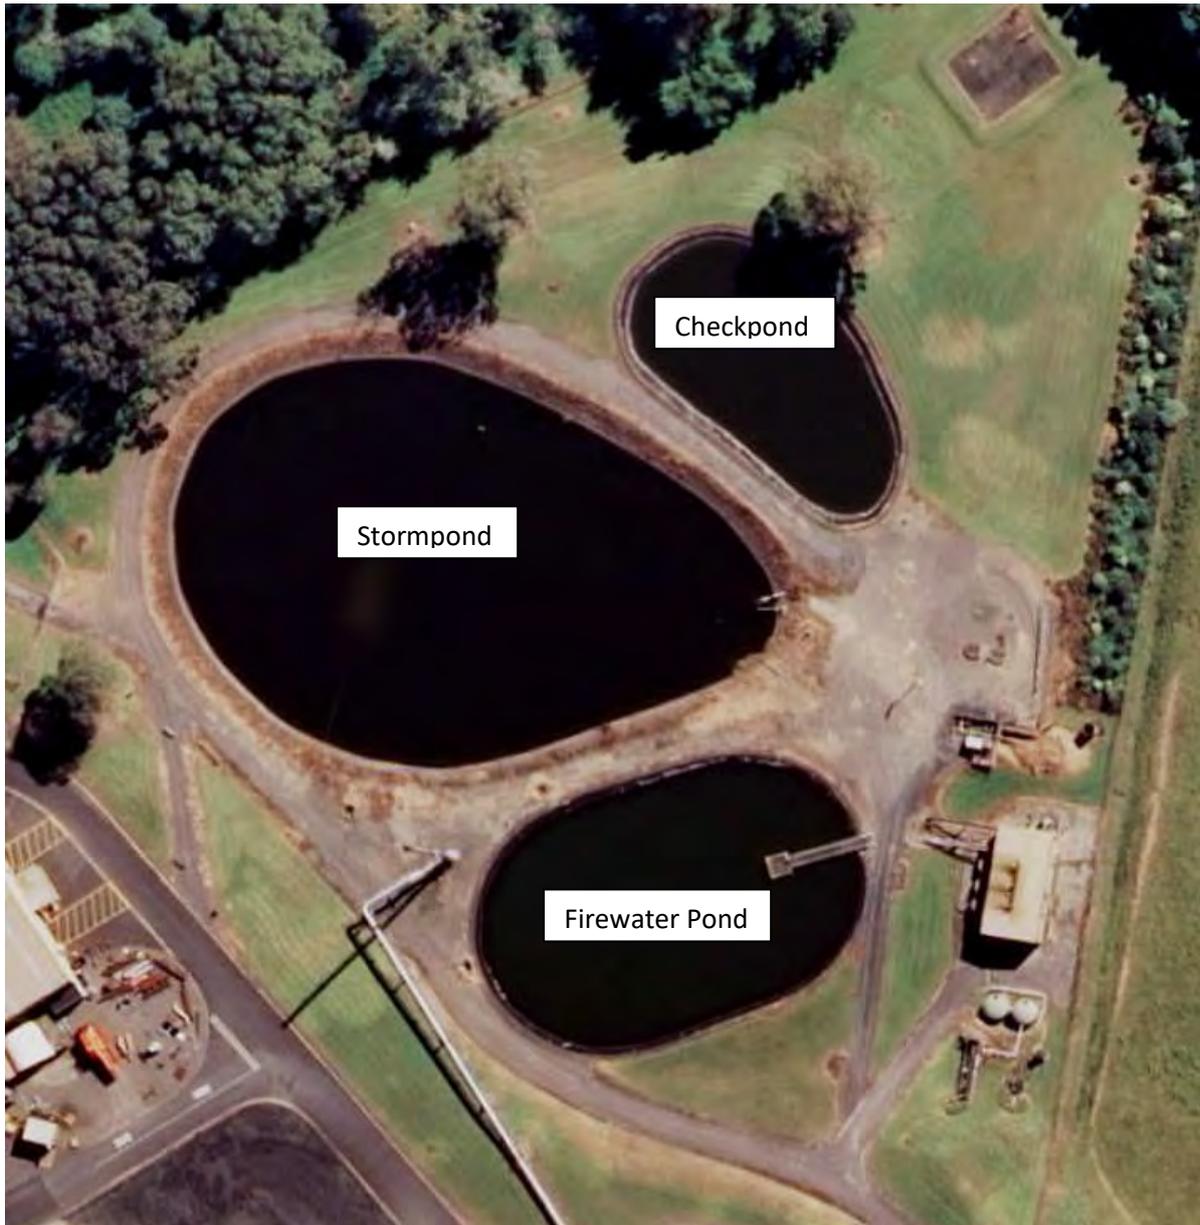
*Figure 2: Aerial Image of the Wastewater System Ponds*
