# Todd Energy Aquatic Centre

Monitoring Programme

Annual Report

2020-2021

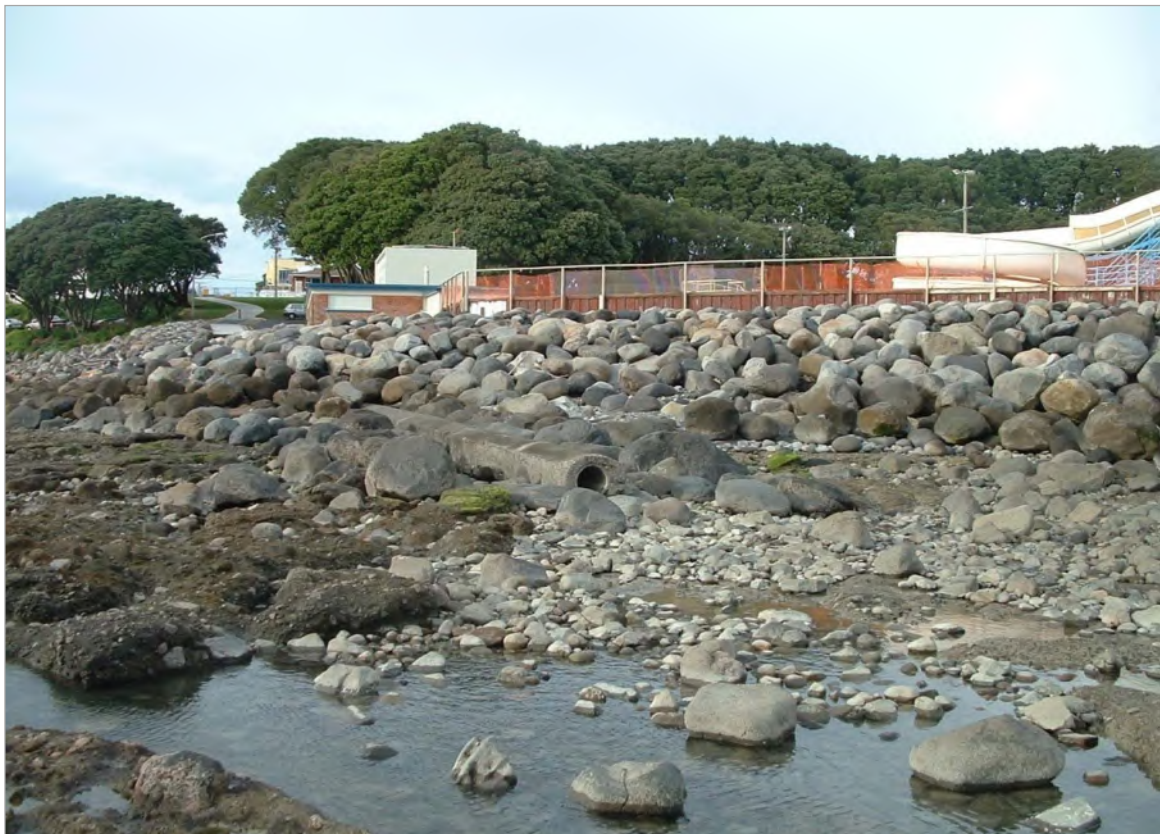
Photo 1 Aquatic Centre ocean outfall along the intertidal zone of the Kawaroa Reef

Discharge of wastewater from the outdoor pool complex filtration system takes place via the original ocean outfall which is situated on the foreshore to the east of the facility (Photo 1). The outfall consists of a 300 mm diameter encased concrete pipe that discharges at approximately mid-tide level. This structure was constructed in 1962 and has been in use ever since for the purpose of backwashing the outdoor pool filters. The outdoor pools are served by two large open gravity sand filters, which are located at the eastern end of the outdoor complex. These are air scoured and then backwashed through the outfall at high tide. Volumes of backwash water are significant (generally 22 m<sup>3</sup>) and the discharge can be a muddy colour for a short time. In the peak of the season, backwashes may be as frequent as 1-2 per week, but generally it is normal to backwash the outdoor pools approximately every two weeks during the summer season (Labour weekend through to Easter).

The ocean outfall was also inspected during the site visit and found to be compliant with consent conditions. Although the structural integrity of the ocean outfall has declined in recent years, the inspection indicated little change since a 2.4 m length of the structure dislodged in the 2016-2017 year.

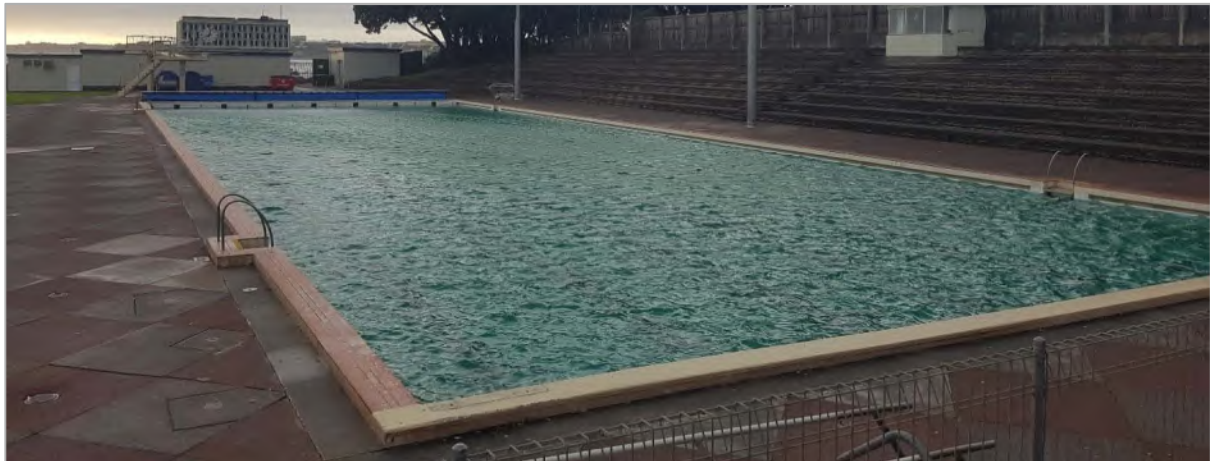
released from 12:00 pm to 16:00 pm on Tuesday 18 May (high tide on this day was at 14:00 pm (2.8 m)). A sample of the receiving water was not collected while the pool was discharging due to unsafe sea conditions (3.3 m swell). However, given the low chlorine, suspended solids and oil and grease concentrations, it is highly unlikely that the discharge would have caused any measurable adverse effects on the receiving waters (especially considering the turbulent sea conditions).

Photo 2 TEAC main outdoor pool, 17 May 2021

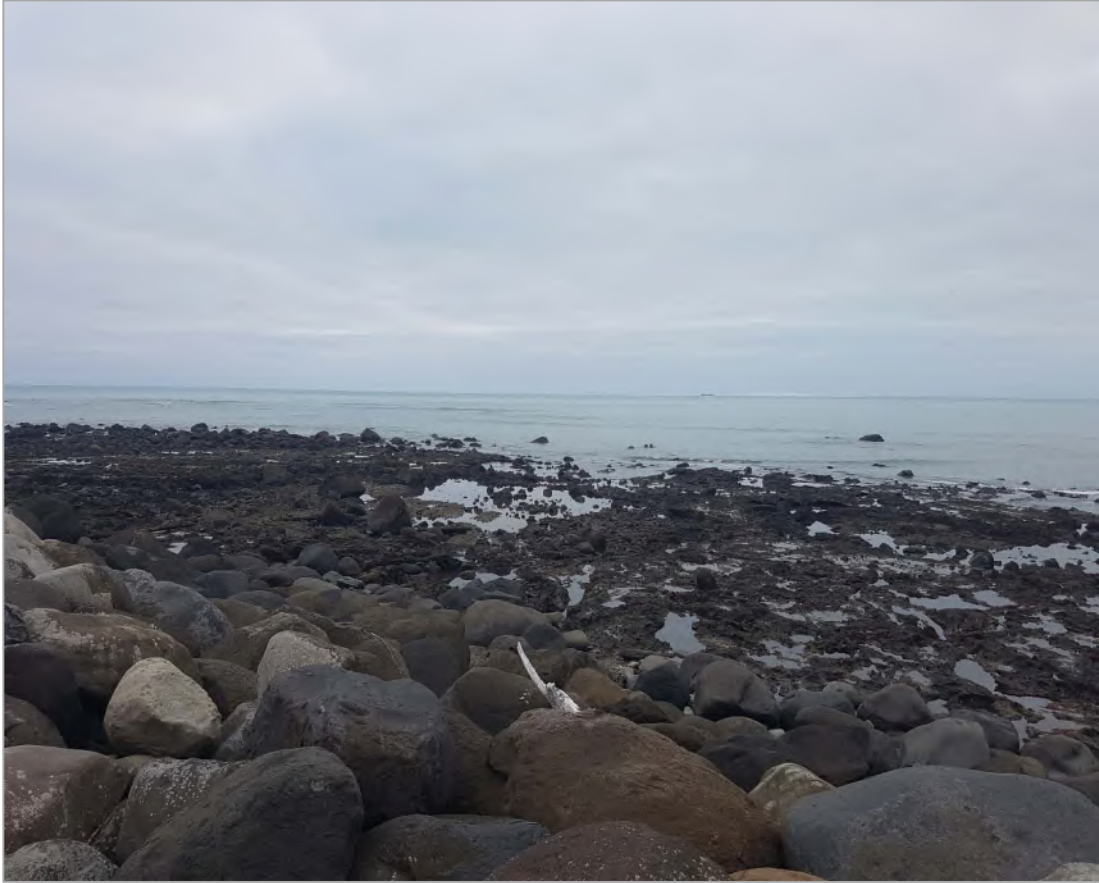
The follow-up ecological inspection was carried out at 08:30 am (NZST) on 21 May 2021 (low tide 1.0m @ 11:01 am). The intertidal rock pools downstream of the discharge had been flushed by two high tides and appeared clean and clear (Photo 3). The composition of intertidal species identified during the inspection was considered normal for this type of environment. No adverse effects on local intertidal communities were observed beyond the 5 m mixing zone as a result of the outdoor pool discharge.

Photo 3 Kawaroa Reef, 21 May 2021

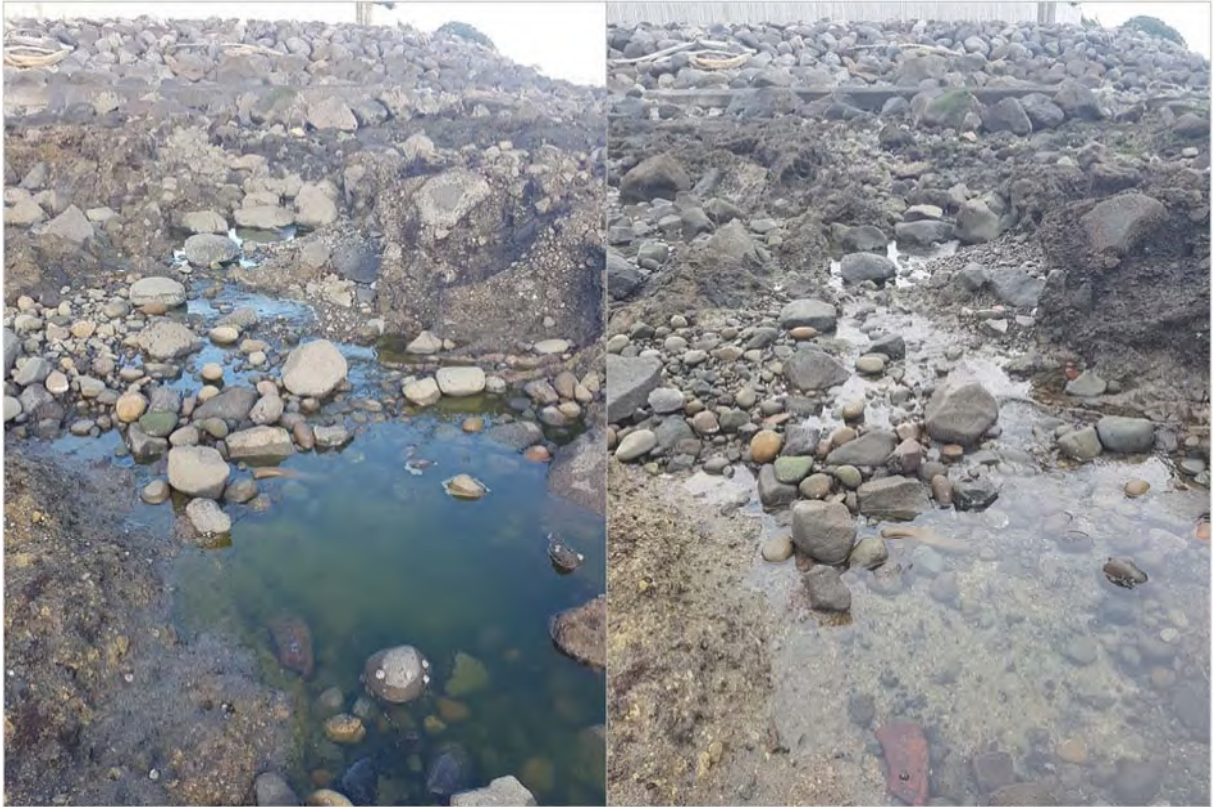
Date	Details	Compliant (Y/N)	Enforcement Action Taken?	Outcome
20 May 2021	Unauthorised discharge continuing outside of tidal window which also resulted in the discolouration of rock pools downstream of the outfall.	N	Y	No lasting adverse effects on local intertidal communities observed. Abatement Notice EAC-24199 issued.

The second marine ecological inspection was set to be carried out at 09:40 am (NZST) on 20 May 2021 (low tide 1.1m @ 09:59 am), however upon arrival at the reef at 09:40 am the outfall was still discharging water at a low-moderate rate and was bright green in colour. The rock pools on the reef downstream of the outfall were significantly discoloured bright green, with some scum and foam also observed (Photo 4). The discolouration was evident to approximately 30m downstream of the outfall. This was raised at the time with the TEAC Manager who sent another staff member out to inspect. The staff member noted that the discharge was likely due to staff water blasting algae off the outdoor pool surfaces. At this stage the main outdoor pool was two-thirds clean, and other small pools were still to be cleaned. The Council Officer advised that this discharge was non-compliant with NPDC's resource consent conditions, and that the water blasting would need to wait until it was within two hours either side of high tide (Special Condition 8), provided the discharge did not have any adverse effects on the receiving waters (Special Condition 6).

Photo 4 Intertidal rock pools downstream of the outfall which were bright green from pool discharge on 20 May 2021 (left), but had cleared by 21 May 2021 (right)

An Inspection Notice and letter of non-compliance were sent to NPDC asking them to explain the reason for the discharge and the response was found to be unsatisfactory. There have been a number of unauthorised discharges from the facility onto Kawarua Reef in recent years which have been attributed to shortcomings in management and staff training regarding the marine outfall and the requirements of Resource Consent 2339-4. As a result Abatement Notice EAC-24199 was issued and NPDC has been asked to undertake steps including, but not limited to, management and staff training with regards to discharges out of the marine outfall to ensure compliance with Resource Consent 2339-4.

NPDC have acknowledged the receipt of Abatement Notice EAC24199 and are working to put the following measures in place:

- formulating a training session for any staff that may require knowledge of the stormwater network on site and the resource consent requirements;
- adding a section in the Aquatic Centre Operations Manual covering details of resource consent conditions and the location of valves discharging from the outdoor pools to the outfall pipe, as well as details of procedures to follow when emptying pools, waterblasting pools and painting pools;
- marking the manhole covers where the valves are located with a blue fish symbol to indicate these valves discharge to stormwater outfall as an additional step to inform others that the pipes discharge directly to the sea;
- ensuring external contractors undertaking works at the facility are aware of their obligations in relation to the outfall through the contractor induction process.
