# **Todd Energy Aquatic Centre**

## **Monitoring Programme**

### **Annual Report**

#### **Technical Report 2024-34**

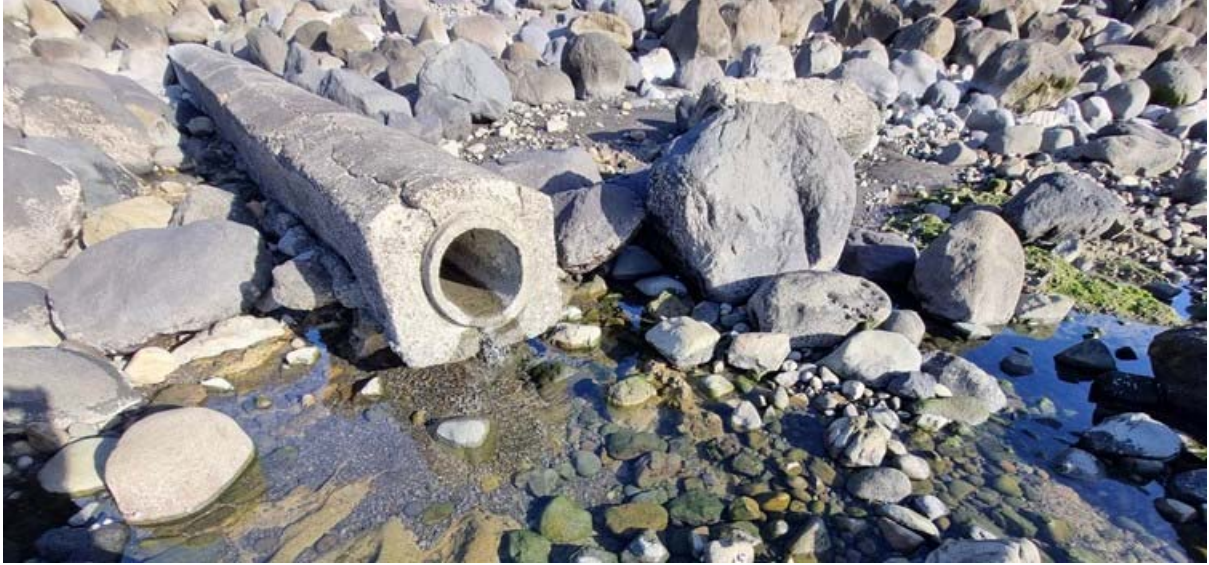
Discharge of wastewater from the outdoor pool complex filtration system takes place via an ocean outfall which is situated on the foreshore to the east of the facility (Photo 1). The outfall consists of a 300mm diameter encased concrete pipe that discharges at approximately mid-tide level. This structure was constructed in 1962 and has been in use ever since for the purpose of backwashing the outdoor pool filters. The outdoor pools are served by two large open gravity sand filters, which are located at the eastern end of the outdoor complex. These are air scoured and then backwashed through the outfall at high tide. Volumes of backwash water are significant (generally 22m<sup>3</sup>) and the discharge can be a muddy colour for a short time. Backwashes occur as frequently 1-2 times per week during the peak of the season, but generally occur every two weeks during the summer season. Backwash from the indoor, spa and children's pool are processed through a Defender Regenerative Media Filter straight to sewer, which was put in place in February 2022. Extra debris screens were put in place in the backwash holding tanks in May 2024 to help prevent the discharge of paint chips. Historical use of the pools filtration and discharges prior to this can be referred to in previous annual reports.

Photo 1 The ocean outfall, situated along the intertidal zone of Kāwaroa Reef (10 May 2024)

No new deterioration was seen on the outfall in this monitoring period however, the cracks in the concrete may need addressing in the near future. Special condition 2 of consent 4588-3.0 state that NPDC shall maintain the ocean outfall structure in a safe and sound condition. It is advised that NPDC Aquatic Centre maintain checks on the ocean outfall integrity to avoid any incidents arising.

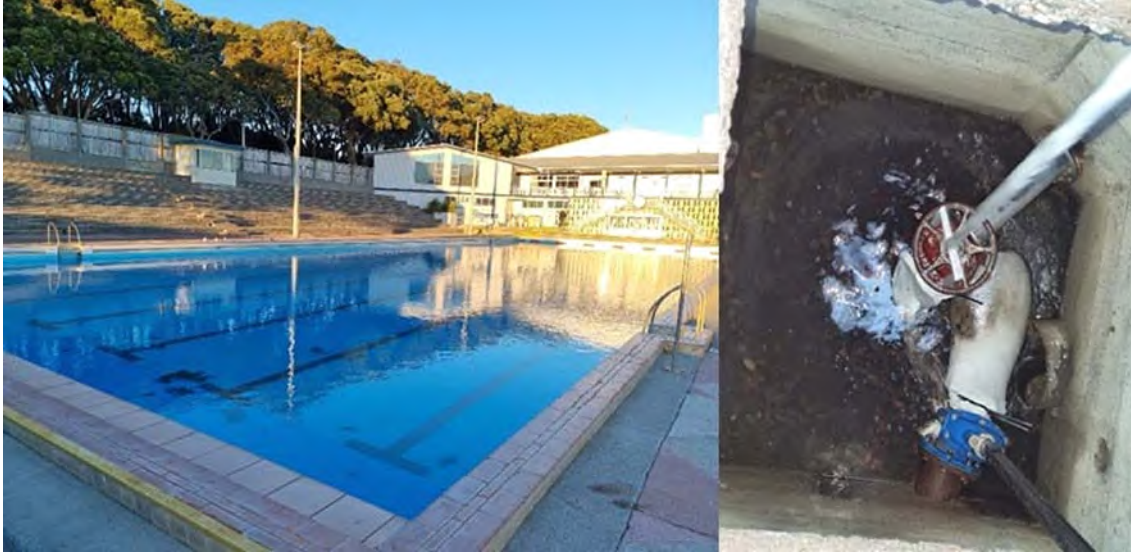
On 8 May 2024, at the end of the summer season, the Council visited NPDC Aquatic Centre to sample the outdoor pools prior to the pools being emptied. The pool water was clear with some Pōhutukawa leaves and dog hair from the "pooch pool party" on 4 May 2024. Muslin cloths had been placed over the outlet pipes to catch debris and dog hair leaving the pool (Photo 2). The total chlorine was below the consented limit (Table 3) and NPDC Aquatic Centre released the first batch of water within their consent window (high tide 0933 NZST ± two hours). The discharge commenced at approximately 7:33am NZST, and the sample of the receiving waters was compliant with consent limits (Table 3). No paint chips were observed either within or beyond the 5m mixing zone from the outfall. At the inspection the Council was shown extra screens to be

Photo 2 Todd Energy Aquatic Centre outdoor pool and muslin cloths in place over outlet pipes (8 May 2024)

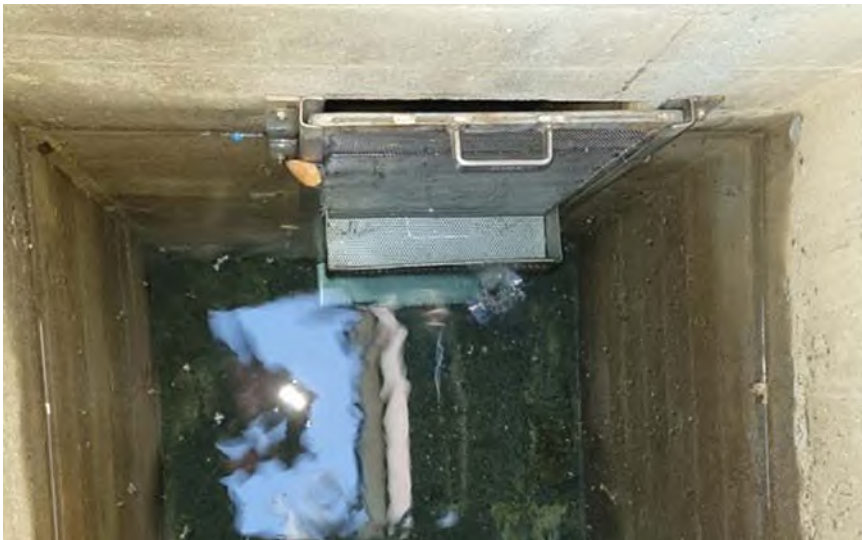
added in the backwash holding tanks at the eastern end of the outdoor pool in efforts to prevent paint chips from being discharged during backwash (Photo 3).

Photo 3 Additional debris screens in place in backwash holding tank at eastern end of the outdoor pool (8 May 2024)

The NPDC Aquatic Centre was managed in compliance with consent conditions for most of the period under review. The continued discharge of paint chips to the reef from the backwash was re-addressed with the Aquatic Centre Manager. NPDC investigated options for installing a screen on the outfall pipe however, a more practical alternative was settled on. NPDC added extra screens to the existing debris screens in the backwash holding tank in efforts to help prevent the discharge of paint chips. The Council's inspections for the 2024/25 period will check on the performance of the screens.

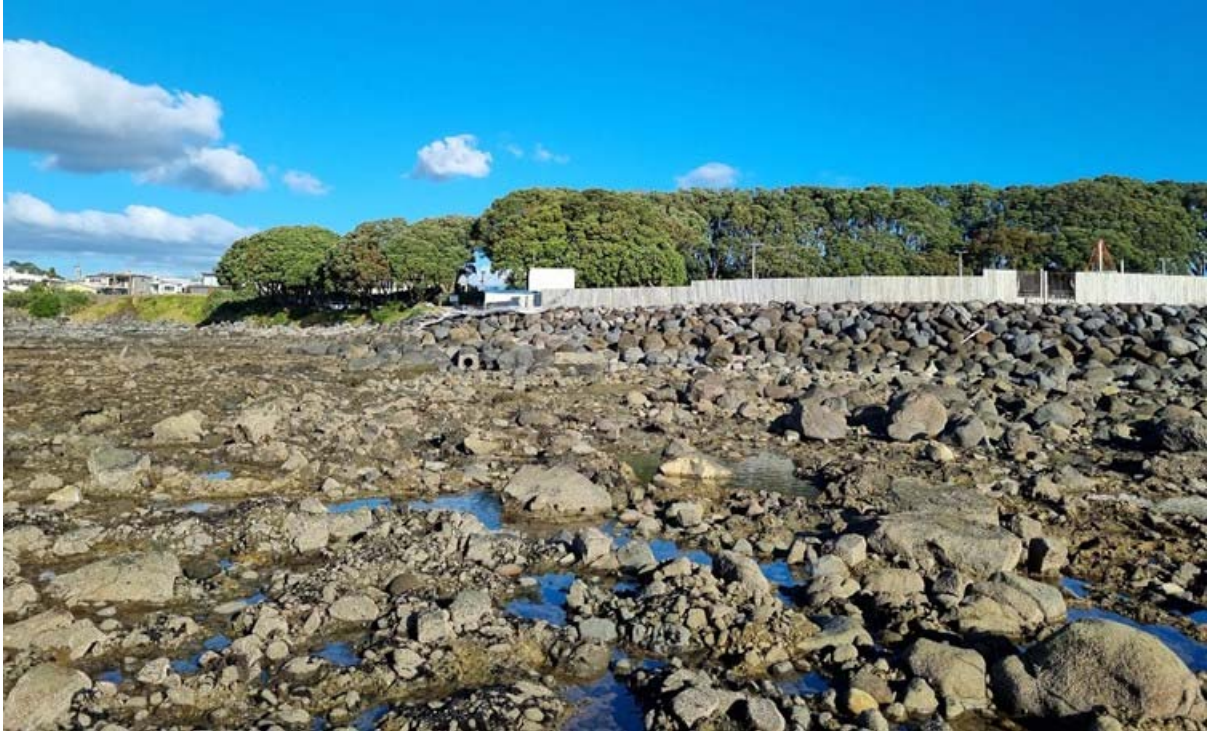
Two marine ecological inspections were conducted on Kāwaroa Reef in the vicinity of the outfall (Photo 4) on 4 April and 10 May 2024 following the backwash discharge and emptying of the outdoor pool. A very small amount of paint chips, less than 20 pieces of less than 3mm in size, were observed on the reef in the 5m vicinity from the outfall pipe after the backwash, but they were not seen elsewhere on the reef. There were no objectionable odours, conspicuous films or scums at the discharge point during either inspection. The composition of intertidal species identified during inspections was considered normal for this environment. Copies of the marine ecological inspection reports are available from the Council upon request.

Photo 4 Downshore from the ocean outfall pipe on Kāwaroa Reef (10 May 2024)

The first marine ecological inspection after the backwash found the outfall had discharged a minor amount of suspended materials (blue paint chips) onto the reef however, no adverse effects on local intertidal communities were observed beyond the 5m mixing zone on this occasion. No suspended material was seen on the reef in the second marine ecological inspection. Neither of the discharges monitored in the period under review appeared to have any long-term significant effects on the ecology of the Kāwaroa Reef beyond the designated mixing zone.
