Fonterra Kapuni  
Air and Water  
Monitoring Programme  
Annual Report  
2012-2013  
Technical Report 2013–106

Taranaki Regional Council  
Private Bag 713  
STRATFORD

July 2014

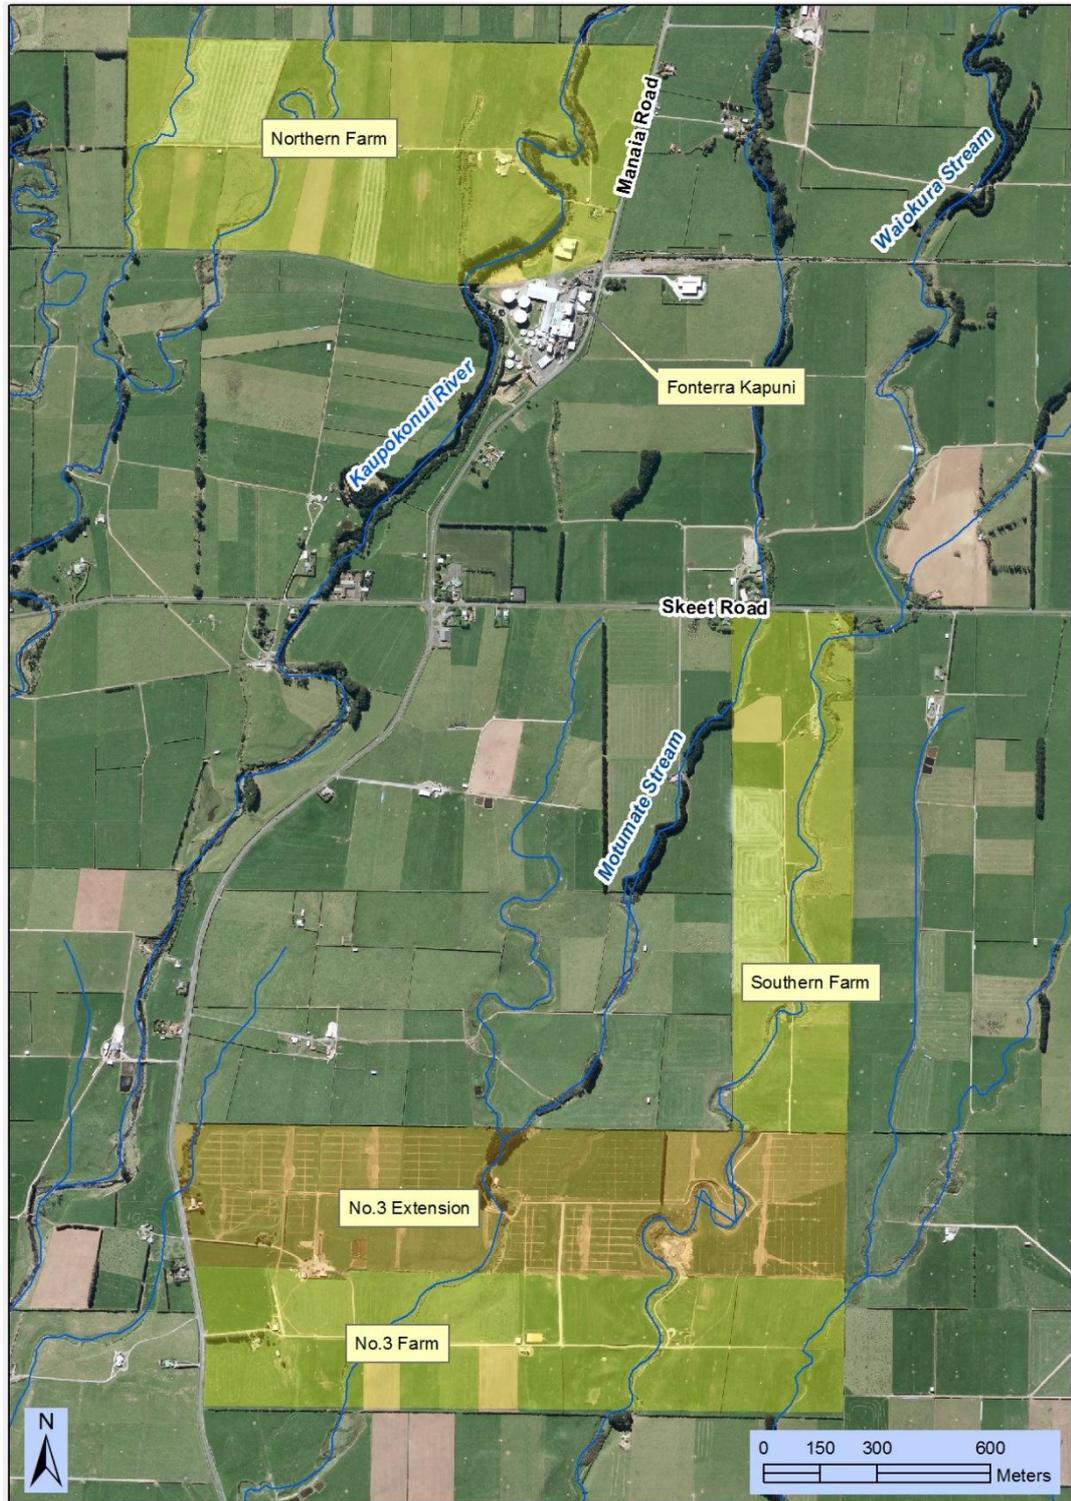
**Figure 1** Fonterra Kapuni lactose factory, North, South and (extended) No 3 farms and the Kaipokonui River, Motumate and Waiokura Streams

Figure 1 shows the location of the Fonterra Kapuni lactose factory, North, South and (extended) No. 3 farms, and the Kaipokonui River, and Motumate and Waiokura Streams, which are referred to throughout this report.

This extension increased the irrigated area during the 2007-2008 dairy season by 49 ha to 169 ha (Figure 1), of which 44 ha is reticulated with in-ground irrigators. The total area farmed is 244 ha.

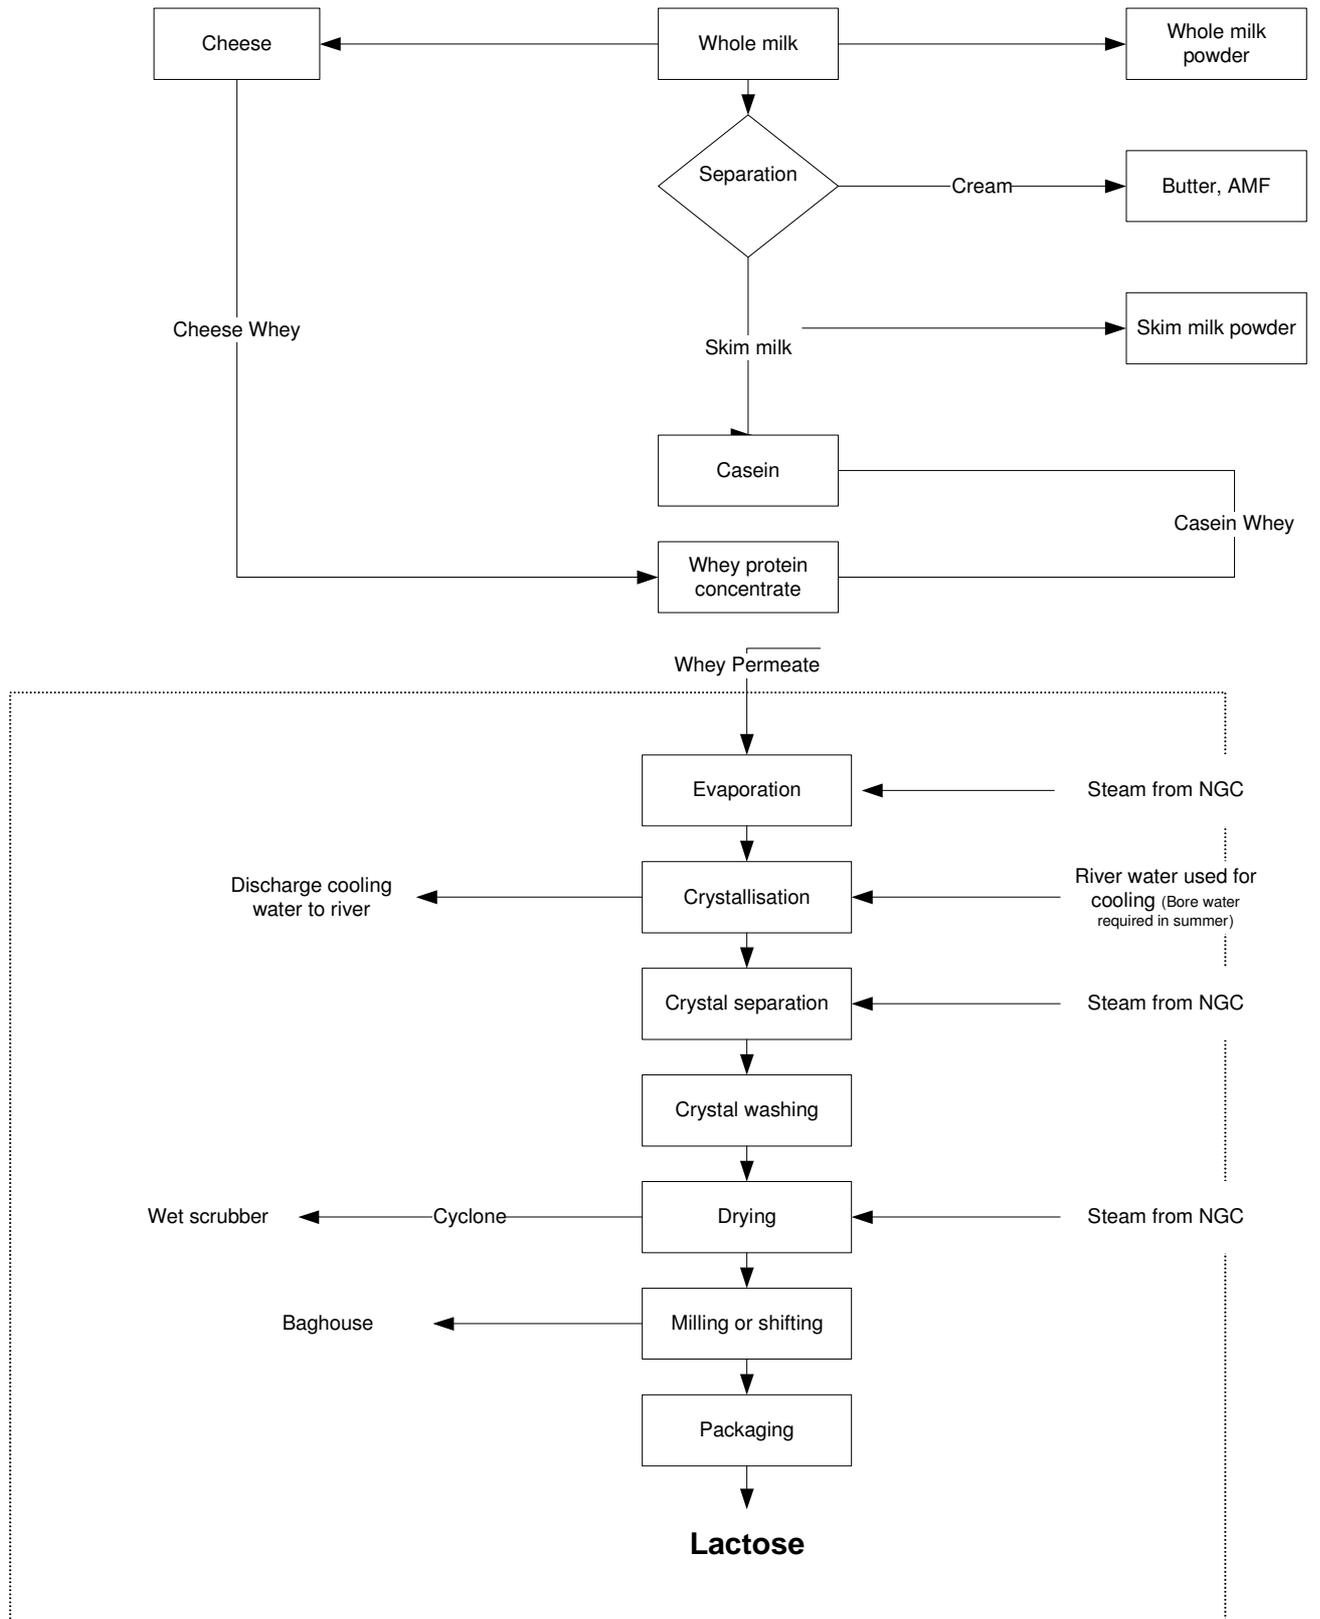
Figure 2 Lactose process diagram

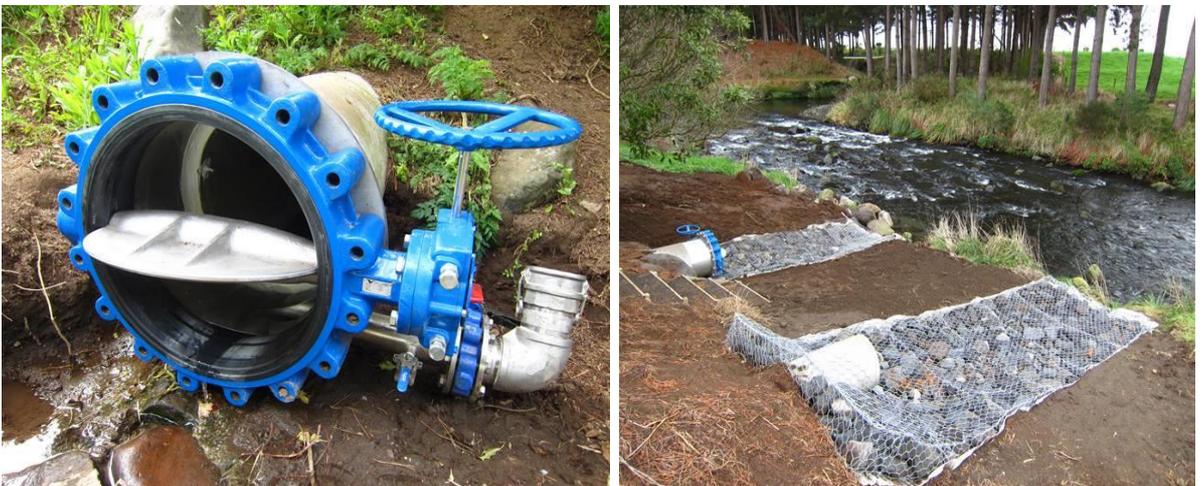
**Photo 1** Valve on northern storm drain, 15 November 2012, and Reno mattresses laid out below storm drains to Kaupokonui River, 27 June 2013

The discharge from the stormwater outfall for the northern part of the main plant was significantly below the lower pH range limit on one occasion. This was attributed to aerial deposition of lactose during a long dry period before sampling. A valve was installed on this stormwater outfall during the review period, in case of accidental spillage of chemicals, and Reno mattresses for erosion control were laid below both northern stormwater outlets, as shown in Photo 1.

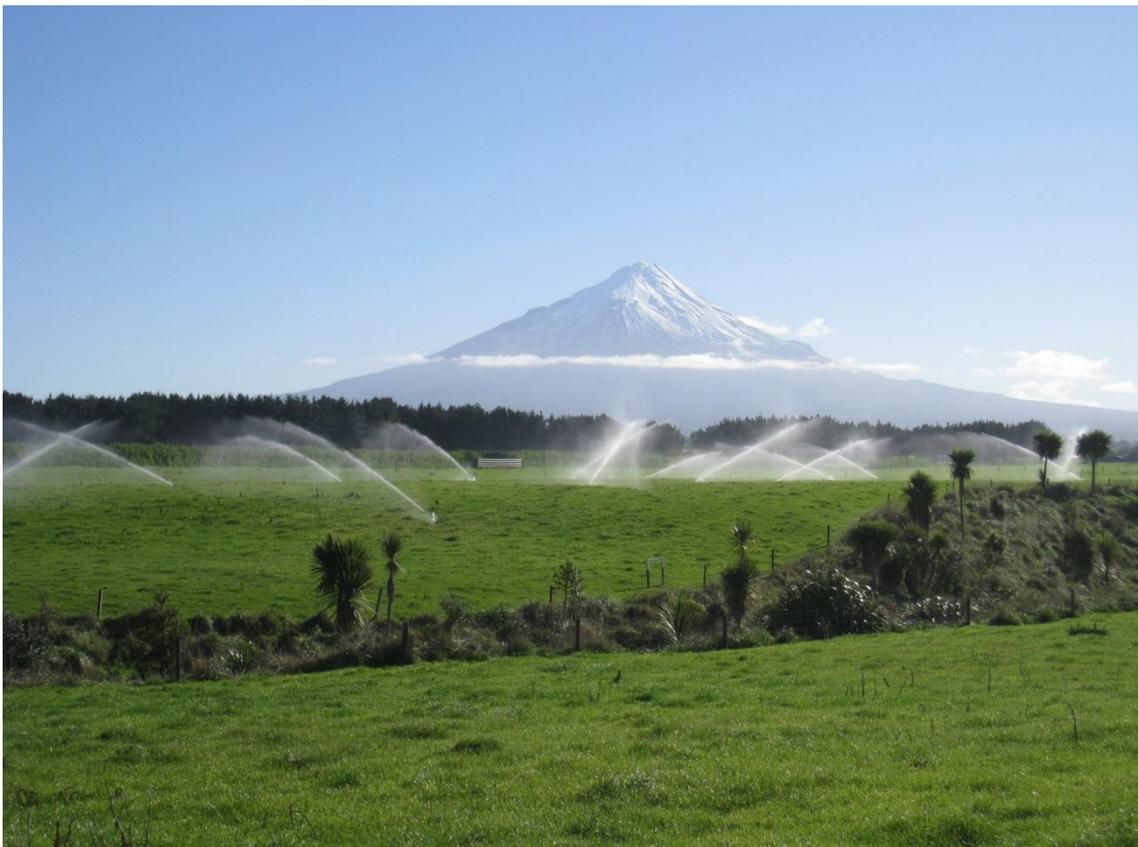
An example of riparian planting is given in Photo 2, along the Waiokura Stream on Farm 2, and about 1.1 km south of Skeet Road (Riparian Management Plan RMP1425). Groundwater monitoring bore GND2050 is situated down-gradient of the fixed-in-place irrigators and up-gradient of the riparian plantings.

**Photo 2** Riparian plantings along Waiokura Stream, Farm 2 with fixed irrigators in operation

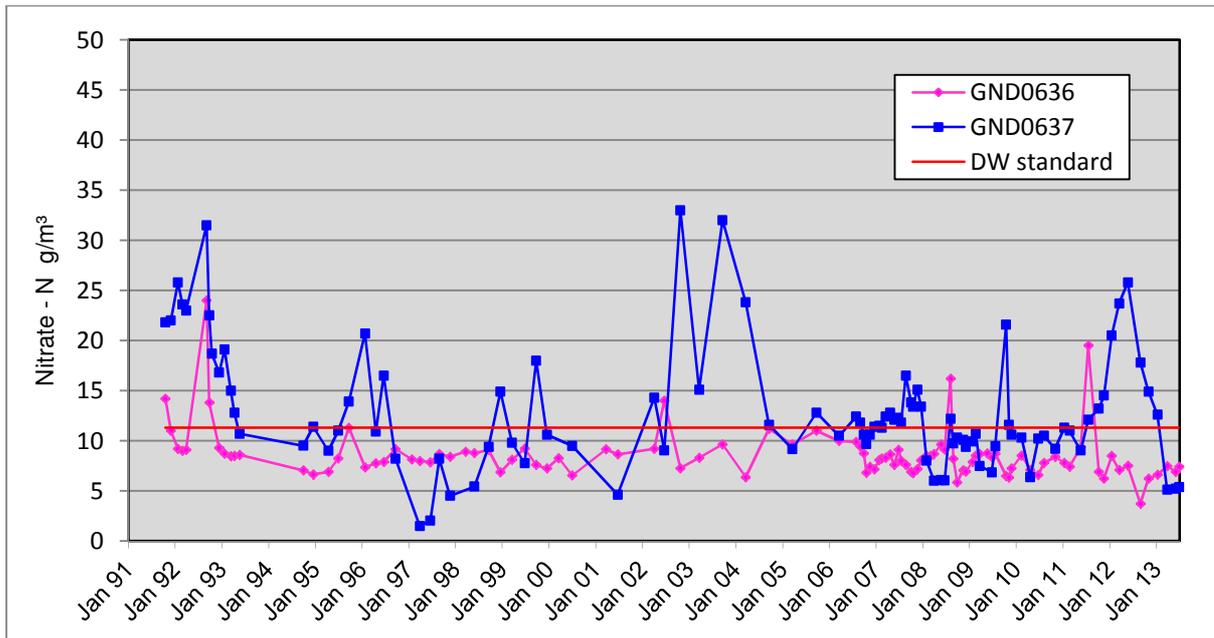
The water quality of the control bore GND0636 groundwater continued to be relatively stable in terms of nitrate. The median nitrate-N concentration of 6.8 g/m<sup>3</sup> was lower than the historical median of 8.4 g/m<sup>3</sup>.

**Figure 5** Trends in groundwater Nitrate-N concentration at Farm 1

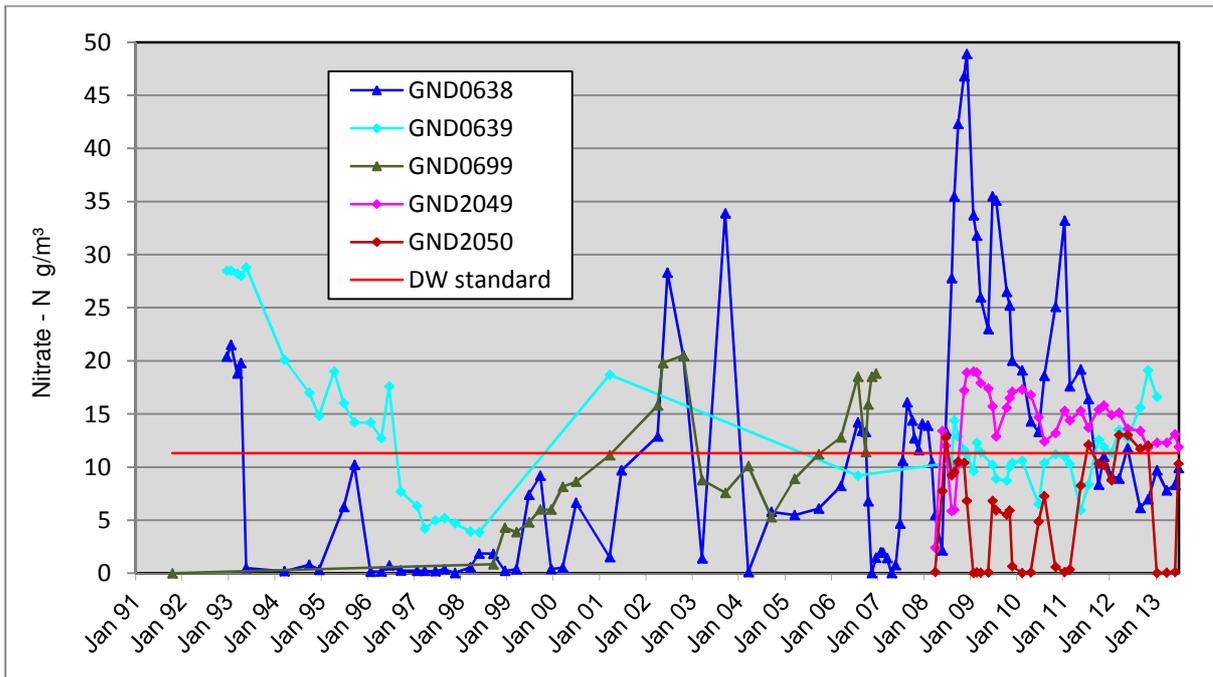
At the new impact bore beside the Waiokura Stream, GND2050, nitrate-N concentration appears to fluctuate with groundwater level, being in the range 5 to 14 g/m<sup>3</sup> when water level is high during winter and spring, and falling to <1 g/m<sup>3</sup> in summer and autumn when the level is low. Nitrate -N did not fall in summer and autumn 2011-2012, when groundwater level remained relatively high throughout. Mineral levels were significantly higher than at the control bore.

**Figure 6** Trends in groundwater Nitrate-N concentration at Farm 2

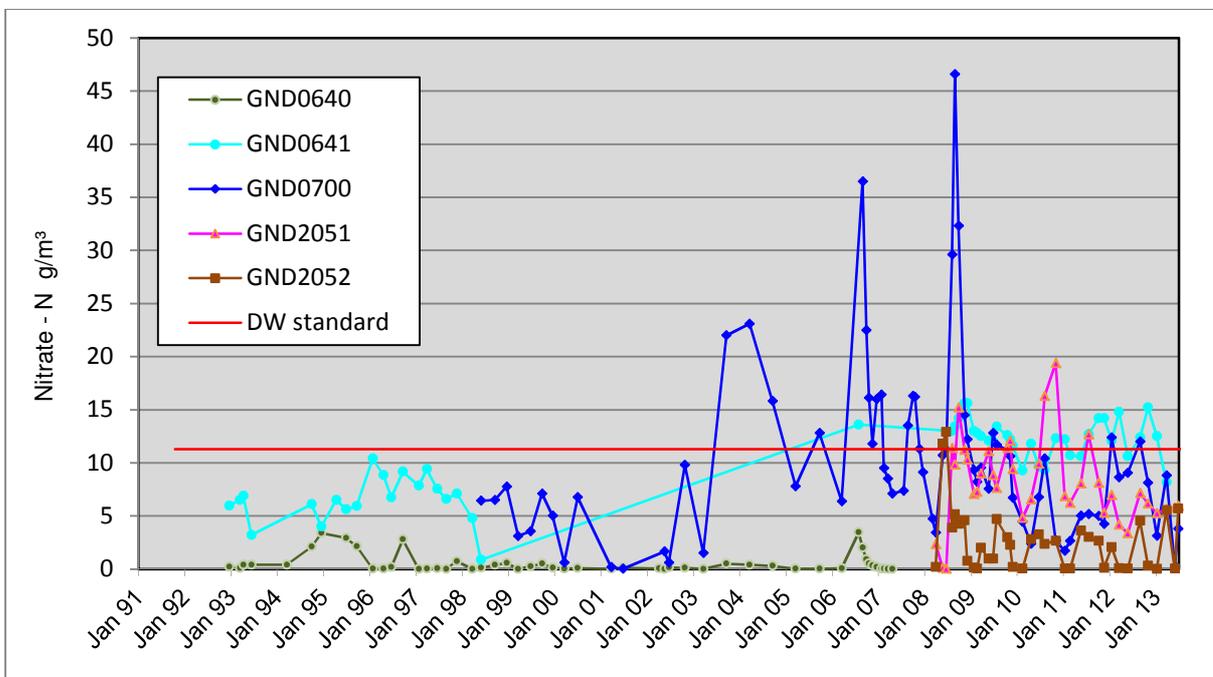
The impact of wastewater irrigation upon the two older impact bores (GND0641 and GND0700, Table 19) was reflected in elevated sodium, chloride, and conductivity levels, the respective values being higher at GND0700, which has a greater length of irrigated area up-gradient.

**Figure 7** Trends in groundwater Nitrate-N concentration at Farm 3

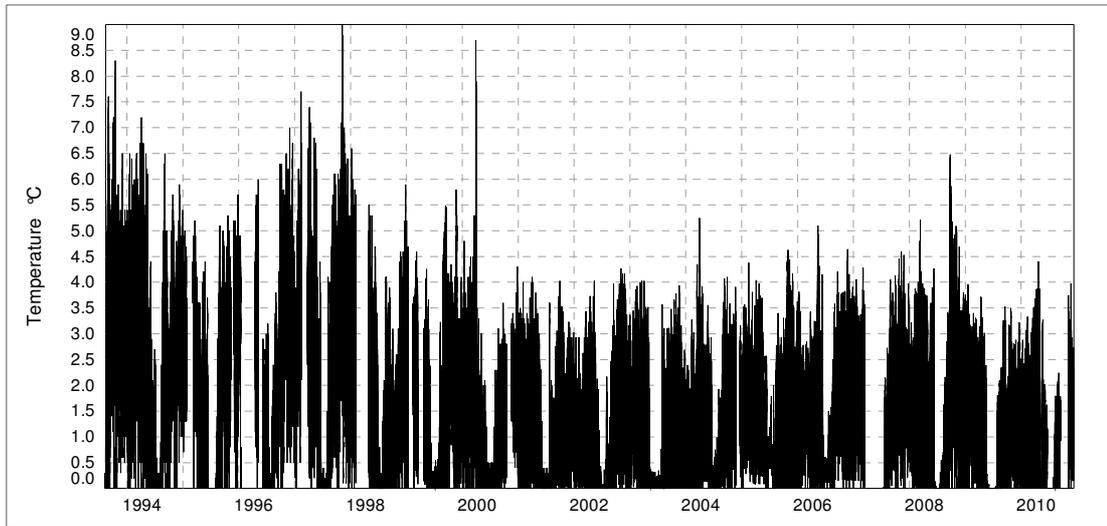
periods of cooler water conditions had been demonstrated towards the right bank of the river and there was gradual mixing of the cooling water discharges with the receiving water.

**Figure 8** Kaupokonui River water temperature differential (LB-RB) records at the periphery of the Fonterra Kapuni spray cooling water discharge zone, 1993-2010

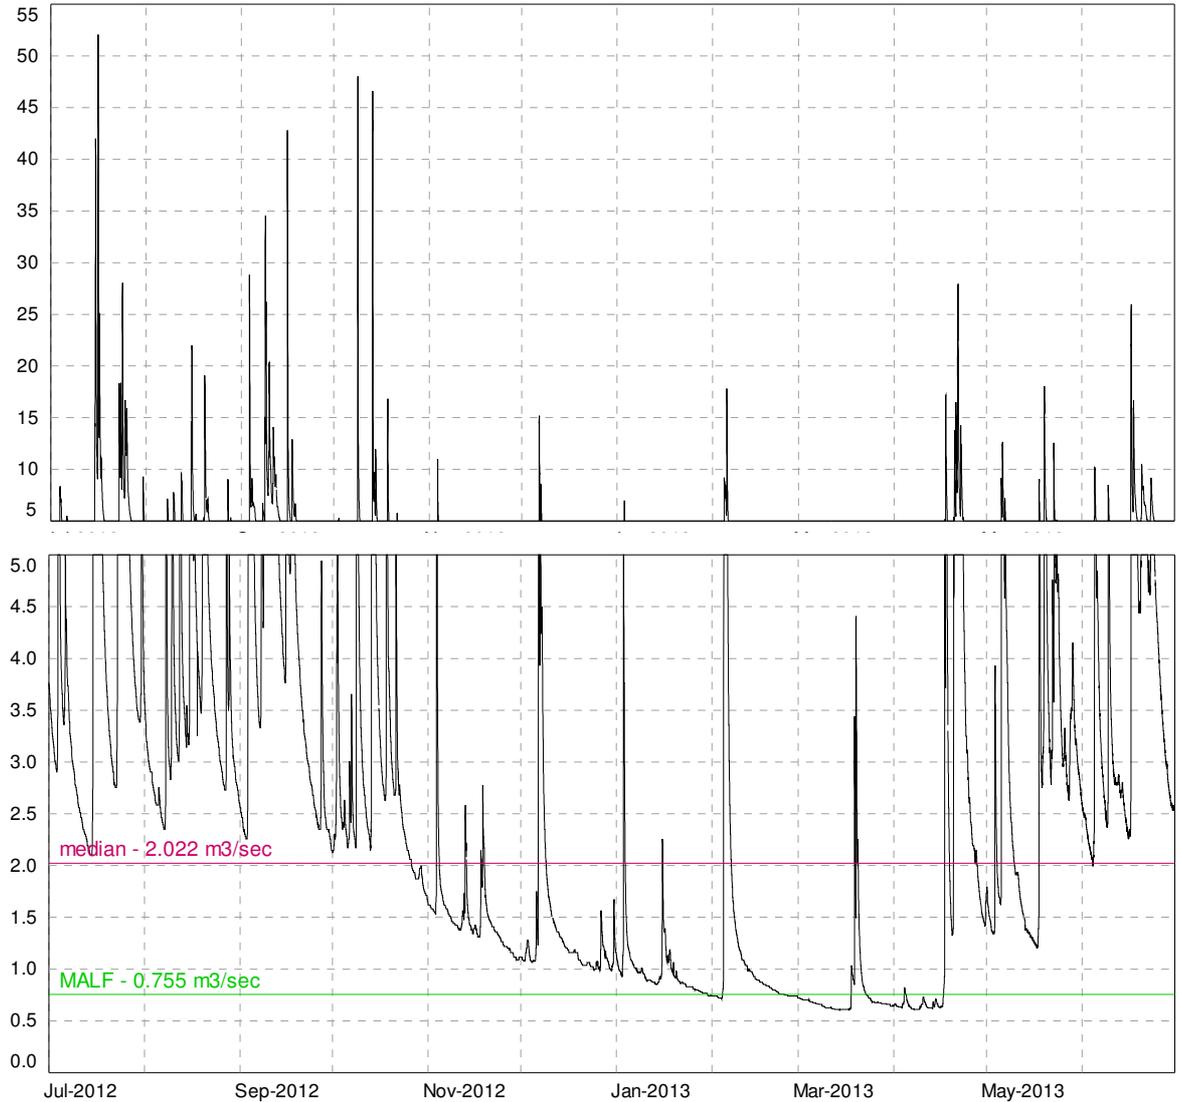
**Figure 9** Kaupokonui River at Glenn Road flow record ( $\text{m}^3/\text{s}$ ) for period 1 July 2012 to 30 June 2013

Kaupokonui River flow records for the monitoring period for the Glenn Road recording station are presented in Figure 9.

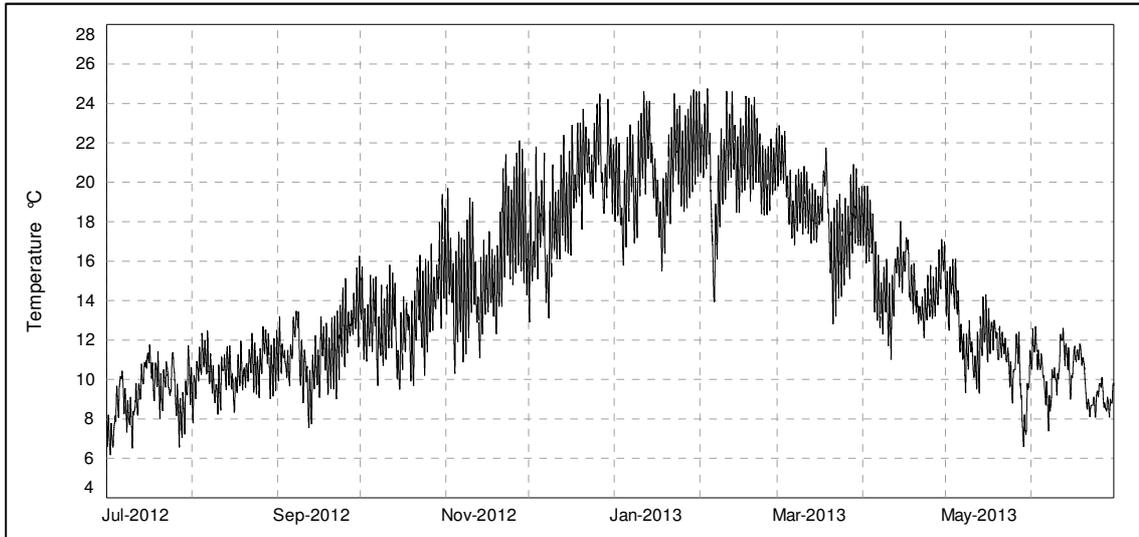
**Figure 10** Water temperature (°C) records for the Kaupokonui River at Glenn Rd during the period 1 July 2012 to 30 June 2013

Water temperature records for these two sites are illustrated in Figure 10 and Figure 11.

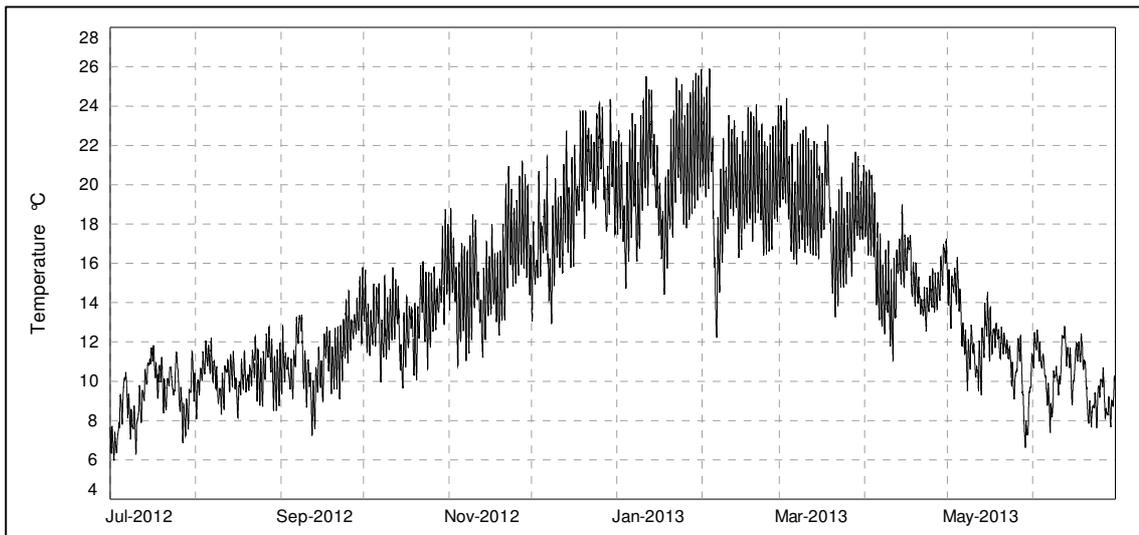
**Figure 11** Water temperature records for the Kaupokonui River at Beach during the period 1 July 2012 to 30 June 2013

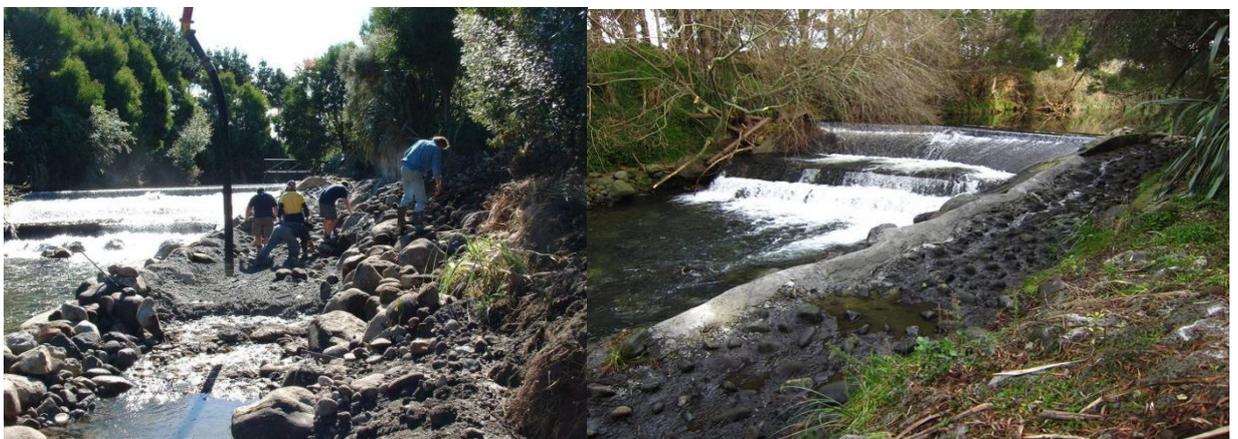
Construction of the fish pass was subsequently completed in late March 2004, and the pass was commissioned in early April 2004. Taranaki Regional Council and Fish and Game Taranaki assisted with the construction, particularly the placement of rocks within the pass. Visual inspections have indicated the pass is functioning well, and trout have been observed immediately upstream that may have used the pass. However, in November 2010, during a routine biomonitoring survey, it was noted that a cut-out had formed in the side of the lower section of the pass, through which a significant amount of the water flow was escaping. Repairs to the upper and central sections were made in May 2013. Further work on the bottom section was scheduled for (and was carried out in) summer 2013-2014. An electric fishing survey, to assess the effectiveness of the pass will be carried out after the repairs are completed.

**Photo 3** Construction of the new fish pass, March 2004, and repaired upper section, May 2013

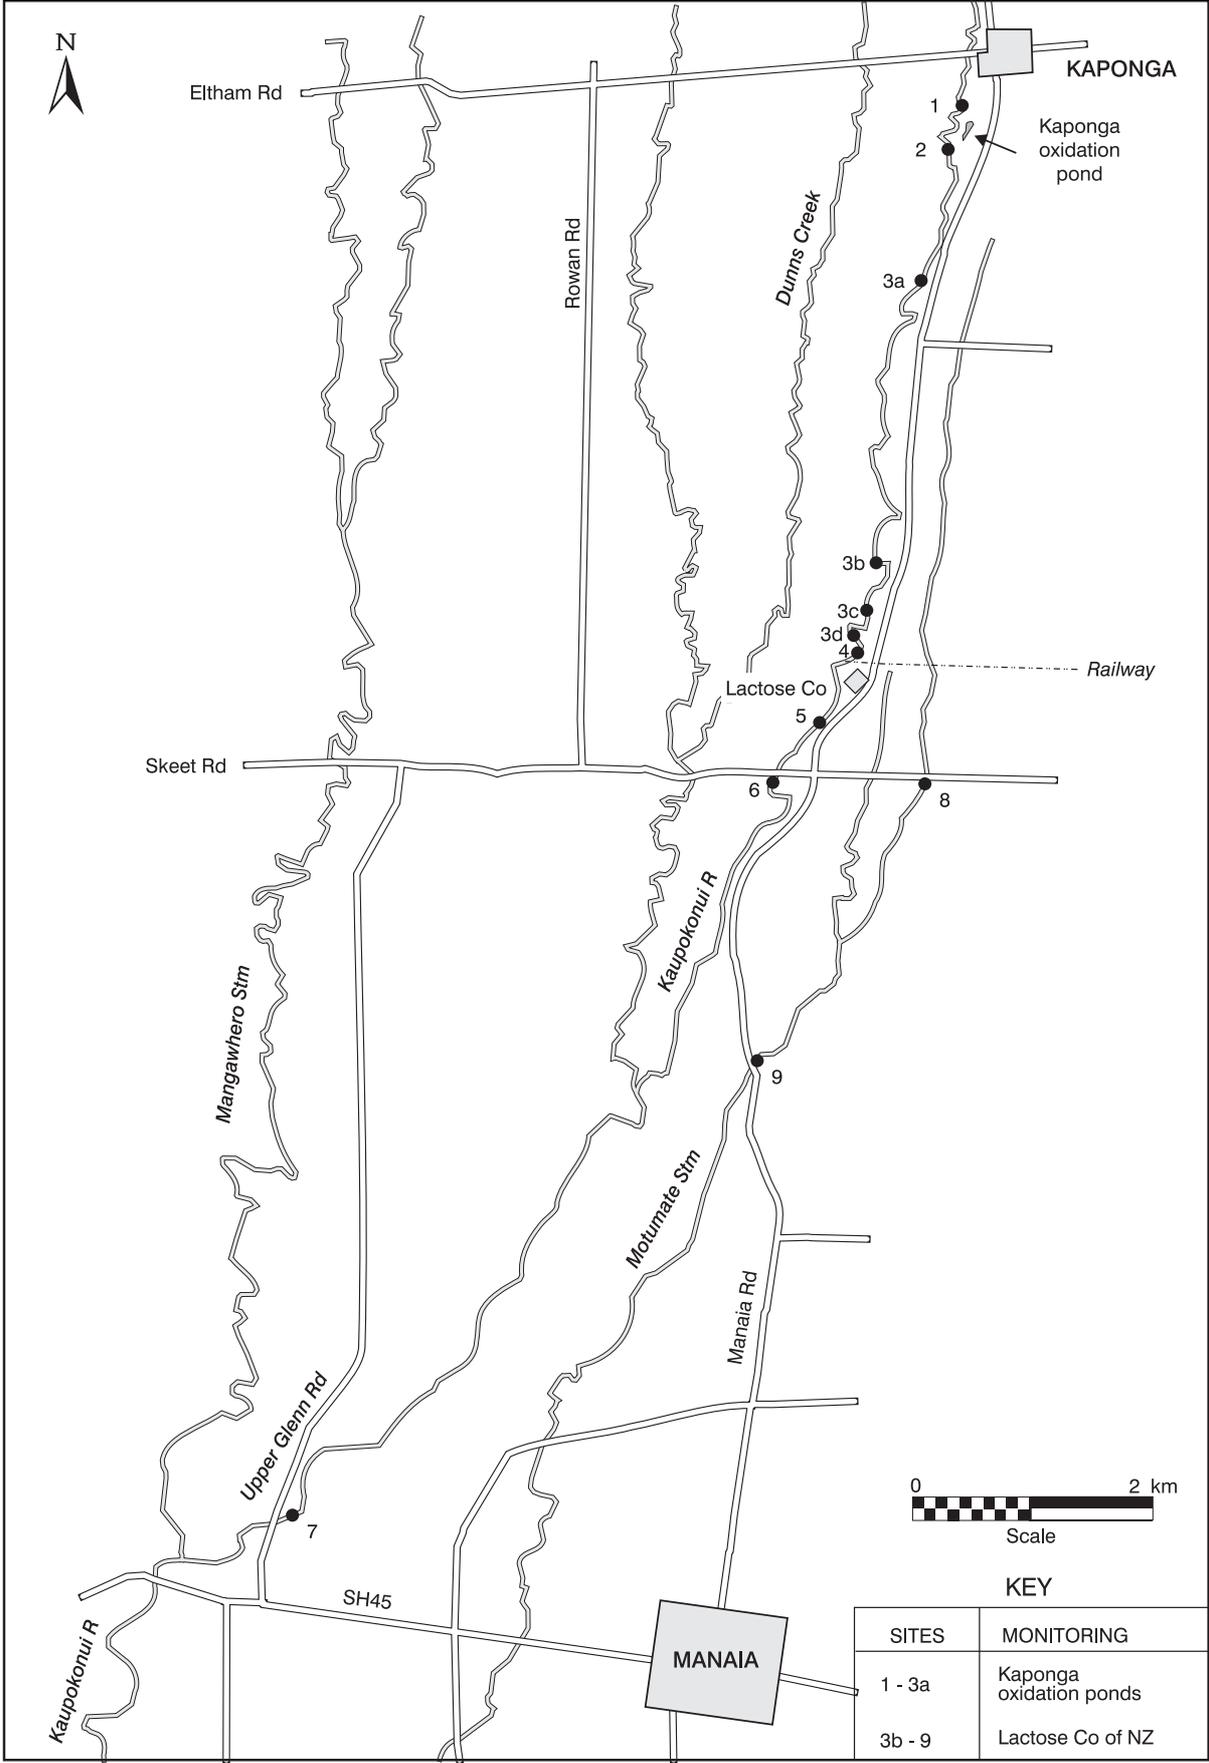
**Figure 1** Biomonitoring sites in the Kaipokonui River sampled in relation to Fonterra Kapuni factory discharges

The standard '400 ml kick-sampling' technique was used to collect streambed macroinvertebrates from five sites in the Kaupokonui River in relation to discharges to the river and on to land in the catchment (Table 1, Figure 1) on 4 October 2012. The 'kick-sampling' technique is very similar to Protocol C1 (hard-bottomed, semi-quantitative) of the New Zealand Macroinvertebrate Working Group (NZMWG) protocols for macroinvertebrate samples in wadeable streams (Stark et al, 2001).

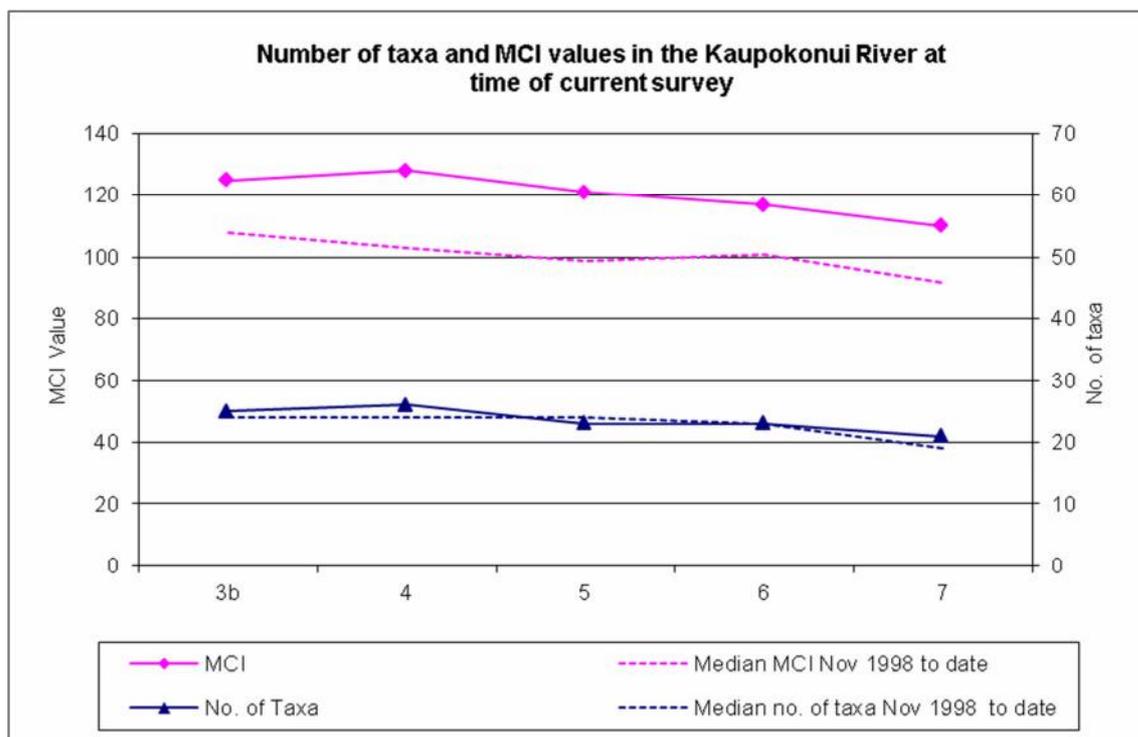
**Figure 2** Numbers of taxa and MCI values recorded in the Kaupokonui River in this survey, together with median values from previous surveys (November 1998 to date)

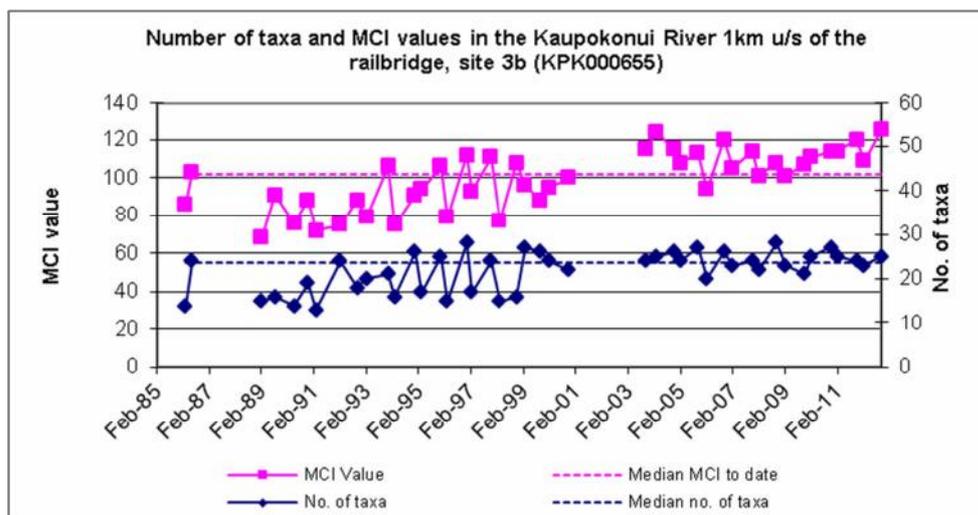
The low proportion of 'tolerant' taxa in the community (16% of taxa richness) was reflected in the MCI score (125) which was significantly higher than the previous summer survey score and also higher than the previous spring score at this site (Figure 3). The presence of eight 'highly sensitive' taxa indicated good preceding physicochemical water quality at this control site, above all Fonterra activities in the Kaupokonui River catchment.

**Figure 3** Numbers of taxa and MCI values recorded at site 3b in the Kaupokonui River since 1985

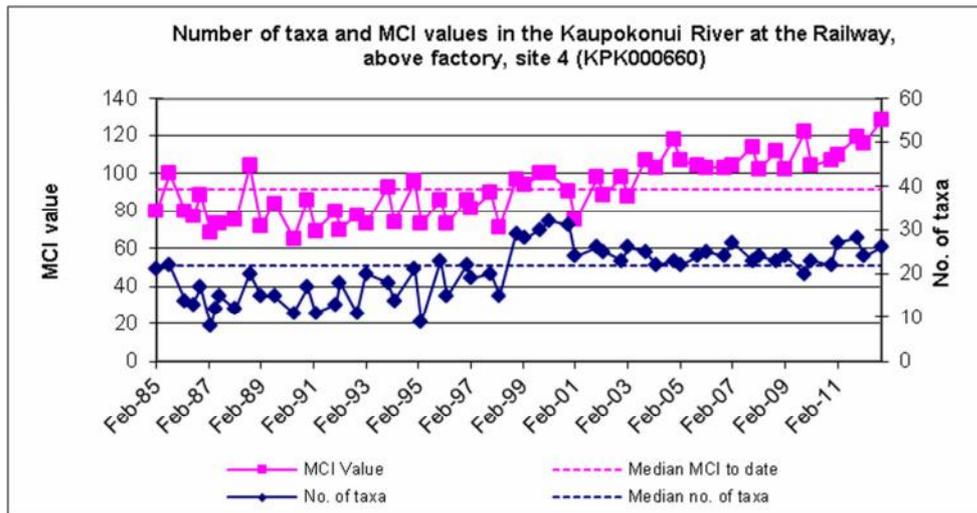
'sensitive' taxa and this was further confirmation that the community had not been recently adversely affected by land irrigation upstream of this site.

**Figure 4** Numbers of taxa and MCI value recorded at site 4 in the Kaipokonui River since February 1985

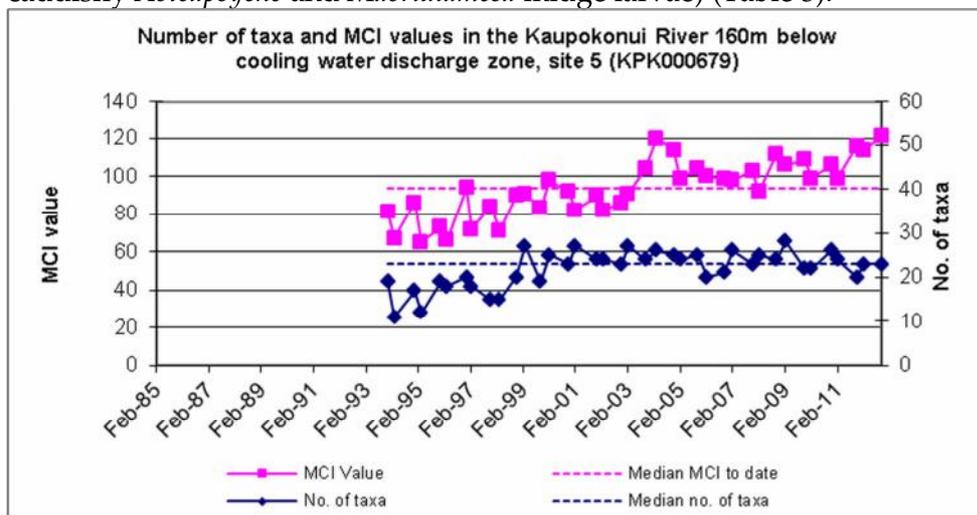
The community was characterised by three 'highly sensitive' taxa (mayfly (*Deleatidium* & *Nesameletus*) and *Beraeoptera* caddisflies), three 'moderately sensitive' taxa (mayfly (*Coloburiscus*), elmid beetles and crane fly (*Aphrophila*)) and two 'tolerant' taxa (net-spinning caddisfly *Aoteapsyche* and *Maoridiamesa* midge larvae) (Table 3).

**Figure 5** Numbers of taxa and MCI values recorded since December 1993 at site 5 in the Kaipokonui River

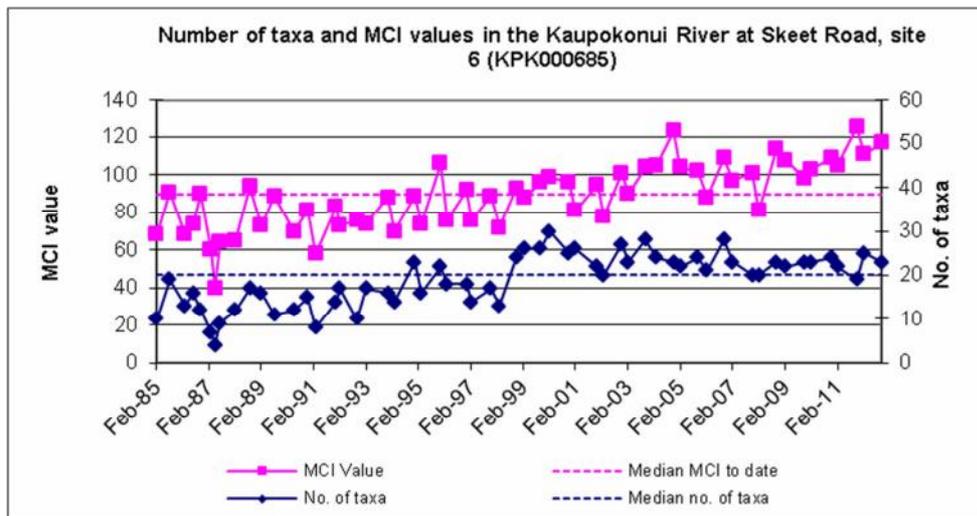
The SQMCI<sub>s</sub> (7.4 units) was similar to that recorded at site 5, suggesting little change in community health. Only two taxa changed significantly in abundance at this site, and this lack of change resulted in the lack of change in SQMCI<sub>s</sub> score. Unlike in the spring 2010 survey, *Chironomus* blood worms and 'sewage fungus' were not recorded at Skeet Road. This indicates that the subtle effect caused by the discharge(s) from the Fonterra Kapuni site in that spring survey was not repeated in the current survey. It is therefore considered that there was no significant adverse effect on the macroinvertebrate communities recorded at this site.

**Figure 6** Numbers of taxa and MCI values recorded at site 6 in the Kaipokonui River, at Skeet Road, since February 1985

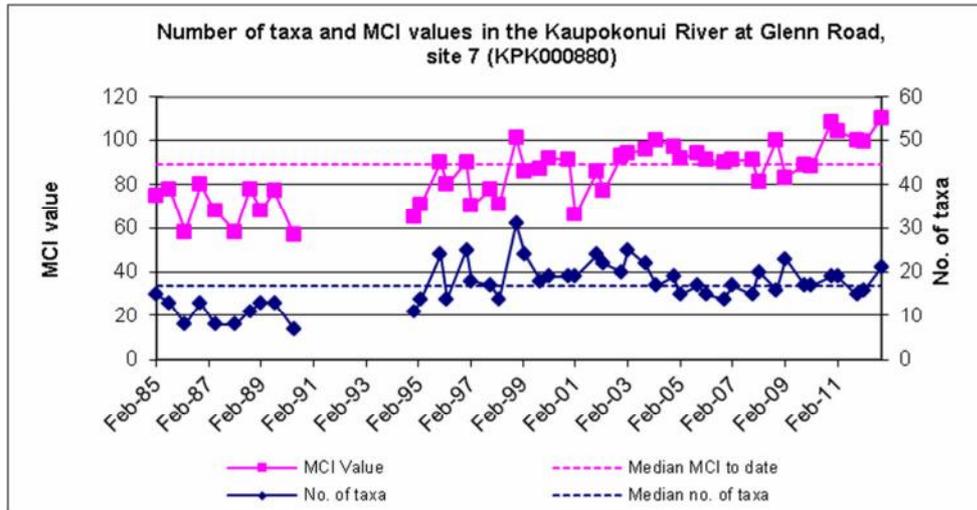
A moderate richness of twenty-one macroinvertebrate taxa was recorded at site 7, at Upper Glenn Road (Table 2), slightly higher than both the long term median and the median richness of surveys since 1998. Four 'highly sensitive' taxa were present in this community, less than that found at the other four upstream sites, but a slight improvement on that recorded in most previous surveys. Characteristic taxa included one 'highly sensitive' taxon (*Deleatidium* mayfly), three 'moderately sensitive' taxa (*Coloburiscus* mayfly, elmids beetles, and caddisfly (*Pycnocentropes*)) and three 'tolerant' taxa (net-spinning caddisfly *Aoteapsyche*, and *Maoridiamesa* and orthoclad midge larvae). Despite the distance between these sites 6 and 7 and a degree of natural deterioration in macroinvertebrate communities normally found in a downstream direction, community composition is usually relatively similar between sites 6 and 7. This has been repeated somewhat in the current survey, with eighteen taxa being common to both communities.

**Figure 7** Numbers of taxa and MCI values recorded at site 7 in the Kaupokonui River, since February 1985

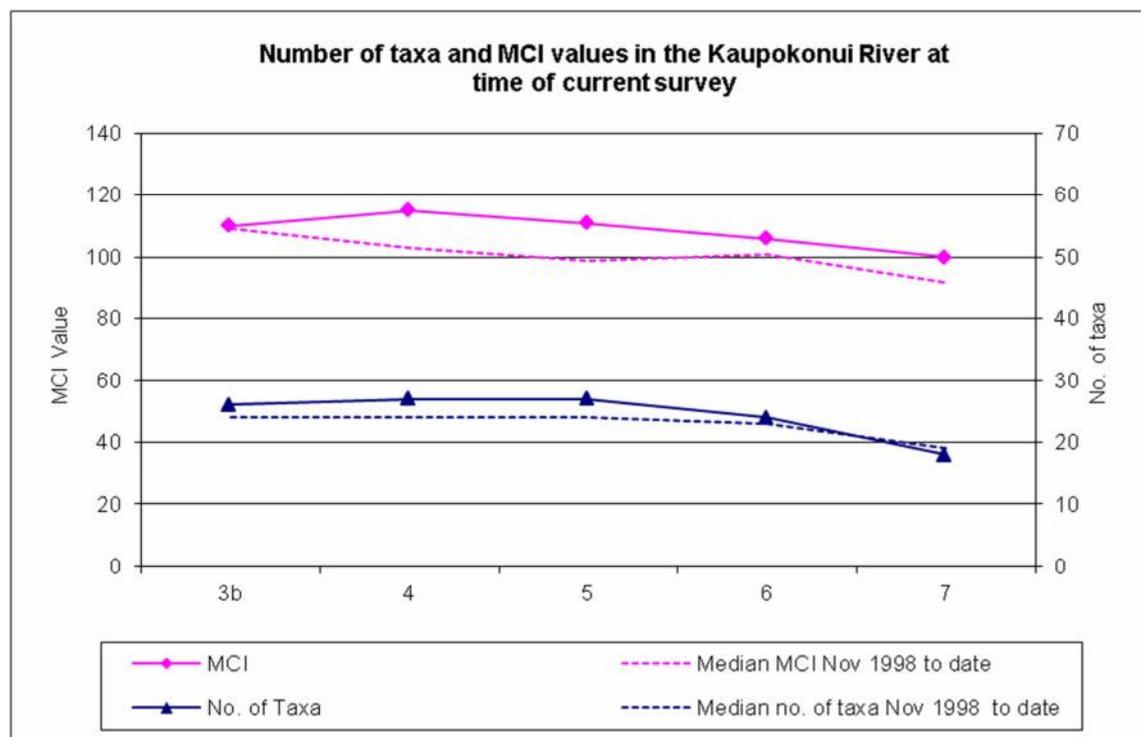
The good MCI results are reinforced by the results of the microscopic scan, which checked for undesirable biological growths. No such growths were recorded at any site. The last time such growths were recorded, was during the spring 2010 survey, which recorded dense growths of filamentous bacteria at two sites.

**Figure 2** Numbers of taxa and MCI values recorded in the Kaipokonui River in this survey, together with median values from previous surveys (November 1998 to date)

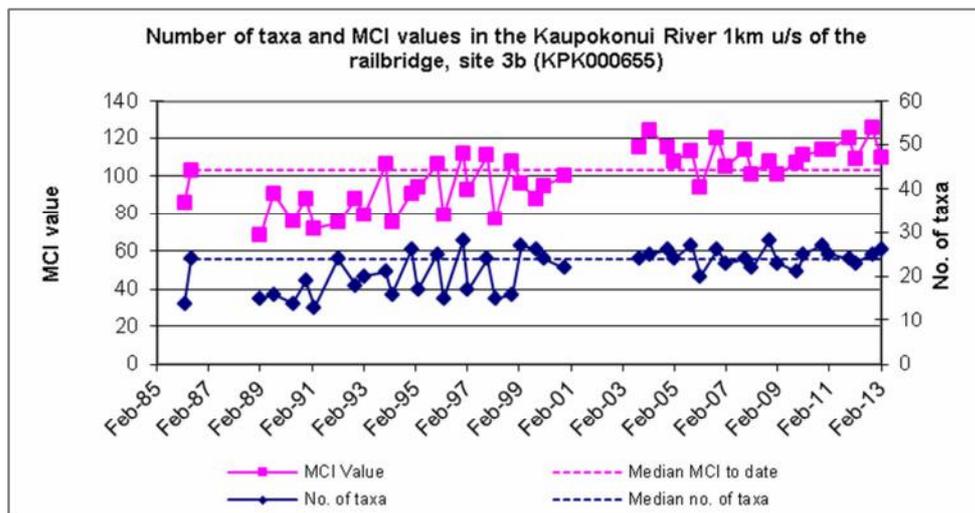
The moderate proportion of 'tolerant' taxa in the community (35% of taxa richness) was reflected in the MCI score (110) which was significantly lower than the previous spring survey score and but similar to the previous summer score at this site (Figure 3). The presence of six 'highly sensitive' taxa indicated good preceding physicochemical water quality at this control site, above all Fonterra activities in the Kaupokonui River catchment.

**Figure 3** Numbers of taxa and MCI values recorded at site 3b in the Kaupokonui River since 1985

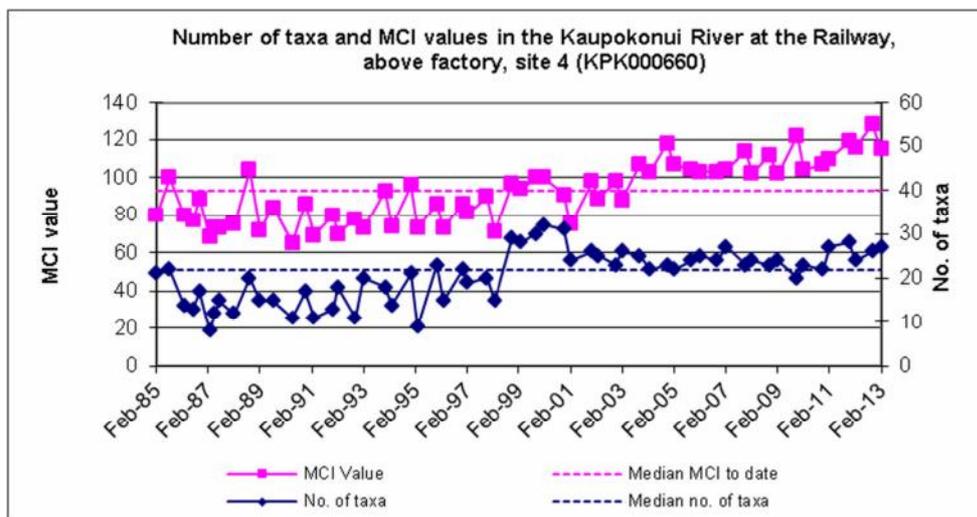
The SQMCI<sub>s</sub> value for this (5.9 units) was an insignificant 0.3 unit higher than that at site 3b (Stark, 1998) (Table 3), primarily due to both sites being dominated by the same two taxa, as both *Deleatidium* mayfly and the net-spinning caddisfly *Aoteapsyche* were both extremely abundant at both sites. This score indicates that the community contained a healthy proportion of 'sensitive' taxa (for a summer survey) and this was further confirmation that the community had not been recently adversely affected by land irrigation upstream of this site.

**Figure 4** Numbers of taxa and MCI value recorded at site 4 in the Kaipokonui River since February 1985

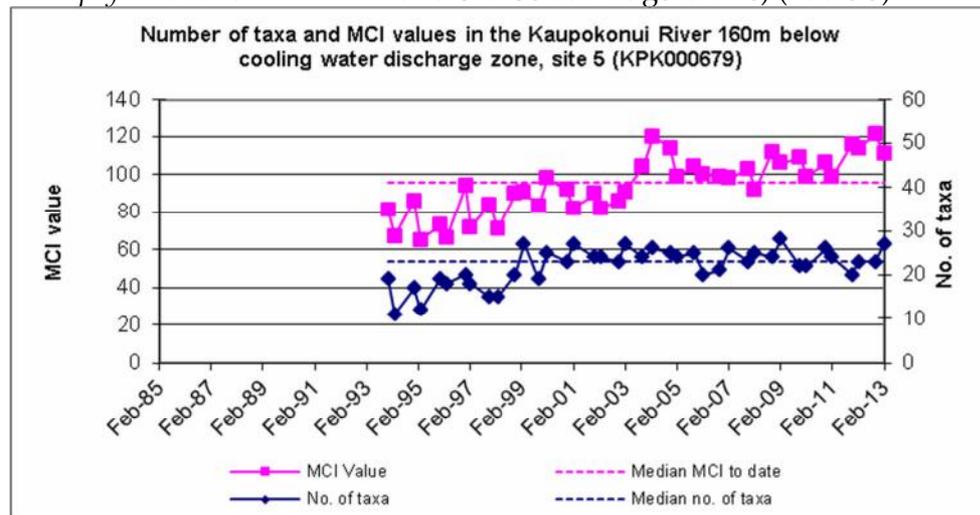
(Archichauliodes) and cranefly (*Aphrophila*)) and three 'tolerant' taxa (net-spinning caddisfly *Aoteapsyche* and *Maoridiamesa* and orthoclad midge larvae) (Table 3).

**Figure 5** Numbers of taxa and MCI values recorded since December 1993 at site 5 in the Kaipokonui River

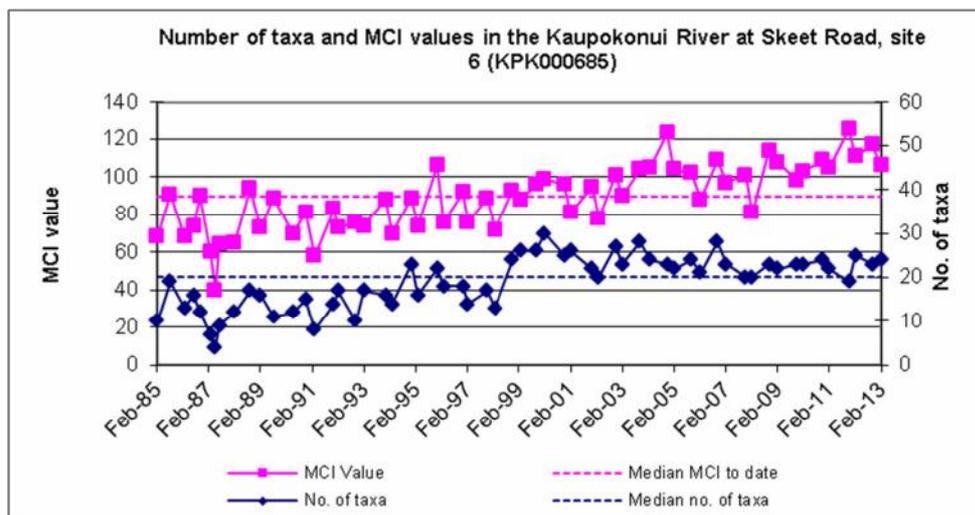
The SQMCI<sub>s</sub> (6.7 units) was the highest recorded in the current survey, and was 0.8 unit higher than to that recorded at site 5, suggesting little change in community health. No two taxa changed significantly in abundance at this site (from site 5), and this lack of change resulted in the lack of change in SQMCI<sub>s</sub> score. Unlike in the spring 2010 survey, *Chironomus* blood worms and 'sewage fungus' were not recorded at Skeet Road. This indicates that the subtle effect caused by the discharge(s) from the Fonterra Kapuni site in that spring survey was not repeated in the current survey. It is therefore considered that there was no significant adverse effect on the macroinvertebrate communities recorded at this site.

Figure 6 Numbers of taxa and MCI values recorded at site 6 in the Kaipokonui River, at Skeet Road, since February 1985
