Fonterra Kapuni  
Air and Water  
Monitoring Programme  
Annual Report  
2012-2013  
Technical Report 2013–106

Taranaki Regional Council  
Private Bag 713  
STRATFORD

July 2014

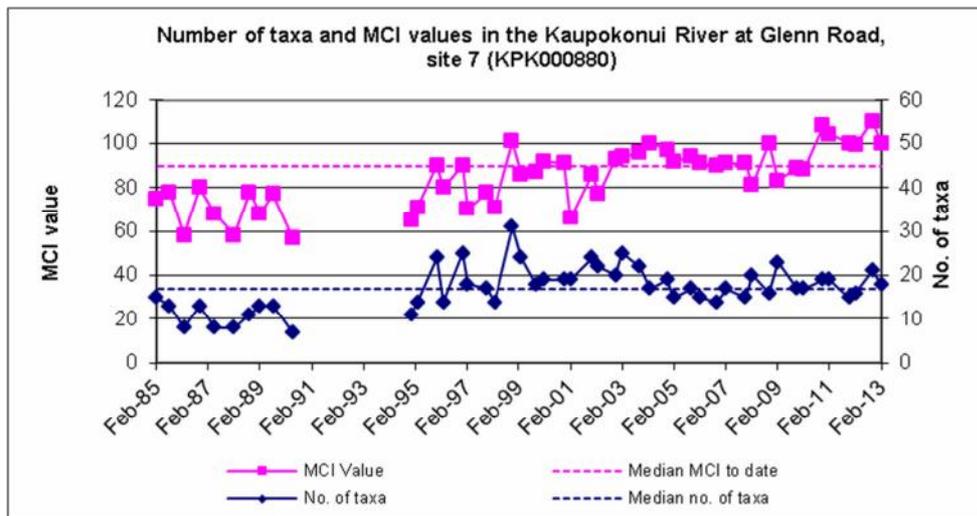
surveys. Characteristic taxa included one 'highly sensitive' taxon (*Deleatidium* mayfly), five 'moderately sensitive' taxa (*Austroclima* mayfly, elmid beetles, dobsonfly larvae (*Archichauliodes*) and caddisfly (*Hydrobiosis* and *Pycnocentroides*)) and four 'tolerant' taxa (nemertean worms, *Potamopyrgus* snails, net-spinning caddisfly *Aoteapsyche*, and orthoclad midge larvae). Despite the distance between these sites 6 and 7 and a degree of natural deterioration in macroinvertebrate communities normally found in a downstream direction, community composition is usually relatively similar between sites 6 and 7. This has been repeated somewhat in the current survey, with sixteen taxa being common to both communities.

**Figure 7** Numbers of taxa and MCI values recorded at site 7 in the Kaipokonui River, since February 1985

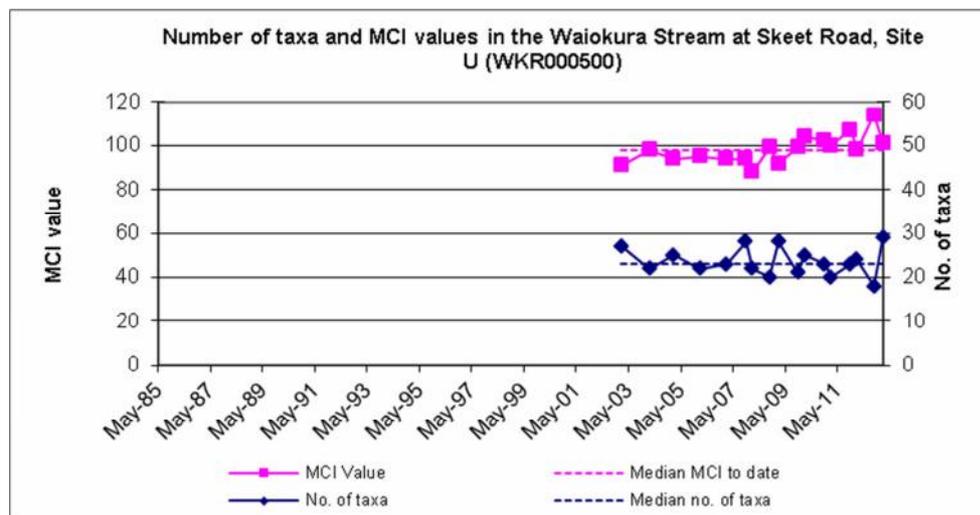
The MCI value of 101 units was three units higher than that recorded in the previous survey, but similar to the median of previous values recorded from the sixteen previous surveys at this site (Table 5, Figure 9) and reflected the moderate proportion of 'tolerant' taxa (38% of taxa richness) in the community (Table 5). The SQMCI<sub>s</sub> score of 6.2 units was near the maximum of the range of previously recorded values at this site, and reflected the dominance of 'sensitive' taxa in particular (Table 5).

**Figure 9** Numbers of taxa and MCI values recorded at site U in the Waiokura Stream since February 1985

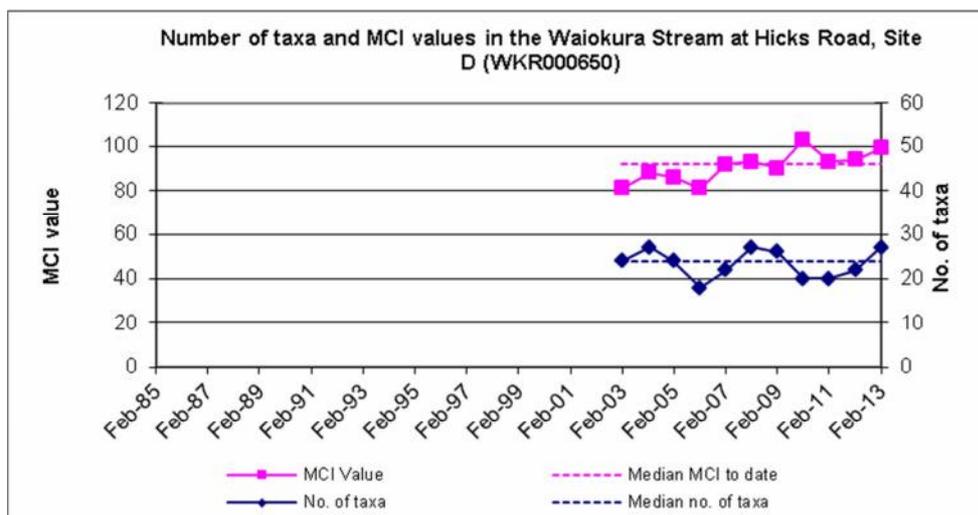
A moderately high of twenty-seven taxa was recorded at this site downstream of the wastes irrigation areas in the Waiokura Stream catchment. This was similar to that recorded at site U and equal to the maximum taxa number previously recorded at this downstream site (Table 2). With the exception of *Austrosimulium* sandfly larvae, those taxa that dominated the community at site U were also dominant at this site, with the addition of one 'moderately sensitive' taxon (*Pycnocentroides* caddisfly) (Table 5). This is despite a significant change in habitat with macrophytes, which were absent at site U, being present throughout the stream at this site.

**Figure 10** Numbers of taxa and MCI values recorded at site D in the Waiokura Stream since February 1985
