Todd Energy Aquatic Centre  
Monitoring Programme  
Annual Report  
2012-2013  
Technical Report 2013–98

The New Plymouth District Council operates the Todd Energy Aquatic Centre located on Tisch Avenue, New Plymouth. This report for the period July 2012-June 2013 describes the monitoring programme implemented by the Taranaki Regional Council to assess the consent holder's environmental performance during the period under review, and the results and environmental effects of the Company's activities.

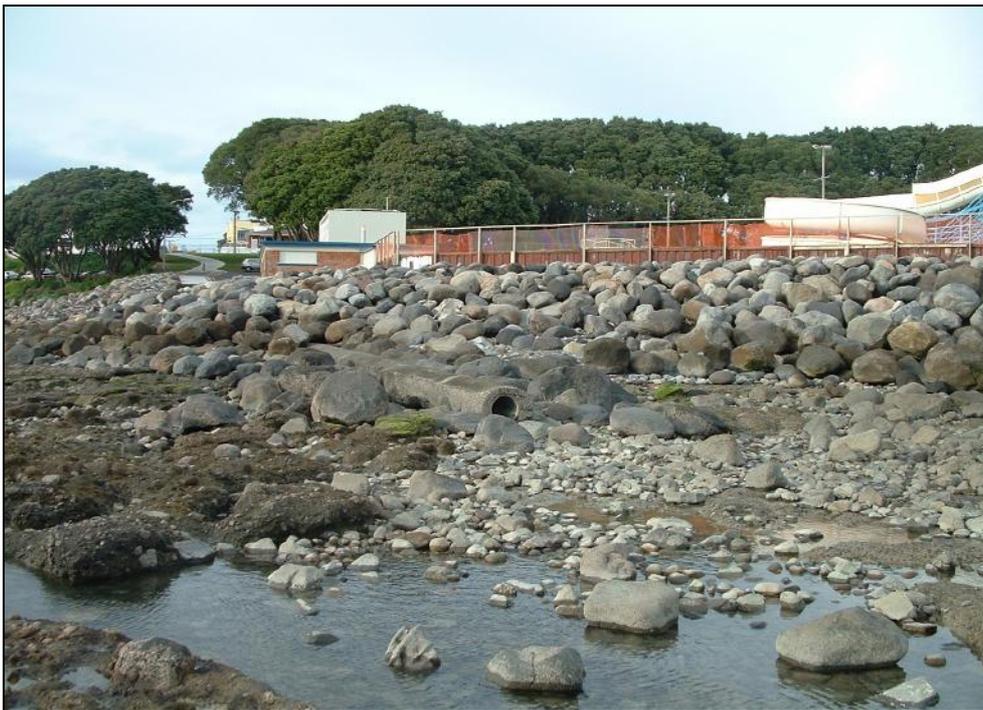
**Photograph 1** Todd Energy Aquatic Centre ocean outfall

The discharge pipe consists of a 300 mm diameter encased concrete pipe and discharges at approximately mid-tide level. This structure was constructed in 1962 and has been in use ever since for the purpose of backwashing the outdoor pool filters.

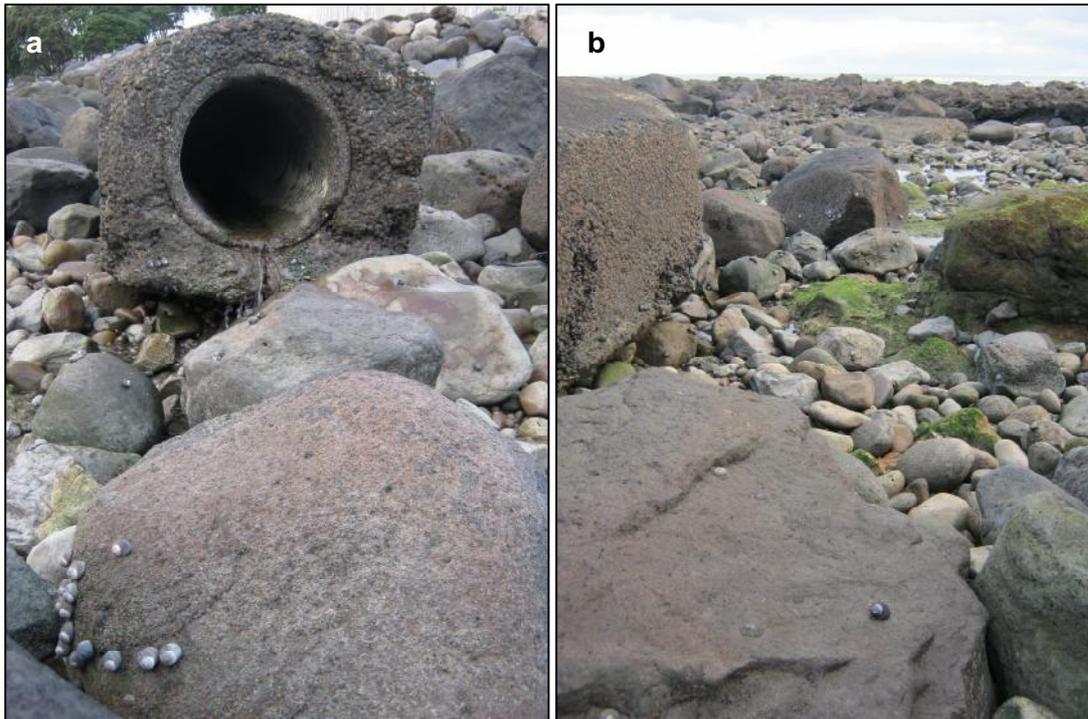
Photograph 1 a) Todd Energy Aquatic Centre discharge pipe and b) surrounding reef

The following invertebrates were present on the upper shore in the vicinity of the pipe (Photograph 1a): molluscs *Melagraphia aethiops* (very abundant), *Turbo smaragdus*, *Cellana radians* and *Sypharochiton pelliserpentis*, barnacle *Chamaesipho* sp. and the polychaete worm *Spirobranchus cariniferus*. A species of green algae resembling *Ulva intestinalis* covered rocks in the vicinity of the pipe (Photograph 1b). The brown alga *Ralfsia* sp. and red alga *Gelidium caulacanthum* were also present. This assemblage is similar to that found on previous inspections in the vicinity of the pipe, and is typical for this height on the shore. The discharge from the outdoor pool did not appear to have had any observable impacts on the organisms surrounding the outfall.

Lower down on the shore, still within the influence of the pipe discharge, the following species were identified: the molluscs *Haustrum scobina* (very abundant), *Melagraphia aethiops*, *Turbo smaragdus*, *Cominella maculosa*, *Cellana radians*, *Cellana ornata*, *Xenostrobus pulex* and *Sypharochiton pelliserpentis*, barnacle *Chamaesipho* sp. and the polychaete worms *Spirobranchus cariniferus* and *Neosabellaria kaiparaensis*. Algae included coralline turf (abundant in pools), *Hormosira banksii* (very abundant), *Notheia anomala*, *Gelidium caulacanthum* and *Ralfsia* sp. These species are similar to what would be expected at this elevation on the shore.

In summary, the range and abundance of intertidal species identified during this inspection are considered normal for this type of environment. No adverse effects on local intertidal biological communities were observed due to effects of the discharge of the outdoor pool from the Todd Energy Aquatic Centre.
