Lower Waiwhakaiho Catchment
Monitoring Programme
Biennial Report
2012-2014
Technical Report 2014–123

September 2015

The Lower Waiwhakaiho River catchment monitoring programme addresses discharges by several consent holders in the Fitzroy area of New Plymouth. The report covers the period July 2012 – June 2014, and is the twenty first report for this combined monitoring programme.

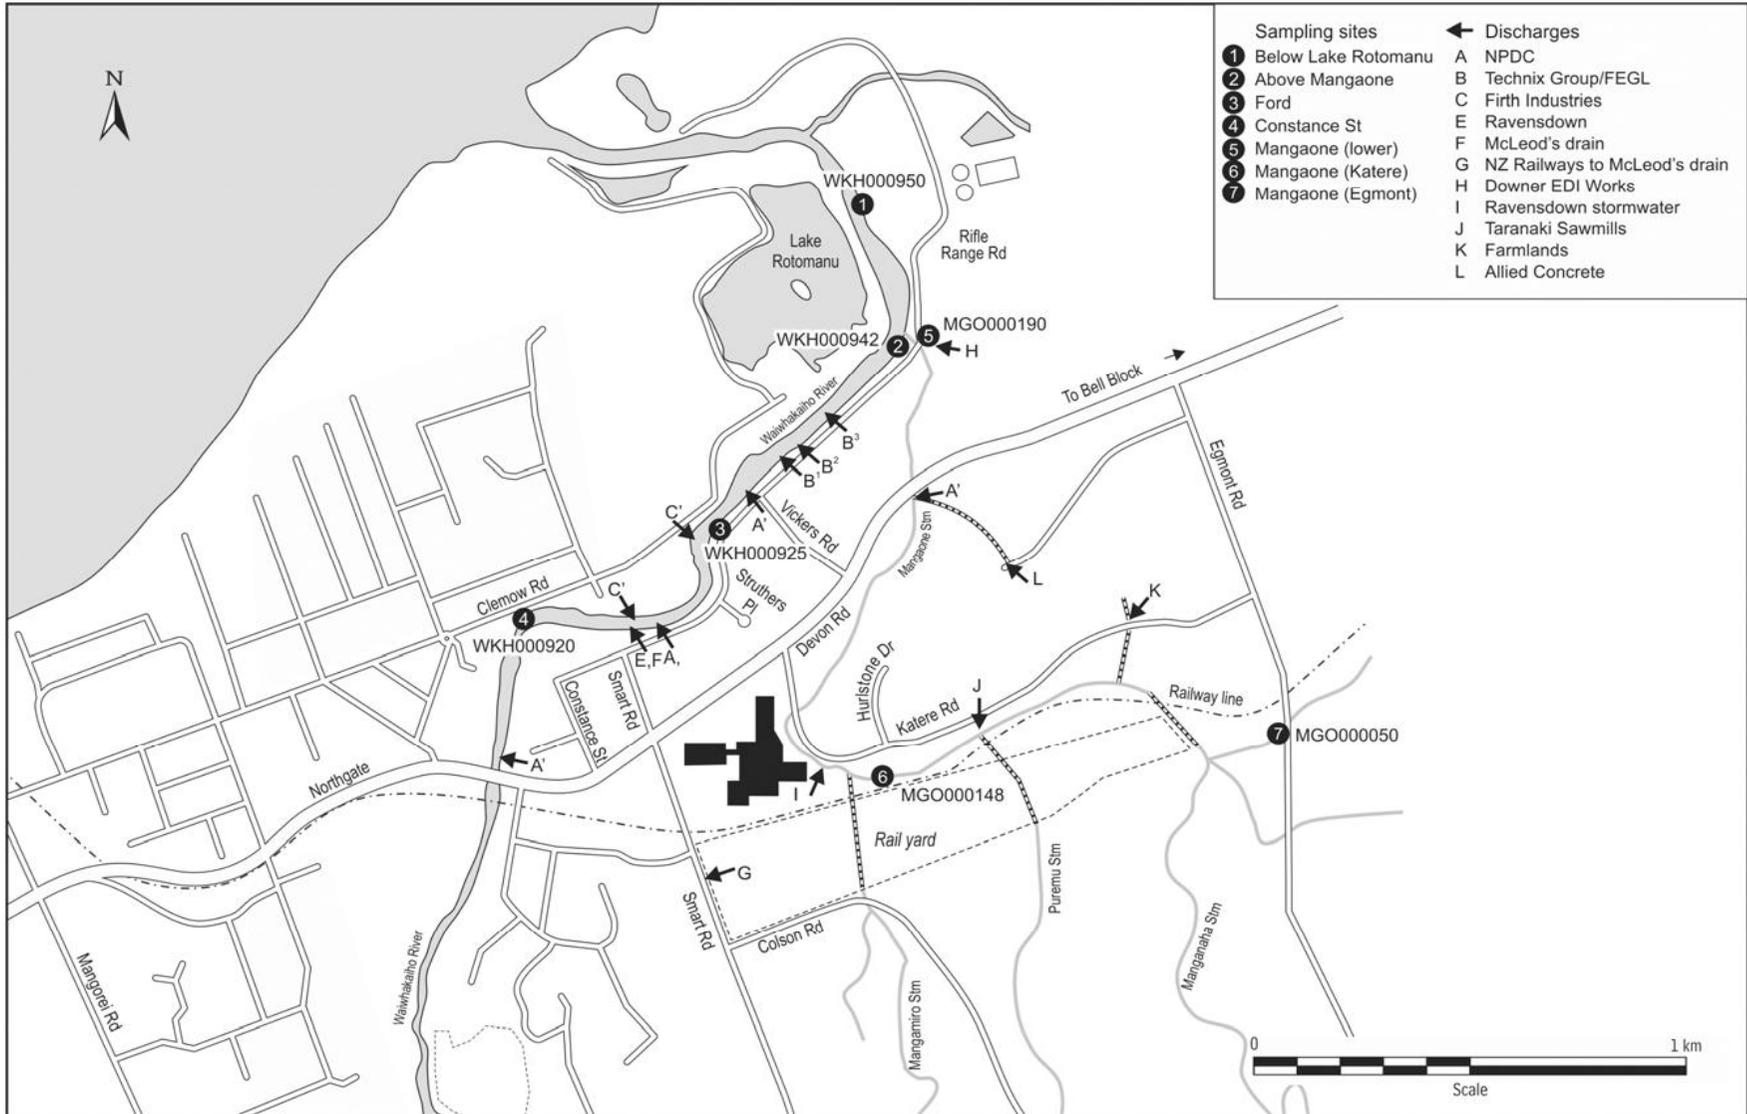
Figure 2 Lower Waiwhakaiho River and Mangaone Stream discharges

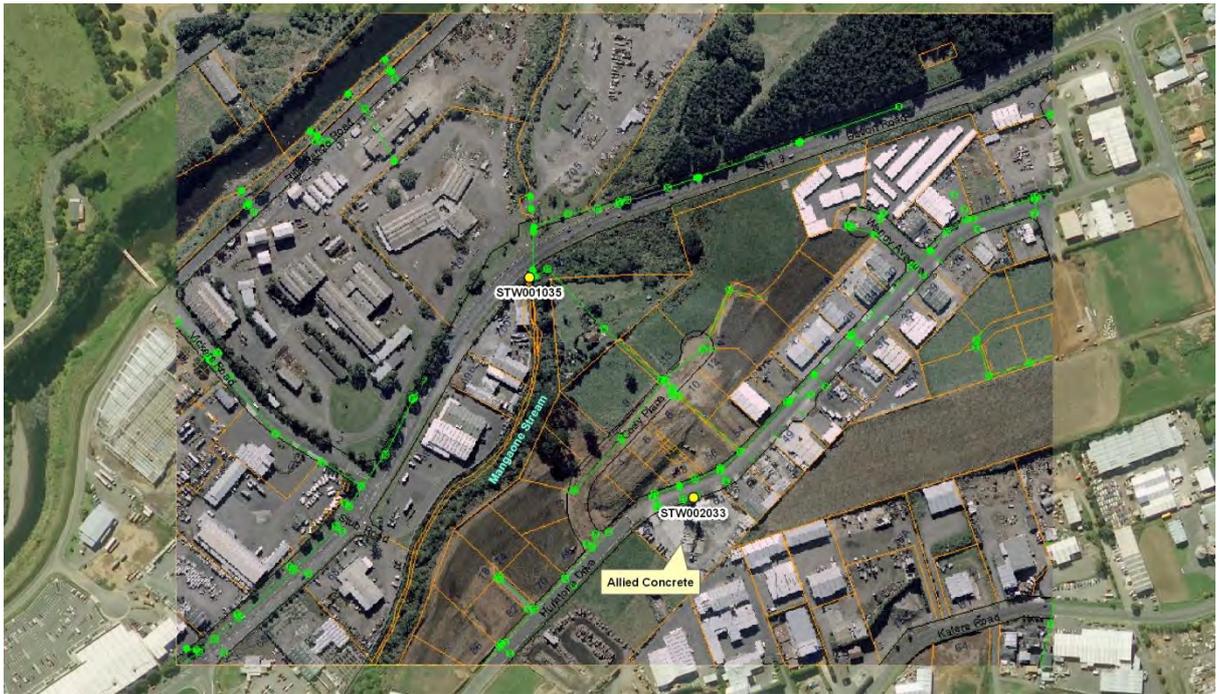
Stormwater from the majority of the site drains directly to the New Plymouth District Council (NPDC) stormwater system and then to the Mangaone Stream.

Figure 5 AML Limited (trading as Allied Concrete) site location and stormwater drainage

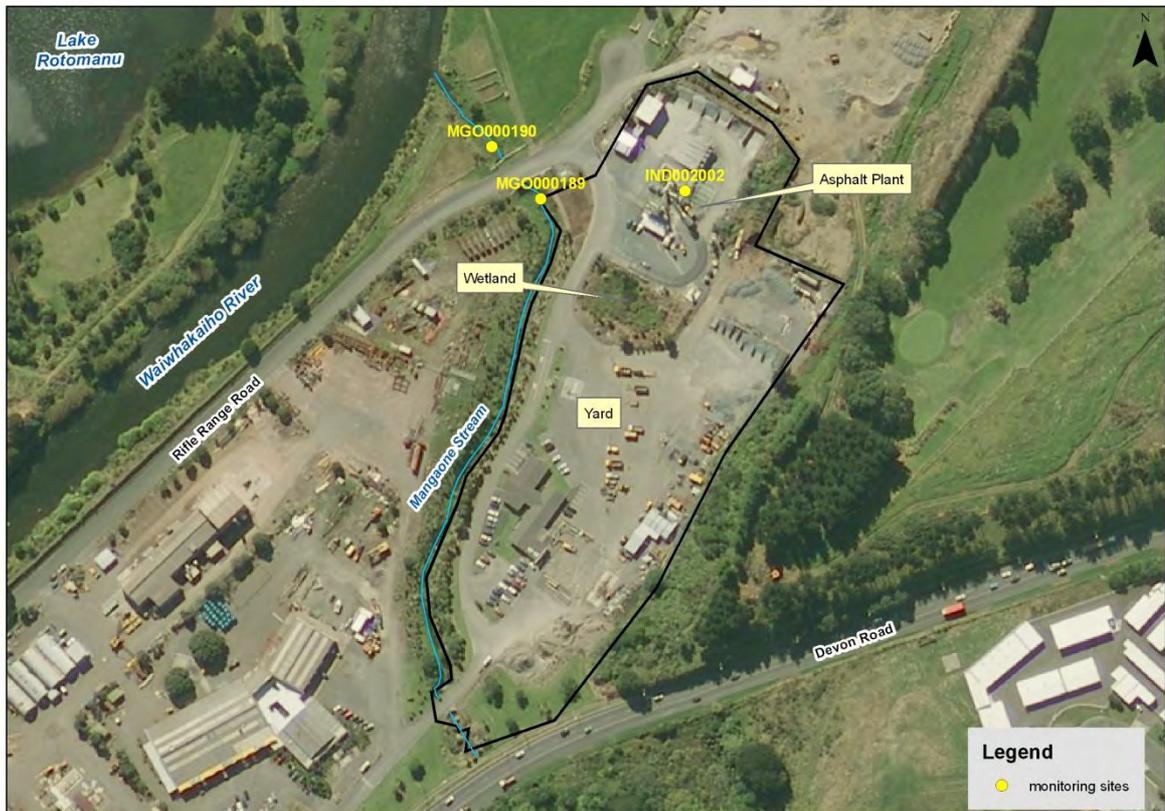
Downer EDI Works Limited operates an asphalt manufacturing plant at a site off Rifle Range Road. A depot for maintenance, parking and storage of equipment and materials used in road-making is also on the site.

Figure 6 Downer EDI Works Limited's site and sampling point locations

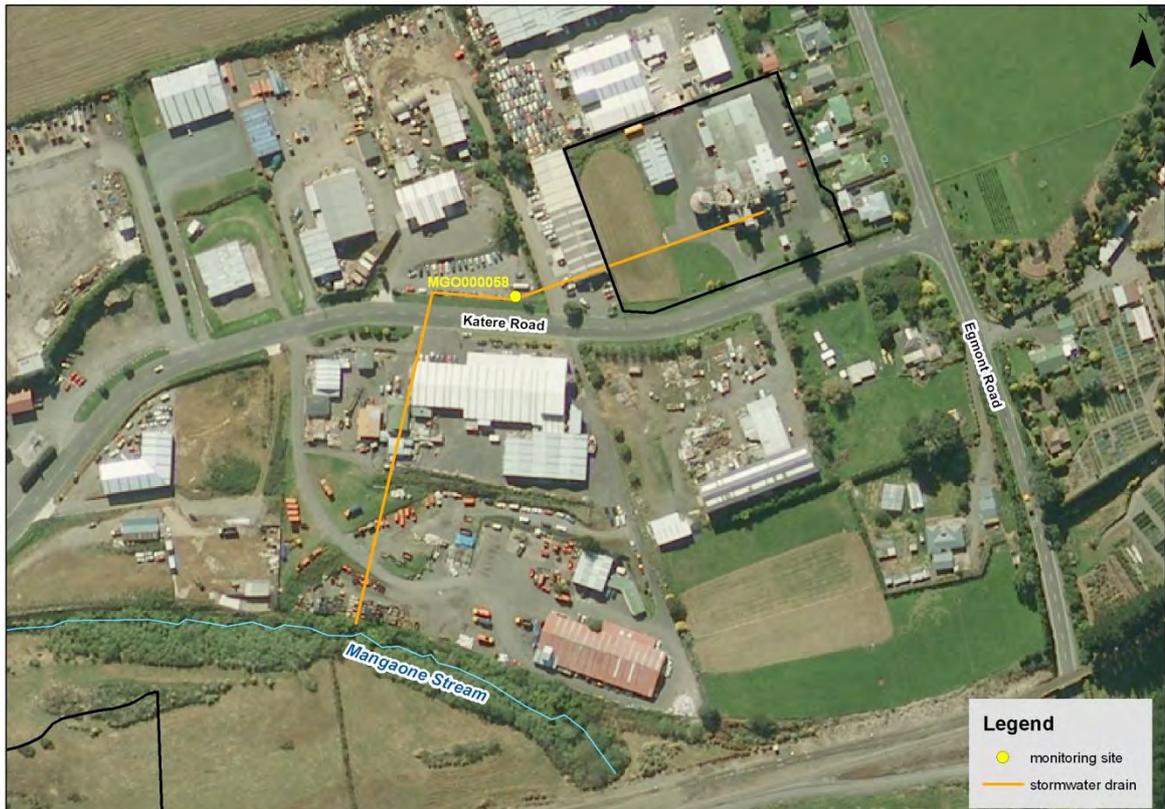
Figure 7 Viterra (NZ) Limited site and sampling point locations

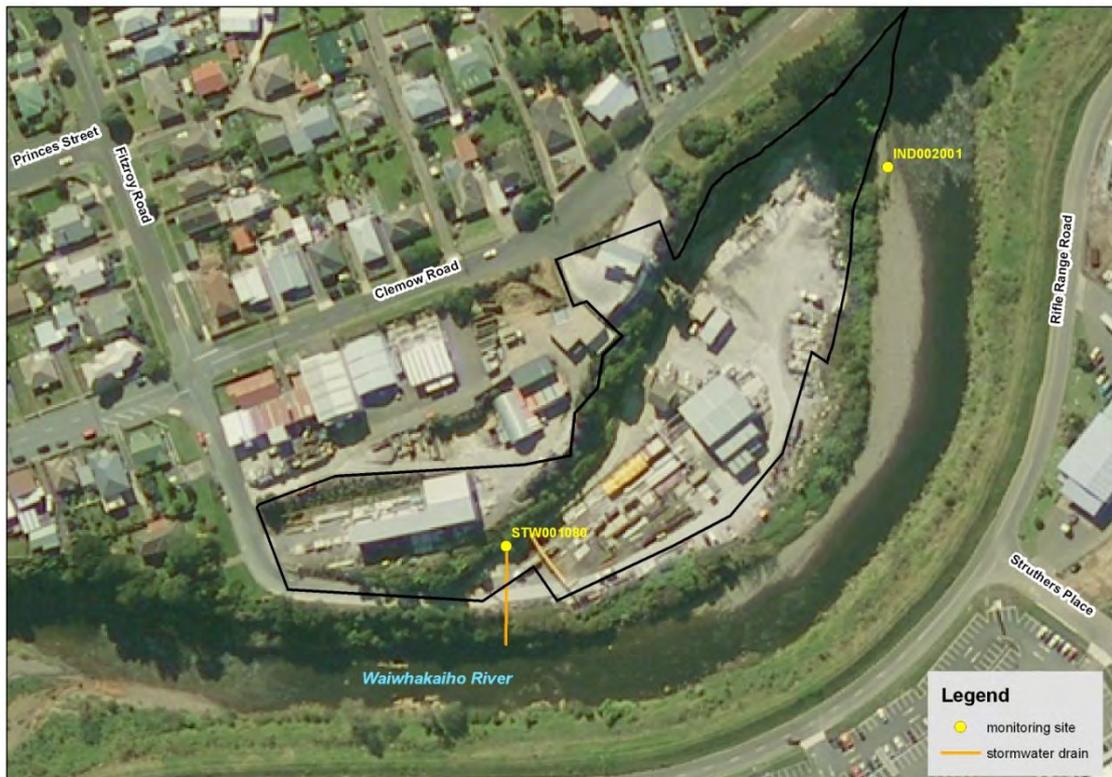
Firth Industries Limited (Division of Fletcher Concrete and Infrastructure Limited) operates a concrete batching plant on a 1.19 ha site off Clemow Road, on the true left bank of the Waiwhakaiho River. The plant is situated partly on the flood plain and partly above the escarpment formed by the river. A concrete precast factory operated by Ultimate Engineered Concrete Limited is on the site. This includes a bedding plant, which operates from an area above the escarpment.

Figure 8 Firth Industries site location and discharge points

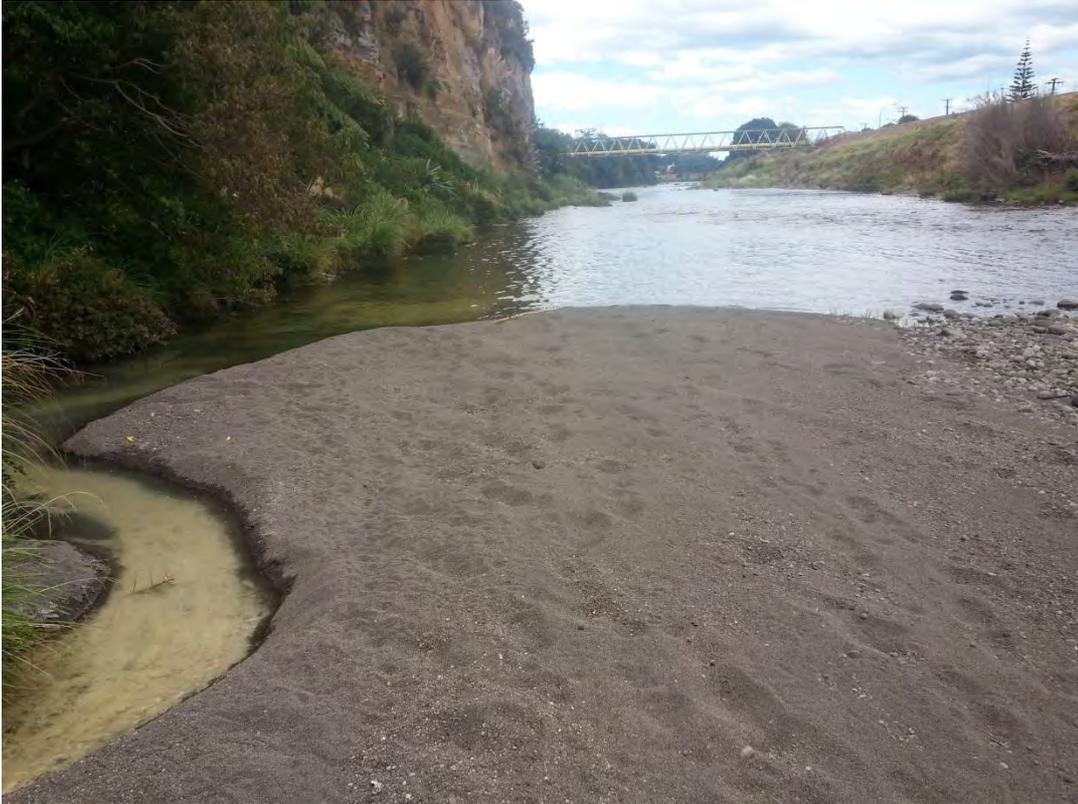
At 12:00 am a complaint was received regarding a discoloured river in Waiwhakaiho, New Plymouth. An inspection was undertaken with the Site Manager. It was found that there was white material on the river bank and slight foaming. There was no visual impact on the receiving waters (Photo 1). The Site Manager said they would remove the sludge from the sand and clean out the area that had pooled before the river. A re-inspection was undertaken on 18 March 2014 to follow up on the complaint. It was found that the sludge had been cleaned up, and there was no foam visible at the time of inspection. The pooled area of discoloured liquid had also been removed, and this was clear during the inspection.

Photo 1 Firth discharge to the Waiwhakaiho River 3 March 2014

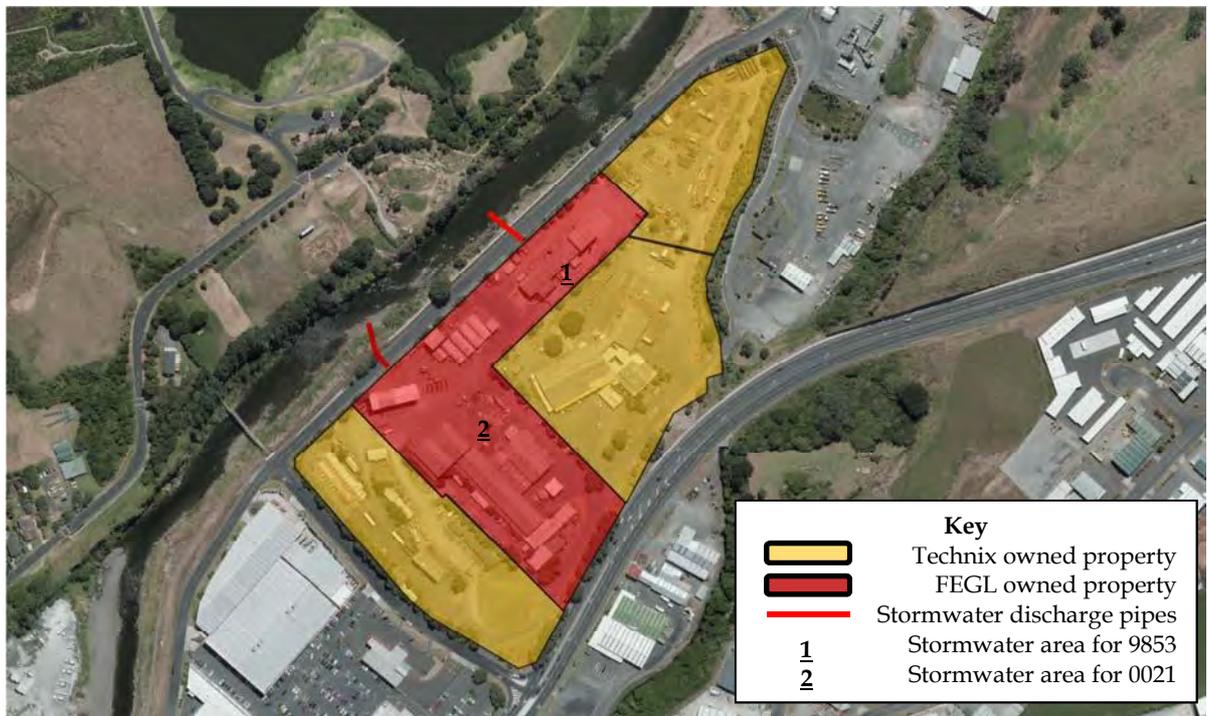
Figure 9 Technix Group Limited and Fitzroy Engineering Group Limited subdivided site

The stormwater area for consent 0021 covers the south-west section of FEGL's property. The stormwater drainage system runs from the south and east boundary towards the east boundary, the drainage then runs north towards the Waiwhakaiho River and discharges into the river via a stormwater drain (STW002001, Figure 10). There are multiple sumps along this system to collect stormwater.

Consent **9853** provides for the discharge of stormwater to the river opposite Fitzroy Engineering Group's blast and paint shop. This is a combined discharge point as the catchment includes FEGL's blast and paint operation, another building complex (which has been occupied by about five tenants, but from 1 January 2008 the only occupants were Fitzroy Engineering, Technix Group Limited and Steelfab), a truck washing area, and a dangerous goods store. The discharges from this whole area were previously covered by one consent, held by Technix (**0291**). A partial transfer of this consent took place on 20 February 2014, with the catchment area now covered by consent 9853 shown **Figure 9** (area 1).

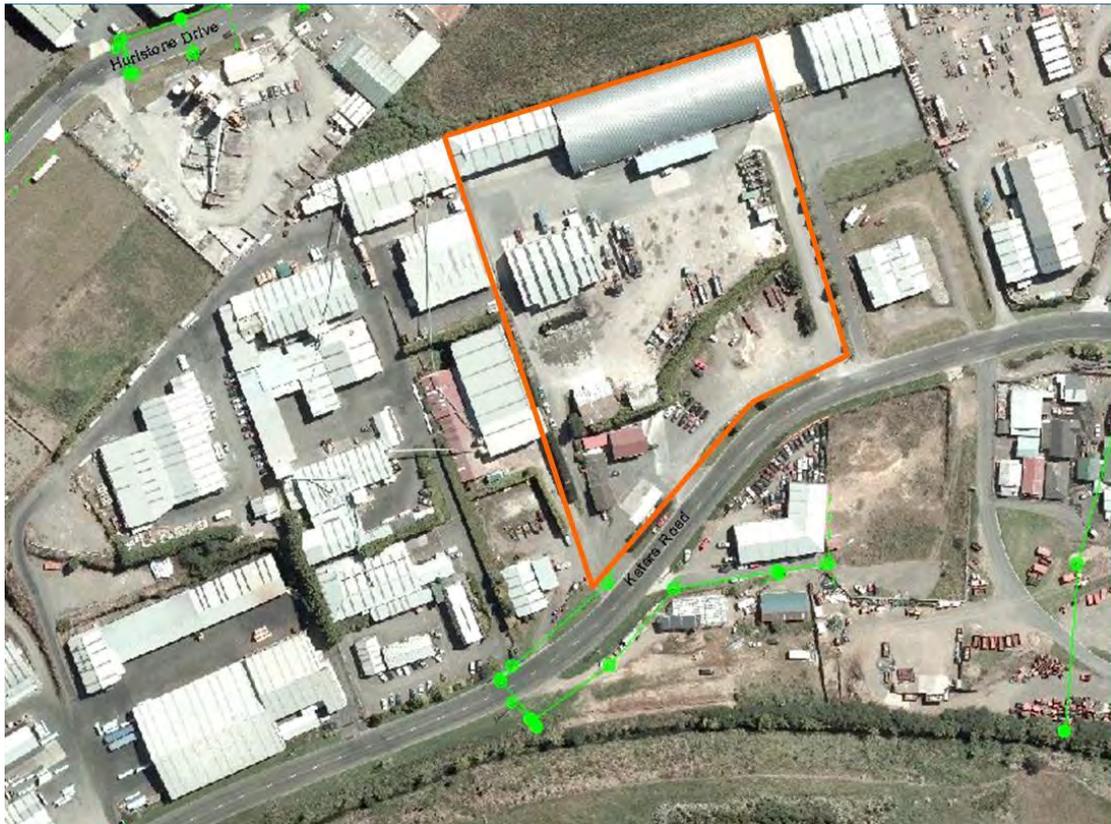
Figure 11 Location of Freight and Bulk Transport Holdings site

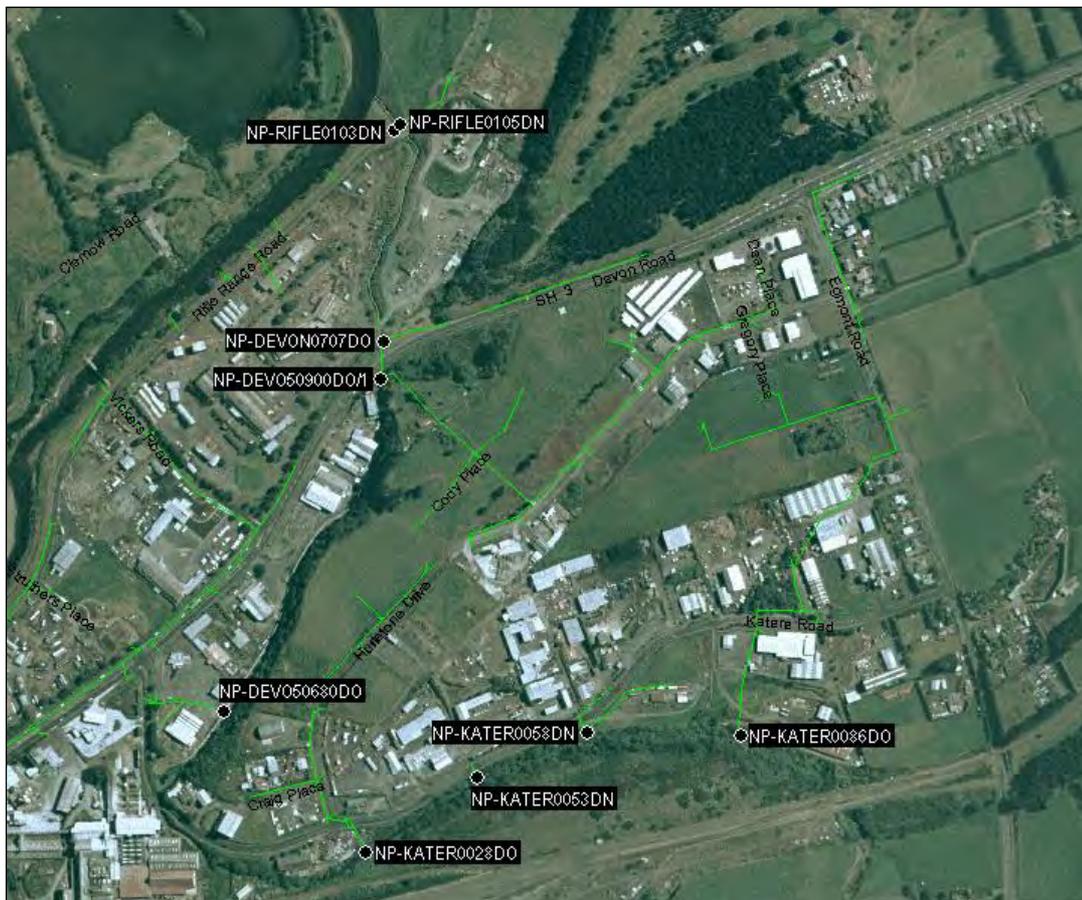
Figure 14 NPDC stormwater drainage and consented discharge points to the Mangaone Stream

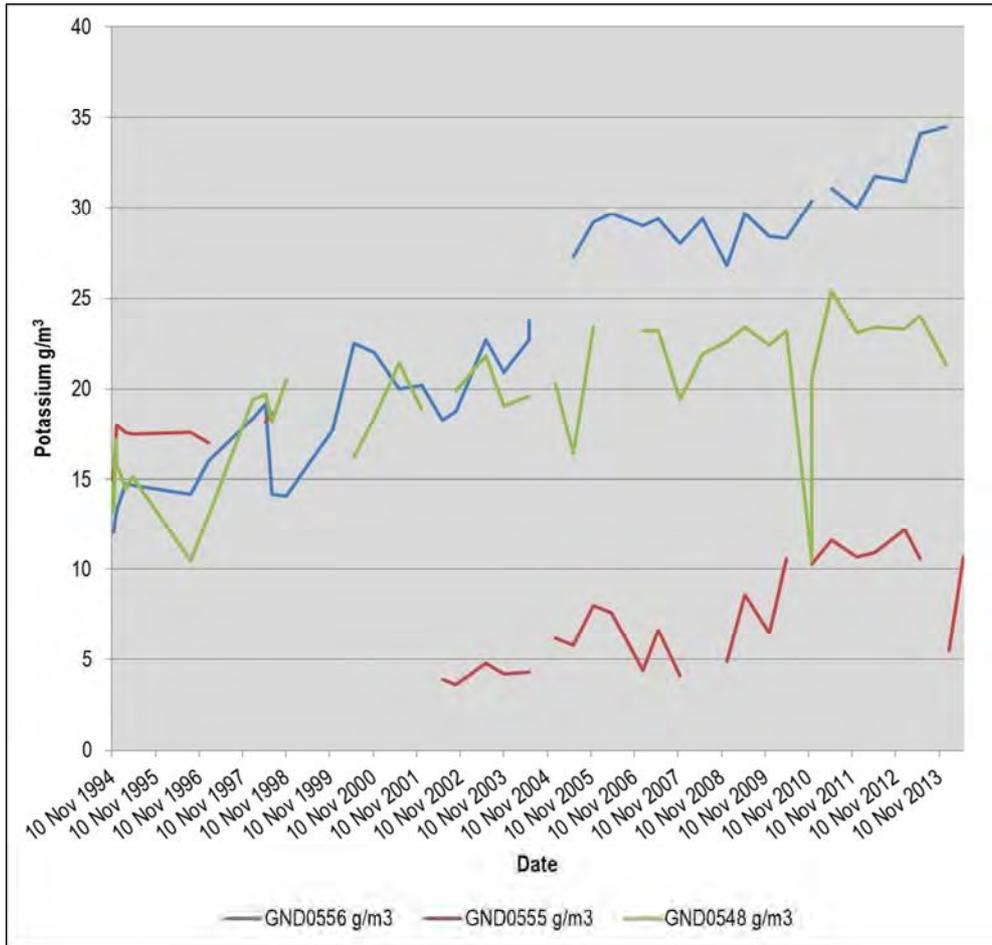
Overall the leachate component concentrations reported are relatively low in comparison to most municipal landfill leachates. There were fluctuations in parameters analysed, but these may also be consistent with the flushing effects of rainfall.

Figure 15 Potassium concentration in the Bewley Road ground water monitoring bores, November 1994 to date

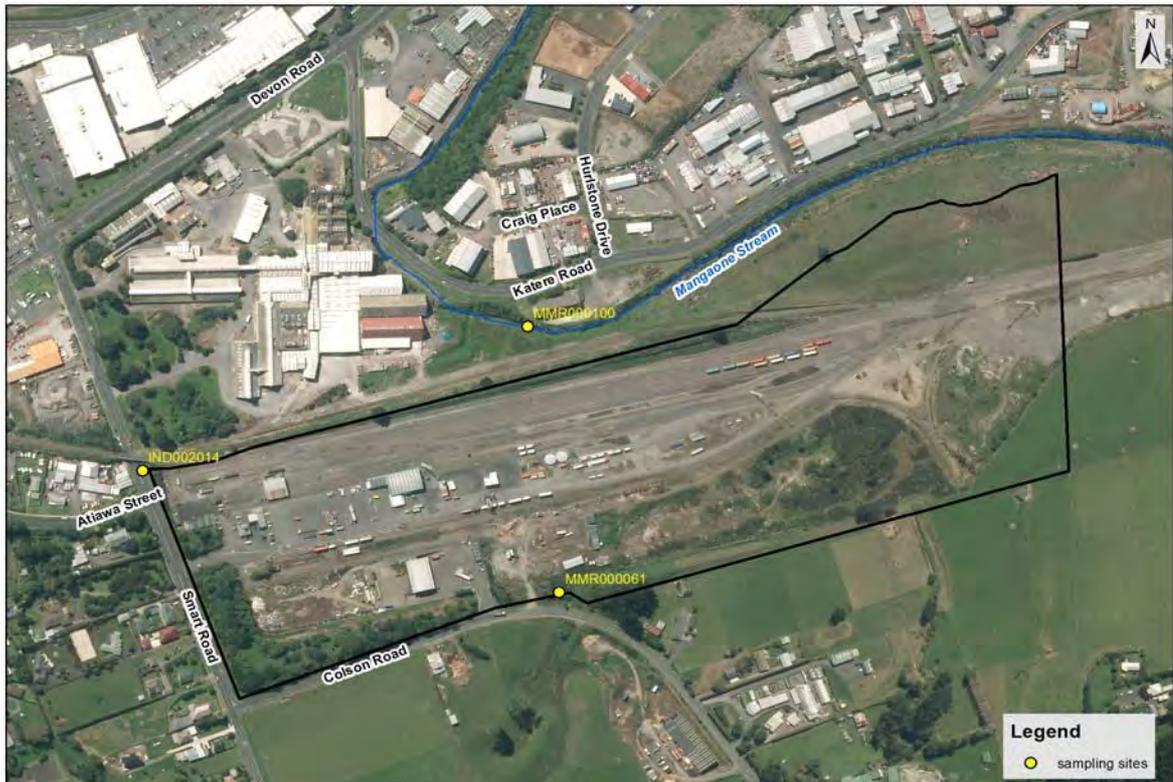
Figure 17 New Zealand Railways Corporation's rail yard and sampling point locations

Drainage from the area to the west and north of the offices (i.e. the refuelling area and maintenance area) flows to the Waiwhakaiho River via McLeod's Drain, an underground pipe that also receives stormwater from Ravensdown's fertiliser depot, other industrial sites, a residential area, and a rural area. Wastewater from washing of wagons, containers and locomotives is treated in a three-stage oil separator before discharge to the river. Liquids from the repair depot and locomotive fuelling point are discharged to an underground holding tank that is emptied by a waste disposal company at two-monthly intervals. The holding tank is also connected to the oil separator via an automatic pump in case of overflowing.

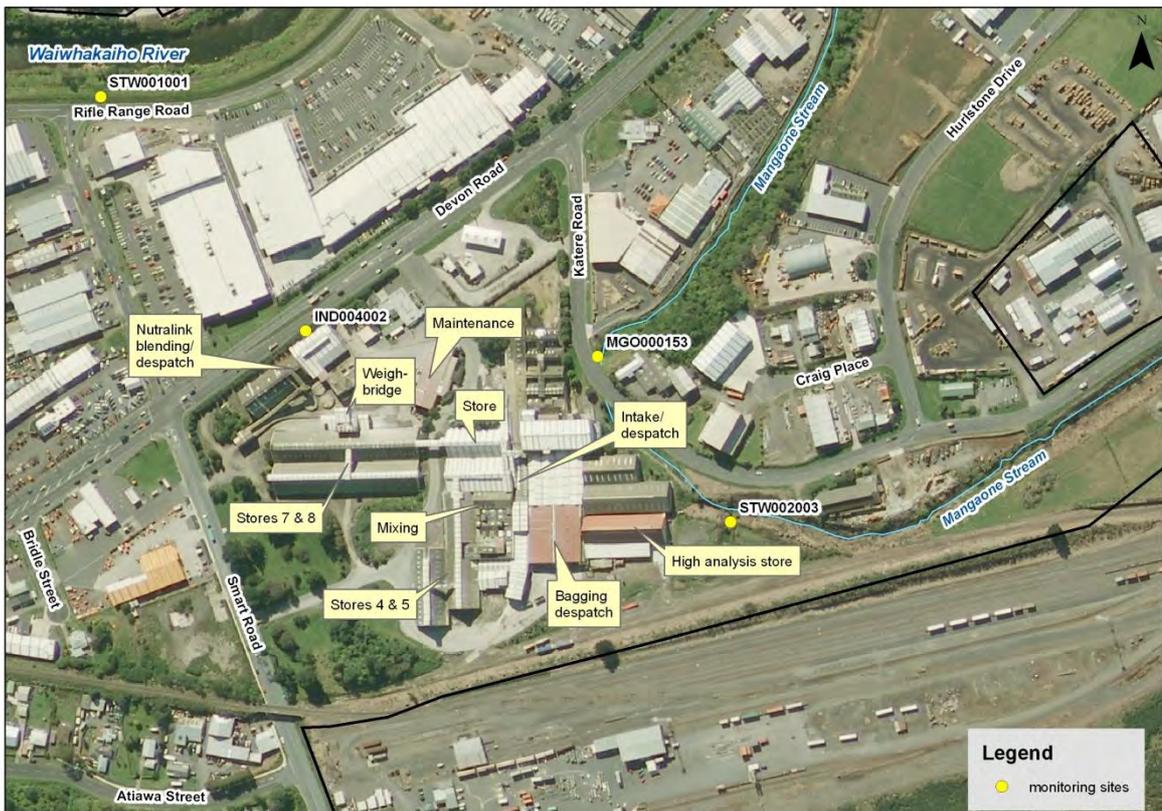
Figure 18 Ravensdown Fertiliser Co-operative Limited site and sampling point locations

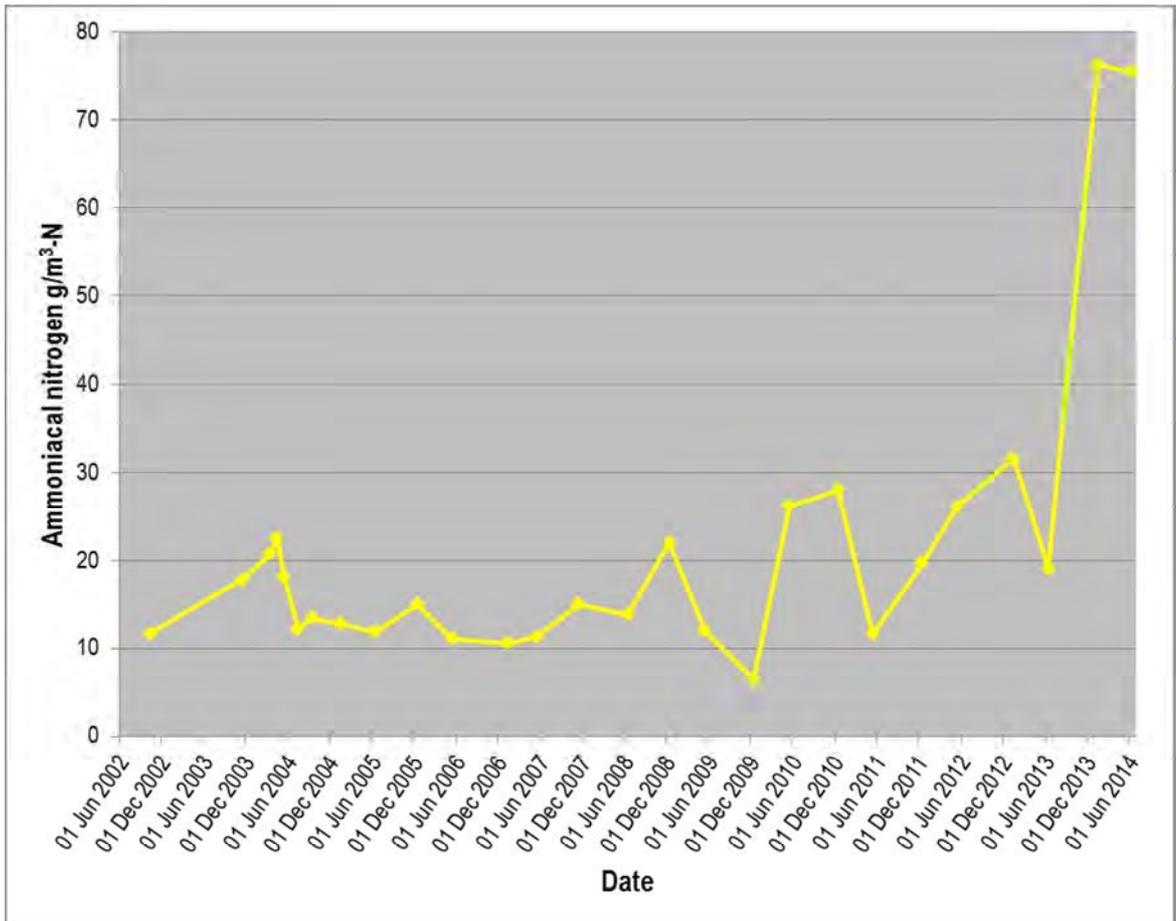
Figure 19 Ammoniacal nitrogen concentration at site GND1218, 2002 to date

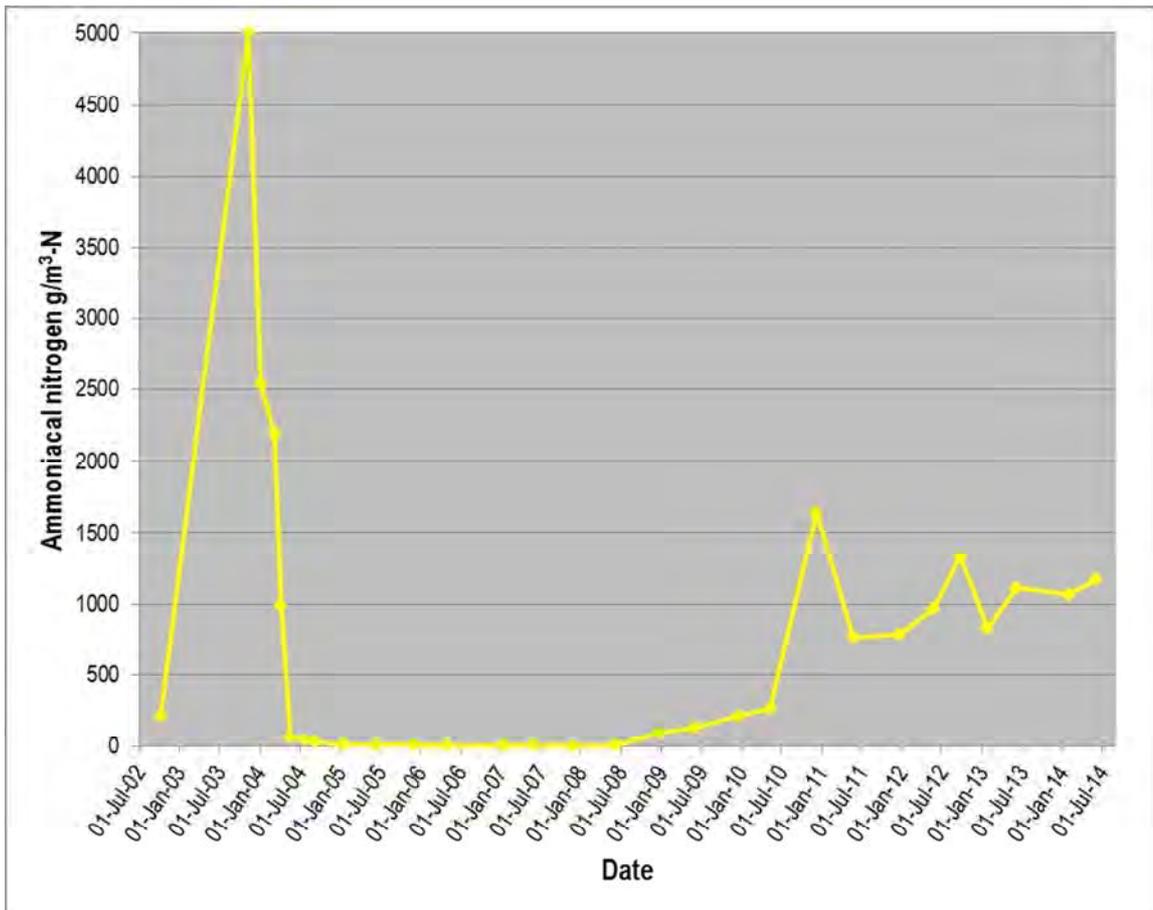
The historical ammoniacal nitrogen results for site GND0517, on the eastern boundary, are illustrated in Figure 20.

Figure 20 Trend in ammoniacal nitrogen concentration at site GND0517, 2002 to date

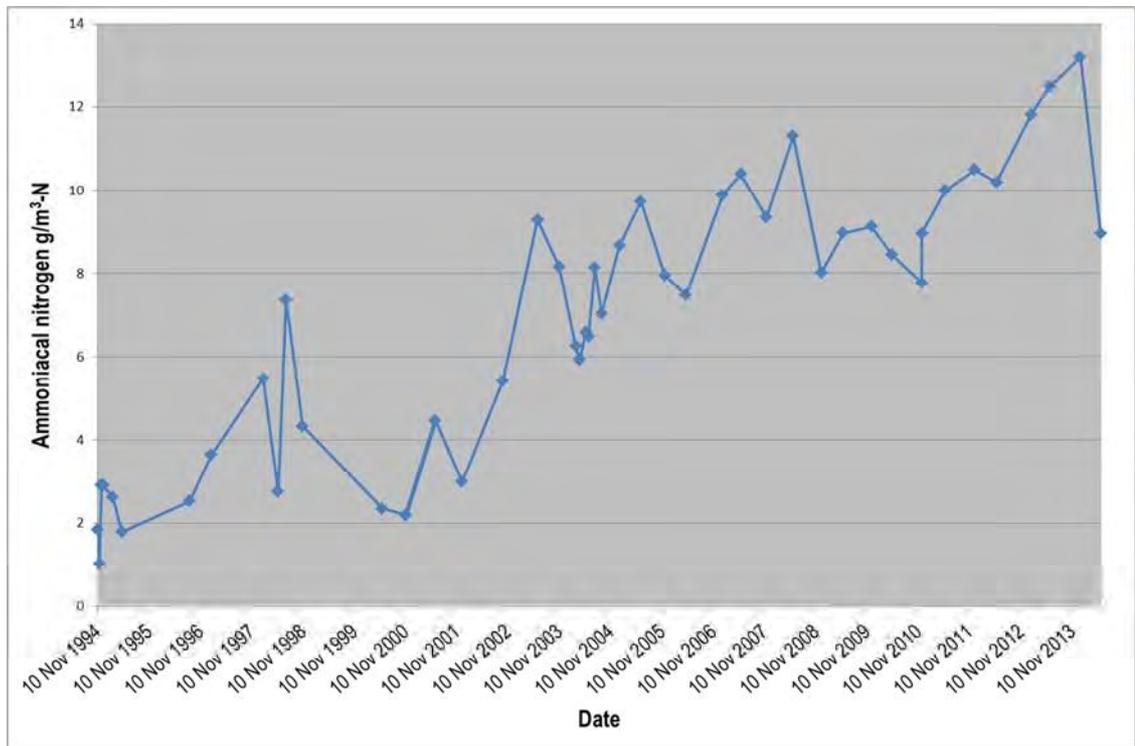
The other bore for which there has been a trend of increasing ammoniacal nitrogen concentration evident is at GND0548. This bore is off site and down gradient of both the Ravensdown site and the Bewley Road landfill. Historically there appeared to be steady increases in ammoniacal nitrogen concentration at this bore, which are illustrated in Figure 21. However, it is noted that there was a notable decrease in the ammoniacal nitrogen concentration found in the sample collected in June 2014. At this stage it is too early to comment on the significance of this result in relation to the previous trend.

Figure 21 Trend in ammoniacal nitrogen concentration at site GND0548, 1996 to date

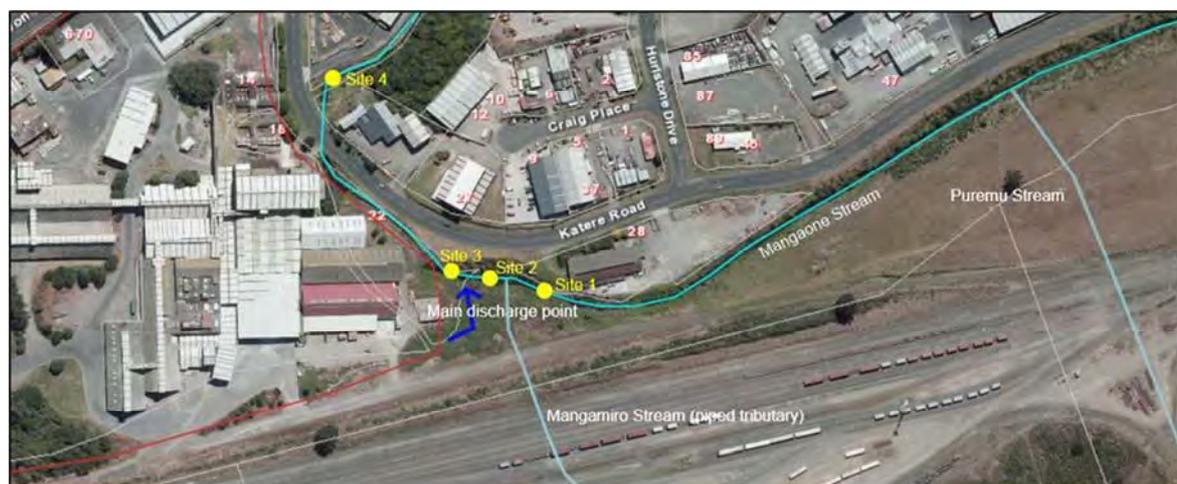
In addition to the scheduled compliance monitoring programme, as part of the Ravensdown consent renewal process, periphyton surveys were conducted. During these surveys both chlorophyll *a* samples and data for periphyton index scores (TRC PI) were collected from each of four monitoring sites in the vicinity of Ravensdown's rear drain. The sites monitored are shown in Figure 22.

Figure 22 Periphyton index and chlorophyll *a* monitoring sites in the Mangaone Stream

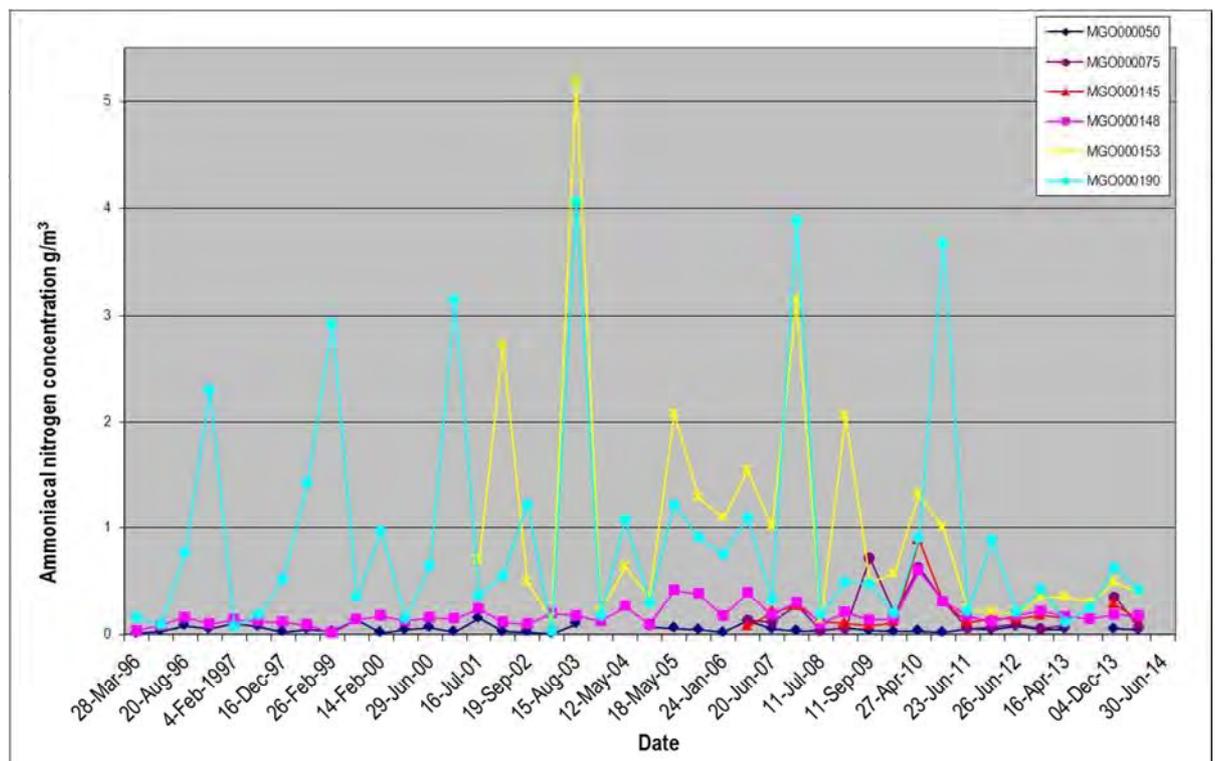
Figure 26 Trends in Mangaone Stream ammoniacal nitrogen concentration

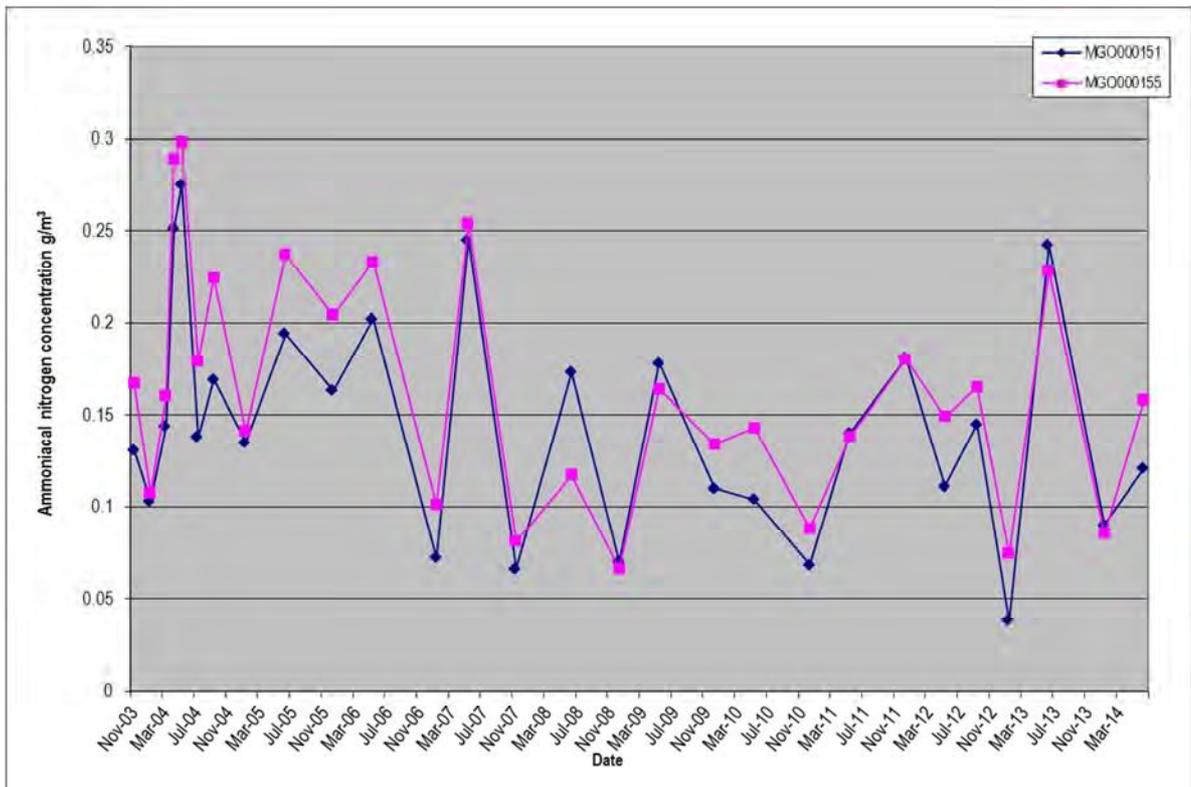
During the years under review dry weather monitoring was undertaken in the Mangaone Stream in conjunction with monitoring of the groundwater in the vicinity of the Ravensdown site (Section 12.3.2.3). The two sites monitored were MGO000151, approximately 20m downstream of the Ravensdown rear drain, and MGO000155, approximately 15m downstream of the Katere Road bridge. As this monitoring is predominantly carried out to assess potential effects from the Ravensdown store, the full results of these surveys are reported in Section 12.3.2.3, Table 43. Due to elevations in the ammoniacal nitrogen concentration observed in a Ravensdown bore on Katere Road, this is the parameter of primary interest here. Figure 27 shows the trends in ammoniacal nitrogen concentrations at the upstream and downstream sites.

Figure 27 Mangaone Stream ammoniacal nitrogen concentrations in the vicinity of the Ravensdown site under dry weather conditions

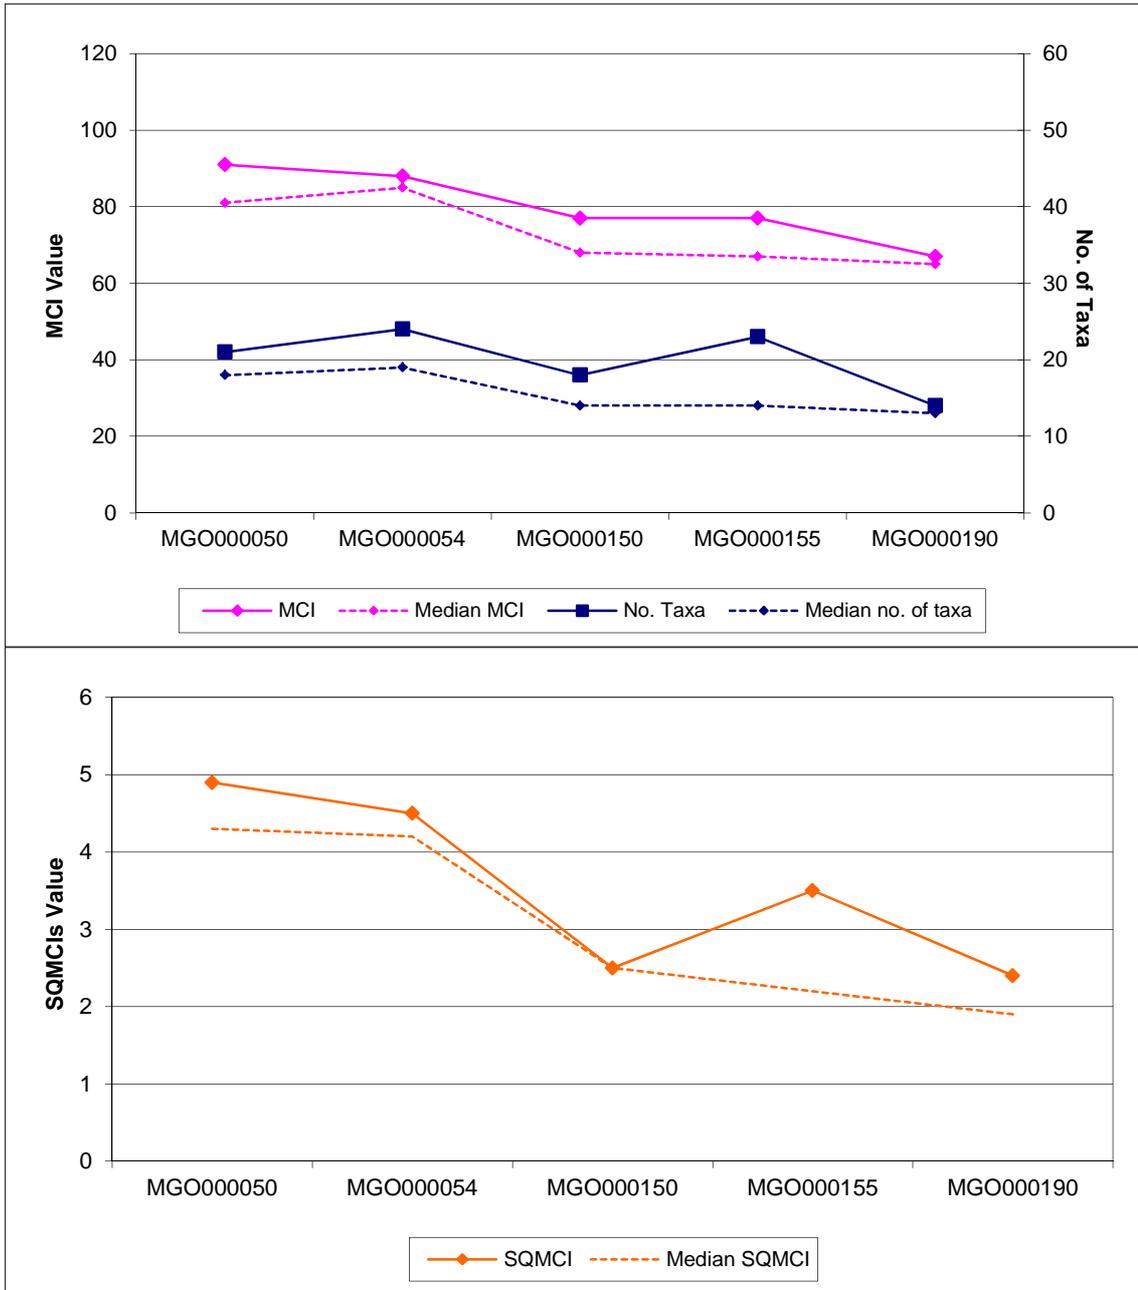
The longitudinal trends in the number of taxa, MCI and SQMCI₅ values along the reach of the Mangaone Stream surveyed in November 2013 are illustrated in Figure 30.

Figure 30 Longitudinal trend in number of taxa, MCI and SQMCI₅ values in the Manganone Stream for the survey of 15 November 2013

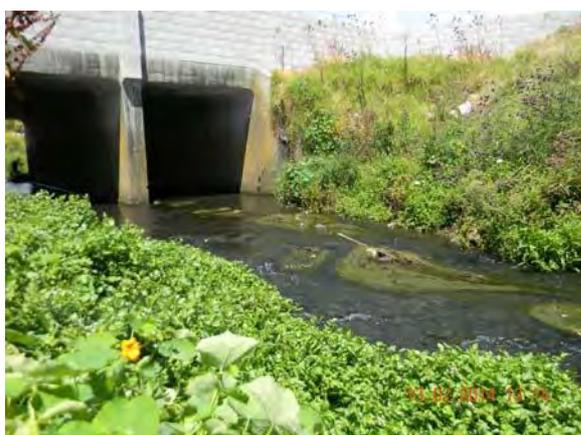
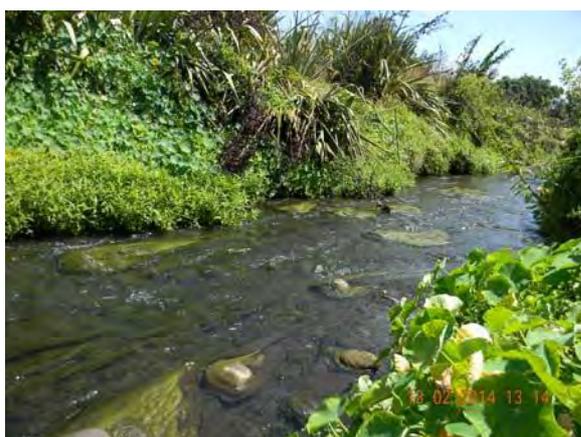
Photos 1 & 2 Thick filamentous algal substrate cover and marginal aquatic vegetation at site 11, February 2014

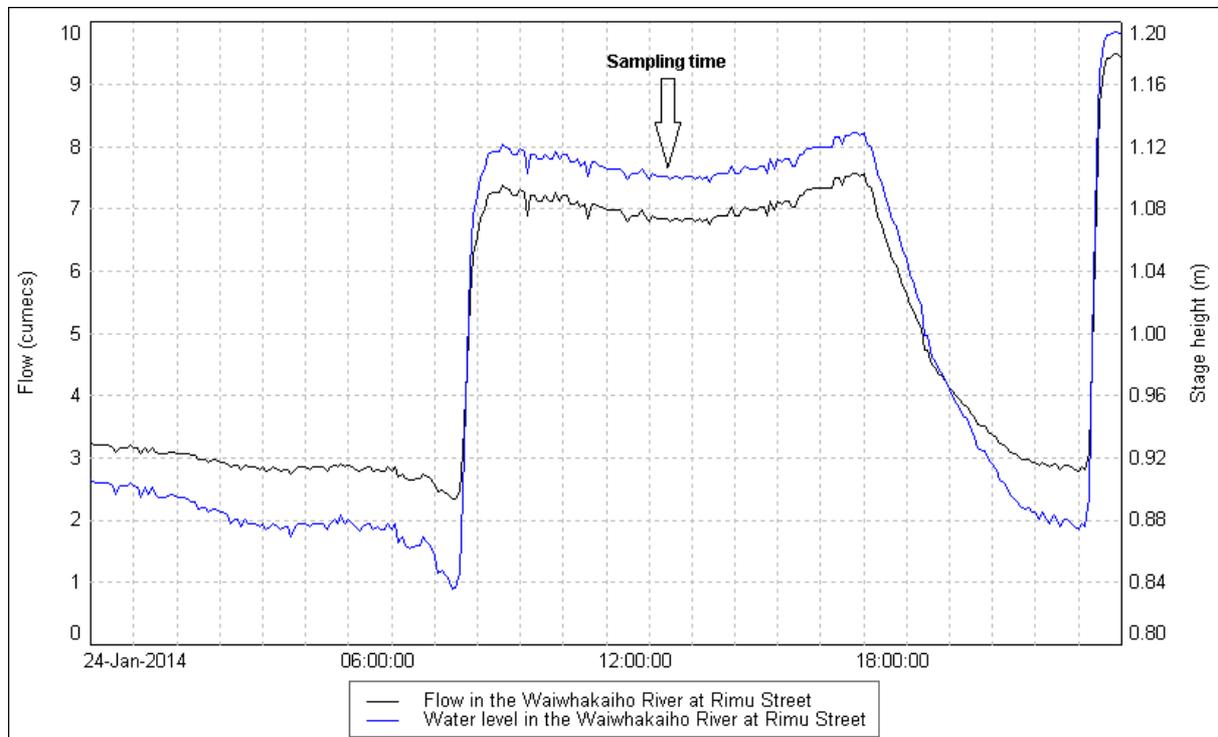
**Figure 2** Flow and water level in the Waiwhakaiho River at Rimu Street on 24 January 2014.
