Taranaki Galvanizers  
Monitoring Programme  
Annual Report  
2013-2014  
Technical Report 2014-31

September 2014

## Executive summary

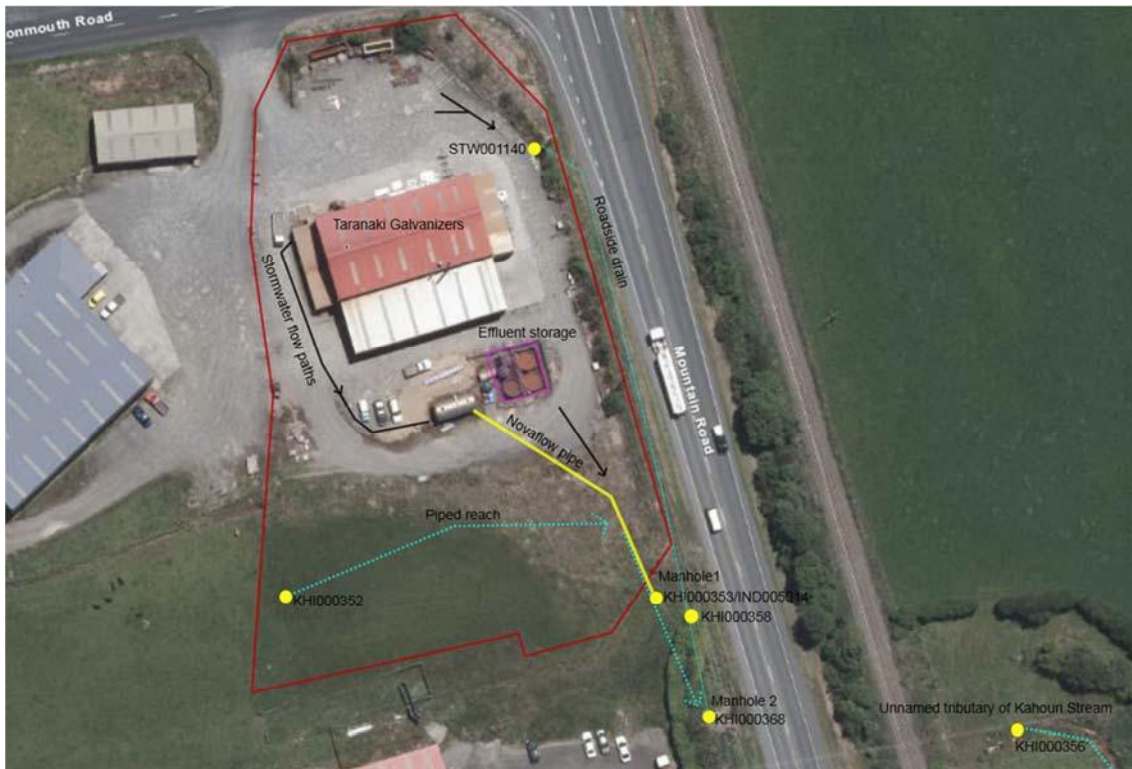
**Figure 1** Taranaki Galvanizers site layout

The galvanising plant owned and operated by Taranaki Galvanizers is situated at the corner of State Highway 3 and Monmouth Road, approximately 1 km north of Stratford (Figure 1). Road access to the site is via Monmouth Road.

Stormwater from the southern side of the site either flows overland to a grated manhole (manhole 1 in Figure 1) on the southeastern corner of the site or via a yellow nova flow pipe that then discharges into this same manhole. The yellow novaflow pipe conveys both site stormwater and some groundwater seepage from the southern end of the site and is therefore referred to as an industrial discharge as opposed to only a stormwater discharge. The piped unnamed tributary enters manhole 1 immediately above the point of discharge from the yellow novaflow pipe (Photo 1).

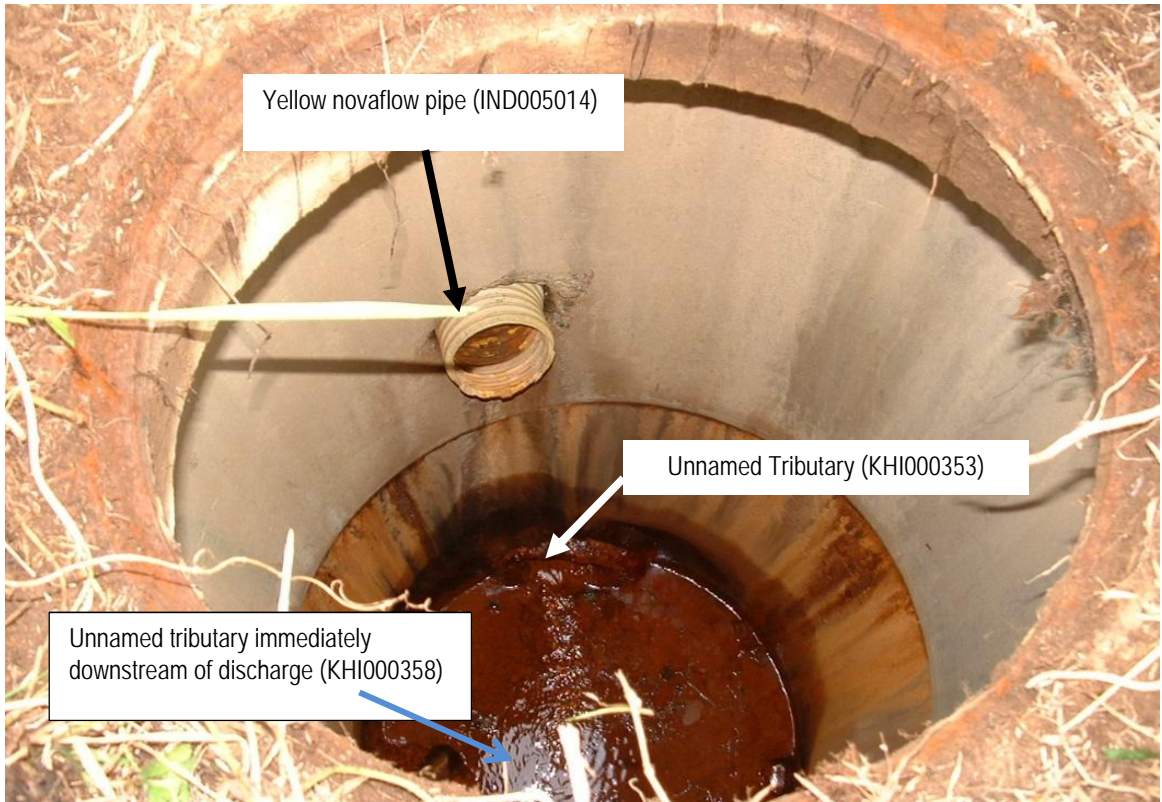
**Photo 1** The view down manhole 1 including outlet of the unnamed tributary, the yellow novaflow pipe from the Taranaki Galvanizers site (IND005014) and the tributary immediately downstream of the discharge (KHI000358)

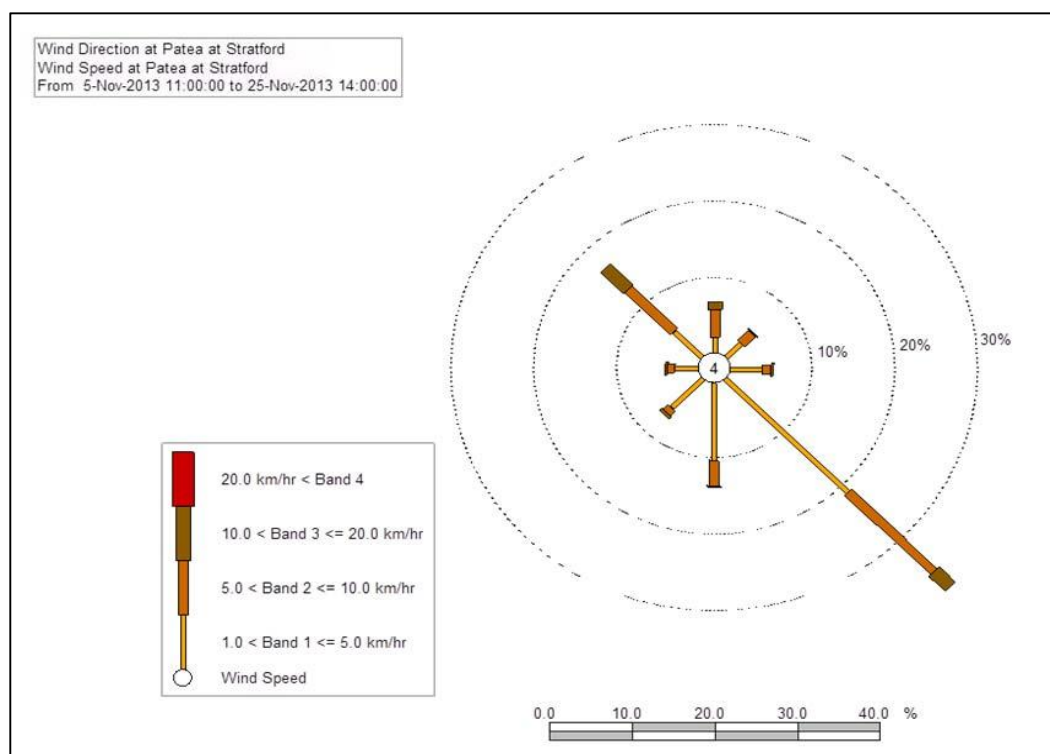
Figure 8 shows that the predominant wind direction over was from a south-easterly direction. The strongest winds during this period came from the nor-northwest. Under the prevailing south-east wind, the two monitoring sites would have been downwind of the galvanising plant site and were therefore likely to entrain high levels of airborne contaminants from the site. However, the result for (AIR006601) was below the historical median and was the same as what was recorded in the previous monitoring occasion in 2011 (0.07 g/m<sup>2</sup>/day). The result for (AIR0006602) was slightly higher than the previous monitoring occasion (0.06 g/m<sup>2</sup>/day) and slightly above the historical median (Table 4).

**Figure 8** Windrose, showing wind direction and speed for the period 05 November 2013 to 25 November 2011. Data collected at Taranaki Regional Council Office, Stratford
