Lower Waiwhakaiho Catchment
Monitoring Programme
Annual Report
2015-2016

Technical Report 2016-98

Taranaki Regional Council
Private Bag 713
STRATFORD

March 2017

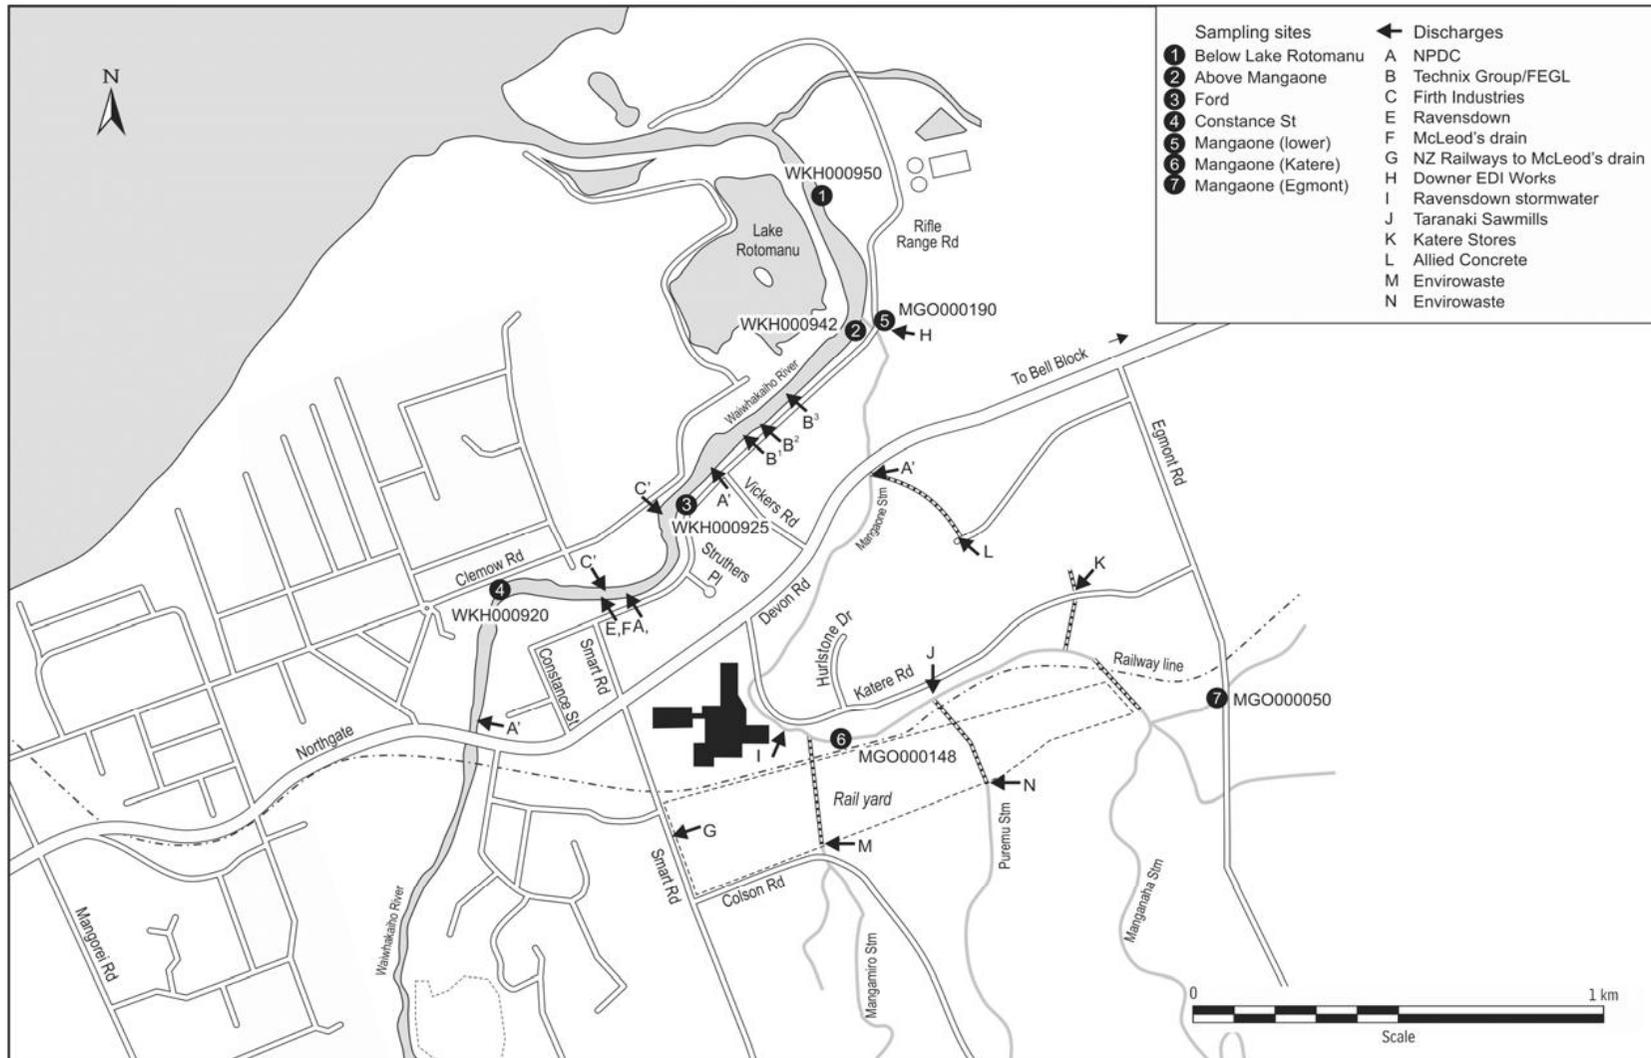
Figure 2 Lower Waiwhakaihō River and Mangaone Stream discharges

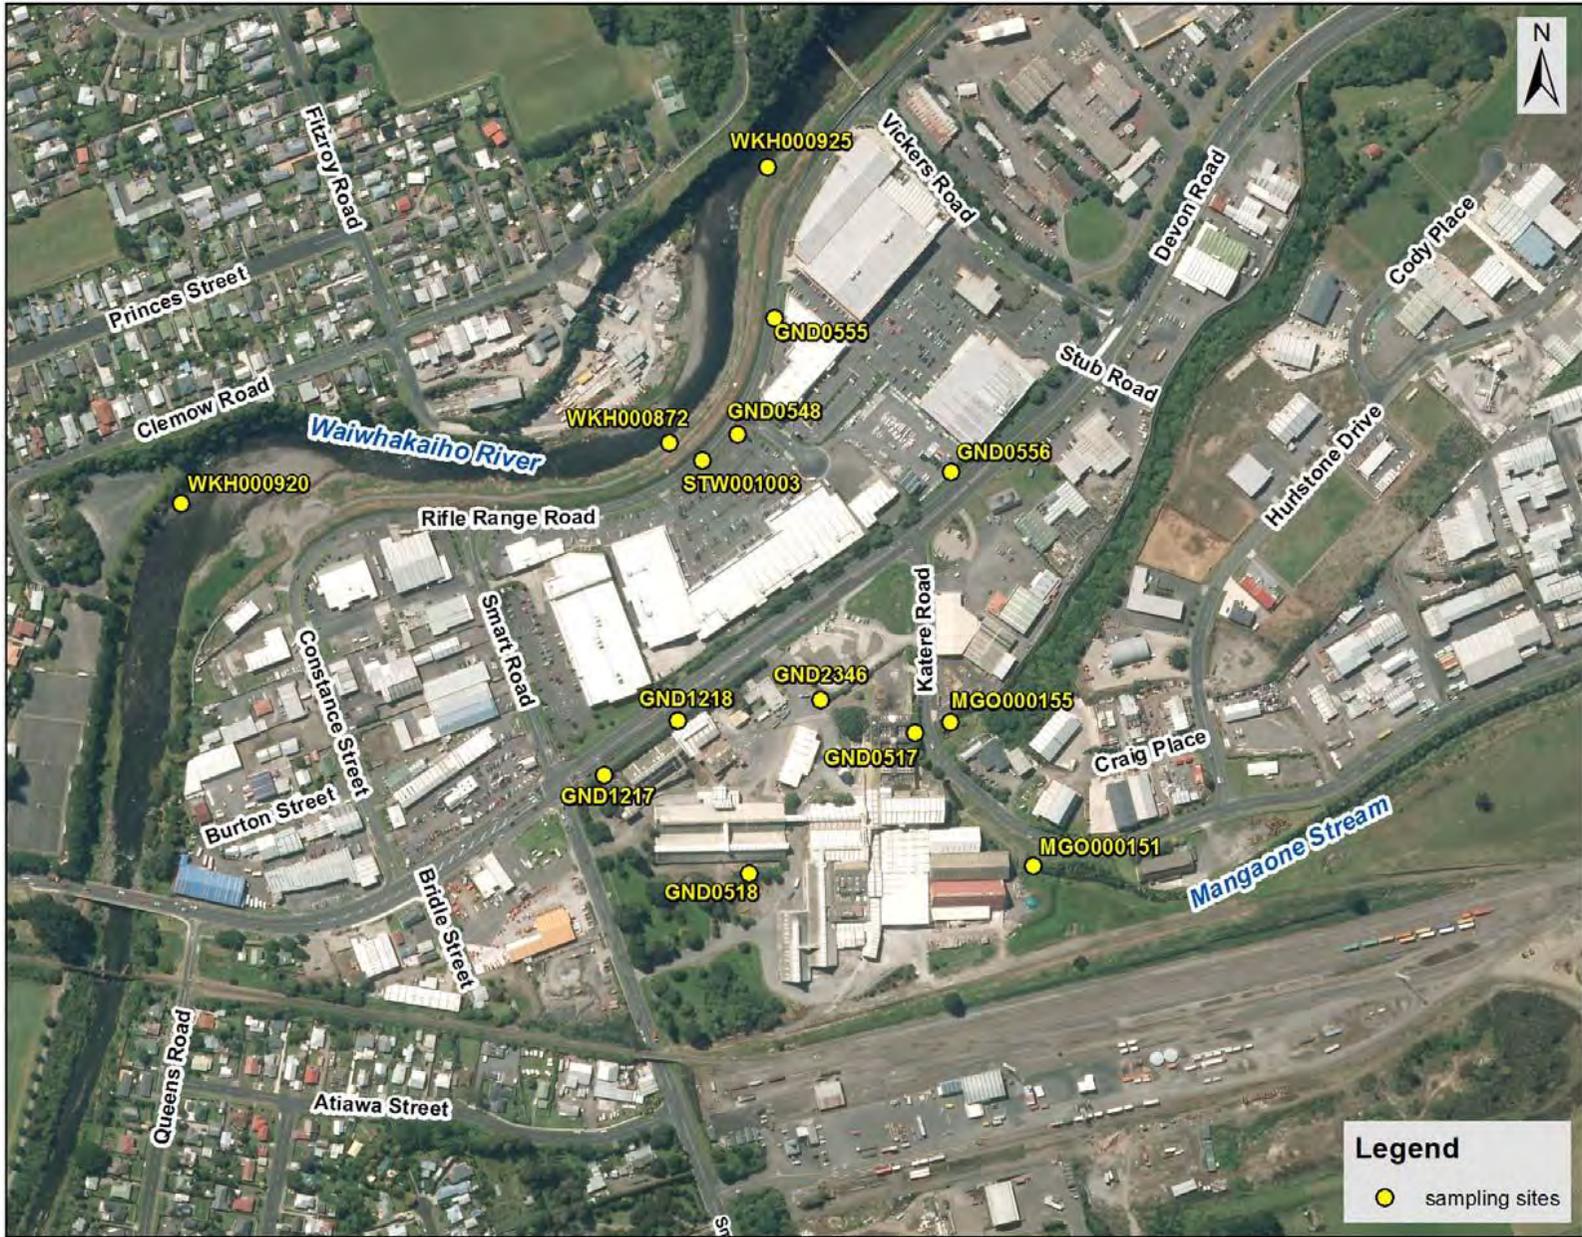
Figure 4 Location of groundwater monitoring bores and associated sampling sites

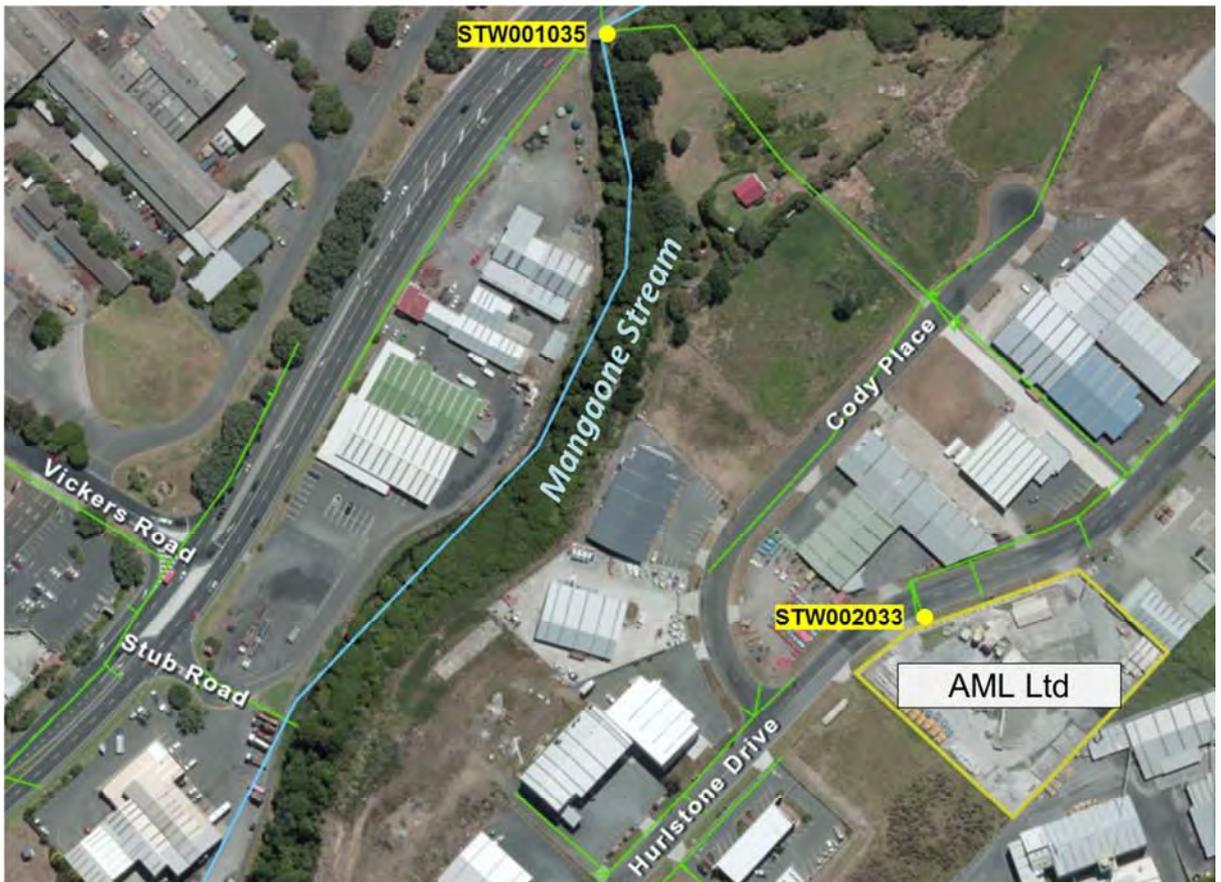
Stormwater from the majority of the site drains directly to the New Plymouth District Council (NPDC) stormwater system and then to the Mangaone Stream.

Figure 5 AML Ltd (trading as Allied Concrete) site location and stormwater drainage

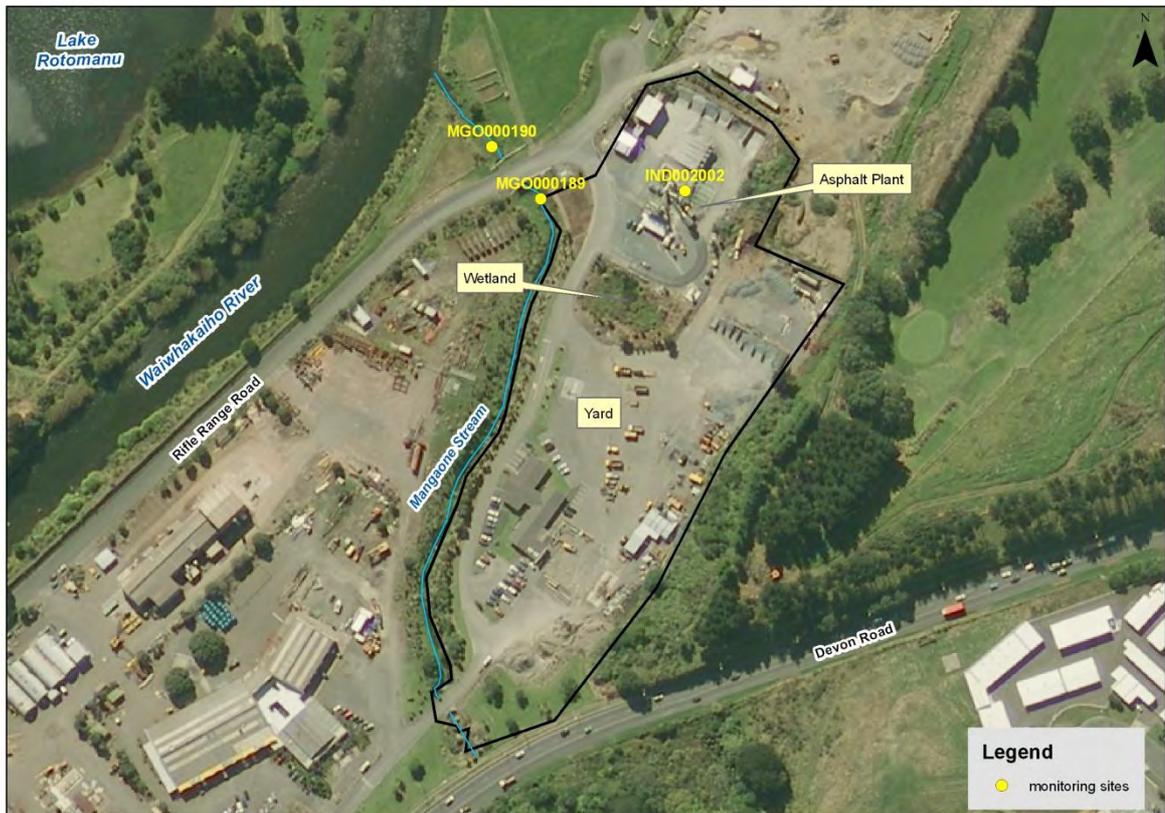
Downer EDI Works Ltd (Downer) operates an asphalt manufacturing plant at a site off Rifle Range Road. A depot for maintenance, parking and storage of equipment and materials used in road-making is also on the site.

Figure 6 Downer's site and sampling point locations

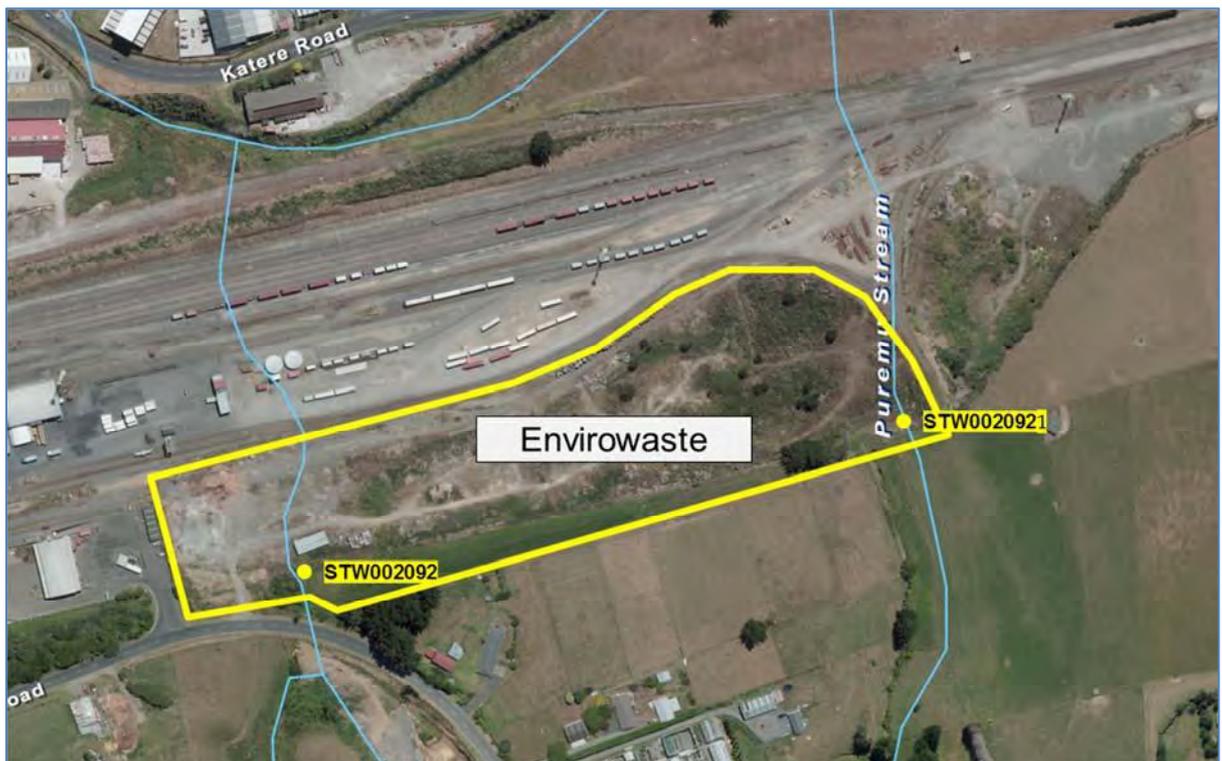
Stormwater from the site discharges via retention ponds to the Puremu and Mangamiro Streams. Prior to discharge the stormwater is treated in long sediment ponds that discharge via grates to prevent litter being carried with it.

Figure 7 Envirowaste's site and sampling locations

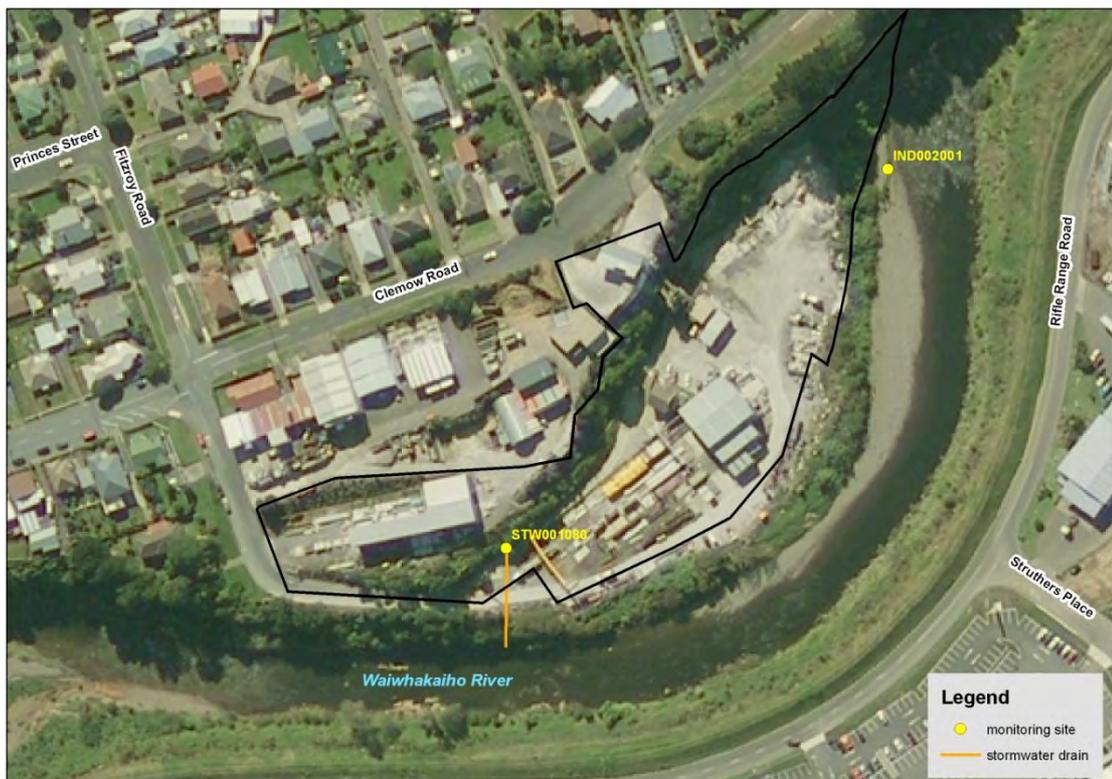
Firth Industries Ltd (Firth) operates a concrete batching plant on a 1.19 ha site off Clemow Road, on the true left bank of the Waiwhakaiho River. The plant is situated partly on the flood plain and partly above the escarpment formed by the river. A concrete precast factory operated by Ultimate Engineered Concrete Ltd is also on the site. This includes a bedding plant, which operates from an area above the escarpment.

Figure 8 Firth Industries site location and discharge points

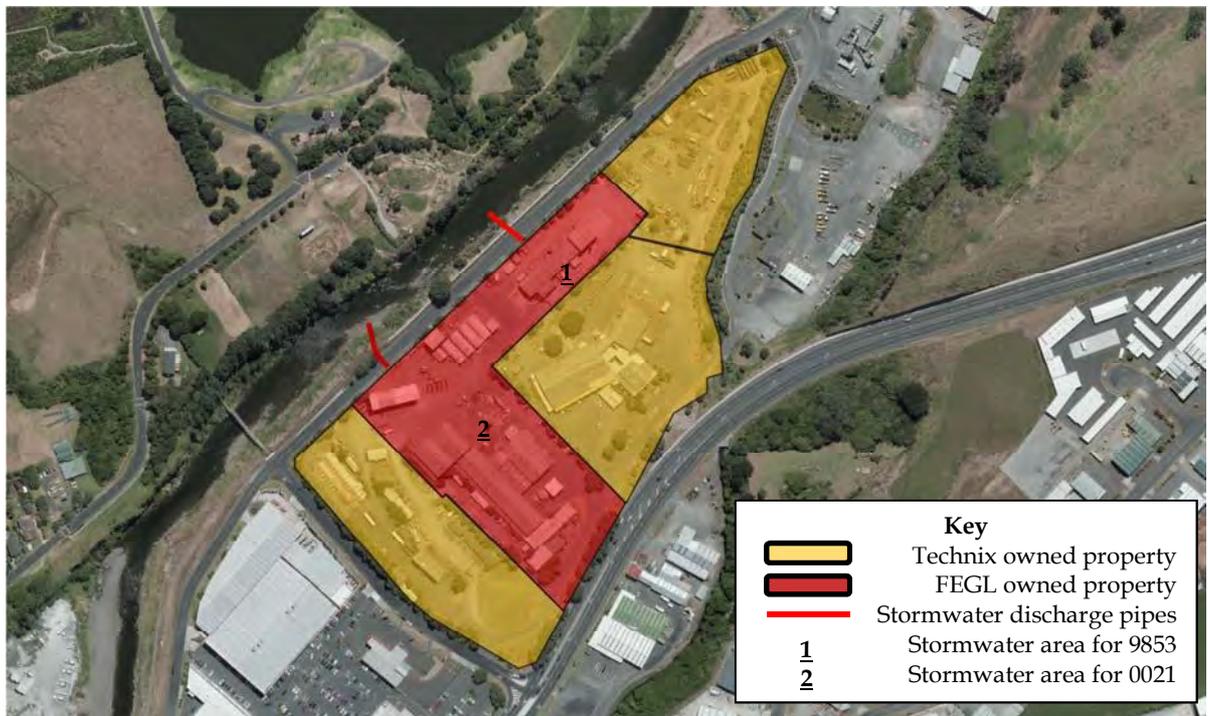
Figure 9 Technix Group Ltd and Fitzroy Engineering Group Ltd subdivided site

The site was previously leased by FEGL from Technix Group Ltd (TGL), and the stormwater discharges from FEGL's activities were covered under consents held by TGL. In 2013 FEGL purchased the part of the property they operate on from Technix (Figure 9). After the purchase of the property resource consent 0021-3 was transferred from Technix to FEGL. Resource consent 0291-3 was split into two consents as the northern area covered by this consent was now owned by FEGL. The consent number assigned to this catchment area was consent number 9853.

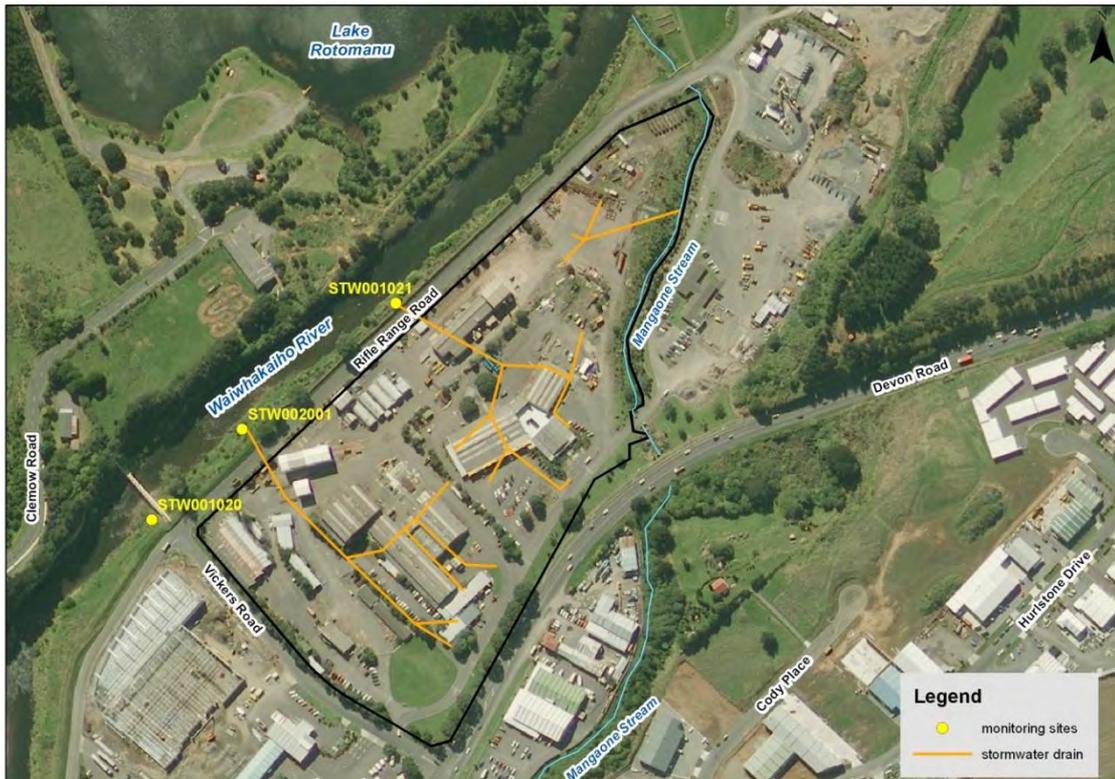
- Staff offices and facilities,
- Workshops (Machining, plate and general),
- Dangerous goods storage,
- Liquid oxygen tanks, and
- Blast and paint storage.

Figure 10 Fitzroy Engineering Group Ltd site and stormwater discharge points

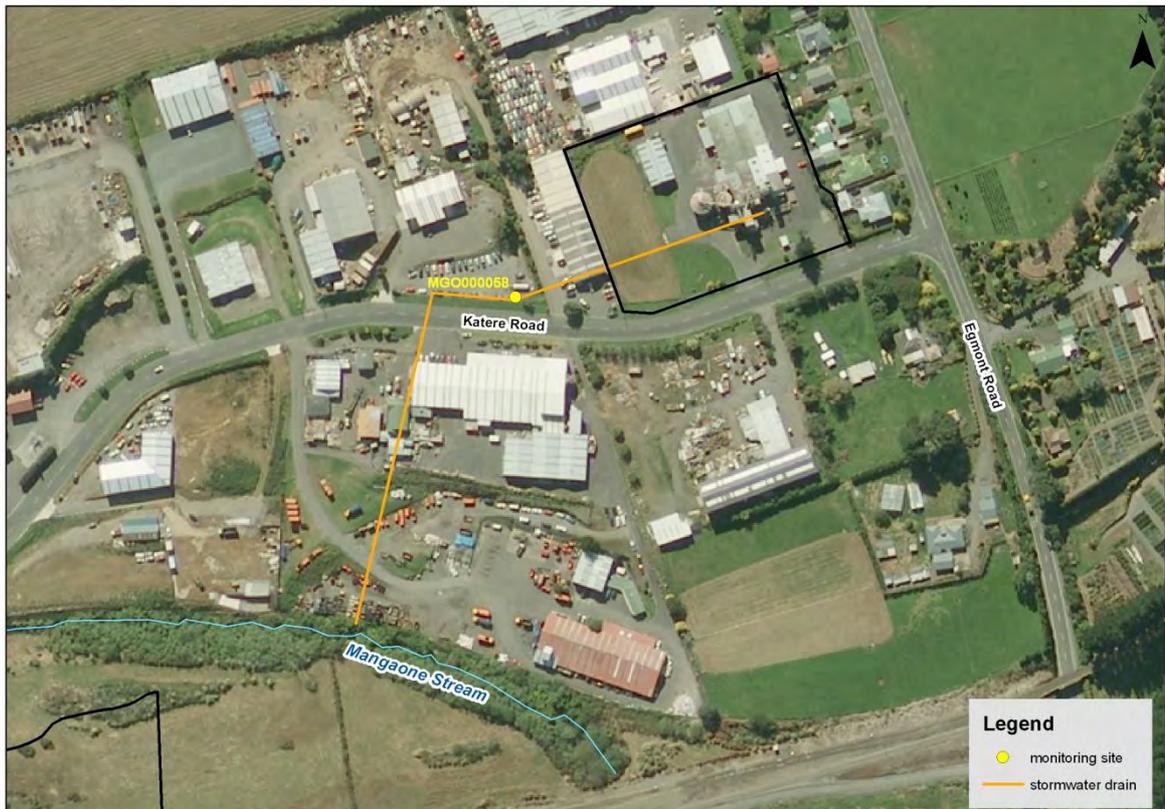
Figure 12 Katere Stores site and sampling point location

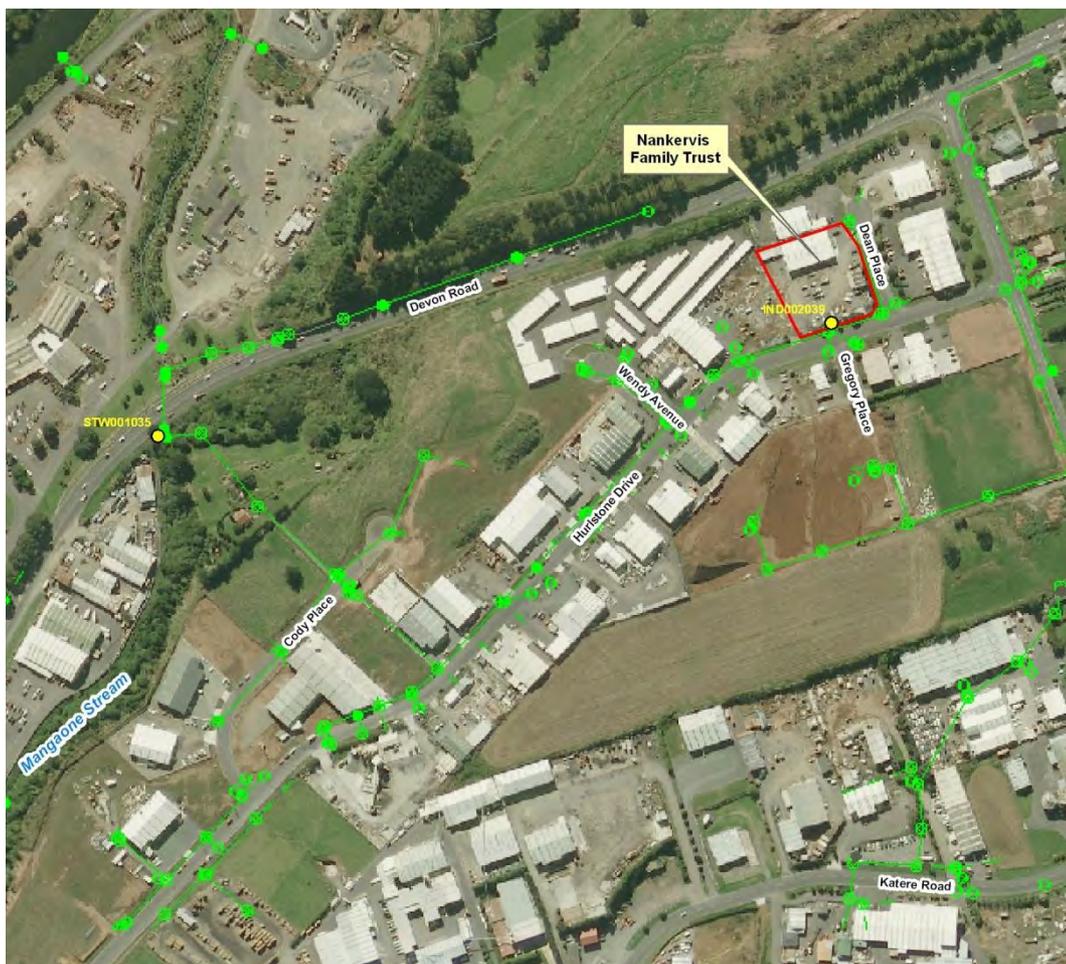
Wash down water, from the truck wash bay discharges to a drain which is directed to an inceptor system. This then discharges into the NPDC's stormwater system (via discharge site IND002039) and then into the Mangaone Stream (via discharge site STW001035). It was stated at the time of the application that up to approximately 1.0 m³ of wash water would be discharged per day.

Figure 13 Nankervis Family Trust site location and discharge point

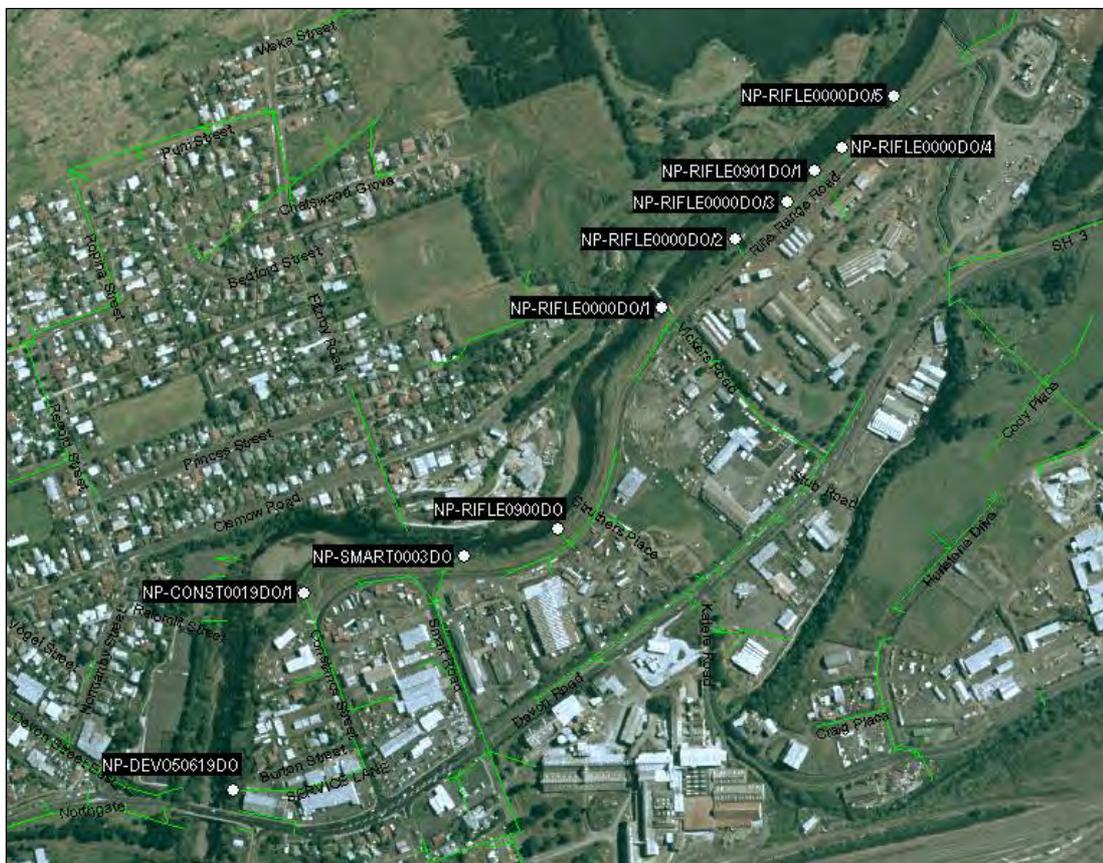
NPDC holds two resource consents in relation to discharges to the Lower Waiwhakaiho River below State Highway 3, and one consent in relation to discharges to the Mangaone Stream.

Figure 14 NPDC stormwater drainage and consented discharge points to the Waiwhakaiho River

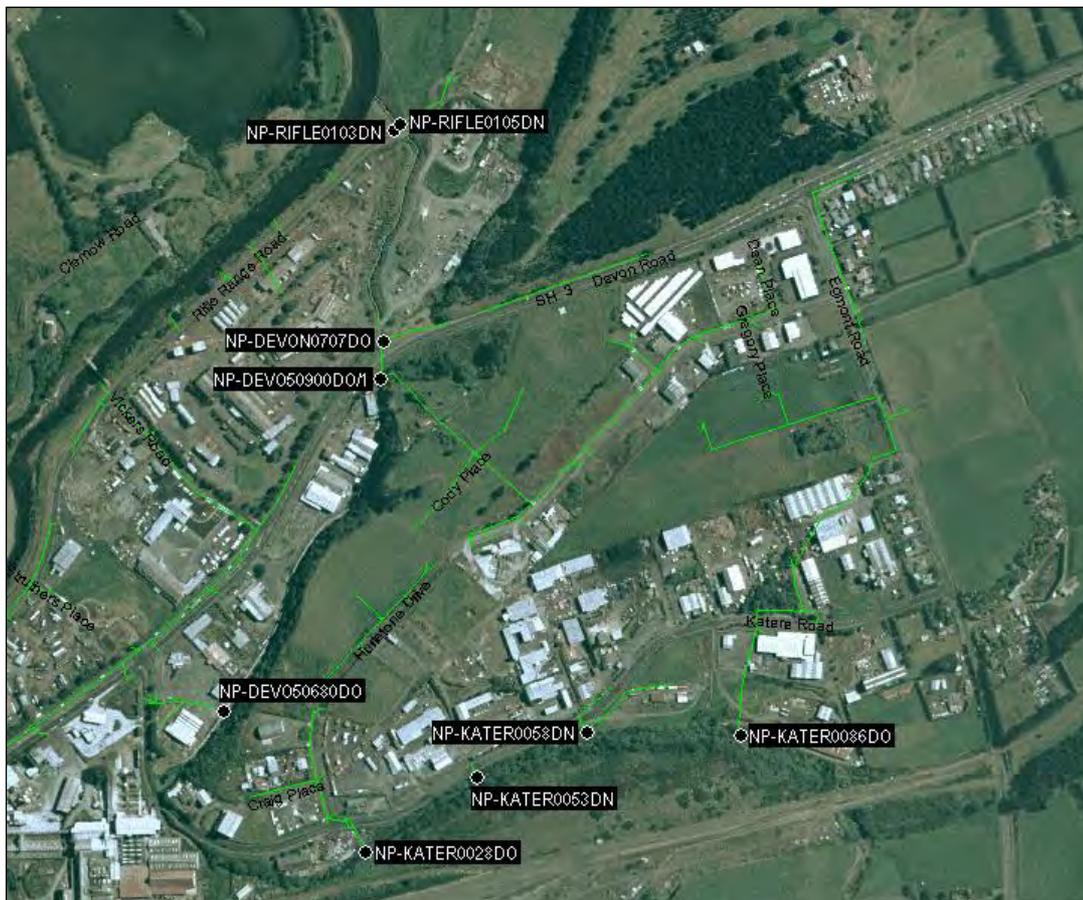
During periods of high rainfall, one of the key features of the performance of the stormwater drainage system is its susceptibility to inlet and outlet blockages. The NPDC maintenance plan aims to reduce reactive maintenance and improve the operation and reliability of the system through preventative maintenance. This includes pipeline condition assessment using video inspection.

Figure 15 NPDC stormwater drainage and consented discharge points to the Mangaone Stream

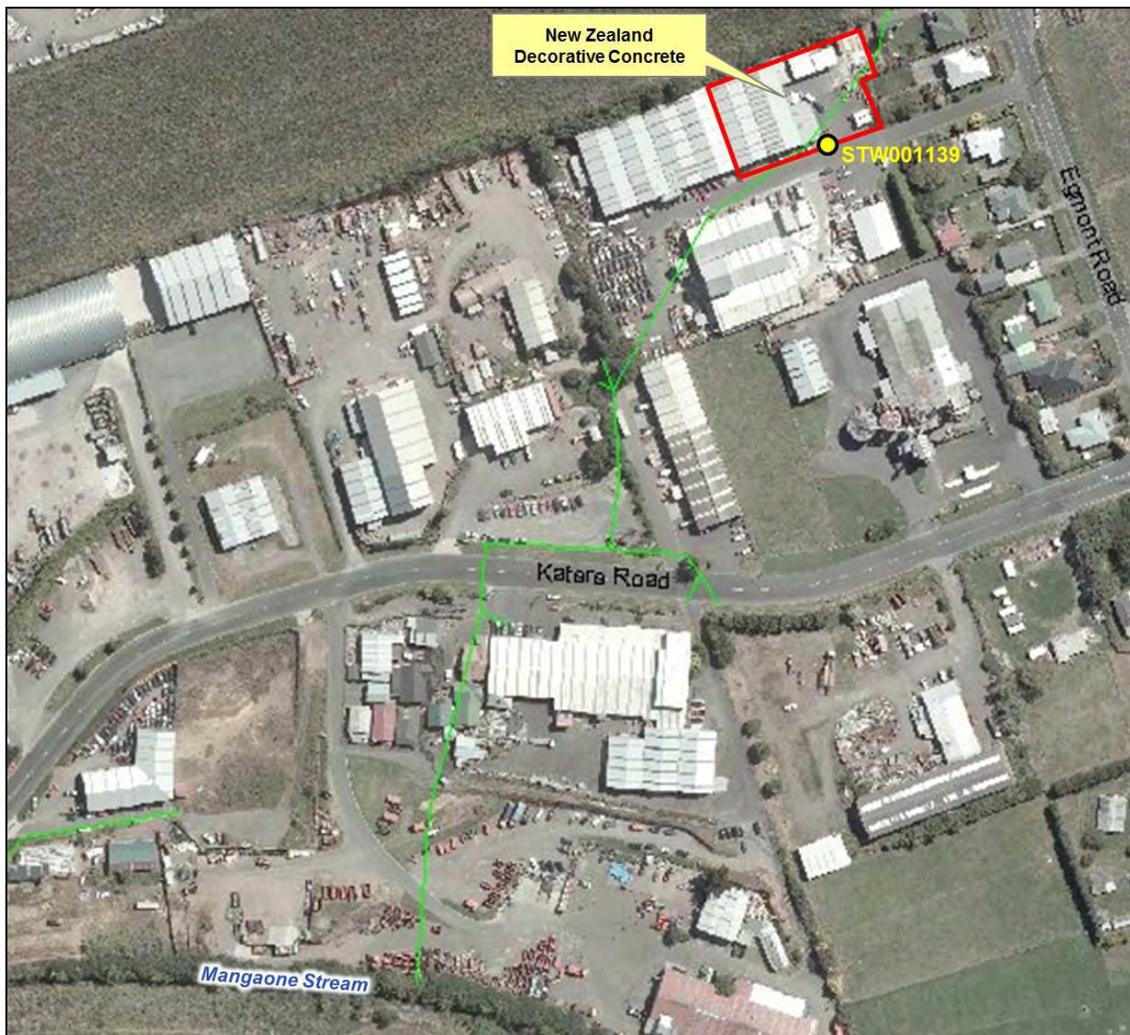
New Zealand Decorative Concrete Ltd manufactures products for sealing and colouring concrete using cement, silica sands, plain sands, iron oxides and titanium dioxide. Organic solvents, acrylic resins, thinners and hydrochloric acid are also used at the site. The bulk of the hazardous substances were originally stored in a shipping container in the stormwater catchment, however a new hazardous goods store and a manufacturing building have been constructed. Stormwater from the site runs via a shallow concrete channel round the front of the office and into a stormwater grate connected to NPDC's stormwater drainage system. The stormwater combines with that from a number of other small industrial sites, including that of Katere Stores Ltd, before discharging into the Mangaone Stream about 350 m downstream of Egmont Road.

Figure 16 New Zealand Decorative Concrete Ltd site and discharge point

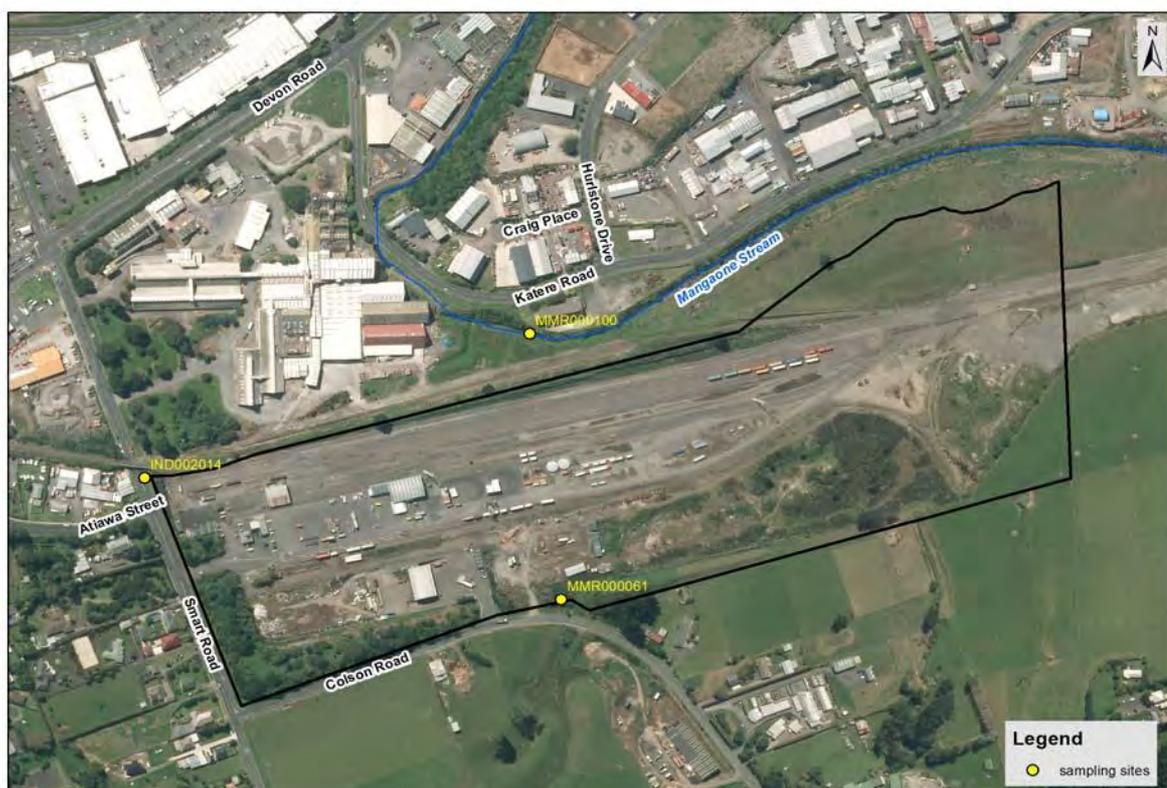
New Zealand Railways Corporation (NZRC) owns a rail terminal on a site off Smart Road. In addition to transportation of freight, the terminal is utilised as a maintenance depot. The freight receipt and dispatch area and the refuelling and maintenance depots are situated at the Smart Road end of the site.

Figure 17 New Zealand Railways Corporation's rail yard and sampling point locations

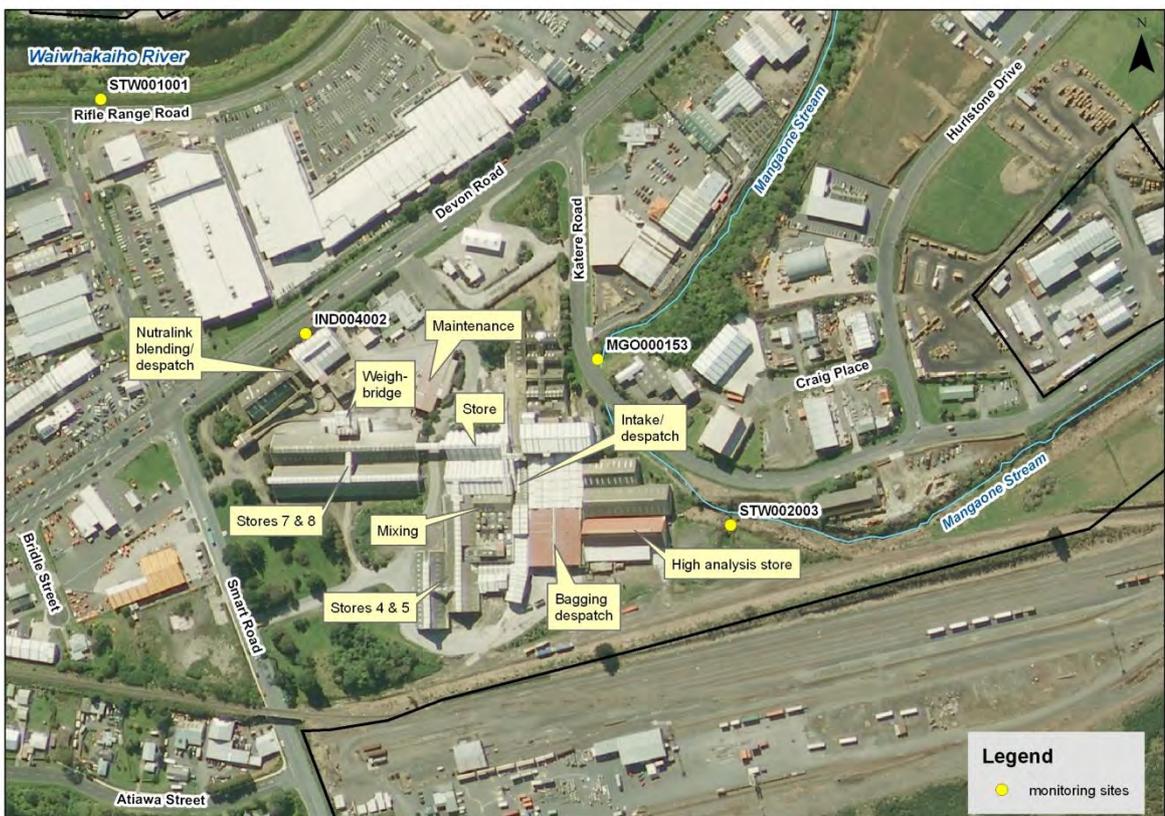
The New Plymouth depot of Ravensdown Fertiliser Co-operative Ltd (Ravensdown) occupies an area of about 7 ha bounded by Devon, Smart and Katere Roads, and the Smart Road rail yard (Figure 18). The Mangaone Stream touches the eastern boundary. The depot receives, bags, blends and distributes fertilisers in various forms, namely superphosphate, lime, dolomite and imported high analysis products such as ammonium sulphate, urea, triple super, potassium chloride (potash) and monoammonium and diammonium phosphates (MAP & DAP). Small volumes of trace element fertilisers such as zinc sulphate are also handled through the store. Approximately 250,000 tonnes of fertiliser are distributed per annum.

Figure 18 Ravensdown Fertiliser Co-operative Ltd site and sampling point locations

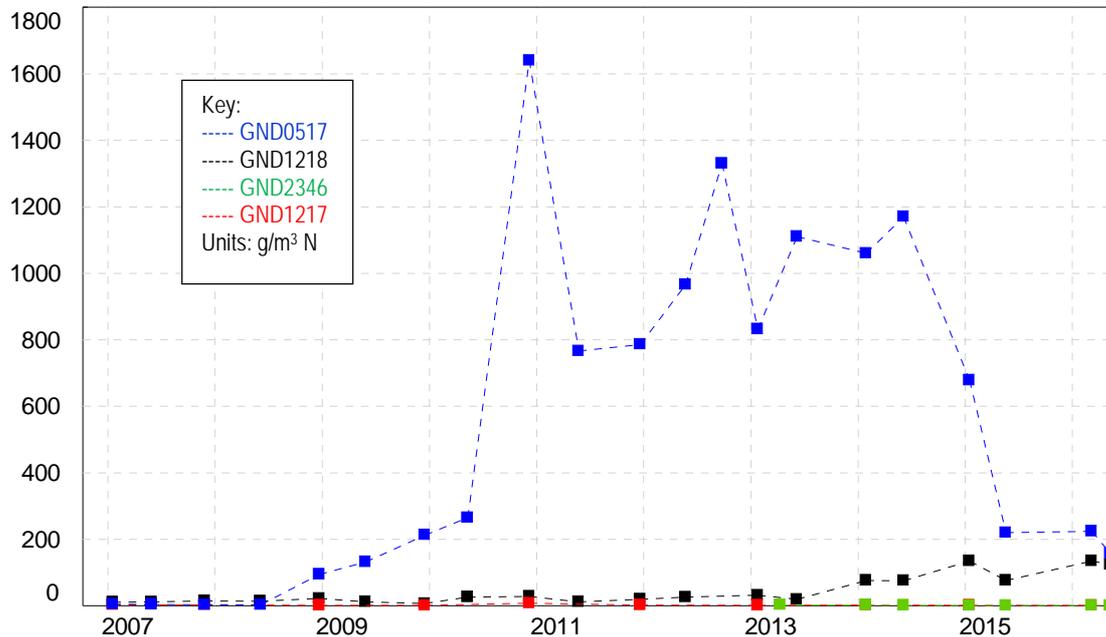
Samples taken from the new bore (GND2346) used in place of GND1342 returned results significantly lower than the range of results previously reported for GND1342.

Figure 19 Ammoniacal nitrogen concentration at sites GND0517, GND1218, GND2346 and GND1217 from 2006 to June 2016

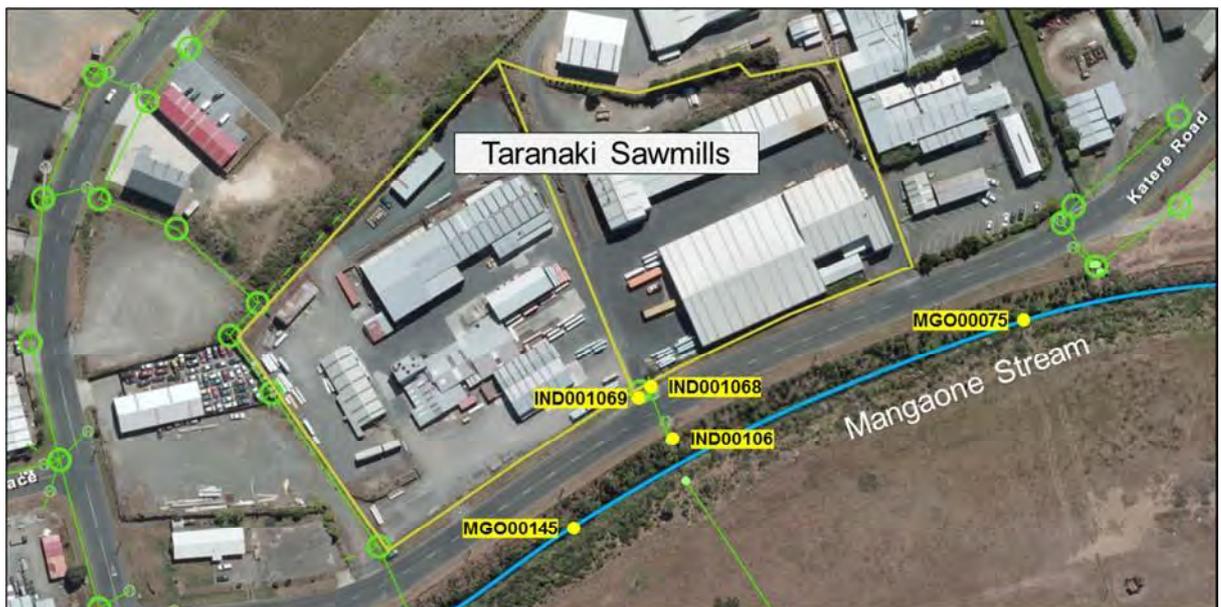
Timber is treated at two plants. At one plant, timber is treated with copper, chromium and arsenic (CCA), and with boron. At the other plant, light organic solvent preservatives (LOSP) is used.

Figure 20 Taranaki Sawmills site and sampling point locations

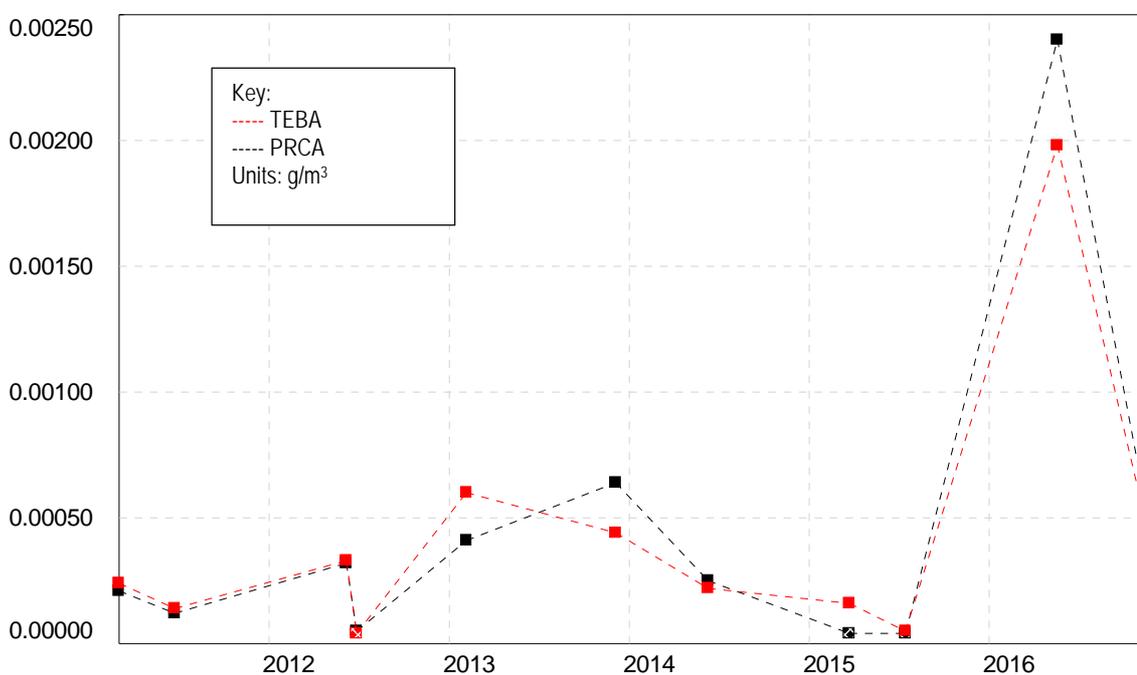
Tributyltin tin was detected in the discharge but was below detection limits in the Mangaone Stream.

Figure 21 Tebuconazole and Propiconazole concentrations downstream of TSM's discharge

Elevated levels of the light organic preservative chemicals Tebuconazole and Propiconazole were found in the Mangaone Stream downstream of Taranaki Sawmills Ltd during one wet weather survey. The levels found, whilst exceeding national environmental exposure limits (EELS), they were found to be well within the empirical NOEC's (no observable effect

concentrations) for aquatic life developed by the European Chemical Agency and the Cawthron Institute.

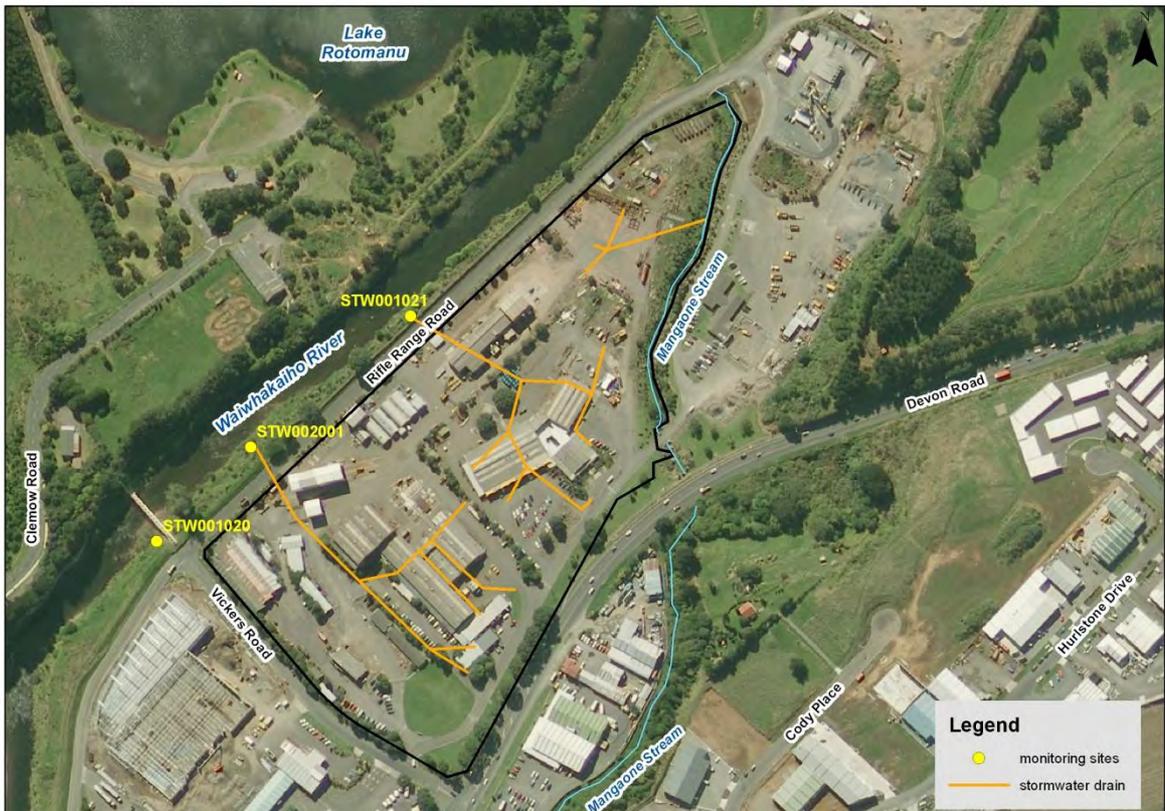
The engineering complex of Technix Group Ltd (Technix) is the largest industrial site along the lower Waiwhakaiho River. Situated on the true right bank of the river immediately above its confluence with the Mangaone Stream, the 8.4 ha area of land is bounded by Rifle Range Road, Vickers Road, State Highway 3, and the Mangaone Stream. The development comprises several building complexes, roading and drainage systems.

Figure 22 Technix site, drainage system and sampling point locations

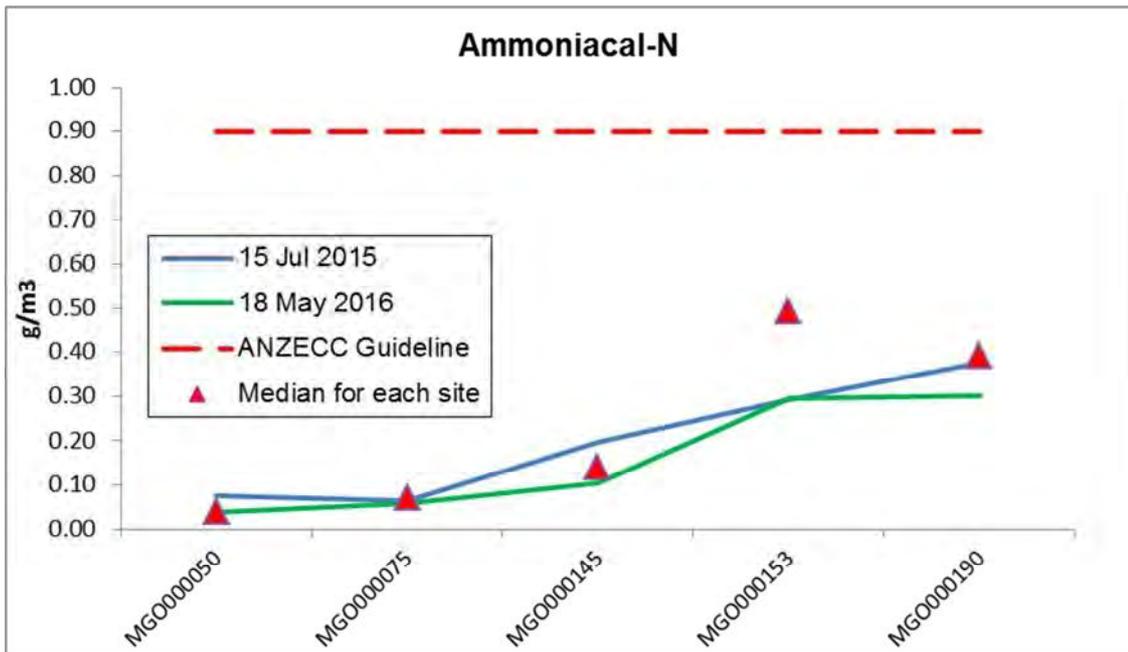
DRP was also found to increase at the site downstream of the Ravensdown site, however all values were found to be similar or below the historical medians as. DRP concentrations appear have reduced at this site since Ravensdown decommissioned and demolished the rock store. In the event that the site is completely demolished and remediated it is expected that phosphorus levels will improve.

Figure 23 Longitudinal profiles of NH₄-N in the Mangaone Stream

There continued to be evidence of nutrient enrichment occurring in the lower Mangaone Stream. Chemical monitoring shows that stormwater from the fertiliser distribution depot (and old fertiliser works) presently owned and operated by Ravensdown Fertiliser Co-operative Ltd, is still a source of nutrients.
