Lower Waiwhakaiho Catchment
Monitoring Programme
Annual Report
2015-2016

Technical Report 2016-98

Taranaki Regional Council
Private Bag 713
STRATFORD

March 2017

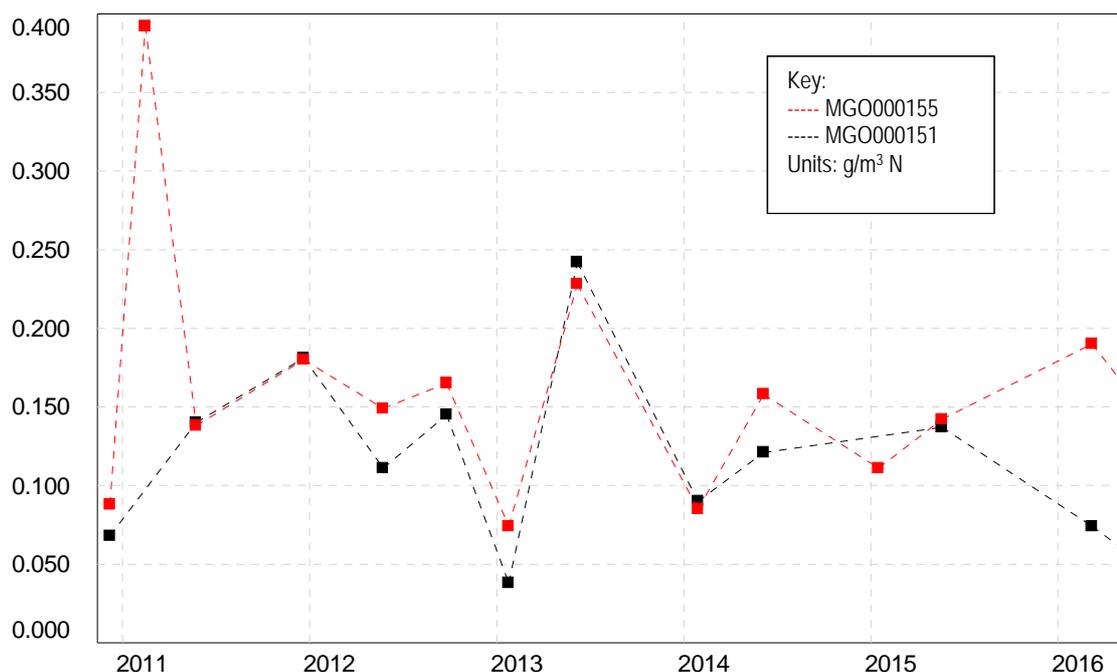
Due to elevations in the ammoniacal nitrogen concentration observed in a Ravensdown bore on Katere Road, this is the parameter of primary interest here and Figure 24 shows the trends in ammoniacal nitrogen concentrations at the upstream and downstream sites.

Figure 24 Mangaone Stream ammoniacal nitrogen concentrations in the vicinity of the Ravensdown site under dry weather conditions 2010-2016

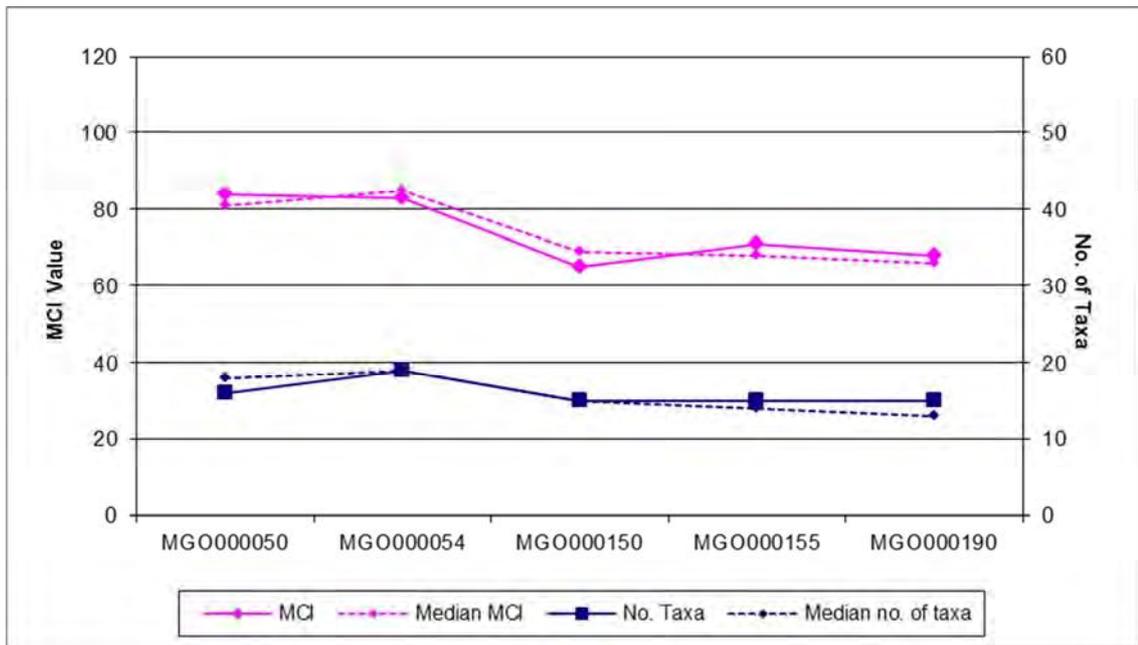
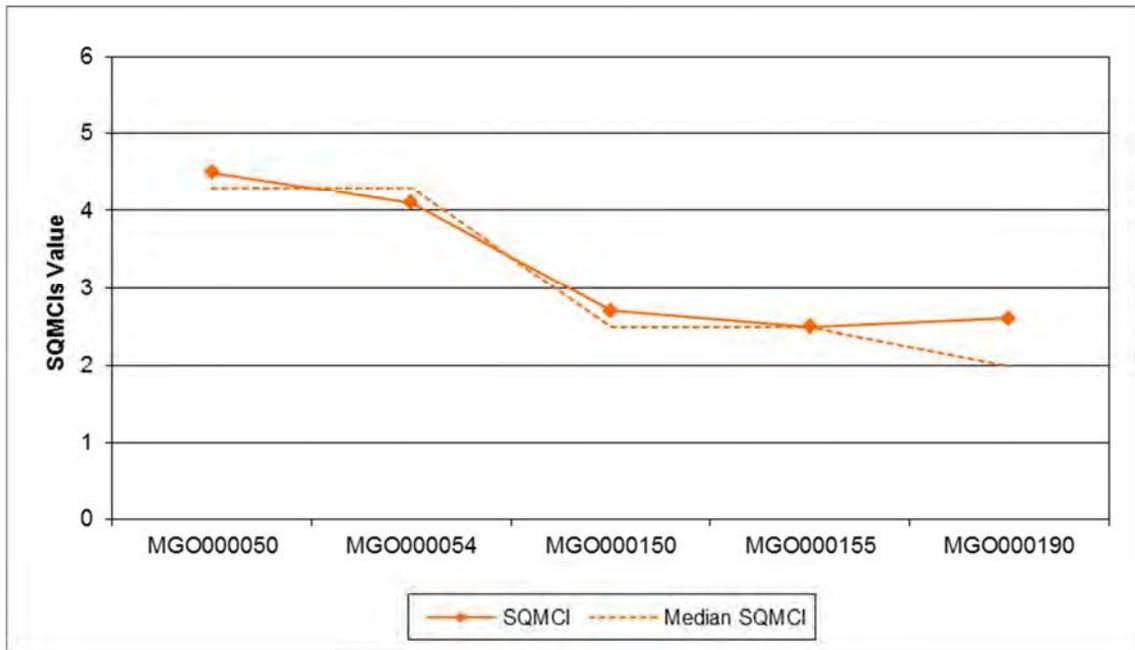
Overall, the results from the current survey indicated some improvements in comparison with historical results although a general deterioration in downstream biological health was found by the current survey. Groundwater inputs may have contributed to some of this deterioration recorded immediately downstream of the fertiliser depot in the lower reaches of the stream.

Figure 25 Longitudinal trend in number of taxa, MCI and SQMCI_s values in the Mangaone Stream for the survey of 21 December 2015

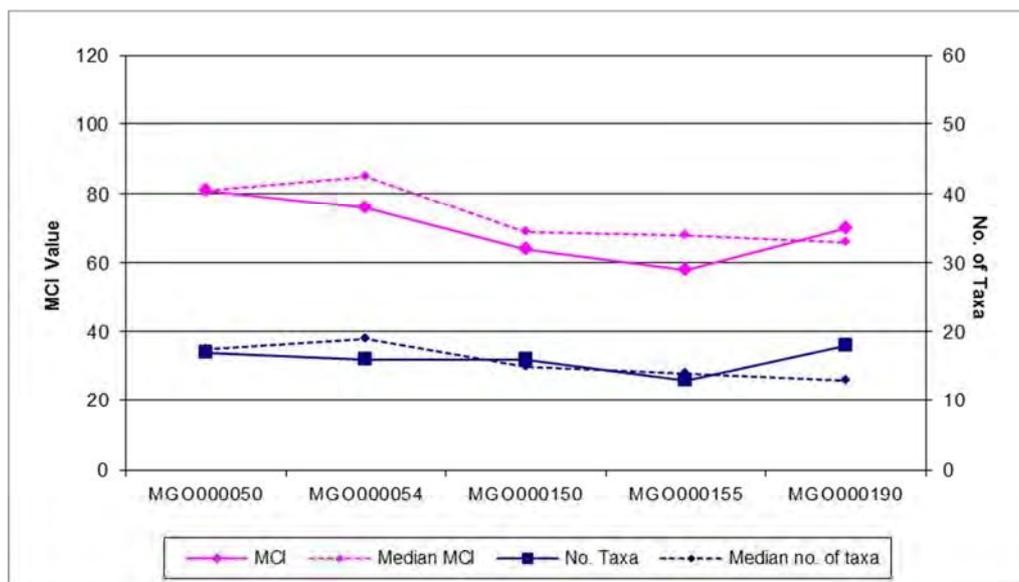
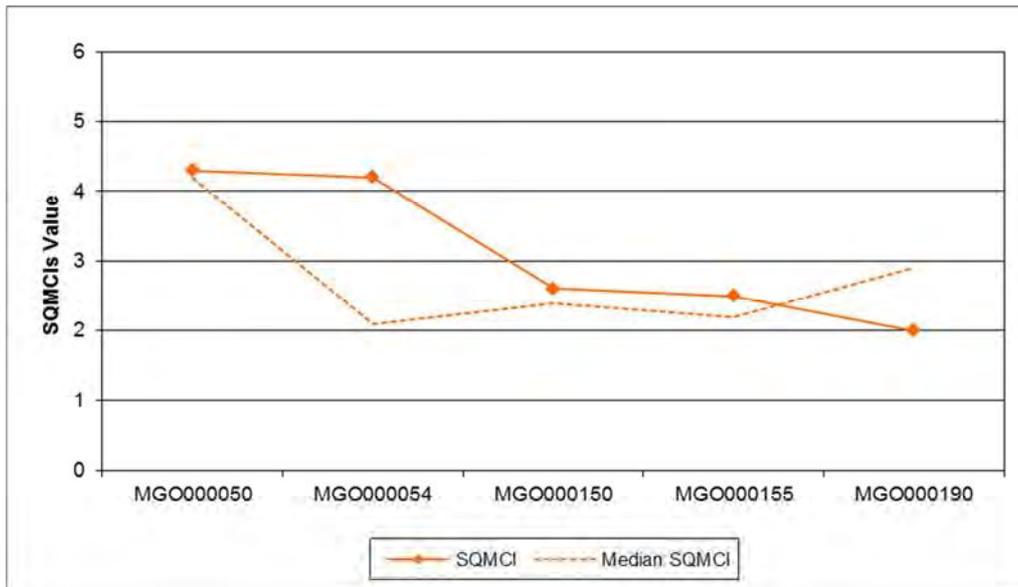
Overall, the results indicated that discharges from the industrial area was not having a negative effect on the macroinvertebrate communities in the lower Waiwhakaiho River but there was evidence that discharges were having a negative effect on macroinvertebrate communities present in the lower Mangaone Stream. Groundwater inputs may have contributed to some of this deterioration recorded immediately downstream of the fertiliser depot but other industries may also be contributing to poor water quality in the lower reaches of the Mangaone Stream.

Figure 26 Longitudinal trend in number of taxa, MCI and SQMCI_s values in the Mangaone Stream for the survey of 16 March 2016

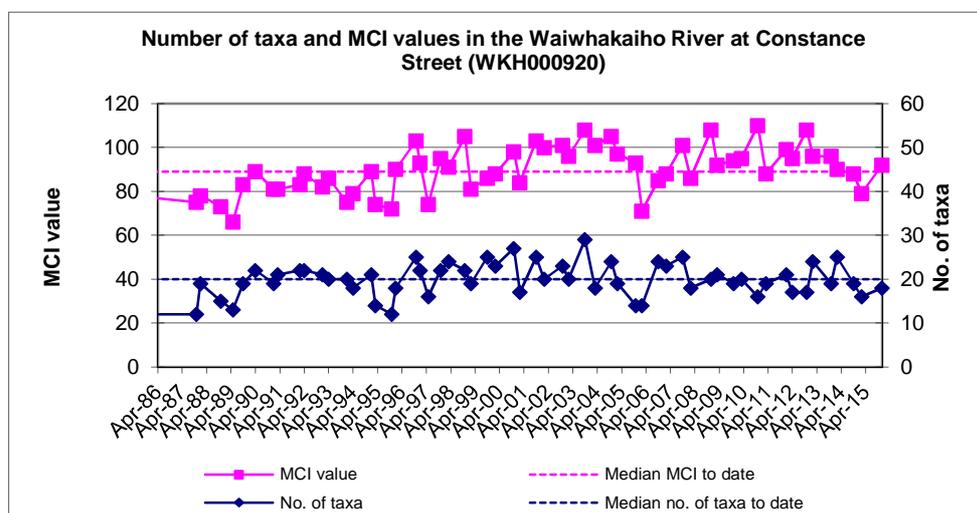
A moderate taxa richness (18 taxa) was found at this site, upstream of all discharges from the Fitzroy industrial area. This was two taxa less than the median richness for this site (Table 2 and Figure 2), but within the range of previous richnesses.

Figure 2 Numbers of taxa and MCI values for Waiwhakaiho River at Constance Street since 1987

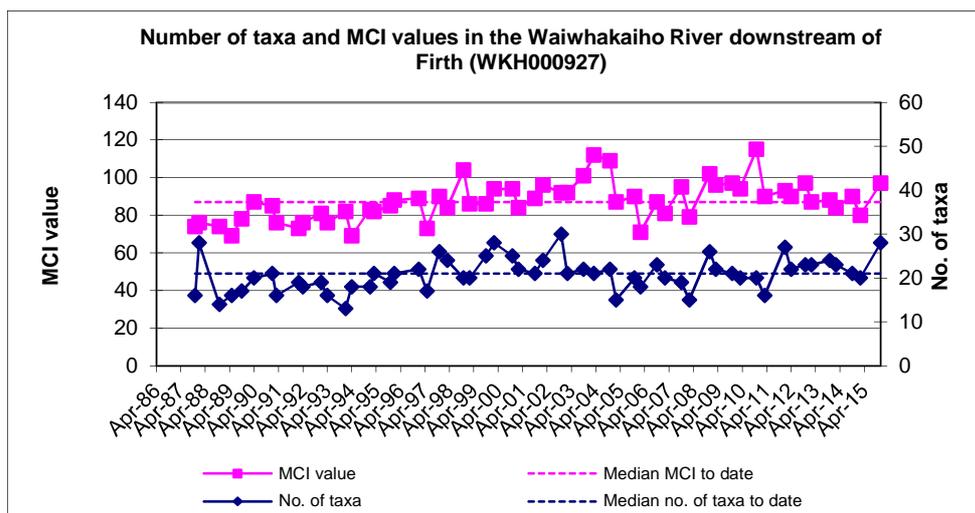
This site had a moderately high community richness (28 taxa); seven taxa more than the historical median at this site (Table 2 and Figure 3).

Figure 3 Numbers of taxa and MCI values for Waiwhakaiho River below Firth Industries (left bank) since 1987

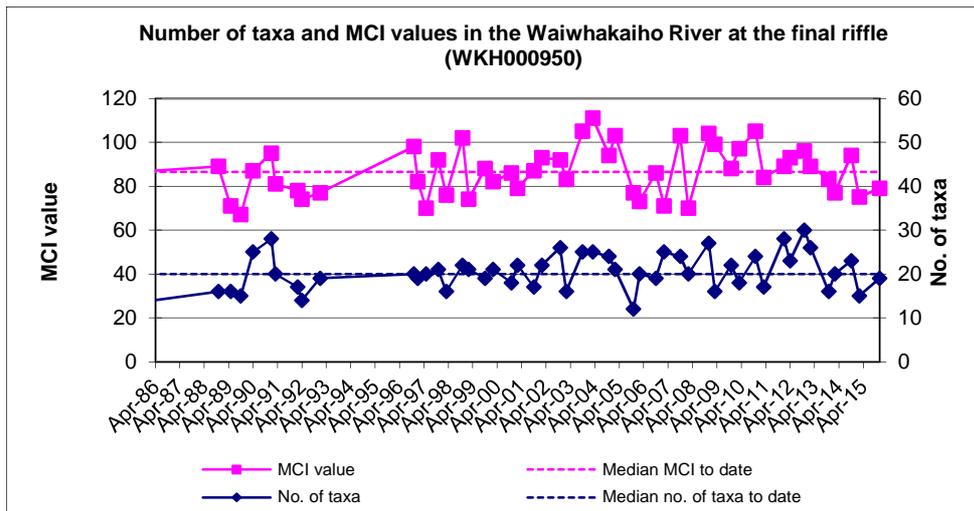
A moderate richness of 19 taxa was found at this site, situated downstream of all industrial discharges to the lower catchment, within a reach where high tides may slow river current speeds (and very occasionally increase salinity) near the river mouth. This richness was four taxa more than that recorded by the previous summer survey and one taxon less than the historical median richness, and nine taxa less than recorded at site 8 below Firth Industries (Table 2 and Figure 4).

Figure 4 Numbers of taxa and MCI values for Waiwhakaiho River d/s of Lake Rotomanu since 1987

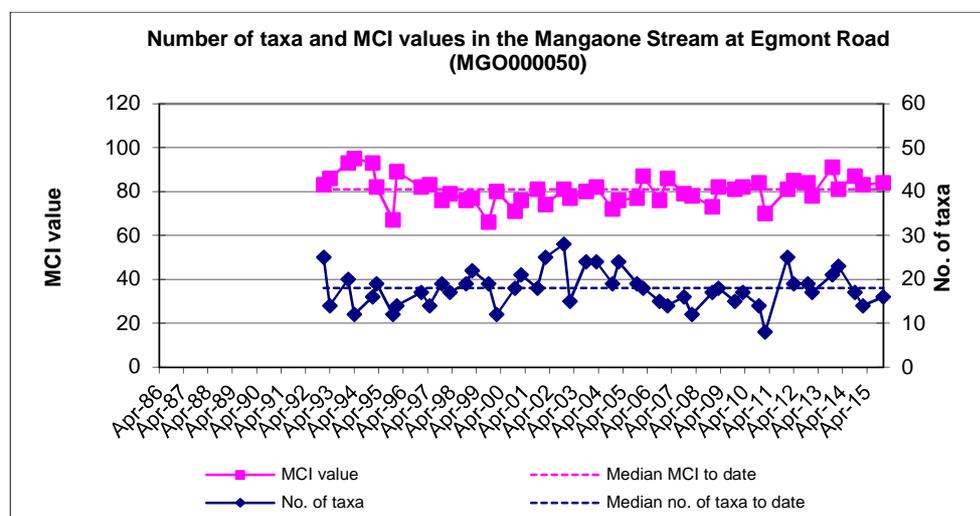
A moderate community richness (16 taxa) was found amongst the vegetation and the soft silt-bottomed habitat of this site. This was two taxa less than the median richness for this site and two taxa more than found by the previous summer (2015) survey (Table 2 and Figure 5).

Figure 5 Number of taxa and MCI values for Mangaone Stream at Egmont Road since 1992

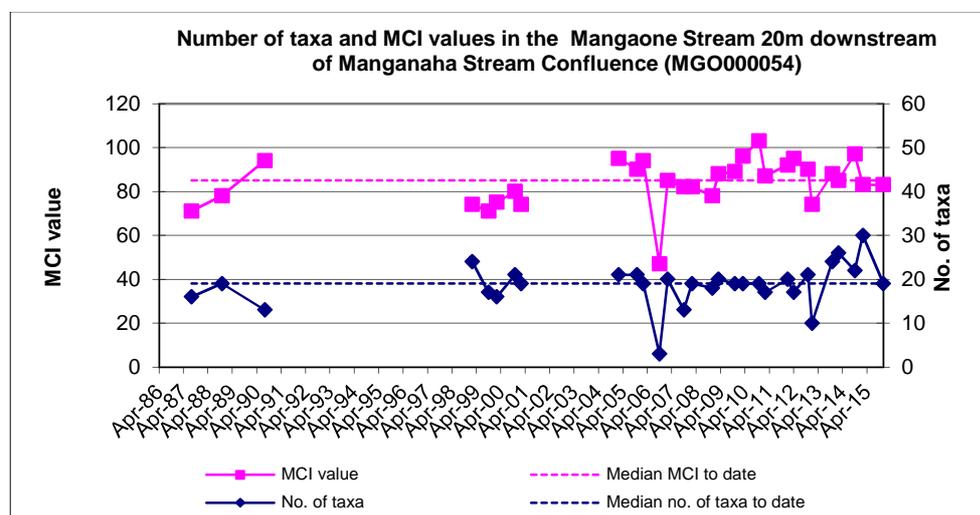
There were twelve significant changes in individual taxon abundances between adjacent sites 12 and 16. The changes were coincident with an increase in periphyton substrate cover and decrease in aquatic vegetation, at the downstream site, increased hard-gravel substrate, and the resultant change in sampling technique.

Figure 6 Numbers of taxa and MCI values for the Mangaone Stream downstream of the confluence with Manganaha Stream since 1987

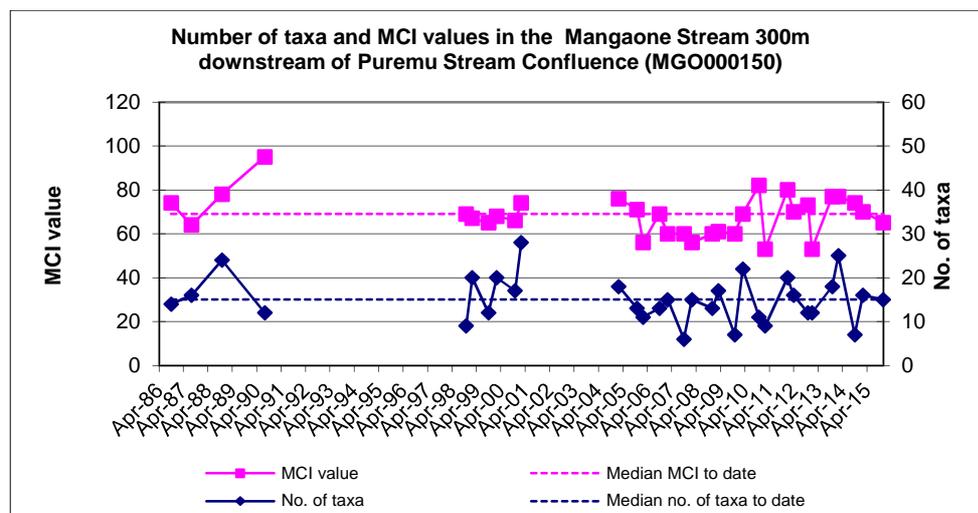
may indicate that the surveyed riffle has become more stabilised with reduced substrate turnover during high flows, allowing for greater periphyton establishment.

Figure 7 Numbers of taxa and MCI values for Mangaone Stream downstream of the confluence with Puremu Stream since 1986

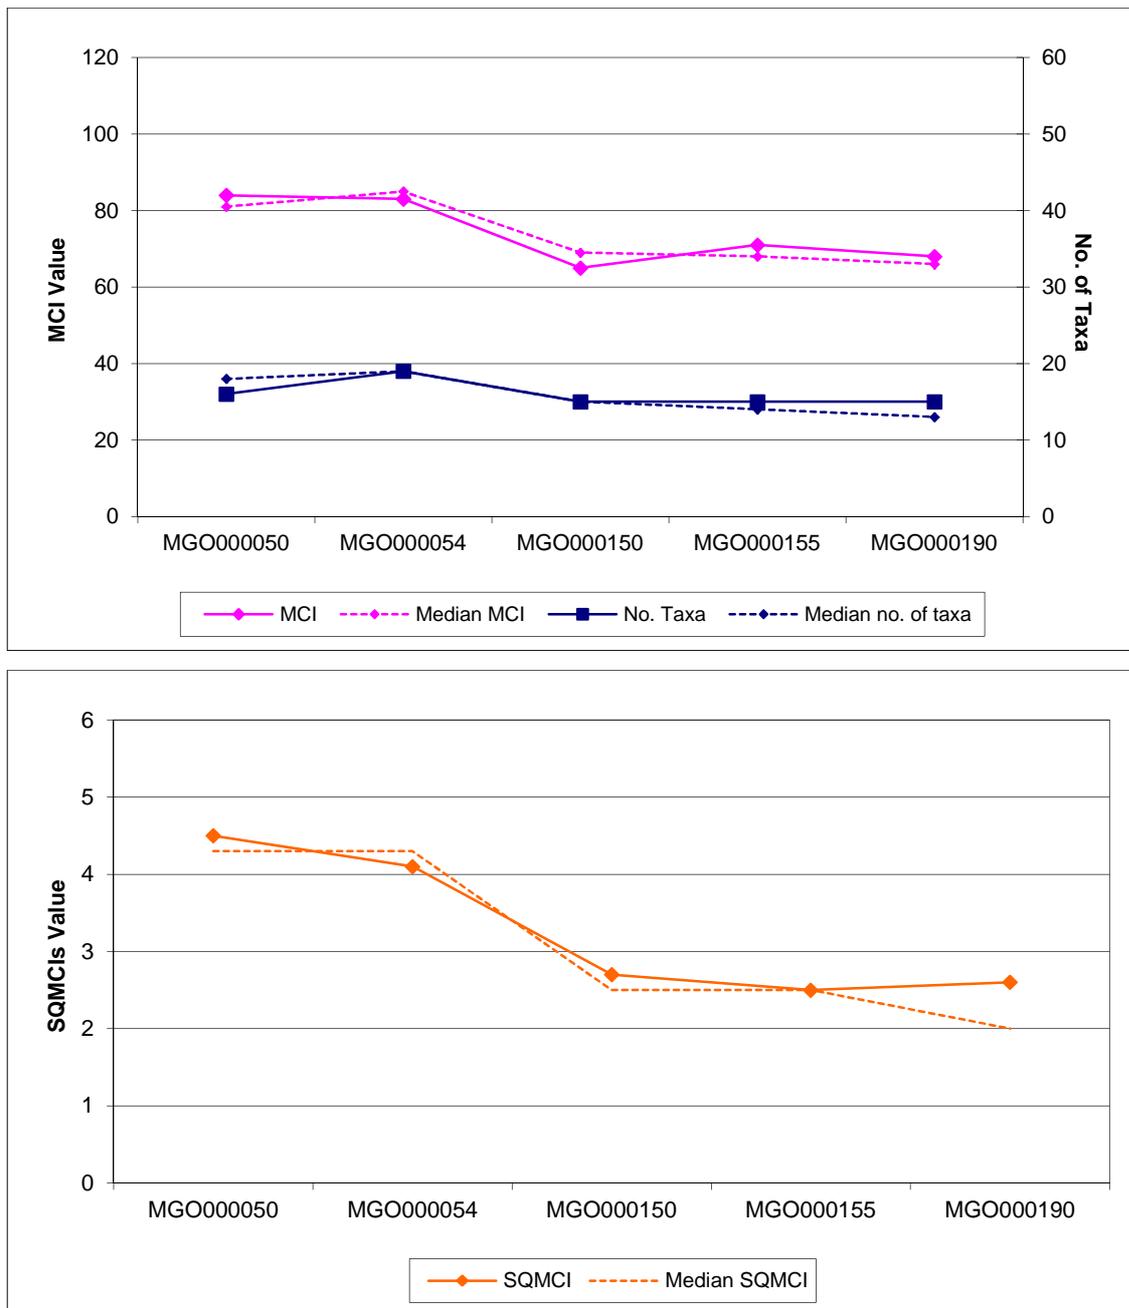
Figure 10 Longitudinal trend in number of taxa, MCI and SQMCI_s values in the Mangaone Stream for the survey of 21 December 2015

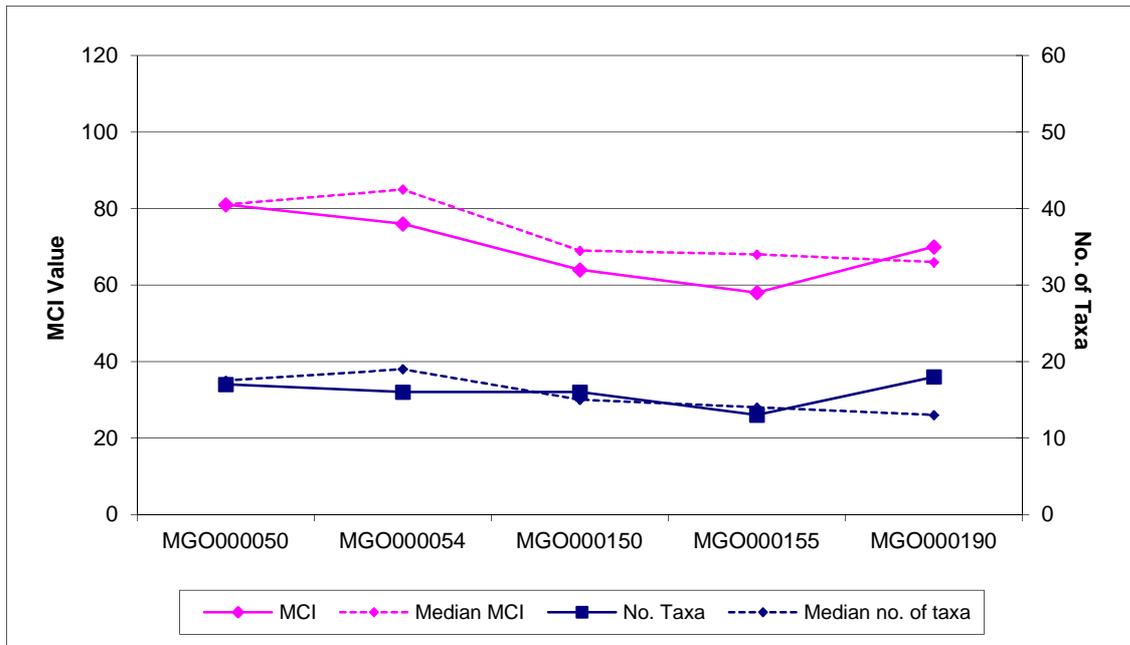
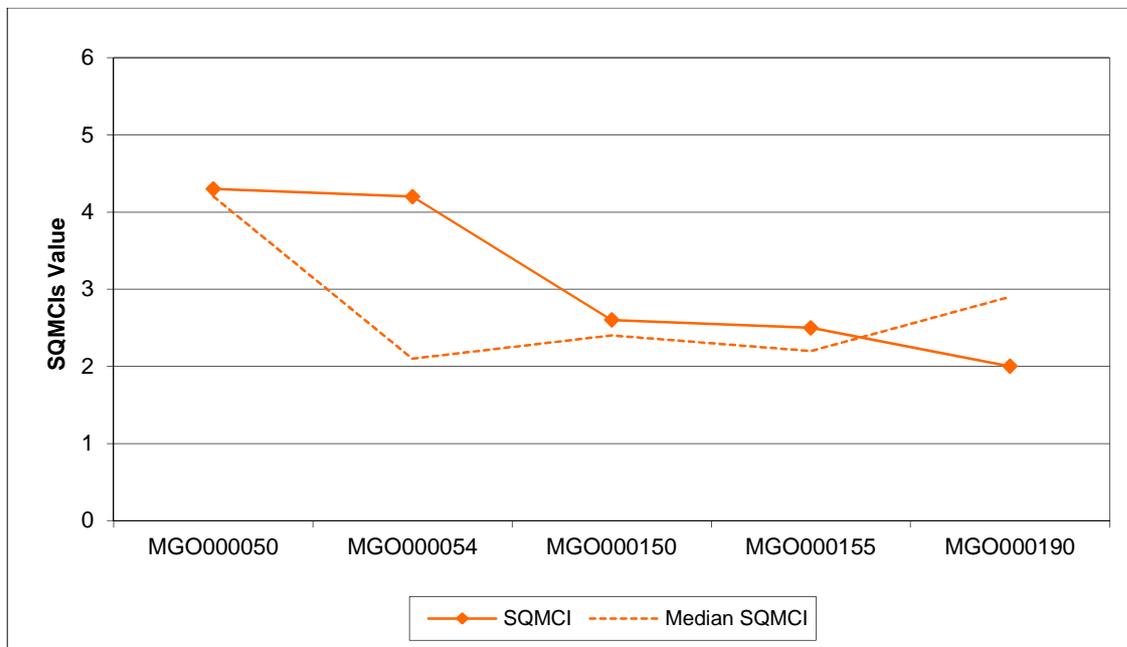
Figure 10 Longitudinal trend in number of taxa, MCI and SQMCI_s values in the Mangaone Stream for the survey of 16 March 2016
