Taranaki By-Products Ltd
Monitoring Programme
Annual Report
2015-2016

Technical Report 2016-80

March 2017

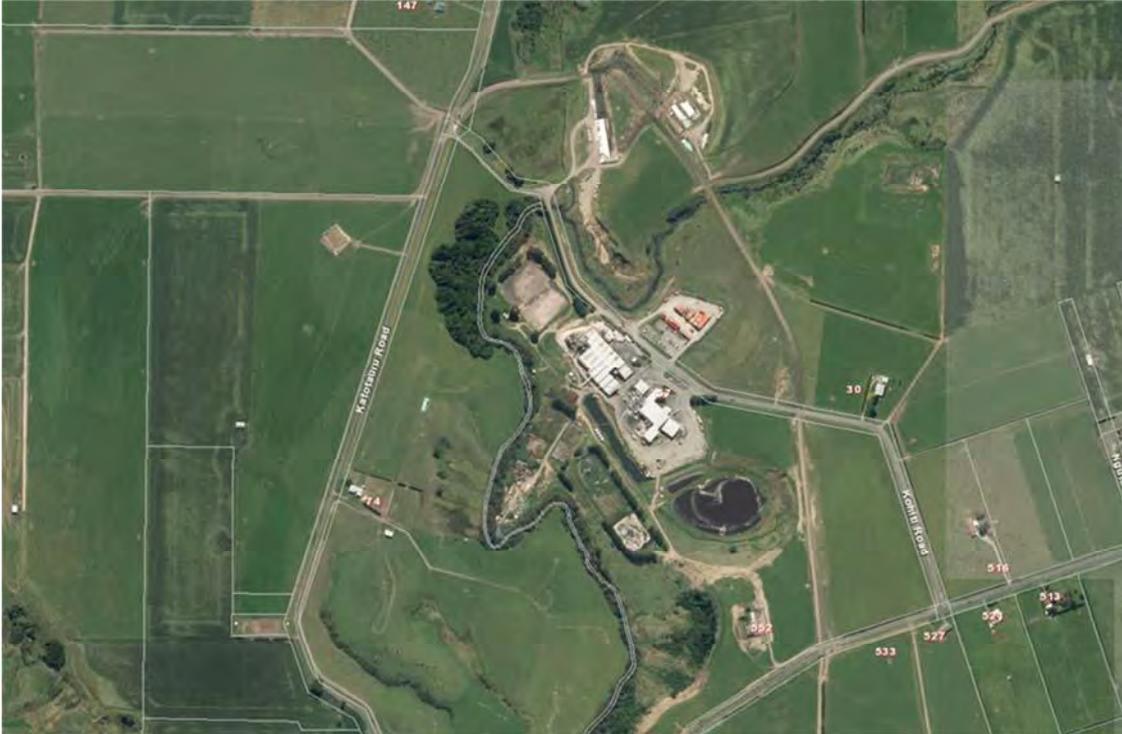
Photo 1 Taranaki By-Products aerial view

Animal rendering is essentially a two-stage process, involving separation of fat and drying of the residual solids. The TBP process is largely continuous low temperature (below 100° C) dry rendering with mechanical de-watering by screw press, and some thermal de-watering. Indirect (Rotadisc) steam-heated driers are employed. The dried product is milled, sieved and stored in bulk.

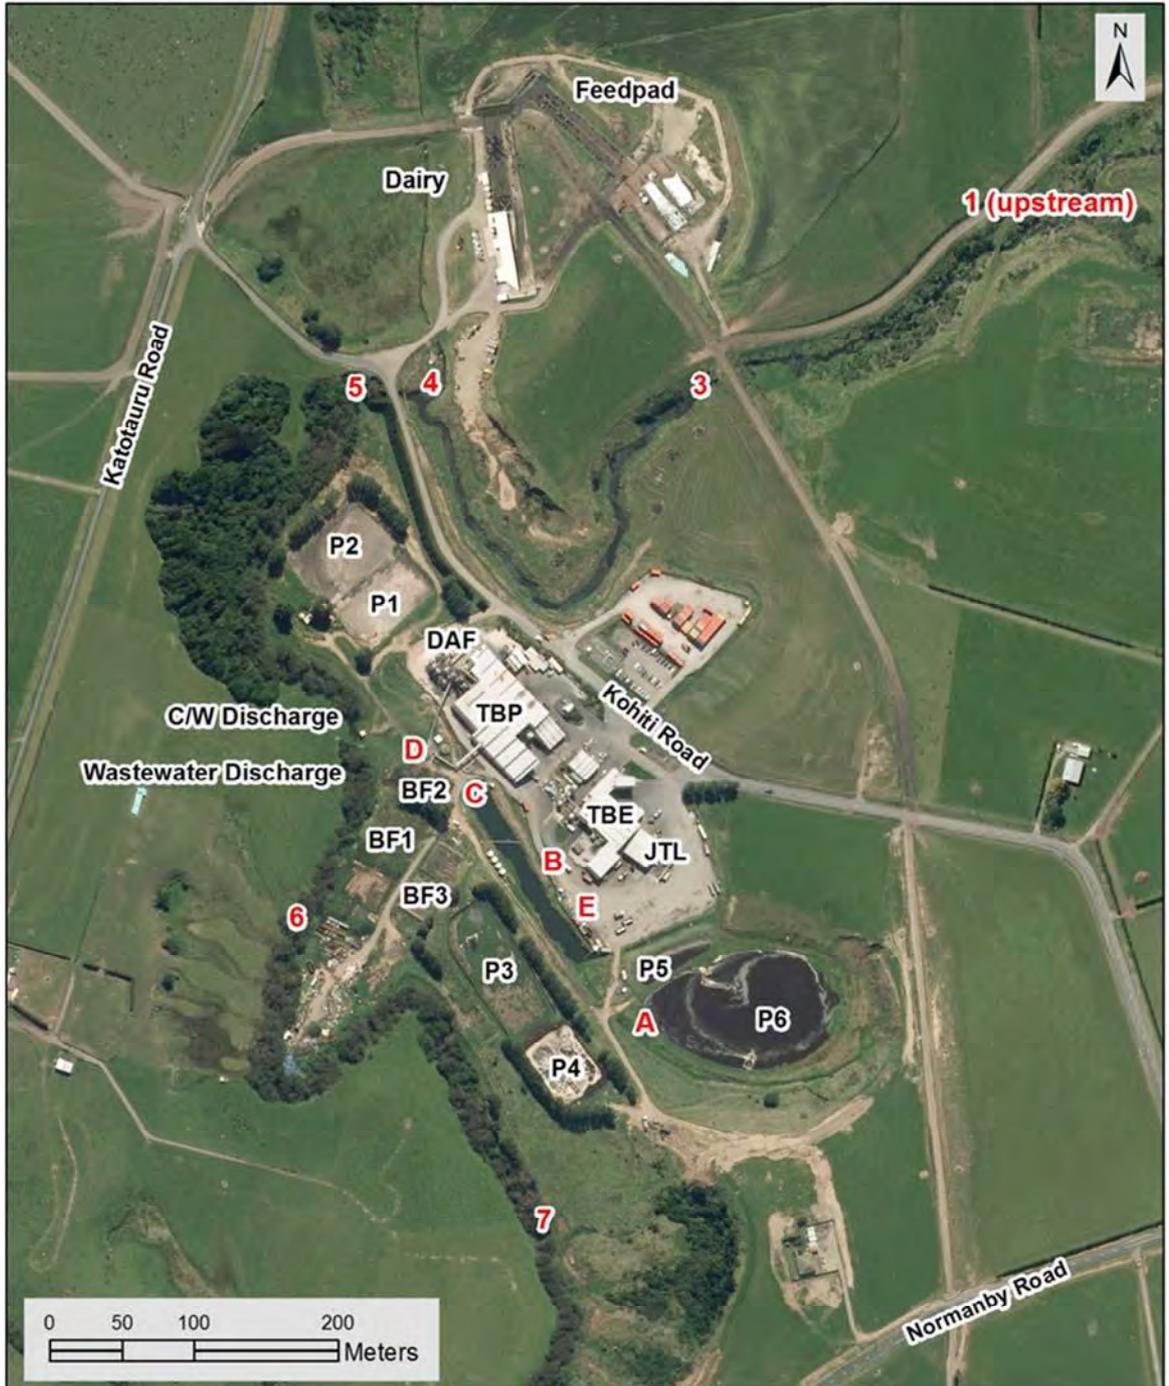
The point-source sampling sites for the rendering operations area are illustrated in Figure 2 and described in Table 2.

Figure 2 Point source sample location and labelling

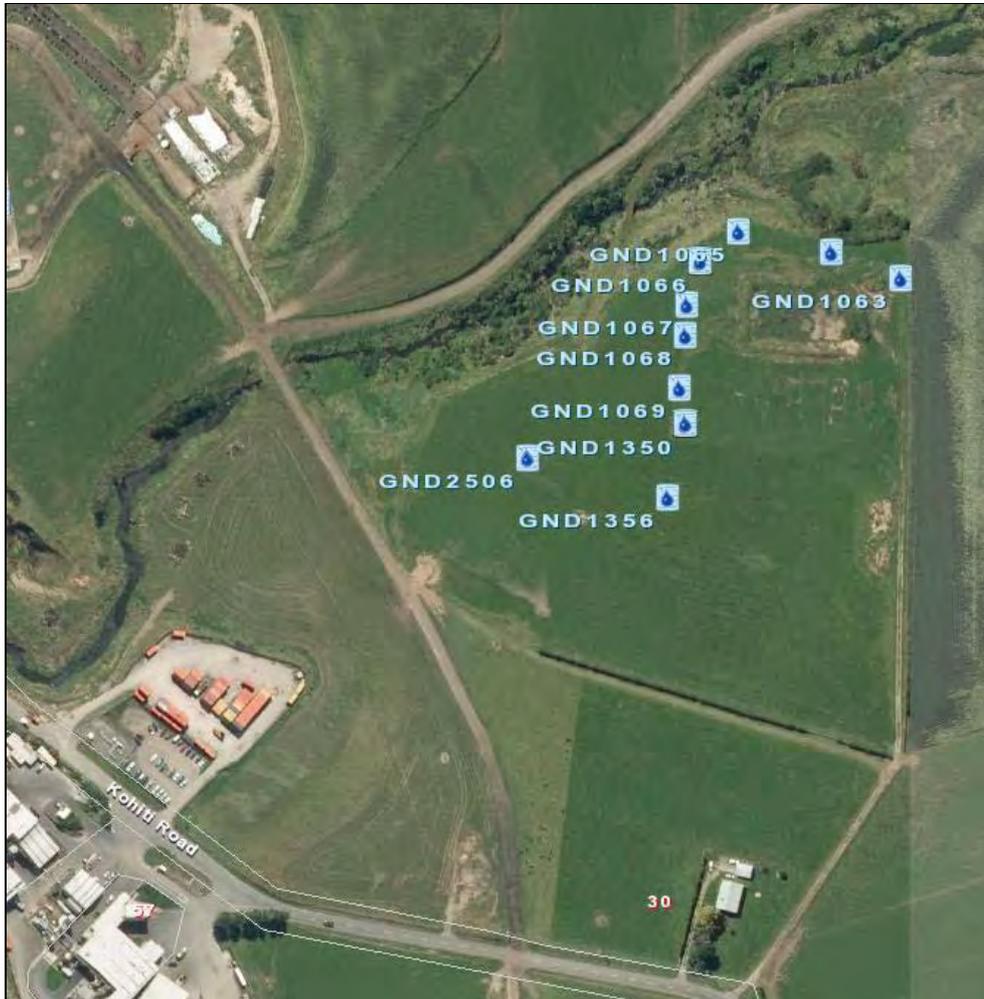
Figure 23 Location of the burial pit monitoring wells

Council. Raw material that cannot be processed is buried on the Kohiti Road property opposite the rendering plant (Figure 10 & Figure 22). Pits must be dug to certain specifications after notification of Council; material placed in the pits must be covered with soil within four hours to control odour and stormwater must be diverted away.

The monitoring undertaken by the Council in respect of the burial pits includes the following:

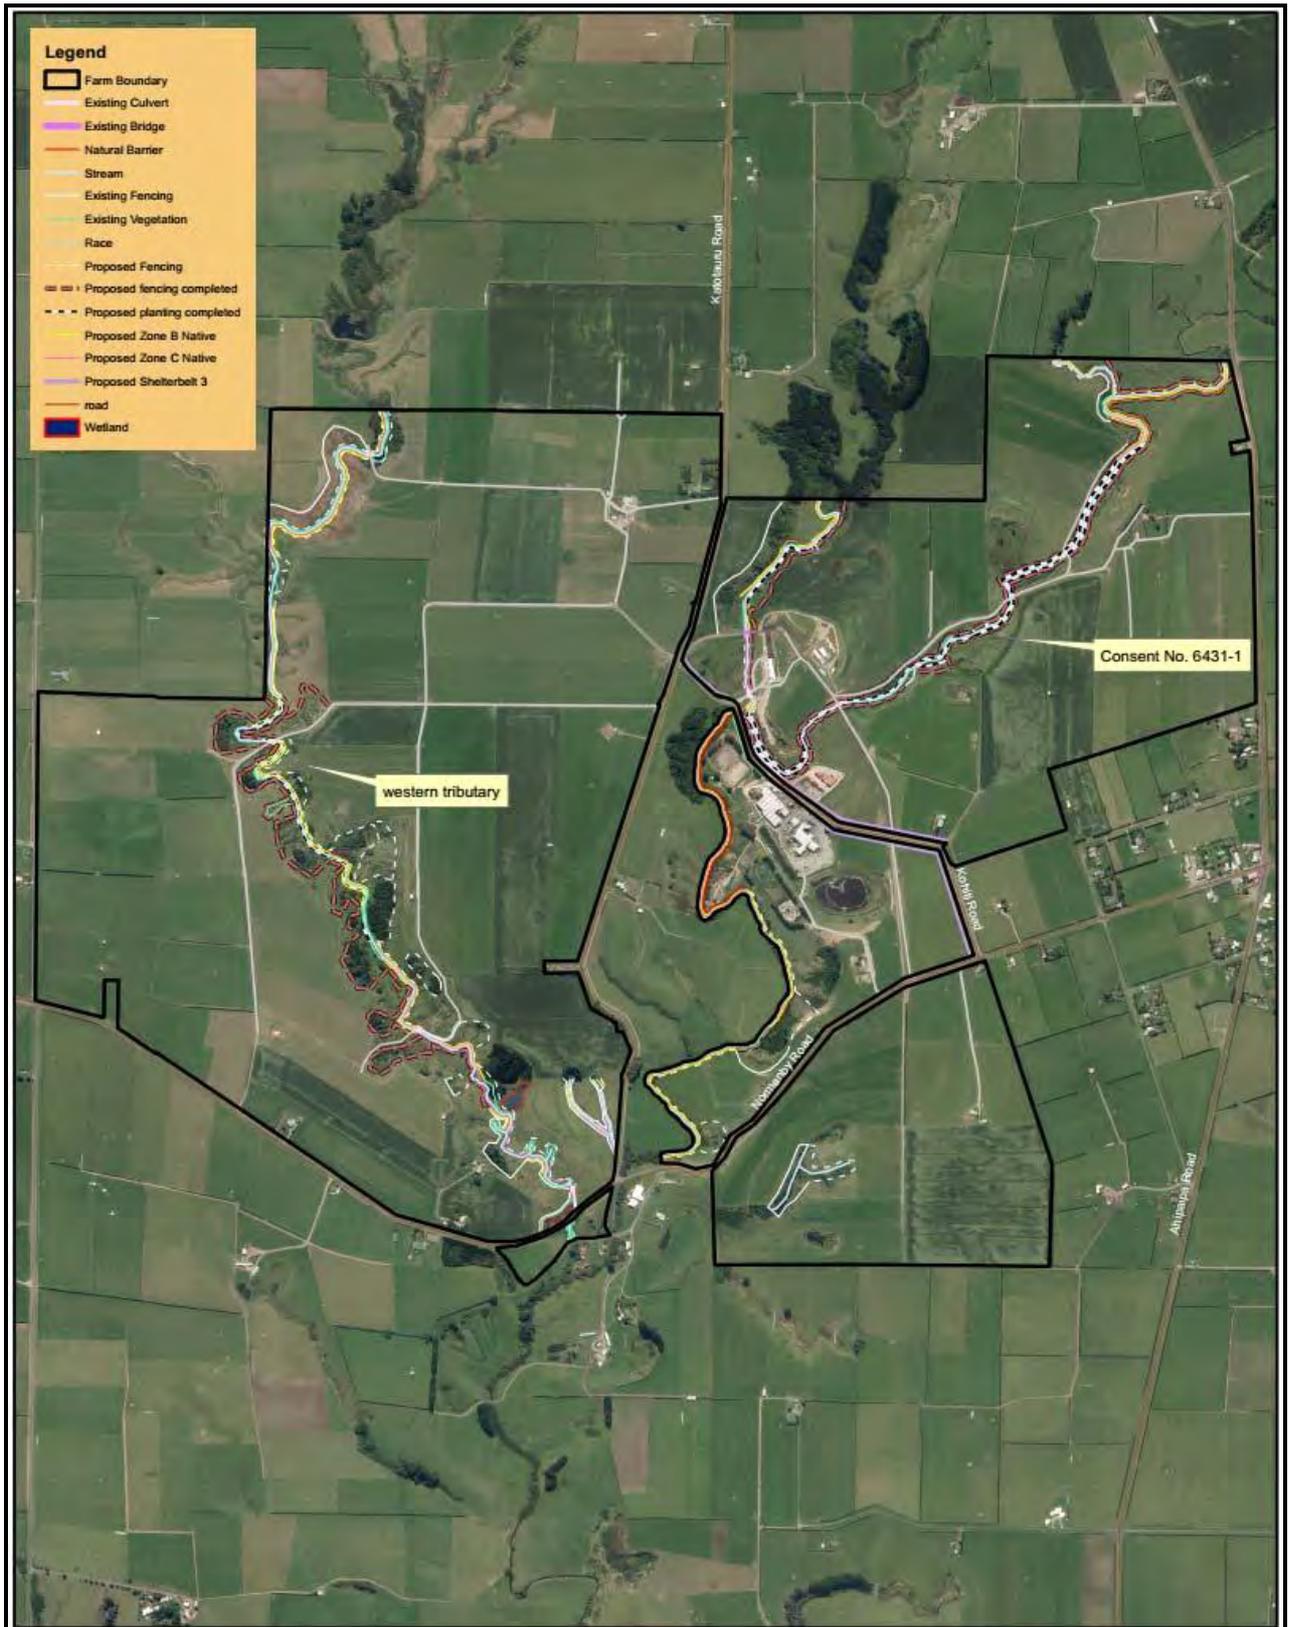
Figure 25 Riparian management plan for the TBP site

TBP have a riparian management plan (RMP) to help manage the natural waterways that are on the property. Originally there were four separate RMPs (RMP 90014, 90921, 90938 and 901363) but in 2015 these were merged into one large plan that covers all the waterways associated with TBP and they now have RMP 90014. The plan relates to the Inaha stem between Ahipaipa and Normanby Roads, covers the area upstream of Kohete Road bridge and the western tributary that runs through the Katotauru/Upper Inaha Roads irrigation area (Figure 25).

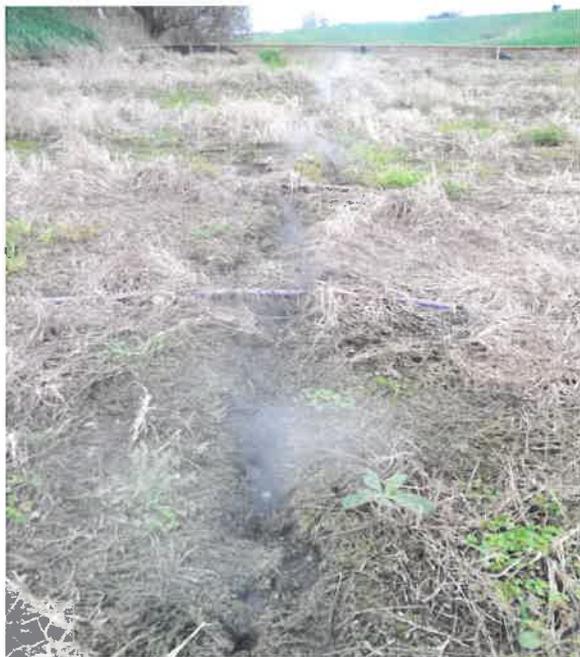
Figure 2: TBE concentrated. sources biofilter bed, with vapour leaking above one of the main ducts.
