Todd Energy Aquatic Centre
Monitoring Programme
Annual Report
2017-2018

Technical Report 2018-08

Taranaki Regional Council
Private Bag 713
STRATFORD
August 2018

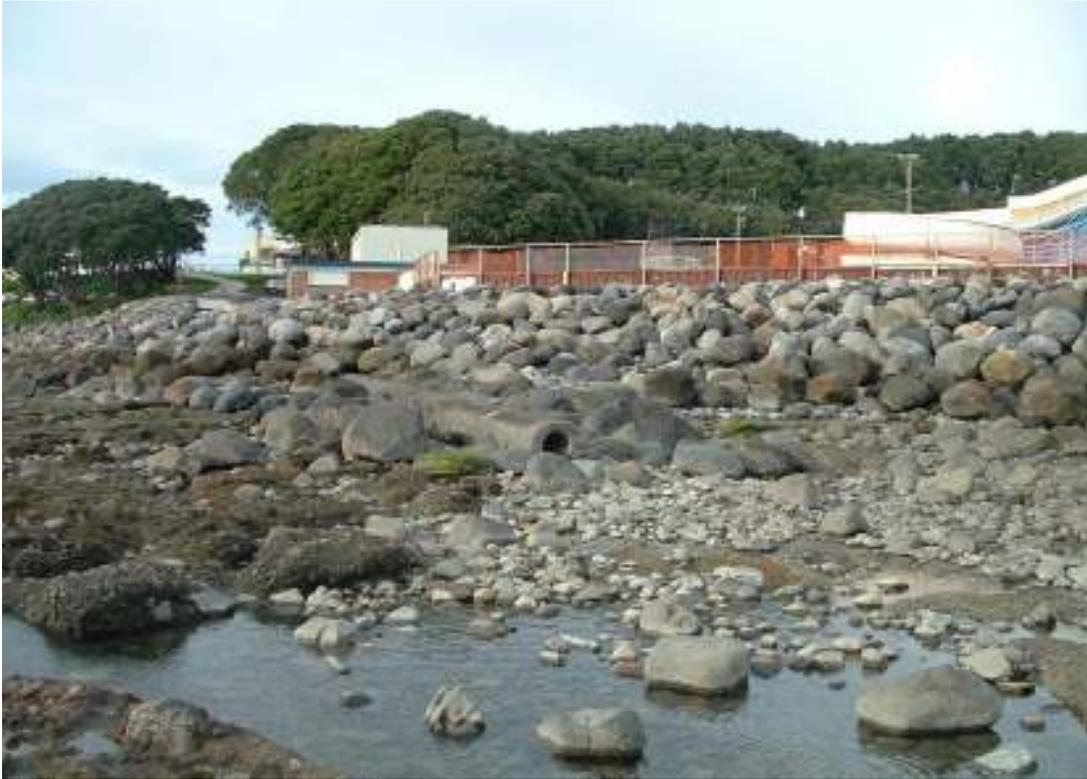
Photo 1 Aquatic Centre marine outfall

The discharge pipe consists of a 300 mm diameter encased concrete pipe and discharges at approximately mid-tide level. This structure was constructed in 1962 and has been in use ever since for the purpose of backwashing the outdoor pool filters.

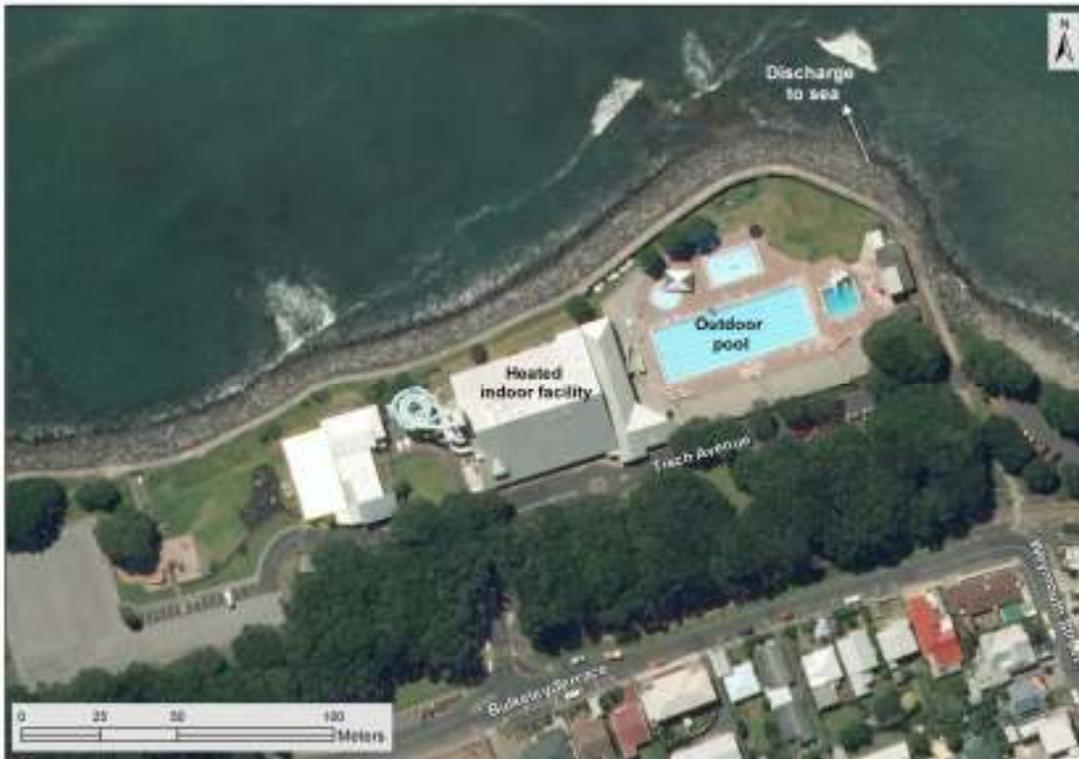
Figure 1 Location of the Aquatic Centre

The Aquatic Centre is sited on the foreshore at Tisch Avenue, New Plymouth. The facility consists of outdoor pools (including a main pool, diving pool and children's pools) and an indoor pool complex (Figure 1).

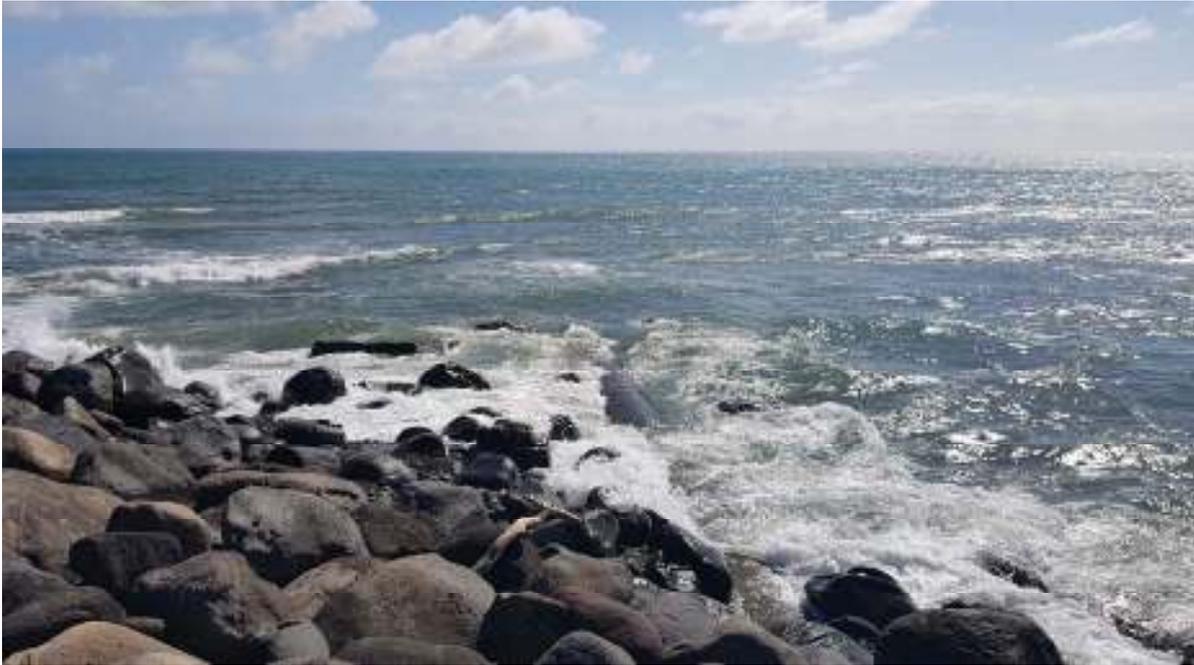
Photo 2 Marine swell at outfall pipe at the time of attempted shoreline water sampling (4 April 2018)

On Wednesday 4 April 2018, a Council officer visited the Aquatic Centre at 11:20 (DST) in order to sample the backwash discharge. High tide was at 12:14 (3.3m) and weather conditions were fine. A sample of backwash wastewater was collected from the discharge pipe in the maintenance shed. A shoreline water sample was unable to be collected on this occasion due to unsafe sampling conditions (Photo 2).

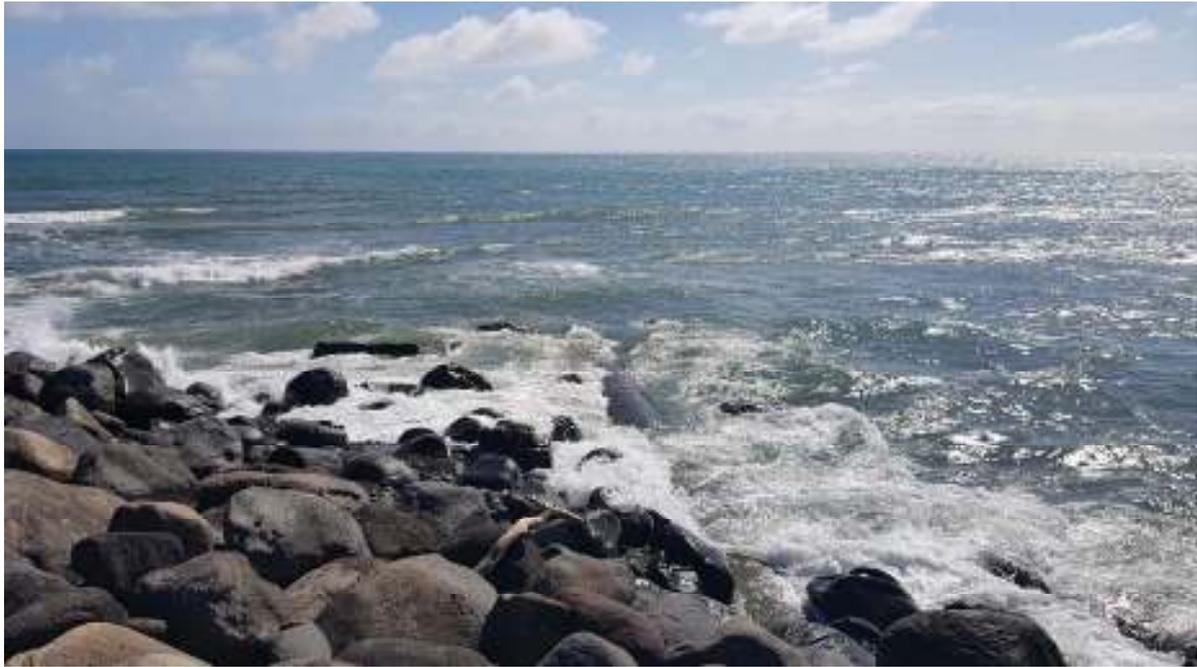
Photo 1 Outfall pipe at the time of attempted shoreline water sampling (4 April 2018)

The inshore waters appeared slightly turbid along the coast at the time of inspection, indicative of the turbulent conditions (Photo 1).

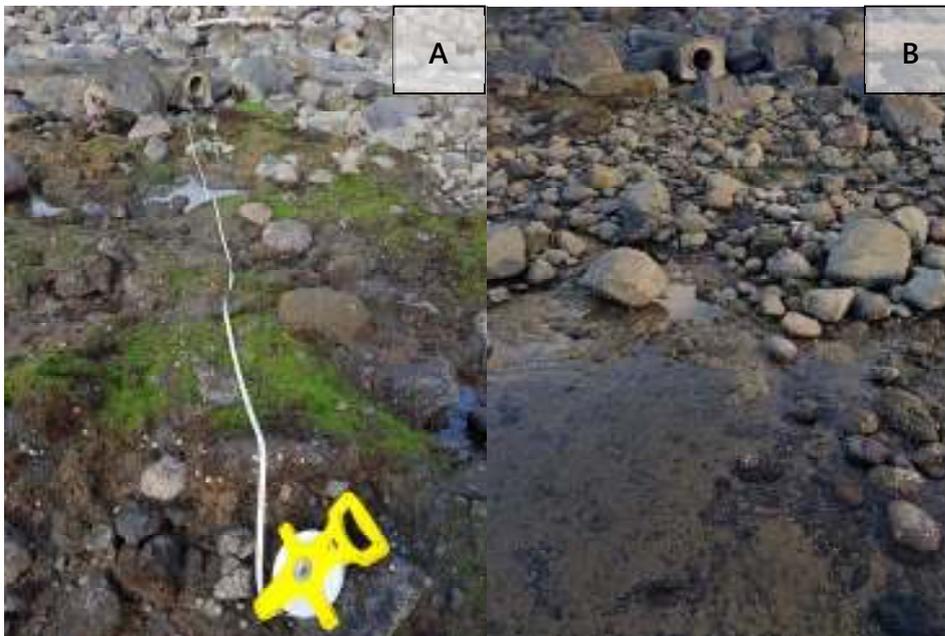
Photo 2 *Ulva* sp. distribution in the vicinity of the marine outfall, before (A, 15 June 2017) and after (B, 4 April 2018) the diversion of greywater from the stormwater system to sewerage network.

The reef inspection was carried out at the next low tide (18:29 on 4 April 2018 at 0.6 m). Upon arrival at the reef at 17:00, a clear, odourless flow was found discharging from the outfall (approximately 0.1-0.2 L/s). There were no objectionable odours, or conspicuous films or scums, at the discharge point. Moderate silt and sediment cover was observed in the vicinity of the outfall (Photo 2). The cover of *Ulva* sp. in the vicinity of the outfall was lower than recorded during the previous inspection on 15 June 2017, possibly due to a reduction in freshwater output from the marine outfall (Photo 2). Since the previous inspection, extensive works had been undertaken at the Aquatic Centre to divert greywater discharge from the stormwater system, leading to the marine outfall, to the sewerage network.

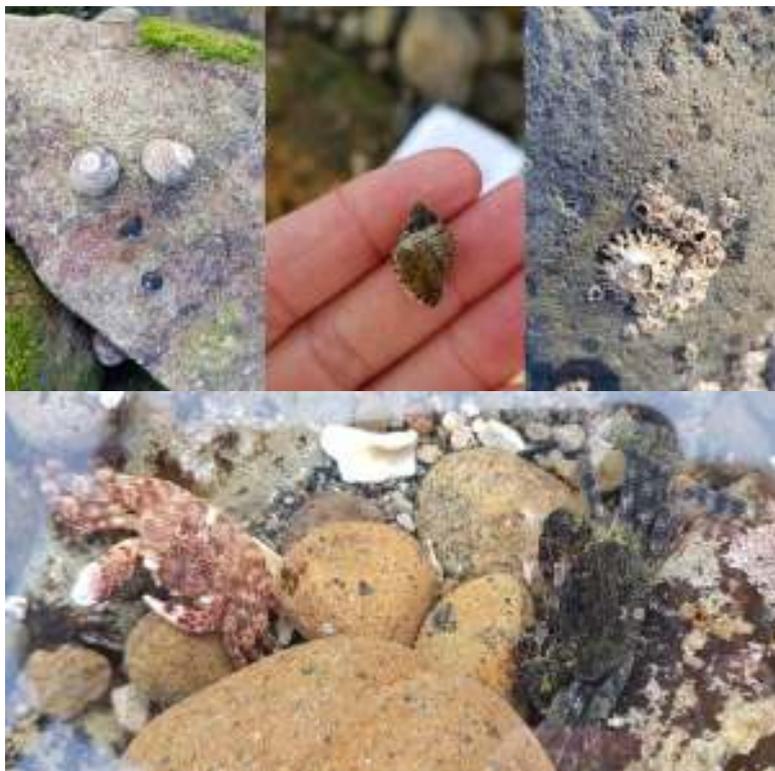
Photo 3 A range of invertebrate species identified within the influence of the outfall during the intertidal reef inspection (4 April 2018)

Midshore species diversity within the influence of the outfall also appeared to be slightly higher than recorded in recent surveys, indicative of a possible improvement in reef health since the completion of works at the Aquatic Centre on 23 September 2017 (Photo 3).

The following invertebrates were present on the upper shore in the vicinity of the pipe: molluscs *Diloma aethiops*, *Diloma zealandica*, *Cellana radians*, *Cellana ornata* and the barnacles *Chamaesipho columna* and *Chamaesipho brunnea*. The green algal species *Ulva sp.* was present with low cover, and the red and brown algal species *Gelidium caulacanthum* and *Ralfsia sp.*, respectively, were also present.

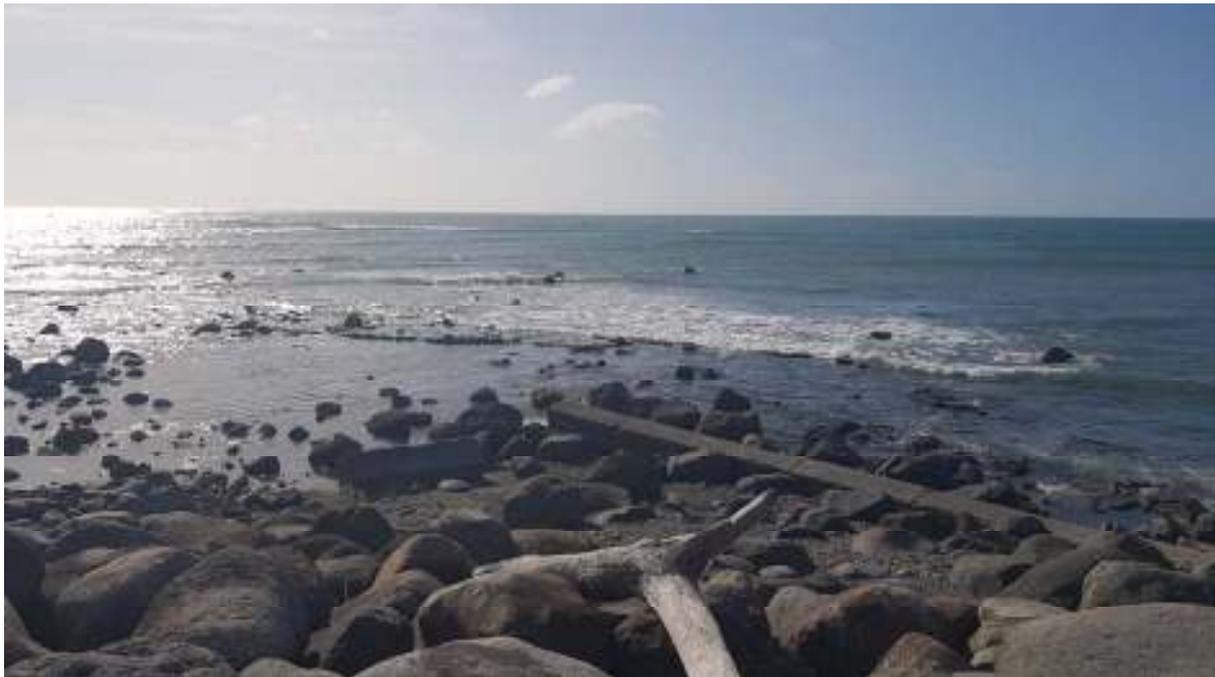
Photo 1 Shoreline seawater sampling adjacent to the marine outfall (7 May 2018)

Pool water testing found that the concentrations of both free and total chlorine were below the detectable limit ($<0.1 \text{ g/m}^3$). Following this, Aquatic Centre staff were advised that the chlorine concentration was in compliance with condition 4 of resource consent 2339-4, and that they could begin emptying their pool within 2 hours of the next high tide (providing compliance with condition 8). High tide was at 14:48 (NZST) on the day of the inspection. Samples were collected from the Tasman Sea at approximately 13:10 (Photo 1).

The results of the pool discharge and shoreline seawater samples are listed in Table 1. Neither sample exceeded any of the consent limits.

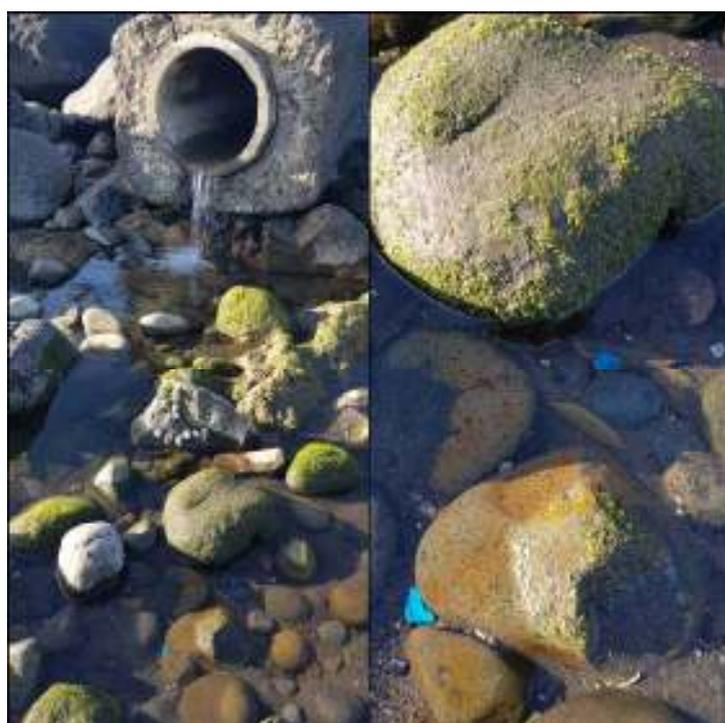
Photo 2 (A) Low flow discharging from outfall at 08:40 (8 May 2018), with blue paint chips visible in the immediate vicinity;
(B) Close-up of paint chips

The next practicable low tide during which a reef inspection could be carried out was at 09:41 on 8 May 2018 (1.2m). Upon arrival at the reef at approximately 08:40, a low flow was discharging from the marine outfall (Photo 2). Blue paint chips were found in the immediate vicinity of the outfall (Photo 2). The outdoor pool had only been partly emptied since the previous day; indicating compliance with the consent condition of only discharging in batches within two hours either side of high tide. The reef inspection found no detectable chlorine odour or any visual issues outside of the designated discharge mixing zone.

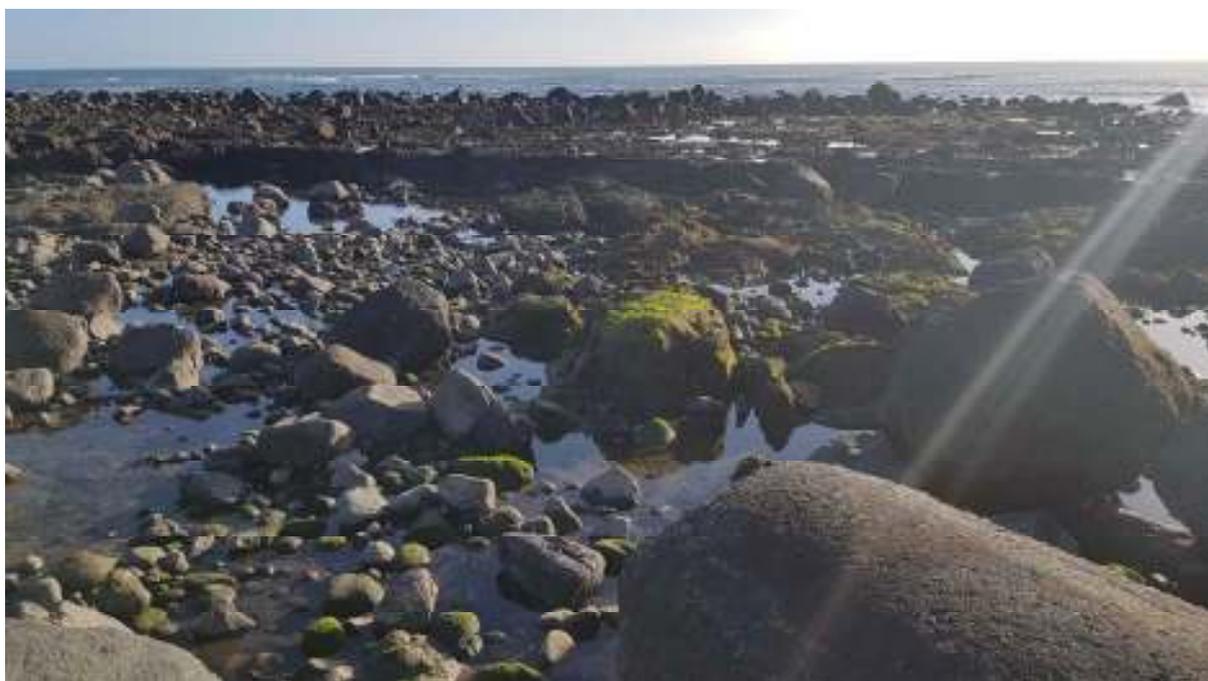
Photo 3 *Ulva* sp. cover extending up to 10 m east of the marine outfall.

The cover of *Ulva* sp. appeared to track the flow path of discharge from the outfall (Photo 3). Although the cover of *Ulva* sp. appeared to be greater during this inspection than the previous inspection carried out on 4 April 2018, there was still a notable decrease in *Ulva* sp. cover, when compared with the inspections carried out during the previous monitoring period. In comparison with the intertidal community further down the shore, the area surrounding the pipe supported very little biomass and was less diverse (Photo 4). However, this assemblage was similar to that found on previous inspections in the vicinity of the pipe, and is typical for this height on the shore. It was also noted that some gastropods (e.g. *Diloma aethiops*) found within 5 m of the marine outfall were more weakly attached to the substrate than gastropods found outside of the mixing zone. Attachment strength is a key determinant of gastropod survival on the rocky shore, as weakly attached individuals are more likely to be dislodged by predation and wave action, leading to higher mortality rates (O'Dwyer, Lynch & Poulin, 2014). However, these adverse effects were not detected outside of the 5 m mixing zone.

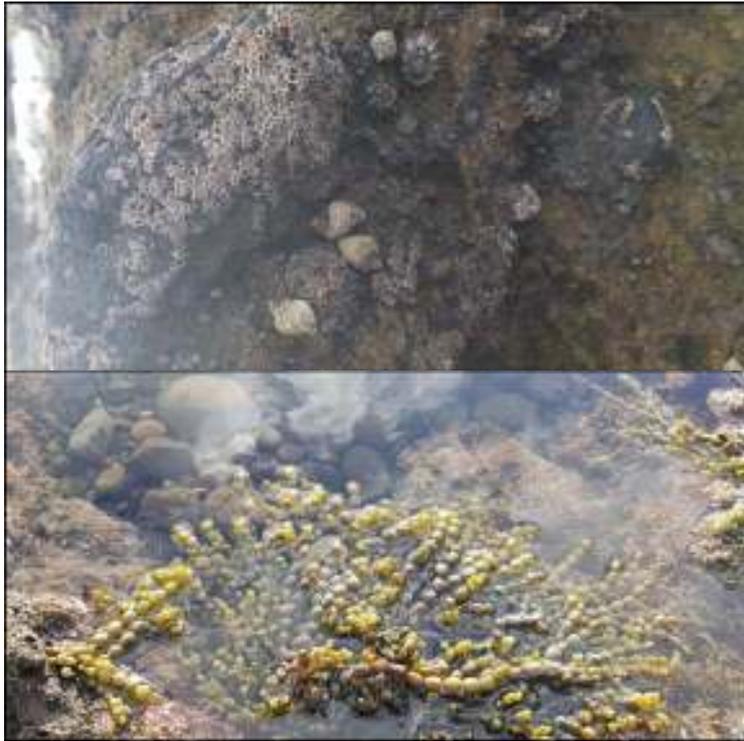
Photo 4 (A) Species (*Haustrum scobina*, *Cellana ornata*, *Chamaesipho columna*) characteristic of the exposed upper shore, within 5 m of the outfall;
(B) Greater abundance and biodiversity in a rockpool approximately 15 m away from the outfall

Further down on the shore, still within the influence of the pipe discharge, the following species were identified: molluscs *H. scobina* (very abundant), *D. aethiops* (very abundant) and *Lunella smaragdus*, the chitons *Ischnochiton maorianus* and *S. pelliserpentis*, limpets *C. radians* and *C. ornata*, the urchin *Evechinus chloroticus*, sea anemone *Isactinia olivacea*, barnacles *C. columnar* and *C. brunnea*, and the polychaete worms *S. cariniferus*, *Spirobis* sp. and *Neosabellaria kaiparaensis*. Red algae included *Corallina officinalis*, encrusting coralline algae and *Gelidium* sp. Brown algae included *Hormosira banksii* and *Ralfsia* sp., and the green algae *Chaetomorpha aerea* and *Ulva* sp. were also present. Overall, these species are similar to what would be expected at this elevation on the shore.

In summary, the composition of intertidal species identified during this inspection was considered normal for this type of environment. However, the extent of *Ulva* sp. cover eastwards of the outfall, up to 10 m from the structure, may indicate a fresh water influence.
