New Plymouth District Council  
Inglewood, Okato, and Marfell Park Landfills  
Monitoring Programme  
Annual Report  
2018-2019

Technical Report 2019-49

Taranaki Regional Council  
Private Bag 713  
STRATFORD  
February 2020

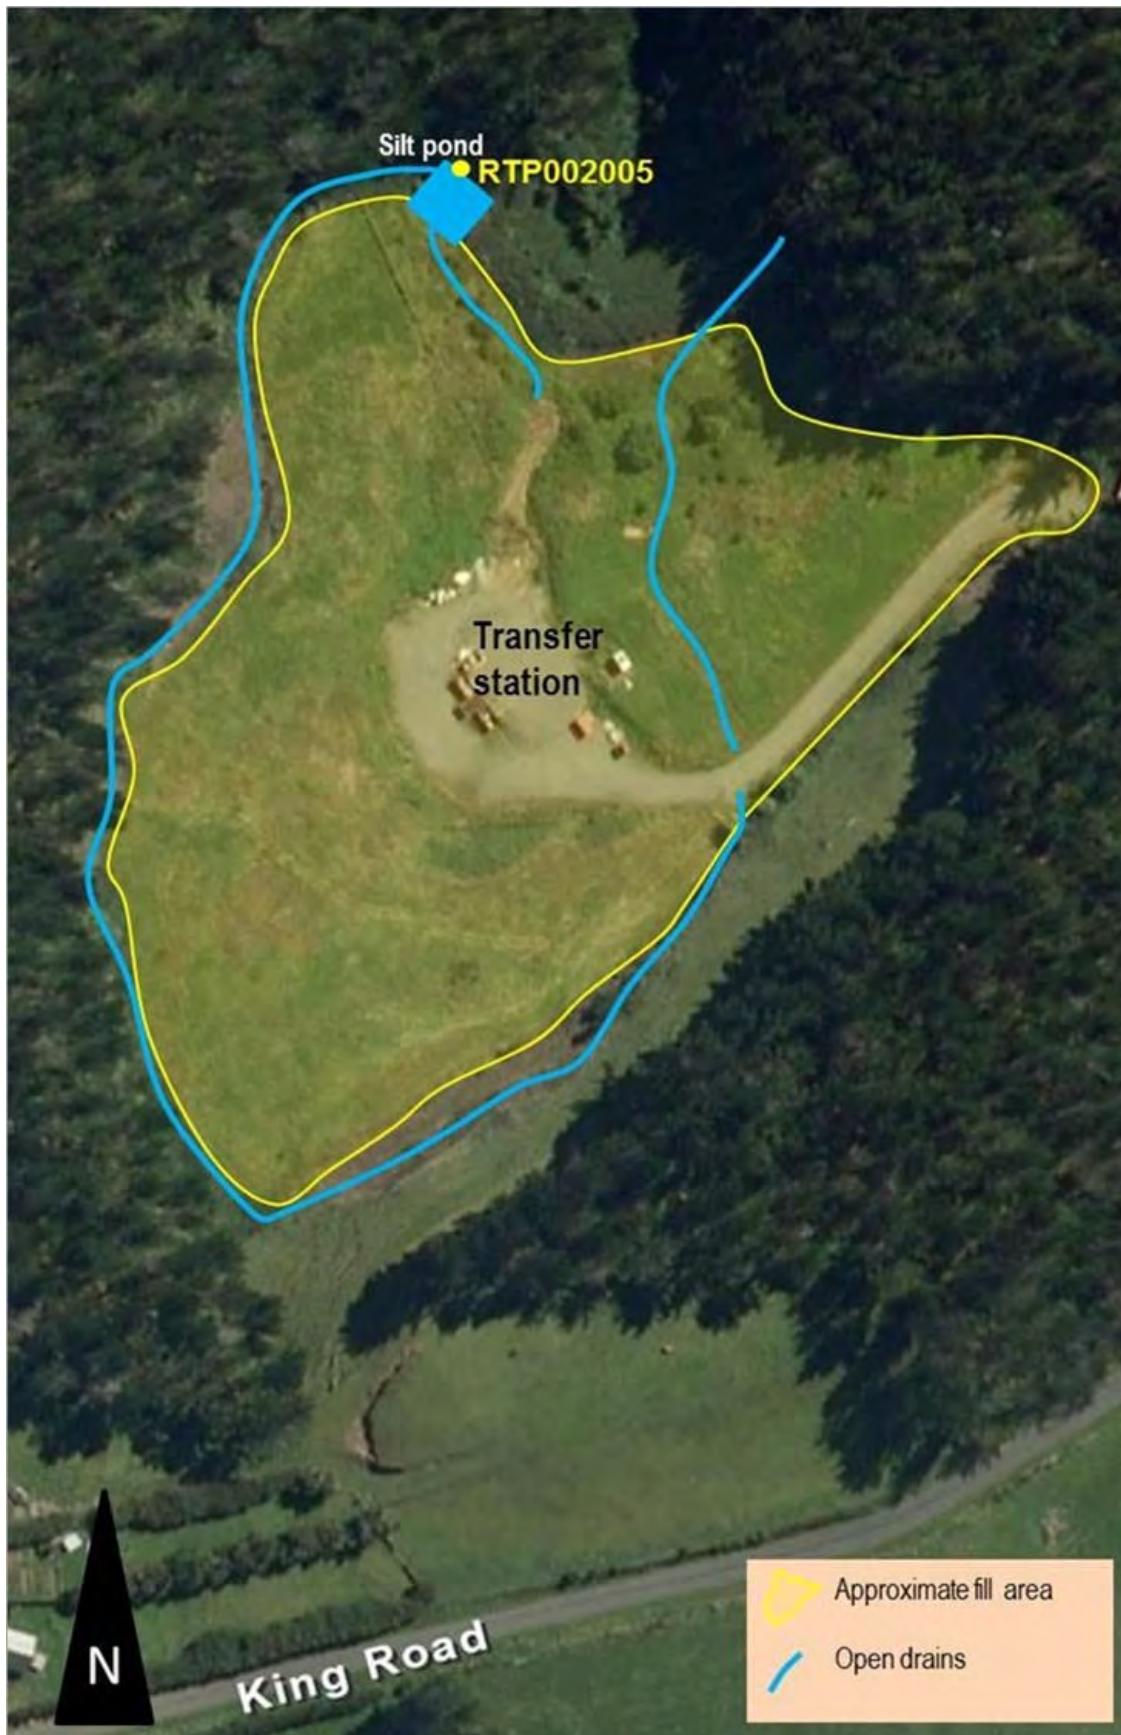
Figure 1 shows the approximate extent of the fill and the general layout of the Inglewood landfill site. The discharge and receiving water monitoring site locations are shown in Figure 2.

Figure 1 Site layout at Inglewood contingency landfill

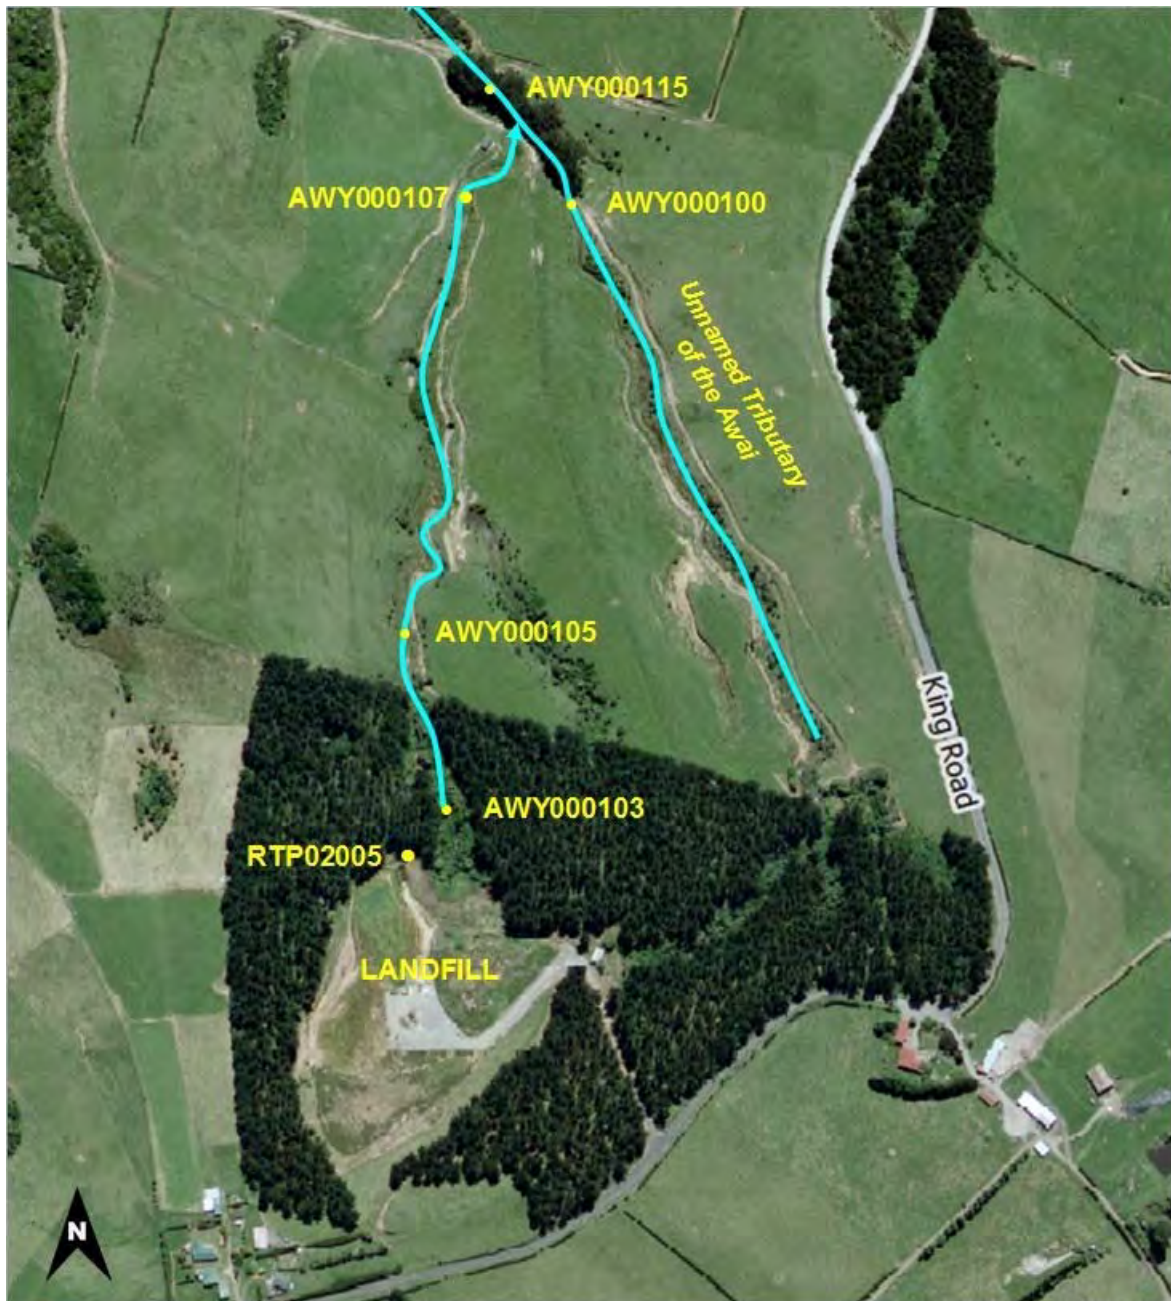
Figure 2 Inglewood landfill and receiving water sampling sites

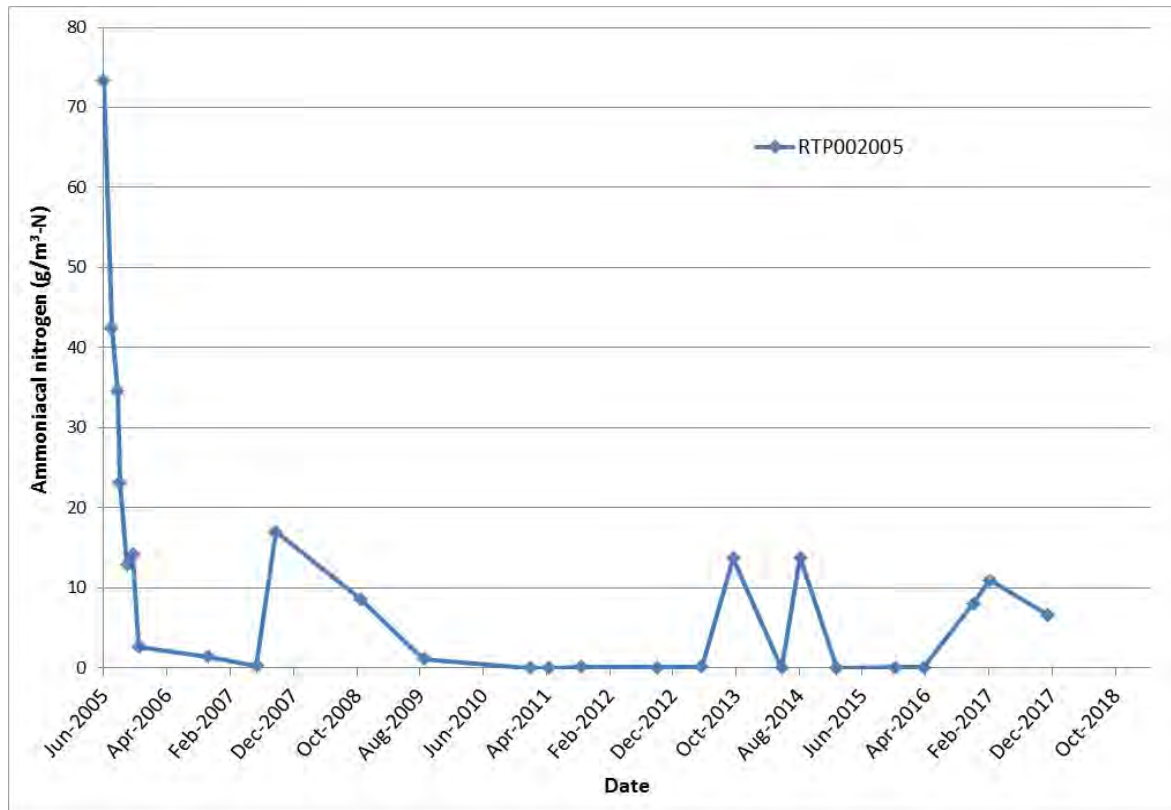
The higher values of ammoniacal nitrogen obtained may have been the result of one or more of a number of factors including: the surrounding area, recent grazing, and/or additional stormwater infiltration causing increased leachate generation. Increased leachate generation is considered to be an unlikely cause as the cap was remediated during the 2014-2015 year, and has been found to be intact and well vegetated since that time.

Figure 3 Ammoniacal nitrogen concentration of the Inglewood landfill stormwater/leachate (RTP002005) for monitoring to date

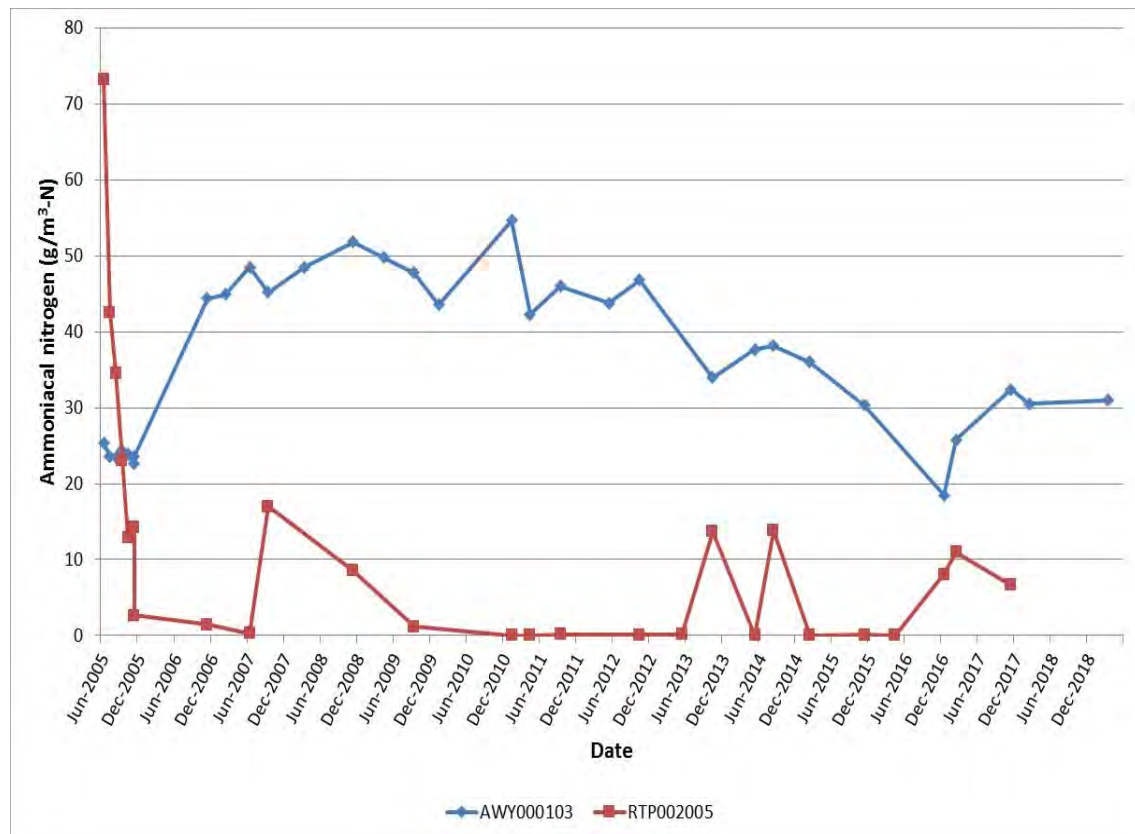
Figure 4 shows the ammoniacal nitrogen results for the stormwater/leachate pond (RTP002005) and the landfill tributary below the culvert outlet (AWY000103). During the year under review there was no discharge occurring at the time of either survey. Historically the concentration is much lower in the pond than in the tributary, and continues to indicate that ammoniacal nitrogen is entering the landfill tributary via another route, potentially via shallow groundwater.

Figure 4 Ammoniacal nitrogen concentration between the Inglewood landfill stormwater/leachate (RTP002005) and the tributary below the culvert outlet (AWY000103)

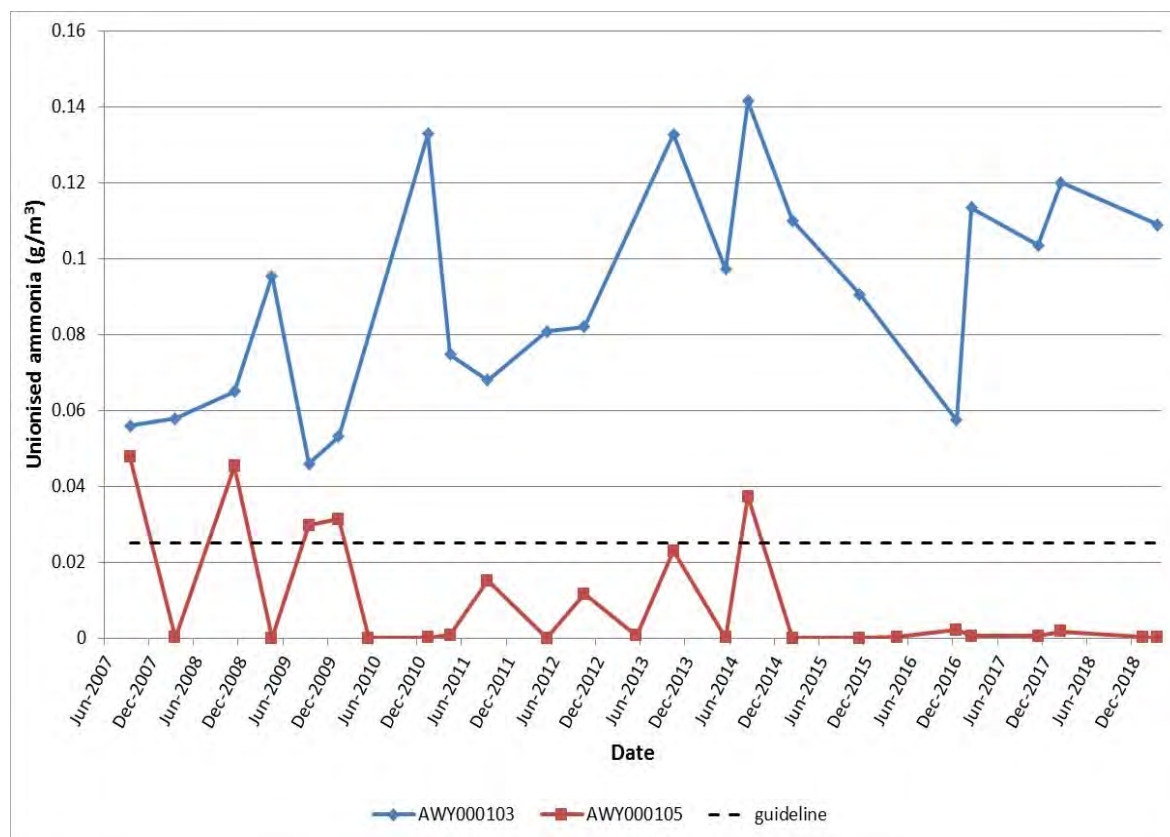
It is also noted that at the culvert outlet the unionised ammoniacal nitrogen concentration has been consistently above the 0.025 g/m³ guideline adopted by the Council to protect aquatic organisms from chronic effects. From a review of the historical results, it appears that there has been an emerging trend of increasing levels of this contaminant at this site. It is however noted that, for the most part, this is generally assimilated in the wetland area, and the concentrations found at the lower end of the landfill tributary (site AWY000105) are normally well below this guideline value (Figure 5).

The concentration range above which acute toxic effects may be seen for New Zealand native fish, for example a fish kill, is 0.75 to 2.35 g/m<sup>3</sup>, and the levels of unionised ammonia found at all monitoring sites during the year under review were well below this concentration range. Although the unionised ammonia concentration was found to be above the 0.025 g/m<sup>3</sup> guideline at the lower end of the tributary on occasion, this has not happened in recent years.

Figure 5 Unionised ammonia concentration in the landfill tributary below Inglewood landfill

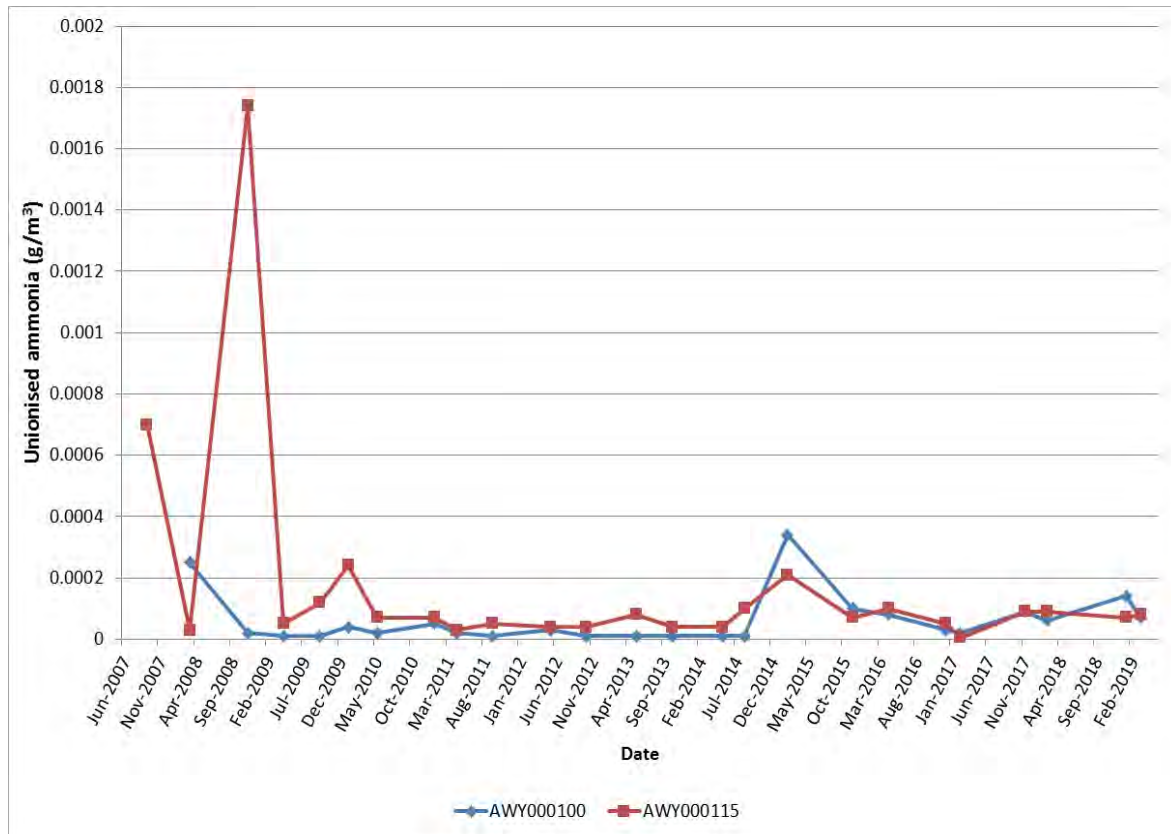
Figure 6 shows that there has generally been little, if any, effect found on the unionised ammonia concentration of the larger (main) tributary (site AWY000115). Any changes that have been found have not been of environmental significance.

Figure 6 Unionised ammonia concentration in the main tributary below Inglewood landfill

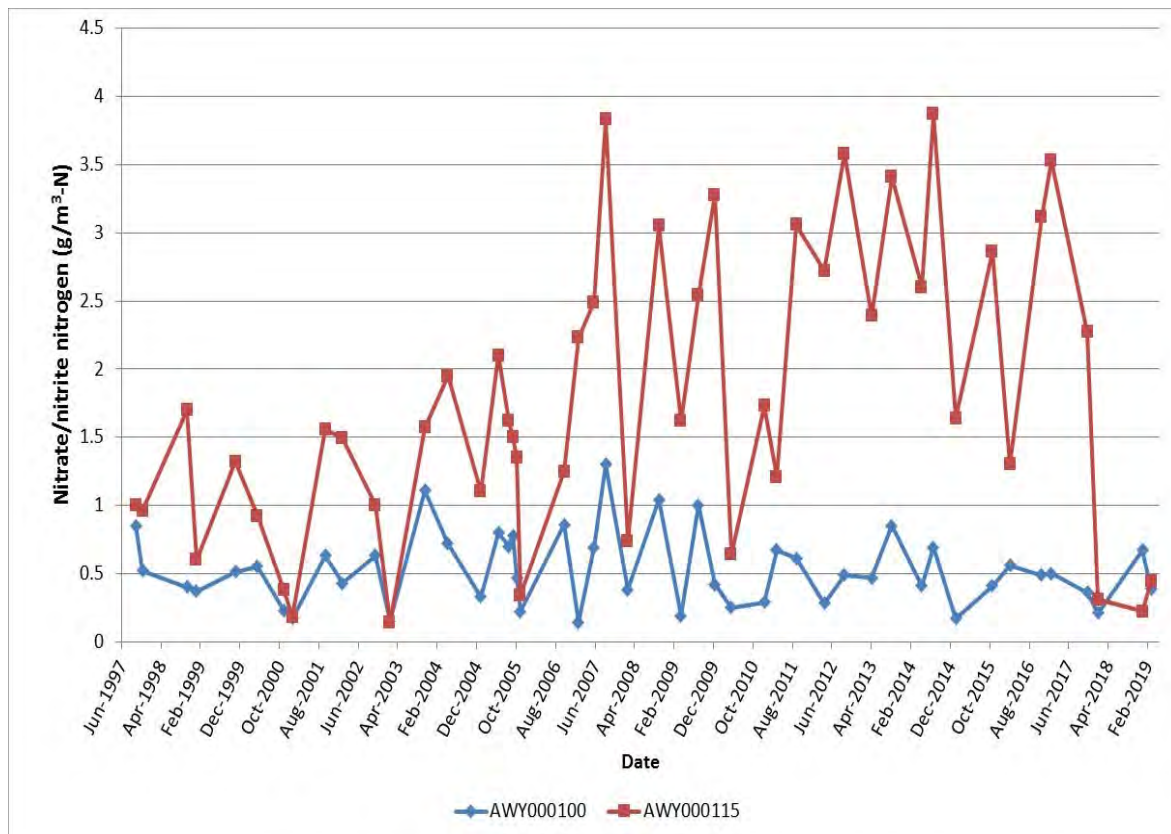
A review of the historical data also shows that the difference in the nitrate/nitrite nitrogen concentrations between sites AWY000100 and AWY000115 appears to be increasing. However, in the three most recent water quality surveys the difference between the upstream and downstream sites has been minimal (Figure 7).

Figure 7 Nitrate/nitrite nitrogen results in the main tributary upstream and downstream of the Inglewood landfill tributary discharge

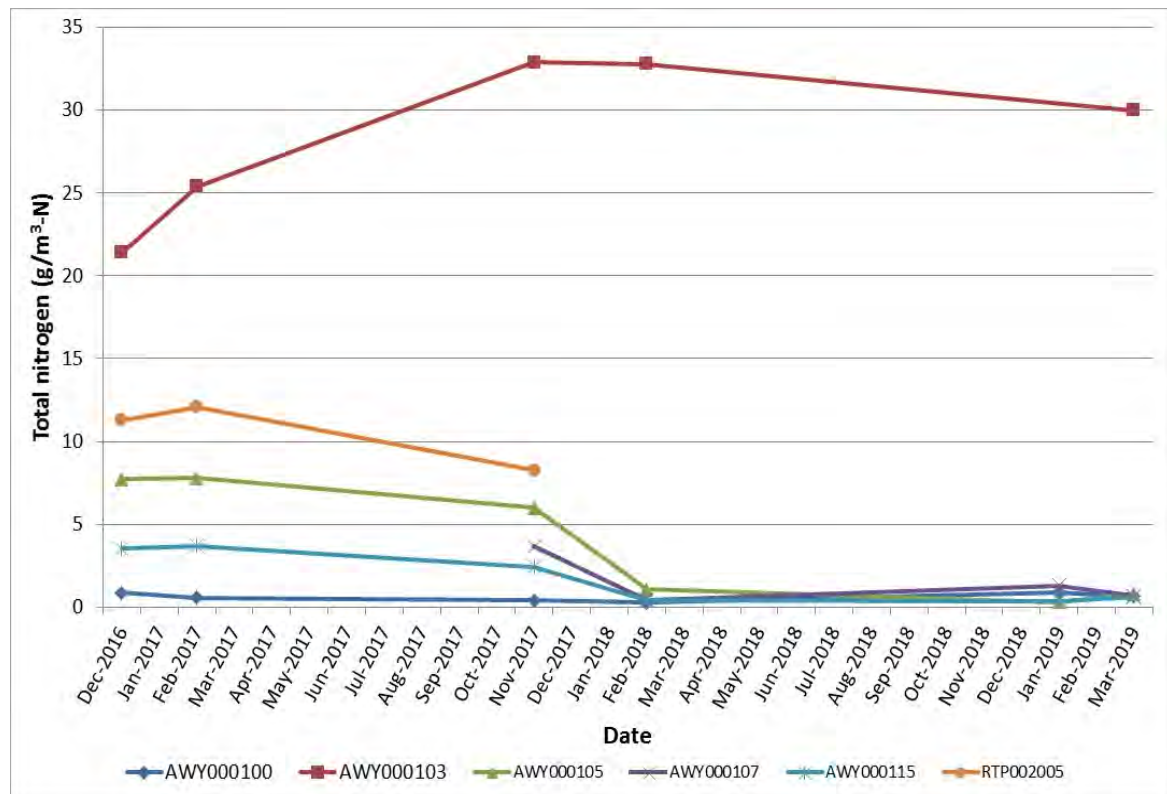
Due to the changes observed in recent years in the ammoniacal nitrogen and nitrate/nitrite concentrations at the various sites, total nitrogen has recently been included in the suite of analyses performed. The results obtained since this analysis was initiated in the 2016-2017 year are depicted in Figure 8, and show that:

- the nitrogen contained in the leachate/stormwater pond is significantly lower than at site AWY000103;
- the wetland below the culvert is effective at decreasing the total nitrogen loading in the landfill tributary, and that this continues to decrease prior to the confluence with the main tributary; and
- that since the February 2018 survey, total nitrogen concentration at all sites other than AWY000103 has remained low and similar to the upstream site.

Figure 8 Total nitrogen concentration in the surface waters below the landfill

The nitrate/nitrite nitrogen concentration is below the National Objectives Framework (NOF) bottom line of 9.8 g/ m<sup>3</sup> (annual 95 percentile) at all sites. At the end of the 2014-2015 year, it was noted that the ammoniacal nitrogen and unionised ammonia concentrations in the landfill tributary at the culvert appeared to be increasing and the difference in the nitrate/nitrogen concentrations between the upstream and downstream sites in the main tributary also appeared to be increasing. It was thought possible that the condition of the cap as found in the 2014-2015 year, with its increased permeability, may have contributed to the increasing trends seen in the nitrogen containing species in recent years. Although the long term trend now appears to be decreasing and this may have resolved with the remediation work undertaken on the cap during the 2014-2015 year, the limited total nitrogen data available (five surveys) still potentially indicated increasing concentrations of nitrogen containing species at the culvert outlet (Figure 8).

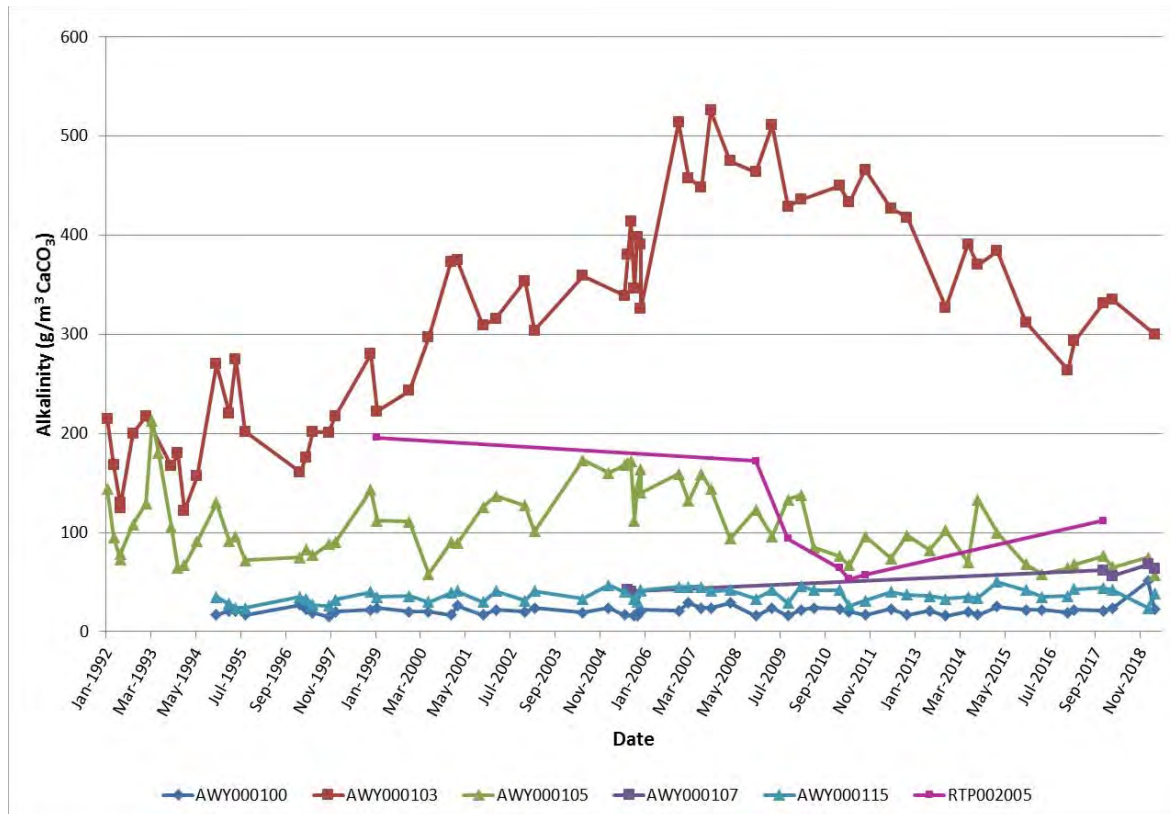
When viewing the long term data, alkalinity, ammoniacal nitrogen and nitrate/nitrite nitrogen concentrations in the discharge from the culvert (AWY000103) all appear to be declining from the peak that was reached following the use of this site for the three months of contingency filling in 2005 and closure of the site to general waste on 1 September 2006 (Figure 9, Figure 10 and Figure 11).

Figure 9 Alkalinity in the surface waters below the Inglewood landfill (1992 to date)

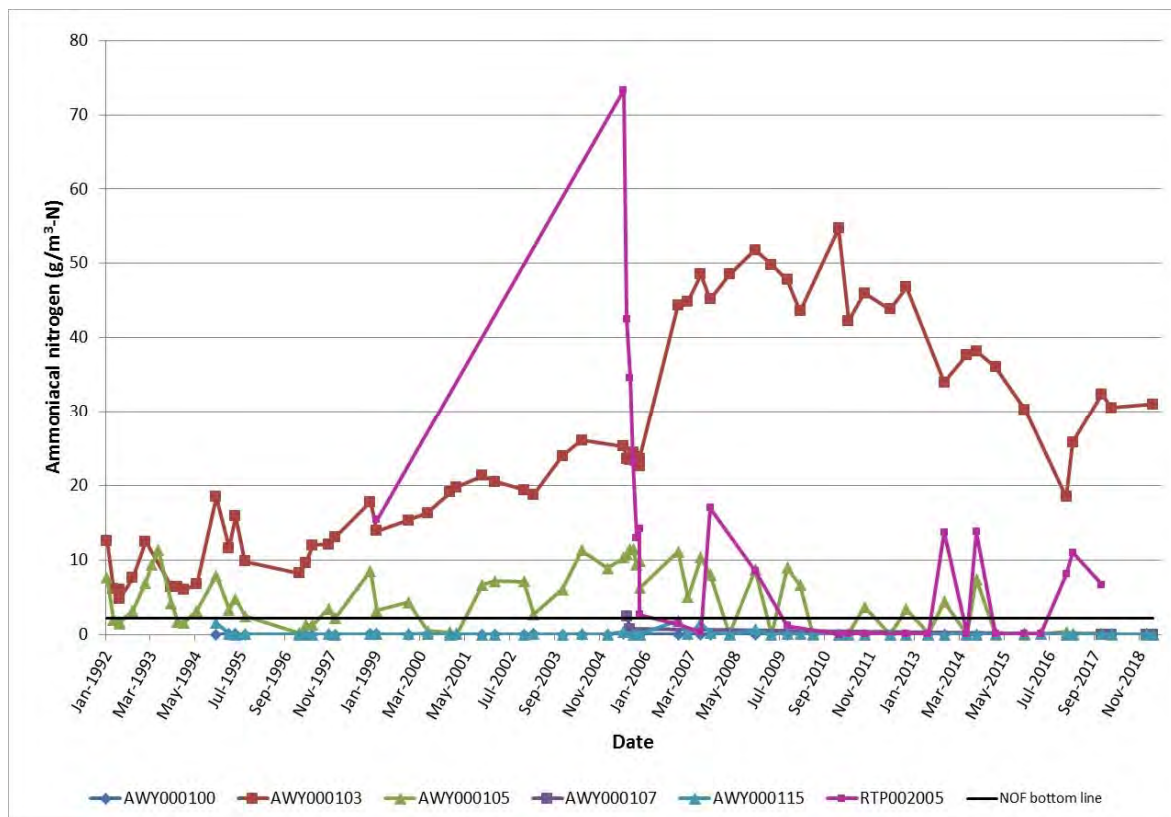
Figure 10 Ammoniacal nitrogen in the surface waters below the Inglewood landfill (1992 to date)

Although the ammoniacal nitrogen concentration is consistently above the National Objectives Framework (NOF) bottom line of 2.2 g/ m<sup>3</sup> (annual 95 percentile)<sup>2</sup> at the culvert outlet (AWY000103), the concentration at the wetland is decreasing, and the concentrations found in the main tributary are well below this level.

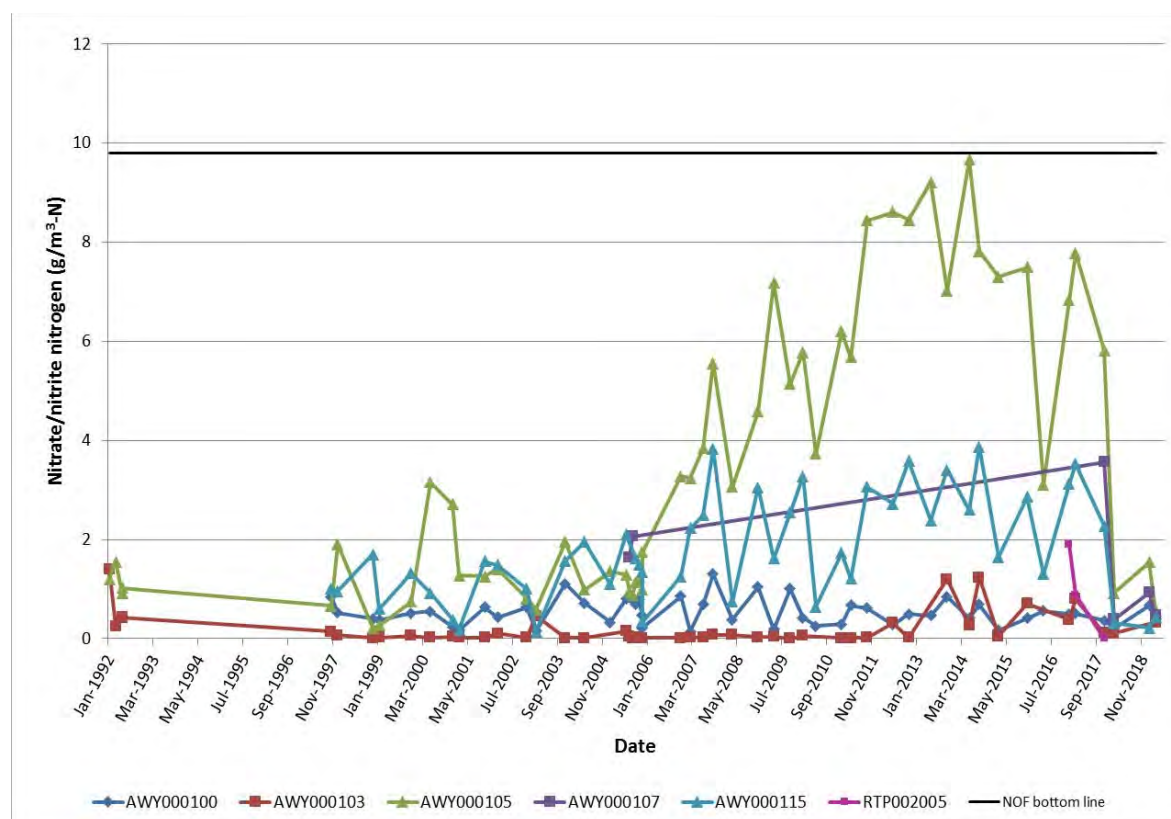
Figure 11 Nitrate/nitrite nitrogen in the surface waters below the Inglewood landfill (1992 to date)

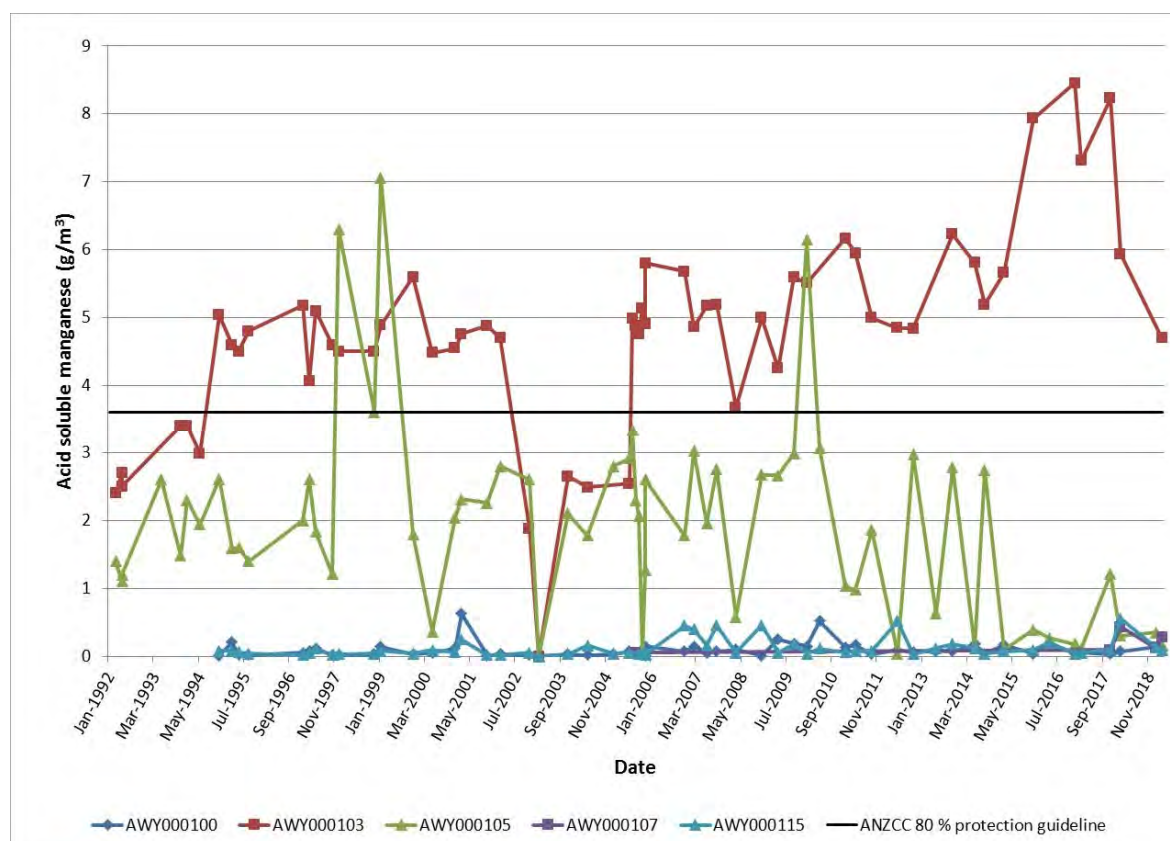
Historical data is also indicating a trend of increasing acid soluble manganese in the discharges from the site (Figure 12). However currently, with a few exceptions at site AWY000105, the tributaries beyond the wetland treatment system are below the ANZECC guideline for the protection of 80 % of species (3.6 g/m<sup>3</sup>), with the landfill tributary well below the guideline for the protection of 99 % of species (1.2 g/m<sup>3</sup>).

Figure 12 Acid soluble manganese in the surface waters below the Inglewood landfill (1992 to date)

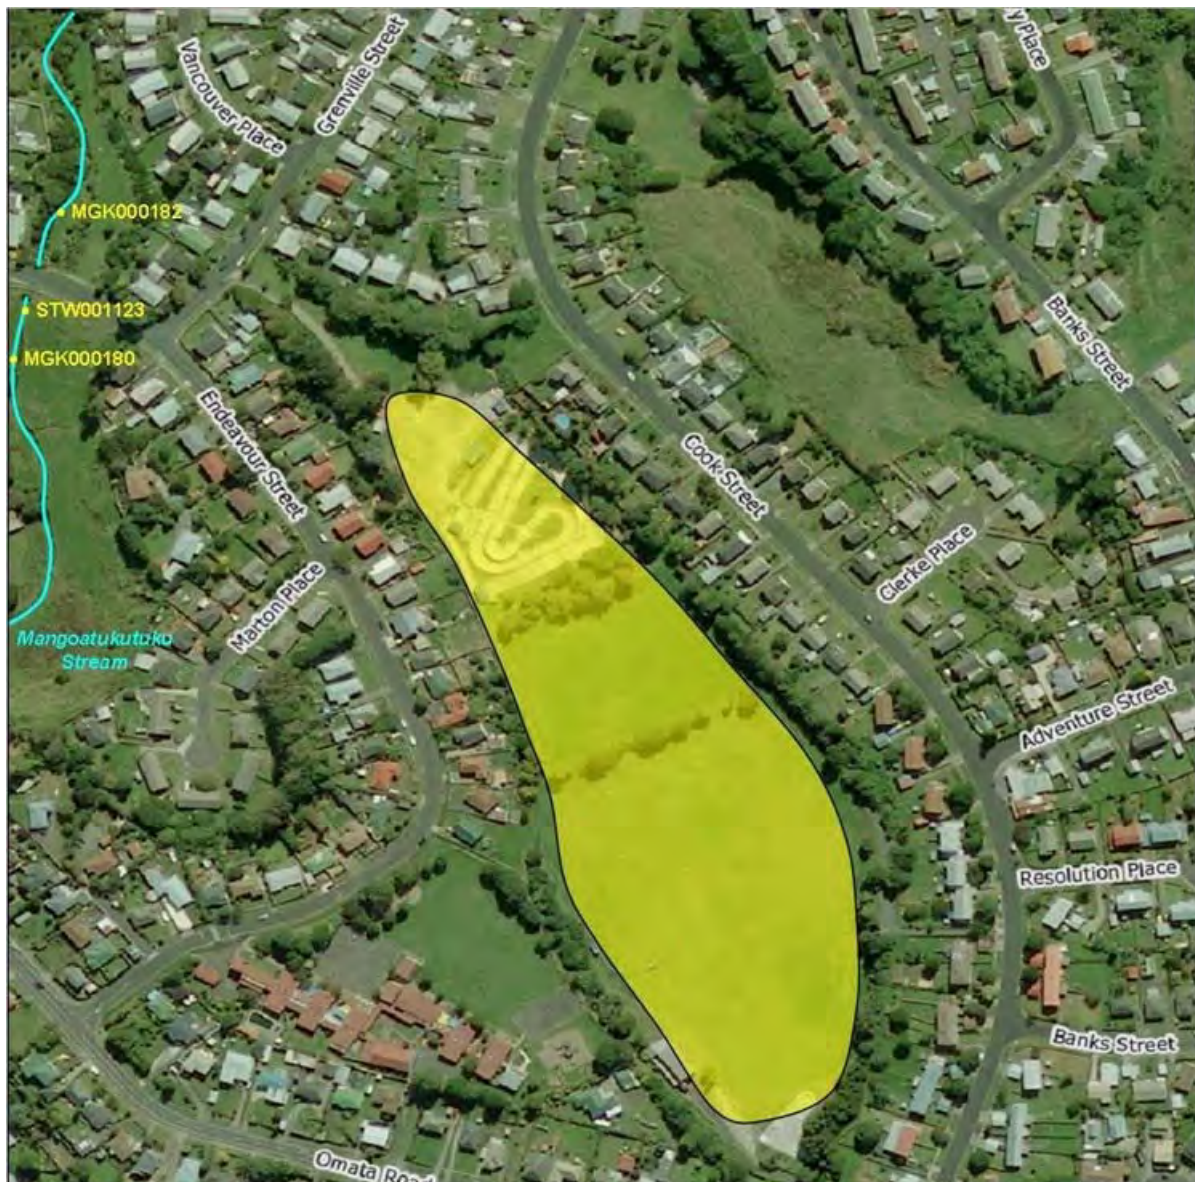
The discharge from the site now is predominantly stormwater. Presently the site is a park with sports field and playground. The BMX track previously located on the site was removed during the monitoring year.

Figure 13 An aerial view showing the former landfill at Marfell Park and associated sampling sites

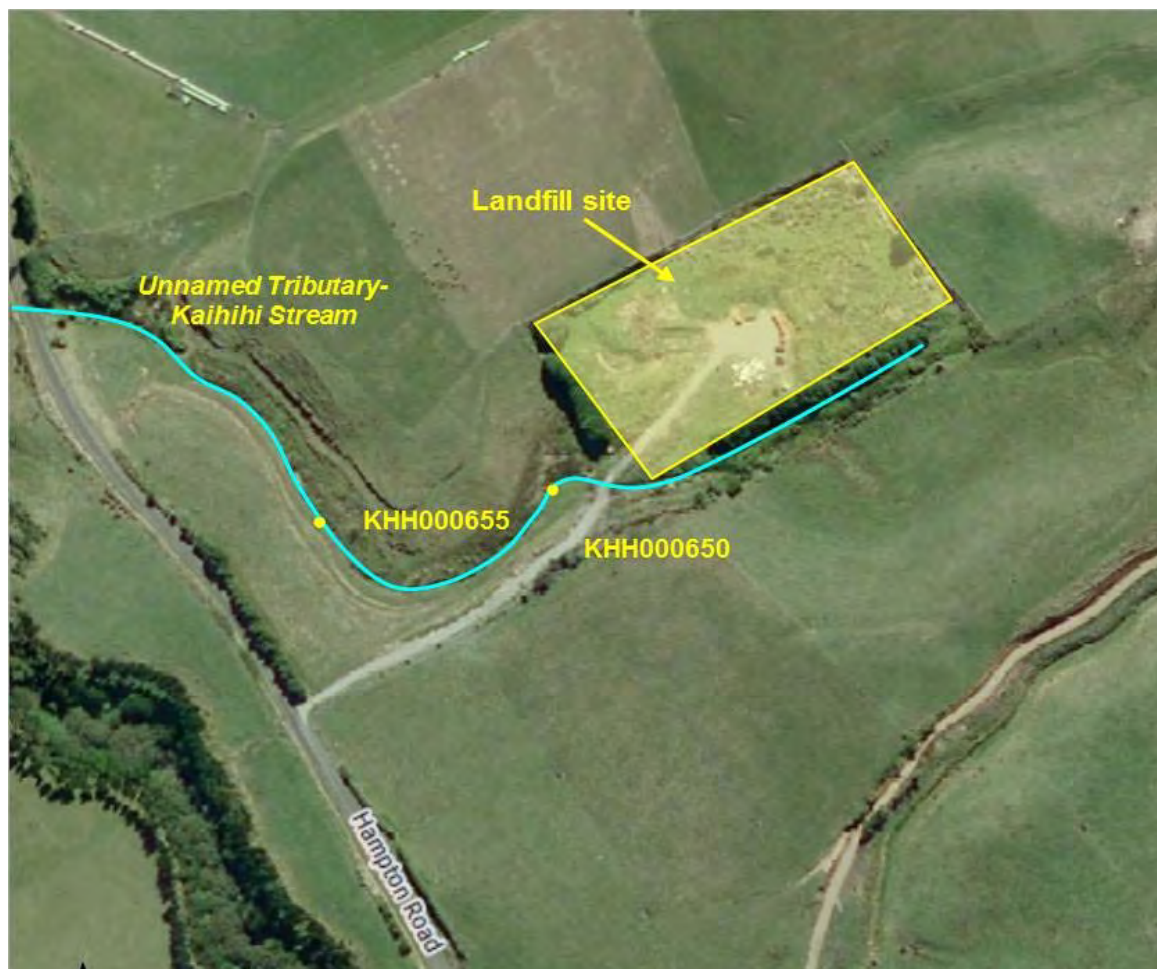
Figure 14 Okato landfill and sampling sites
