Value Timber Ltd
Monitoring Programme
Annual Report
2018-2019

Technical Report 2019-76

Taranaki Regional Council
Private Bag 713
STRATFORD
February 2020

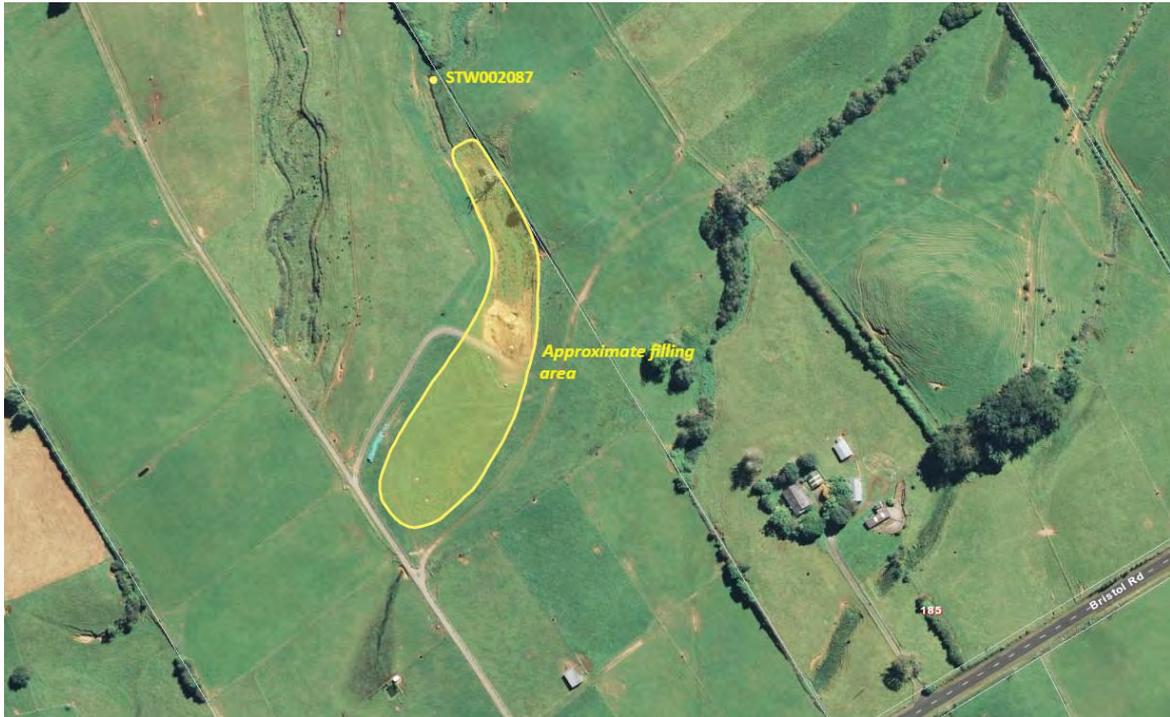
Figure 1 Aerial image of the Bristol Road site and sampling site

The samples were taken from site STW002087, which is in the receiving drain downstream of the fill area, just upstream of the property's boundary fence (Figure 1).

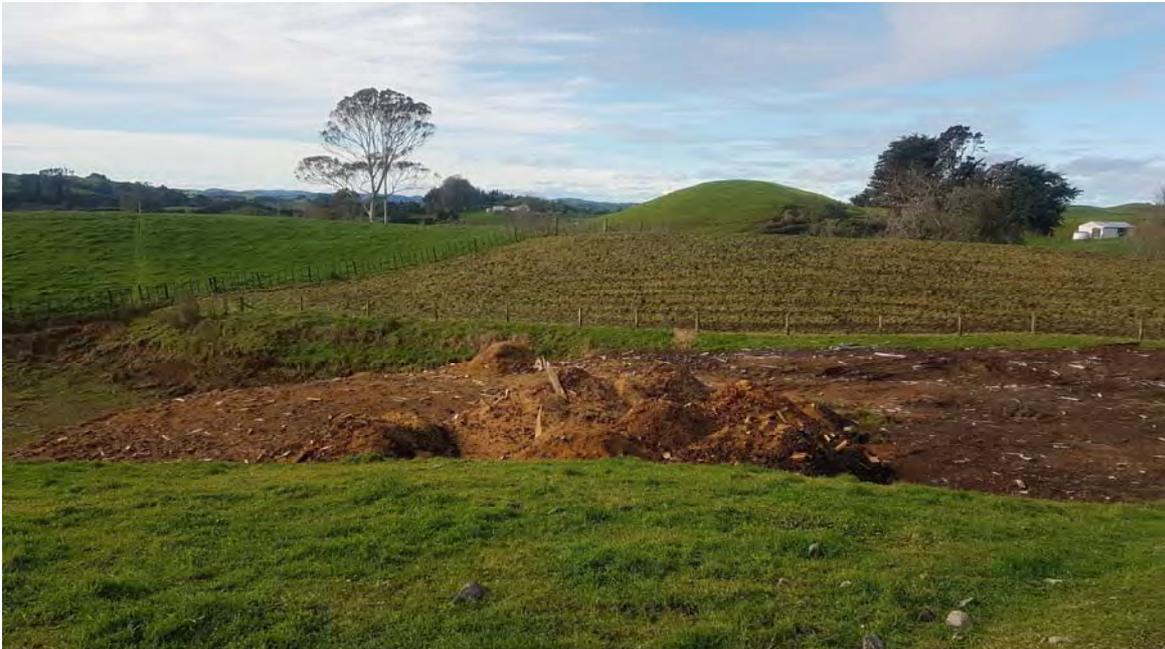
Photo 1 Value Timber Ltd wood waste cap, June 2018
