Waverley Sawmills Ltd
Monitoring Programme
Annual Report
2018-2019

Technical Report 2019-91

Taranaki Regional Council
Private Bag 713
STRATFORD
March 2020

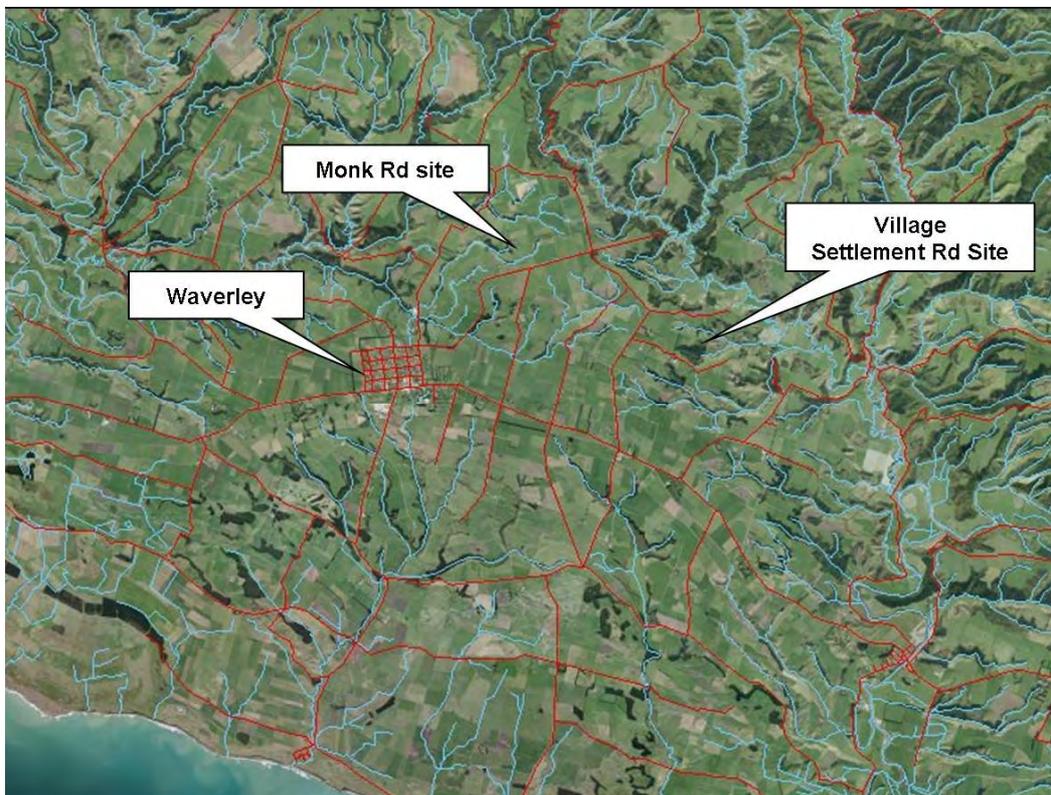
Figure 1 Waverley Sawmills Ltd discharge sites

The site at Monk Road is a gully in the upper reaches of a catchment that is predominately comprised of dairy farm land. Immediately above the discharge area is a small farm dam. The Company installed a culvert at the site that piped the tributary from this dam around and downstream of the discharge area, effectively bypassing the discharge area. The aim of this work was to reduce the quantity of water entering the discharge area and coming into contact with the wood waste discharged therein.

The discharge site on Village Settlement Road was chosen because it is elevated and therefore dry. The site is small in size compared to the Monk Road site and while it is situated close to an unnamed tributary at the north west end of the site, the surface gradient and contours ensure that surface water from the site flows in a south easterly direction, away from the water body. The Company ceased producing treated wood waste by ensuring that all machining was done prior to treatment and as a result, the Company's Village Settlement Road site was closed in June 2014. Site remediation work was undertaken in the 2013-2014 year to ensure that the consent soil component concentrations for the cap and surface soils down gradient of the fill area were met. This was discussed in the 2013-2014 Annual Report.

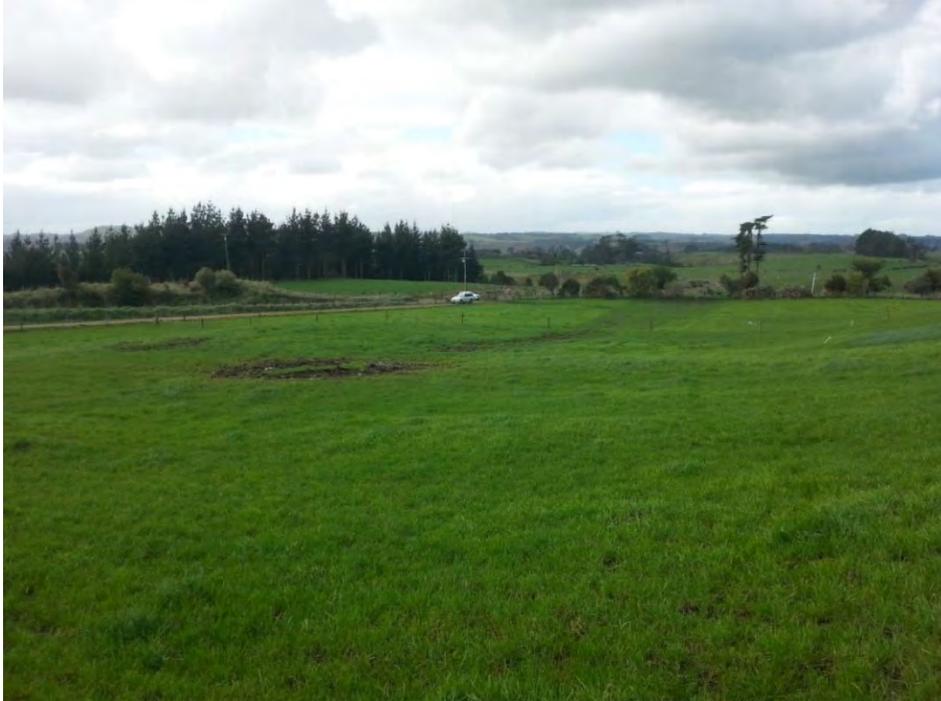
Photo 1 Waverley Sawmills Ltd discharge site at Village Settlement Road, Waverley – post closure

The cap was found to be in a satisfactory condition, with healthy vegetative cover across the site and no evidence of slumping observed.

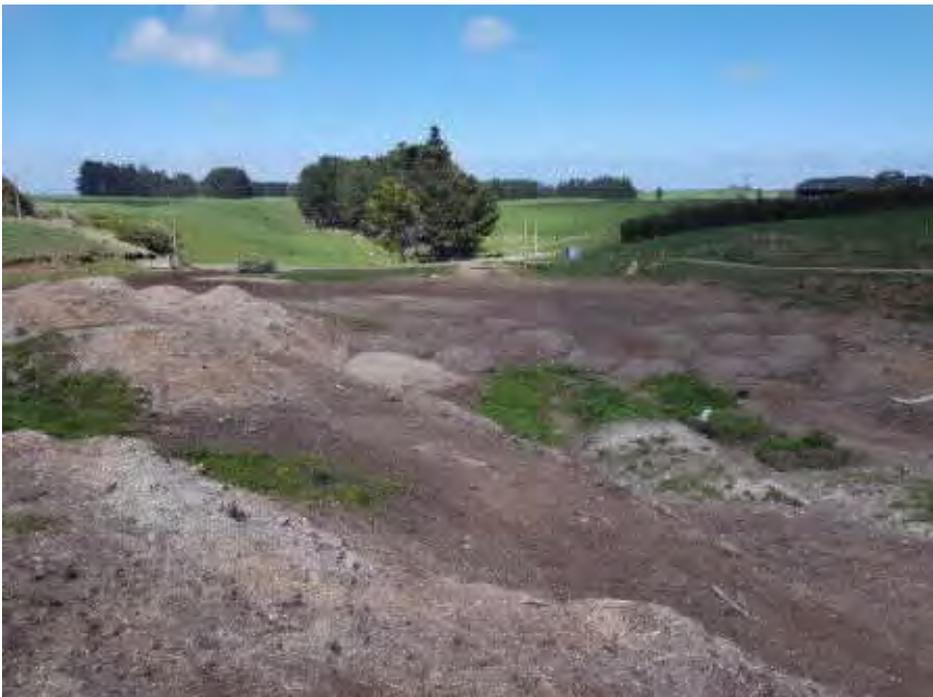
Photo 2 Waverley Sawmills Ltd discharge site at Monk Road, Waverley, September 2018

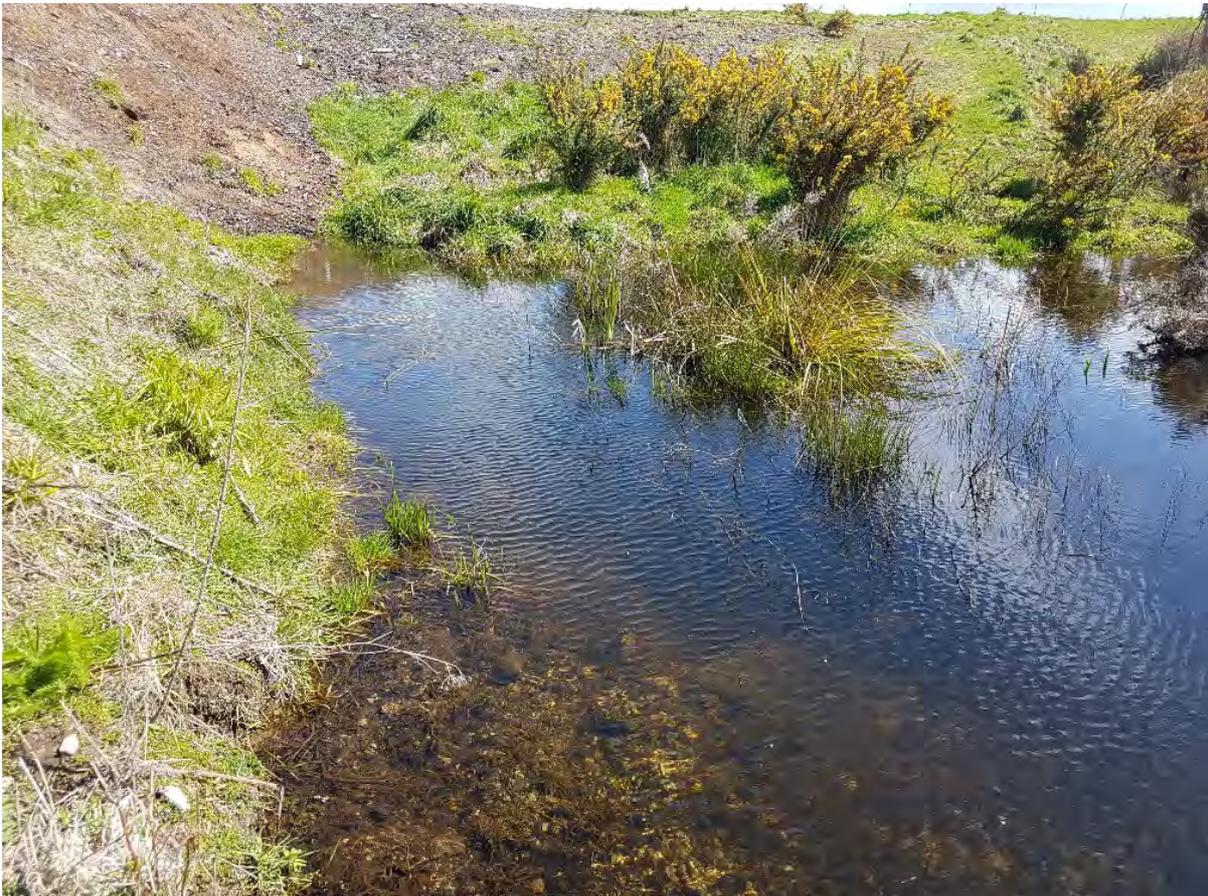
Photo 3 Pounded water upstream of the site in contact with the sawdust fill material, 26 September 2018

The Company was contacted immediately after the inspection with regards to the high pond level at monitoring site upstream of the fill. The Company was advised that there may be an obstruction somewhere in the pipe and that this should be checked. The Company followed up on the Council's advice to check the pond level and investigation of a possible obstruction in the pond discharge system. The inspecting officer was informed that the level had receded. As it appeared that the sawdust disposal site was no longer being used, the Company was informed that the Council would follow up to discuss decommissioning plans and time frames for remedial works as required. The consent non-compliances were logged on the Council's incidents register and a letter of explanation was requested. This is discussed further in Section 2.3.

- There was an obstruction causing an increase in the level of the pond upstream of the fill area resulting in the ponded tributary coming in contact with previously discharged wood waste and the potential for increased leachate generation. This was non-complaint with condition 1 of consent 6412-1.
- Cattle had winter access to partially vegetated areas of the fill that did not have a final cap. Extensive pugging was found that would result in localised ponding and stormwater infiltration, increasing leachate generation. This was non-complaint with conditions 6 and 7 of consent 6413-2.1 and condition 1 of consent 7342-2.1.

- Approximately one week after the impoundment was reported a staff member attempted to unblock the outflow from the pond above the fill area. The water level was still too high to see the grate and a rake was pulled over the outlet structure in an attempt to clear the any trapped weeds/debris that may have been obstructing the outlet grate. The site was re-visited and it was found that the pond level had dropped, however the outlet structure was still partially obstructed. The grate was cleared and the culvert outflow was checked at Monk Road. The estimated flow rate was 20 L/s showing that the pipe carrying the tributary under the fill are was now cleared. A further inspection was undertaken by the Company two weeks later and it was confirmed that the water level above pond outlet structure was at normal levels. Photos were provided to show the work undertaken.

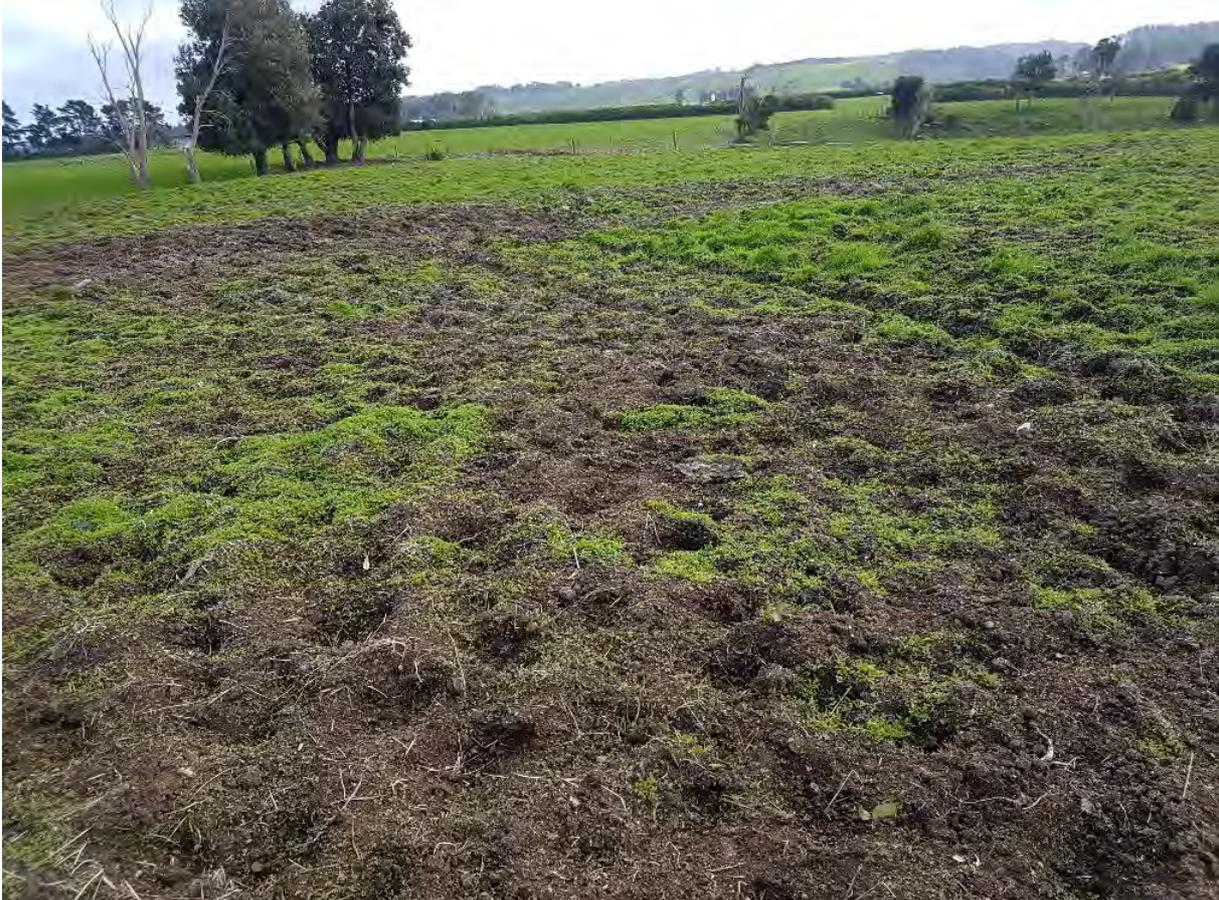
It was found that there were no recent disposals of sawdust at the site and therefore no sawdust samples were collected on this occasion. It was observed that no further remediation work had been carried out on the sawdust cap. It appeared that cattle have had access to the site over the winter period and have caused extensive pugging (Photo 4). This was non-compliant with conditions 6 and 7 of Company's discharge of sawdust to land consent (6413-2.1).

Photo 4 Pugging on filled area that does not have an acceptable final cap, 26 September 2018

- Investigation found that the instructions that the area should not be grazed had not been passed on to the land owner's farming operations staff. This instruction was relayed and all fencing was removed from the perimeter of the cap to ensure that there was no future grazing until the capping had been completed. A revised management plan was provided to Council detailing the capping methodology and a timeframe for the works to be undertaken. It was also explained that a mitigating circumstance for the capping not having been completed at that stage was that the Company had been suffering significant financial difficulties for a 10 year period, restricting the ability of the Company to expend funds. It was acknowledged that this in itself did not absolve the Company from the responsibility of managing consent compliance. It was intended that the works would be undertaken over the Christmas period, but was waiting on approval of the methodology from Council. However, the plan was not received until 17 December resulting in feedback on the plan not being provided until early January.

At the second inspection it was found that the fill area had not been capped as per the management plan and an abatement notice was issued requiring that works be undertaken to comply with the conditions of the consent by 28 June 2019. Due to the issues in finding a consultant to help refine the capping plan an extension to this date was requested. Council is continuing to work with the Company to ensure that the site is adequately capped and the abatement notice is complied with prior to the Company being liquidated.

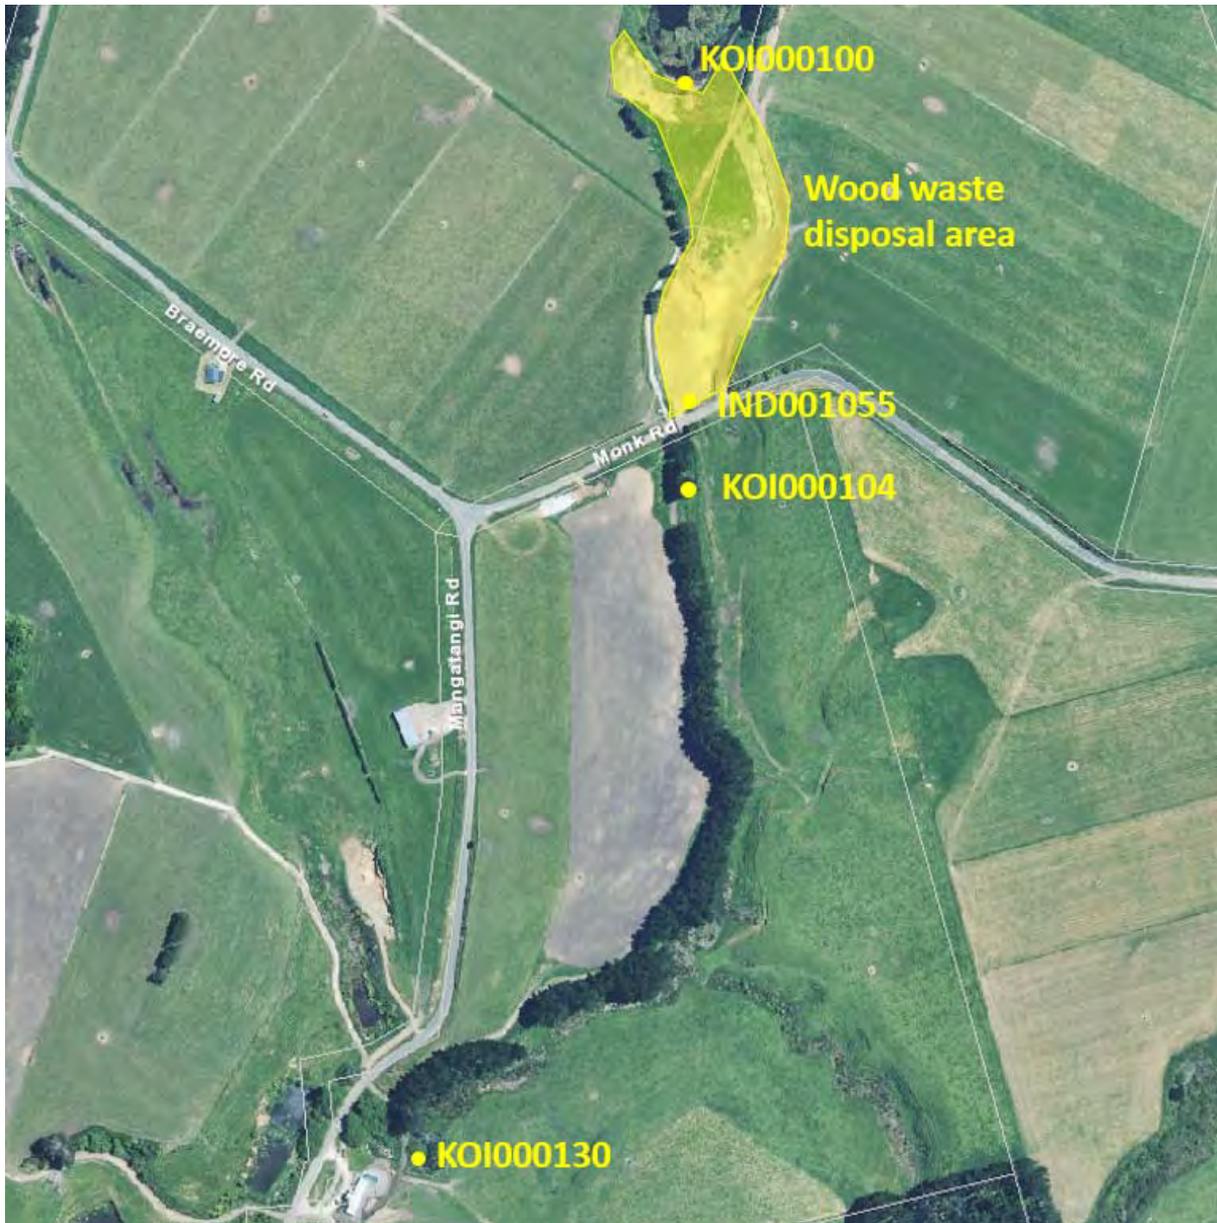
IND001055 was previously located in an open drain below the fill site, which is fed by a spring that originates (and is partially culverted) under the fill. At the inspection on 20 September 2017, it was found that the remainder of the drain had been piped, with a manhole installed downstream of the remaining area to be filled. Two samples of the discharge were collected during the monitoring period, one of which was obtained from the pipe outlet within the manhole, and one of which was obtained from the Monk Road culvert outlet. The results of this sampling are presented in Table 3.

Figure 2 Monk Road sampling sites, Waverley

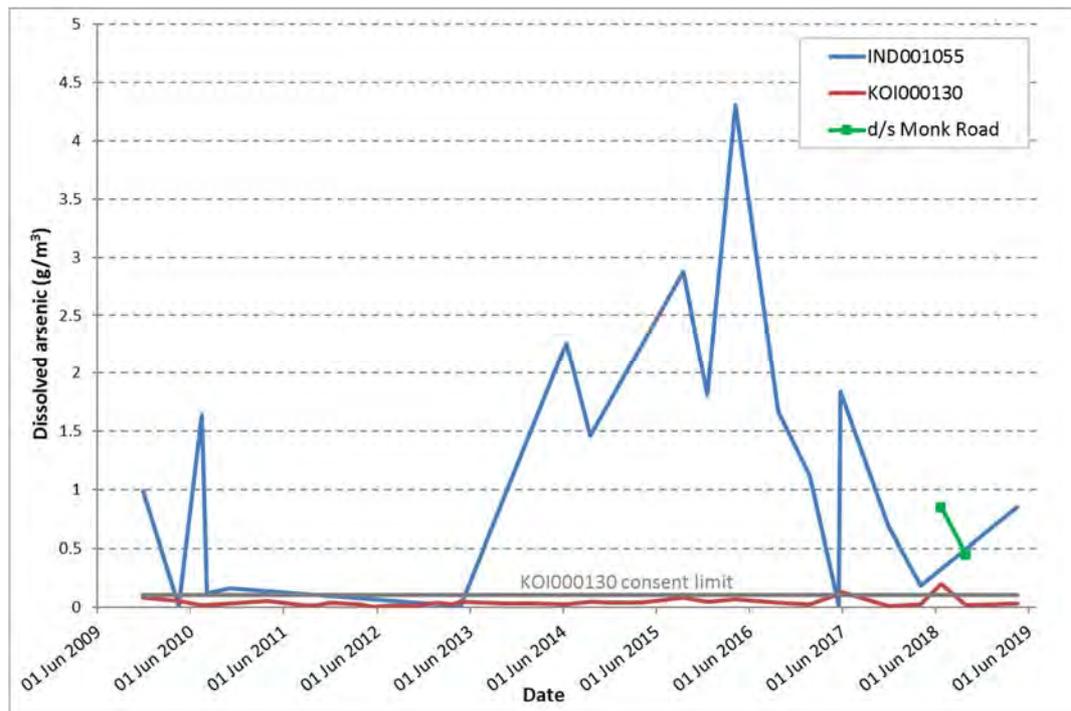
During the period under review it was found that the spring water at the source (site IND001055) continued to show higher than usual levels of dissolved arsenic and BODCF when compared to 2008 to 2013 (Figure 3 and Figure 4). However, in contrast to the 2017-2018 year, there were no resultant exceedances of the receiving water consent limits.

Figure 3 Graph showing trends in dissolved arsenic at site IND001055 and KOI000130

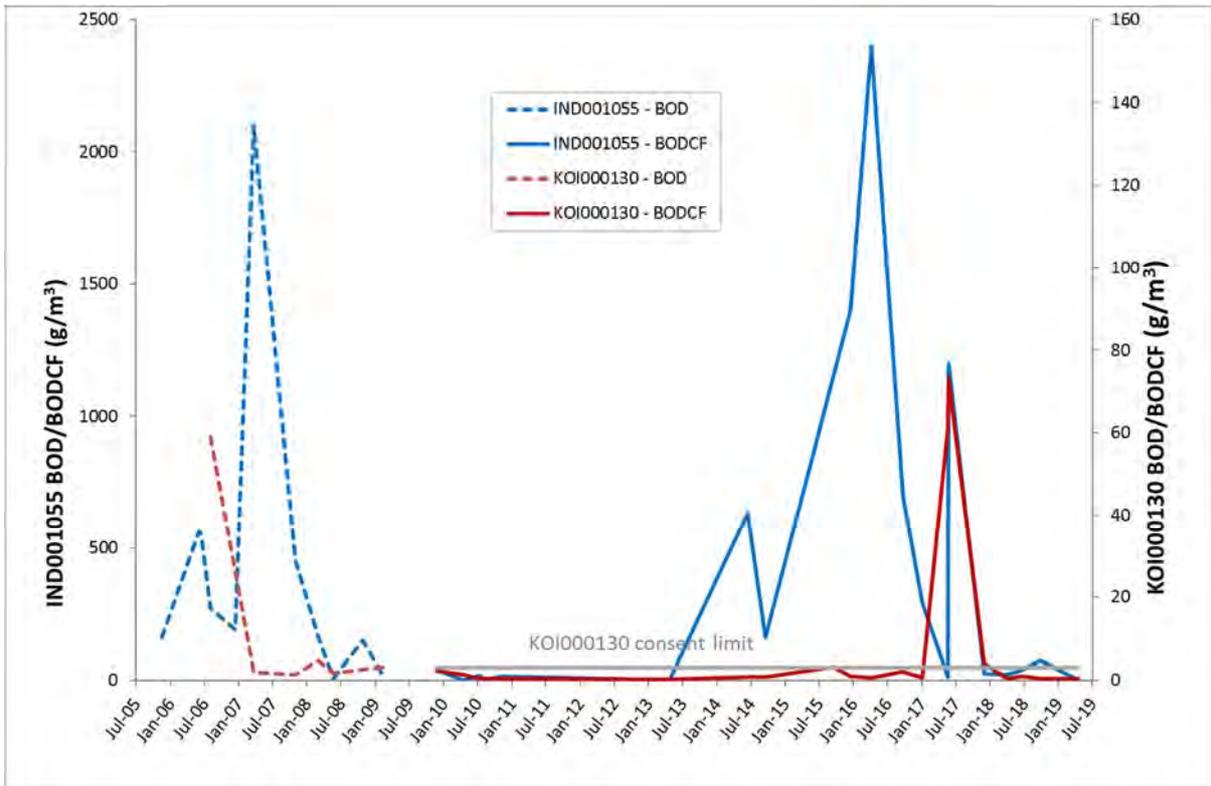
Figure 4 Graph showing trends in BOD at site IND001055 and KOI000130

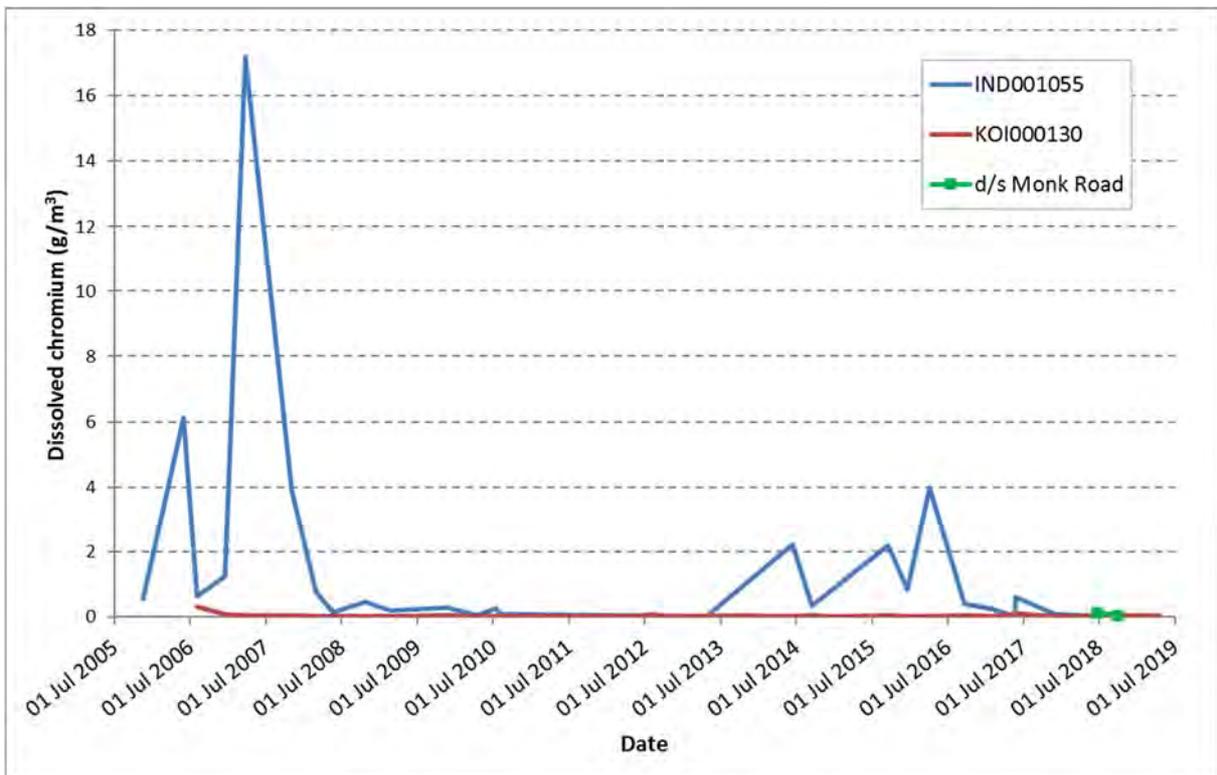
As with the 2017-2018 year, the chromium and copper concentrations in both the contaminated spring water and the receiving water at the compliance point continued to at a lower level, comparable with the results obtained for the 2008-2013 years (Figure 5 and Figure 6).

Figure 5 Graph showing trends in dissolved chromium at site IND001055 and KOI000130

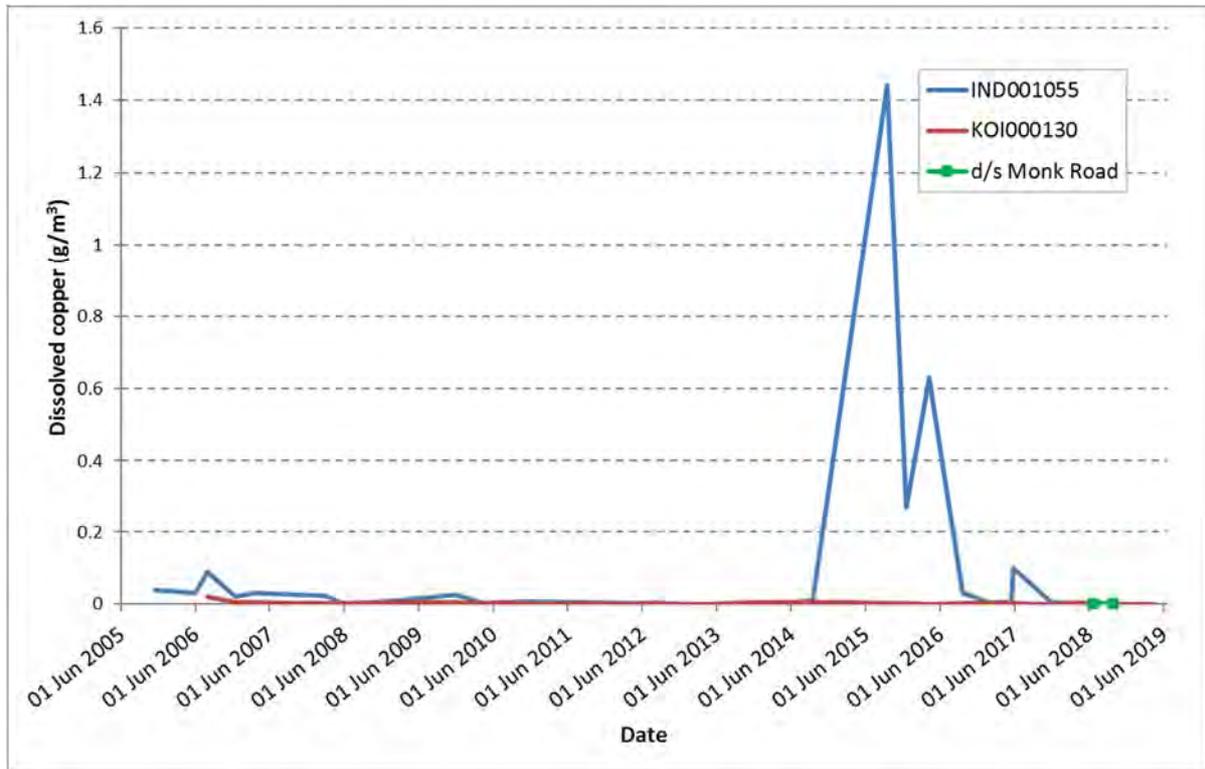
Figure 6 Graph showing trends in dissolved copper at site IND001055 and KOI000130

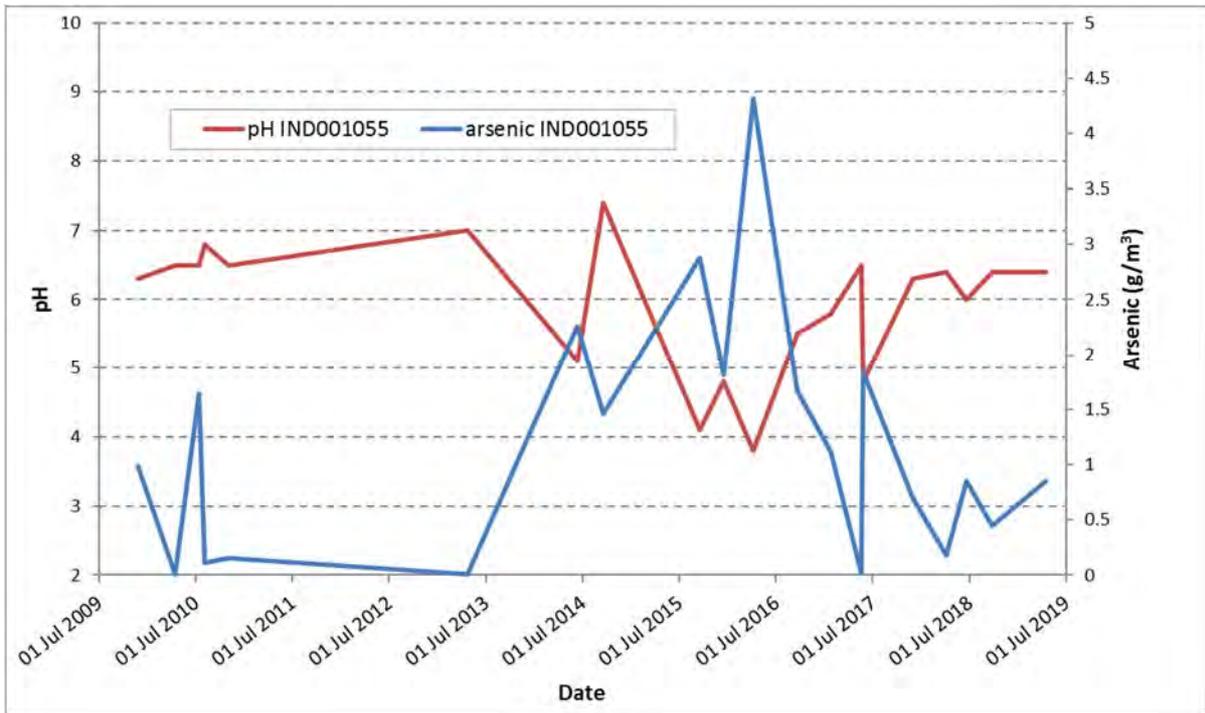
The pH of the discharge from the wood waste disposal area had decreased significantly, resulting in the discharge/spring water sampled at IND001055 becoming more acidic (Figure 7). The combination of the increased acidity and the elevated temperature at this site (Figure 8), is likely to be the cause of the mobilisation of metals from treated timber wood waste that was thought to have been disposed of at the site under previous management. This was prior to consent being sought by the current consent holder. The apparent pH dependence is shown in Figure 7 and Figure 9, with the arsenic concentration reducing as the pH moves towards more typical levels. It is noted that the effect observed at the downstream site will also depend on the relative flow rates of the tributary and the leachate/spring water at the time that the grab samples were collected. It is also noted that the flow rate of the tributary through the pipe under the fill area was likely to have been reduced at the time of the September survey due to an obstructed pipe inlet structure in the upstream pond (Section 2.3).

Figure 7 Graph showing pH and arsenic of the discharge at site IND001055

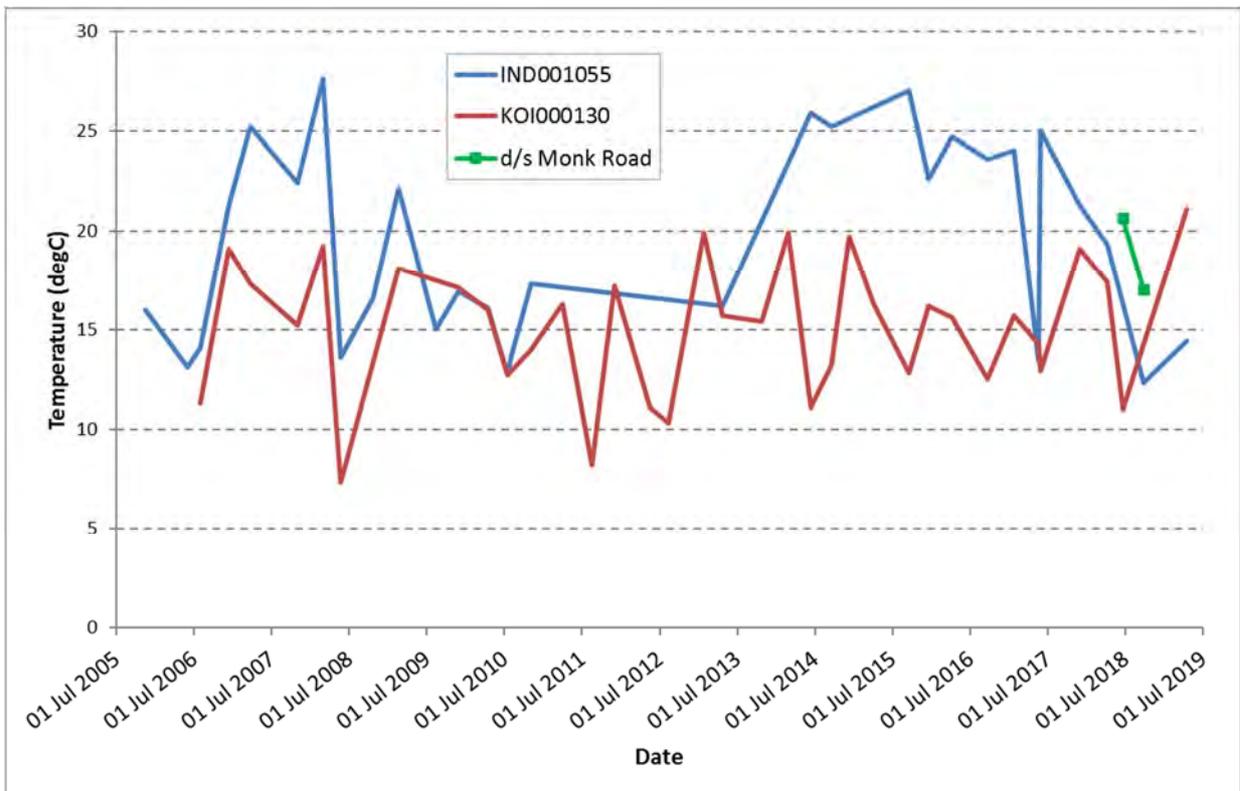
Concurrent changes were noted in the temperature and the pH of the contaminated spring water, which are both physicochemical changes that are likely to affect the BODCF and the solubility of the metals present in the previously discharged treated timber wastes.

Figure 8 Graph showing the temperatures at site IND001055 and KOI000130

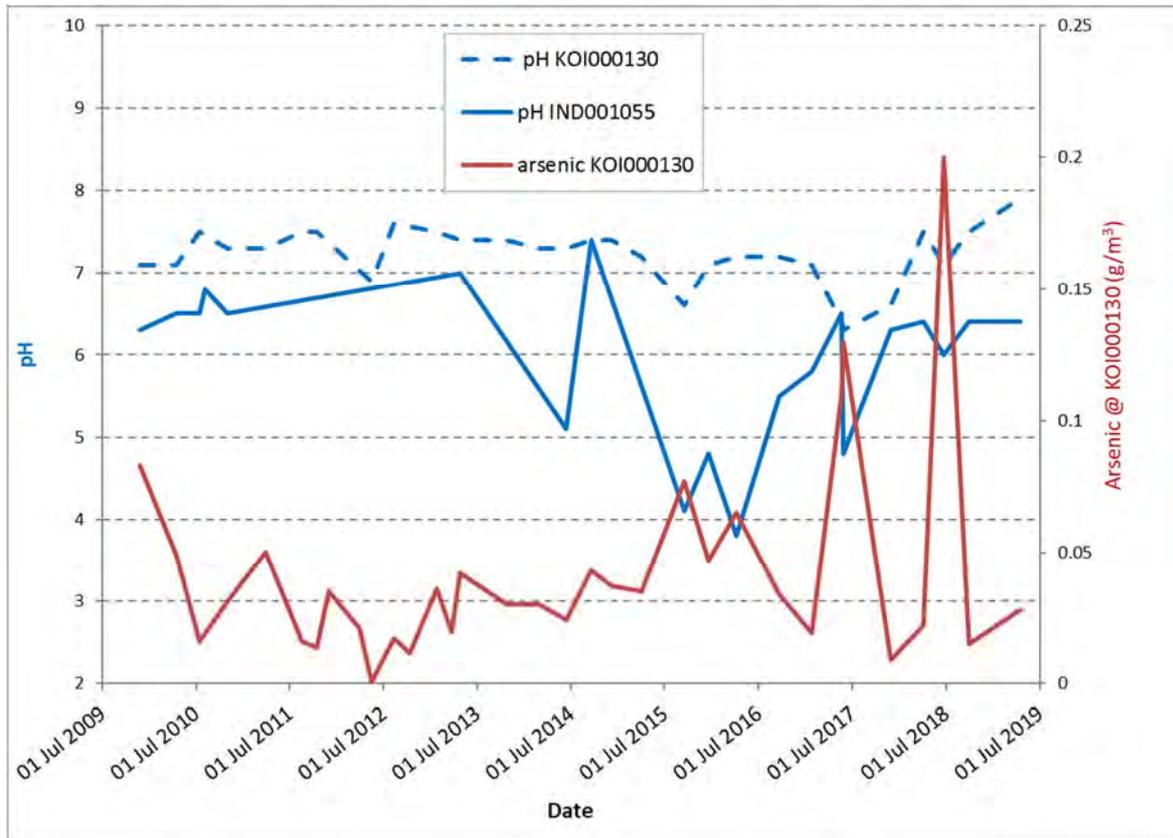
Figure 9 Graph showing pH at sites IND001055 and KOI000130 and arsenic of the receiving water site KOI000130

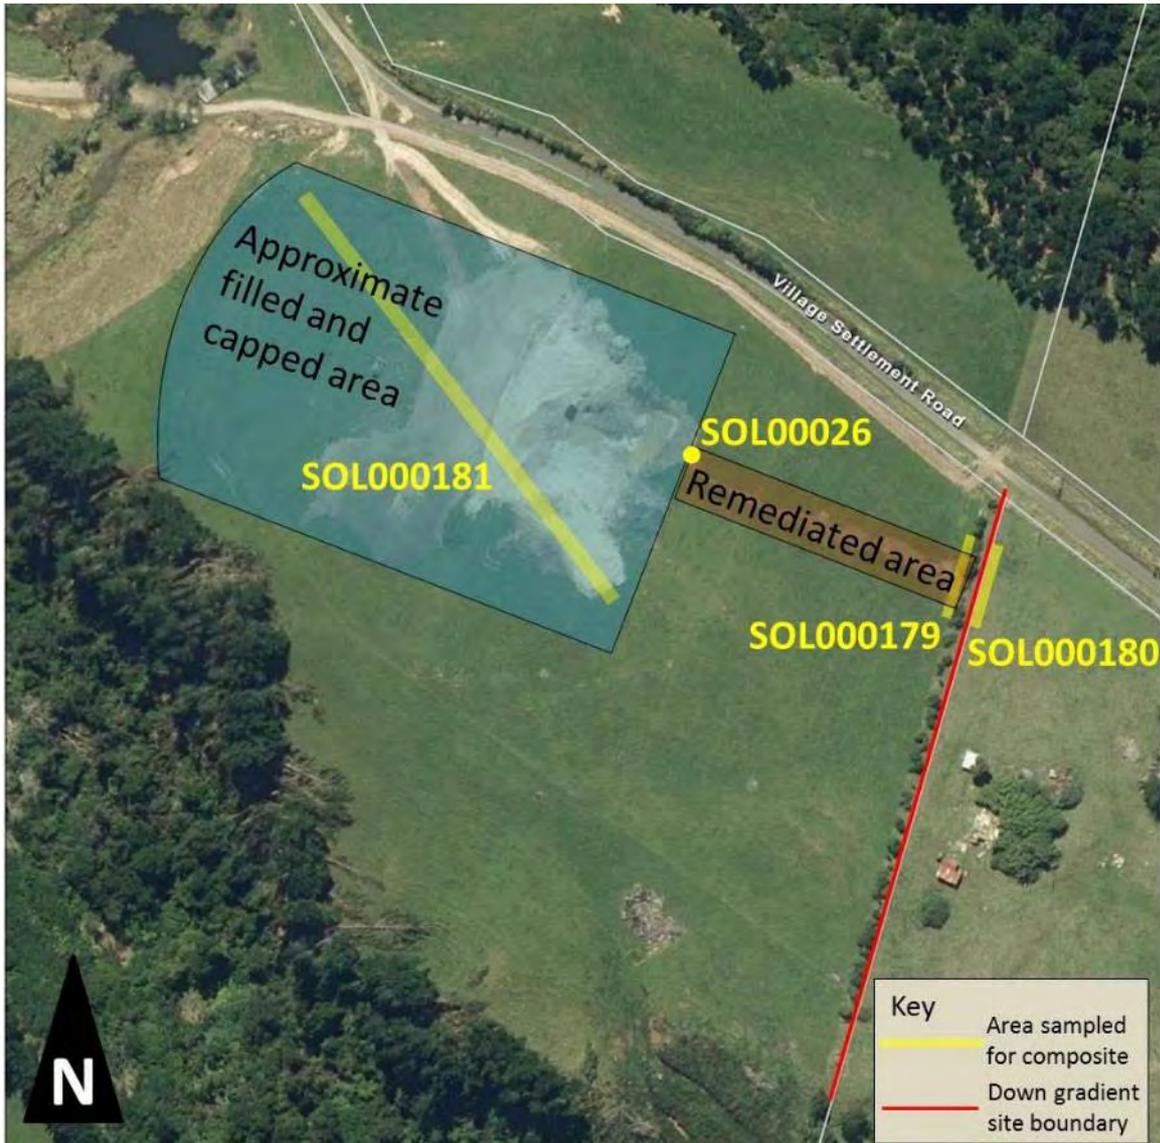
Soil samples were taken from the capped areas, on virgin ground down-gradient of the landfill footprint and from the neighbouring property. The sampling sites are shown in Figure 10 and the results of the soil analysis are given in Table 5 and Table 6.

Figure 10 Aerial view of the discharge site and sampling sites at Waverley Sawmills Ltd's Village Settlement Road site

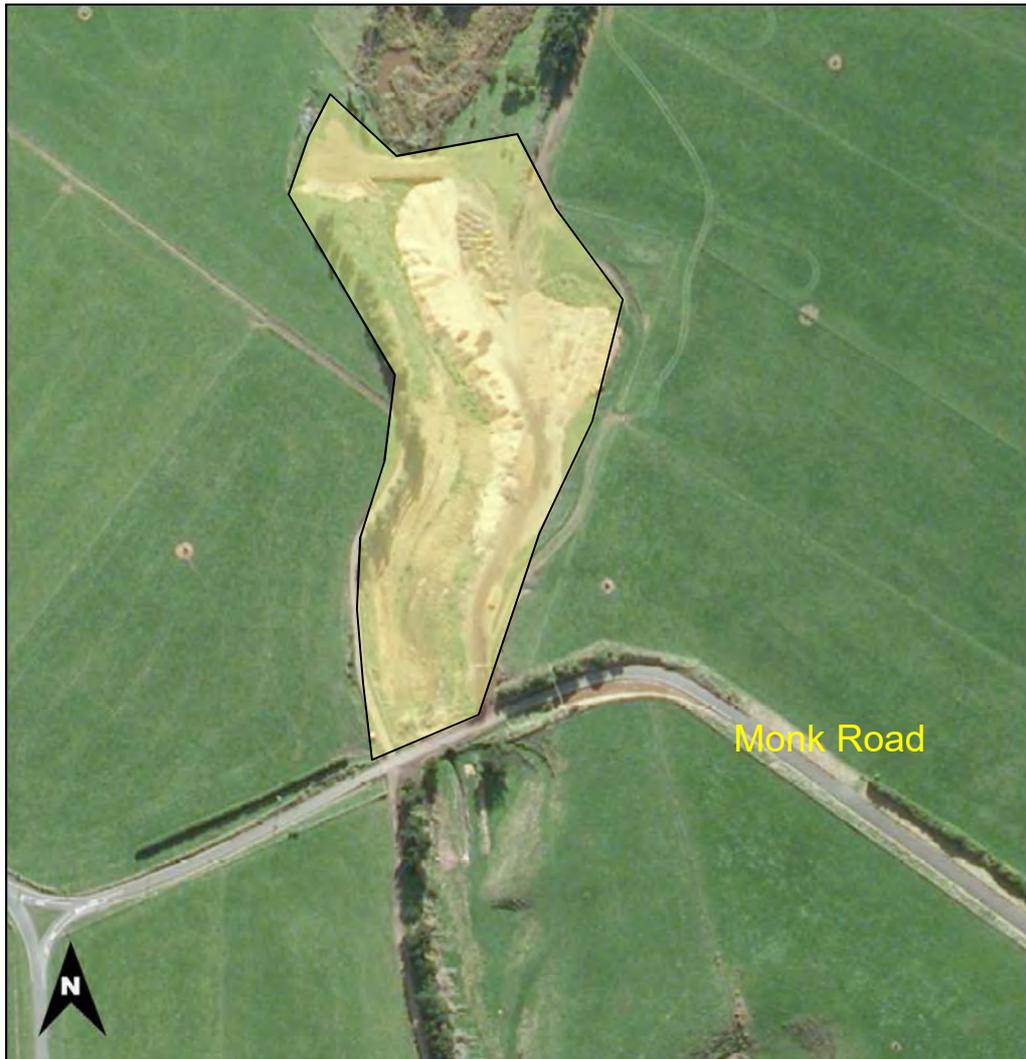
Figure 1 Discharge area at Waverley Sawmill's Monk Road site

- Broken fillet sticks;
 - Furnace ash; and
 - Yard sweepings.
3. The discharge of materials shall only occur in the shaded area shown in Figure 1 (attached).
