South Taranaki District Council
(Eltham, Hawera, Kaponga, Manaia, Patea,
Opunake and Otakeho) Landfills
Monitoring Programme
Annual Report
2019-2020

Technical Report 2020-90

Taranaki Regional Council
Private Bag 713
STRATFORD
February 2021

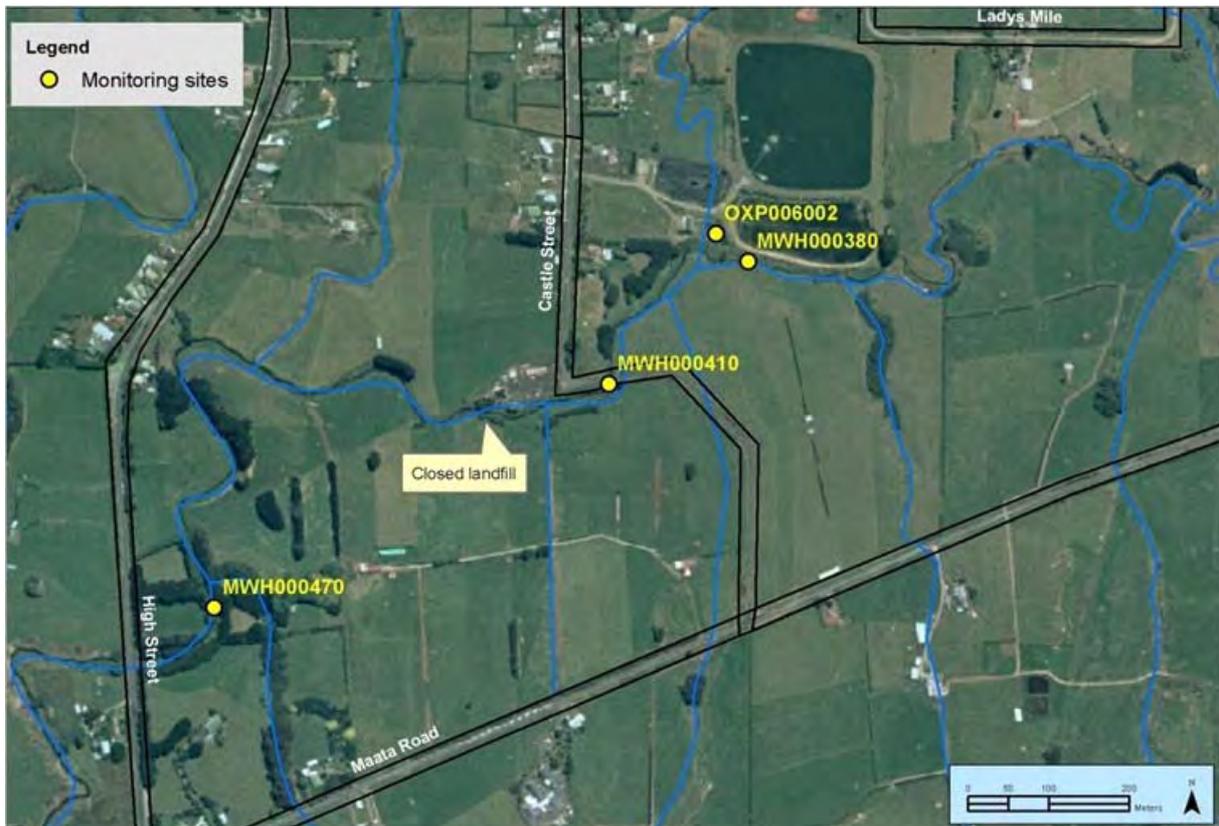
Figure 2 Eltham landfill and sampling sites

This landfill used to service the township of Eltham and surrounding rural areas but was closed in 1992 due to exhaustion of landfill capacity. The 0.71 ha site is located on Castle Street, just downstream of the Eltham oxidation ponds (Figure 2). The area is generally well rehabilitated, with the majority of the area grassed. The landfill is monitored by the Council under the Eltham wastewater treatment plant/Eltham landfill combined monitoring programme.

Inspections of the closed landfill were undertaken on 16 October 2019 and 29 January 2020. There was good pasture growth over the landfill cap and no slumping or leachate discharge was observed. No adverse environmental effects from the closed landfill were noted.

The landfill closed in September 1998, and STDC reinstated the site. Leachate is captured via leachate collection lines in the landfill and is pumped to the Hawera wastewater treatment plant from a pump station located near the upstream end of the culvert under the landfill as illustrated in Figure 2 (RTP001008).

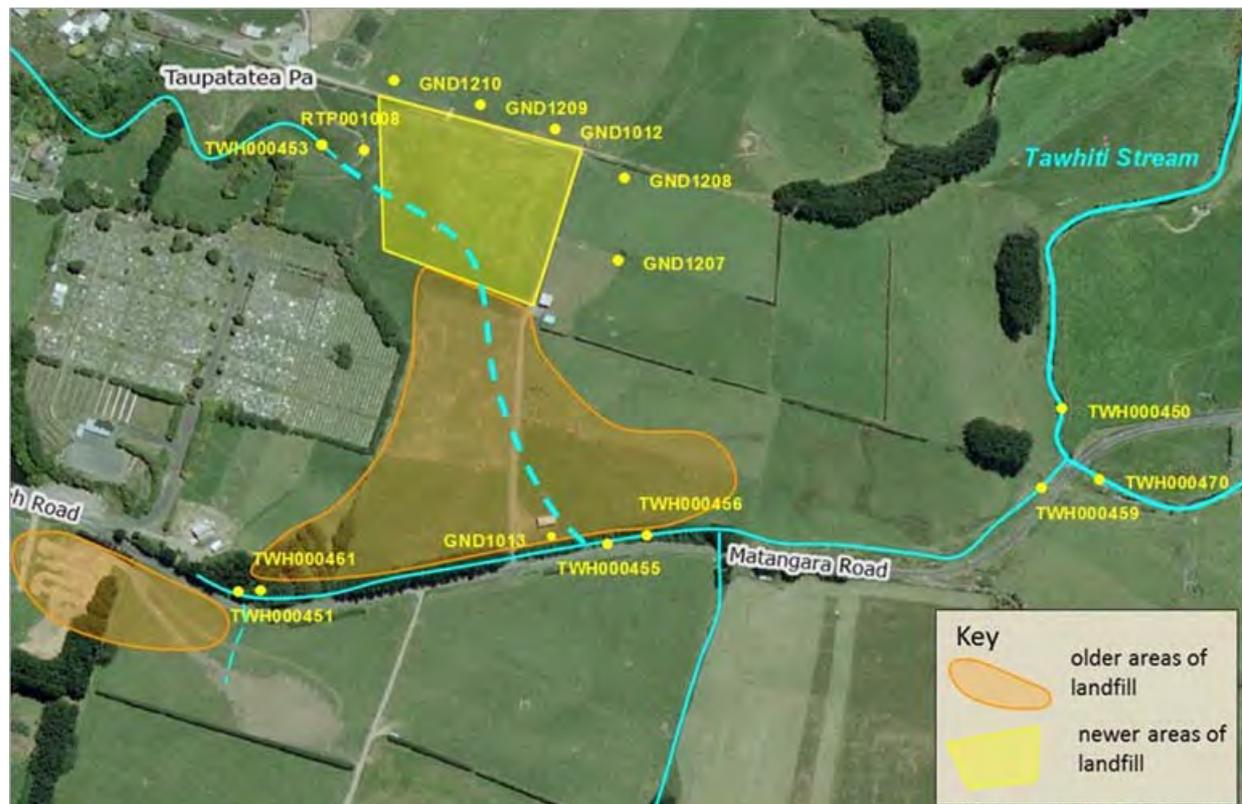
Figure 3 Aerial view of Hawera landfill and sampling sites

The roadside tributary shows moderate levels of contamination, mostly in the form of BOD, iron and ammoniacal nitrogen. Historically, the uppermost monitoring site in the roadside tributary has been found to contain similar levels of contaminants to the landfill tributary at the culvert outlet, which is unsurprising given the extent of historical filling in the area as shown in Figure 3.

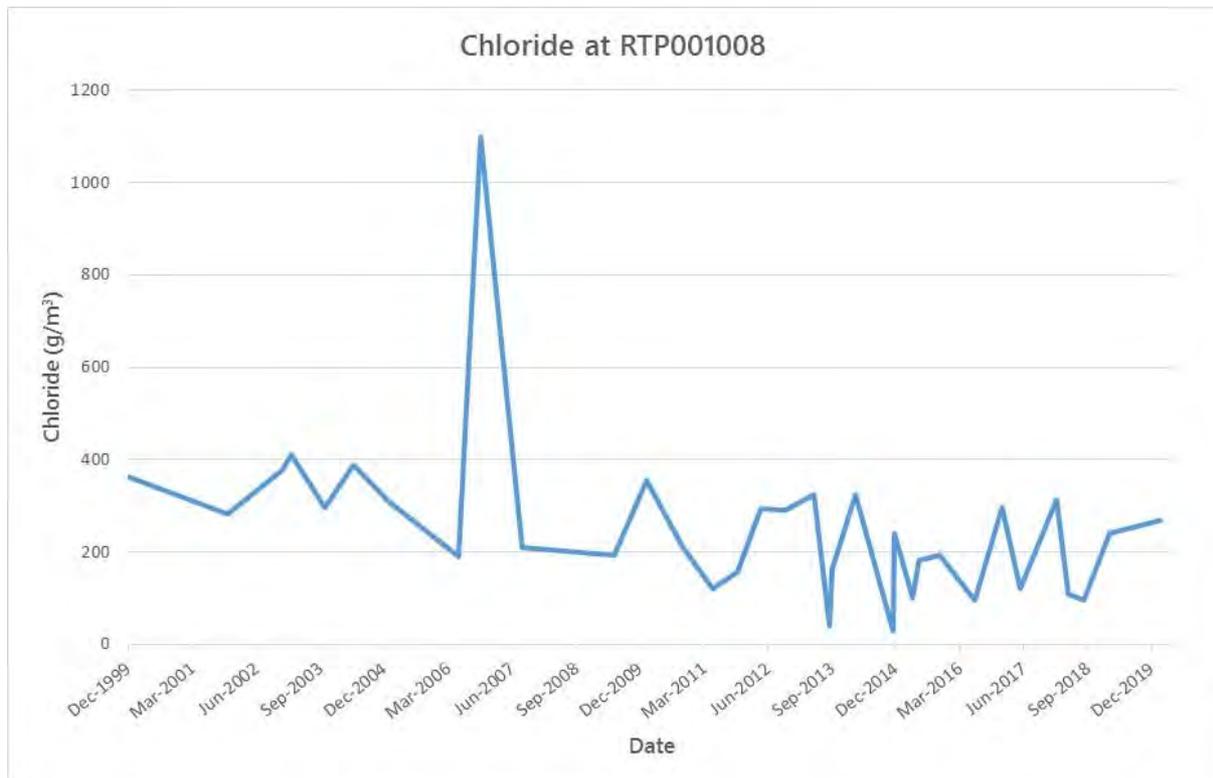
Results indicate that waste in the landfill is still actively degrading and releasing contaminants. The high alkalinity, chloride, chemical oxygen demand and ammoniacal nitrogen concentrations are typical values for landfill leachate and, as expected, these contaminants are gradually trending down over time (Figure 4, Figure 5, and Figure 6). All of the results obtained during the year under review were below the maximum values previously recorded, although a number were above the historical medians.

Figure 4 Hawera landfill leachate chloride concentration; 1999-2020

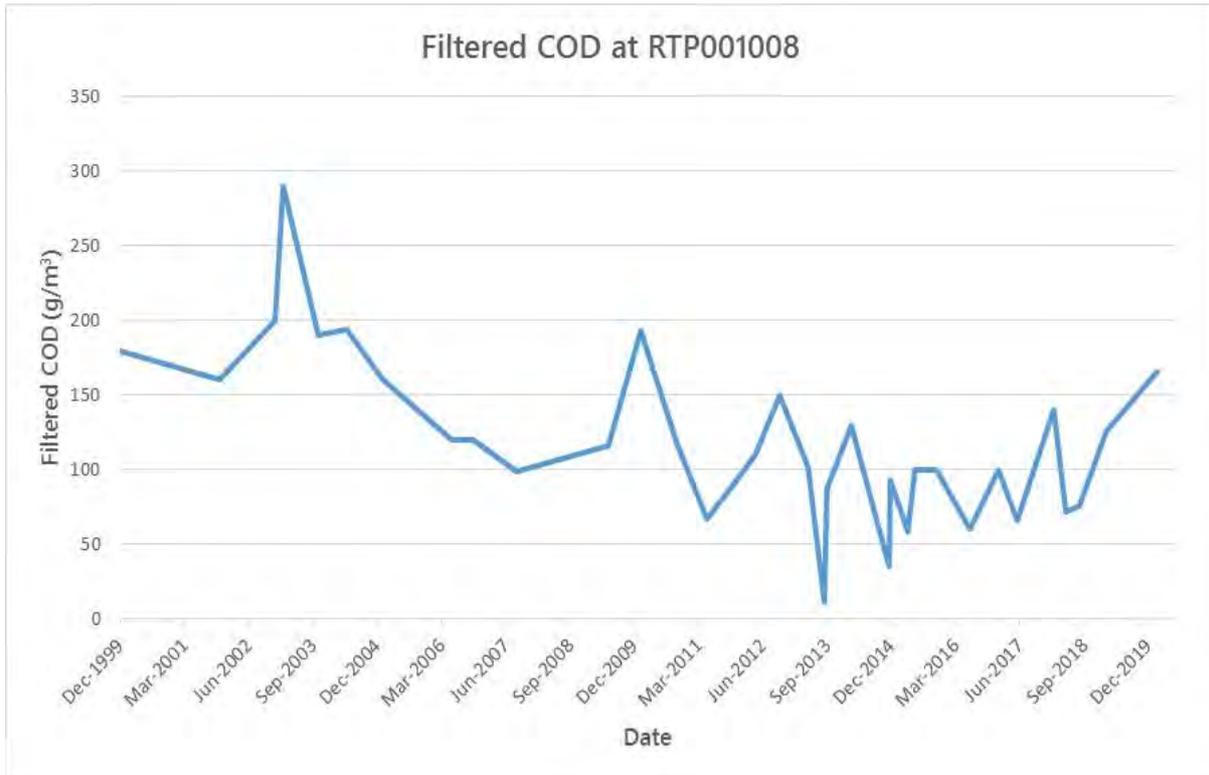
Figure 5 Hawera landfill leachate filtered chemical oxygen demand; 1999-2020

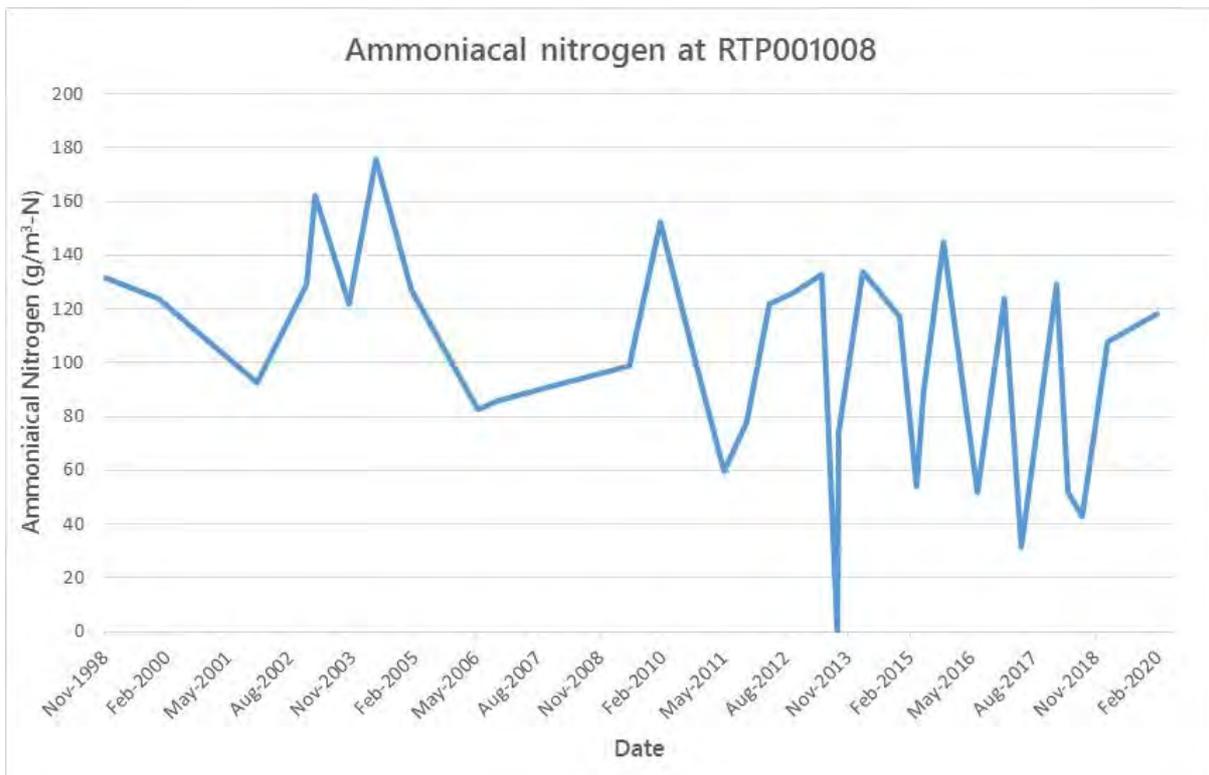
Figure 6 Hawera landfill leachate ammoniacal nitrogen, 1998-2020

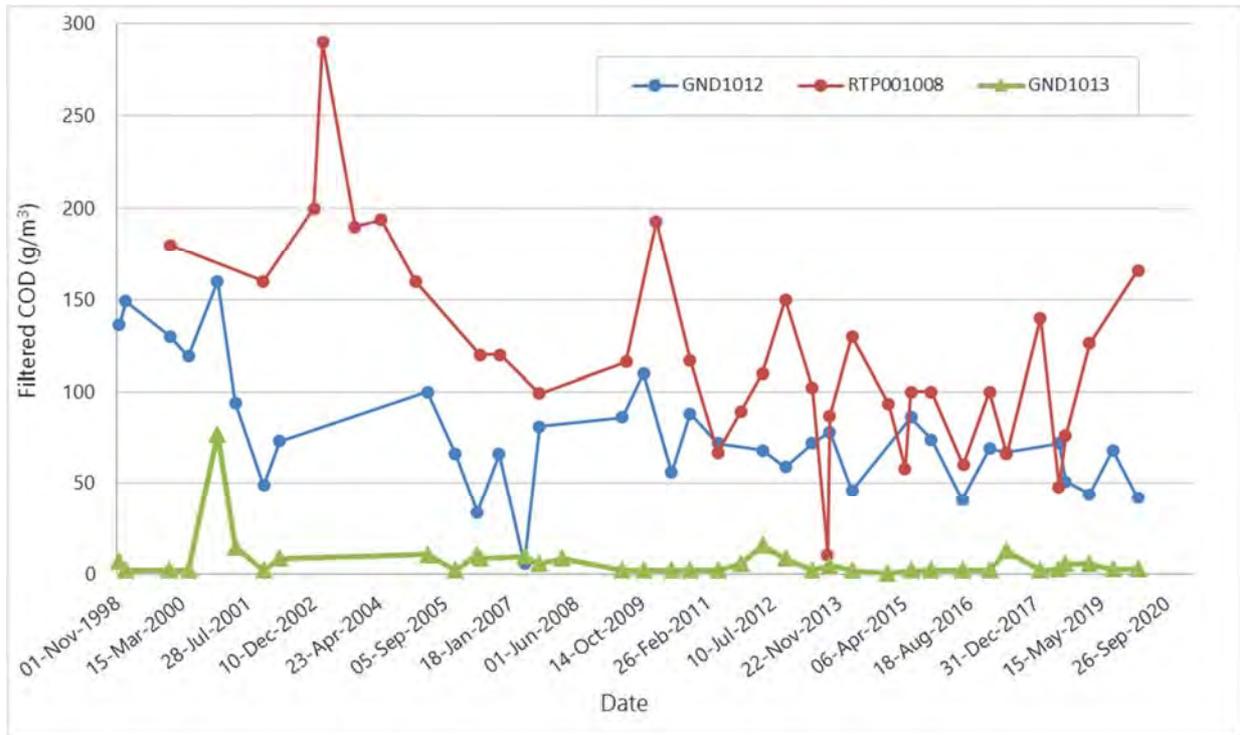
As with previous monitoring periods, bore GND1012 exhibits elevated levels of landfill contamination indicators, such as increased chlorides, alkalinity, iron, and ammoniacal nitrogen. This bore is immediately adjacent to, and down gradient of the landfill footprint, and in recent years has contained a similar level of contaminants to the leachate as indicated by the relative alkalinity, conductivity and chemical oxygen demands. It is noted that bore GND1013 is further from the most recently landfilled areas and as a result has far lower levels of these landfill indicator species (Figure 7, Figure 8 and Figure 9).

Figure 7 Comparison of filtered chemical oxygen demand between GND1012, GND1013 and RTP001008

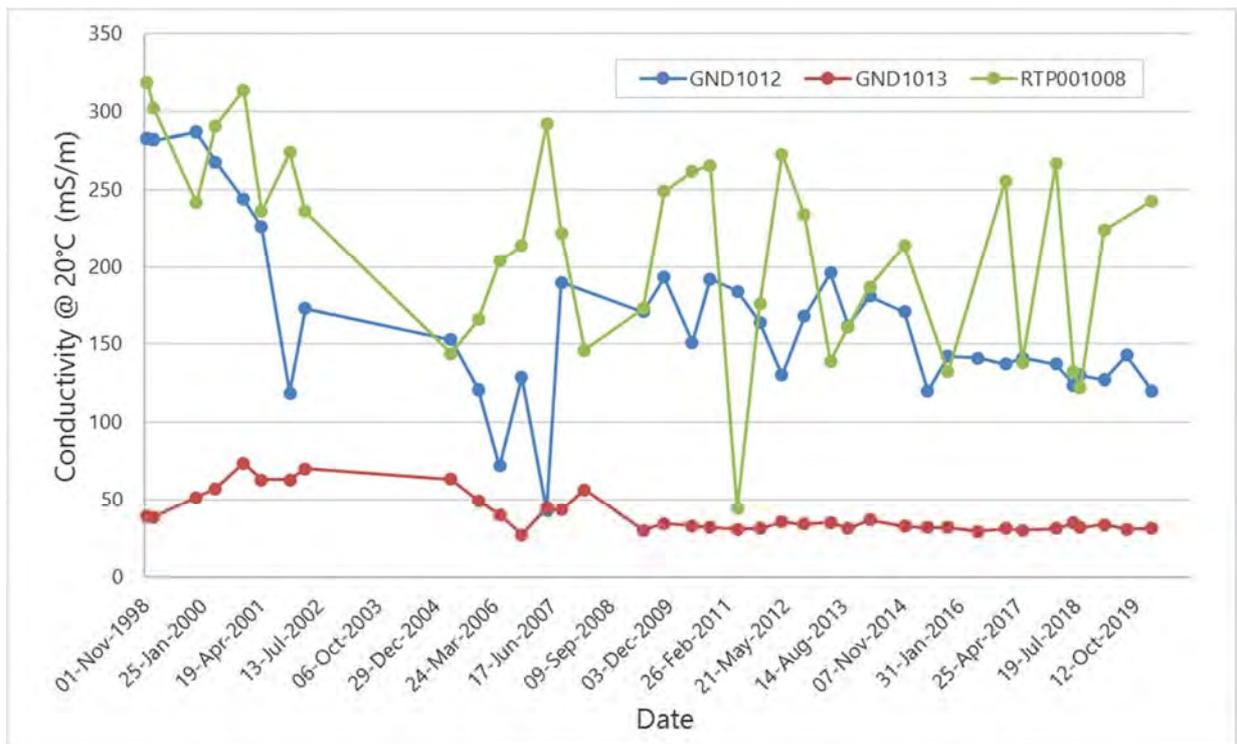
Figure 8 Comparison of conductivity between GND1012, GND1013 and RTP001008

* conductivity is now measured @25°C and results from June 2018 have been converted to 20°C for the graph

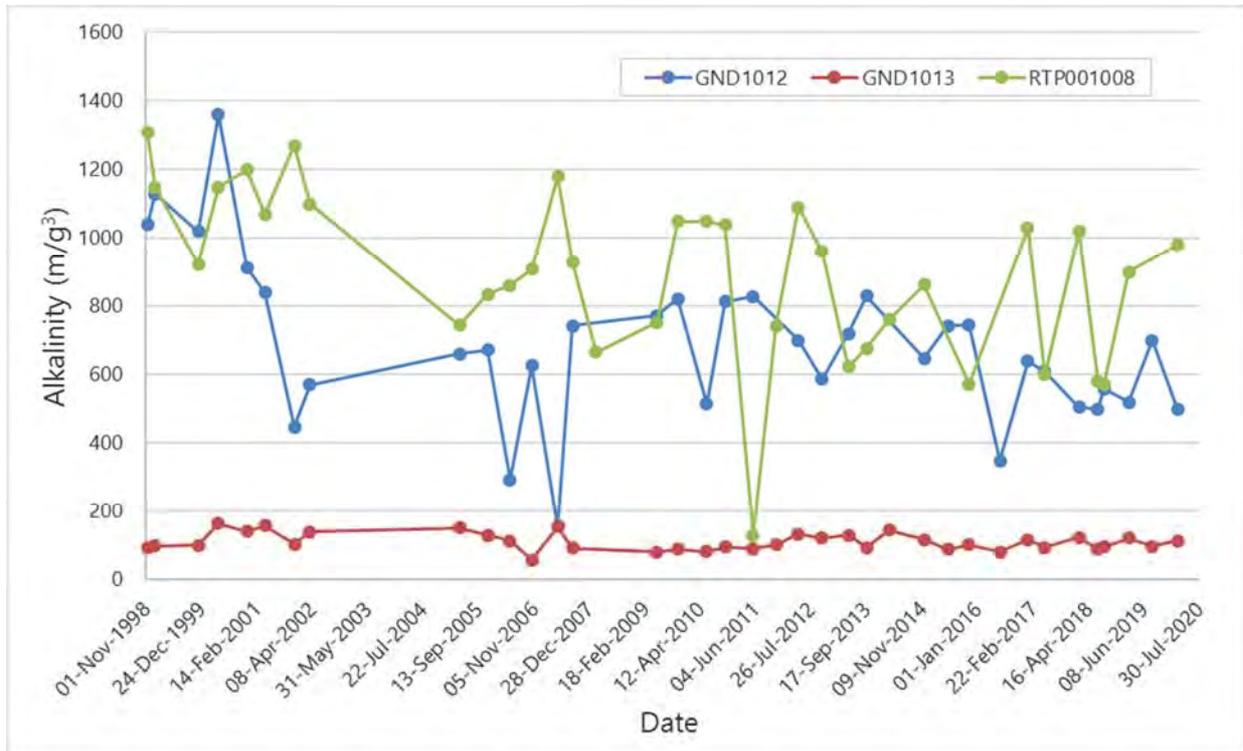
Figure 9 Comparison of alkalinity between GND1012, GND1013 and RTP001008

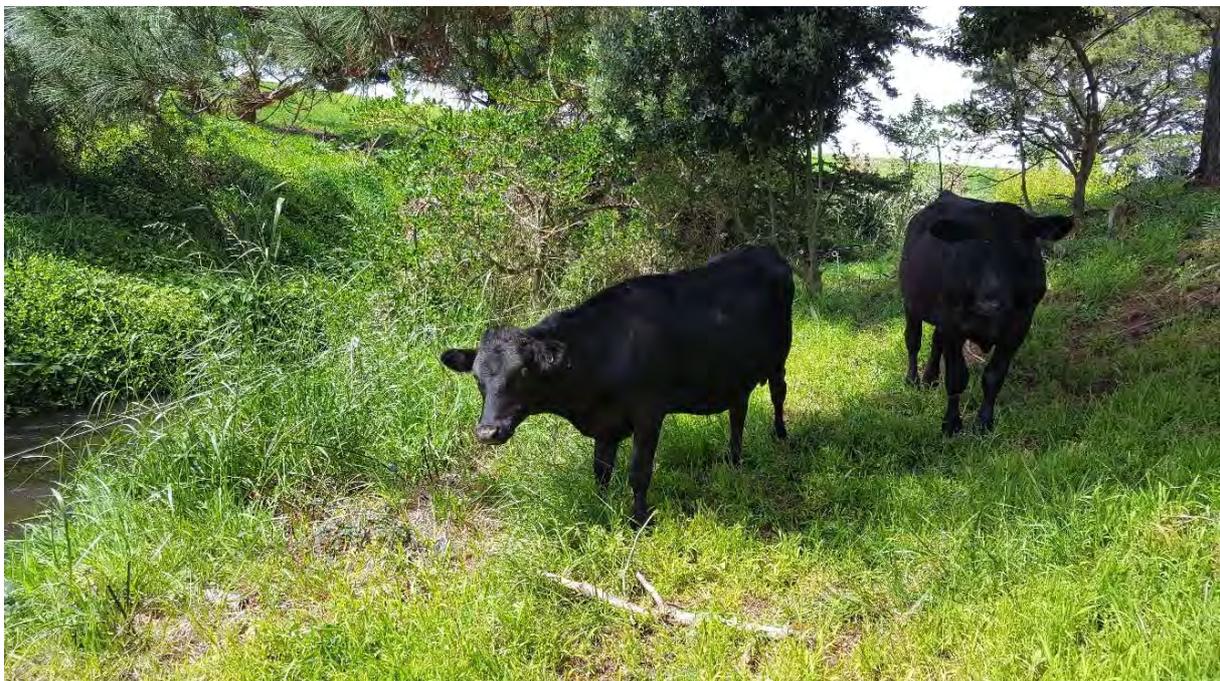
Photo 1 Cattle on Waiokura Stream bank, October 2019

The consent holder was asked to undertake works to remediate the slumping to the cap and minimize stormwater infiltration, to ensure that all stormwater and leachate drains and swales were clear and free-flowing and to ensure measures were installed to prevent further damage to the edge of the cap.

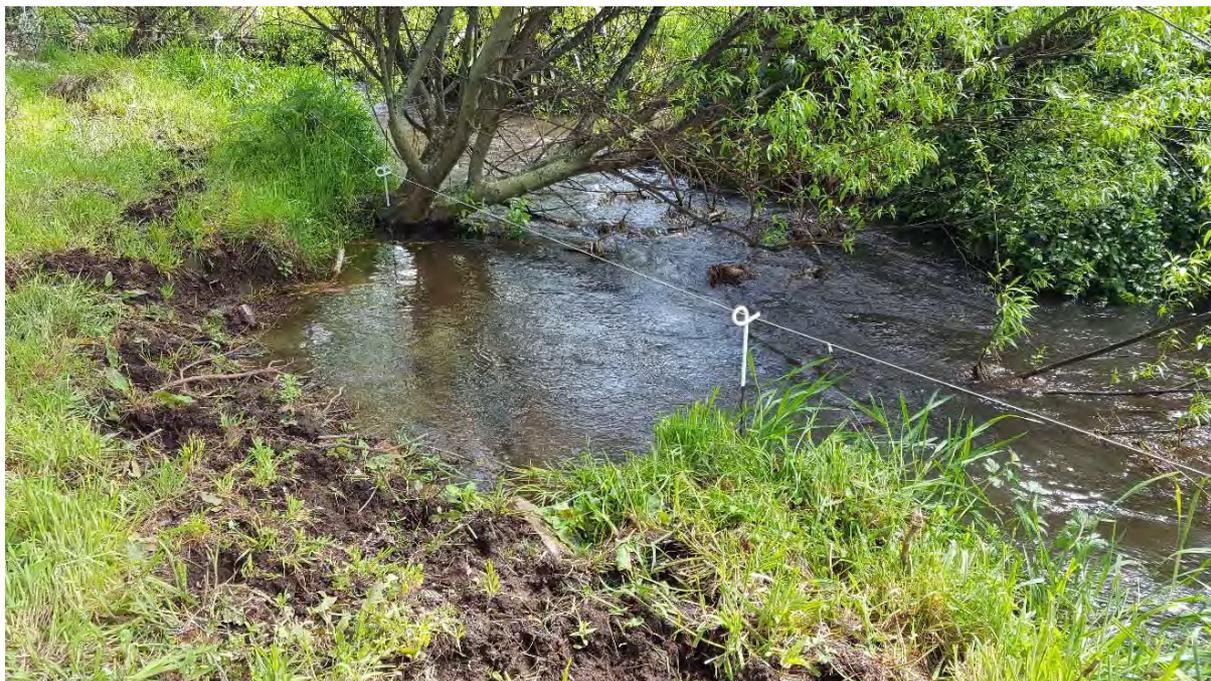
Photo 2 Inadequate fencing along the Waiokura Stream, October 2019

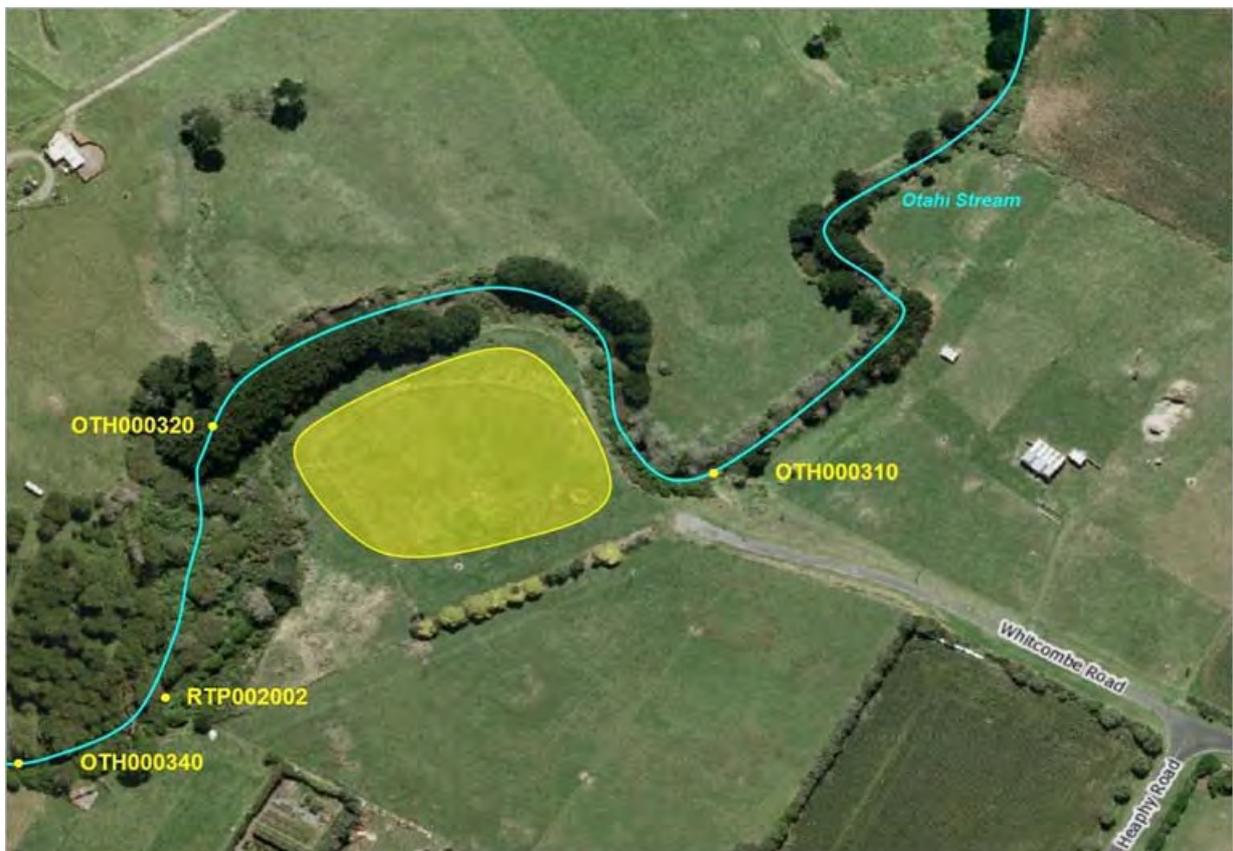
Figure 12 Aerial view of Opunake landfill footprint and sampling sites

The Opunake landfill was operational from 1979, closing in 1999 with the expiry of the 20 year lease of the land. The landfill site is located on Whitcombe Road, and was used to service the township of Opunake and the surrounding rural areas. Waste from Rahotu and Pungarehu was also disposed of at the landfill. The 4.73 ha site was initially operated in an uncontrolled manner for many years with a significant amount of rubbish being burnt. In 1990 a ban on fires was imposed and the site began to operate under restricted hours. In 1999 STDC submitted a landfill closure plan and had the site reinstated.

Samples were collected from the leachate drain, and the Otahi Stream at sites above, below and adjacent to the landfill (Figure 12) on 30 October 2019. The results are presented in Table 14.

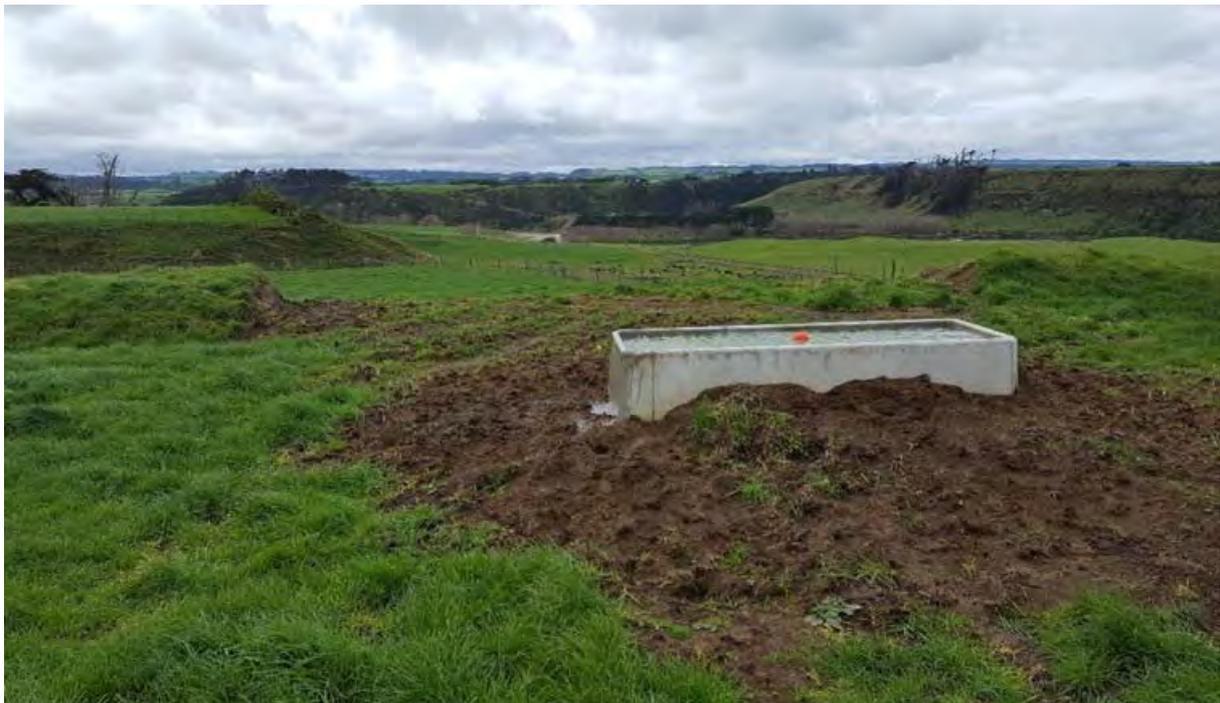
Photo 3 New trough on cap with cut to bund in background, September 2019

It was also noted that water troughs had recently been installed on top of the cap, which presents risks for the integrity of the cap (both during installation and when in use), with the possibility of increased leachate generation due to the pugging that occurs around water troughs and the potential for water troughs to overflow. The consent holder was requested to update the landfill management plan (as per condition 3 of consent 0427) to ensure that appropriate monitoring and preventative maintenance is carried out to prevent these and similar issues, and that the best practicable option is being adopted at all times as per condition 8 of the consent. It was noted that controls also needed to be included around stocking densities on the cap.

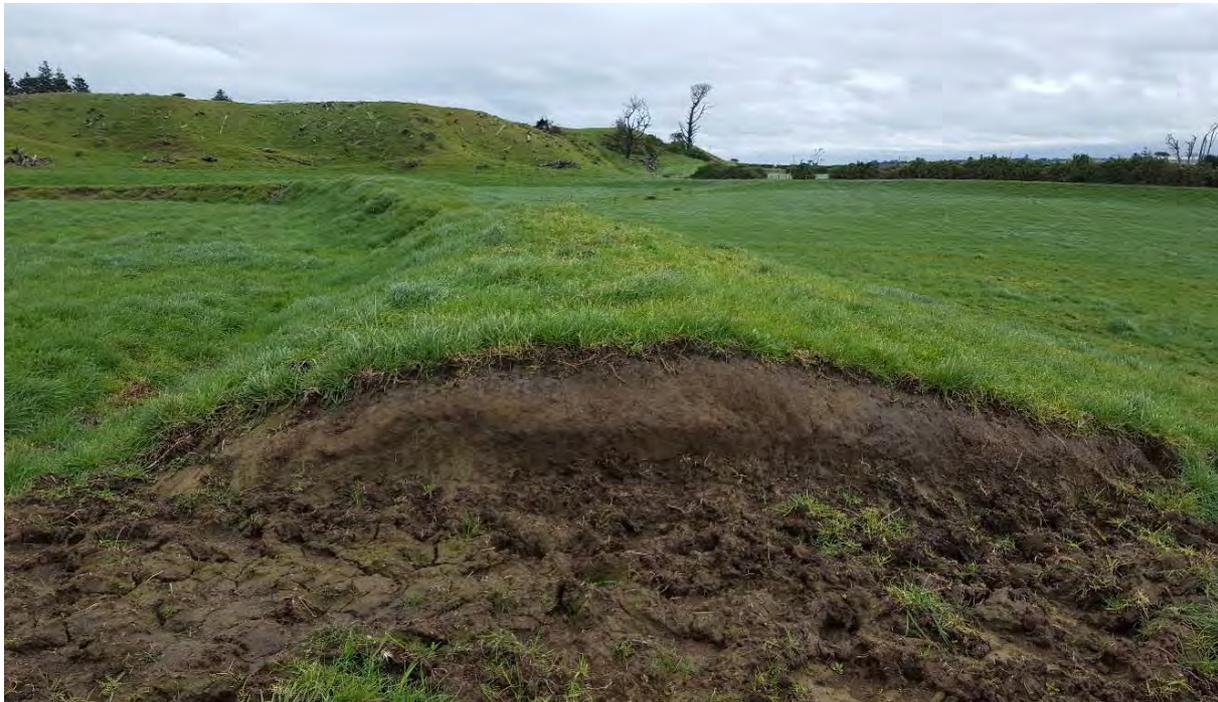
The majority of the landfill cap was intact and was showing no signs of slumping, although it was noted that a section of the perimeter stormwater bund wall had been dug out, resulting in a breach in condition 6 of consent 0427. An approximately 6-8 m section of the landfill cap bund had been deliberately levelled (Photos 3 and 4), which would adversely affect the stormwater diversion, collection, treatment and discharge system.

Photo 4 Cut through bund September 2019
3 October 2019

A follow-up inspection was carried out to assess compliance following the breach in condition 6 of consent 0427-3 observed during the inspection undertaken on 9 September 2019. The bund had been reinstated and it was considered that the height, size, compaction, and general condition of the bund was sufficient for adequate stormwater control (Photo 5). Vegetation re-establishment still required attention on the altered sections of the bund. Additional soil had been placed around the troughs since the previous inspection. STDC had previously advised that a contractor had been contacted to remove the plastic on the side of the hill, however this was still present.

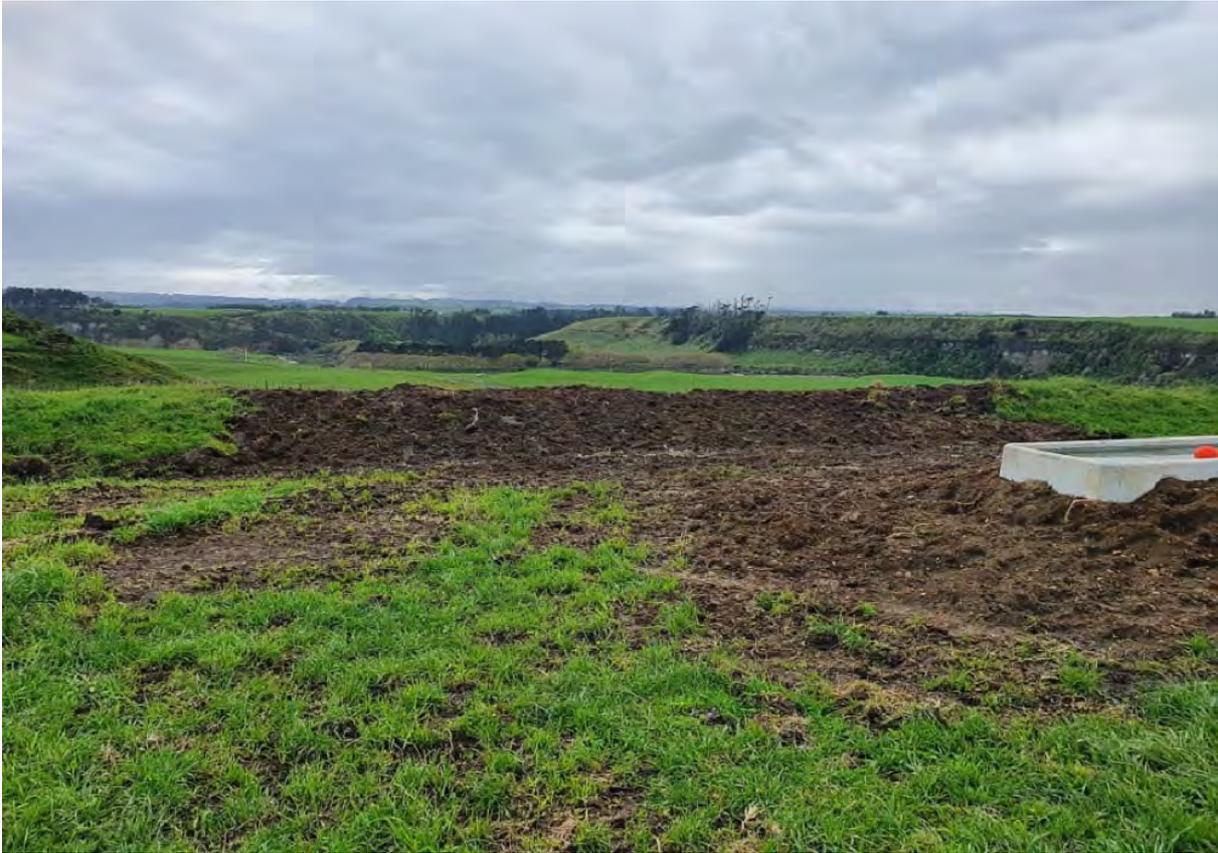
Photo 5 Repaired bund October 2019

The landfill management plan has been updated to include ongoing monitoring of the landfill by the consent holder every 6 months to ensure that water reticulation and the cap remain compliant and any remedial works are carried out as required. The updated plan also defines and prohibits heavy grazing on the site (and any of the closed landfill sites).
