Value Timber Ltd
Monitoring Programme
Annual Report
2020-2021

Technical Report 2021-27

Taranaki Regional Council
Private Bag 713
Stratford

ISSN: 1178-1467 (Online)
Document: 2788692 (Word)
Document: 2832422 (Pdf)
October 2021

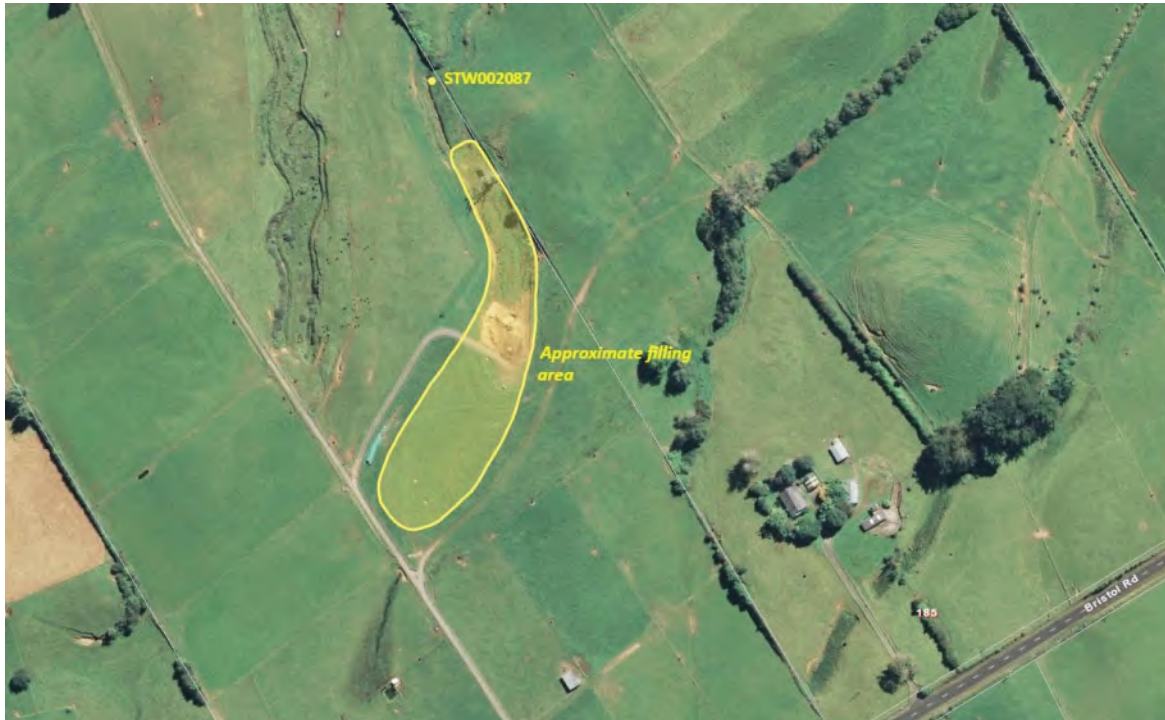
Figure 1 Aerial image of the Bristol Road site and sampling site

The samples were taken from site STW002087, which is in the receiving drain downstream of the fill area, just upstream of the property's boundary fence (Figure 1).

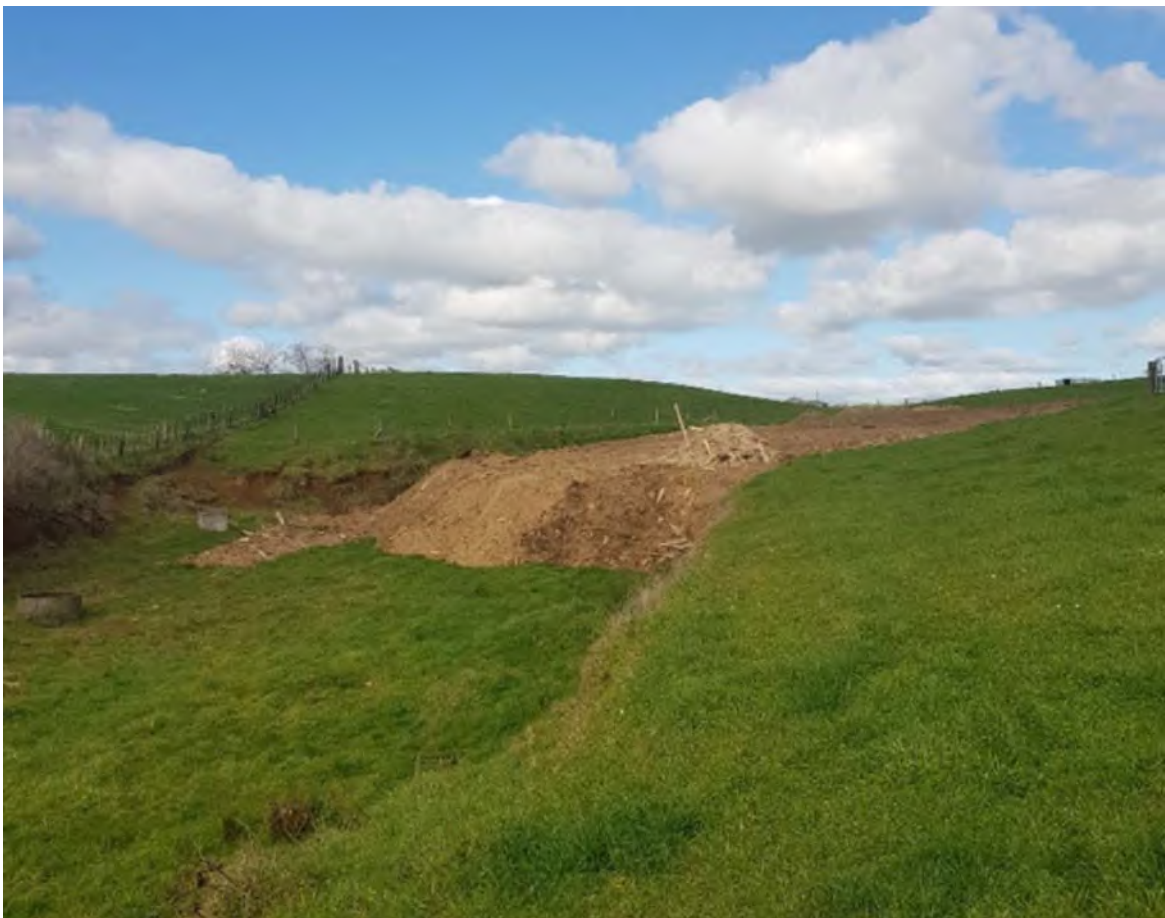
Photo 1 Value Timber Ltd wood waste cap 10/08/2020

The site was inspected in fine weather with moderate easterly wind. The fill area had one small stockpile of wood waste material to be spread. The cap area was tidy and well-managed. The tip face appeared stable with no cracking or slumping observed. The pre-fill gully was tidy and well-grassed with no sign of runoff. The post-fill gully was well-grassed and intact, with no slumping or ponding. The stormwater drains were clear and not discharging, with no obstructions of flow. The stormwater ponds were full with pond number 3 discharging. No significant effects were observed downstream. The silt controls were in place and appeared to be working well. There was a large amount of iron oxide present in the stream. The water was slightly turbid and a sample was taken downstream of the cap. The site was well fenced and secure, with no sign of stock grazing in the gully. There were no odour or dust issues and no unauthorised material was noted onsite.

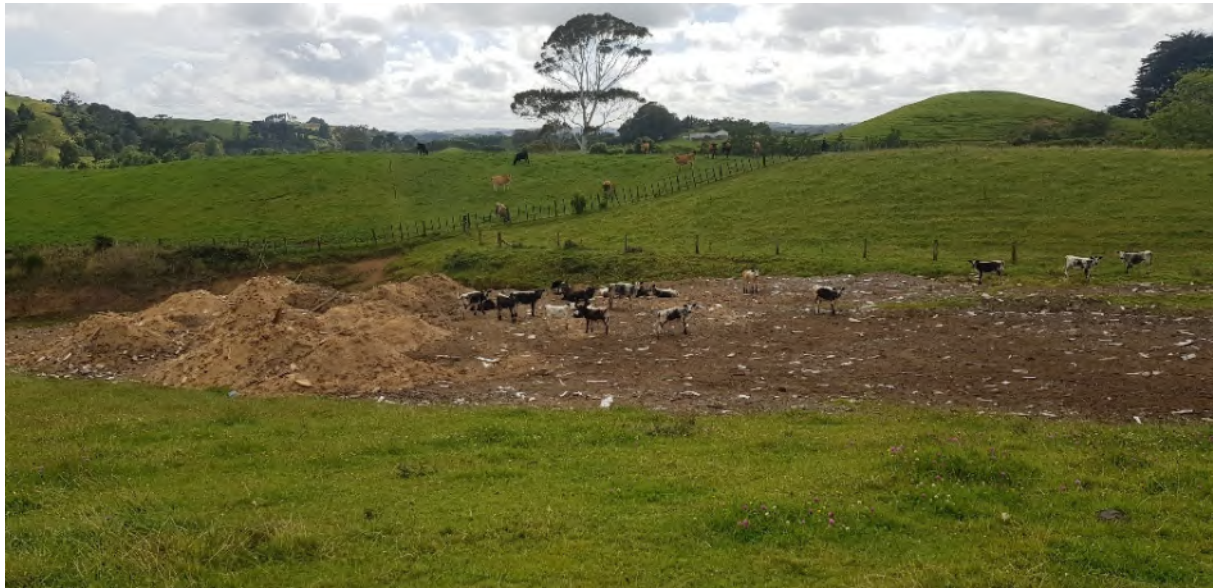
Photo 2 Value Timber Ltd 29/01/2021

The Value timber site was inspected in cloudy weather with light easterly wind. The fill area had approximately ten small stockpiles of sawdust on top of the cap yet to be spread. The area was tidy and the tip face appeared stable with no cracking or slumping observed. The pre-fill gully was tidy and well-grassed with no sign of runoff. The post-fill gully was well-grassed and intact, with no slumping or ponding. The stormwater drains were clear and dry with no sign of recent flow. The stormwater ponds were empty and not discharging. The site was well fenced and secure. There was a mob of young cattle stock in the gully and on top of the cap. There were no odour or dust issues. Samples of sawdust material were collected and sent for CCAB analysis. No unauthorised material was noted onsite.

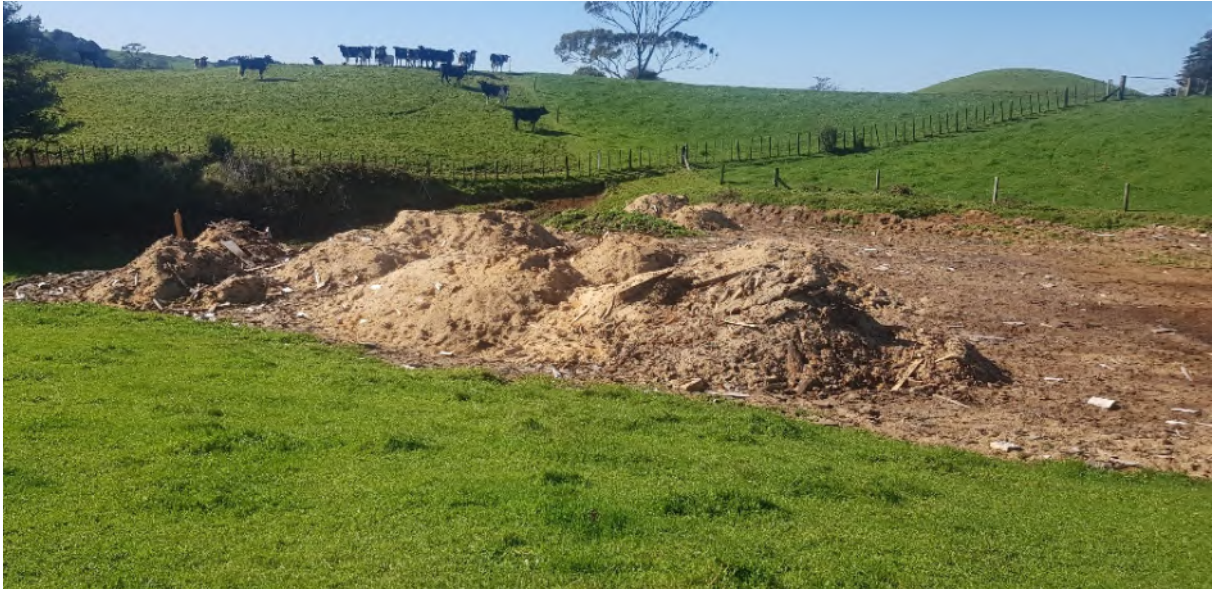
Photo 3 Value Timber Ltd site inspection 13/05/2021

The site was inspected in fine weather with light wind. The fill area had twelve small stockpiles of wood waste material to be spread. The cap area was tidy and well-managed. The tip face appeared stable with no cracking or slumping observed. The pre-fill gully was tidy and well-grassed with no sign of runoff. The post-

fill gully was well-grassed and intact, with no slumping or ponding. The stormwater ponds were full with the final pond discharging. No significant effects were observed downstream. The silt controls were in place and appeared to be working well. There was a large amount of iron oxide present in the stream. The water was clear with a sample taken downstream of the cap. The site was well fenced and secure, although young cattle stock were grazing in the gully. There were no odour or dust issues and no unauthorised material was noted onsite.
