Westown Haulage Ltd
Cleanfill and Wood Waste
Monitoring Programme
Annual Report
2020-2021

Technical Report 2021-14

Taranaki Regional Council
Private Bag 713
Stratford

ISSN: 1178-1467 (Online)
Document: 2808700 (Word)
Document: 2816819 (Pdf)
August 2021

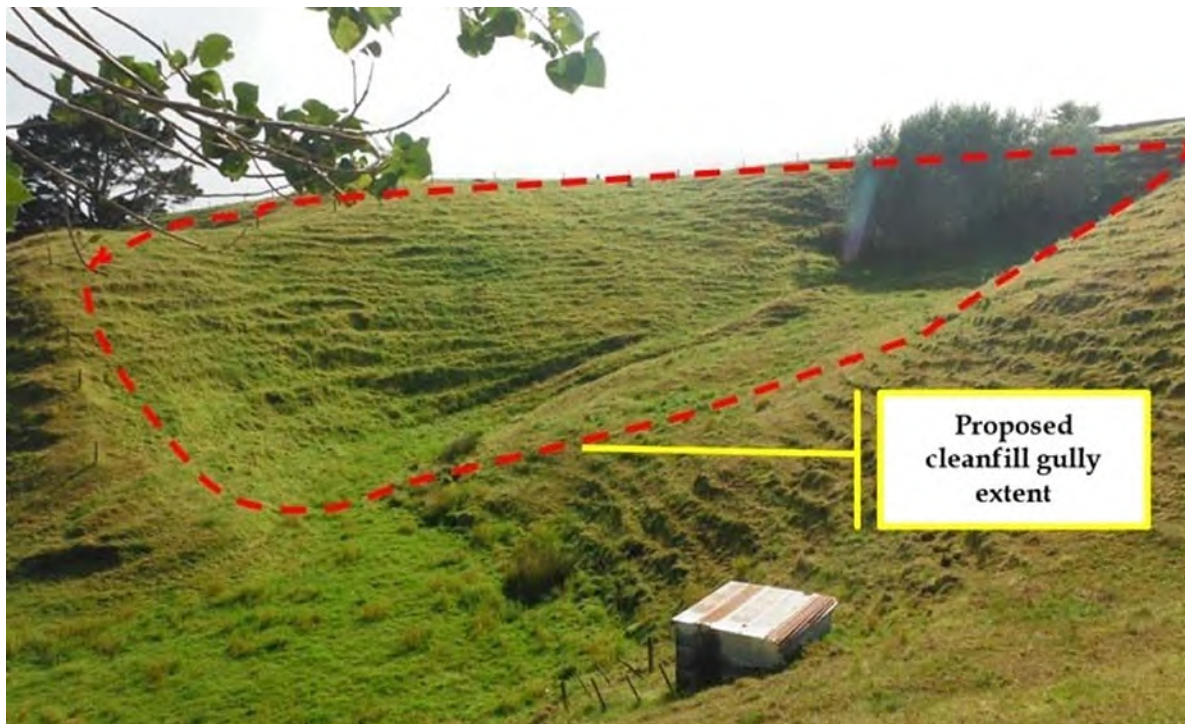
Photo 1 Proposed and consented extent of the fill area

The Company operates a cleanfill and wood waste site at 70 Cowling Road, Hurdon, in the Huatoki catchment, which is planned to be up to approximately 0.5 ha in size (Figure 1, Photo 1). The cleanfill and wood waste is being used to fill a deep horse shoe shaped gully on the farm, which is located at the fringe of the New Plymouth urban area. The Mangaotuku Stream runs towards the north across the site, approximately 80 m away from the closest part of the area to be filled.

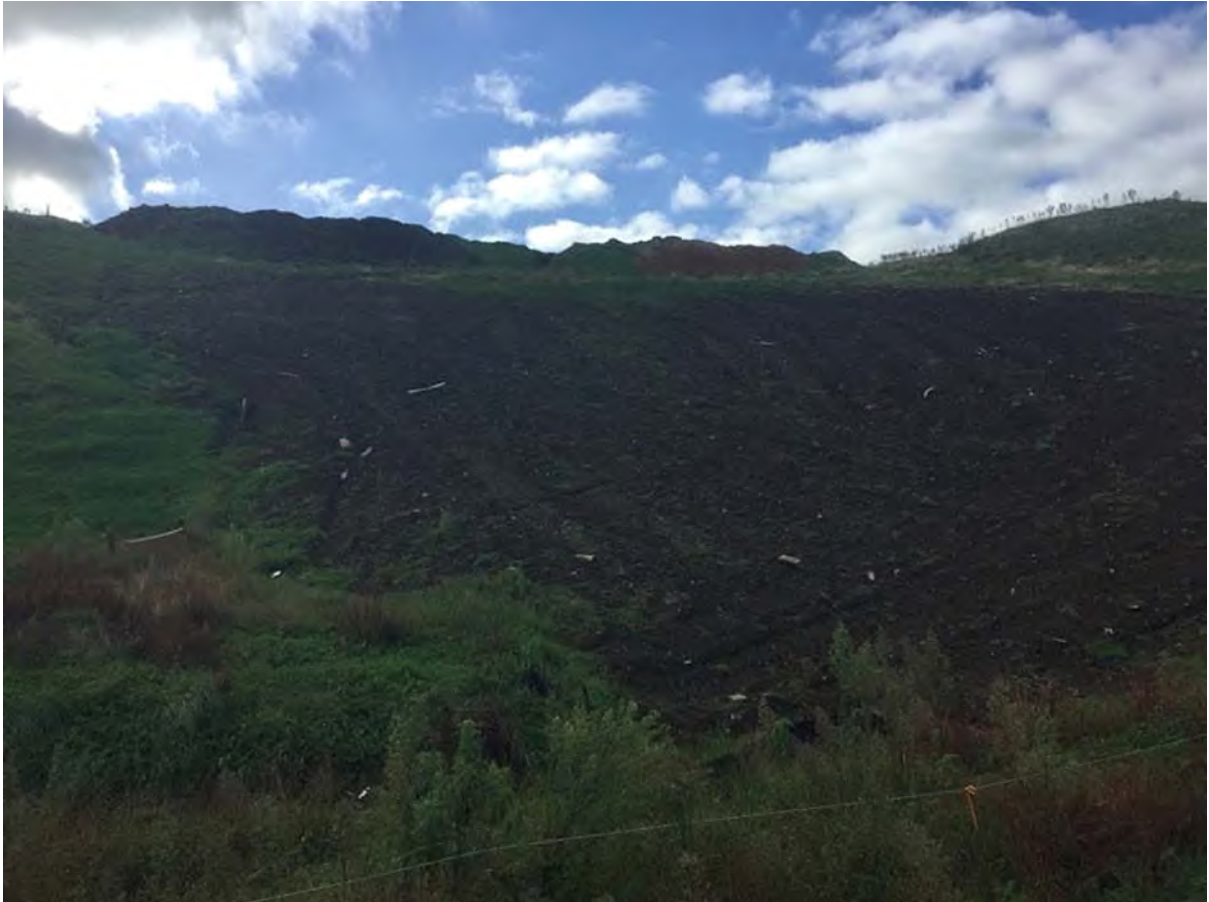
Photo 2 Cleanfill and woodwaste site May 2021

No activity was occurring on the site during the inspection. There were some piles of soil at the top of the face along with one pile of sawdust. No unauthorised material was observed anywhere on the site. The lower area had been contoured but vegetation was sparse (Photo 2). No dust or odours were noted. A small amount of clear water was flowing through the silt fence at the bottom of the site. Samples were collected further down from the tributary, along with upstream and downstream of the tributary discharge. The tributary was clear in appearance and no visual effects noted downstream of where this entered the Mangaotuku Stream. A composite sample was collected from the sawdust pile.

The site was visited during fine weather with no recent significant rain. The clean fill was of similar appearance to the previous inspection and no new material was observed. No unauthorised material was observed and no odours were noted. Additional grass growth had occurred on the lower section since the previous visit.

The site is no longer operational, with the final discharge received at the site in February 2021. Clay has been rolled over the site and piles of mulch and topsoil are waiting at the top of the slope ready to be spread and drilled with grass seed before the site is returned to pasture. This work will be weather depend and is likely to occur in spring 2021.

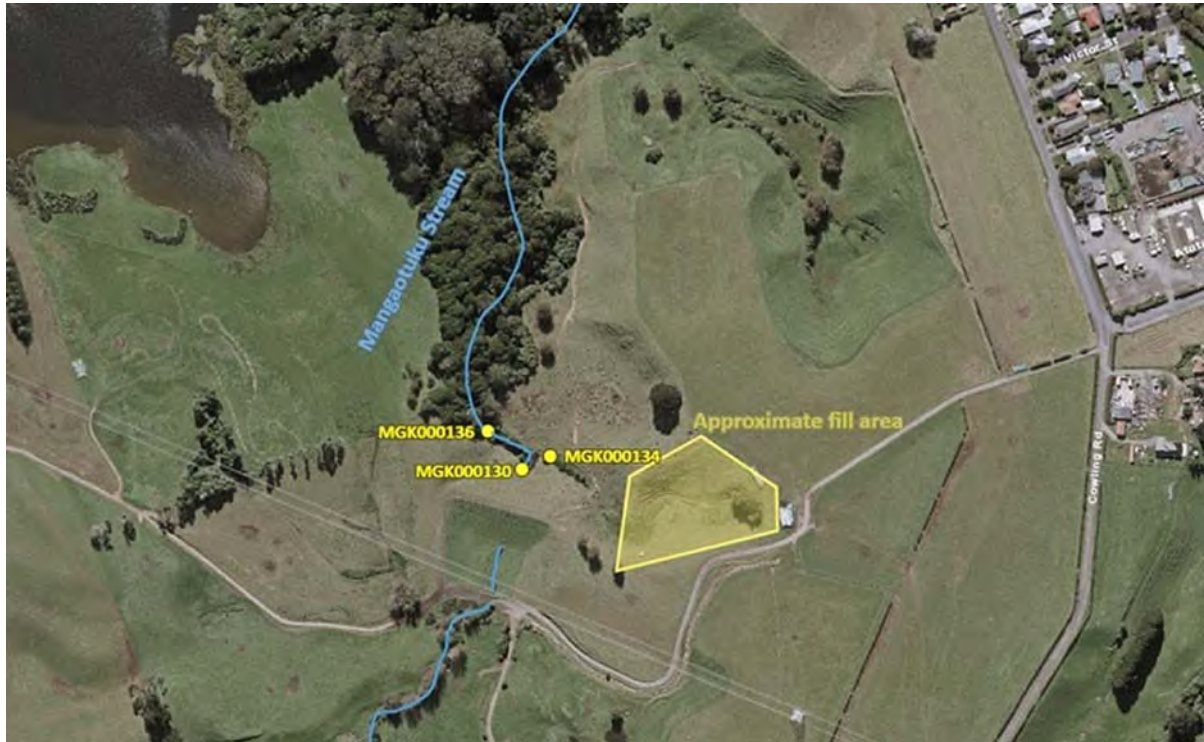
Figure 2 Location of Westtown Haulage sampling sites

During the monitoring period samples were collected on one occasion from three sites in the Mangaotuku Stream, as shown in Table 3 and Figure 2. The results are presented in Table 4.

Site code	Site	Location
MGK000130	Mangaotuku Stream, upstream	Barrett Domain weir
MGK000134	Unnamed tributary of Mangaotuku	Below Westtown Haulage woodwaste/cleanfill
MGK000136	Mangaotuku Stream, down stream	Southern end of Barrett Domain, off Davies Road
