**Regional Cleanfill
Monitoring Programme
Annual Report
2023/24
Technical Report 2024-39**

Taranaki Regional Council
Private Bag 713
Stratford

ISSN: 1178-1467 (Online)
Document: TRCID-176456519-99 (Word)
Document: TRCID-1188382587-469 (Pdf)
March 2025

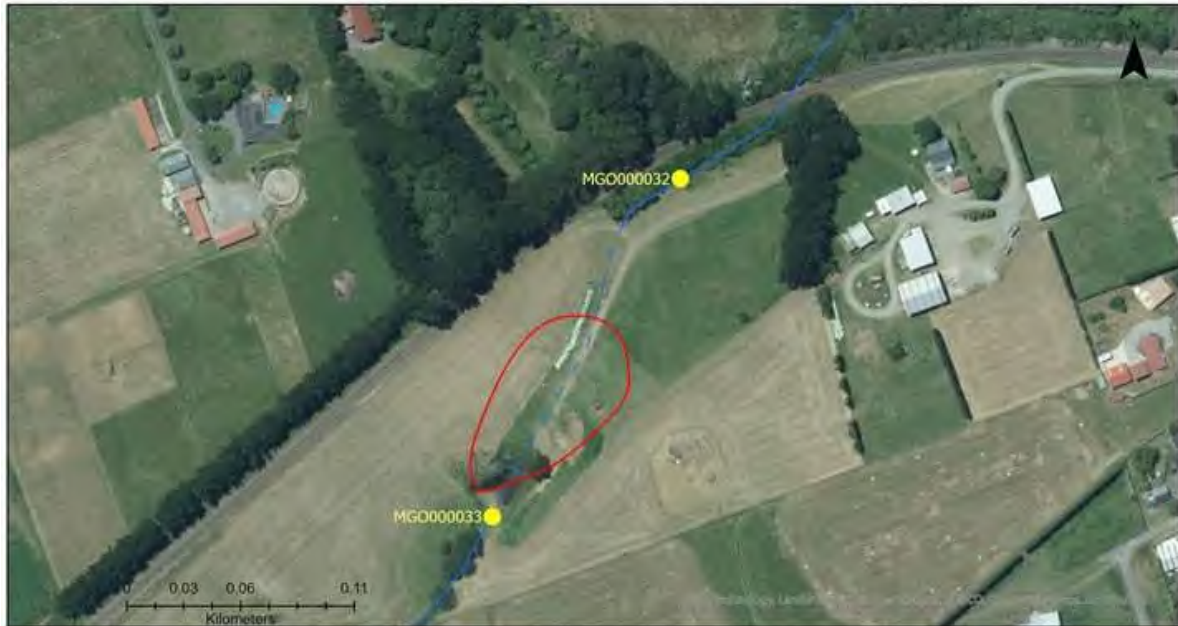
Figure 2 AA Contracting Ltd cleanfill and sampling sites at Henwood Road, New Plymouth

AA Contracting Ltd (AA Contracting) holds Resource Consent 5180-2.1 to discharge cleanfill onto and into land and Resource Consent 5179-2 to install and maintain a culvert at a site on Henwood Road, New Plymouth. Cleanfill materials are being used to fill in a depression in the paddock to enhance its farming potential. The approximate fill area is shown in Figure 2. The full extent consented is shown in the consent (Appendix I).

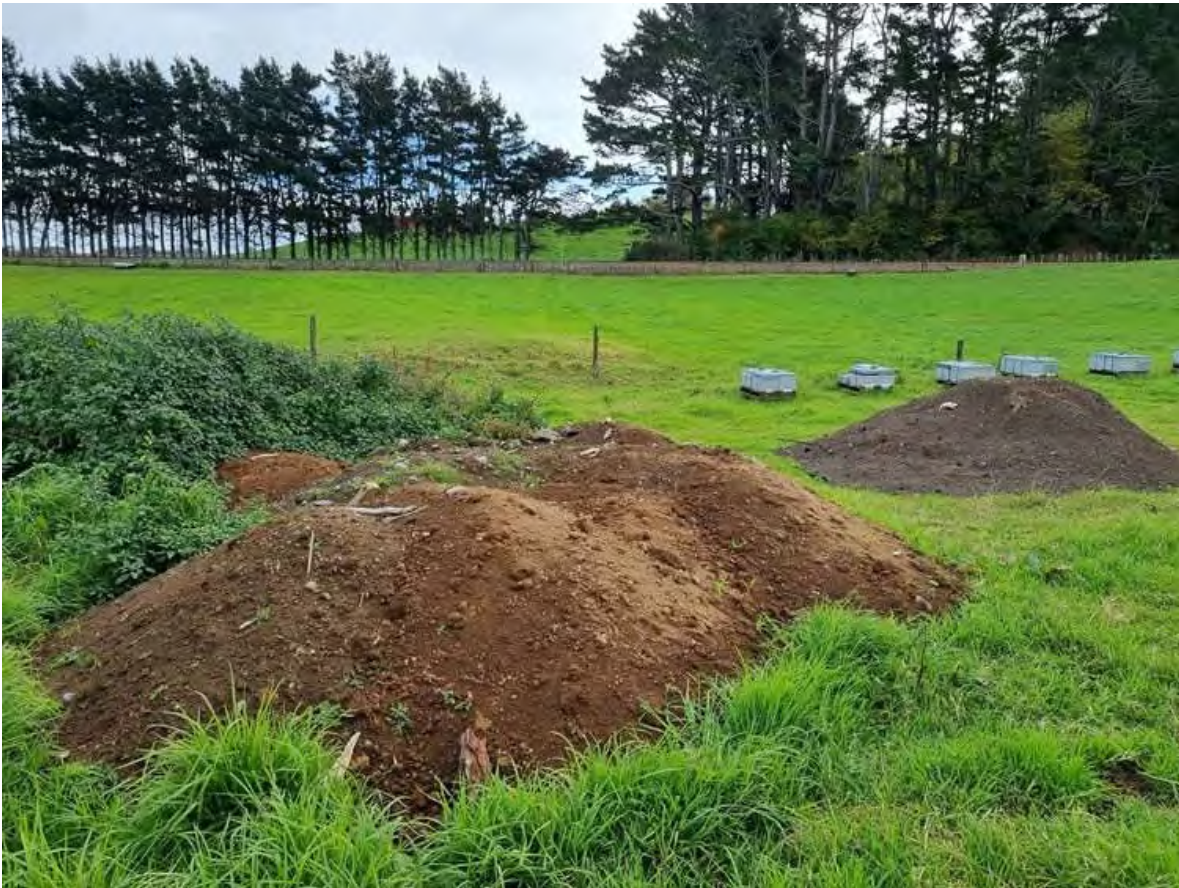
The cleanfill appeared to have been disused for some time. A very small pile of dirt and a large stump constituted the most recently discharged material (Photo 1). The pond to the front of the cleanfill was turbid in colour and was discharging to the tributary. A water sample was obtained downstream. A light sheen was noted on the water's surface, but there was no odour. A second sample was obtained upstream of the cleanfill and the water was clear and had no odour. The consent holder was informed that if the cleanfill was no longer in use, they may wish to surrender the consent. The site was deemed compliant with consent conditions.

Photo 1 A small amount of earth had been deposited at the cleanfill site, 27 May 2024

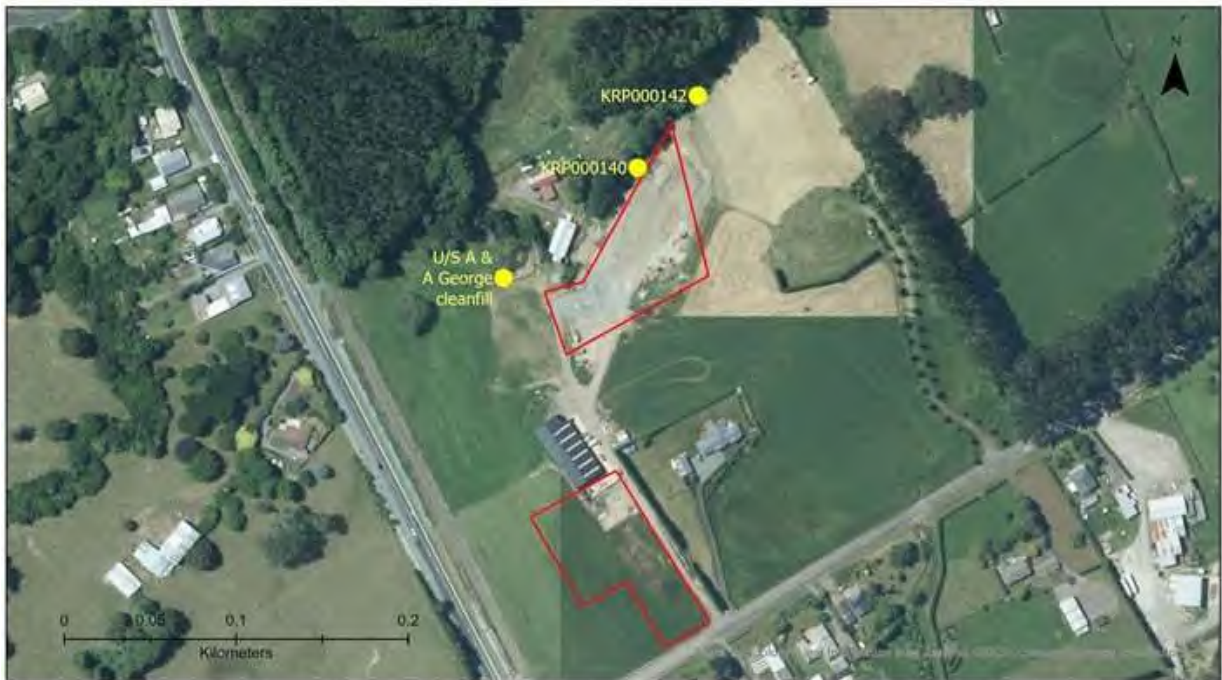
Figure 3 A & A George Family Trust consented cleanfill area at Dudley Road, Inglewood

A & A George Family Trust (George Family) holds Resource Consent 9680-1.1, obtained in September 2013, to discharge cleanfill onto and into land at a site on Dudley Road, Inglewood (Figure 3). The consent holder is using cleanfill material to fill a depression on the property. Once filled, the site will be contoured and re-grassed. Consent 9680-1.1 is a variation of the original cleanfill Consent (9680-1) and was obtained retrospectively following the discovery that cleanfill had been discharged beyond the original permitted area. To accommodate the cleanfill extension, the George Family obtained a retrospective piping Consent (10748-1.0), to account for 30m of existing piping. This consent also permitted the installation of an additional 65m of piping in an unnamed tributary of the Kurapete Stream.

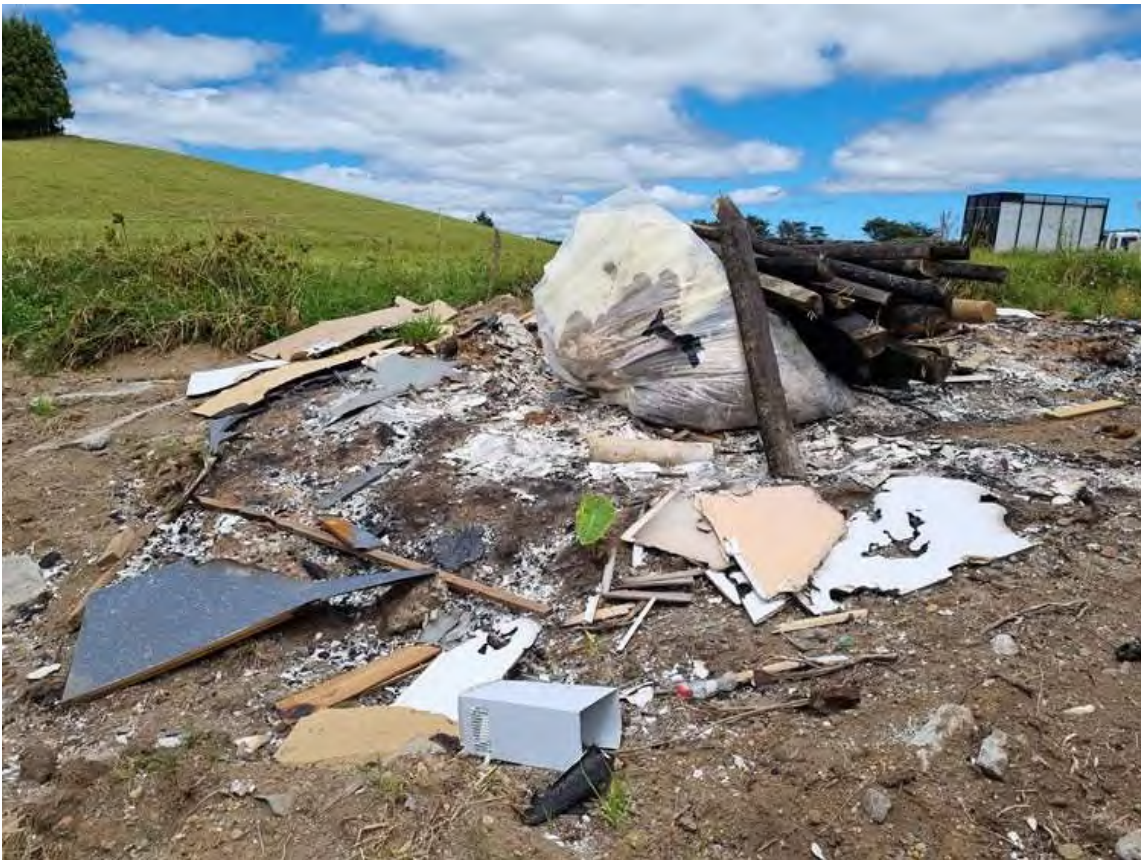
The site inspection was conducted during fine weather. Upon arrival at the cleanfill discharge area, the inspecting officers noted that a pile of unacceptable material had been discharged at the top of the fill (Photo 2). Items included polystyrene and treated timber. There was evidence that this was intended as a burning pile and the area had been used as such recently. A fresh pile of earth had been discharged in the near vicinity. A small quantity of grass clippings and treated timber were observed near the base of the fill face. A request was made to the consent holder to refrain from discharging prohibited material to the cleanfill as this may generate leachate which could adversely affect the receiving environment. A rill was noted to have formed down the western side of the unstabilised tip face. The area at the toe of the face was well vegetated and no sediment appeared to be making its way into the unnamed tributary. As the small sediment retention ponds were dry and vegetated at the time of inspection, no discharge was occurring to the tributary. The culverted section of the tributary was observed to be discharging and the bed of the unnamed tributary had a moderate iron oxide coating.

Photo 2 Prohibited material deposited at the top of the George cleanfill, 14 February 2024

During the year under review, there was one instance where prohibited material was noted to have been discharged to the consented cleanfill site (Photo 2) and two instances where prohibited material was discharged to an unconsented site on the neighbouring property (Photo 3, Photo 4 and Figure 4). The consent holder was issued an abatement notice which stated that discharge to the site must cease. Upon reinspection, it was apparent that the site had been cleared and tidied and the abatement notice was being complied with at the time of inspection. The results of physico-chemical analysis demonstrated that apart from ammoniacal nitrogen which had the highest value of all the cleanfill sites, all other analytes fell within the range of results for this monitoring year. The result for ammoniacal nitrogen is likely to be related to sources in the near vicinity of the sampling site however, none were apparent at the time of the monitoring inspections. This elevated trend will be monitored more closely in the 2024/25 year.

During the year, the George Family demonstrated a high level of administrative performance and improvement was required in relation to their environmental performance for the resource consent defined in Appendix II. On one occasion, inspecting officers discovered that prohibited material had been discharged to the consented cleanfill site. On two occasions inspecting officers observed that cleanfill material had been discharged to an unconsented site on the adjacent property. The results of chemical sampling show elevated ammoniacal nitrogen values.

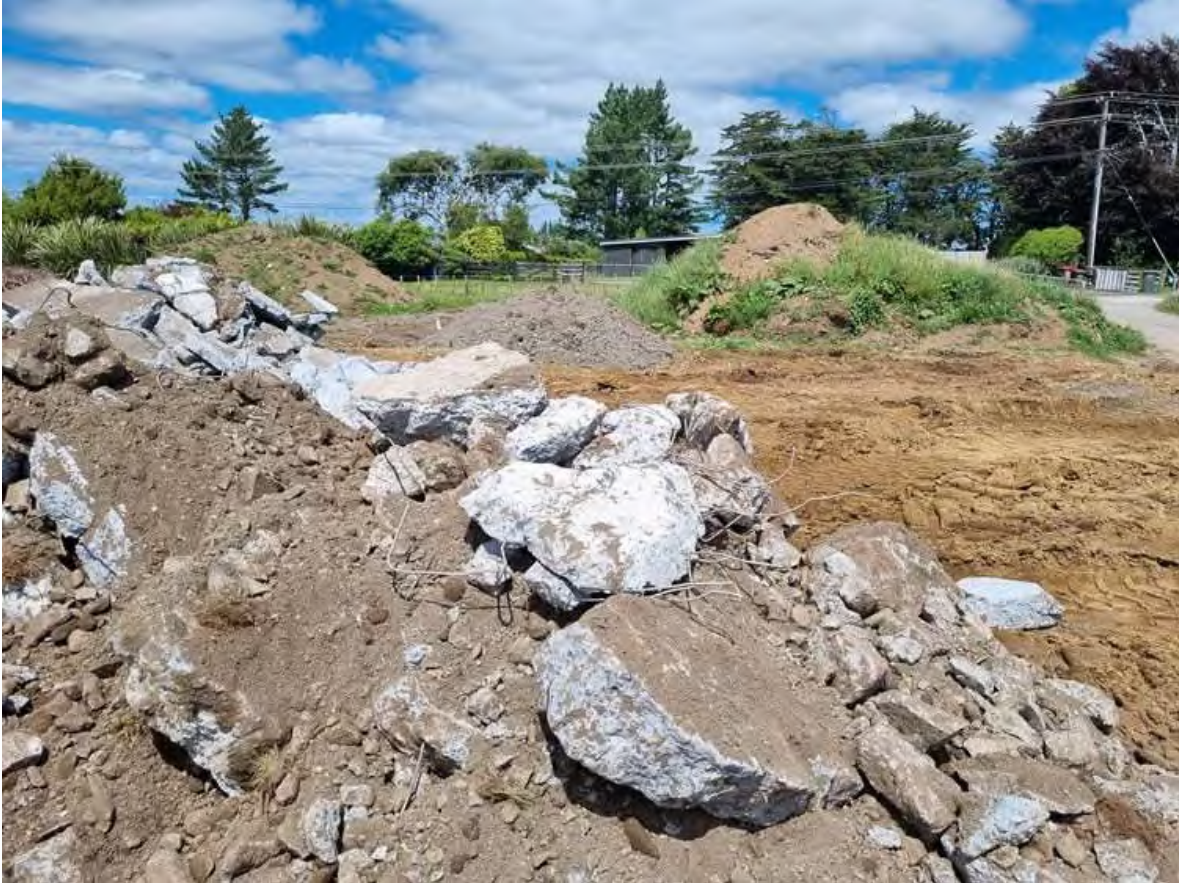
The property to the right of the site entrance was observed to contain piles of cleanfill material which included soil, some treated timber and broken concrete with some protruding rebar (Photo 3). It was apparent that earthworks were underway. A small amount polystyrene and cardboard had been deposited at the site. The inspecting officers noted that this area was not part of the consented cleanfill discharge extent. The personnel onsite at the time of inspection were informed that an inspecting officer would return within a week to conduct water sampling. This sampling occurred on the 19 February 2024 and samples were obtained at two downstream locations and one location upstream of the cleanfill. The culverted section of tributary was discharging. The results of the water sampling demonstrated that the site was compliant with consent conditions. The piles of cleanfill material at the property adjacent to the site entrance were no longer evident and the site had been levelled since the last inspection. Broken concrete was visible within the slope of the newly levelled area. The small amount of refuse had also been removed.

Photo 3 Cleanfill material discharged to an unconsented area of the neighbouring property, 14 February 2024

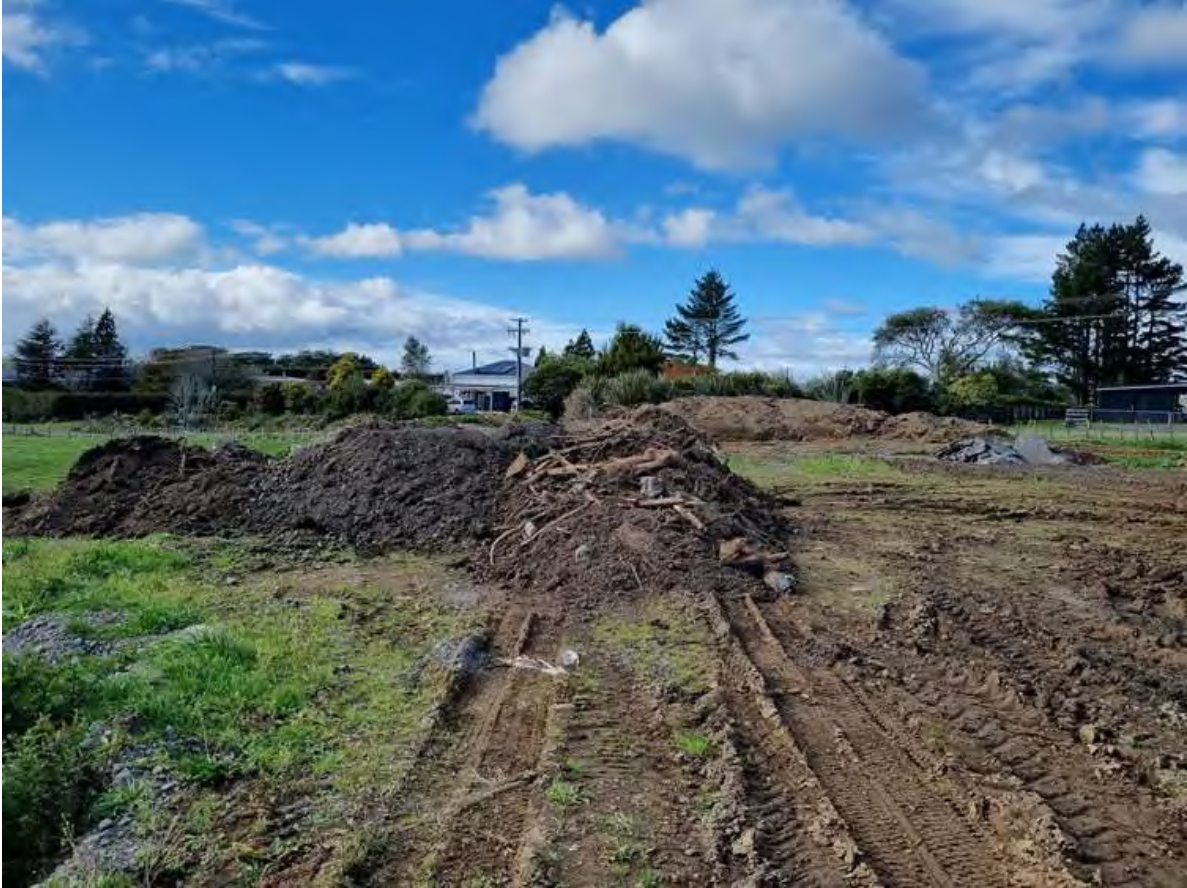
The consented cleanfill site was inspected and looked disused. No prohibited substances were noted. The fill face was well vegetated and no sediment or discharge was observed at the toe of the cleanfill. The small settling ponds were dry and no discharge to the tributary was observed. The inspecting officer noted that the unconsented cleanfill site on the adjacent property appeared to have been used since the previous inspection. Discharged material included piles of dirt, roading aggregate, tree stumps, concrete-filled steel drums, green waste and tanalised timber (Photo 4). The fill face was un-stabilised with no silt retention fencing in place. There was a small amount of water ponding at the base of the fill face. The site was deemed non-compliant at this inspection. The inspecting officer contacted the consent holder to discuss the unconsented discharge and advised that the activity needed to cease pending an evaluation of consent requirements.

Photo 4 Fresh cleanfill material had been discharged to the unconsented site on the neighbouring property, 28 May 2024

1. THAT in the first instance, monitoring of discharges from the A & A George cleanfill in the 2024/25 period continues at the same level as scheduled for 2023/24.
2. THAT the consent holder apply for a new resource consent should they wish to discharge cleanfill material to the adjacent property.
3. THAT should there be issues with environmental or administrative performance in 2024/25, monitoring may be adjusted to reflect any additional investigation or intervention as found necessary.

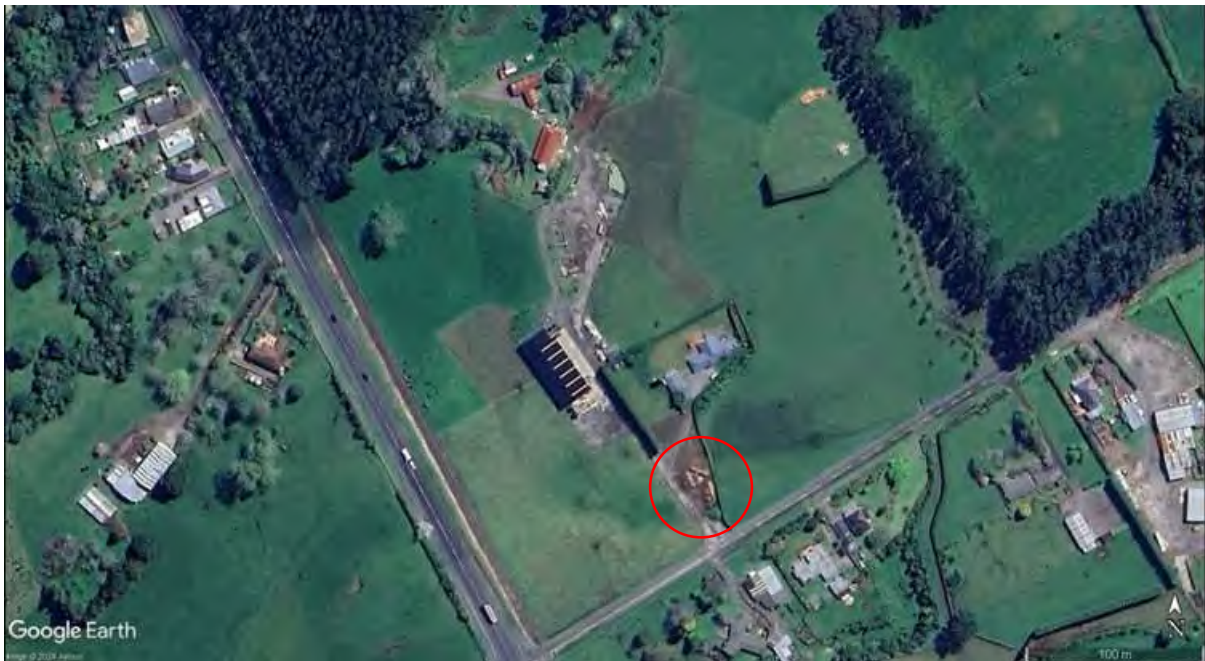
Figure 4 Location of unauthorised cleanfill discharge on neighbouring property

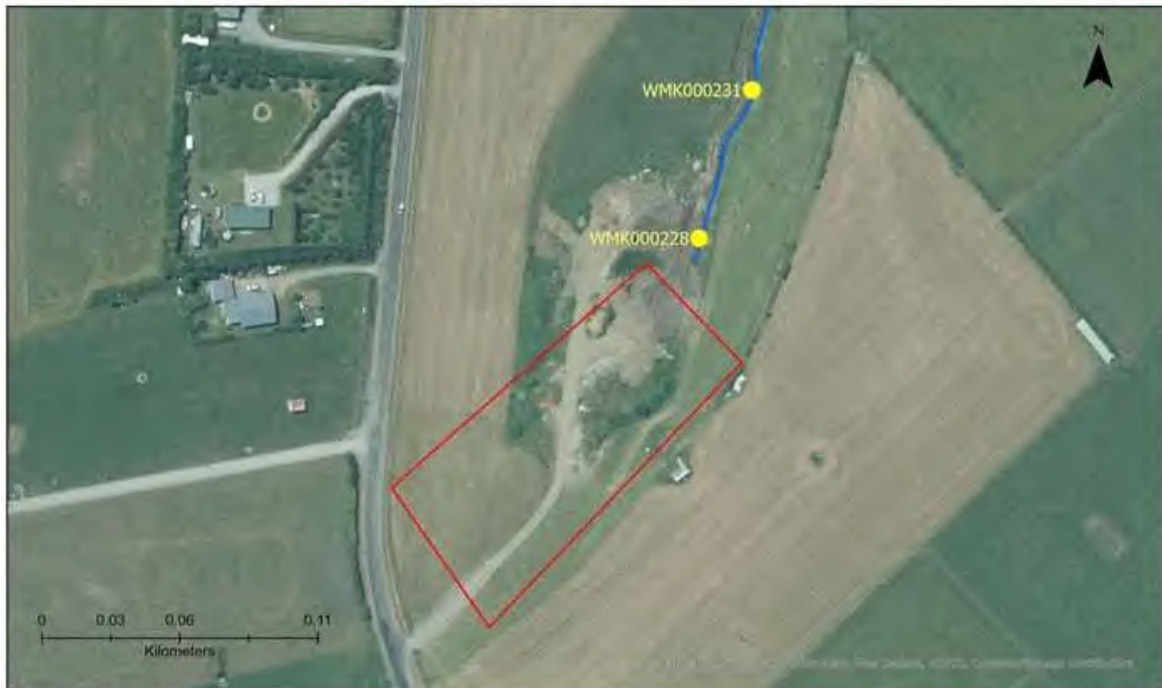
Figure 5 BJ & LB Bishop's cleanfill and sampling sites at Ahu Ahu Road, Oakura

BJ and LB Bishop (Bishop) hold Consent 5877-2 to discharge cleanfill onto and into land and Consent 5888-2 to install and maintain a culvert on their property on Ahu Ahu Road. A small gully is being infilled to enhance grazeable area (Figure 5). A 70m culvert which passes through the cleanfill conveys surface water from the Ahu Ahu Road roadside drain.

The types of materials accepted at the Bishop cleanfill include construction concrete, road and track metal, clay and topsoil. Following the completion of the filling, the area will be restored with topsoil and pasture grass. The location of the cleanfill and the current approximate area filled is shown in Figure 5. The full consented extent is shown in the consent (Appendix I).

Two sampling sites are situated downstream of the cleanfill in a tributary of the Waimoku Stream (Figure 5). A sample was collected from each of these two locations on 27 May 2024. The results are presented in Table 12.

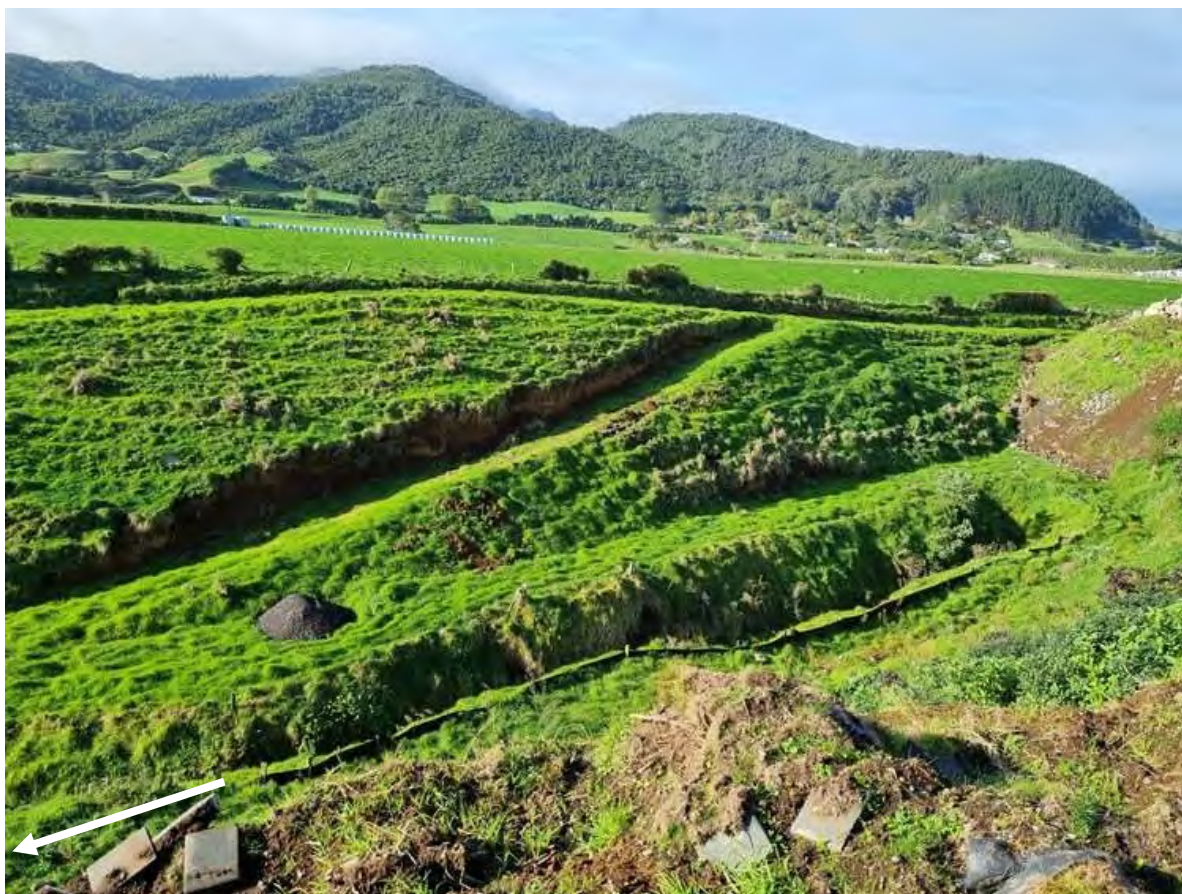
The site generally appeared to be well managed during the year under review. Little to no prohibited material was observed and the site was tidy. It was noted that the silt retention fence did not extend for the entire length of the cleanfill site (Photo 5). This was raised with the consent holder as the adjacent unnamed tributary was not adequately protected. Laboratory sampling results showed that the site was compliant with consent conditions at the time of inspection.

A desk assessment of aerial imagery of the site revealed that the cleanfill had extended beyond its consented area. This was referred to the Council's Compliance Department. The Company indicated that they wished to apply to extend their cleanfill area. Given that the cleanfill consent is contingent upon being granted an extension of piping for the tributary, the Company was informed that under current legislation, it would be unlikely that they would be granted either consent. They were advised to only discharge material within the consented area until the outcome of the consent application was finalised. The Company investigated a new potential discharge area however, decided to stop accepting material and closed the site to the public. As the consent expires in 2031, the Company wishes to keep it in the event that government legislation changes. Inspections and sampling will continue until such a time as the consent is surrendered.

Photo 5 Bishop cleanfill. The silt retention fence required extension in the direction indicated by the arrow, 27 May 2024

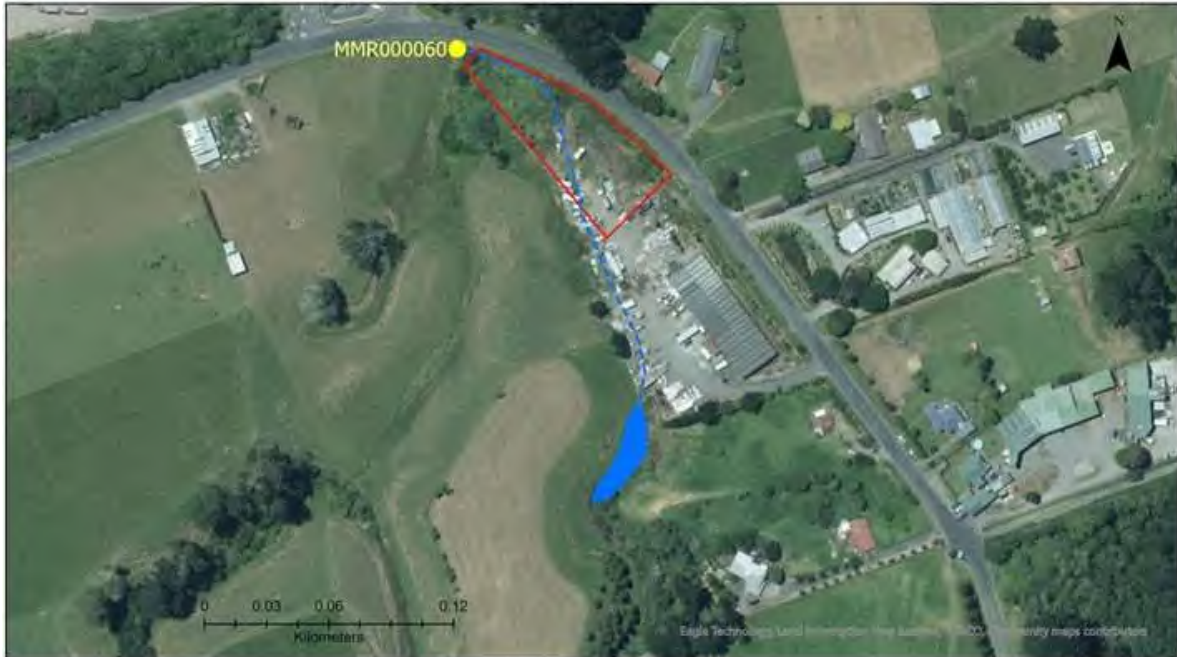
Figure 6 Gas and Plumbing Ltd's cleanfill and sampling site at Colson Road, New Plymouth

The site (Figure 6) is situated opposite the Colson Road transfer station entrance and clean filling operations at this site commenced in late 2007. The associated culvert consent is held by Wayne Eustace who is a director of Gas and Plumbing. A portion of the permitted cleanfill extent has been utilised for development as part of site expansion. The remainder of the cleanfill area toward the sampling site is densely overgrown.

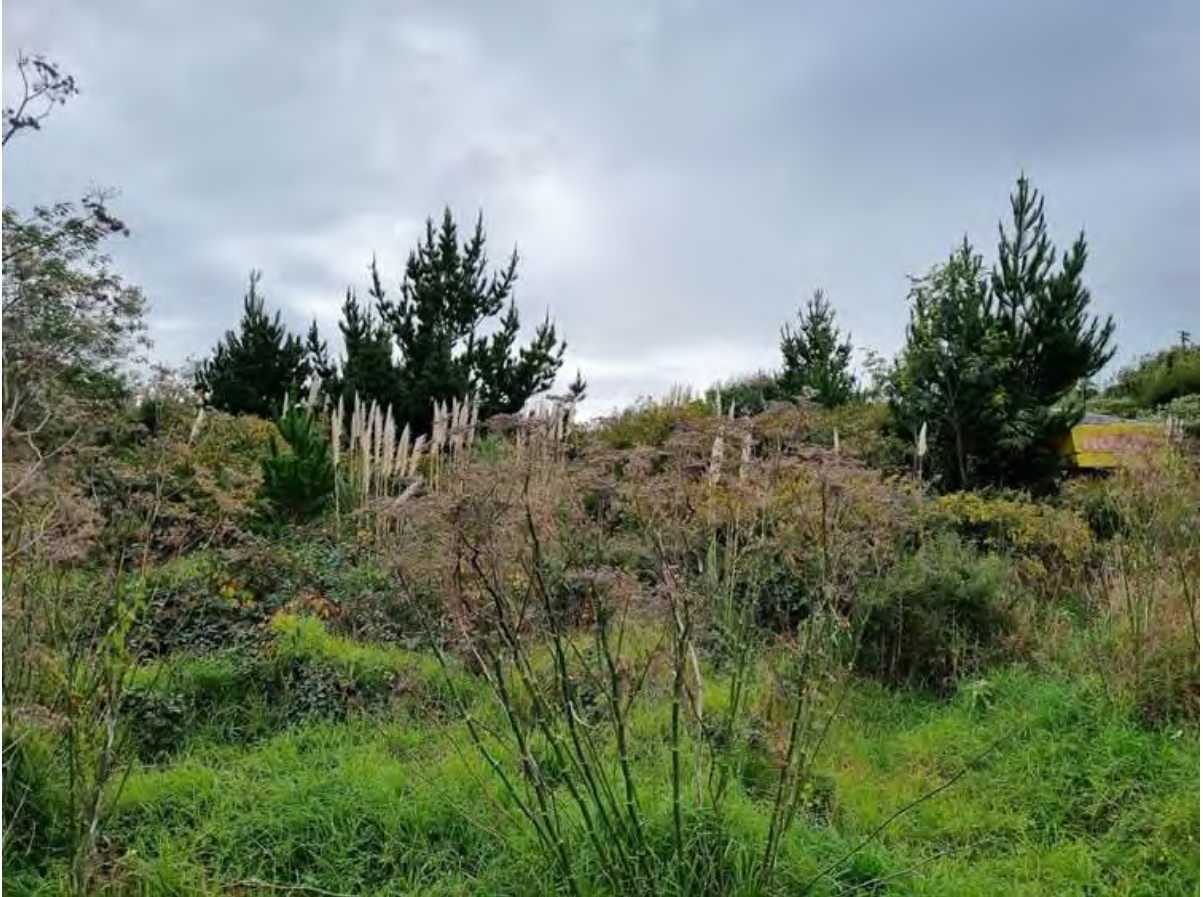
Upon arrival, the inspecting officer spoke to an employee at the site who confirmed that the cleanfill had not been used for a long time. As the cleanfill was overgrown, it was difficult to access the site and determine where its extent began (Photo 6). The inspecting officer noted that old trailers were scattered

around the site. A sample was obtained from the designated sampling area. The consent holder was advised that they may wish to surrender the consent to avoid on going inspection fees.

Photo 6 Gas & Plumbing cleanfill, 27 May 2024

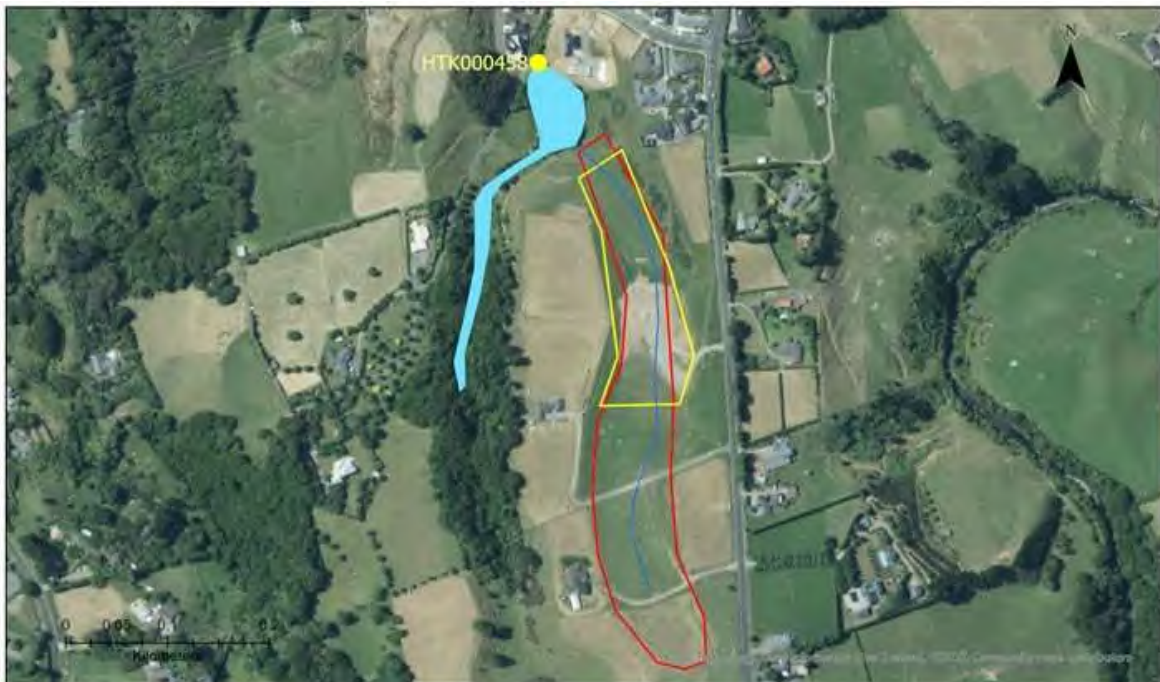
Figure 7 Taranaki Civil Construction cleanfill and sampling location, Carrington Road, Hurworth

Any stormwater and potential leachate discharged from the cleanfill was anticipated to enter the unnamed tributary followed by the natural wetland and then the Huatoki River 2.6km downstream. The Council has been monitoring potential effects upon the receiving environment.

A water sample was obtained for analysis from the designated wetland outlet sampling site (Figure 7) on 14 February 2024. The results are presented in Table 20.

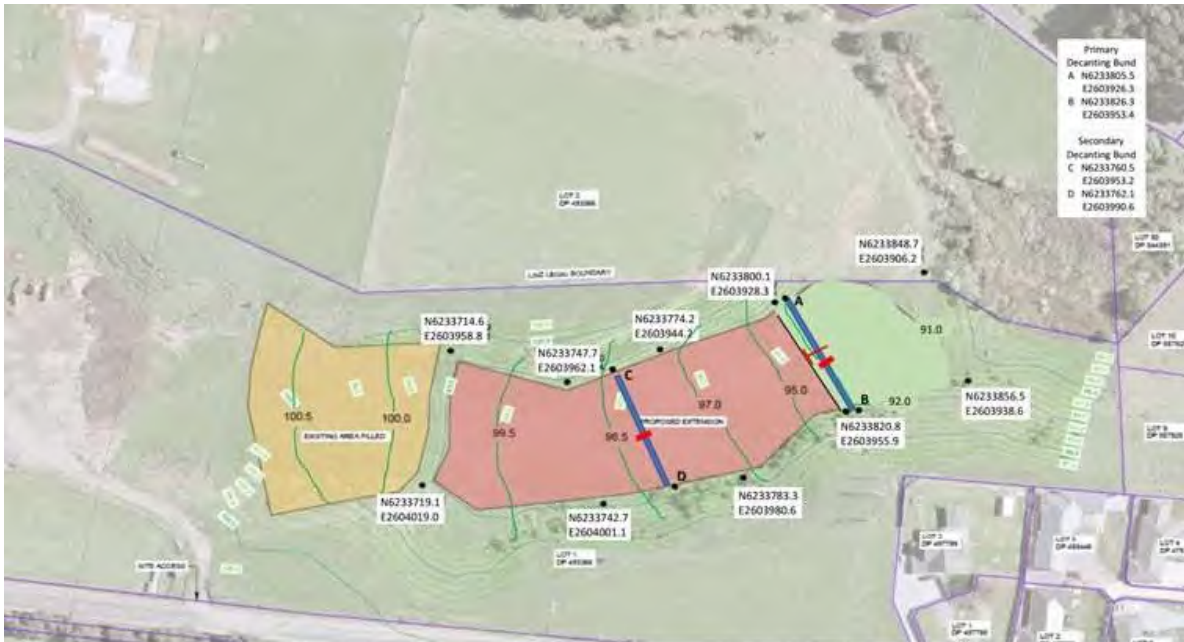
Figure 8 Permitted extent of the Taranaki Civil Construction cleanfill on Carrington Road, Hurworth

Taranaki Civil obtained Resource Consent 10990-1.0 on 4 March 2022 to extend the existing fill site by continuing a second lift on top of the earlier fill. The extension was for an area of 3,900m², with an average fill depth of 4m prior to the capping of the site. The toe of the fill site was to be contoured to a grazeable grade that would finish 50m from the natural wetland associated with an unnamed tributary of the Huatoki Stream. The stream runs across the bottom of the property (Figure 7). The total volume of the extension was approximately 20,000m³ and had an expected lifespan of between four and 10 years. The consented area of the cleanfill is shown in Figure 7. Once cleanfilling activity ceased, the site was contoured, capped and stabilised with vegetation. The Council is currently working with the Company to finalise stabilisation requirements.

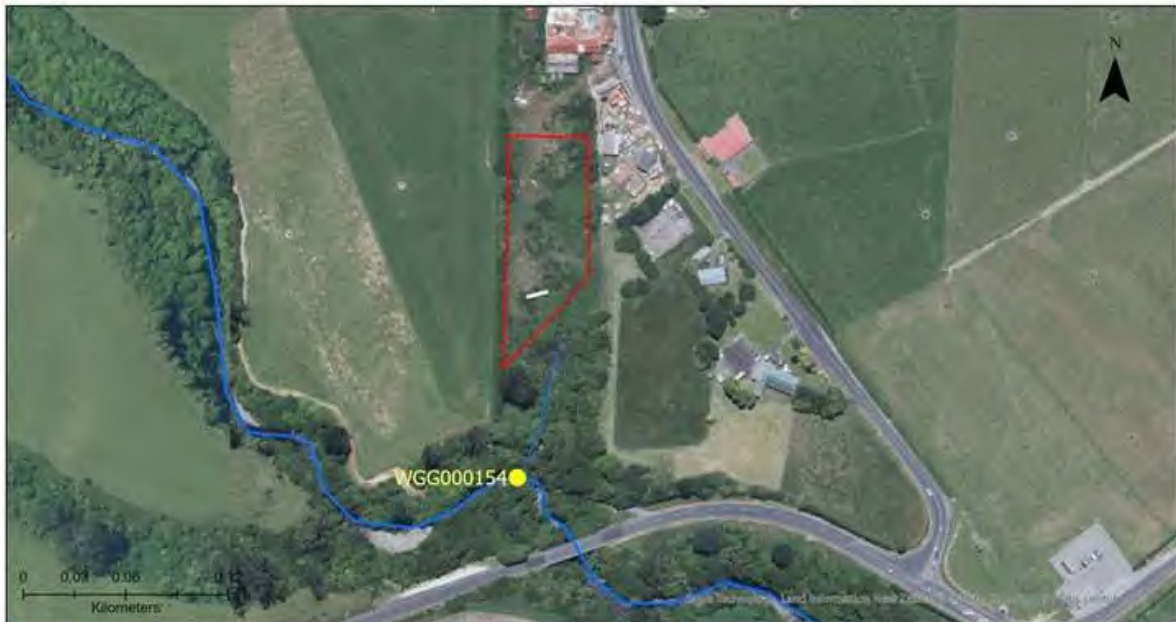
Figure 9 Taranaki Trucking Company Ltd's cleanfill and sampling site at Cardiff Road Stratford

The site is bounded by Cardiff Road to the east, the Waingongoro River to the west, and an old dairy factory to the north (Figure 9). The fill area is a steep, narrow gully approximately 35m wide. The capacity of the site is limited and this is one of the smaller cleanfills described in this report.

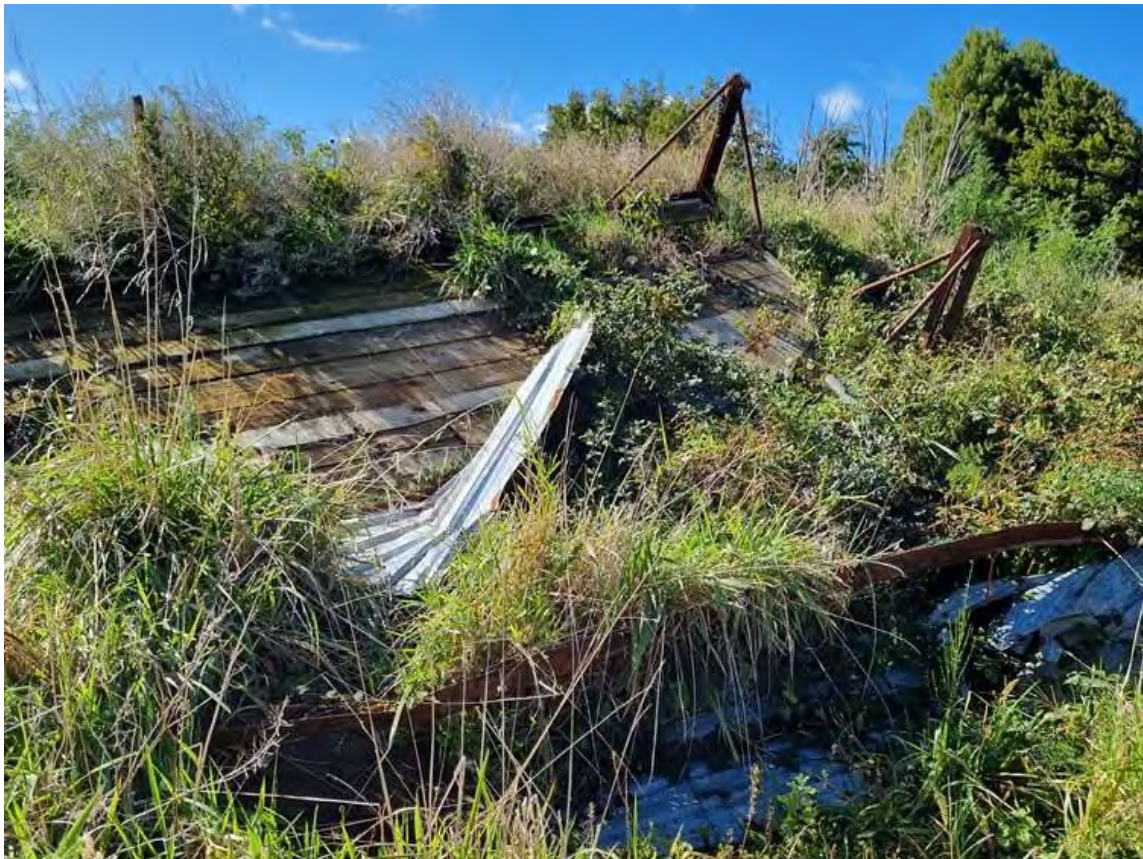
The inspection was conducted during fine weather conditions. The Council's inspecting officers were the sole personnel onsite. It was evident that no new material had been deposited at the front and mid-section of the cleanfill area. The site did not appear to have been contoured or capped as a small amount of exposed roading aggregate was visible and cleanfill material presented as hummocky mounds which were stabilised with dense grass growth. Broken concrete seemed to constitute a large portion of the material still visible within the mounds. Some prohibited material was observed on site (Photo 8), this included galvanised metal. There were also pieces of rusted machinery. Some small areas of surface ponding were evident on top of the fill, particularly in the digger tracks. It appeared that grass growth had not established at the rear of the site and the material was still quite soft underfoot. The fill face appeared to be well vegetated and stabilised. A water sample could not be obtained from the tributary at the time of inspection as it was dry. The inspecting officers noted that the Company should actively pursue consent surrender.

Photo 8 Galvanised metal and treated timber constituted part of the prohibited material observed on 23 April 2024
