Dimar Partnership Landfill
Monitoring Programme
Annual Report
2013-2014

Technical Report 2014-100

March 2015

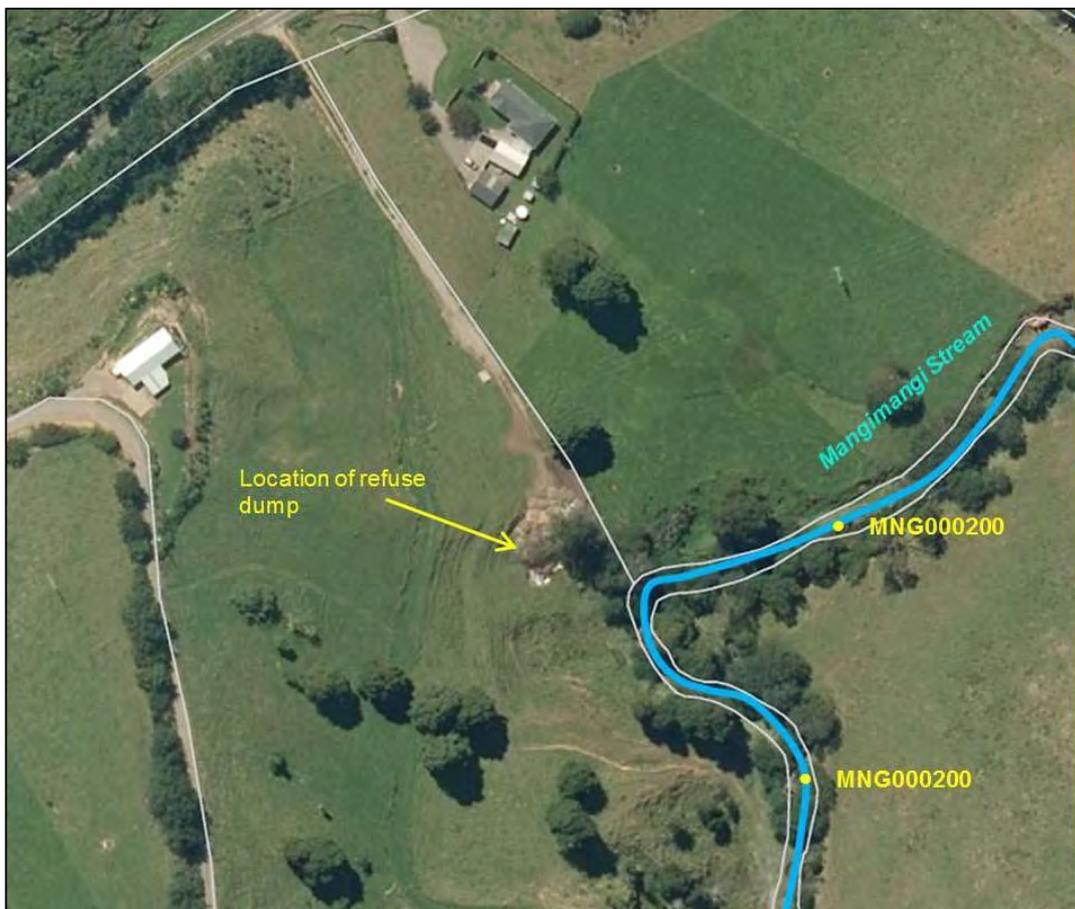
Figure 1 Aerial map of site and location of refuse dump and sampling sites

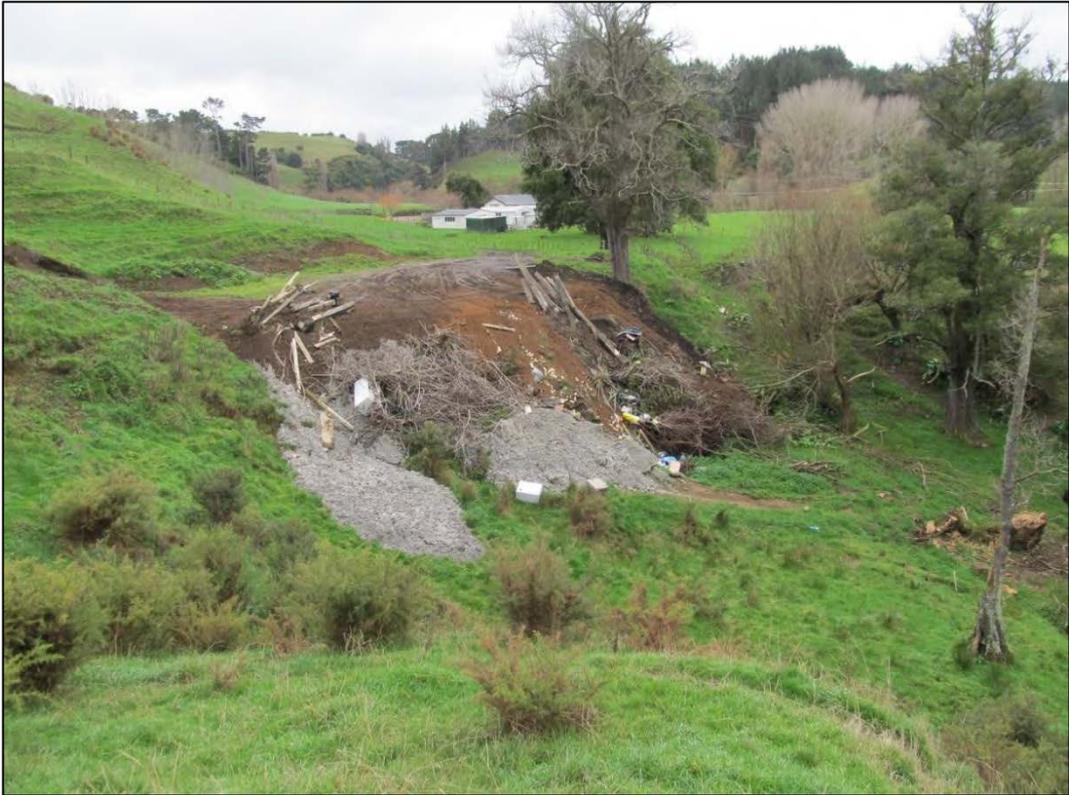
Photo 1 Photograph showing the refuse dump prior to capping

During this compliance monitoring inspection it was found that the filled area was not properly capped or vegetated and there was exposed refuse in several places. The consent holder informed the Council Officer that he had been away and this had delayed capping works. It was also outlined that another Council officer had been dealing with the consent holder. As works under abatement notice 12029 (to scrape back and cap) were still outstanding, the matter was referred back to inspectorate. Routine compliance monitoring will be still carried out to take water samples and monitor capping progress. Water samples were taken up and downstream of the site. During sampling it was noted that spring water was draining out from under the fill and flowing toward the stream in numerous places. No visual effects were noted in the waterway.

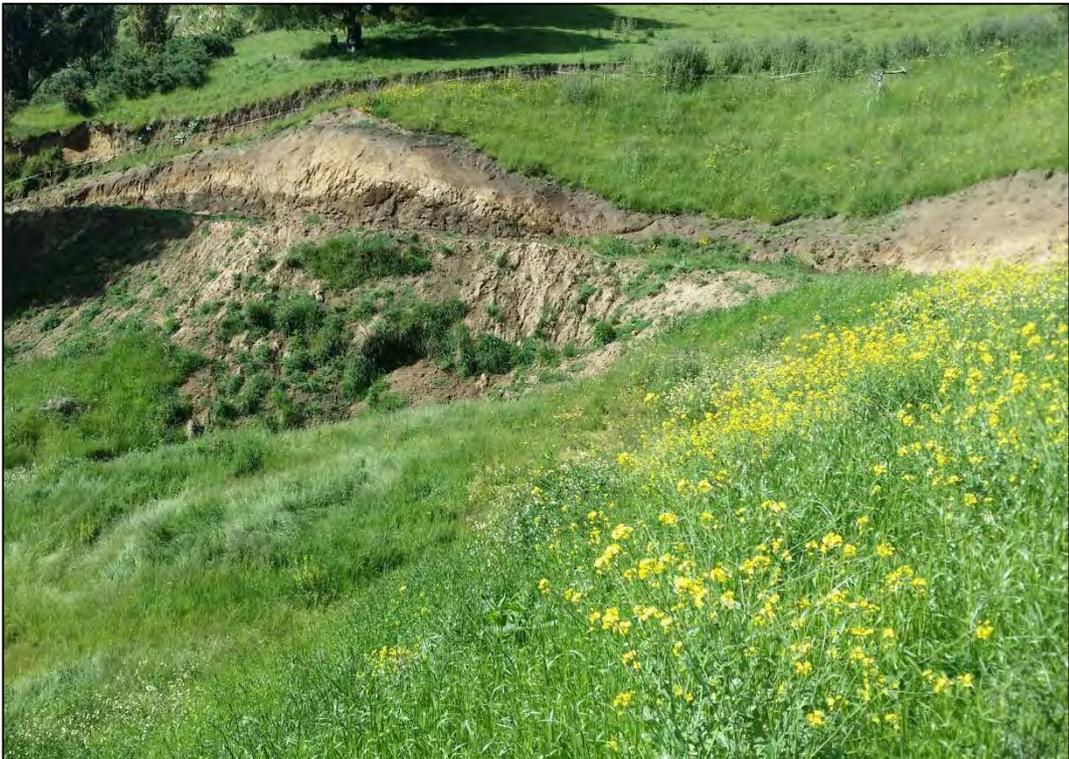
Photo 2 Photograph showing the refuse dump after capping (foreground)

During this compliance monitoring inspection, it was found that some more work had been done on capping of the tipface, however, there were still areas where refuse was exposed. There was also no vegetative cover on the cap as required by abatement notice 12029 and consent 9640-1. Routine compliance monitoring water samples were taken up and downstream of the site. During sampling it was noted that spring water was draining out from under the fill and towards the stream in numerous places. The stream was at a moderate flow and quite turbid. No visual effects on stream quality were noted.

The consent holder did not comply with the required timeframes in terms of having the necessary works undertaken to scrape back and cap the refuse. Until these works were undertaken it was not possible for consent 9640 to be complied with in regards to capping and vegetative growth on the site. The site was however found have been capped shortly after the end of the period under review, and the capped area was found to be well vegetated during a later inspection.
