Dimar Partnership Landfill
Monitoring Programme
Annual Report
2014-2015

Technical Report 2015-62

March 2016

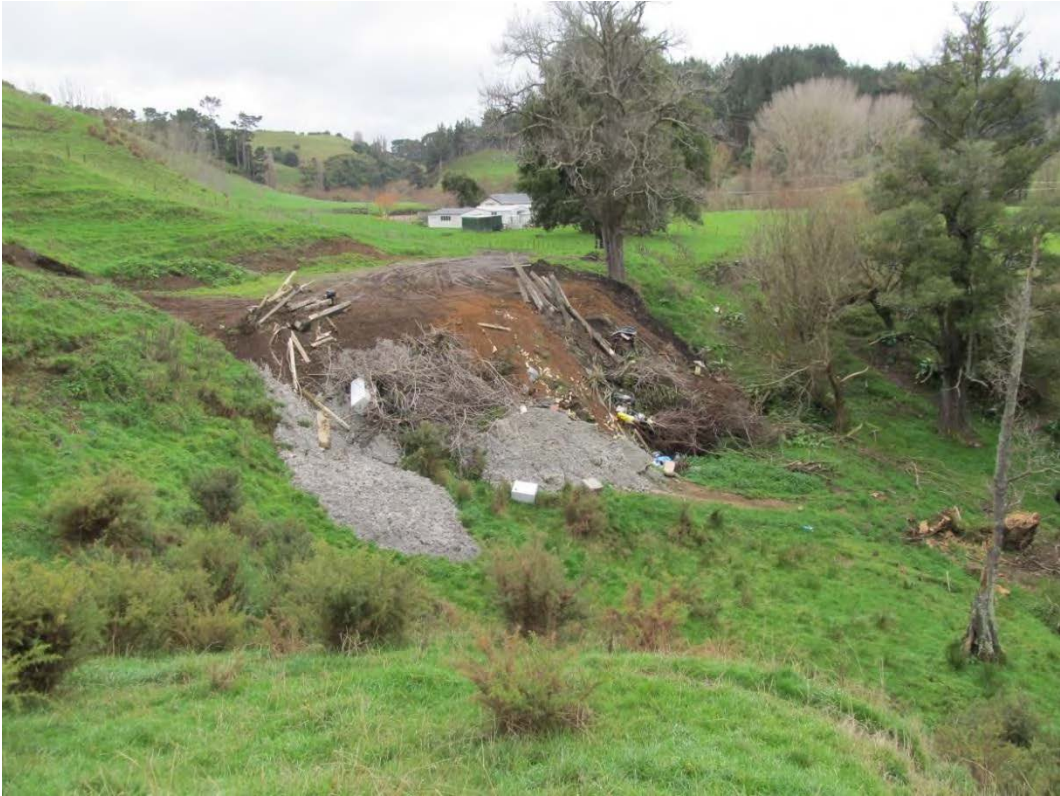
For a number of years the dump was filled with household rubbish, broken concrete, timber, tree prunings and farm waste from several of the surrounding properties. The dump is located approximately 22 m away from the Mangimangi Stream, therefore the discharge of contaminants (leachate) into the Mangimangi Stream has the potential to result in the contamination of surface water.

Photo 1 Photograph showing the refuse dump prior to capping

Since the recent closure of the dump, the consent holder has rehabilitated the site. This has involved removing all rubbish located within 25 m of the stream, covering the site with 500 mm of clay, which was shaped to the desired contour, capping with 500 mm of top soil and re-vegetating with grass.

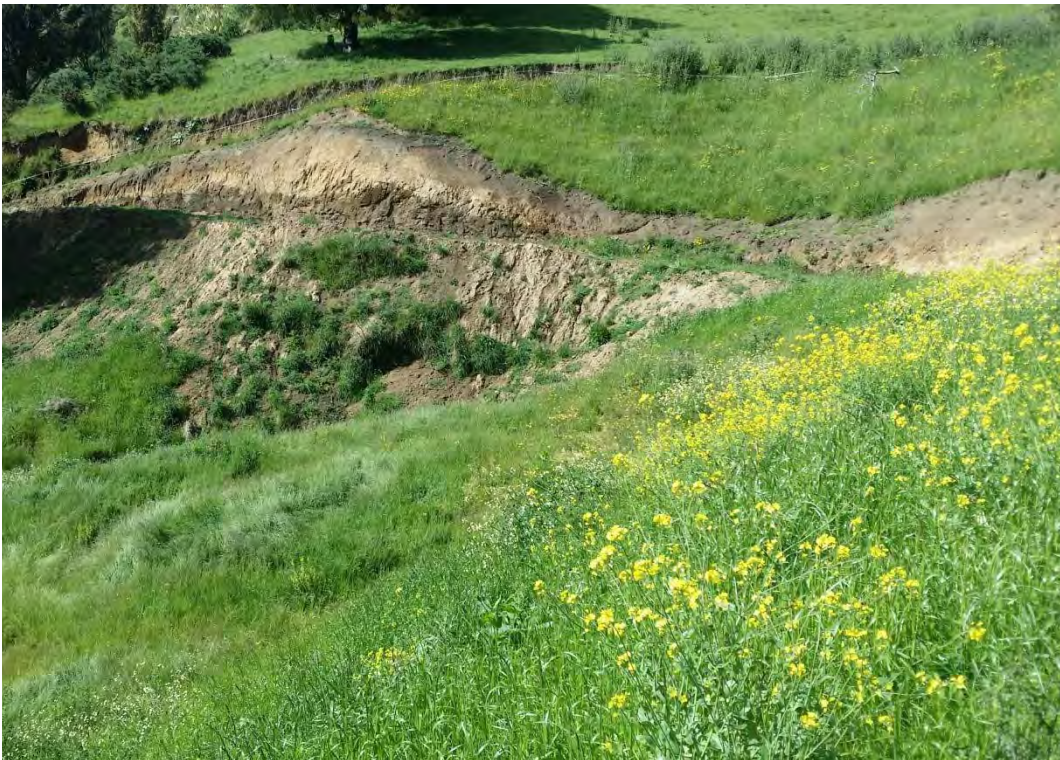
Photo 2 Photograph showing the refuse dump after capping (foreground)

A site visit was made in dry weather to conduct a compliance monitoring inspection and take samples. It was found that the area was capped and well vegetated. The cap was in good condition and no exposed refuse was observed. There was a temporary electric fence in place to prevent stock access. The abatement notice issued during the previous monitoring period was being complied with at the time of inspection. Routine compliance monitoring water samples were taken upstream and downstream of the site. The stream was at a moderate flow and was slightly turbid both upstream and downstream of the filled area, and no visual effects on stream quality were noted. It was observed that a drain had been constructed above the race up gradient of the cap that, at the time of inspection, was directing spring water around the cap. It was considered that the drain would also be adequate to direct stormwater from above the site, around the cap, during rainfall.

The cap appeared sound, with no evidence of slumping or erosion. It also had thick grass cover, and appeared to have performed well in the heavy rain. Spring water from the hill above the area continued to be directed around the cap.
