NPDC – Colson Road Landfill  
Monitoring Programme  
Annual Report  
2014-2015

Technical Report 2015-74

February 2016

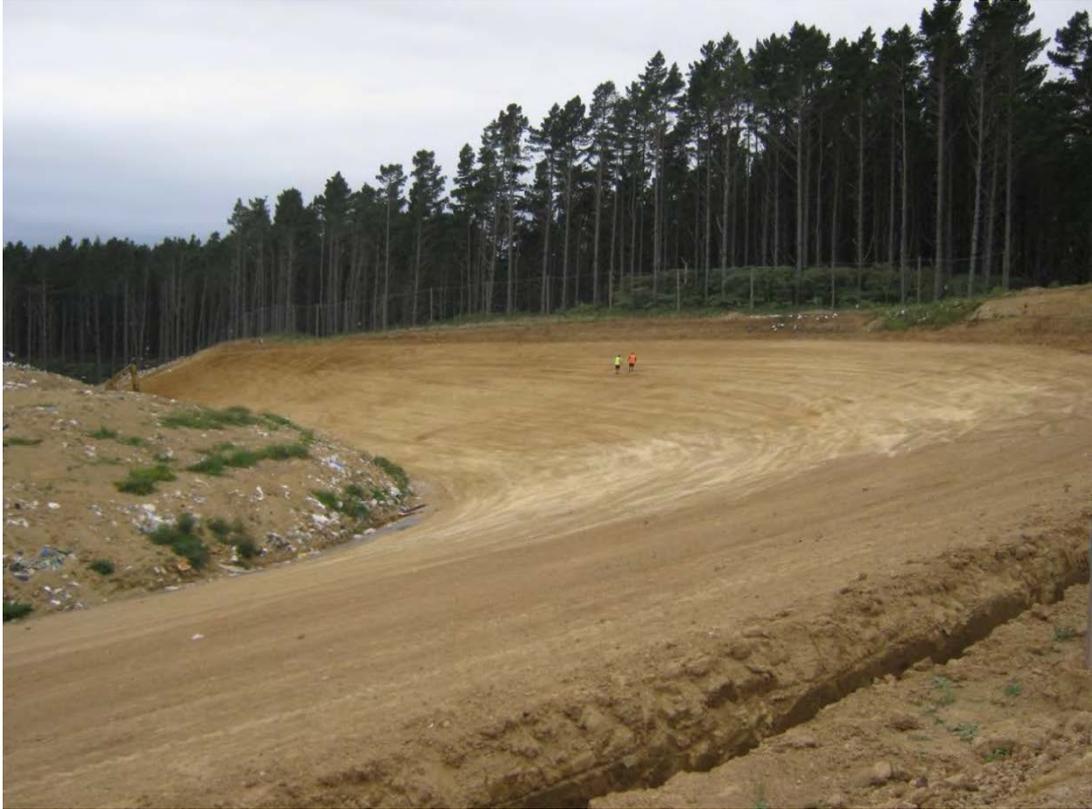
Photograph 1 Stage three extension works, February 2011

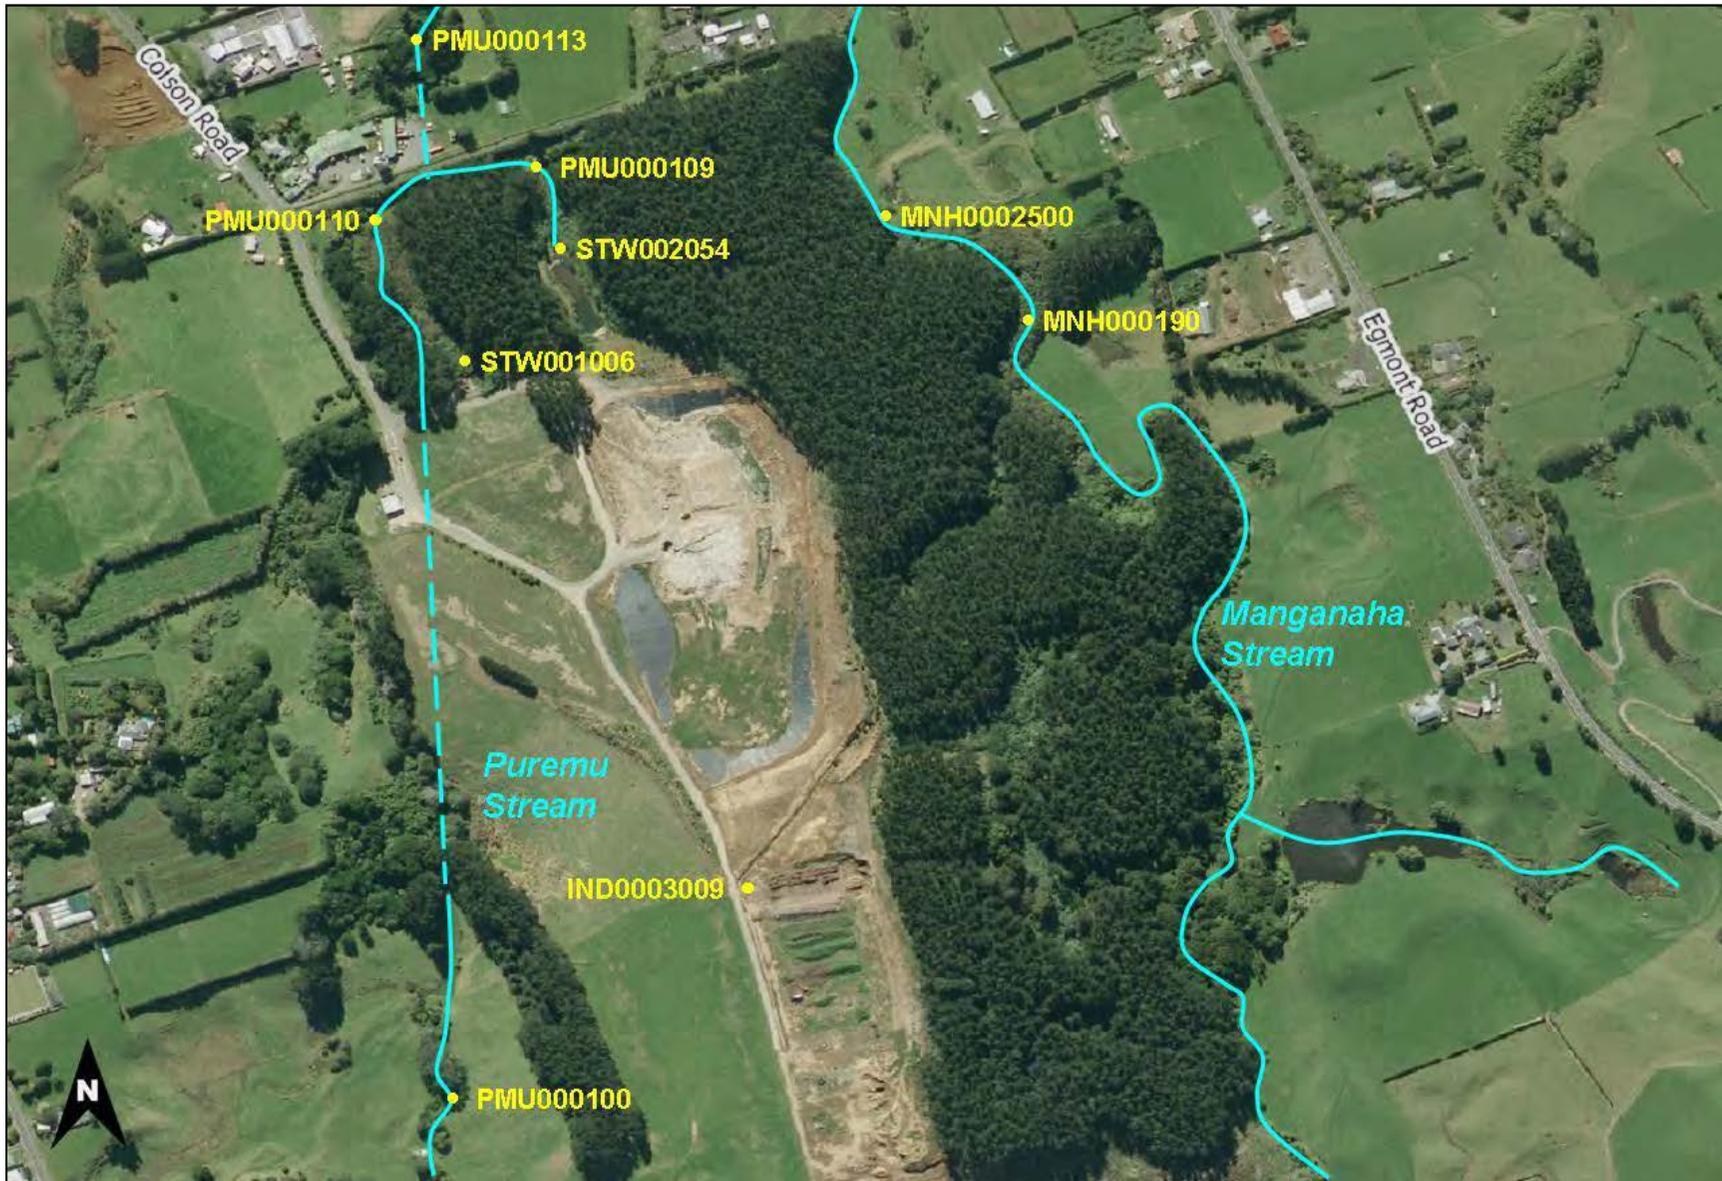
**Figure 2** Aerial photo showing the stormwater and receiving water sampling sites at Colson Road landfill

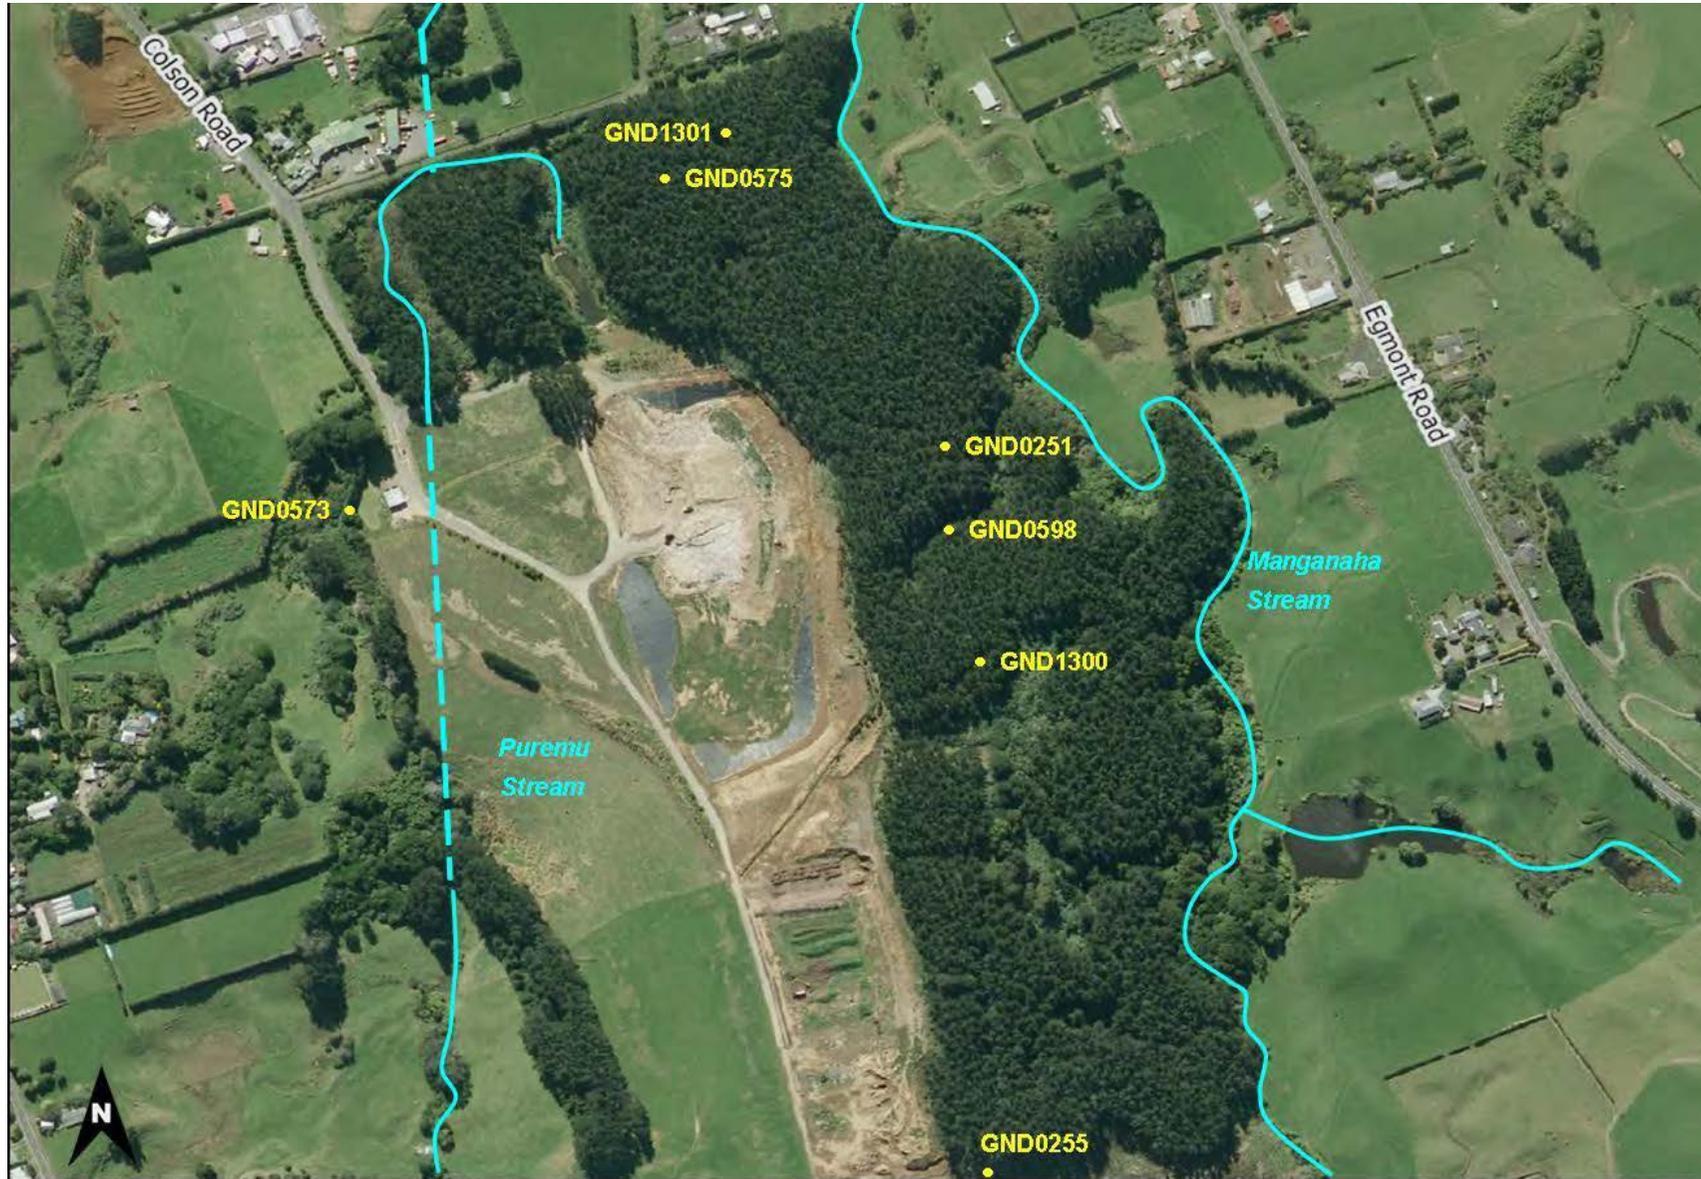
**Figure 3** Aerial view of Colson Road landfill showing the positions of groundwater monitoring bores

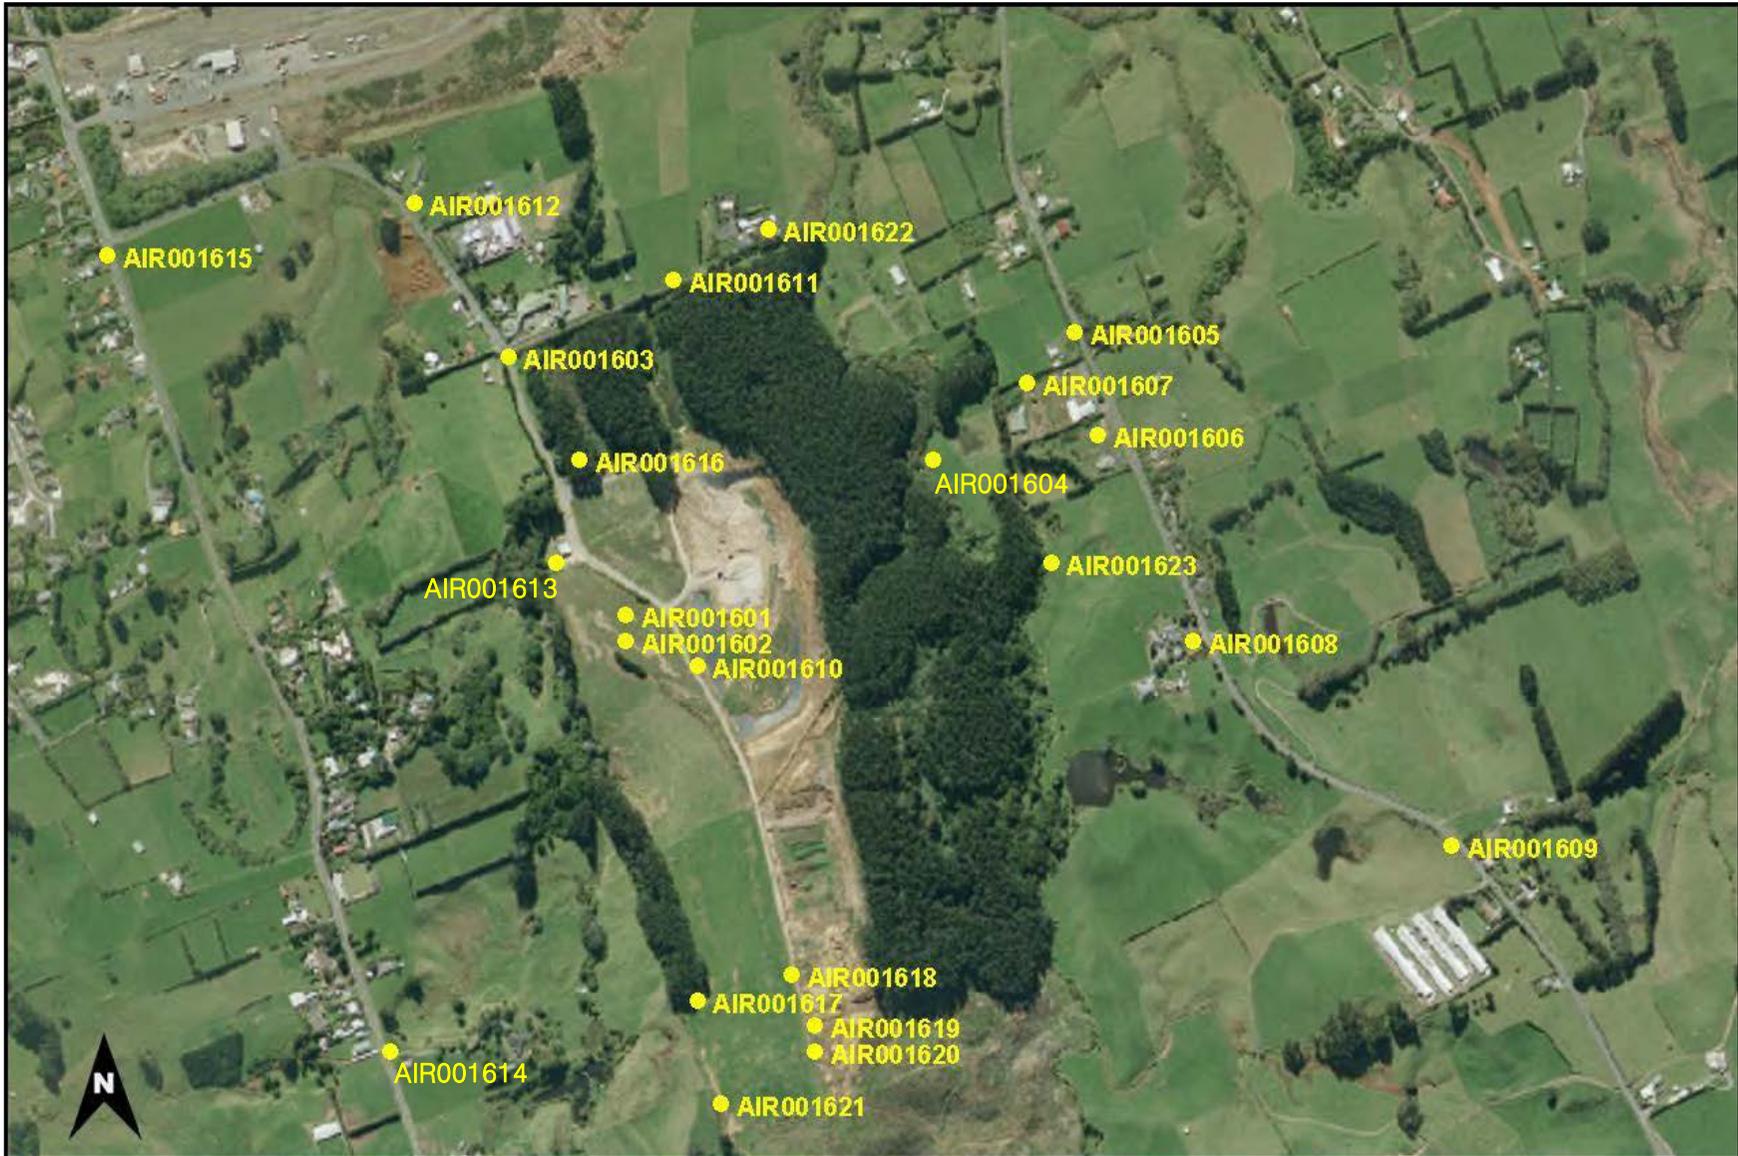
**Figure 4** Aerial view of Colson Road landfill showing the positions of air quality monitoring sites

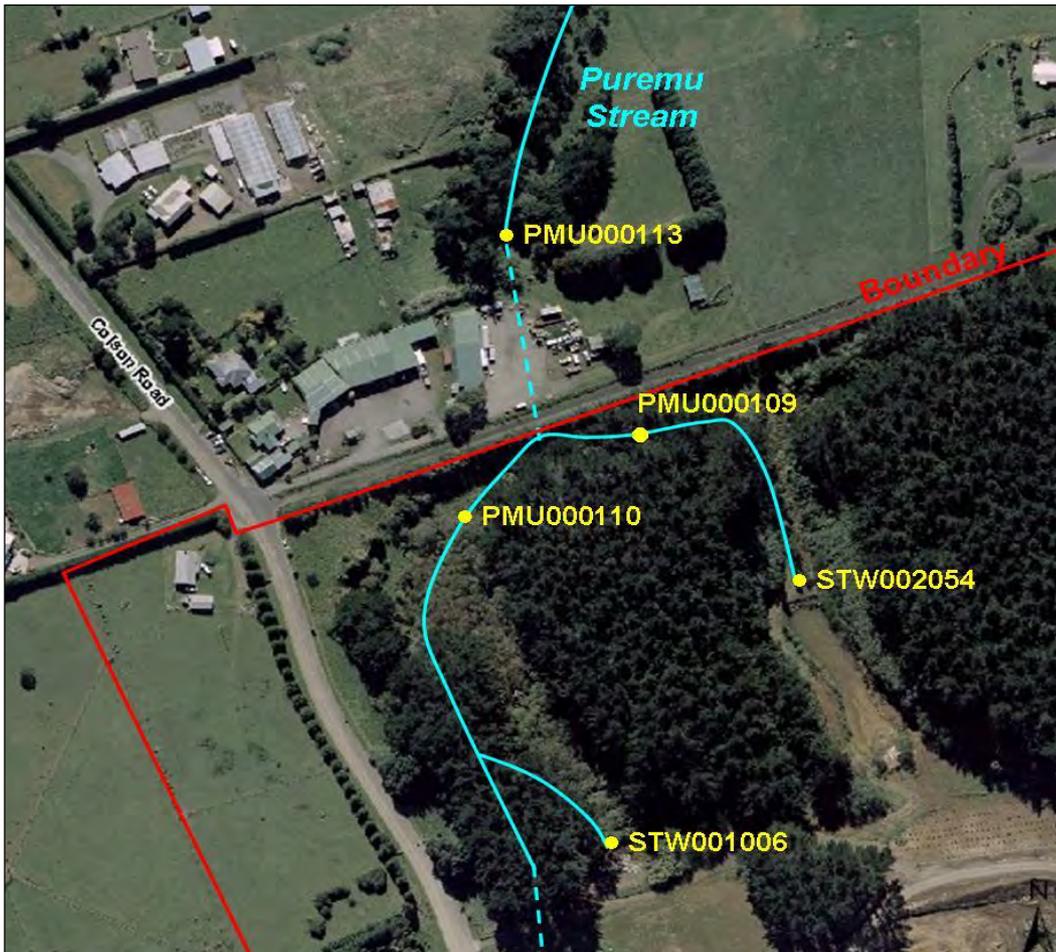
The downstream sampling sites shown in Figure 5 and the results are given in Tables 6 and 7.

**Figure 5** Sampling sites on the Puremu Stream down stream of the landfill

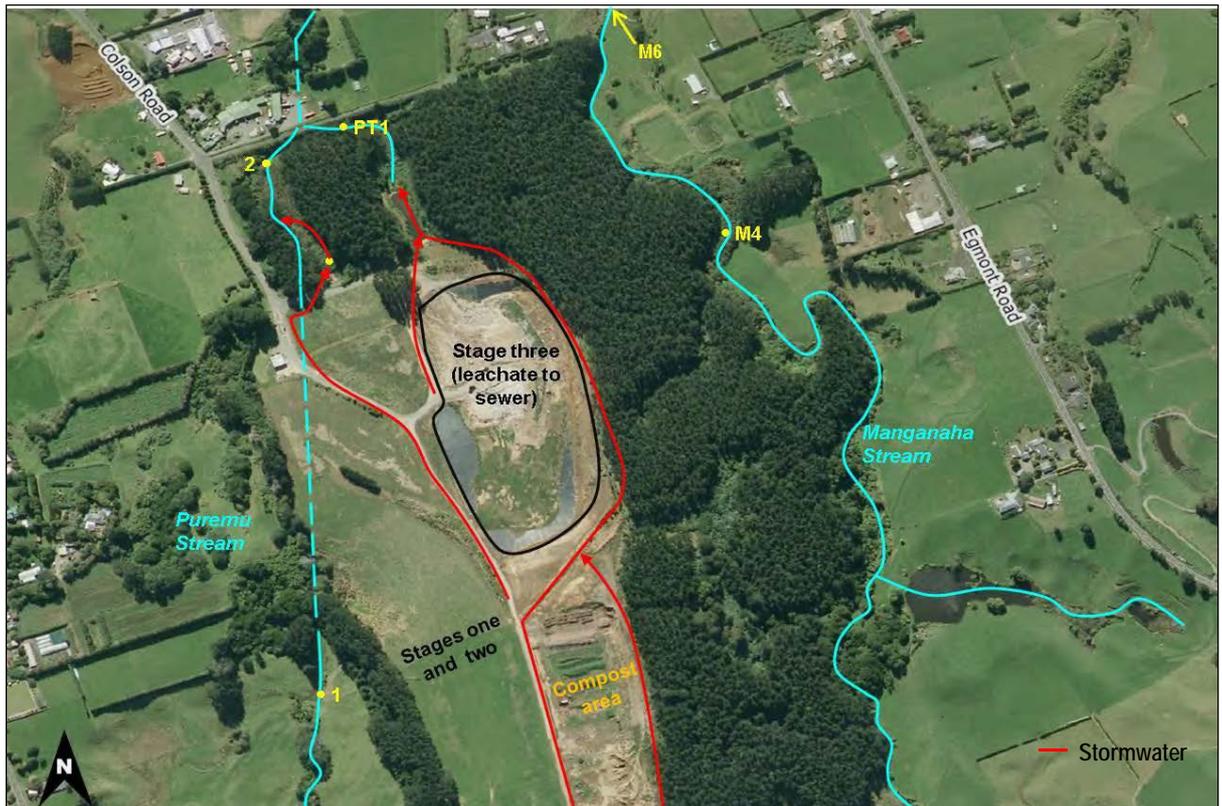
The sites sampled are shown in Figure 6, and are described in Table 12.

**Figure 6** Biomonitoring sites related to the Colson Road landfill, New Plymouth.

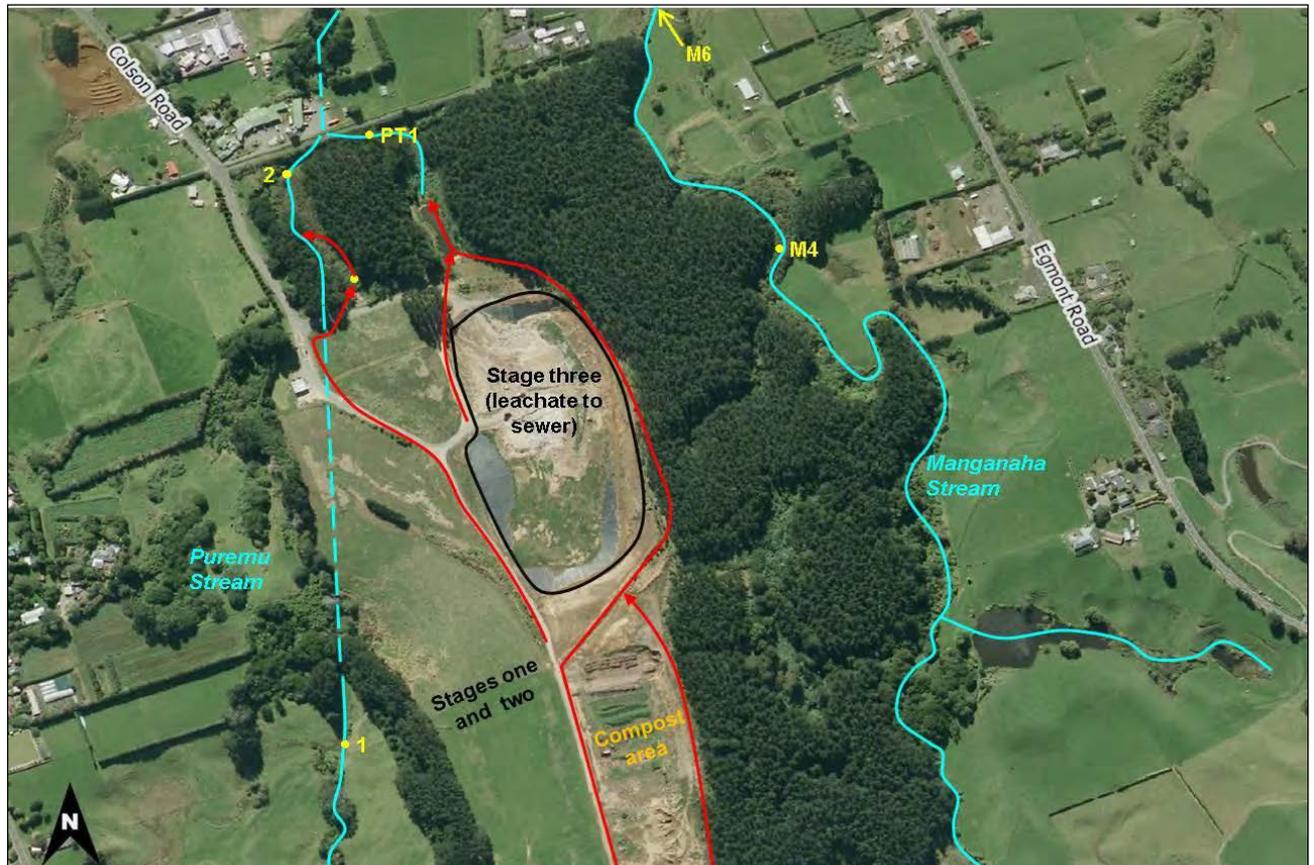
**Figure 1** Biomonitoring sites related to the Colson Road landfill, New Plymouth. The red lines on the aerial photograph indicate the direction of stormwater runoff from the land fill site.

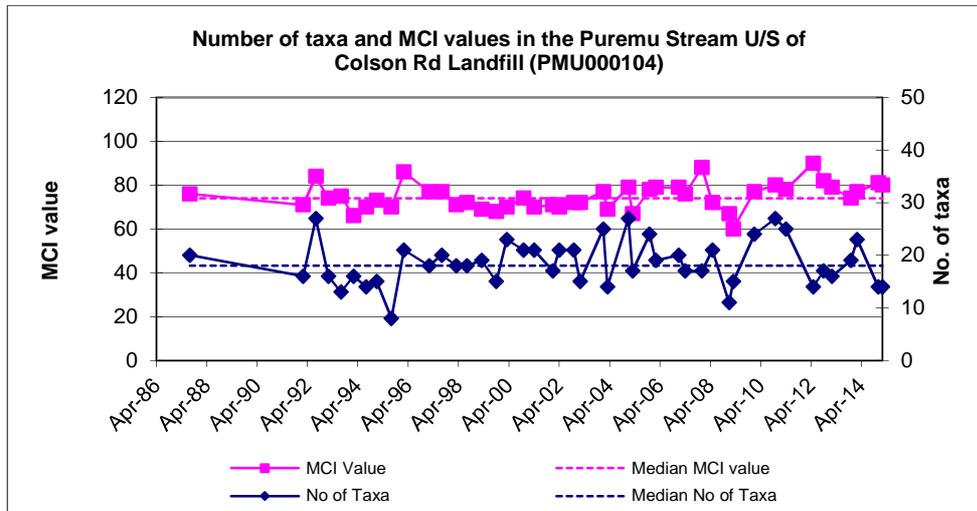
The MCI score of 80 units indicated a community of 'fair' biological health which was not significantly different (Stark, 1998) to the median value recorded for the site (median MCI score 74 units; Table 3) or from the previous survey score (MCI score 81 units; Figure 2). The

**Figure 2** Number of macroinvertebrate taxa and MCI values recorded at site 1 in the Puremu Stream, upstream of Colson Road Landfill since April 1987.

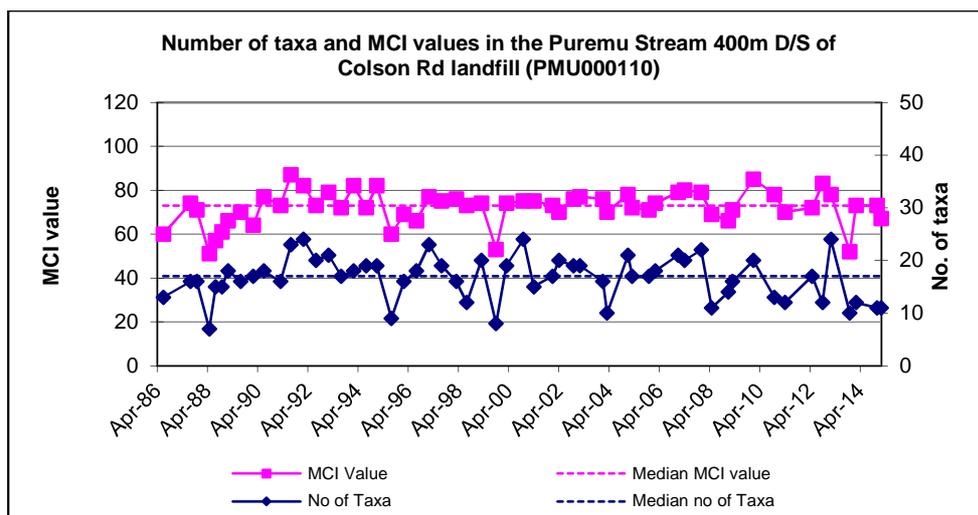
A low taxa richness of 11 taxa was found at site 2 at the time of the survey which was six less than the median number recorded for the site (median taxa richness 17; Table 3) and the same as the previous sample (taxa richness 11; Figure 3).

The MCI score of 67 units indicated a community of ‘poor’ biological health which was not significantly different (Stark, 1998) to the median value recorded for the site (median MCI score 73 units; Table 3) and to the previous survey score (MCI score 73 units; Figure 3). The SQMCI<sub>s</sub> score of 2.1 units was lower than the median value recorded at the site (median SQMCI<sub>s</sub> score 3.1 units; Table 3) and to that of the previous survey (SQMCI<sub>s</sub> score 3.3 units).

**Figure 3** Taxa numbers and MCI values recorded at site 2, 400 m downstream of Colson Rd Landfill.

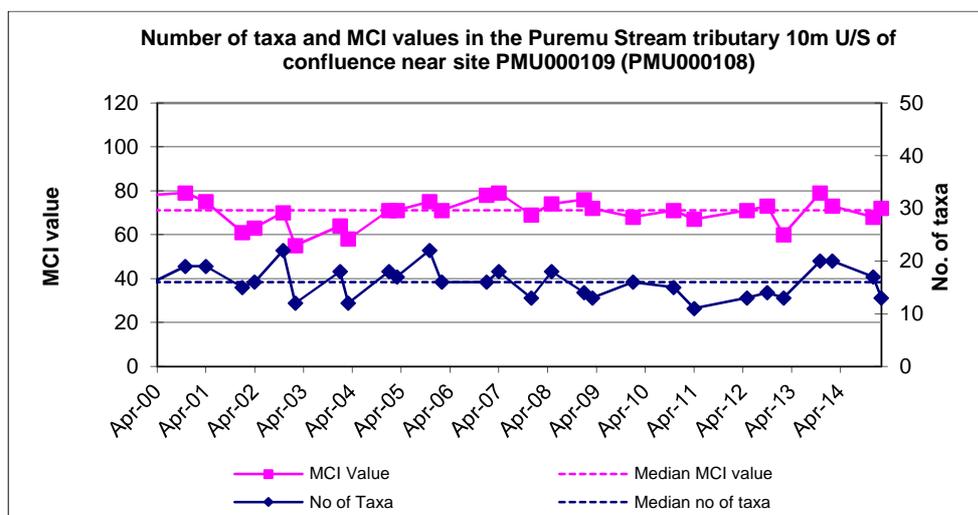
A low taxa richness of 13 taxa was found at site PT1 at the time of the survey which was three less than the median number recorded for the site (median taxa richness 16; Table 3) and four taxa less than the previous sample (taxa richness 17; Figure 4).

The MCI score of 72 units indicated a community of 'poor' biological health which was not significantly different (Stark, 1998) to the median value recorded for the site (median MCI score 71 units; Table 3) and the previous survey score (MCI score 68 units; Figure 4). The SQMCI<sub>s</sub> score of 2.0 units was slightly lower than the median value recorded at the site (median SQMCI<sub>s</sub> score 2.6 units; Table 3) and the same as the previous survey (SQMCI<sub>s</sub> score 2.0 units).

**Figure 4** Numbers of taxa and MCI values recorded to date at site PT1, downstream of Colson Road Landfill.

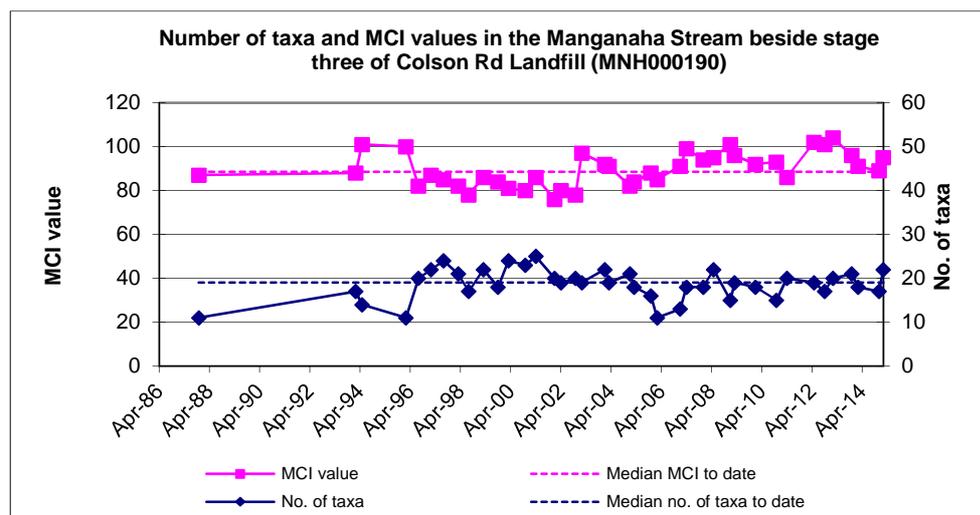
A moderate taxa richness of 22 taxa was found at site M4 at the time of the survey which was three more than the median number recorded for the site (median taxa richness 19; Table 3) and five more than the previous sample (taxa richness 17; Figure 3).

The MCI score of 95 units indicated a community of ‘fair’ biological health which was not significantly different (Stark, 1998) to the median value recorded for the site (median MCI score 88 units; Table 3) and to the previous survey score (MCI score 89 units; Figure 3). The SQMCI<sub>s</sub> score of 4.1 units was similar to the median value recorded at the site (median SQMCI<sub>s</sub> score 4.9 units; Table 3) but was markedly lower than the previous survey (SQMCI<sub>s</sub> score 5.8 units).

**Figure 5** Taxa numbers and MCI values recorded at site M4, in the Manganaha Stream adjacent to Colson Road landfill.

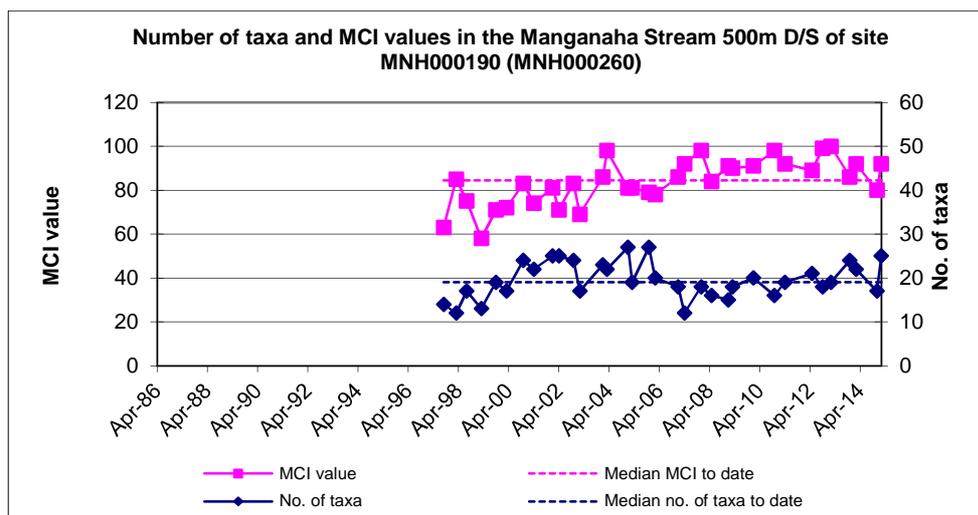
A moderate taxa richness of 25 taxa was found at site M6 at the time of the survey which was six more than the median number recorded for the site (median taxa richness 19; Table 3) and eight more than the previous sample (taxa richness 17; Figure 3).

The MCI score of 92 units indicated a community of ‘fair’ biological health which was not significantly different (Stark, 1998) to the median value recorded for the site (median MCI score 84 units; Table 3) and was significantly (Stark, 1998) more than the previous survey score (MCI score 80 units; Figure 3). The SQMCI<sub>s</sub> score of 5.8 units was markedly higher than the median value recorded at the site (median SQMCI<sub>s</sub> score 4.1 units; Table 3) and that of the previous survey (SQMCI<sub>s</sub> score 4.1 units).

**Figure 6** Taxa numbers and MCI values recorded at site M6, in the Manganaha Stream downstream of Colson Road landfill.

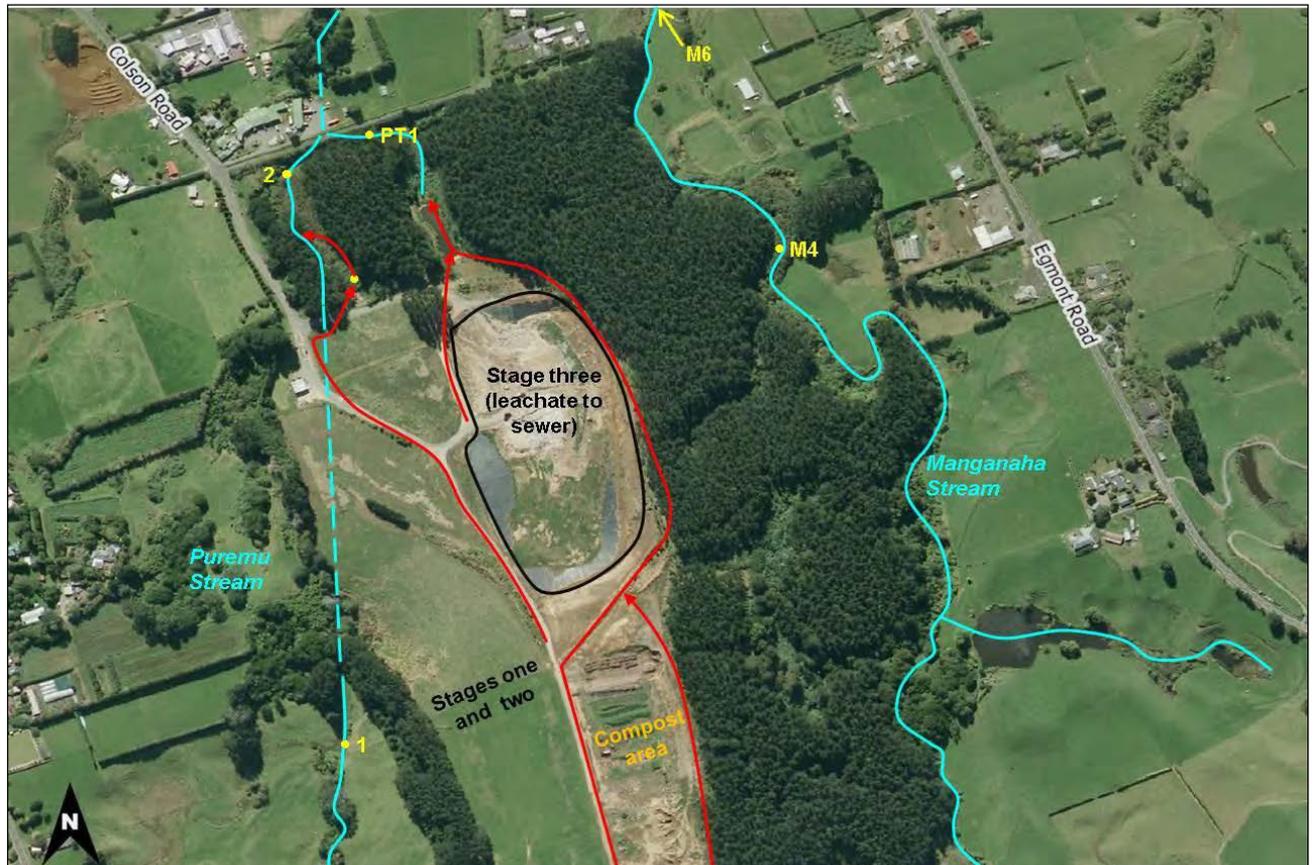
**Figure 1** Biomonitoring sites related to the Colson Road landfill, New Plymouth. The red lines on the aerial photograph indicate the direction of stormwater runoff from the land fill site.

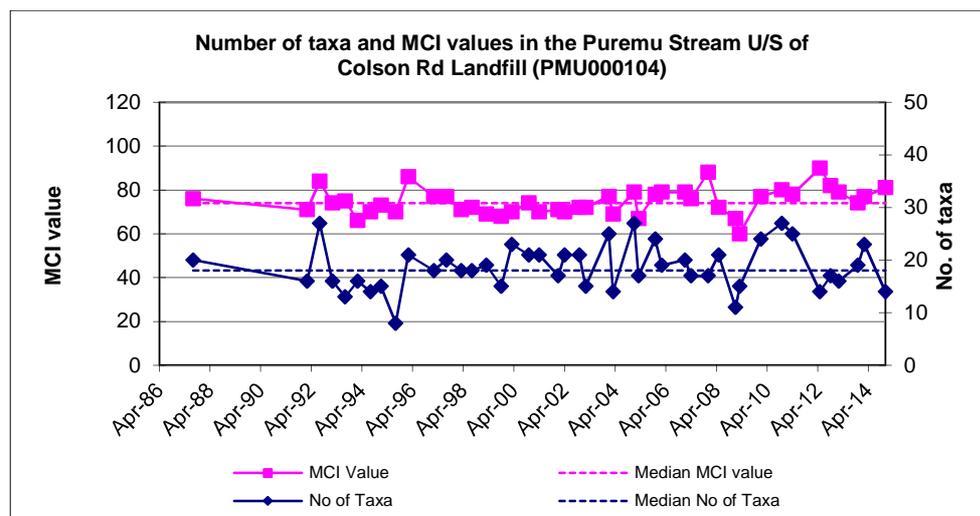
A moderately low taxa richness of 14 taxa was found at site 1 ('control' site) at the time of the survey which was four less than the median number recorded for the site (median taxa richness 18; Table 3) and nine less than the previous sample (taxa richness 23; Figure 2).

The MCI score of 81 units indicated a community of 'fair' biological health which was not significantly different (Stark, 1998) to the median value recorded for the site (median MCI score 74 units; Table 3) or from the previous survey score (MCI score 77 units; Figure 2). The SQMCI<sub>s</sub> score of 3.2 units was similar to the median value recorded at the site (median SQMCI<sub>s</sub> score 3.7 units; Table 3) and to the previous survey (SQMCI<sub>s</sub> score 3.3 units).

**Figure 2** Number of macroinvertebrate taxa and MCI values recorded at site 1 in the Puremu Stream, upstream of Colson Road Landfill since April 1987.

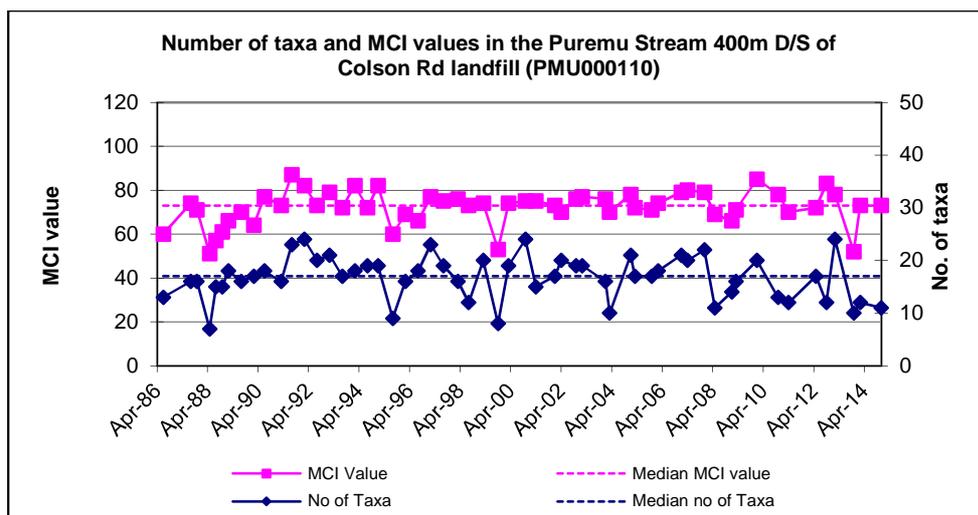
A low taxa richness of 11 taxa was found at site 2 at the time of the survey which was six less than the median number recorded for the site (median taxa richness 17; Table 3) and one more than the previous sample (taxa richness 12; Figure 3).

The MCI score of 73 units indicated a community of 'poor' biological health which was the same as the median value recorded for the site (median MCI score 73 units; Table 3) and the previous survey score (MCI score 73 units; Figure 3). The SQMCI<sub>s</sub> score of 3.3 units was similar to the median value recorded at the site (median SQMCI<sub>s</sub> score 3.0 units; Table 3) and markedly higher than the previous survey (SQMCI<sub>s</sub> score 1.2 units).

**Figure 3** Taxa numbers and MCI values recorded at site 2, 400 m downstream of Colson Rd Landfill.

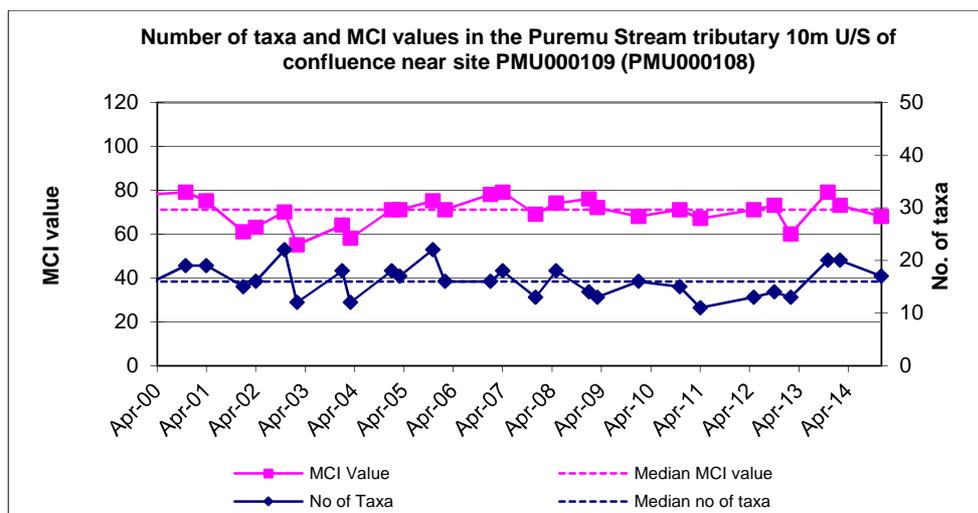
A moderately low taxa richness of 17 taxa was found at site PT1 at the time of the survey which was one more than the median number recorded for the site (median taxa richness 16; Table 3) and three less than the previous sample (taxa richness 20; Figure 4).

The MCI score of 68 units indicated a community of 'poor' biological health which was not significantly different (Stark, 1998) to the median value recorded for the site (median MCI score 71 units; Table 3) and to the previous survey score (MCI score 73 units; Figure 4). The SQMCI<sub>s</sub> score of 2.0 units was similar to the median value recorded at the site (median SQMCI<sub>s</sub> score 2.6 units; Table 3) and lower than the previous survey (SQMCI<sub>s</sub> score 3.0 units).

**Figure 4** Numbers of taxa and MCI values recorded to date at site PT1, downstream of Colson Road Landfill.

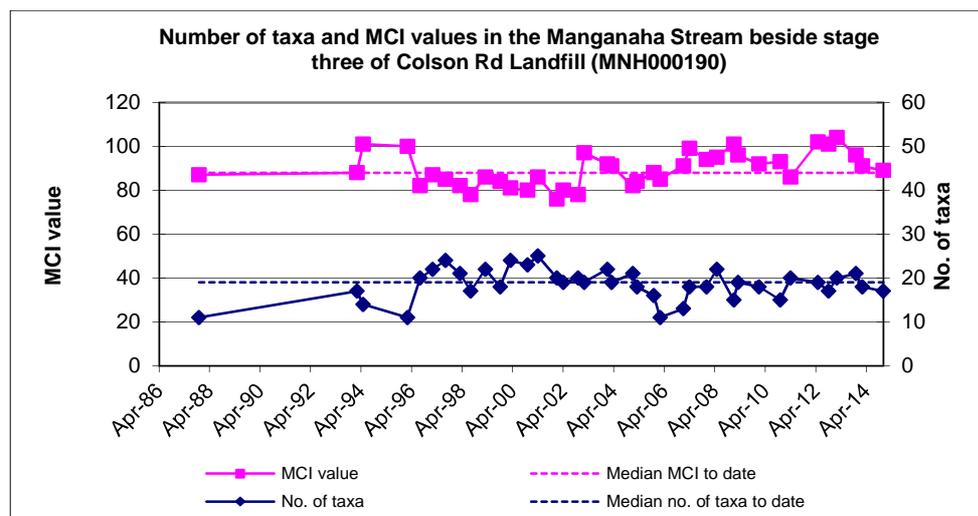
A moderately low taxa richness of 17 taxa was found at site M4 at the time of the survey which was two more than the median number recorded for the site (median taxa richness 19; Table 3) and one less than the previous sample (taxa richness 18; Figure 3).

The MCI score of 89 units indicated a community of 'fair' biological health which was not significantly different (Stark, 1998) to the median value recorded for the site (median MCI score 88 units; Table 3) and to the previous survey score (MCI score 88 units; Figure 3). The SQMCI<sub>s</sub> score of 5.3 units was similar to the median value recorded at the site (median SQMCI<sub>s</sub> score 4.8 units; Table 3) and to the previous survey (SQMCI<sub>s</sub> score 5.8 units).

**Figure 5** Taxa numbers and MCI values recorded at site M4, in the Manganaha Stream adjacent to Colson Road landfill.

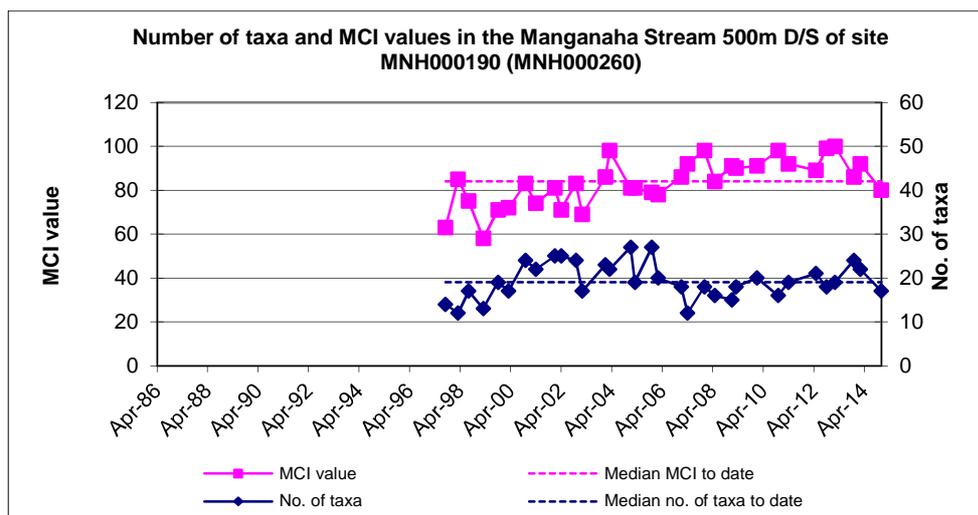
A moderately low taxa richness of 17 taxa was found at site M6 at the time of the survey which was two more than the median number recorded for the site (median taxa richness 19; Table 3) and five less than the previous sample (taxa richness 22; Figure 3).

The MCI score of 80 units indicated a community of 'fair' biological health which was not significantly different (Stark, 1998) to the median value recorded for the site (median MCI score 84 units; Table 3) and was significantly less (Stark, 1998) than the previous survey score (MCI score 92 units; Figure 3). The SQMCI<sub>s</sub> score of 4.1 units was the same as the median value recorded at the site (median SQMCI<sub>s</sub> score 4.1 units; Table 3) and markedly lower than the previous survey (SQMCI<sub>s</sub> score 5.5 units).

**Figure 6** Taxa numbers and MCI values recorded at site M6, in the Manganaha Stream downstream of Colson Road landfill.
