NPDC – Colson Road Landfill
Monitoring Programme
Annual Report
2015-2016

Technical Report 2016-68

November 2016

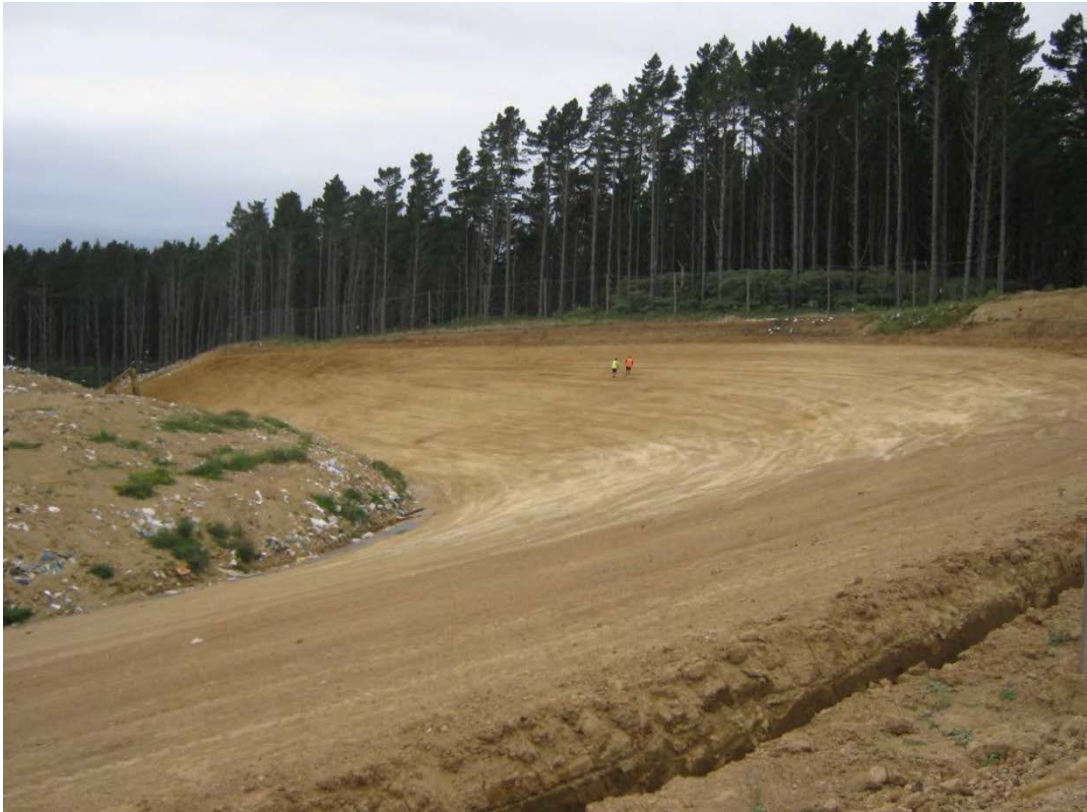
Photograph 1 Stage three extension works, February 2011

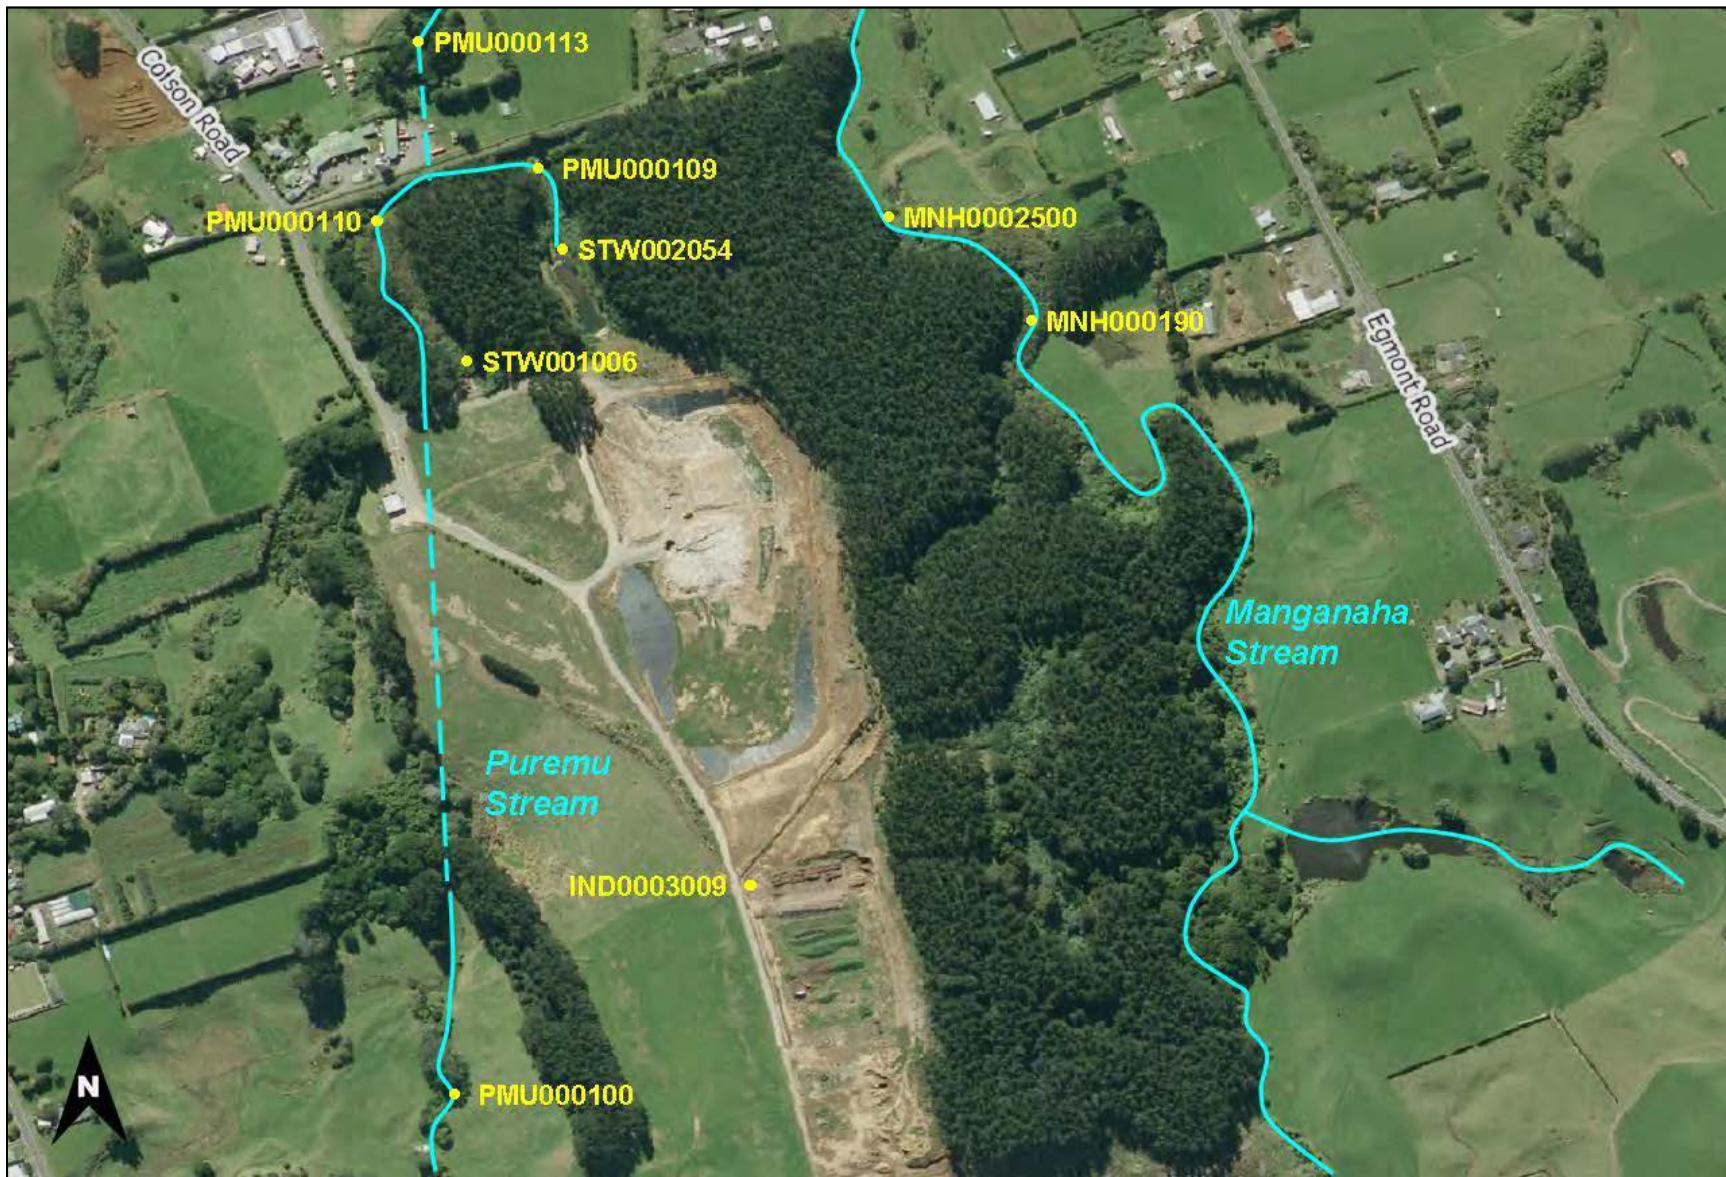
Figure 2 Aerial photo showing the stormwater and receiving water sampling sites at Colson Road landfill

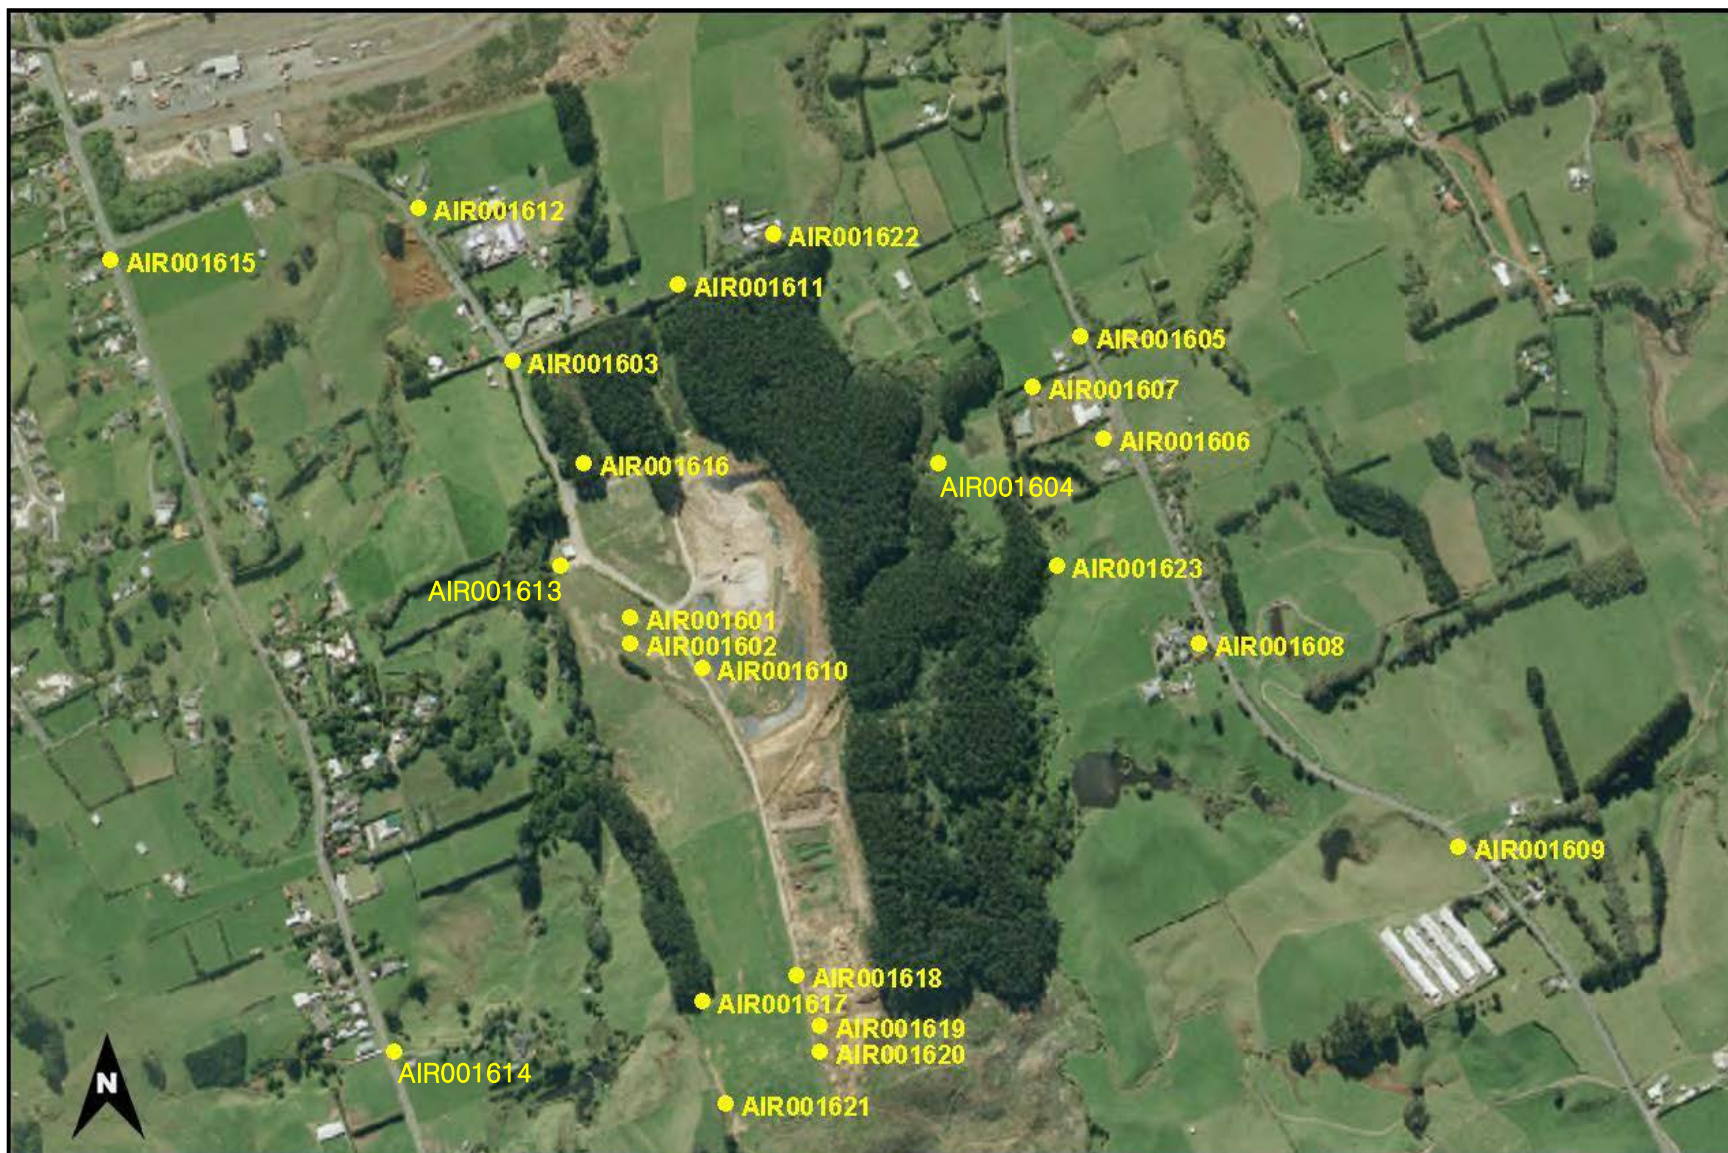
Figure 4 Aerial view of Colson Road landfill showing the positions of air quality monitoring sites

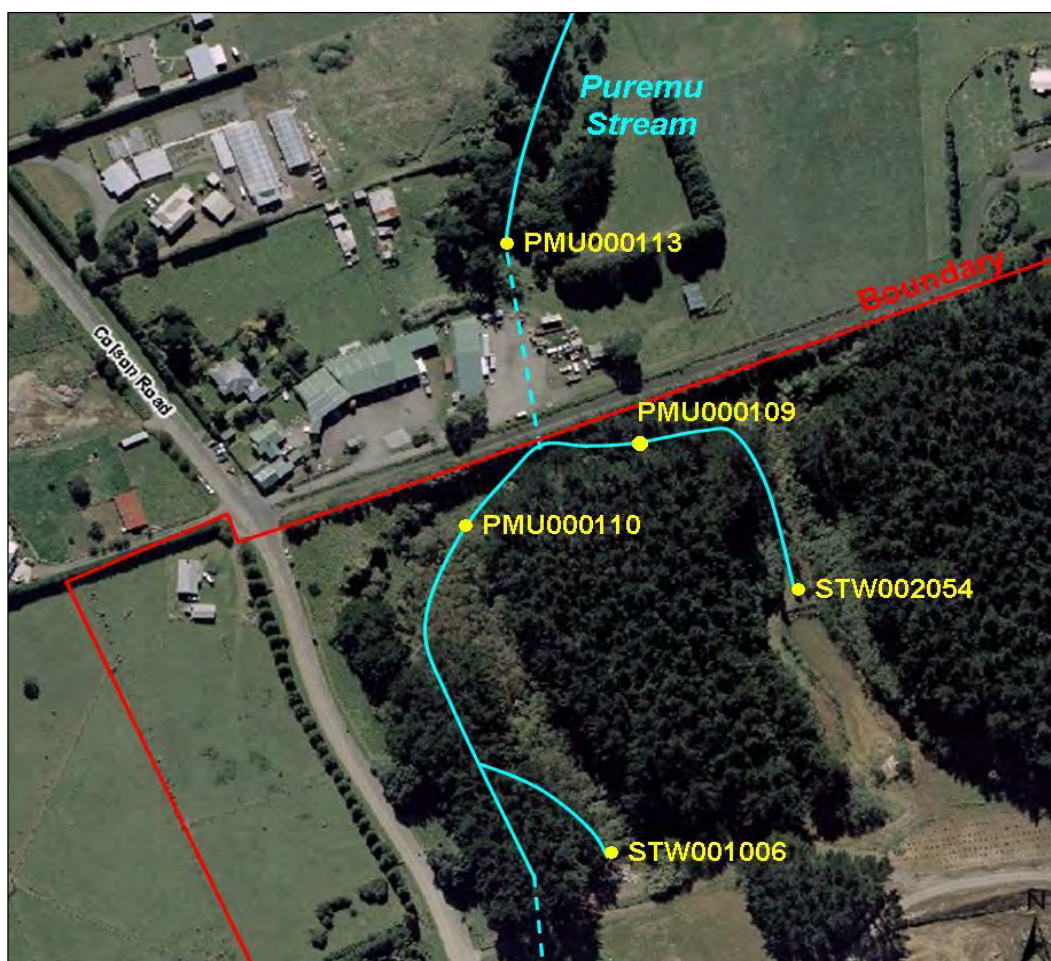
The downstream sampling sites shown in Figure 5 and the results are given in Tables 6 and 7.

Figure 5 Sampling sites on the Puremu Stream down stream of the landfill

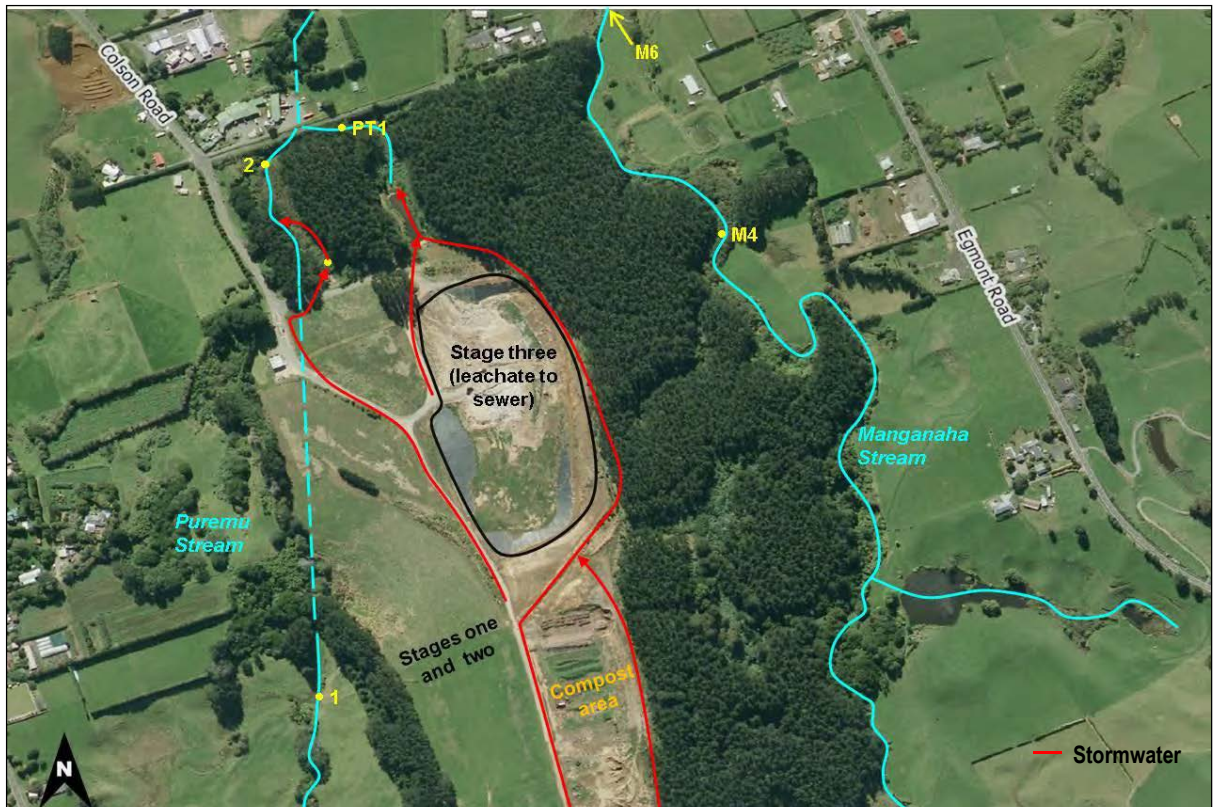
Figure 6 Biomonitoring sites related to the Colson Road landfill, New Plymouth

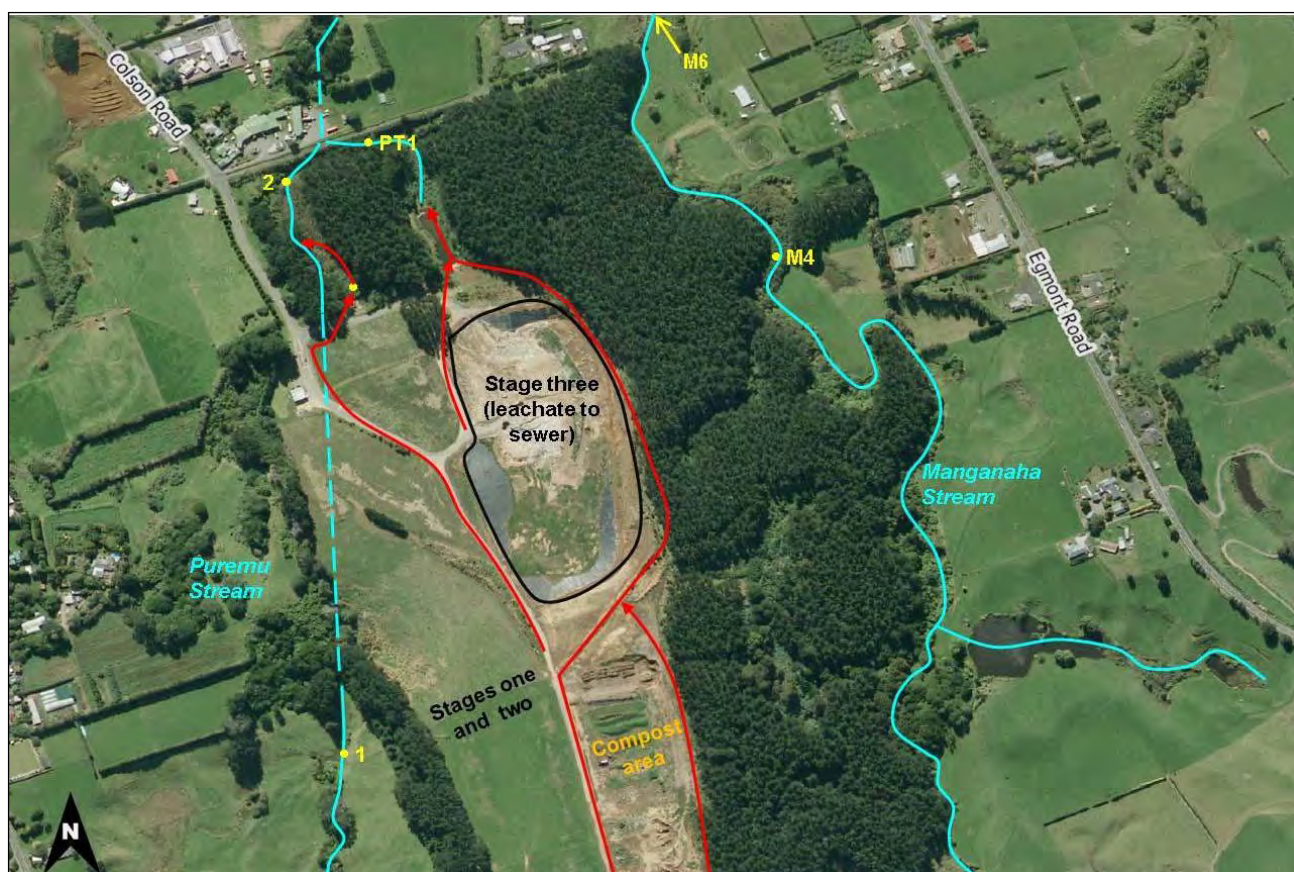
Figure 1 Biomonitoring sites related to the Colson Road landfill, New Plymouth. The red lines on the aerial photograph indicate the direction of stormwater runoff from the land fill site.

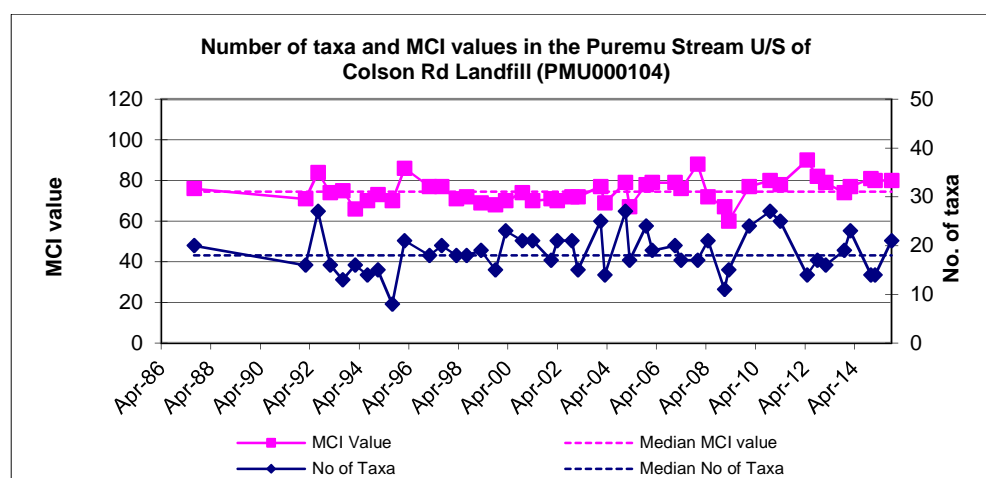
A total taxa richness of 21 taxa was recorded at site 1 in this spring survey (Table 3 and Figure 2). This result was three taxa more than the historical median.

Figure 2 Number of macroinvertebrate taxa and MCI values recorded at site 1 in the Puremu Stream, upstream of Colson Road Landfill since April 1987

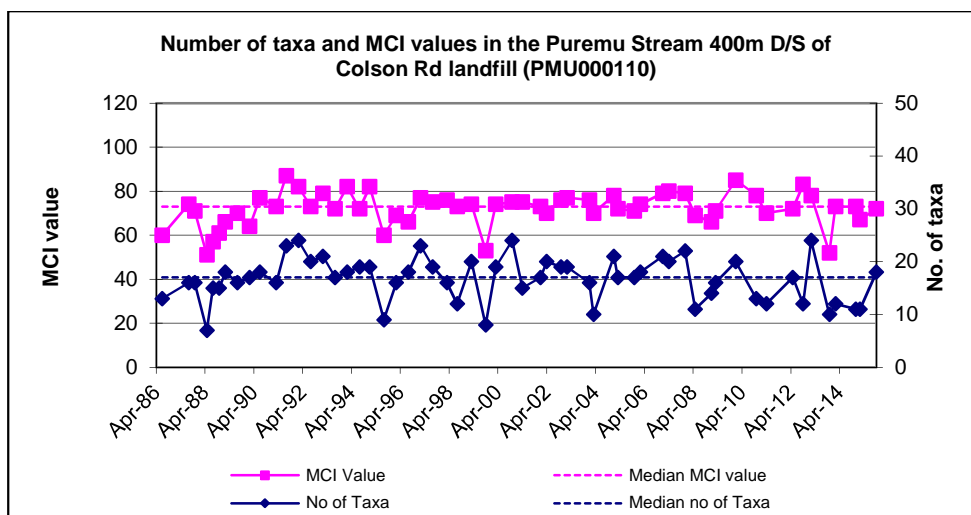
A moderate number of taxa (18) was recorded at this site, one taxon more than the median of previous surveys at this site, and seven taxa more than the richness recorded in the previous survey (Table 3 and Figure 3).

Figure 3 Taxa numbers and MCI values recorded at site 2, 400 m downstream of Colson Rd Landfill

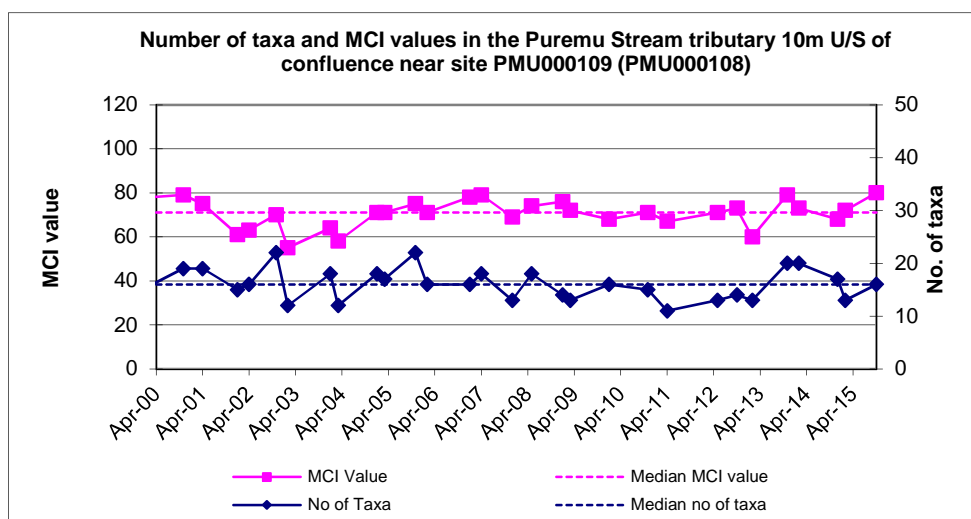
Sixteen taxa were recorded at site PT1 in the unnamed tributary of the Puremu Stream, the same number of taxa as the historical median for the site and a slightly lower number than the richness recorded at sites 1 and 2 in the Puremu Stream (Table 3 and Figure 4).

Figure 4 Numbers of taxa and MCI values recorded to date at site PT1, downstream of Colson Road Landfill

The community at site PT1 was characterised by four ‘tolerant’ taxa (oligochaete worms, ostracod seed shrimps, midge larvae (*Chironomus*) and (*Polypedilum*)) and three ‘moderately sensitive’ taxa (isopods, mites (Acarina) and amphipods (*Paracalliope*)) (Table 4). The higher proportion of ‘sensitive’ taxa (62%) was reflected in the MCI score of 80 units, which indicated ‘fair’ biological health. This MCI score was the same as that recorded at site 1 and was 8 units higher than the median MCI score for the site and 8 units higher than that recorded at site 2 (Table 3 and Figure 4).

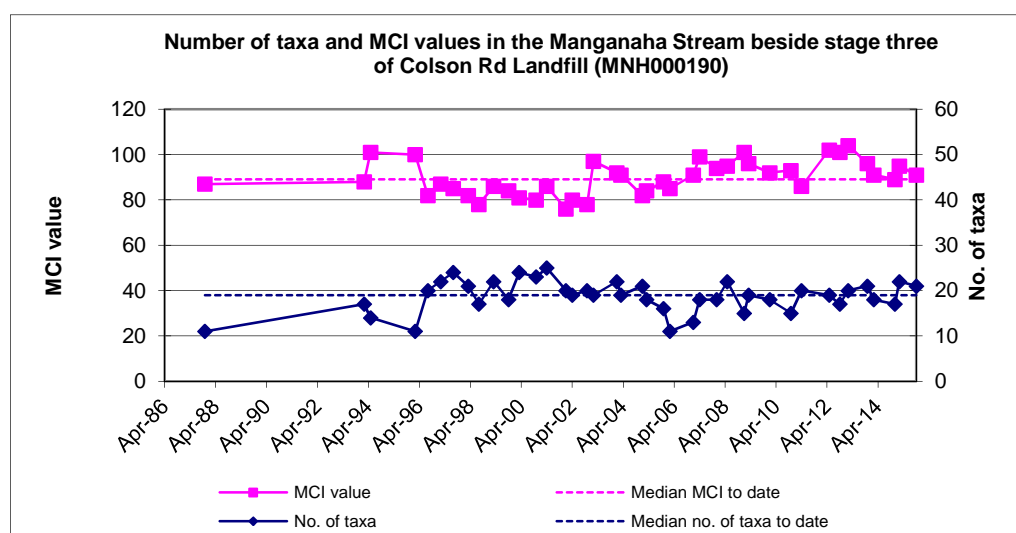
Twenty-one taxa were recorded at site M4 in this survey which was two taxa more than the historical median for the site (Table 3 and Figure 5). The community at this site was characterised by one 'highly sensitive' taxon (net-building caddisfly (*Hydropsyche*)), one 'moderately sensitive' taxon (amphipod (*Paracalliope*)) and two 'tolerant' taxa (snail (*Potamopyrgus*) and oligochaete worms) (Table 5), which was indicative of good preceding water quality.

Figure 5 Taxa numbers and MCI values recorded at site M4, in the Manganaha Stream adjacent to Colson Road landfill

The moderate proportion of 'sensitive' taxa (52% of total taxa) in the community resulted in the MCI score of 91 units, which was an insignificant (Stark, 1998) two units higher than the historical median and an insignificant six units lower than the previous survey results for this site (Table 3 and Figure 5).

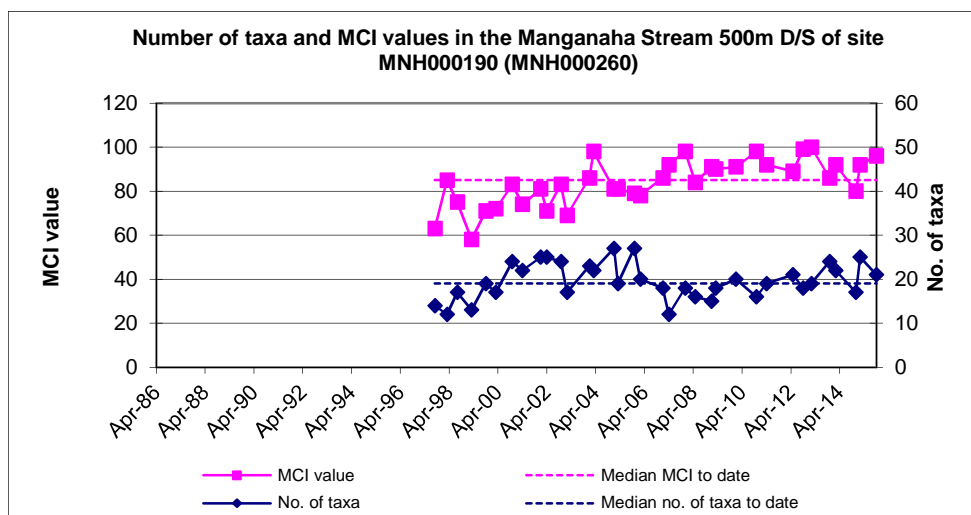
Twenty-one taxa were recorded at site M6, two taxa more than the median for the site and the same number of taxa as that recorded upstream at site M4 (Table 3 and Figure 6).

Figure 6 Taxa numbers and MCI values recorded at site M6, in the Manganaha Stream downstream of Colson Road landfill

The moderate proportion of 'sensitive' taxa (57 %) in the community resulted in an MCI score of 96 units, 5 units higher than the MCI score recorded at site M4. This score was a significant (1998) 11 units higher than the historical median recorded for the site but an insignificant (Stark, 1998) 4 units higher than that recorded by the previous survey at this site (Table 3 and Figure 6).

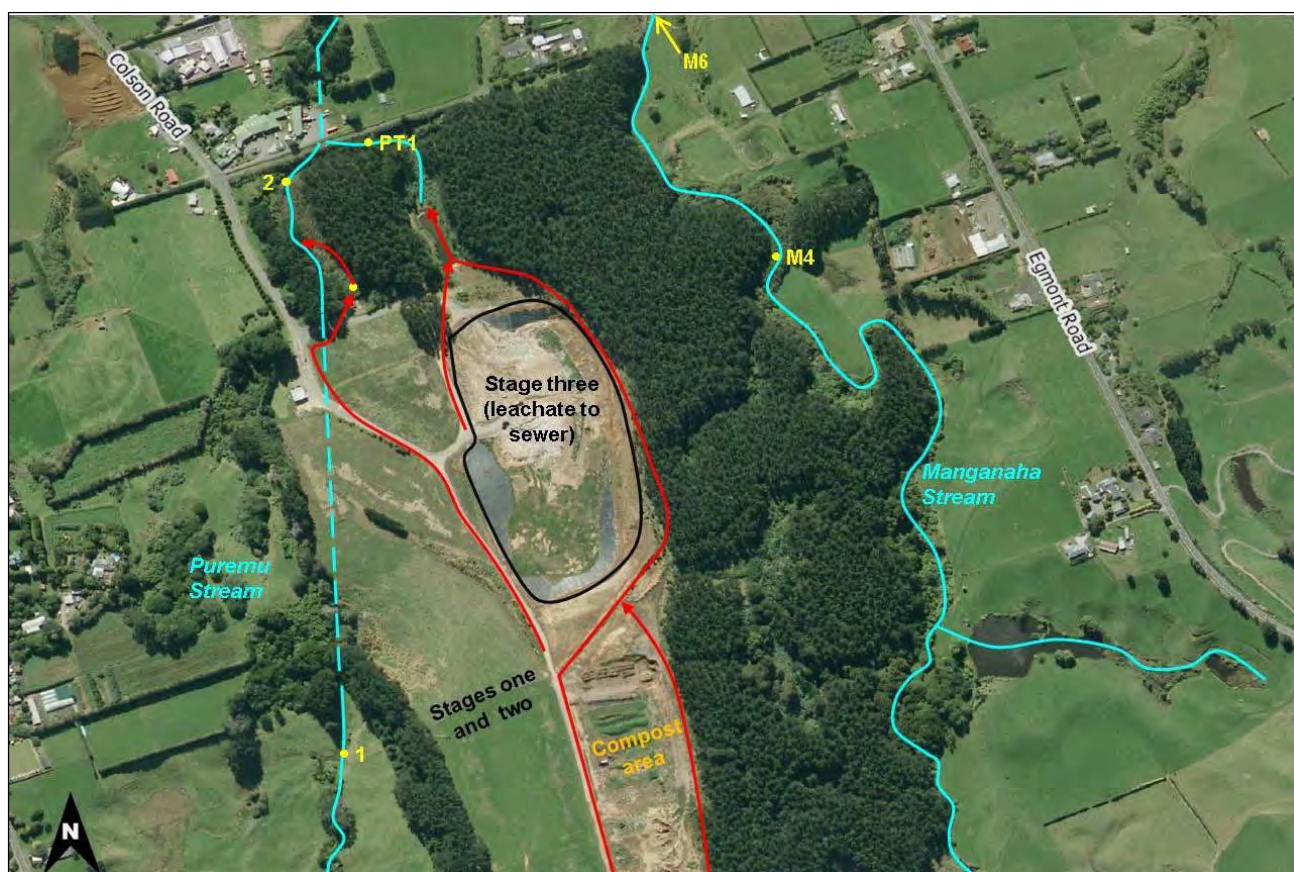
Figure 1 Biomonitoring sites related to the Colson Road landfill, New Plymouth. The red lines on the aerial photograph indicate the direction of stormwater runoff from the land fill site.

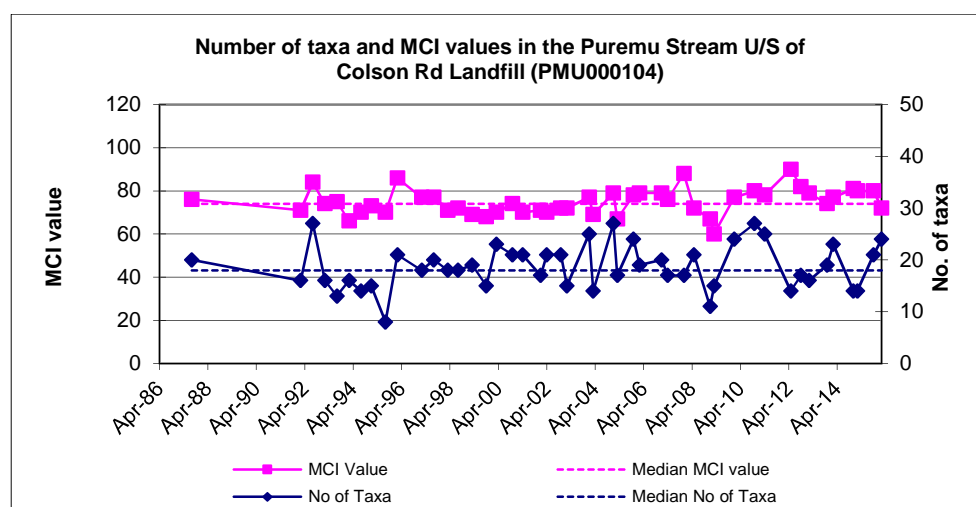
A total taxa richness of 24 taxa was recorded at site 1 in this summer survey (Table 3 and Figure 2). This result was six taxa more than the historical median.

Figure 2 Number of macroinvertebrate taxa and MCI values recorded at site 1 in the Puremu Stream, upstream of Colson Road Landfill since April 1987

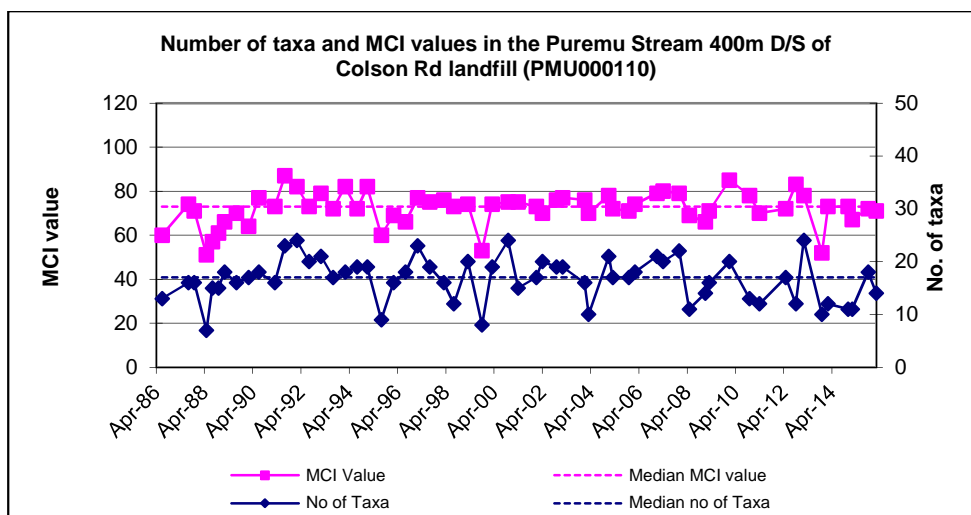
A moderately low number of taxa (14) was recorded at this site, three taxa less than the median of previous surveys at this site, and four taxa less than the richness recorded by the previous survey (Table 3 and Figure 3).

Figure 3 Taxa numbers and MCI values recorded at site 2, 400 m downstream of Colson Rd Landfill

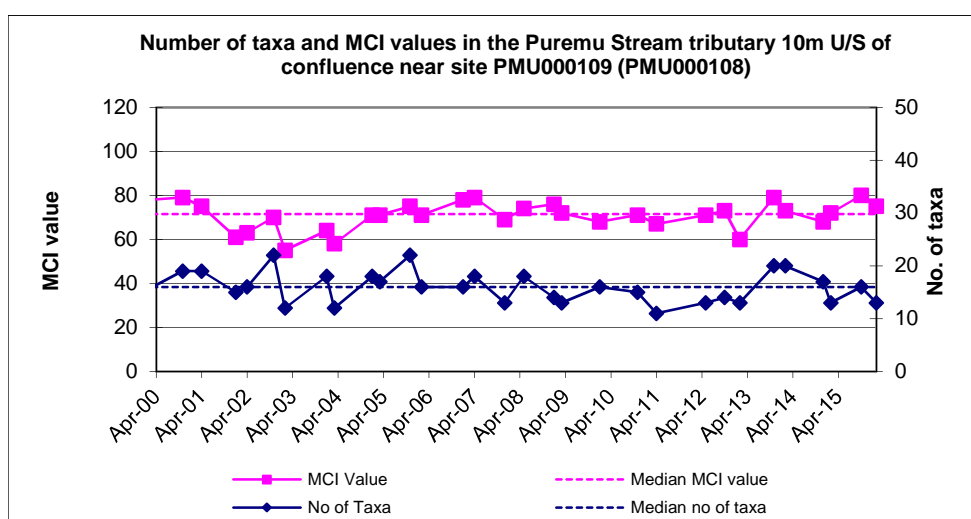
Thirteen taxa were recorded at site PT1 in the unnamed tributary of the Puremu Stream, three taxa less than the historical median for the site and eleven taxa less than that recorded at the ‘control’ site 1 (Table 3 and Figure 4).

Figure 4 Numbers of taxa and MCI values recorded to date at site PT1, downstream of Colson Road Landfill

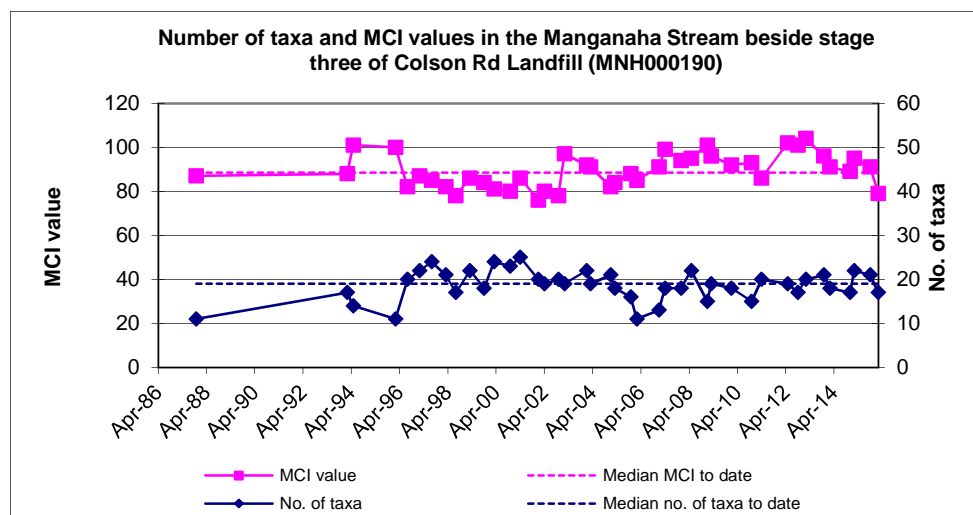
Seventeen taxa were recorded at site M4 in this survey which was two taxa less than the historical median for the site (Table 3 and Figure 5). The community at this site was characterised by two 'moderately sensitive' taxa (amphipod (*Paracalliope*) and stick caddis (*Triplectides*)) and two 'tolerant' taxa (snail (*Potamopyrgus*) and oligochaete worms) (Table 5), which was indicative of reasonable preceding water quality.

Figure 5 Taxa numbers and MCI values recorded at site M4, in the Manganaha Stream adjacent to Colson Road landfill

The moderate proportion of 'sensitive' taxa (53% of total taxa) in the community resulted in the MCI score of 79 units, which was an insignificant (Stark, 1998) three units lower than the historical median and a significant (Stark, 1998) 12 units lower than the previous survey results for this site (Table 3 and Figure 5).

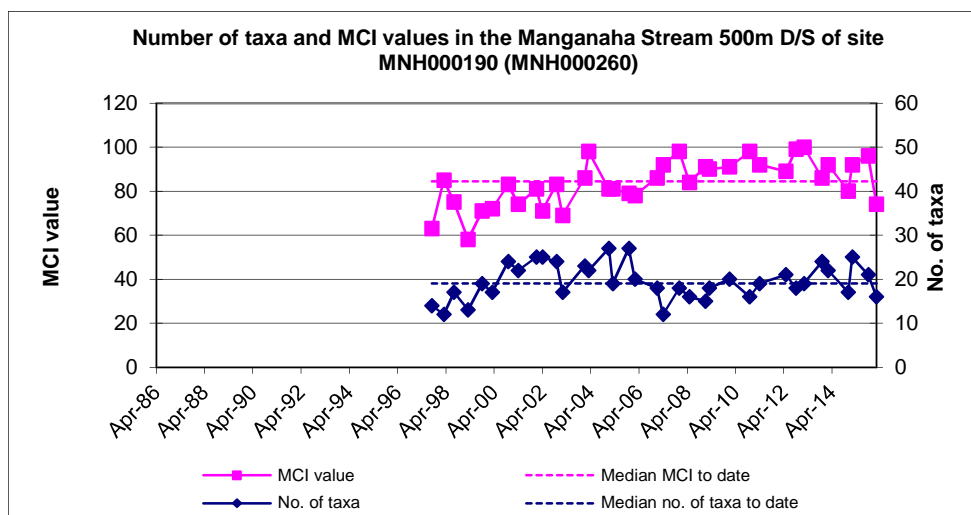
Sixteen taxa were recorded at site M6, three taxa less than the median for the site and one taxon less than that recorded upstream at site M4 (Table 3 and Figure 6).

Figure 6 Taxa numbers and MCI values recorded at site M6, in the Manganaha Stream downstream of Colson Road landfill

The moderate proportion of 'tolerant' taxa (63 %) in the community resulted in a MCI score of 74 units, 5 units lower than the MCI score recorded at site M4. This score was a significant (1998) 11 units lower than the historical median recorded for the site and a significant (Stark, 1998) 22 units lower than that recorded by the previous survey at this site (Table 3 and Figure 6).
