New Plymouth District Council
Inglewood, Okato,
and Marfell Park Landfills
Monitoring Programme
Annual Report 2015-2016
Technical Report 2016-69

New Plymouth District Council
Inglewood, Okato,
and Marfell Park Landfills
Monitoring Programme
Annual Report 2015-2016

Technical Report 2016-69

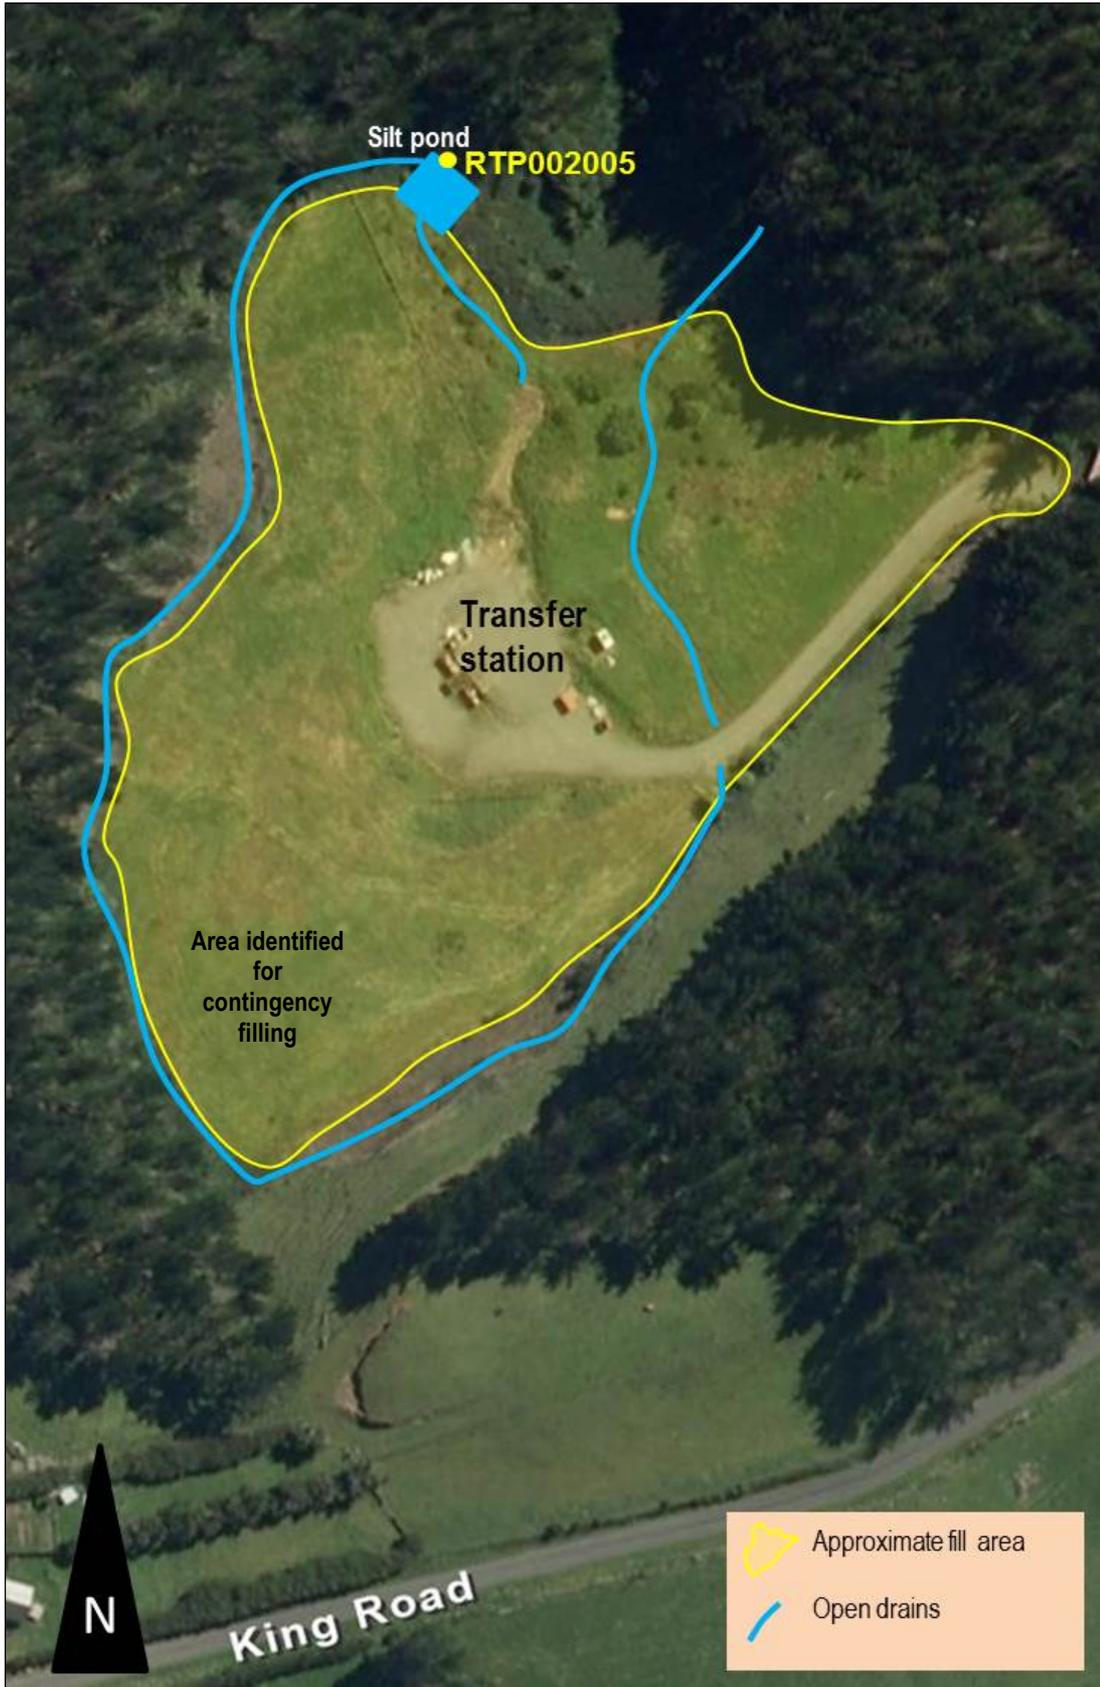
Figure 1 shows the approximate extent of the fill and the general layout of the Inglewood landfill site. The discharge and receiving water monitoring site locations are shown in Figure 2.

Figure 1 Site layout at Inglewood contingency landfill

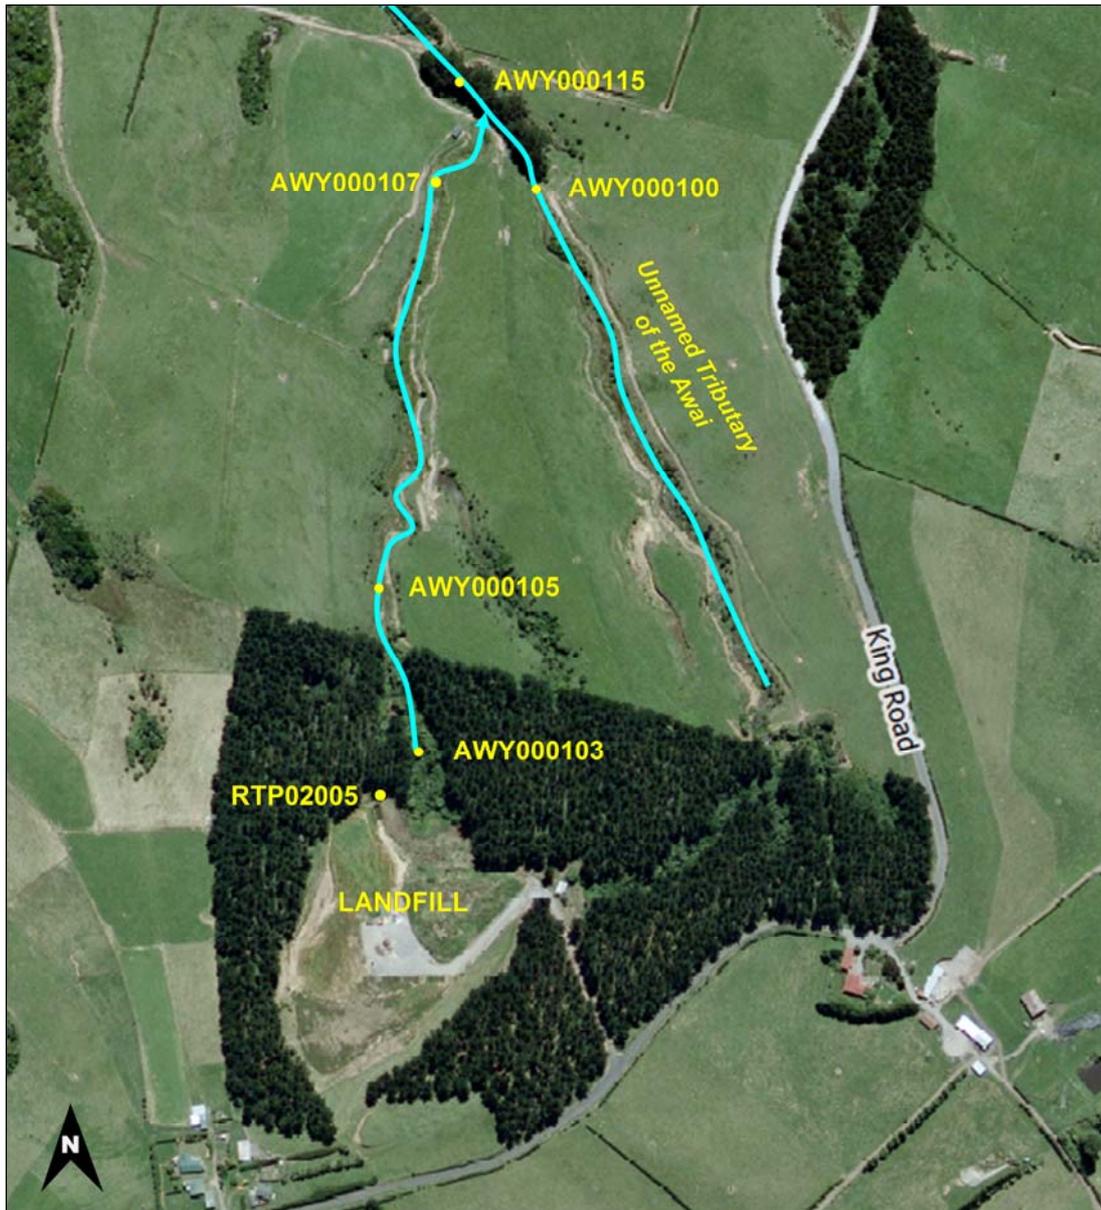
Figure 2 Inglewood landfill and receiving water sampling sites

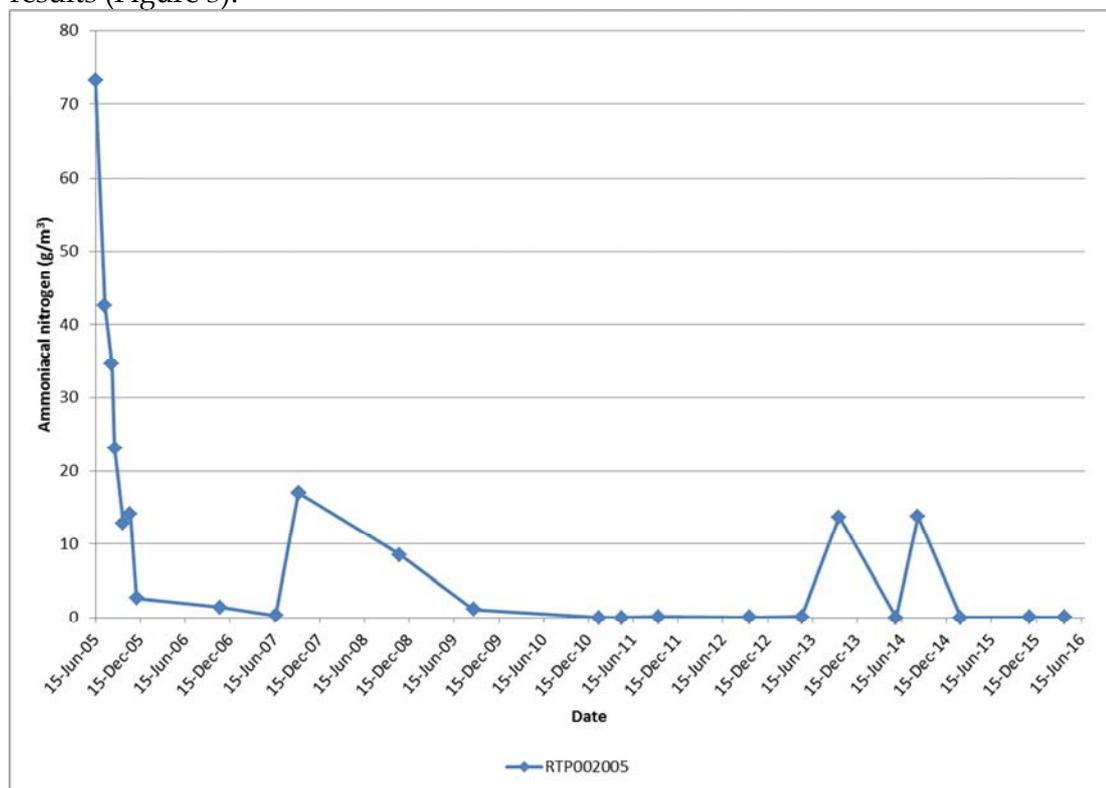
Unlike the autumn samples collected after heavy rainfall in the 2013-2014 and 2014-2015 years, the ammoniacal nitrogen concentration of the November 2015 sample was not found to be inconsistently high when compared to more recent historical results (Figure 3).

Figure 3 Ammoniacal nitrogen concentration of the Inglewood landfill stormwater/leachate (RTP002005) for monitoring to date

The inconsistently high values obtained previously may have been the result of one or more of a number of factors including; the surrounding area and the drain being cleared of vegetation, the dying sprayed vegetation in the stormwater drains, the recent grazing, seasonal variation and/or additional stormwater infiltration causing increased leachate generation due to the condition of the cap on the central area of the landfill as noted at the August 2014 inspection. This crack was remediated during the 2014-2015 year, and this may have contributed to the apparent reduction in the spring ammoniacal nitrogen concentration found during the year under review.

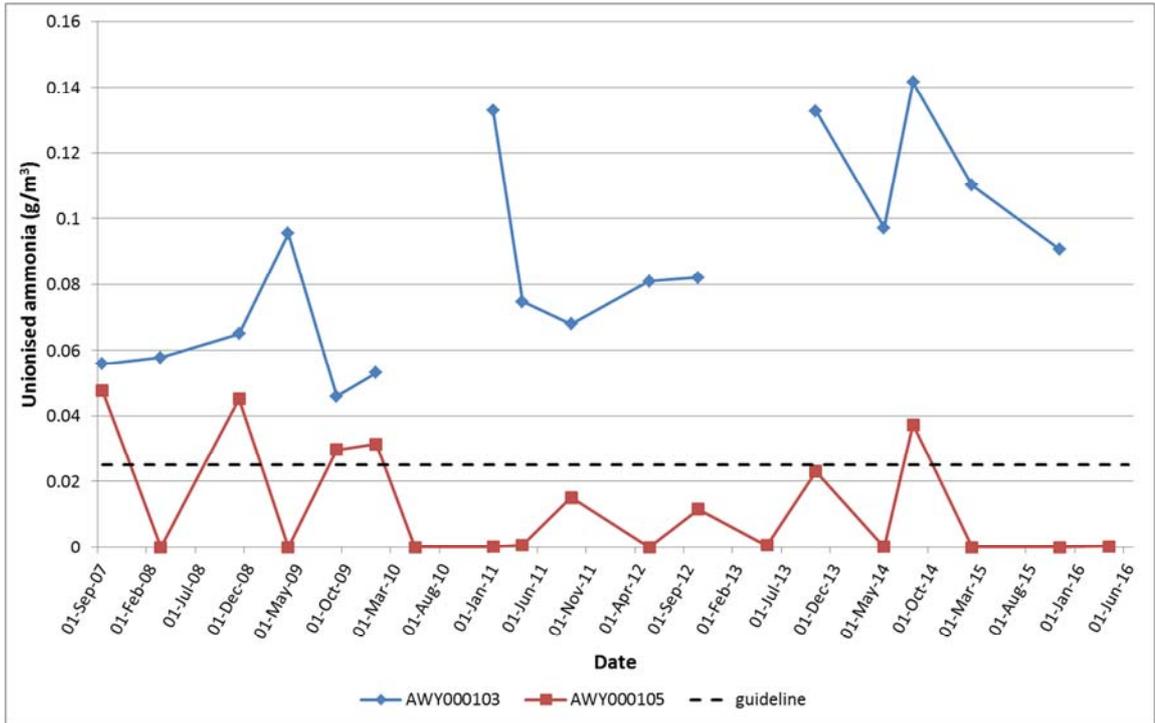
It is also noted that the unionised ammoniacal nitrogen concentration has been consistently above the 0.025 g/m³ guideline adopted by the Council to protect aquatic organisms from chronic effects at the culvert outlet. From a review of the historical results, it appears that there has been an emerging trend of increasing levels of this contaminant at this site. It is however noted that, for the most part, this is generally assimilated in the wetland area, and the concentrations found at the lower end of the landfill tributary are normally well below this guideline value (Figure 4).

Figure 4 Unionised ammonia concentration in the landfill tributary below Inglewood landfill

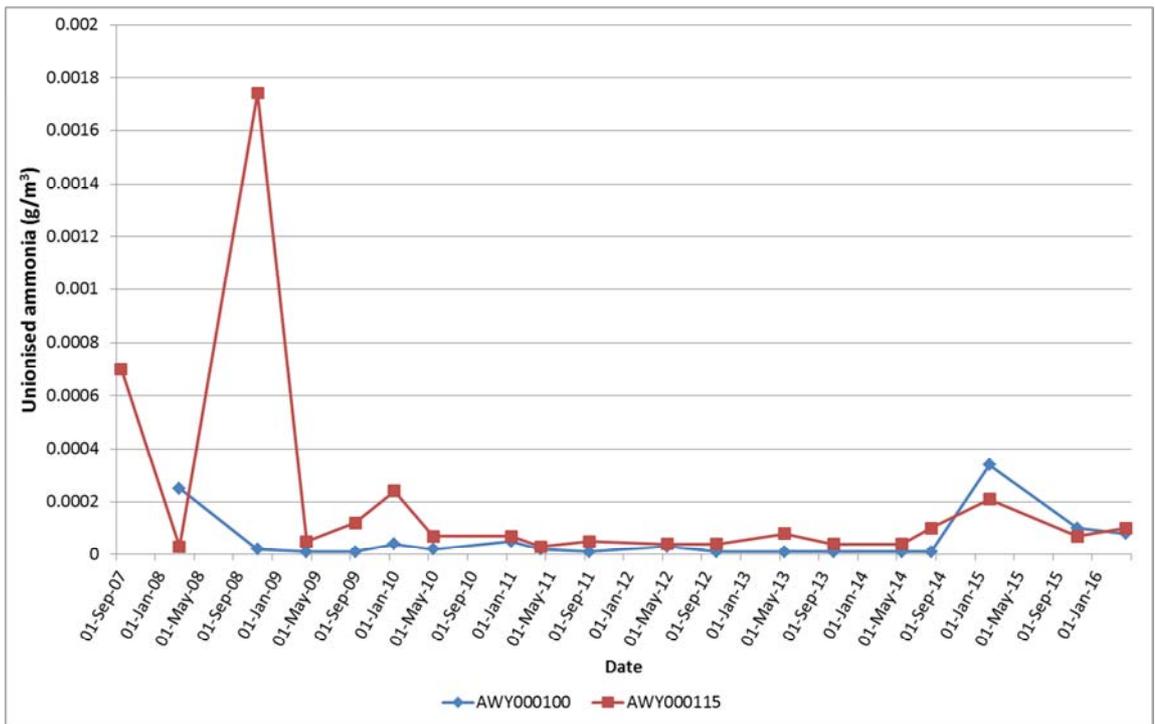
The concentration range above which acute toxic effects may be seen for New Zealand native fish, for example a fish kill, is 0.75 to 2.35 g/m³, and the levels of unionised ammonia found at all monitoring sites during the year under review were well below this concentration range. It can be seen from Figure 5 that, although the unionised ammonia concentration was found to be above the 0.025 g/m³ guideline at the lower end of the tributary on occasion, there was little, if any, effect found on the unionised ammonia concentration of the larger (main) tributary (site AWY000115).

Figure 5 Unionised ammonia concentration in the main tributary below Inglewood landfill

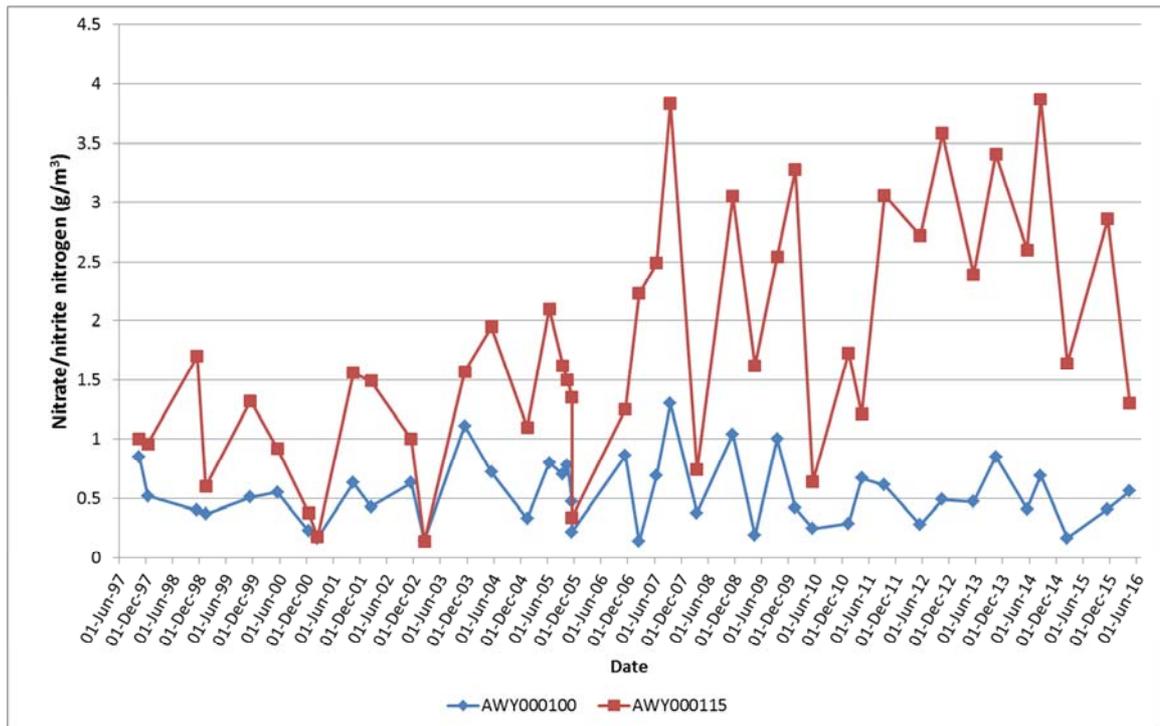
The main unnamed tributary that receives the discharge from the landfill tributary displays slight elevations in conductivity, pH, alkalinity and ammoniacal nitrogen and nitrite/nitrate nitrogen at AWY000115 when compared to the upstream site (AWY000100). These minor increases have been noted in previous monitoring years and have been considered most likely a result of the presence of the landfill and from inputs from stock grazing in the area immediately downstream of the landfill site.

Figure 6 Nitrate/nitrite nitrogen results in the main tributary upstream and downstream of the Inglewood landfill tributary discharge

A review of the historical data also shows that the difference in the nitrate/nitrite nitrogen concentrations between sites AWY000100 and AWY000115 appeared to be increasing (Figure 6), although the difference may be starting to reduce since the cracked cap was remediated. The current levels of contaminants found were within acceptable ranges in the main tributary and would therefore be considered a minor effect, at most, on the aquatic environment.

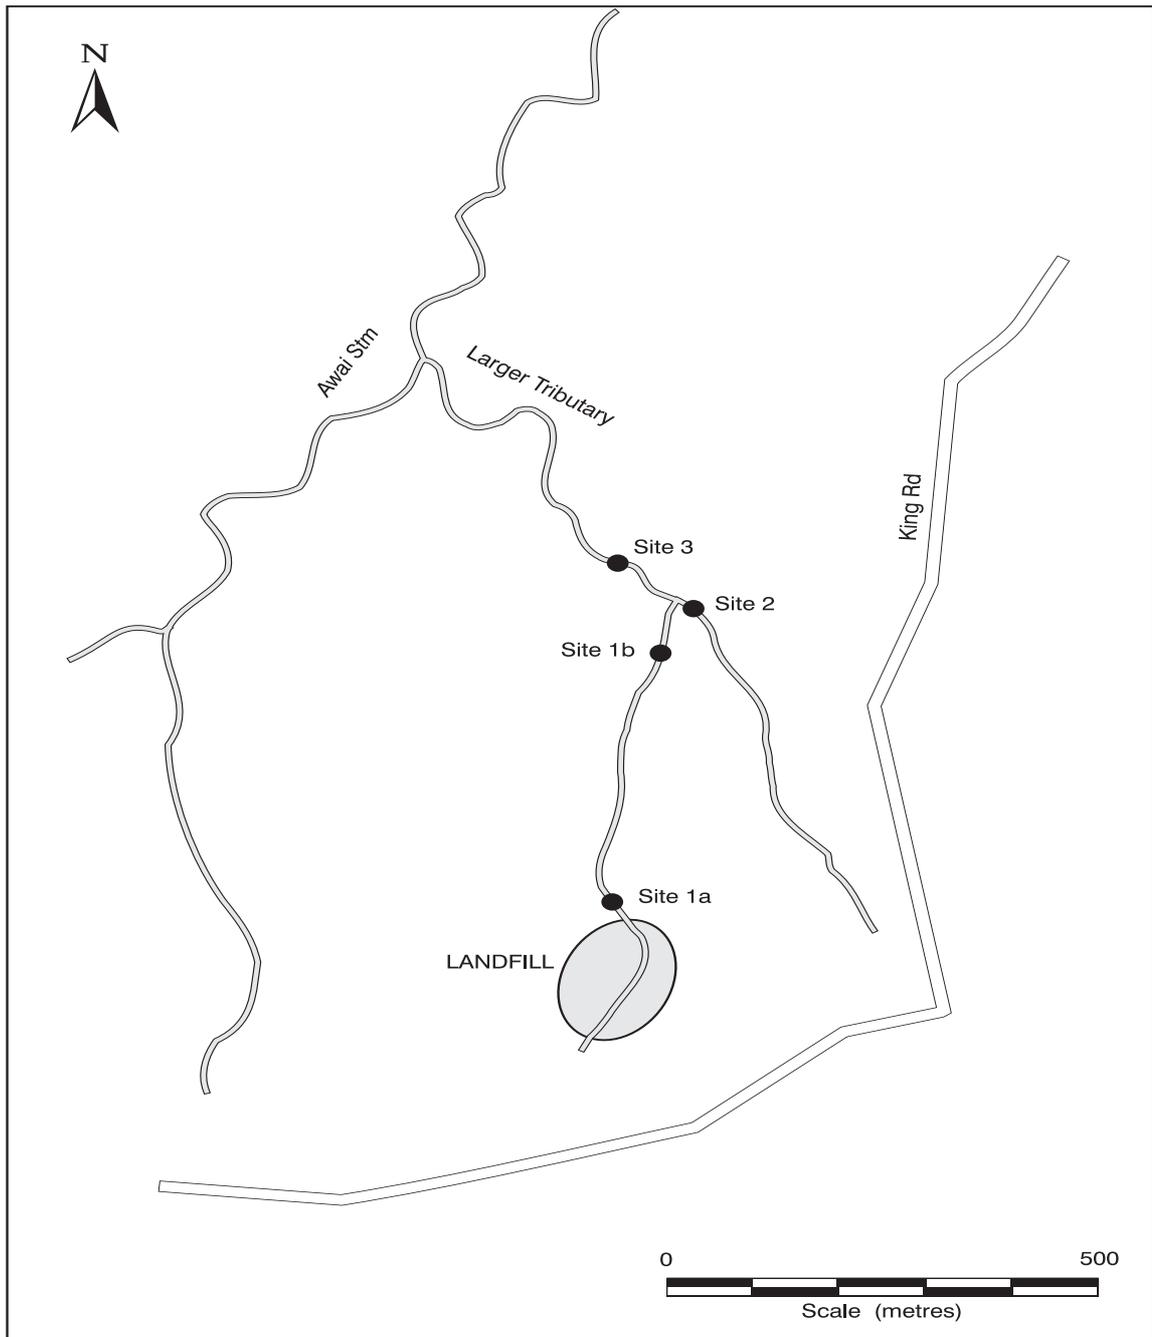
Figure 7 Biomonitoring sites in tributaries of the Awai Stream related to the Inglewood landfill

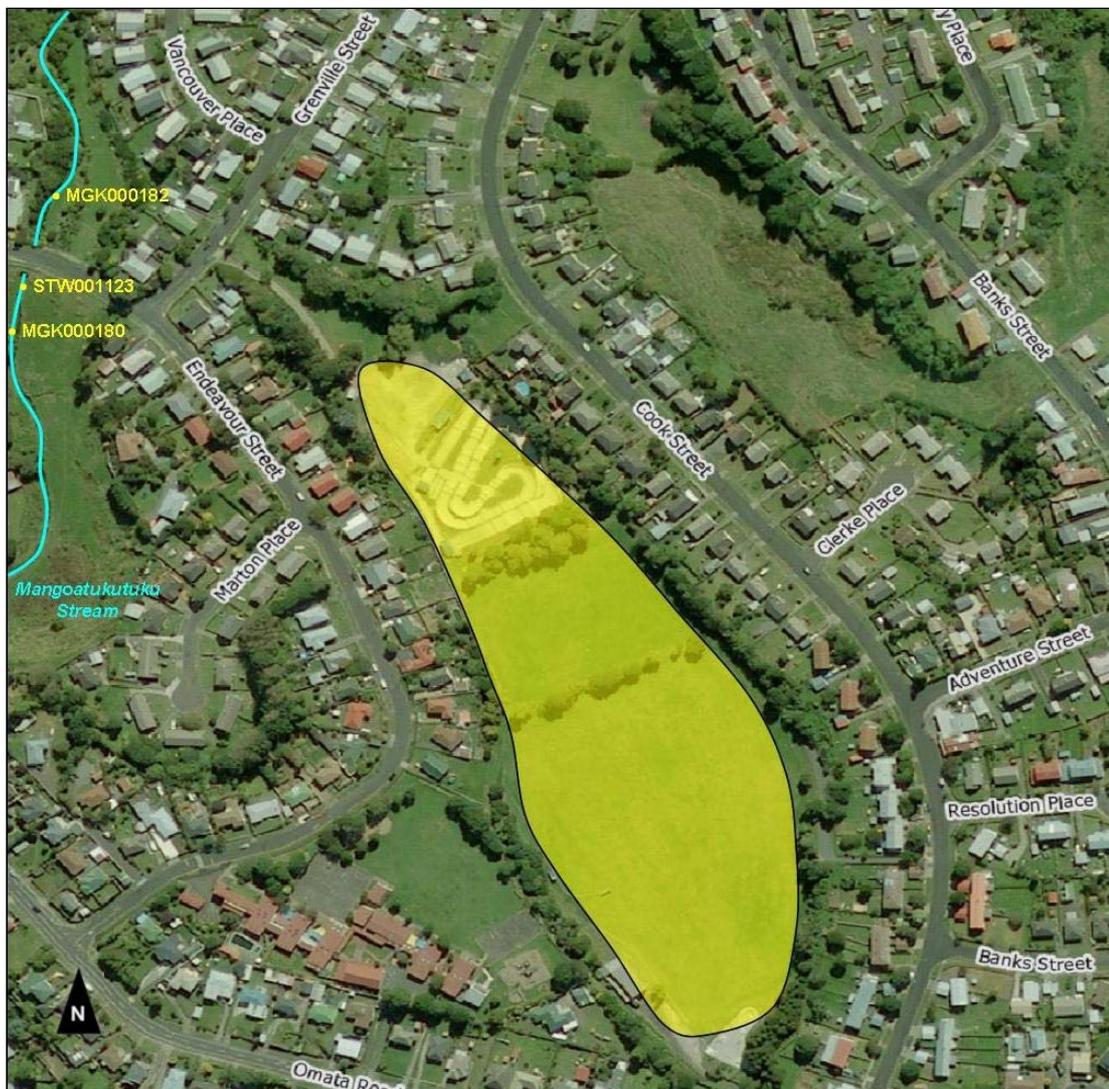
Figure 8 An aerial view showing former landfill at Marfell Park and sampling sites

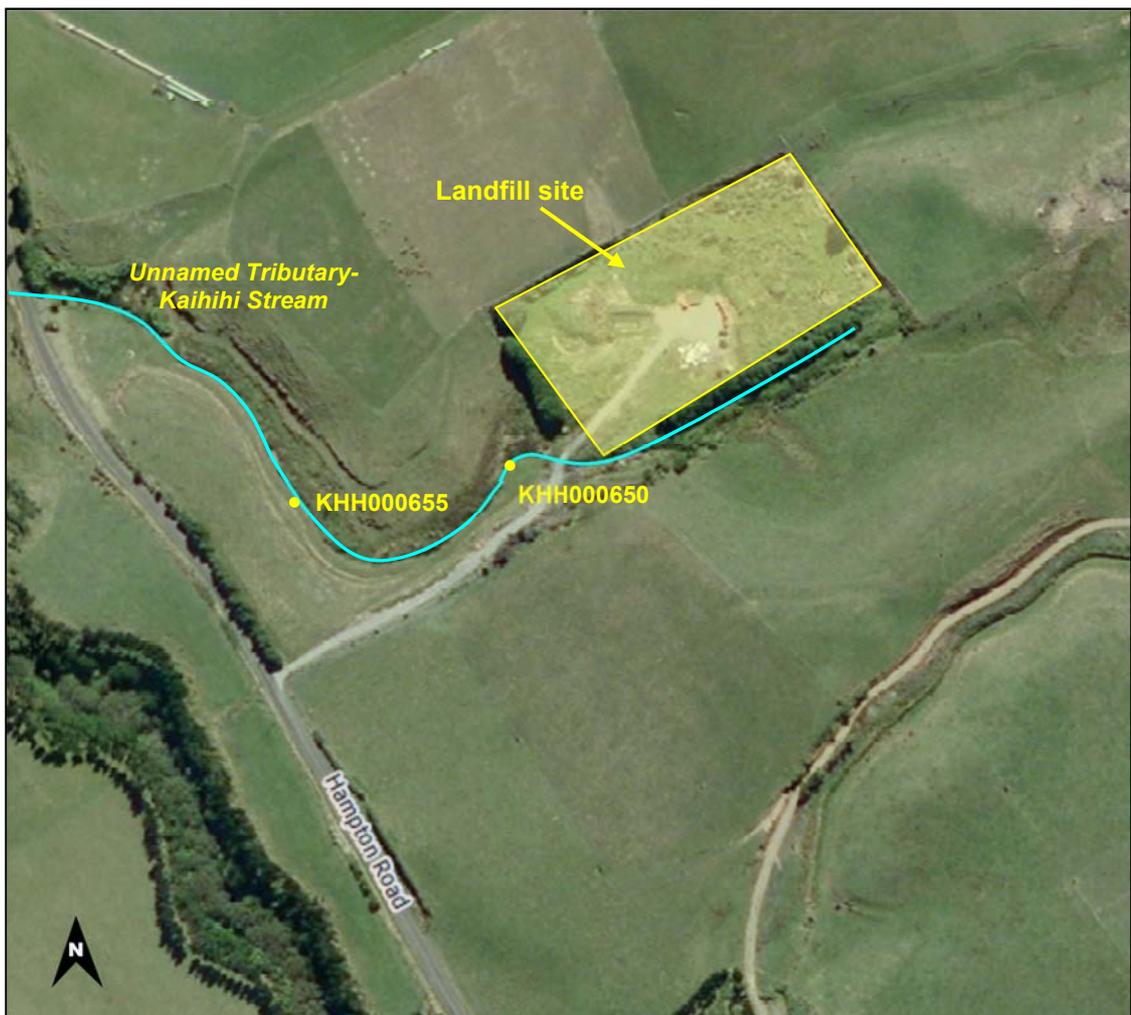
Figure 9 Okato landfill and sampling sites

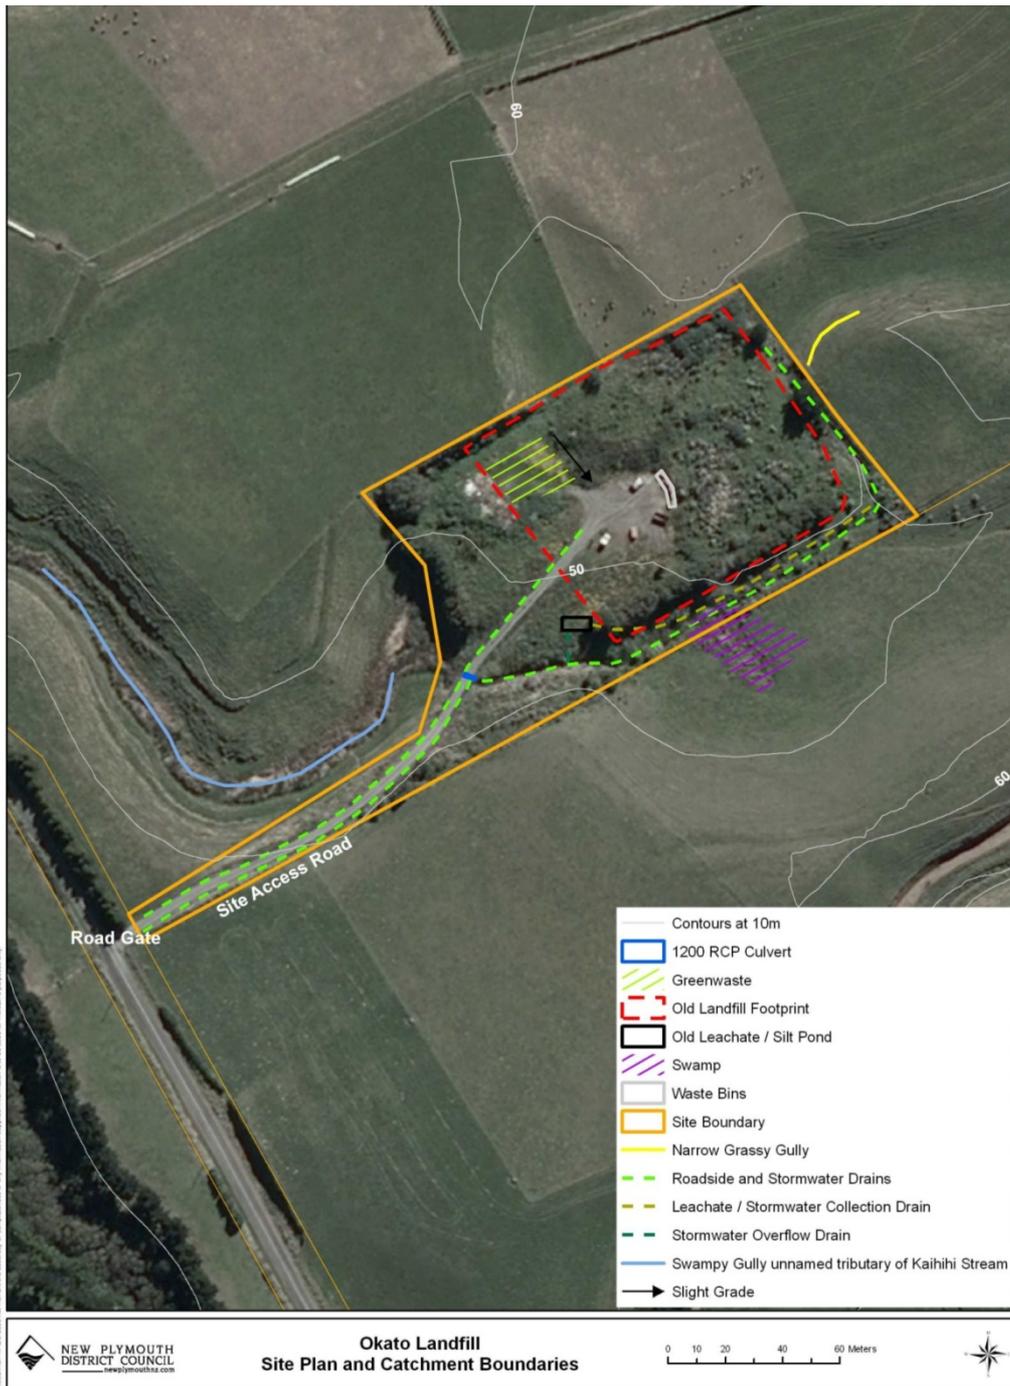
Figure 1 Aerial plan of Okato landfill site

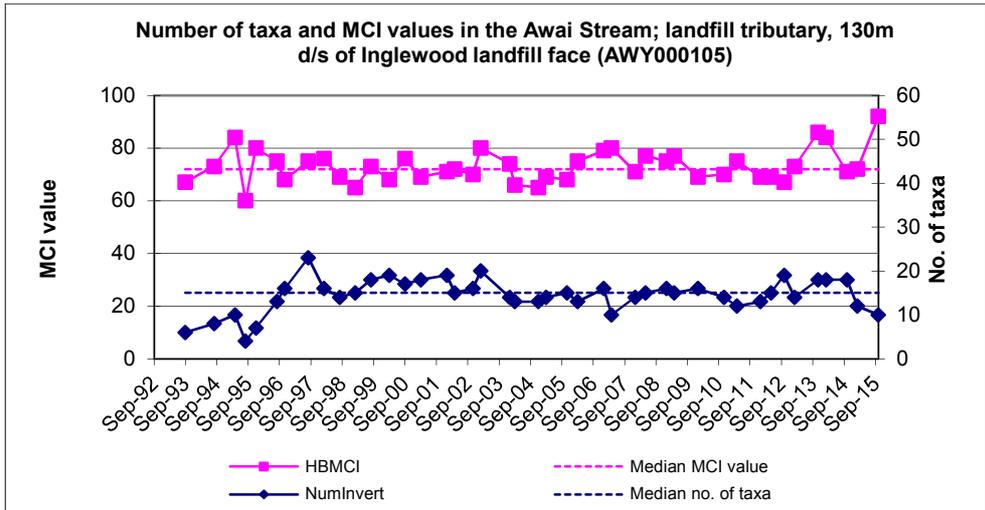
A total of 10 taxa was recorded at site 1a, 100 metres downstream of the landfill face. This result was five taxa less than the median richness recorded at this site. The majority of taxa (70%) recorded at the site were 'sensitive' taxa which was reflected in the moderate MCI score of 92 units. This MCI score was significantly higher than the median and the highest MCI recorded to date (Stark, 1998). There was a significant increase of 20 units in the MCI score at this site from the previous February 2015 survey (Figure 2) (Stark, 1998).

Figure 2 Number of taxa and MCI values at site 1a in a tributary of the Awai Stream

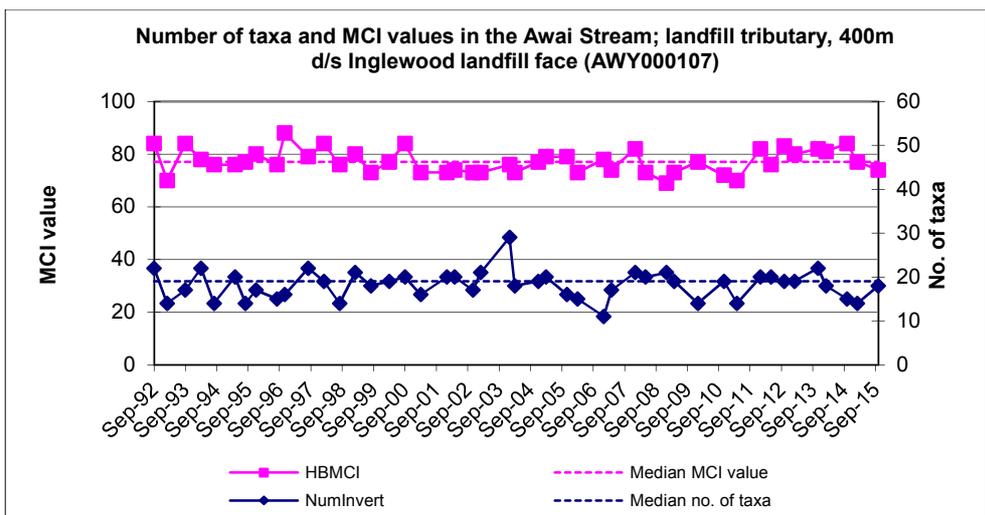
Eighteen taxa were recorded at site 1b, approximately 400 metres downstream of the landfill face, one taxon less than the median recorded at this site but eight taxa higher than that recorded at site 1a in this same survey. At the time of this survey, a higher proportion of ‘tolerant’ than ‘sensitive’ taxa was recorded. A low MCI score of 74 units was recorded, three units lower than the median score for the site (Figure 3) and a significant (Stark, 1998) 18 units lower than the MCI score recorded at site 1a in this survey.

Figure 3 Number of taxa and MCI values at site 1b in a tributary of the Awai Stream

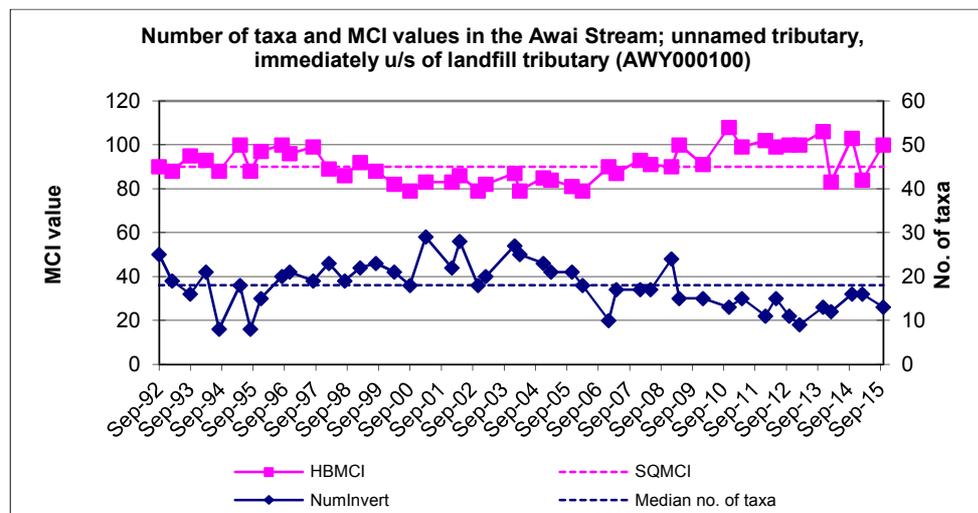
The 'control' site 2 upstream of the confluence with the landfill tributary had a community richness of 13 taxa, five taxa lower than the median number found by previous surveys (Table 2, Figure 4). A high proportion of the community recorded at this site in the current survey were 'sensitive' taxa (61%) which resulted in a relatively high MCI score of 100 units for the site (Table 3). This MCI score was 10 units higher than the median score recorded at the site previously and was higher than the MCI score recorded at the two sites in the small unnamed tributary (1a and 1b) (by 8 and 26 units respectively) (Stark 1998).

Figure 4 Number of taxa and MCI values at site 2 in a tributary of the Awai Stream

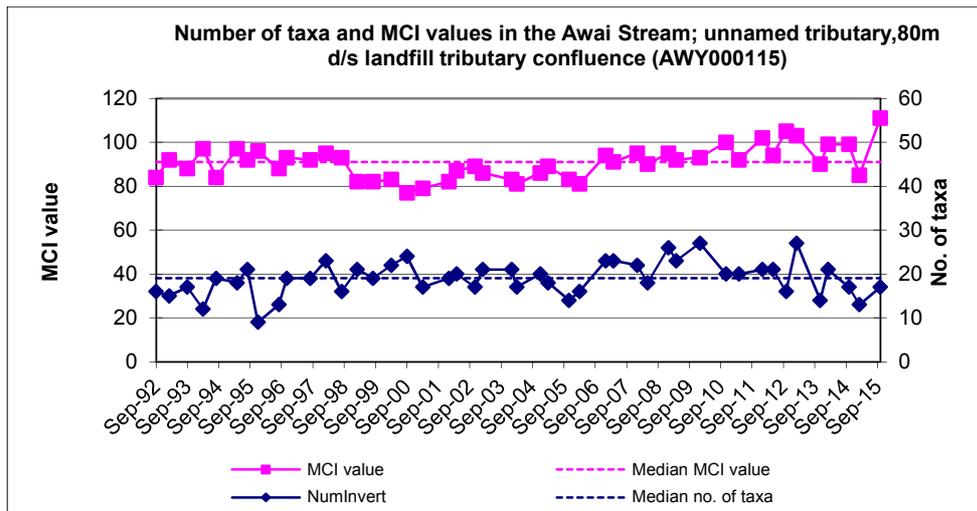
A total of 17 taxa was found at site 3 below the confluence with the landfill drainage tributary, which was two taxa less than the median richness recorded by previous surveys. The MCI score of 111 units reflected the high proportion of 'sensitive' taxa (76%) present in the community at this site in the current survey. This MCI score was significantly (Stark, 1998) higher (by 20 units) than the median for this site and a significant 26 units higher than that recorded in the previous survey (Figure 5).

Figure 5 Number of taxa and MCI values at site 3 in a tributary of the Awai Stream

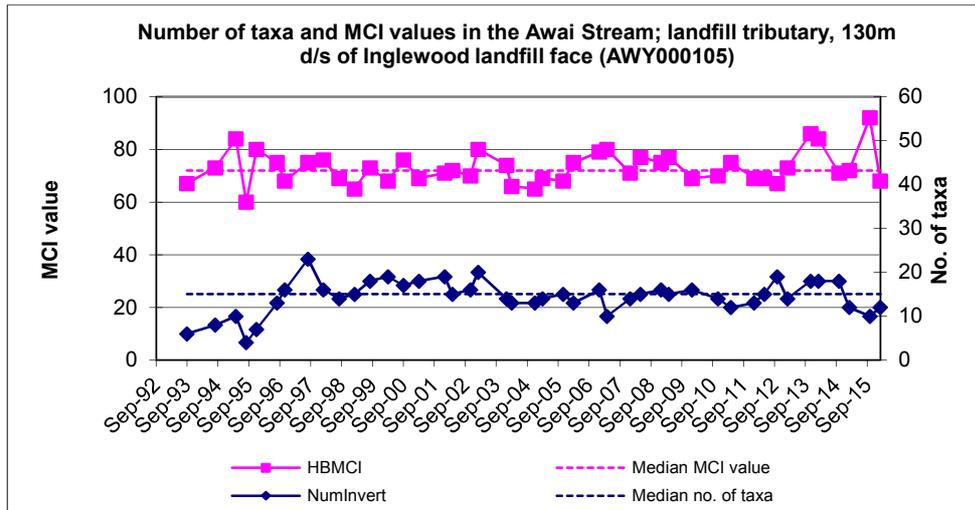
A total of 12 taxa was recorded at site 1a, 100 metres downstream of the landfill face. This result was three taxa less than the median richness recorded at this site. The majority of taxa (67%) recorded at the site were 'tolerant' taxa which was reflected in the poor MCI score of 68 units. This MCI score was slightly lower than the median but within the range of MCI scores recorded to date. There was a significant decrease of 24 units in the MCI score at this site from the previous October 2015 survey, a reflection of the extremely low flow recorded at the time of sampling (Figure 2) (Stark, 1998).

Figure 2 Number of taxa and MCI values at site 1a in a tributary of the Awai Stream

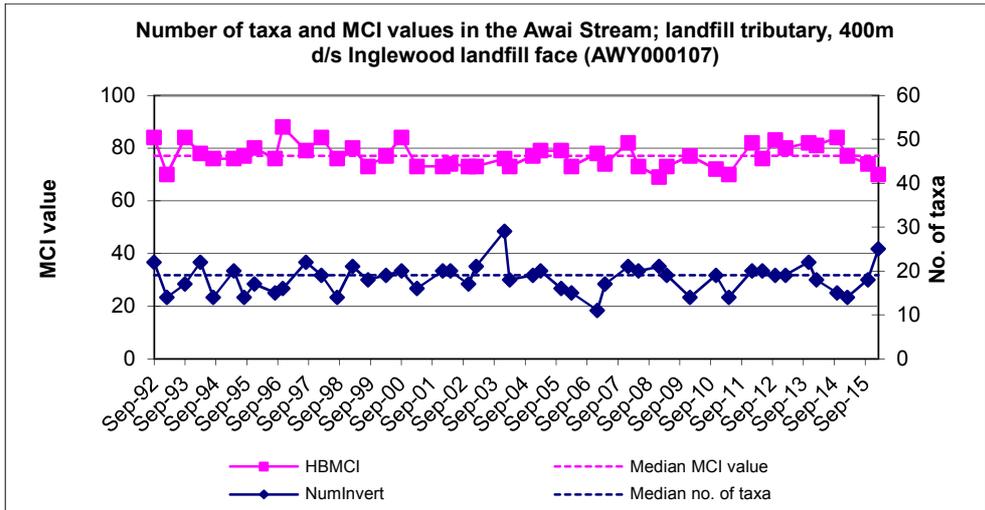
Twenty-five taxa were recorded at site 1b, approximately 400 metres downstream of the landfill face, six taxa more than the median recorded at this site and 13 taxa higher than that recorded at site 1a in this same survey. At the time of this survey a higher proportion of 'tolerant' taxa was recorded. A low MCI score of 70 units was recorded, 7 units lower than the median score for the site (Figure 3) and 2 units higher than the MCI score recorded at site 1a in this survey.

Figure 3 Number of taxa and MCI values at site 1b in a tributary of the Awai Stream

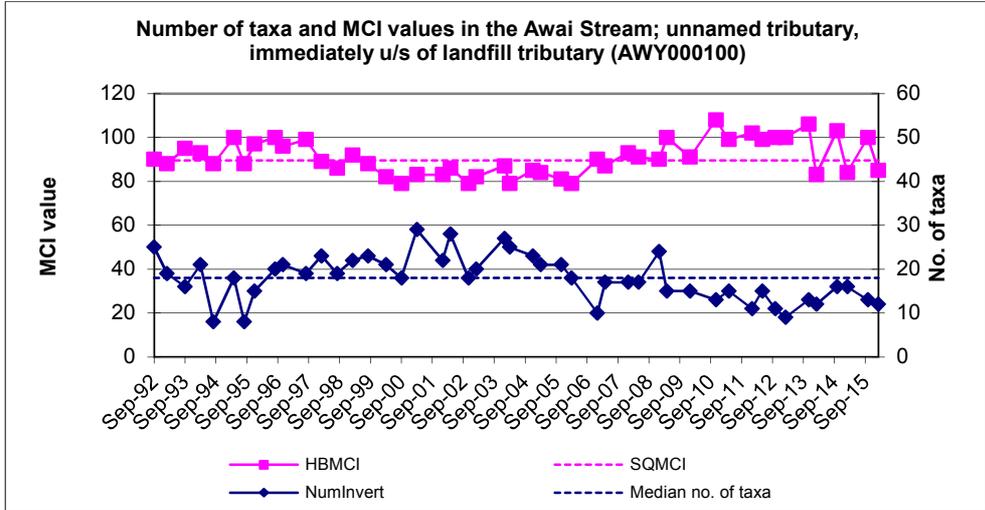
The ‘control’ site 2, upstream of the confluence with the landfill tributary had a community richness of 12 taxa, six taxa lower than the median number found by previous surveys (Table 2, Figure 4). A moderate proportion of the community recorded at this site in the current survey were ‘sensitive’ taxa (58%) which resulted in a moderate MCI score of 85 units for the site (Table 3). This MCI score was 5 units less than the median score recorded at the site previously and was significantly (Stark, 1998) higher than the MCI score recorded at the two sites in the small unnamed tributary (1a and 1b) (by 17 and 15 units respectively) (Stark 1998).

Figure 4 Number of taxa and MCI values at site 2 in a tributary of the Awai Stream

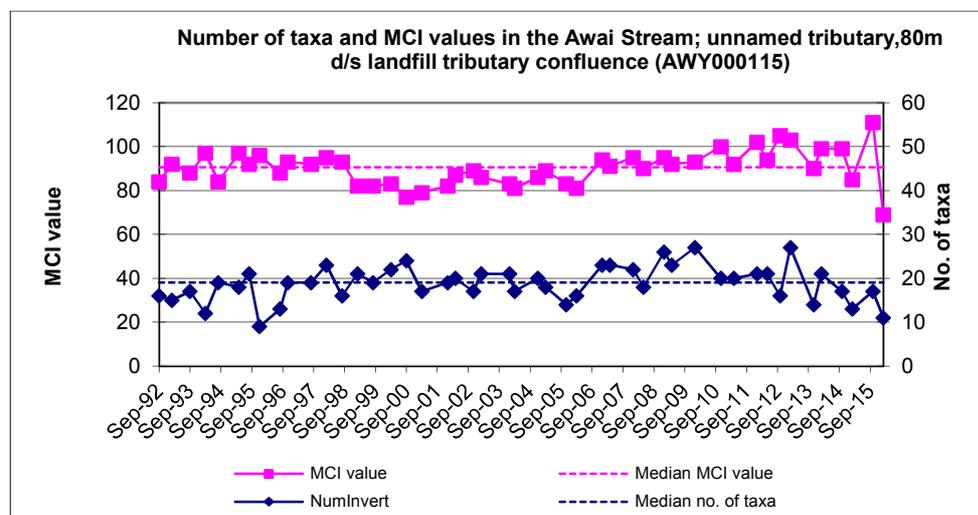
A total of 11 taxa was found at site 3 below the confluence with the landfill drainage tributary, which was eight taxa less than the median richness recorded by previous surveys. The MCI score of 69 units reflected the high proportion of 'tolerant' taxa (64%) present in the community at this site in the current survey. This MCI score was significantly (Stark, 1998) lower (by 22 units) than the median for this site and a significant 42 units lower than that recorded in the previous survey (Figure 5).

Figure 5 Number of taxa and MCI values at site 3 in a tributary of the Awai Stream
