Dimar Partnership Landfill  
Monitoring Programme  
Annual Report  
2016-2017

Technical Report 2017-96

Taranaki Regional Council  
Private Bag 713  
STRATFORD  
March 2018

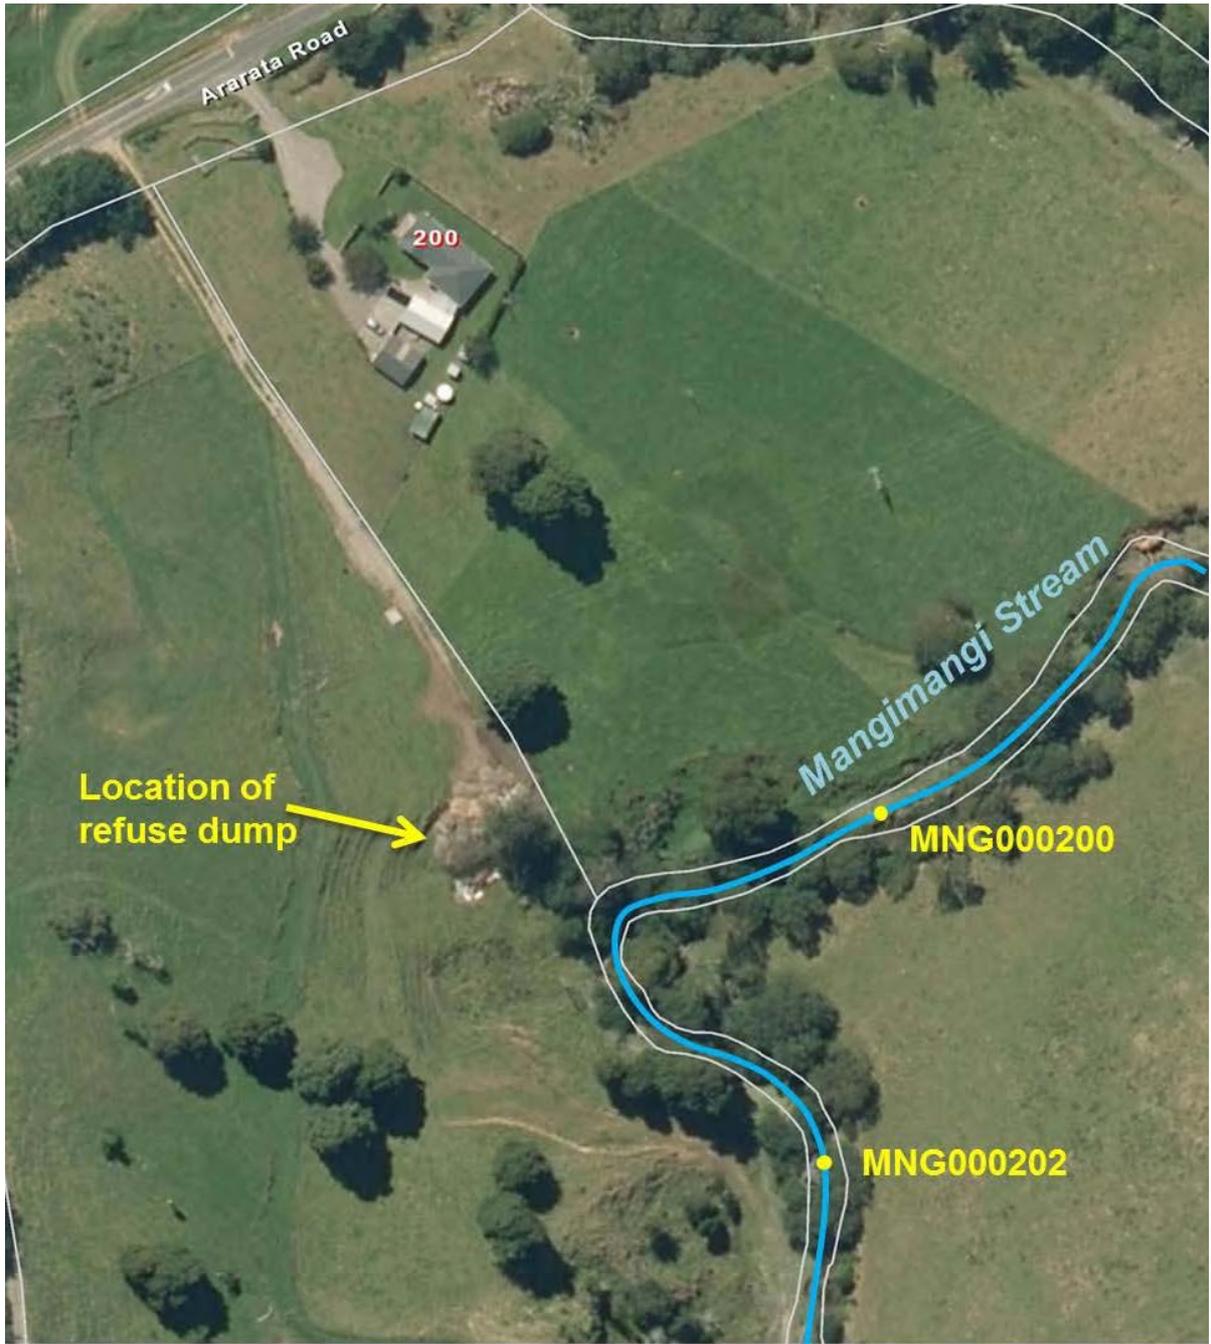
Figure 1 Aerial map of the site showing the location of the refuse dump and sampling sites

The consent holder previously operated a refuse dump on a farm located at Ararata Road, Hawera. The total area of the site is approximately 17.8 hectares with the surrounding land uses being predominantly agricultural. The Mangimangi Stream is located to the west and southwest of the site (Figure 1).

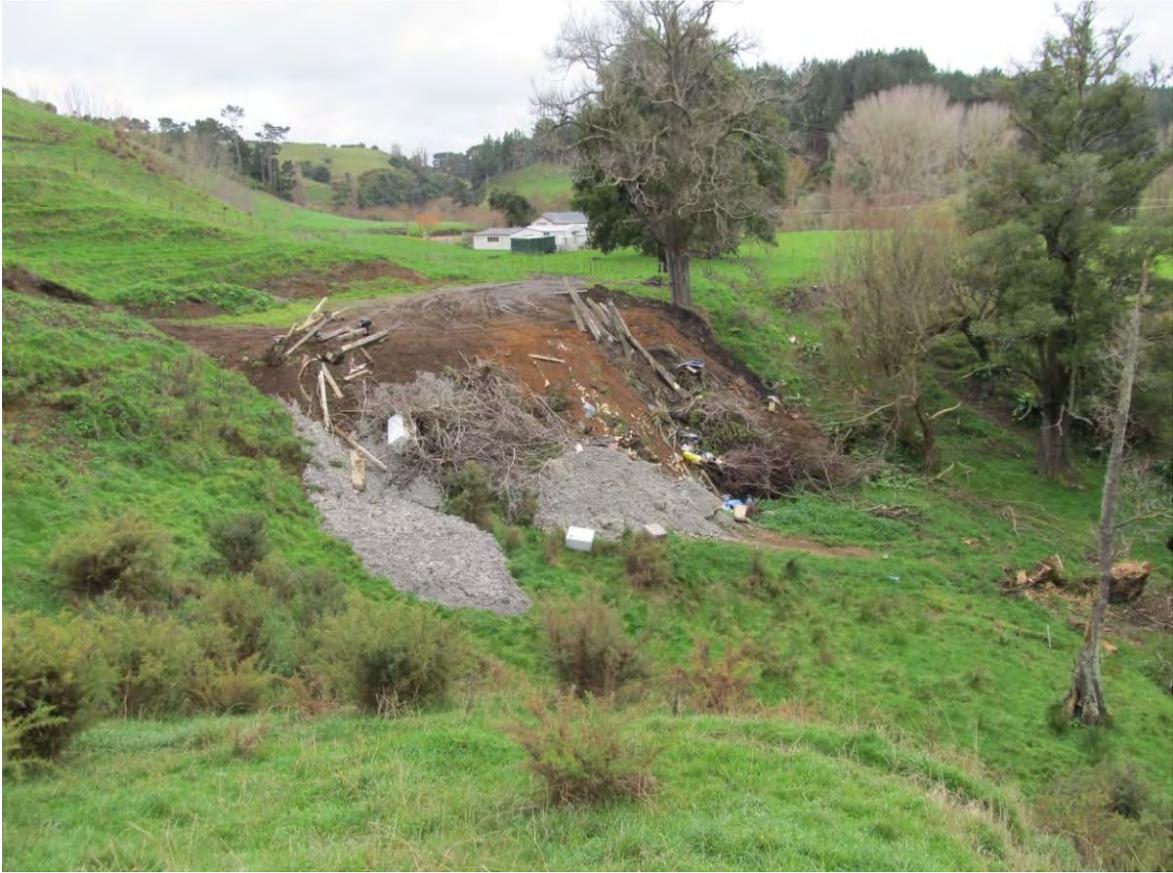
Photo 1 Photograph showing the refuse dump prior to capping

For a number of years the dump was filled with household rubbish, broken concrete, timber, tree prunings and farm waste from several of the surrounding properties (Photo 1). The dump was located approximately 22 m away from the Mangimangi Stream, therefore the discharge of contaminants (leachate) into the Mangimangi Stream has the potential to result in the contamination of surface water.

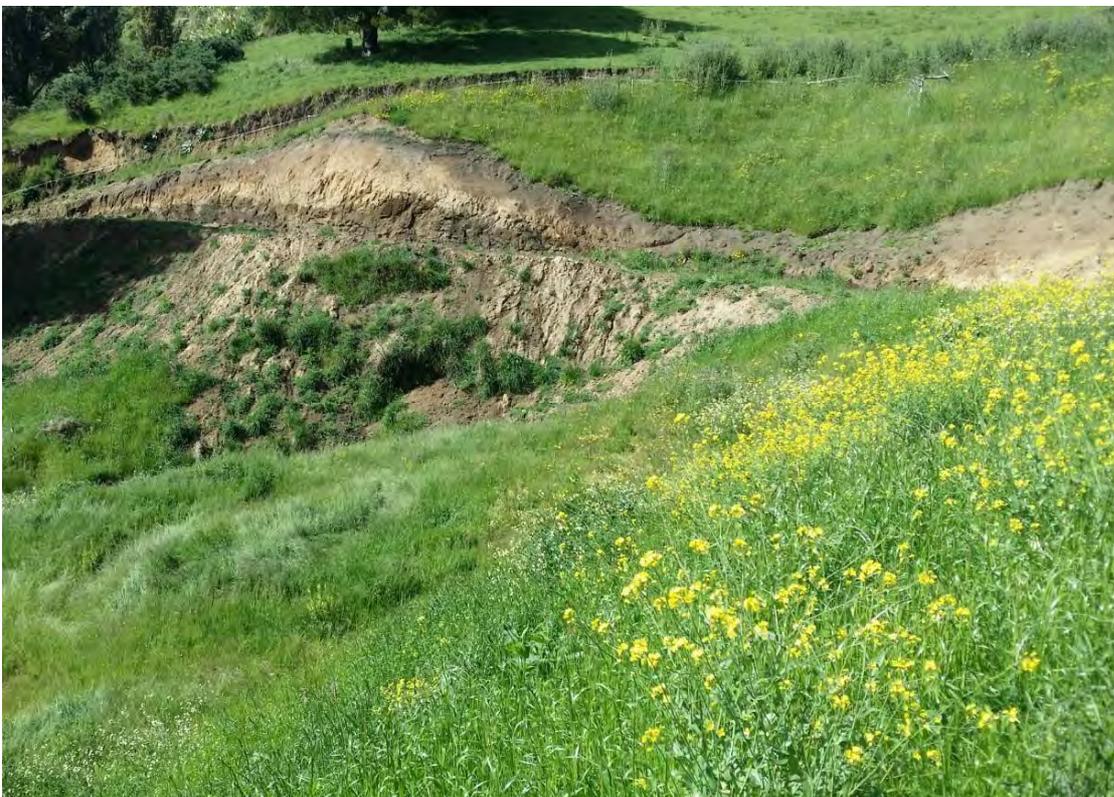
Photo 2 Photograph showing the refuse dump after capping (foreground)

Since the closure of the dump, the consent holder has rehabilitated the site. This has involved removing all rubbish located within 25 m of the stream, covering the site with 500 mm of clay, which was shaped to the desired contour, capping with 500 mm of top soil and re-vegetating with grass (Photo 2).
