NPDC – Colson Road Landfill
Monitoring Programme
Annual Report
2016-2017

Technical Report 2017-30

October 2017

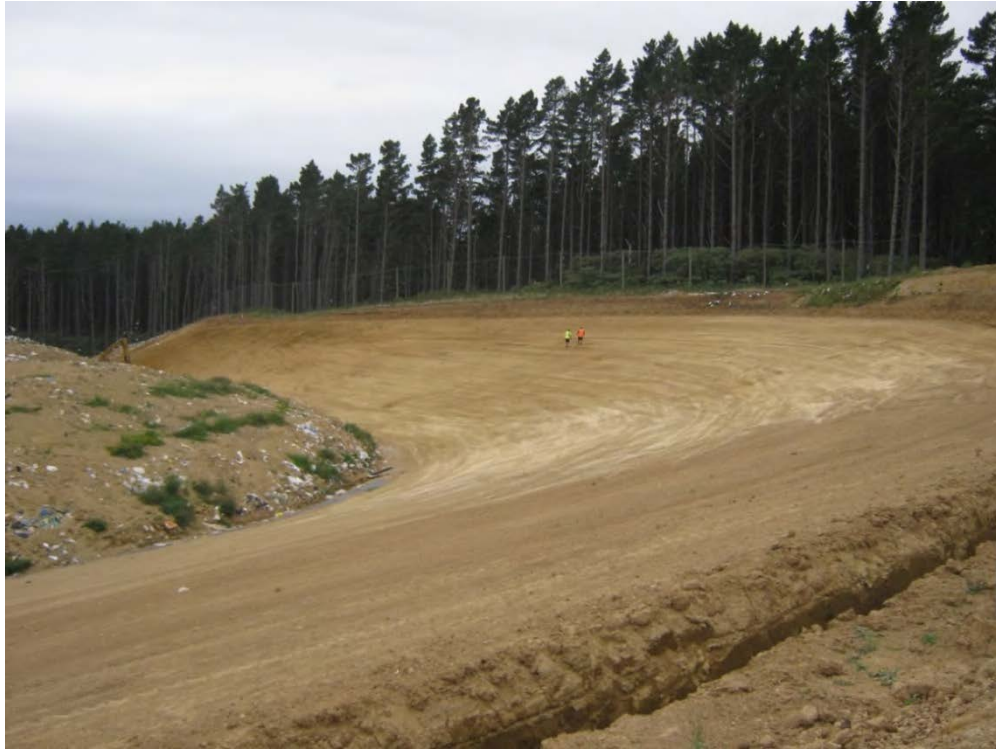
Photo 1 Stage 3 extension works, February 2011

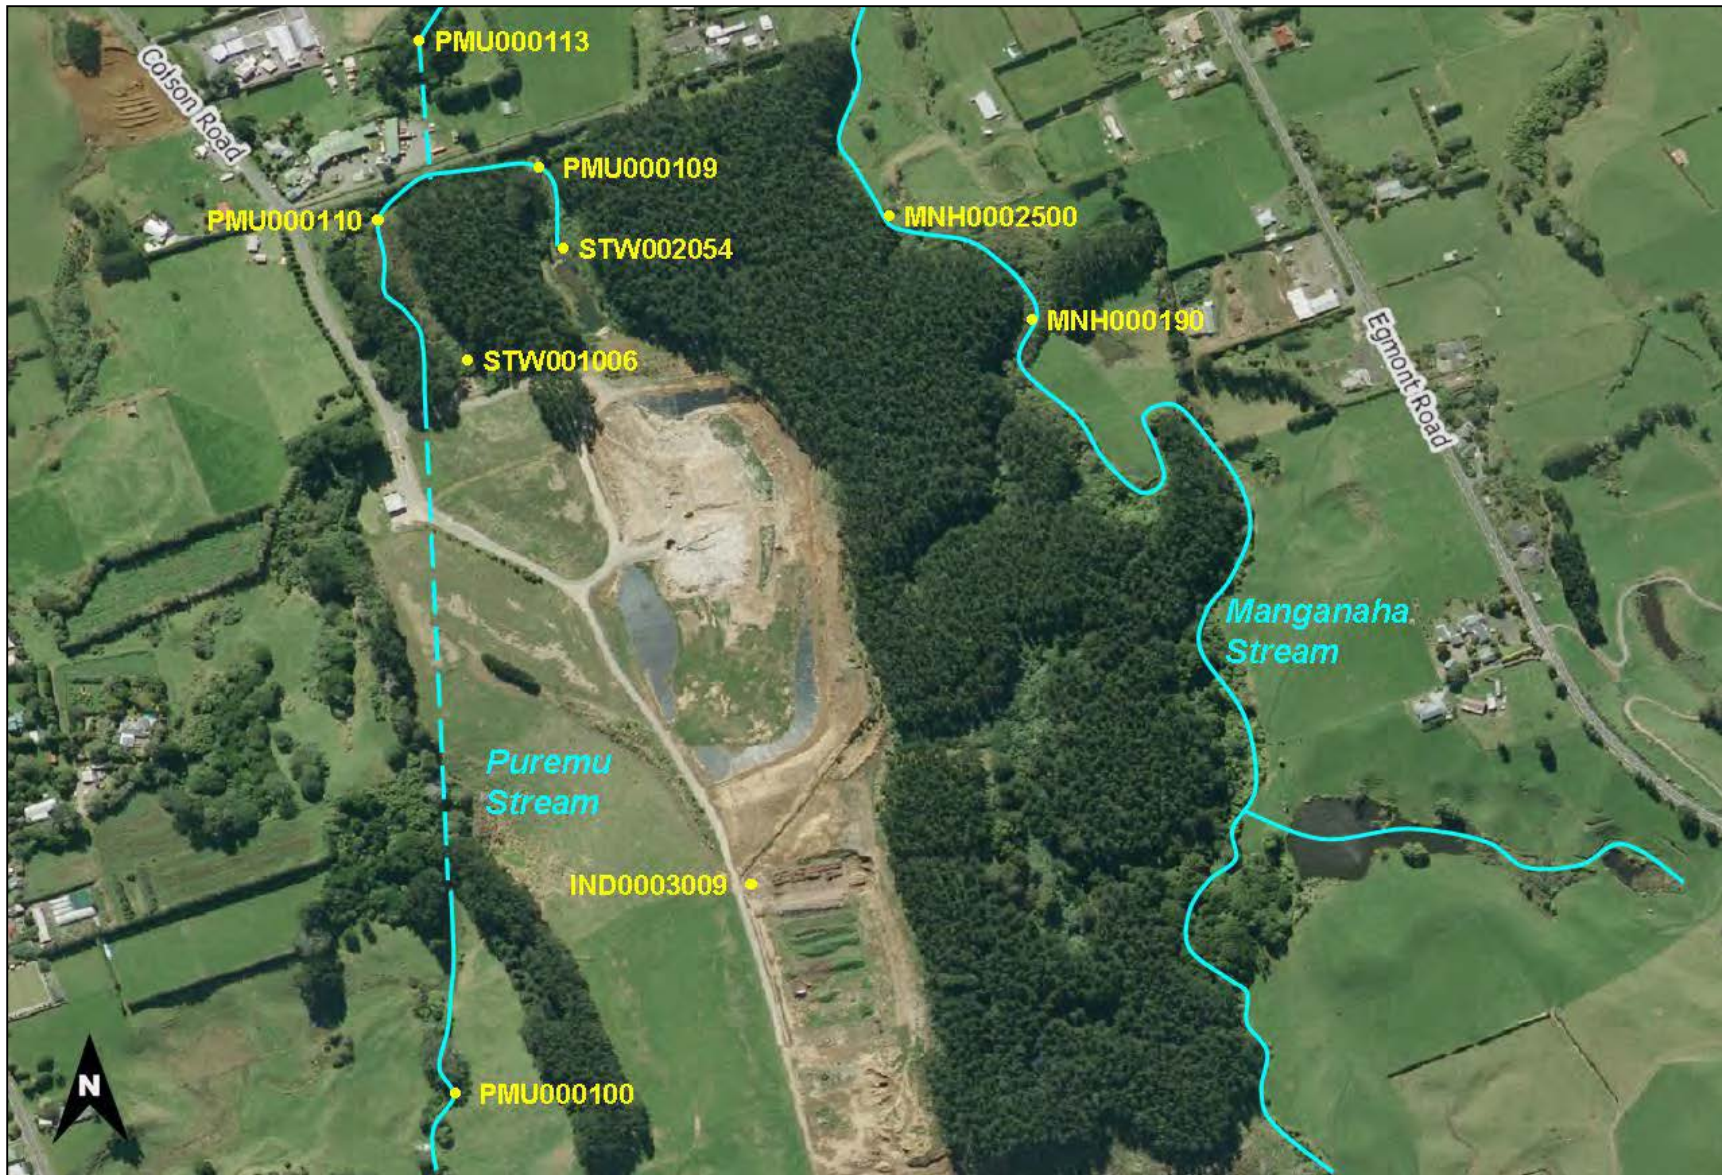
Figure 2 Aerial photo showing the stormwater and receiving water sampling sites at Colson Road landfill

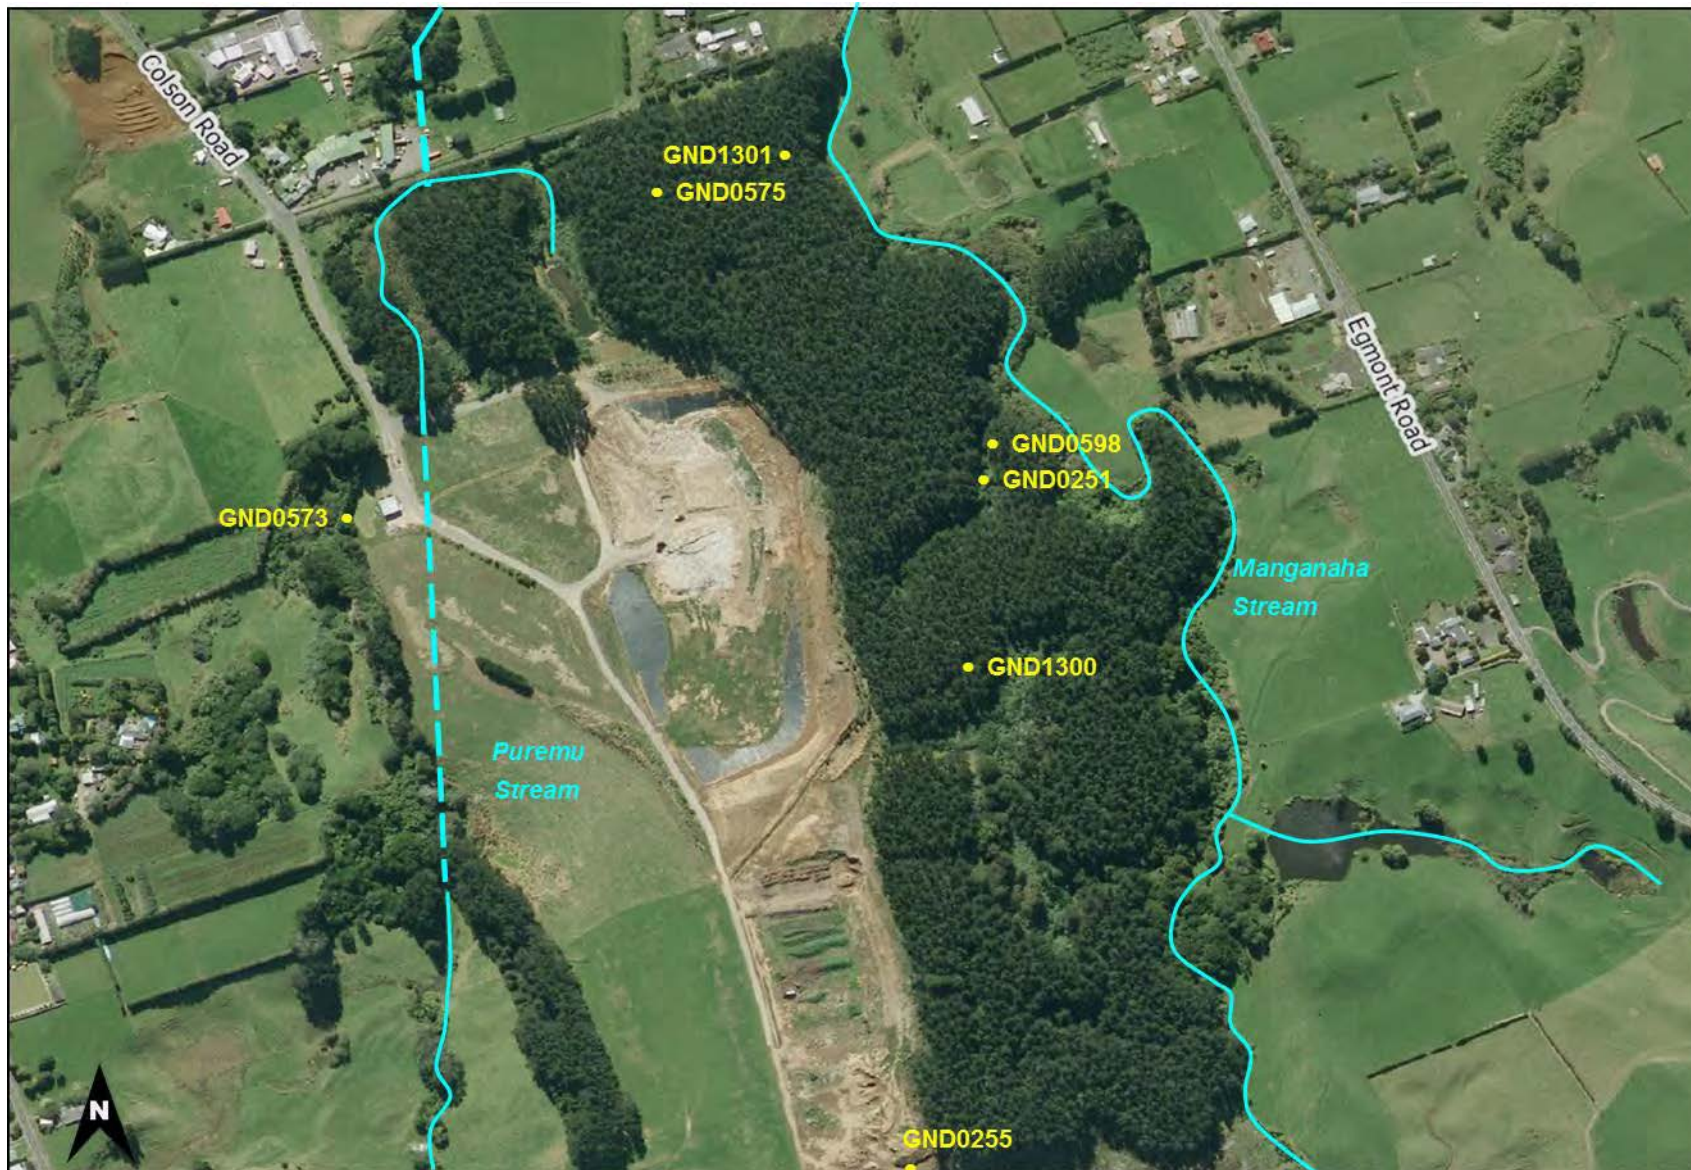
Figure 3 Aerial view showing the groundwater sampling sites at Colson Road landfill

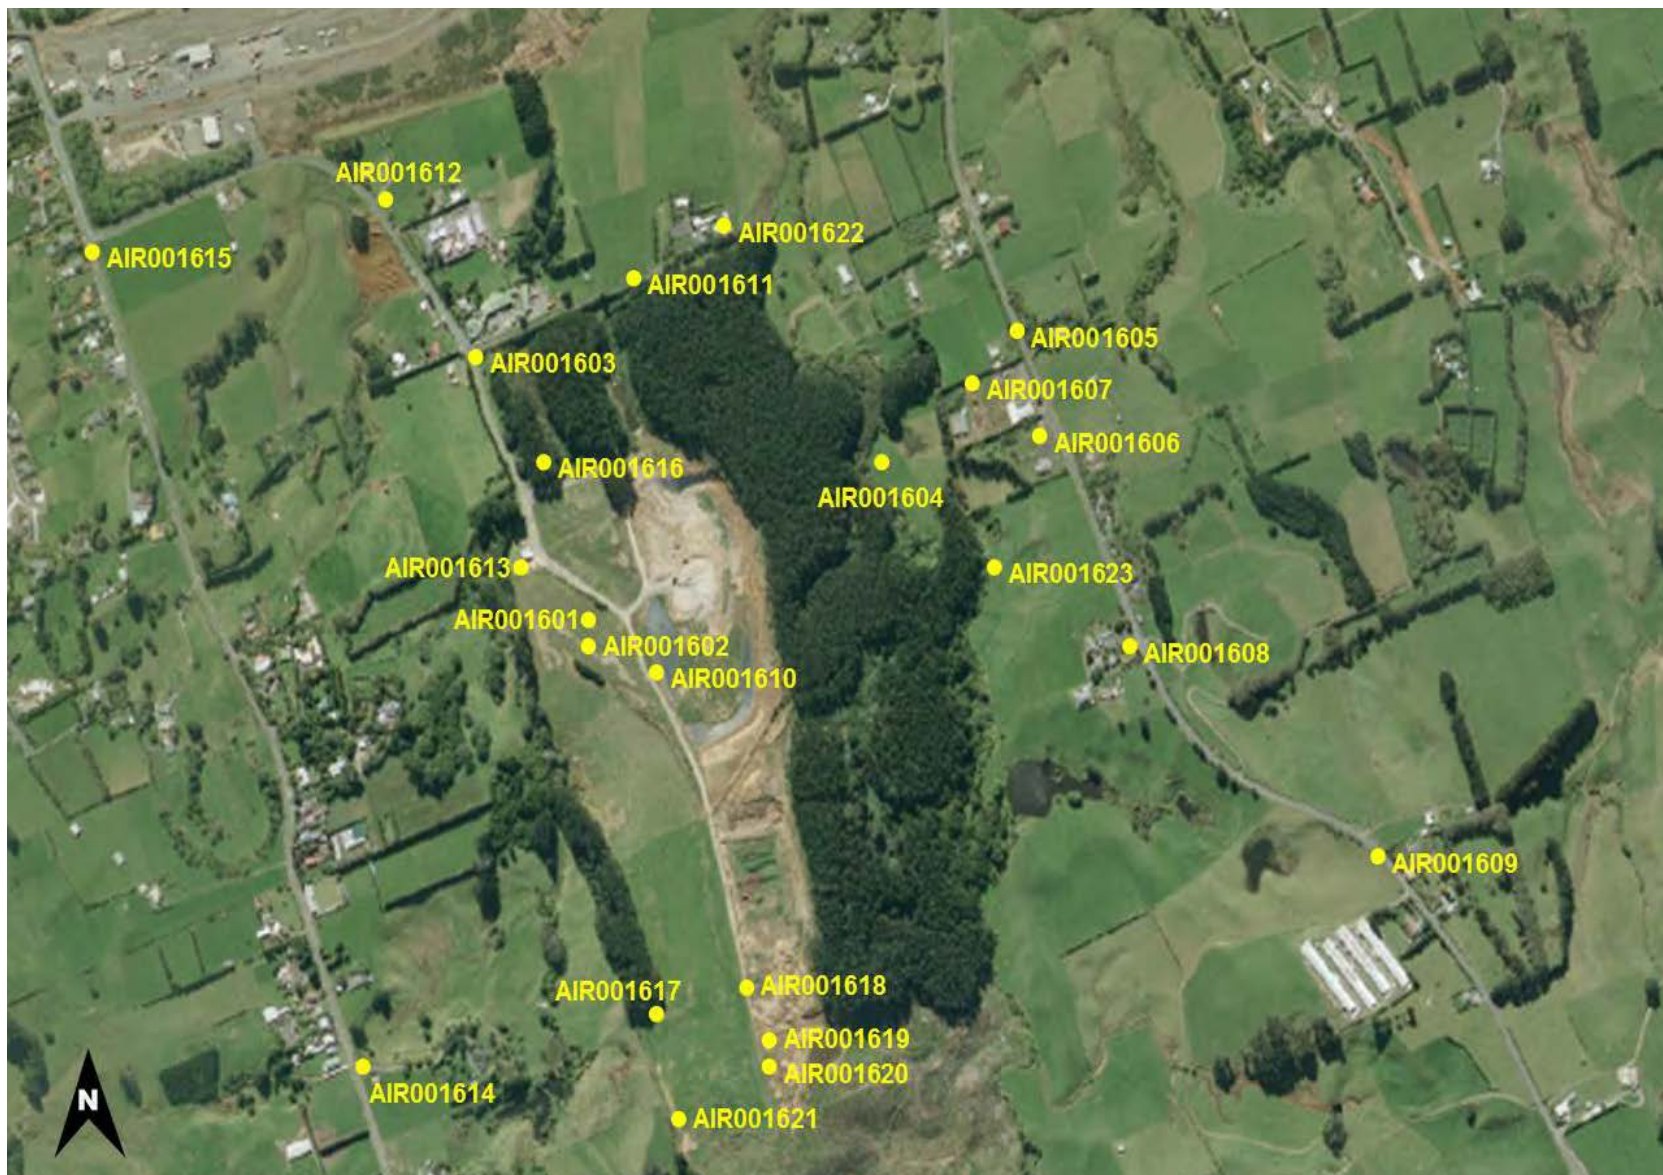
Figure 4 Aerial view showing the positions of air quality monitoring sites at and around Colson Road landfill

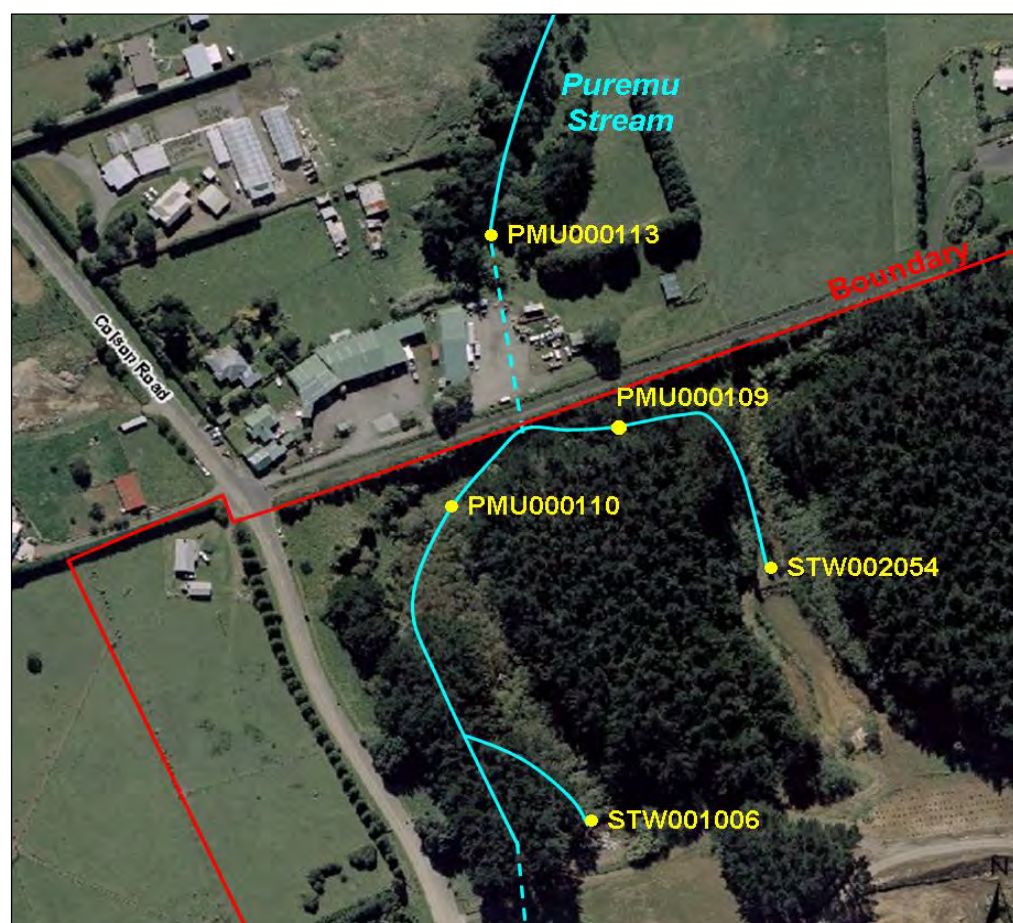
Figure 5 Sampling sites on the Puremu Stream down stream of the landfill

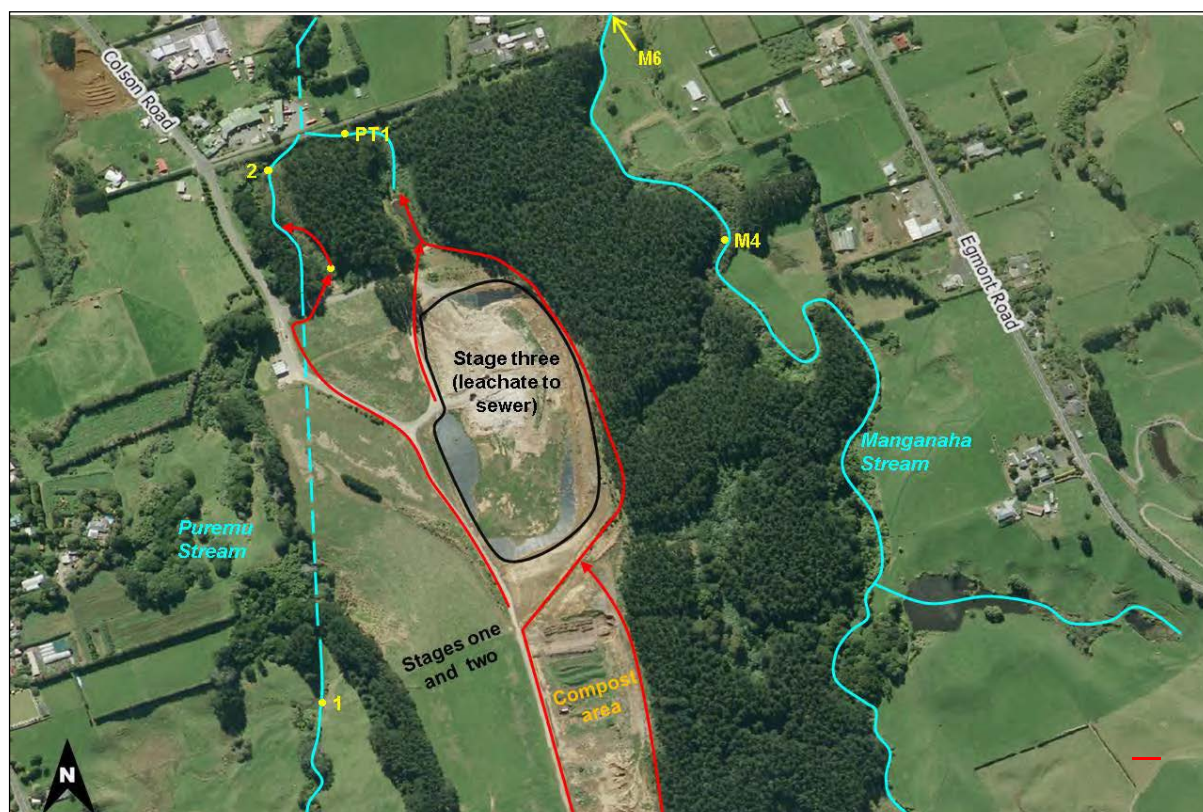
Figure 6 Biomonitoring sites related to the Colson Road landfill, New Plymouth

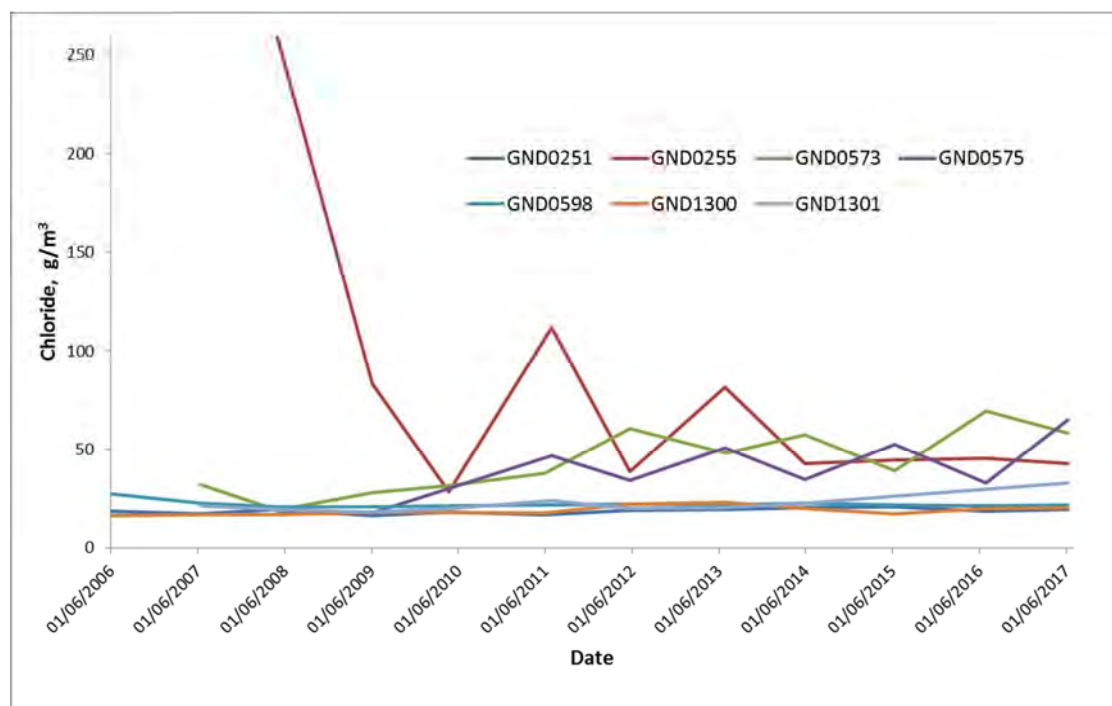
Figure 7 Chloride concentrations in the Colson Road groundwater bores, June 2006 to date

It can be seen that the chloride concentration in bore GND0255 (up gradient of the landfill) have been decreasing since the spike found in April 2008. Conversely, in bores GND0573, GND0575 (and to a lesser extent GND1301) although the changes are relatively small, it does appear that there may be an emerging trend of increasing chloride concentrations. These bores are down gradient of landfill stages two and three, and may be indicative of some minor leachate contamination.

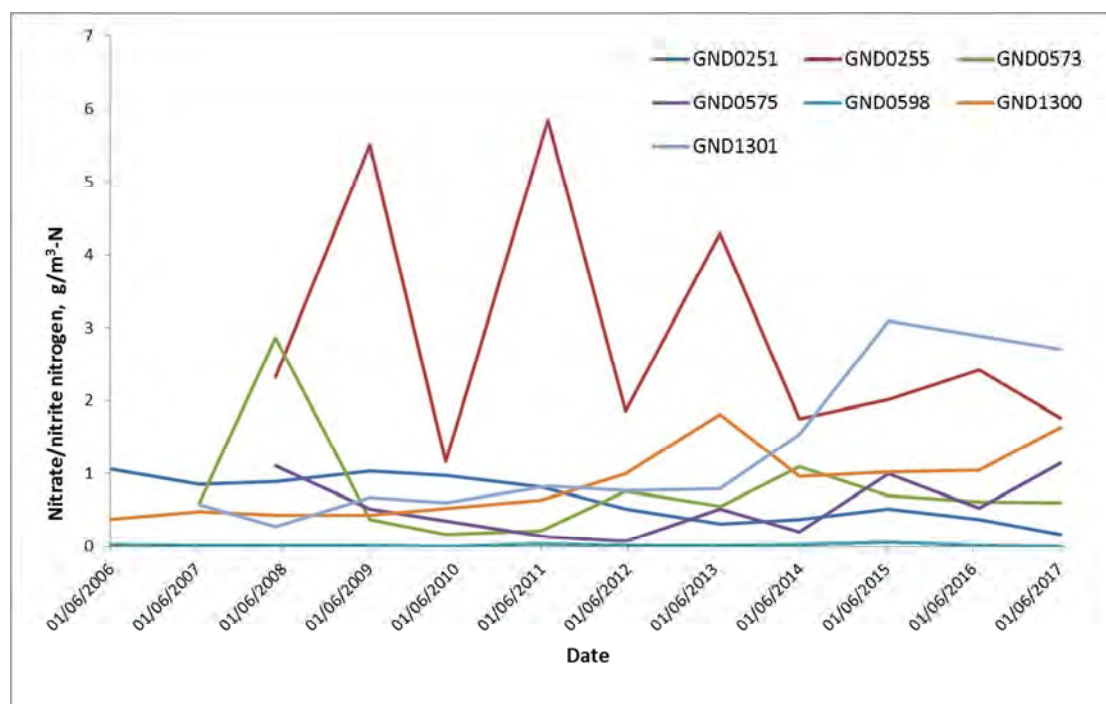
Figure 8 shows that there may be an emerging trend of increasing nitrate/nitrite nitrogen concentrations in bores GND1300 (north east of the composing area and east of the southern end of the landfill) and GND1301 (north east of the landfill).

Figure 8 Nitrite/nitrite nitrogen concentrations in the Colson Road groundwater bores, June 2006 to date

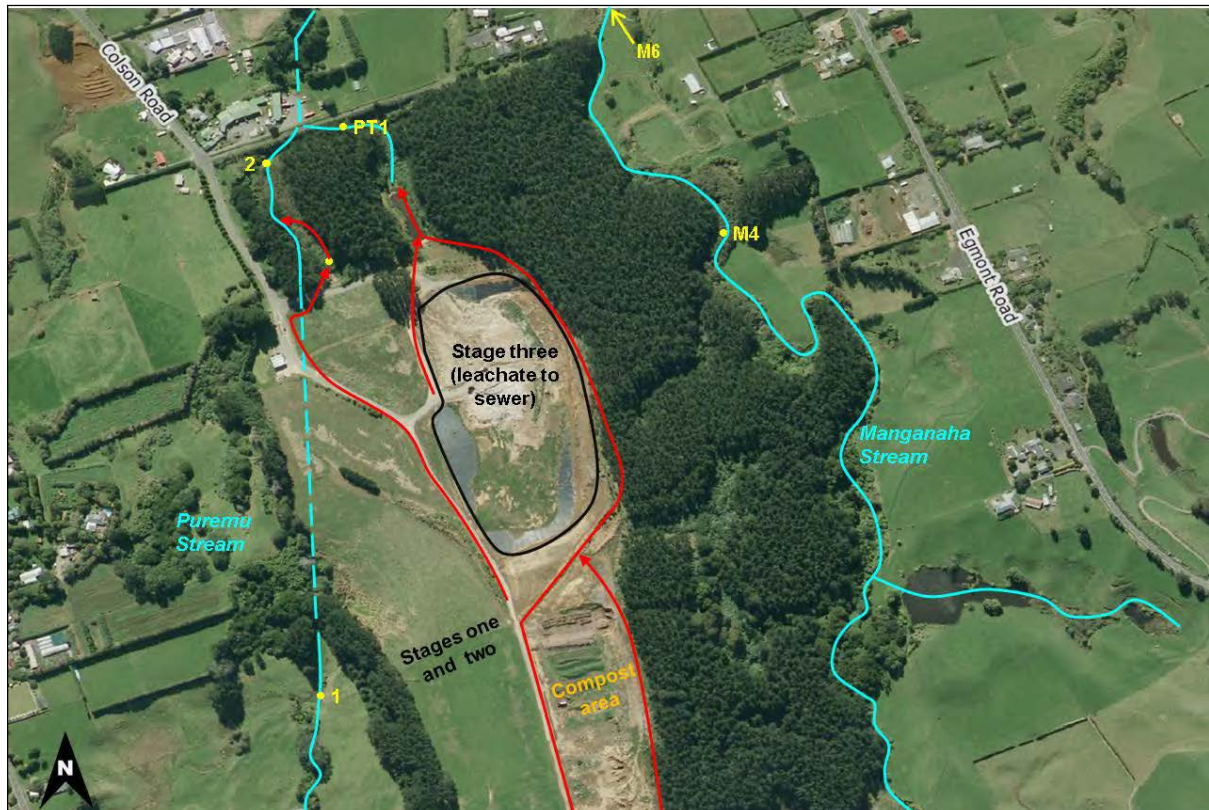
Figure 1 Biomonitoring sites related to the Colson Road landfill, New Plymouth. The red lines on the aerial photograph indicate the direction of stormwater runoff from the landfill site.

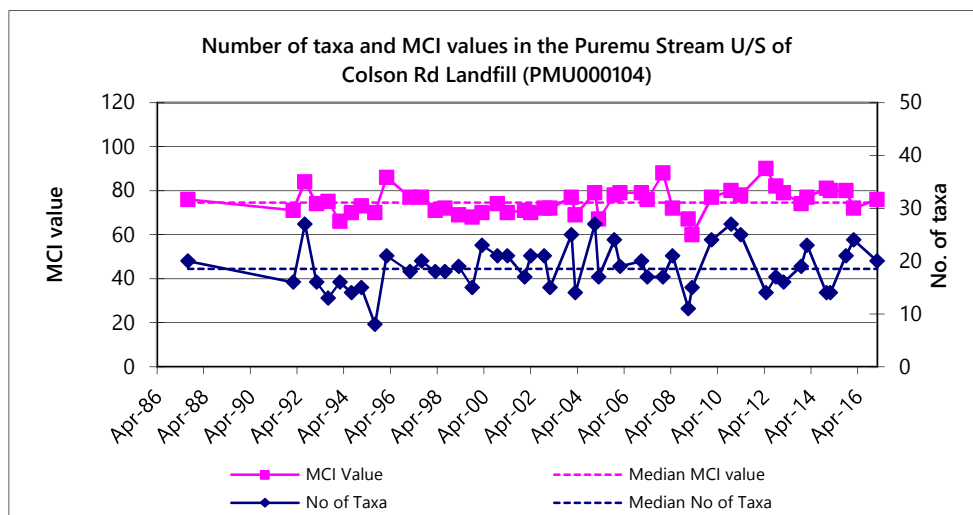
A total taxa richness of 20 taxa was recorded at site 1 (Table 3 and Figure 2). This result was two taxa more than the historical median but four taxa less than the previous survey result.

Figure 2 Number of macroinvertebrate taxa and MCI values recorded at site 1 in the Puremu Stream, upstream of Colson Road Landfill since April 1987

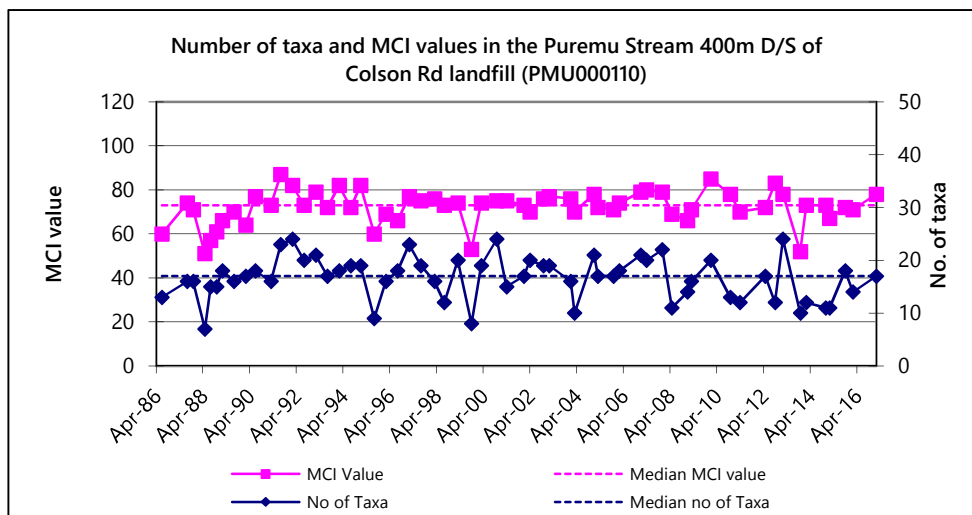
A moderate number of taxa (17) was recorded at this site which was the same as the median recorded by previous surveys at this site, and three taxa more than the richness recorded by the previous survey (Table 3 and Figure 3).

Figure 3 Taxa numbers and MCI values recorded at site 2, 400 m downstream of Colson Rd Landfill

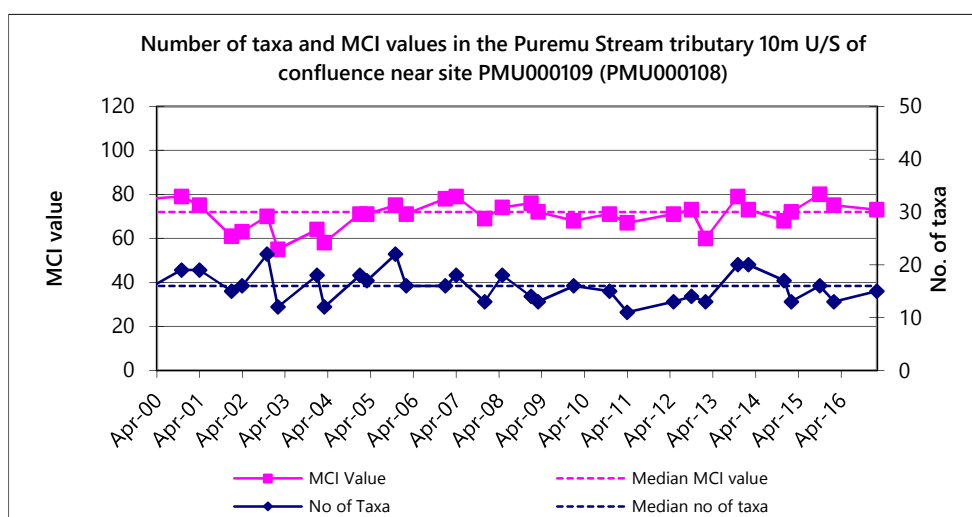
Figure 4 Numbers of taxa and MCI values recorded to date at site PT1, downstream of Colson Road Landfill

The community at site PT1 was characterised by three 'tolerant' taxa [oligochaete worms, leeches (Hirudinea) and ostracod seed shrimp]] and one 'moderately sensitive' taxon [mites (Acarina)] (Table 4). The similar proportion of 'tolerant' (47%) and 'sensitive' (53%) taxa in the macroinvertebrate community was reflected by the MCI score of 73 units, which indicated 'poor' biological health. This MCI score was 1 unit higher than the median MCI score for the site and an insignificant 3 units and 5 units lower than that recorded at sites 1 and 2 respectively (Table 3 and Figure 4).

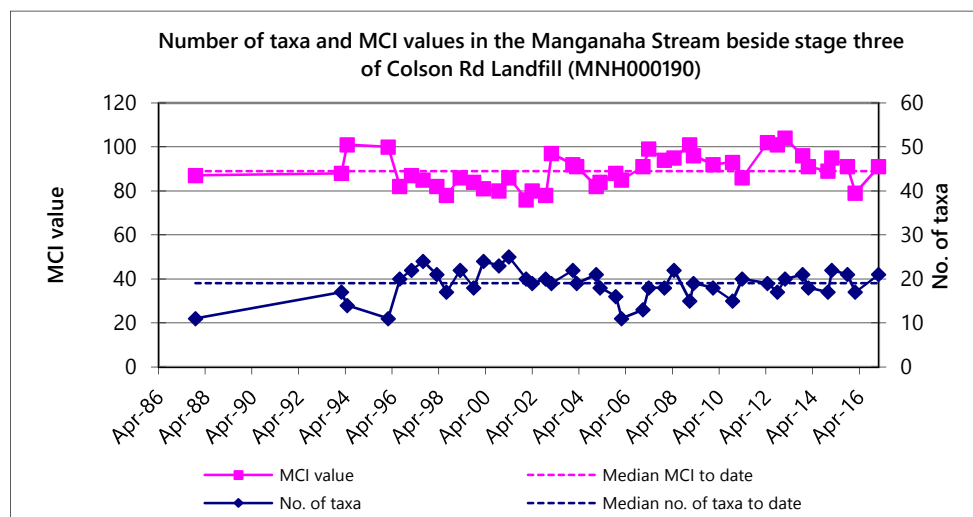
A total of 21 taxa was recorded at site M4 in this survey which was two taxa more than the historical median for the site (Table 3 and Figure 5). The community at this site was characterised by three 'moderately sensitive' taxa [amphipods (*Paracalliope*), stick caddis (*Triplectides*) and mayfly (*Zephlebia group*)] and two 'tolerant' taxa [snail (*Potamopyrgus*) and oligochaete worms] (Table 5), which was indicative of reasonable preceding water quality.

Figure 5 Taxa numbers and MCI values recorded at site M4, in the Manganaha Stream adjacent to Colson Road landfill

A moderate proportion of 'sensitive' taxa (57% of total taxa) in the community resulted in the 'fair' MCI score of 91 units, which was an insignificant (Stark, 1998) 2 units higher than the historical median but a significant (Stark, 1998) 12 units higher than the previous survey results for this site (Table 3 and Figure 5).

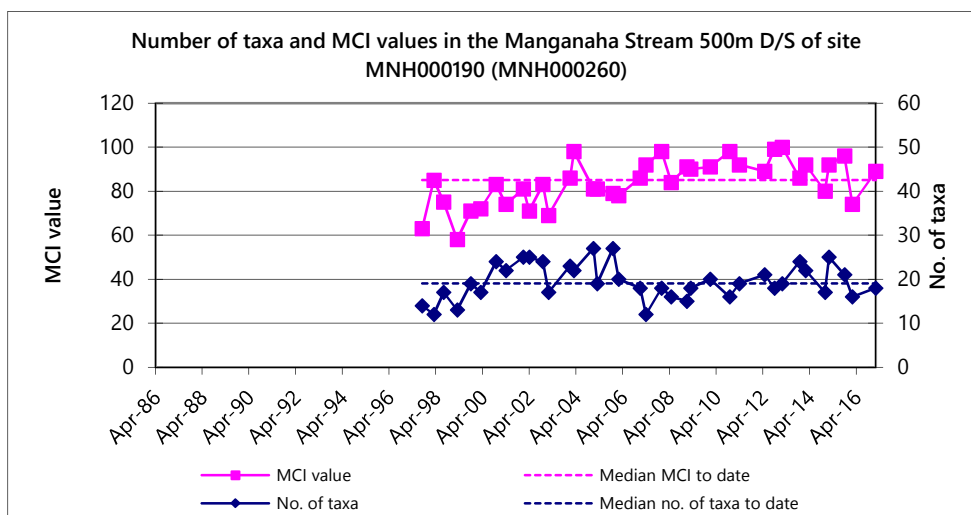
A total of 18 taxa was recorded at site M6, one taxon less than the median for the site and three taxa less than that recorded upstream at site M4 (Table 3 and Figure 6).

Figure 6 Taxa numbers and MCI values recorded at site M6, in the Manganaha Stream downstream of Colson Road landfill

The equal proportion of 'tolerant' and 'sensitive' taxa in the macroinvertebrate community resulted in the 'fair' MCI score of 89 units, which was 2 units lower than the MCI score recorded at site M4. This score was an insignificant (Stark,1998) 4 units higher than the historical median recorded for the site but a significant (Stark, 1998) 15 units higher than that recorded by the previous survey at this site (Table 3 and Figure 6).

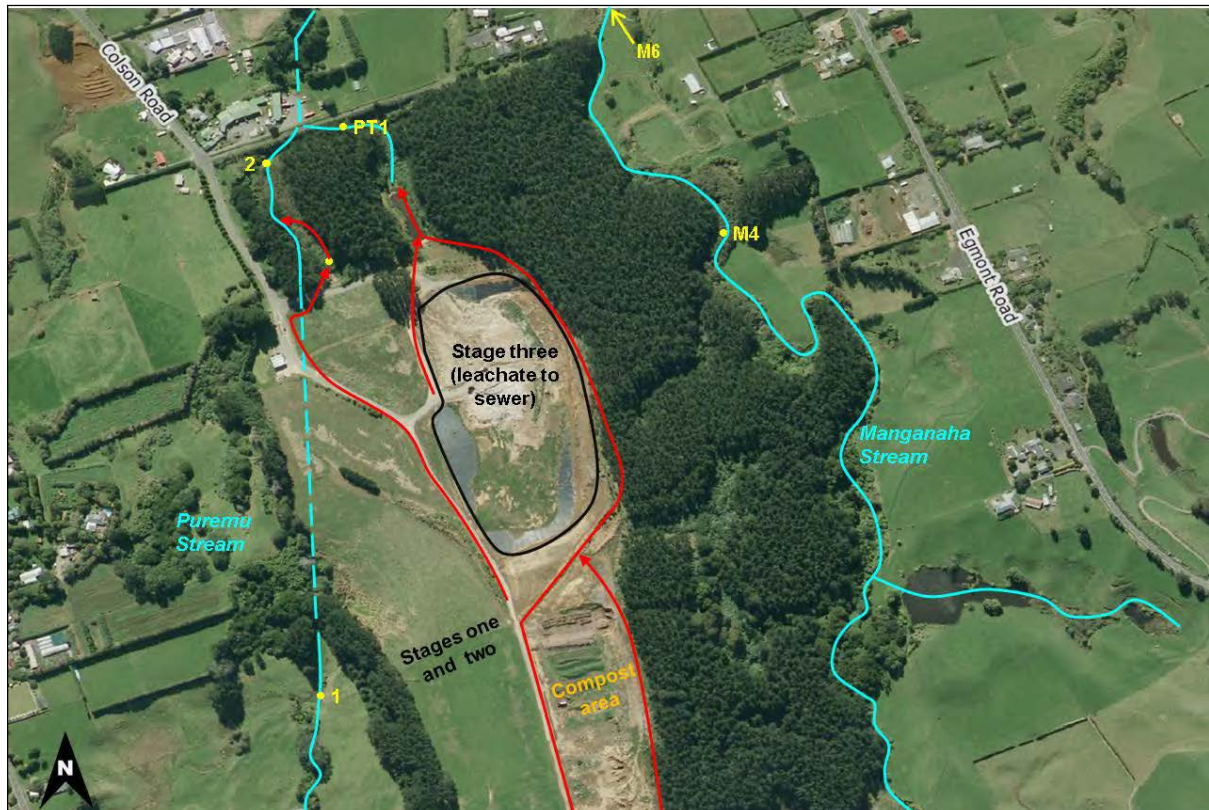
Figure 1 Biomonitoring sites related to the Colson Road landfill, New Plymouth. The red lines on the aerial photograph indicate the direction of stormwater runoff from the landfill site.

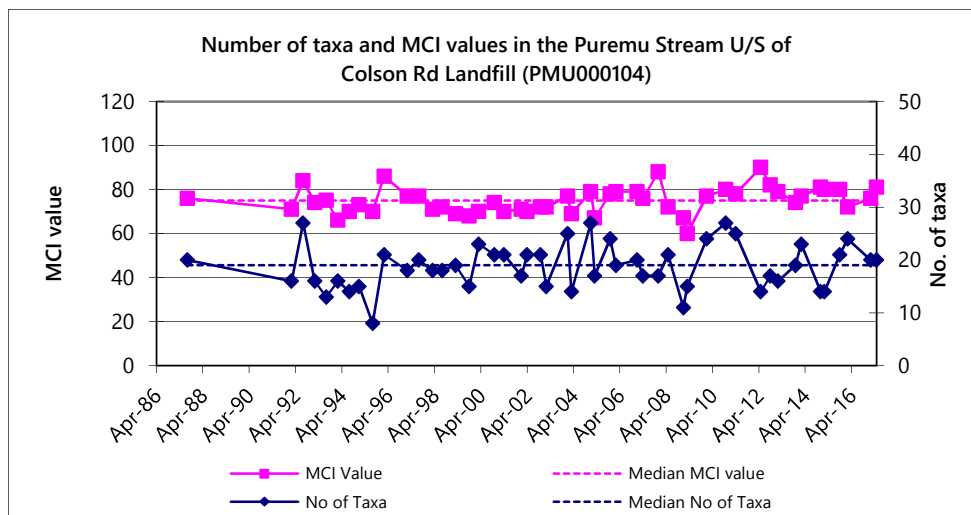
A total taxa richness of 20 taxa was recorded at site 1 (Table 3 and Figure 2). This result was one taxon more than the historical median and the same as the previous survey result.

Figure 2 Number of macroinvertebrate taxa and MCI values recorded at site 1 in the Puremu Stream, upstream of Colson Road Landfill since April 1987

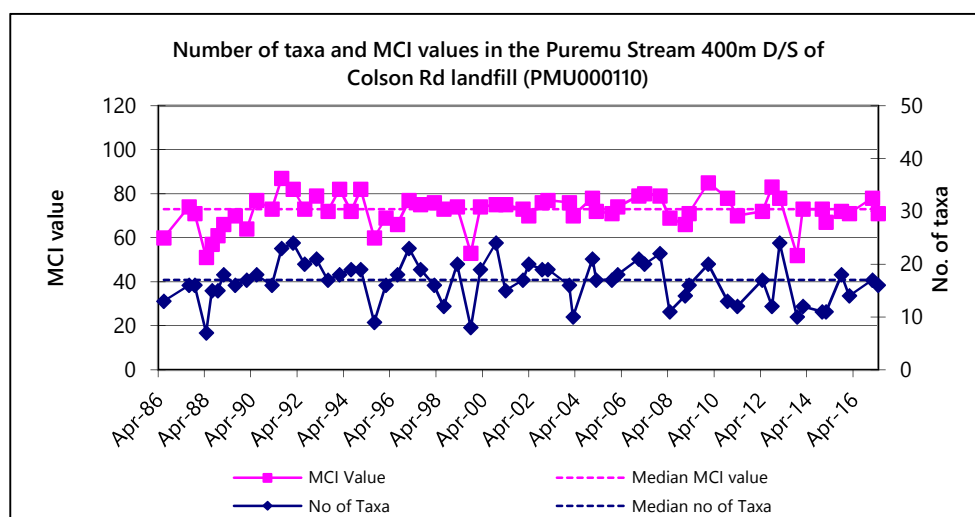
A total taxa richness of 16 taxa was recorded at this site, which was one taxon less than the median recorded by previous surveys at this site, and one taxon less than the richness recorded by the previous survey (Table 3 and

Figure 3 Taxa numbers and MCI values recorded at site 2, 400 m downstream of Colson Rd Landfill

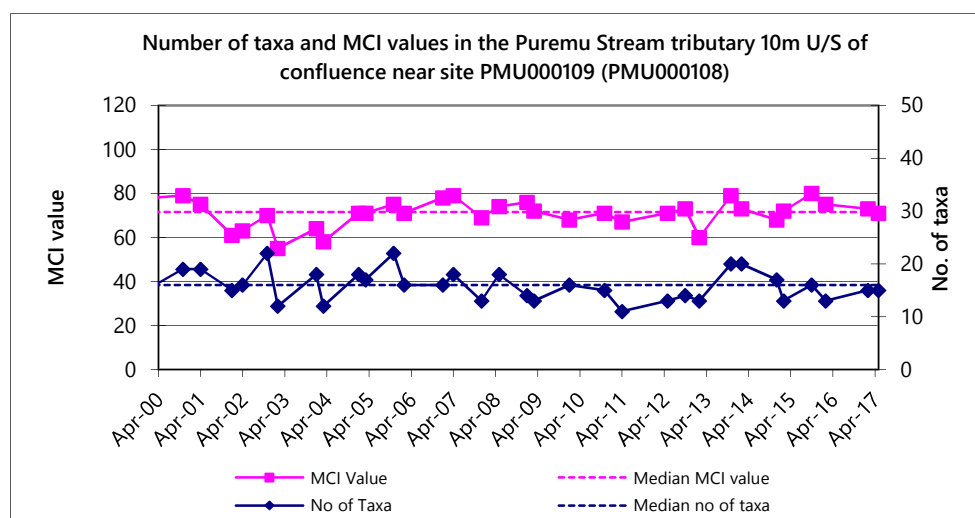
Figure 4 Numbers of taxa and MCI values recorded to date at site PT1, downstream of Colson Road Landfill

The community at site PT1 was characterised by three 'tolerant' taxa [oligochaete worms, ostracod seed shrimp and proboscis worms (Nemertea)] (Table 4). A higher proportion of 'tolerant' (60%) taxa in the macroinvertebrate community was reflected by the MCI score of 71 units, which indicated 'poor' biological health. This MCI score was 1 unit lower than the median MCI score for the site, an insignificant (Stark, 1998) 10 units lower than that recorded at site 1, and the same as that recorded at site 2 (Table 3 and Figure 4).

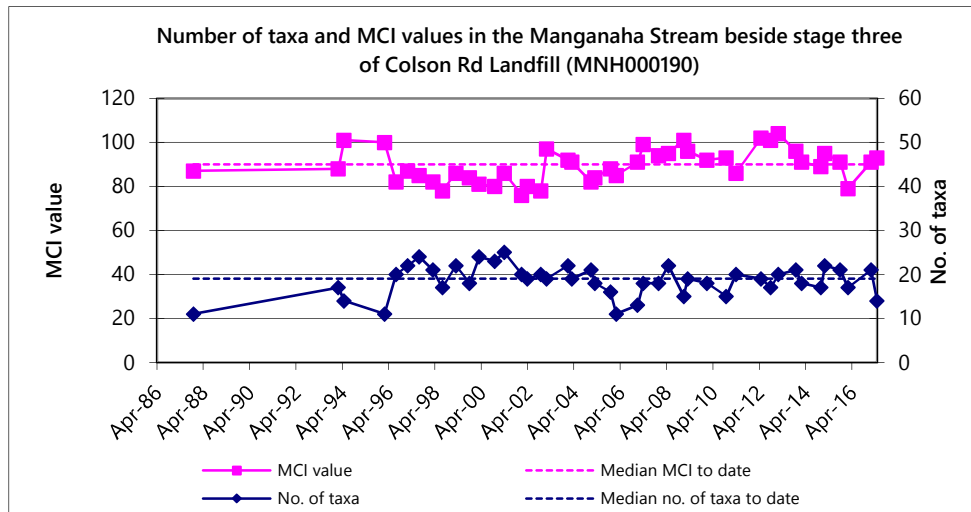
A total of 14 taxa was recorded at site M4 in this survey which was five taxa less than the historical median for the site (Table 3 and Figure 5). The community at this site was characterised by one 'moderately sensitive' taxon [amphipods (*Paracalliope*)] and two 'tolerant' taxa [snail (*Potamopyrgus*) and oligochaete worms] (Table 5), which was indicative of reasonable preceding water quality.

Figure 5 Taxa numbers and MCI values recorded at site M4, in the Manganaha Stream adjacent to Colson Road landfill

A higher proportion of 'sensitive' taxa in the macroinvertebrate community resulted in the 'fair' MCI score of 93 units, which was an insignificant (Stark, 1998) 4 units higher than the historical median and an insignificant 2 units higher than the previous survey results for this site (Table 3 and Figure 5).

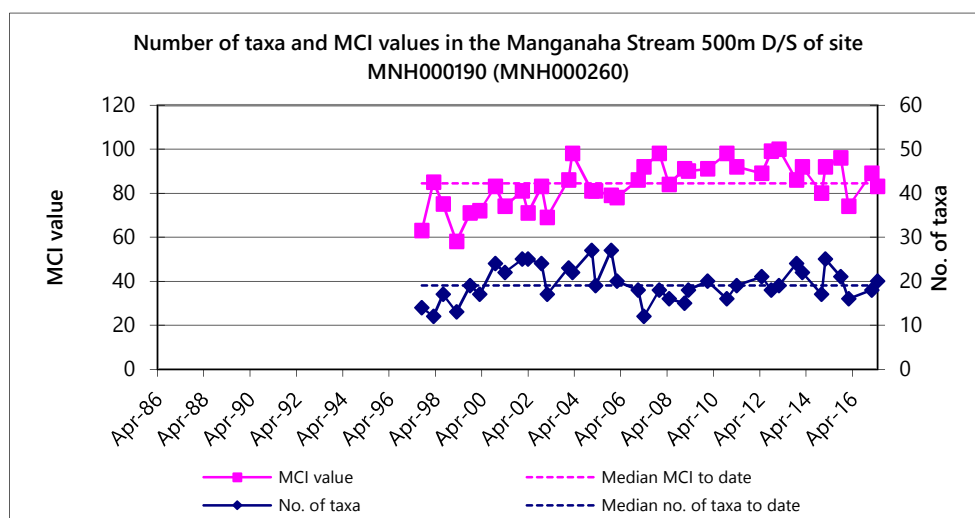
A total of 20 taxa was recorded at site M6, one taxon more than the median for the site and six taxa more than that recorded upstream at site M4 (Table 3 and Figure 6).

Figure 6 Taxa numbers and MCI values recorded at site M6, in the Manganaha Stream downstream of Colson Road landfill

The equal proportion of 'tolerant' and 'sensitive' taxa in the macroinvertebrate community resulted in the 'fair' MCI score of 83 units, which was an insignificant (Stark, 1998) 10 units lower than the MCI score recorded at site M4. This score was also an insignificant (Stark, 1998) 2 units lower than the historical median recorded for the site and an insignificant 6 units lower than that recorded by the previous survey at this site (Table 3 and Figure 6).
