New Plymouth District Council  
Inglewood, Okato,  
and Marfell Park Landfills  
Monitoring Programme  
Annual Report  
2016-2017

Technical Report 2017-77

Taranaki Regional Council  
Private Bag 713  
STRATFORD  
October 2017

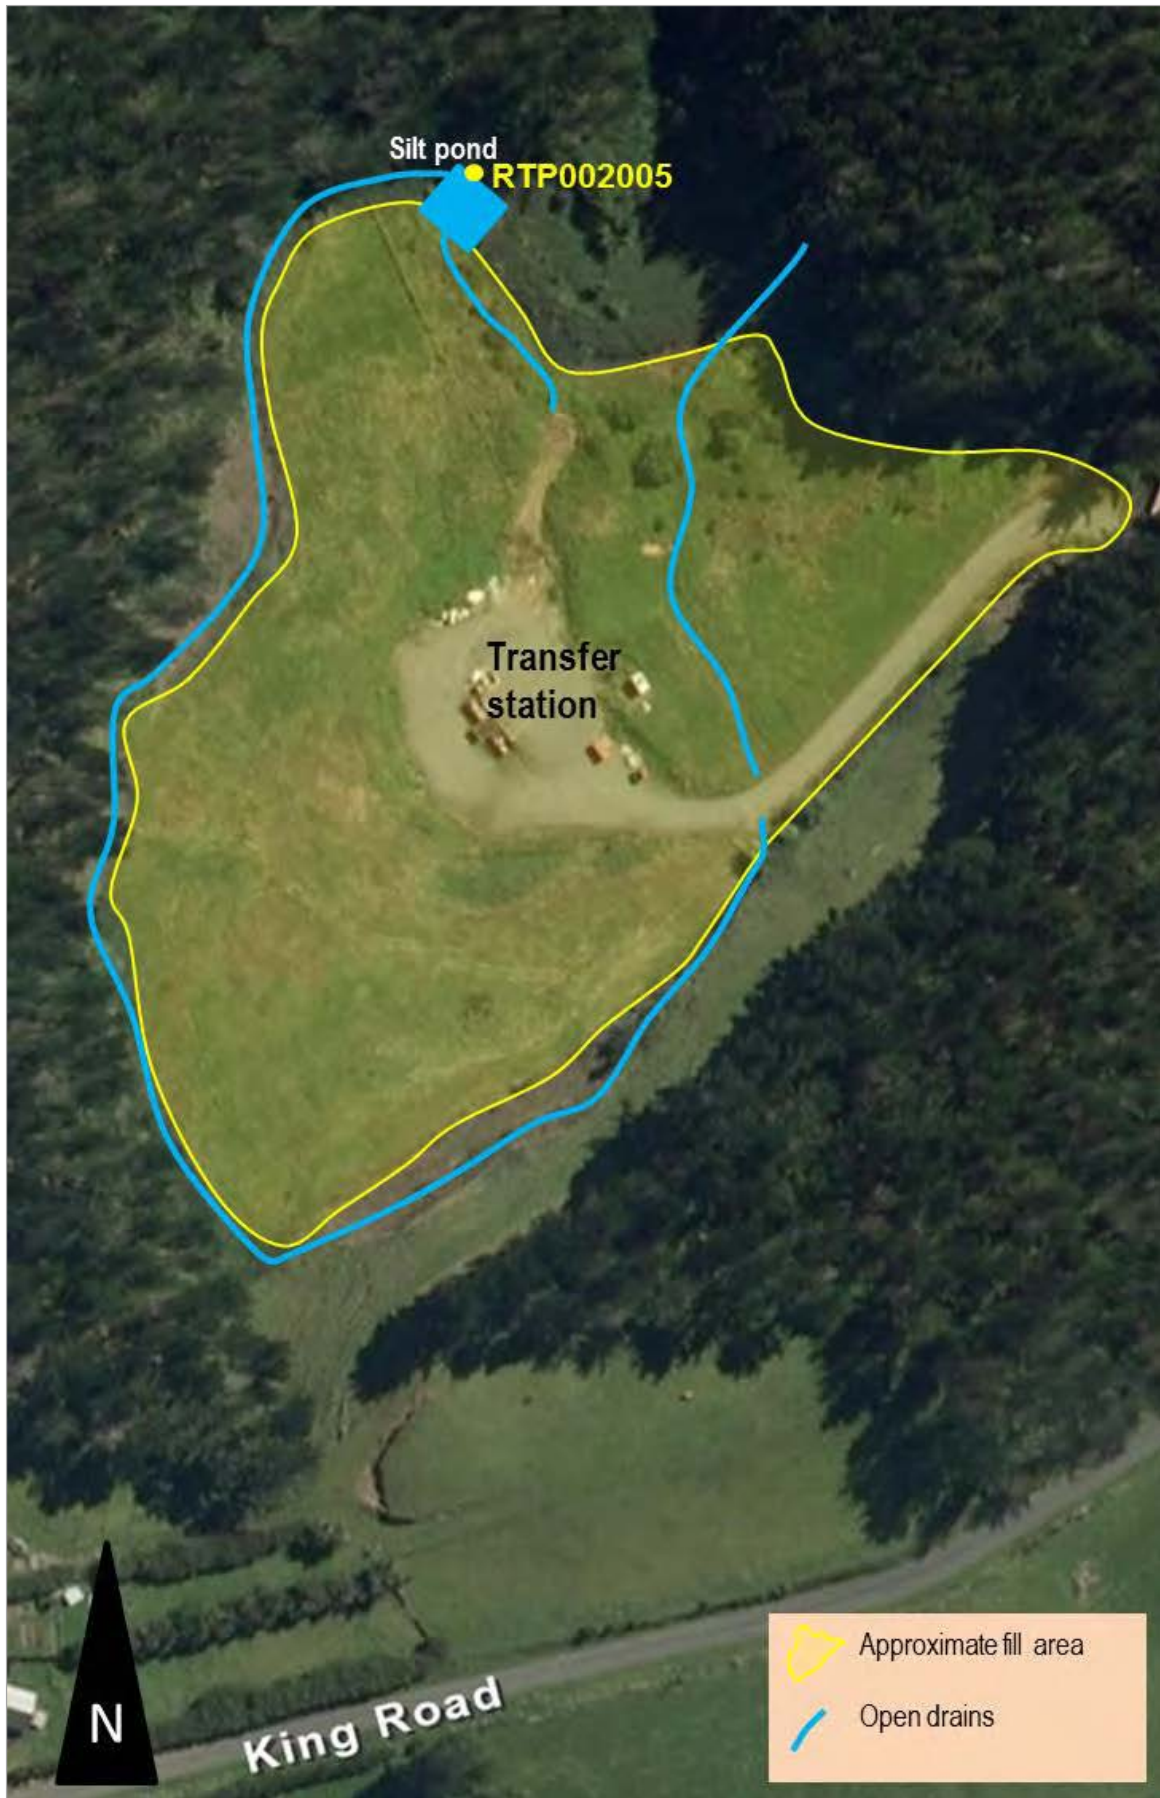
Figure 1 shows the approximate extent of the fill and the general layout of the Inglewood landfill site. The discharge and receiving water monitoring site locations are shown in Figure 2.

Figure 1 Site layout at Inglewood contingency landfill

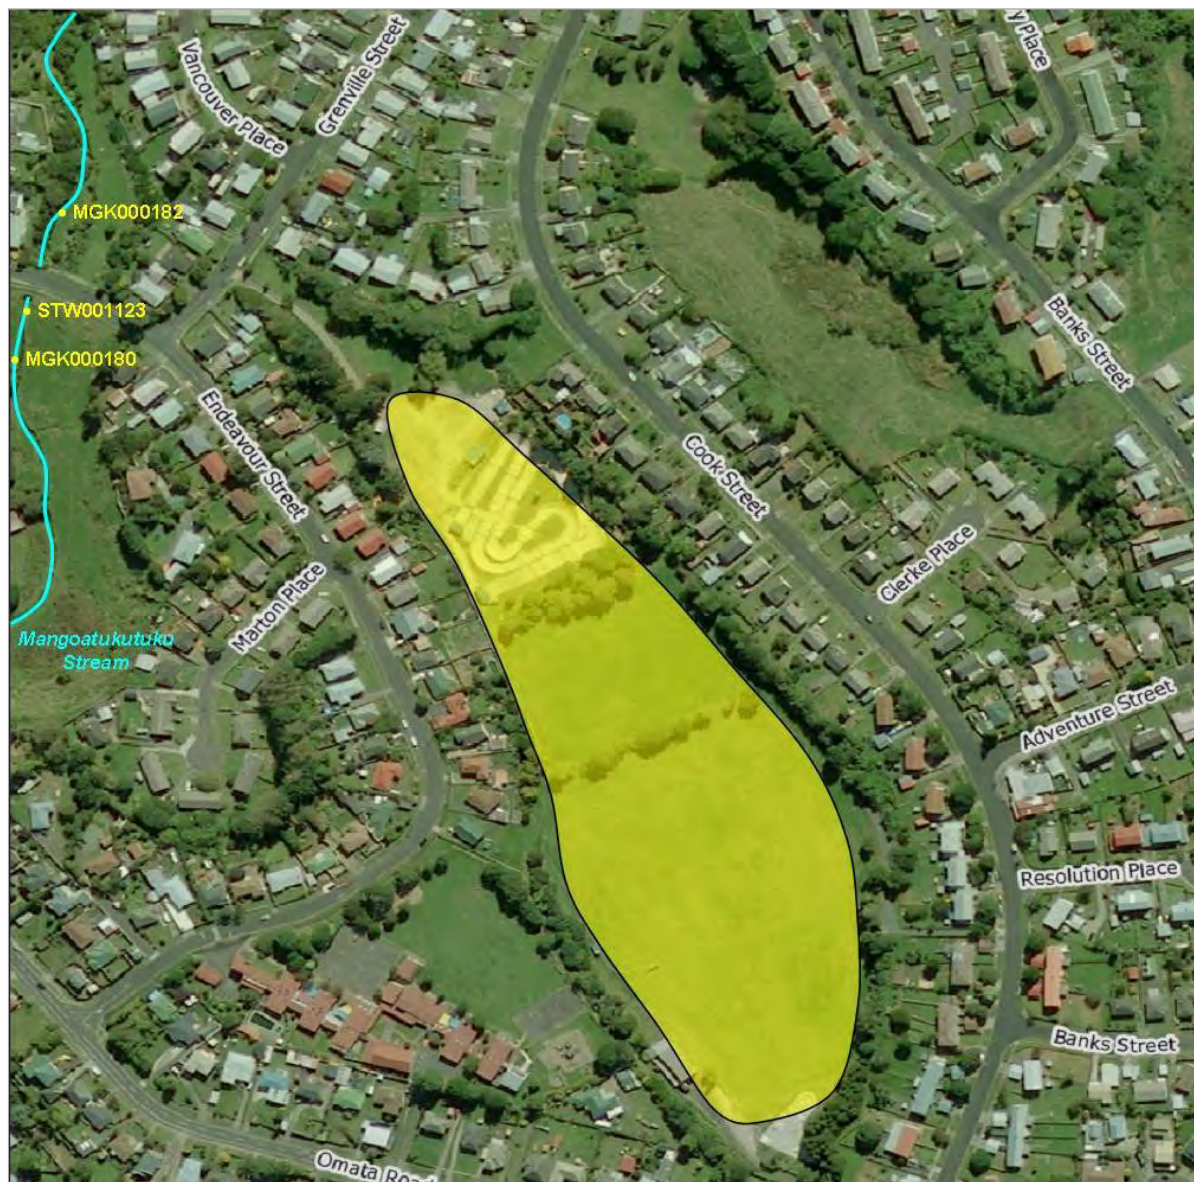
Figure 8 An aerial view showing former landfill at Marfell Park and associated sampling sites

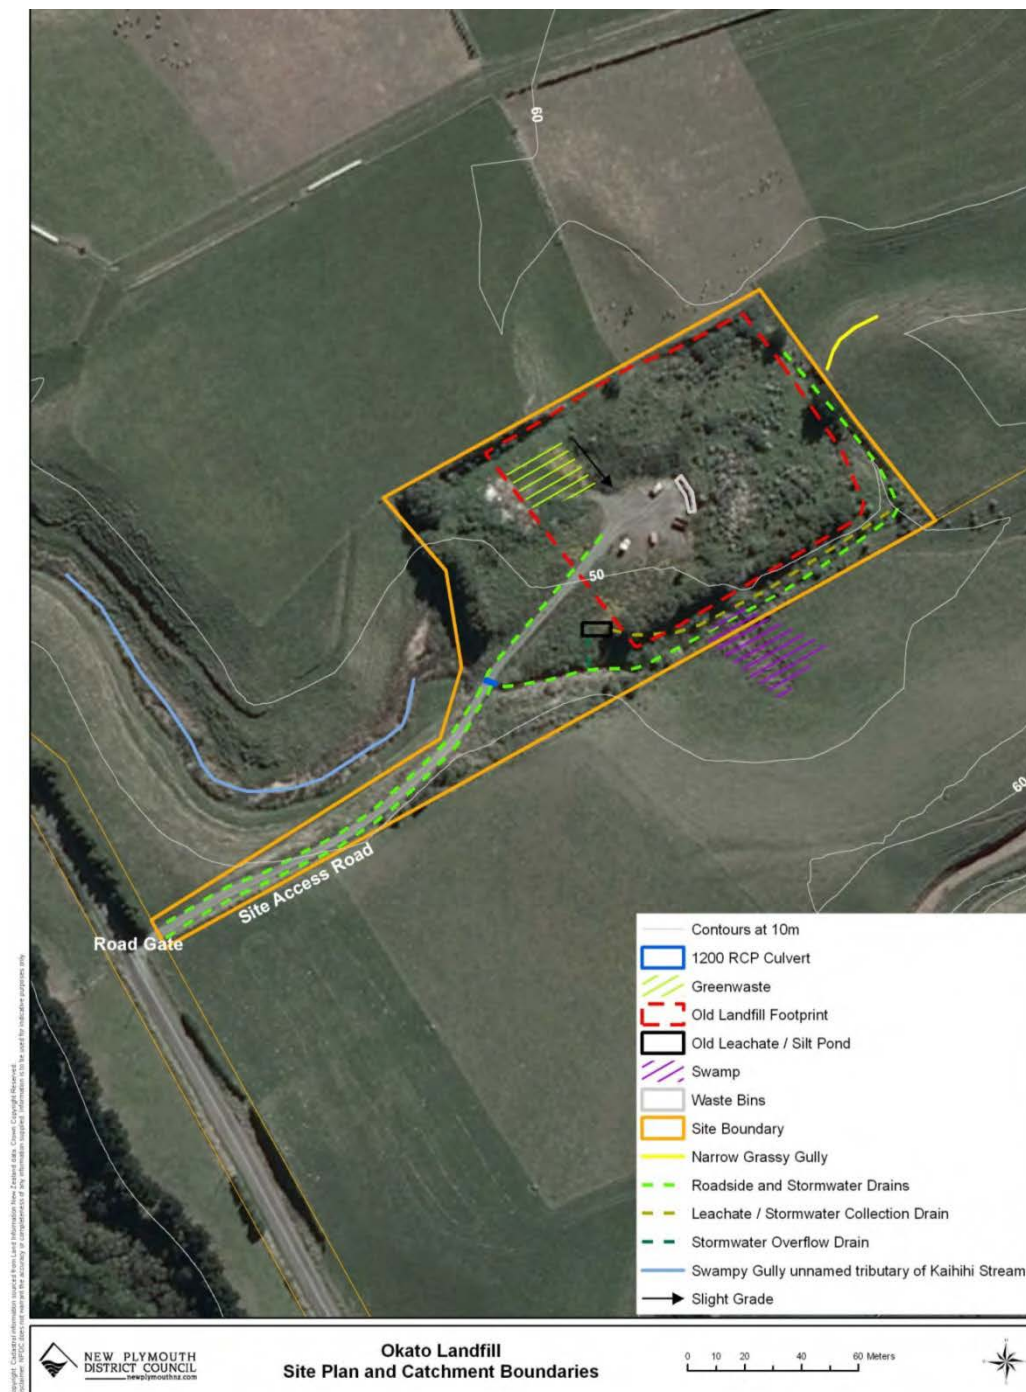
**Figure 1** Aerial plan of Okato landfill site
