Regional Cleanfill
Monitoring Programme
Annual Report
2016-2017

Technical Report 2017-32

Taranaki Regional Council

March 2018

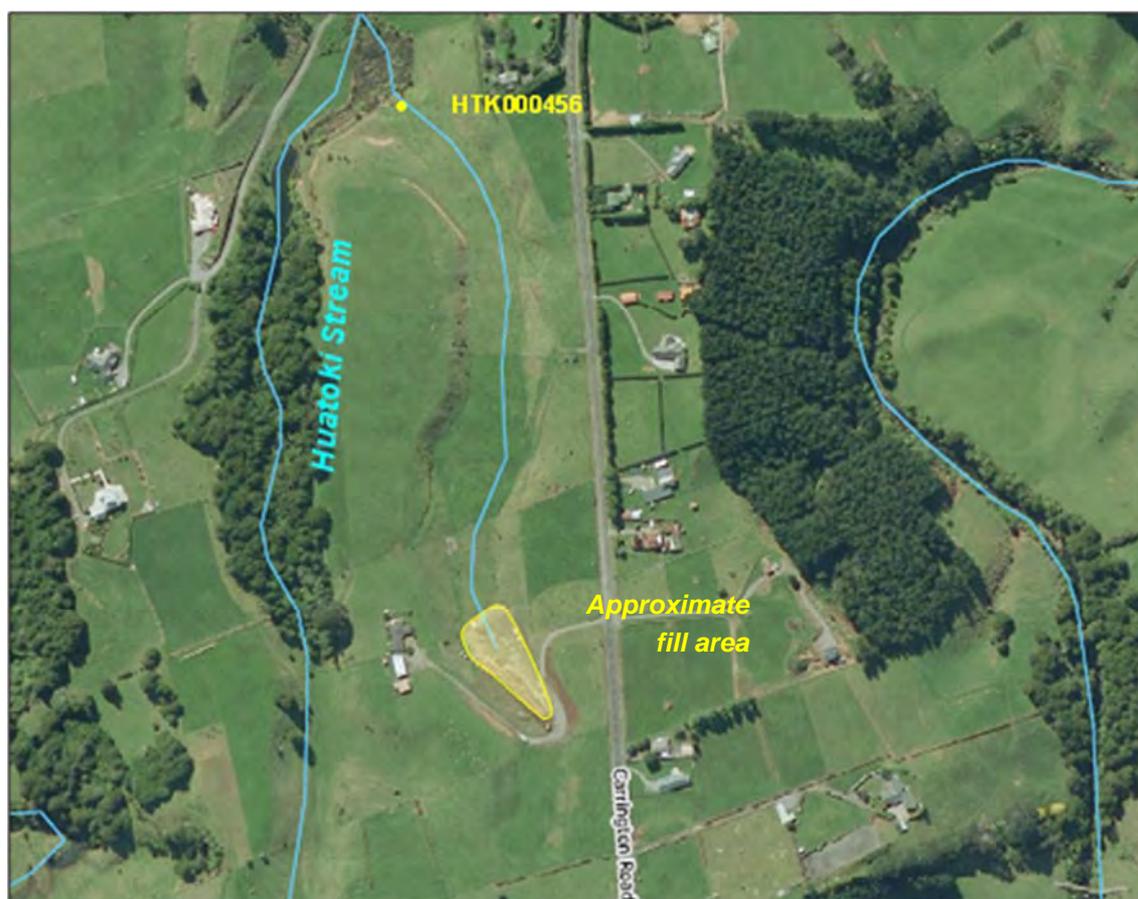
Figure 4 AE Riddick's cleanfill and sampling site at Carrington Road, New Plymouth

AE Riddick (Riddick) holds consent 3977-4 to discharge cleanfill to land. This cleanfill on Carrington Road is in a gully at the head of an unnamed tributary of the Huatoki Stream. The area was previously a swampy gully, with surface water flows arising from a small spring for parts of the year. In 1990 the gully began to be filled with cleanfill.

Access to the site is by a locked gate, and only an authorised contractor holds a key. All stormwater is controlled so that it flows around the cleanfill areas, to the wetland below the site. Most of the filled areas have been re-grassed, leaving only the tip face exposed.

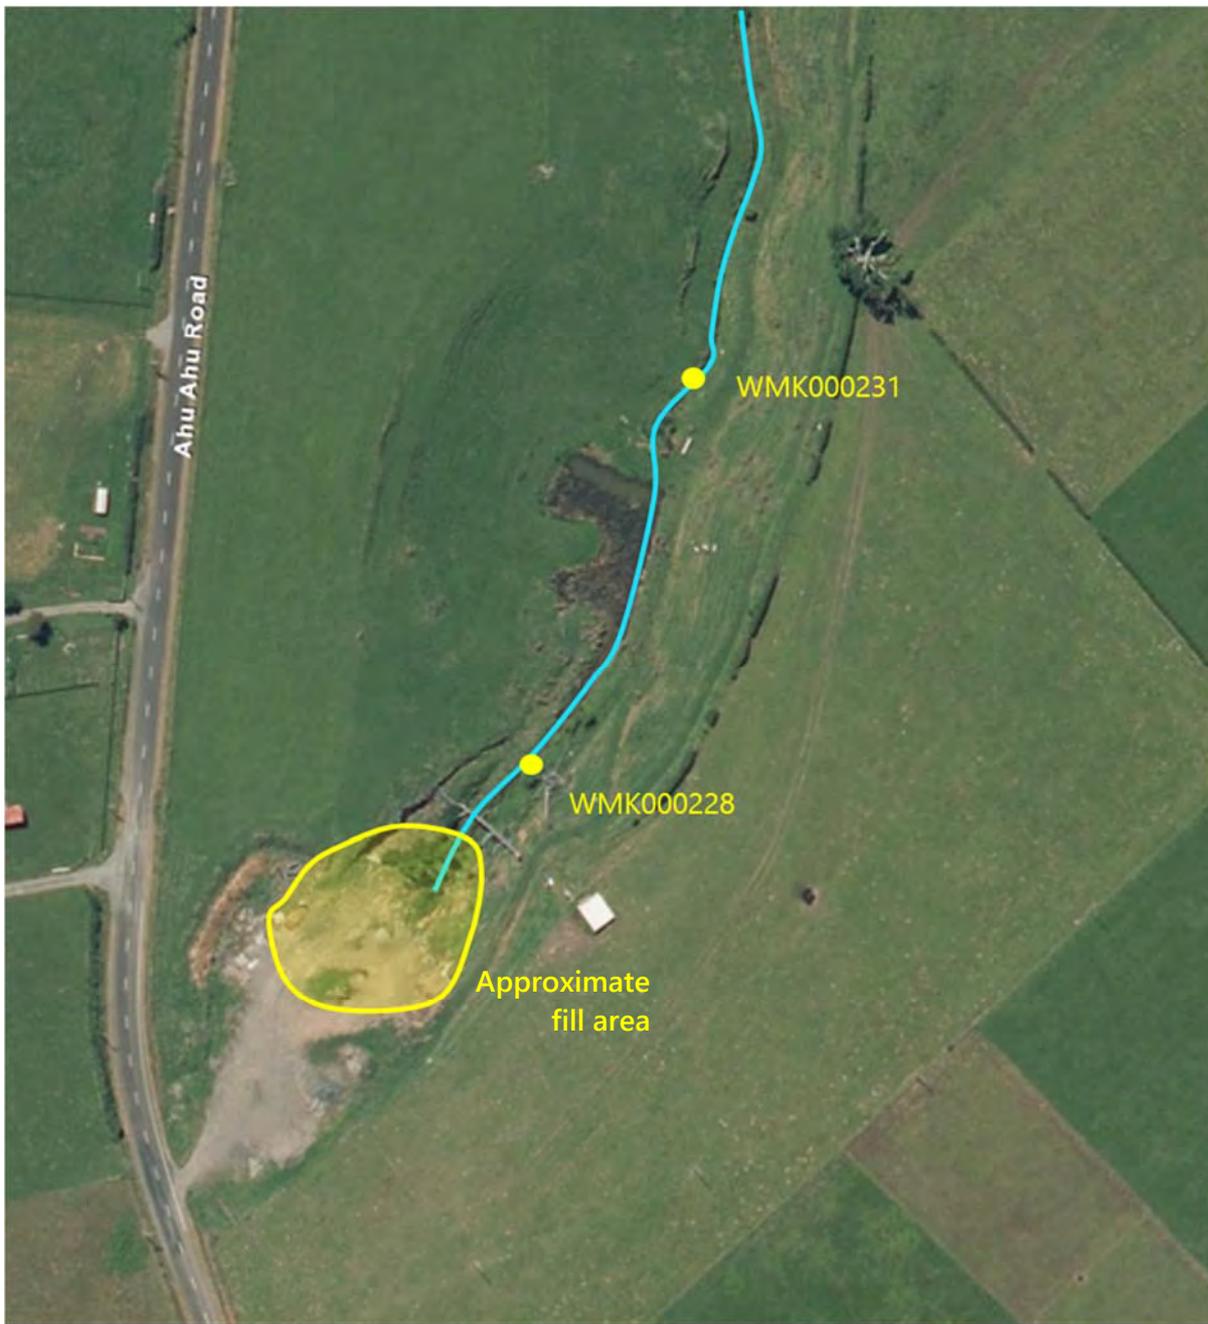
Figure 5 BJ & LB Bishop's cleanfill and sampling sites at Ahu Ahu Road, Oakura (approximate fill area indicated in yellow)

BJ and LB Bishop (Bishop) hold consents 5877-2 to discharge cleanfill and 5888-1 to install and maintain a culvert on their property on Ahu Ahu Road. They are filling in a small gully to enhance their farmlet for grazing. A culvert passes through the cleanfill which carries surface water from the Ahu Ahu Road roadside drain.

The types of materials they accept at their cleanfill are construction concrete, road and track metal, clay and topsoil. Following the completion of the filling the area will be restored with topsoil and pasture grass. The location of the cleanfill is shown in Figure 5.

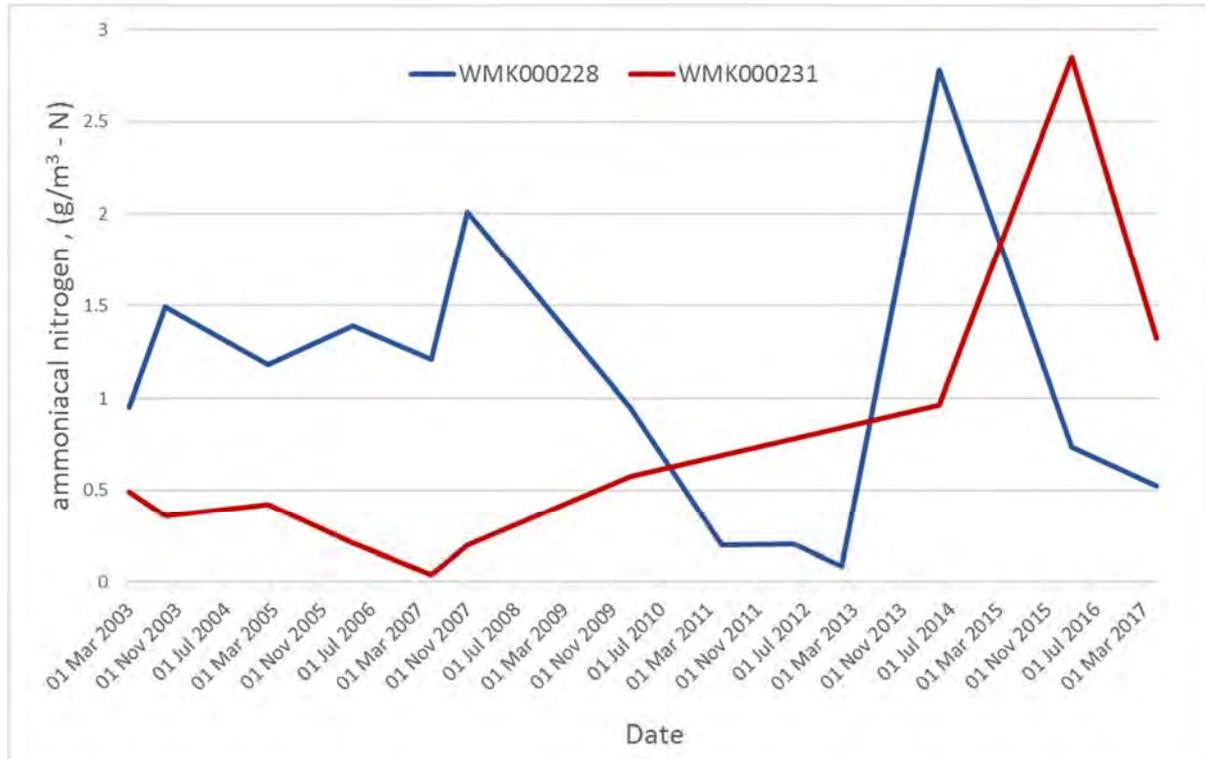
Figure 6 Receiving water ammoniacal nitrogen concentration below the BJ & LB Bishop cleanfill Ahu Ahu Road, New Plymouth

The results indicated that there was a slightly elevated level of ammoniacal nitrogen in the receiving waters immediately downstream of the tip face. On this sampling occasion it is noted that there was a further elevation in the ammoniacal nitrogen concentration in the sample taken at a point 60 metres downstream. When compared to the historical data, the level of ammoniacal nitrogen found at site WMK000228 does fluctuate, with the result obtained for the sample collected on 12 May 2017 below the median of historical results. At site WMK000231 there has been an increasing trend in the ammoniacal nitrogen results. The result obtained for this site during the year under review is less than half that obtained during the 2015-2016 year, but was still slightly higher than the 2014-2015 value. The National Policy Statement for Freshwater Management (Ministry for the Environment 2014) gives an annual maximum National bottom

line of 2.20 g/m³ of ammoniacal nitrogen (corrected to a pH of 8). The ammoniacal nitrogen concentrations found below the site are significantly less than this, at 0.48 g/m³ (site WMK000231).

When expressed as unionised ammonia both samples were also found to be well below the 0.025 g/m³ guideline value given in the RFWP for the long term protection of aquatic ecosystems. It is possible that the increase observed at site WMK000231 could be as a result of the agricultural land use between these two sites, and continued sampling at both sites is recommended.

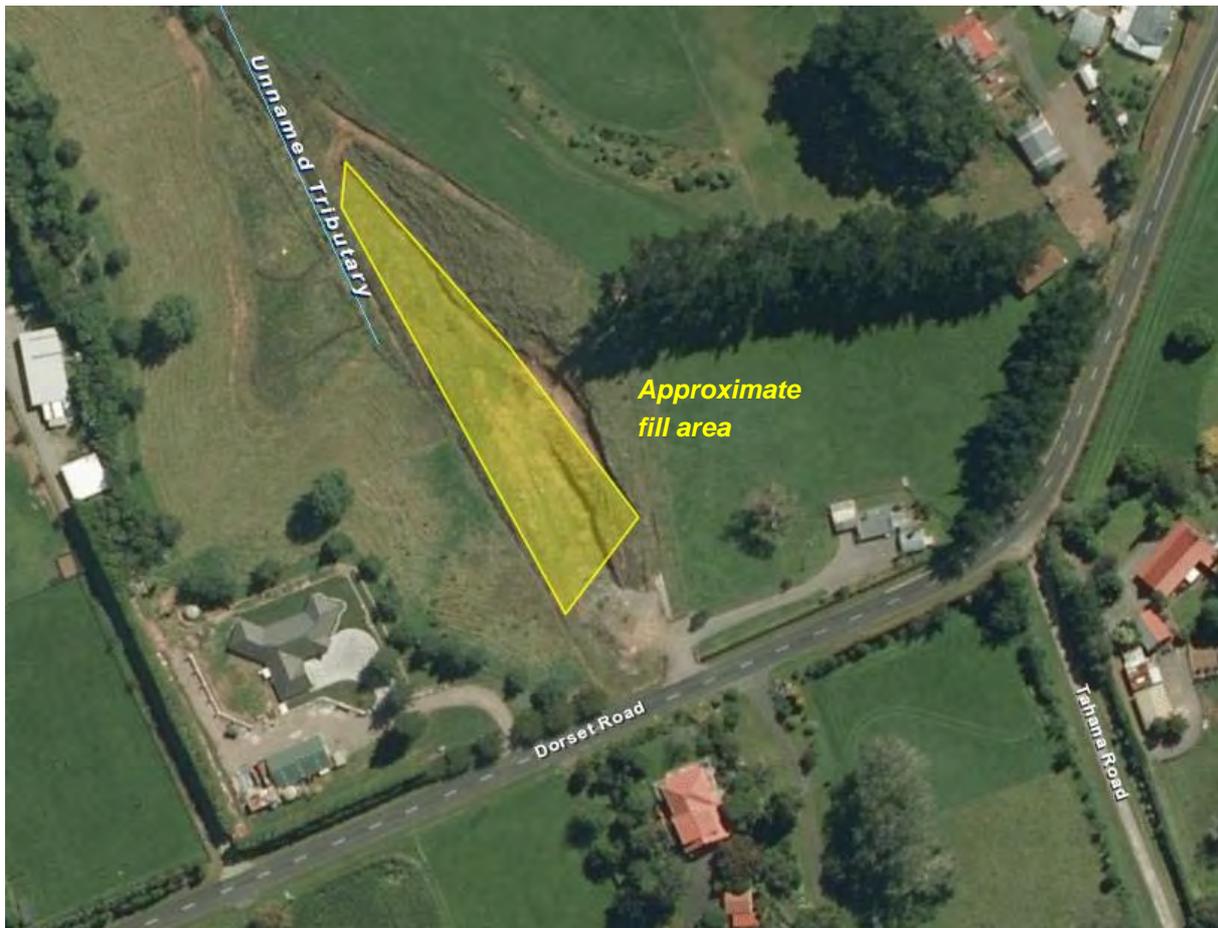
Downer EDI Works Ltd (Downer) holds resource consent 9532-1 to discharge cleanfill at a site on Dorset Road, New Plymouth. This application was originally granted to Dorset Fibre Farm retrospectively after Council officers found that the site was receiving material without consent. The consent was transferred to Downer on 24 May 2016. The site accepts cleanfill. Primarily construction and demolition material dug up from an on-going carriageway/broadband project.

Figure 8 Downer EDI Works Ltd cleanfill at Dorset Road, New Plymouth

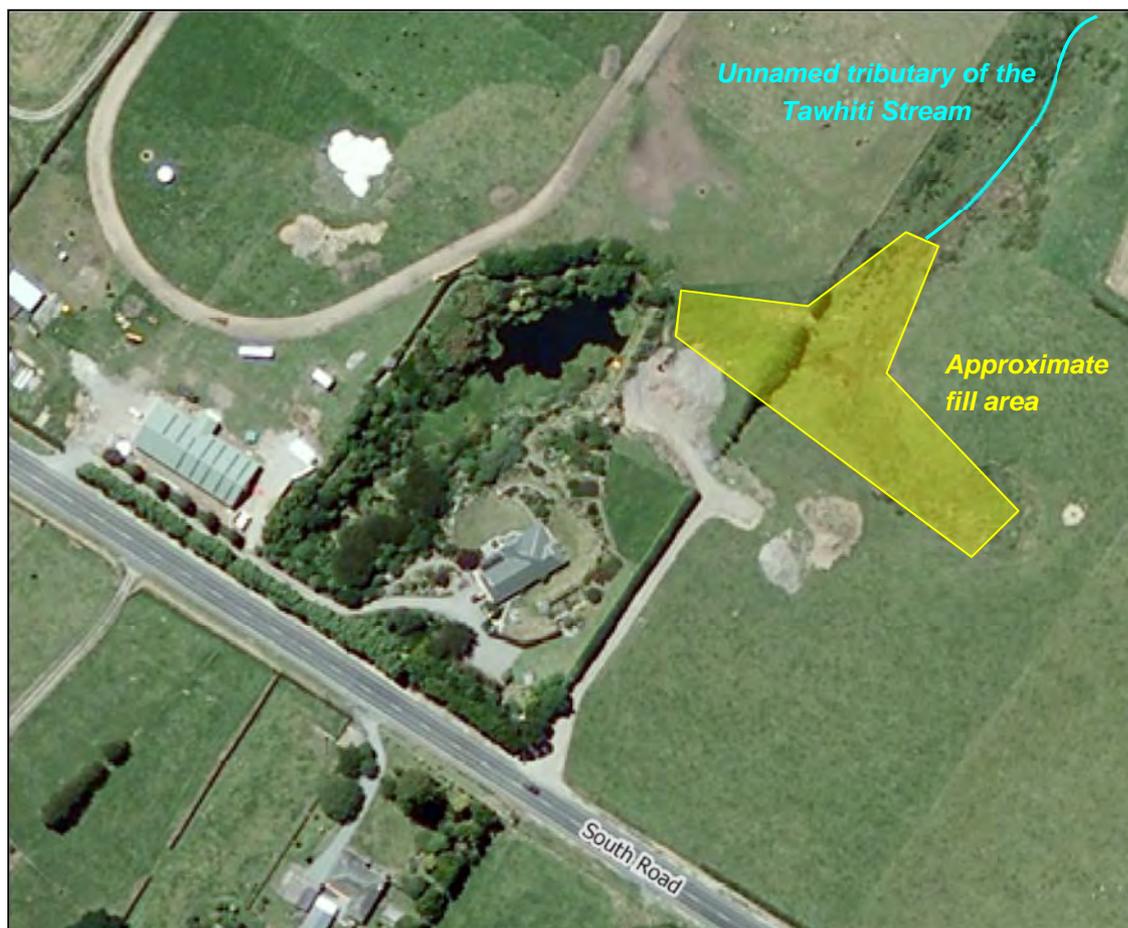
Downer EDI Works Ltd (Downer) holds consent 6964-1 to discharge cleanfill at two adjacent properties on South Road, Hawera. The site is a small gully which is being filled to enhance a paddock for grazing. A small spring emerges in one leg of the gully, and a garden pond is situated at the head of the other leg of the gully. The discharge from the garden pond has been directed away from the cleanfill area, and now discharges below the designated area of the cleanfill. Following the completion of filling, the area will be restored with topsoil and pasture grass.

Figure 10 Downer EDI Works Ltd cleanfill and sampling site at South Road, Hawera

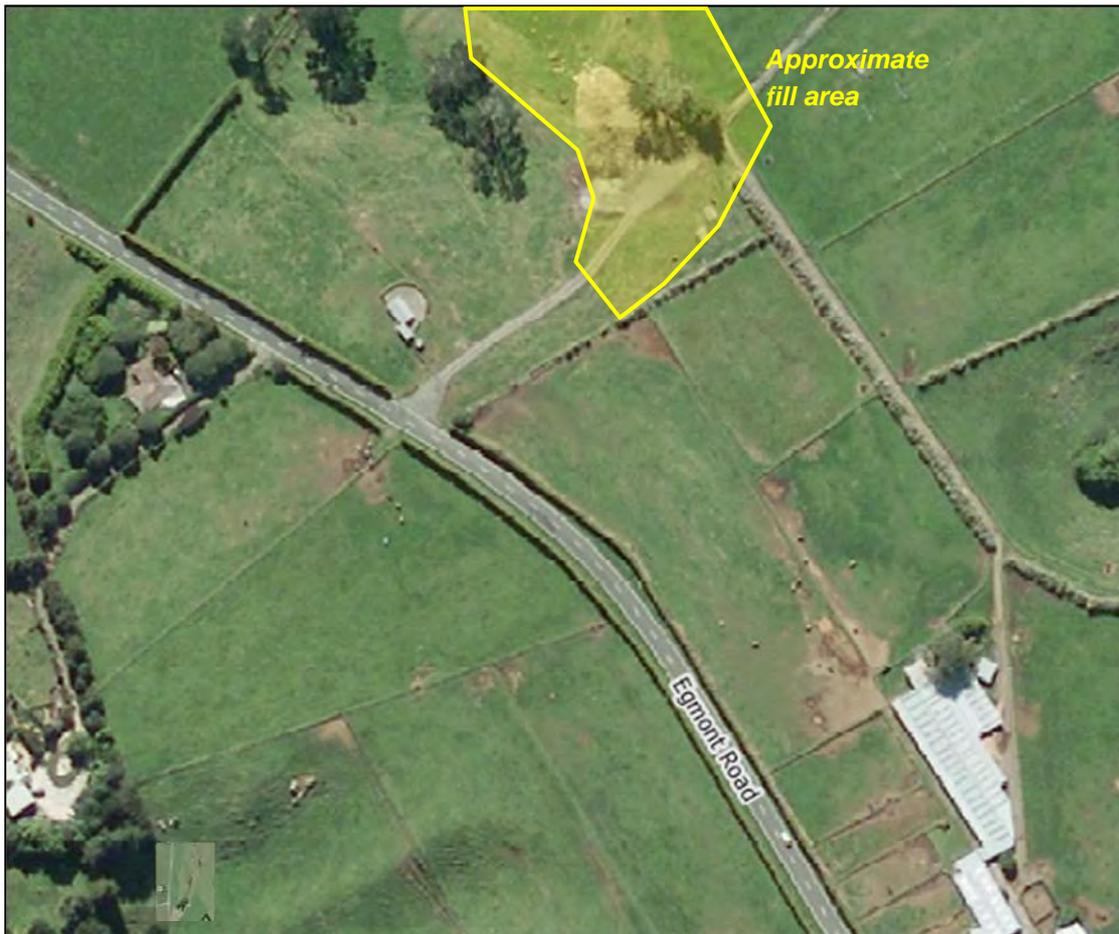
Graham Harris (2000) Ltd (Graham Harris) holds consent 6771-1 to discharge cleanfill to land. The site is located at 341 Egmont Road, and is surrounded by farm land. The site was consented to accept cleanfill waste in December 2005. The area being filled is a moderately large depression in the centre of a paddock, and is becoming Taranaki's largest cleanfill. The site has one entrance which is secured by a locked gate. Surface water interceptor drains have been installed around the designated fill area.

Figure 12 Graham Harris [2000] Ltd's cleanfill at Egmont Road, New Plymouth

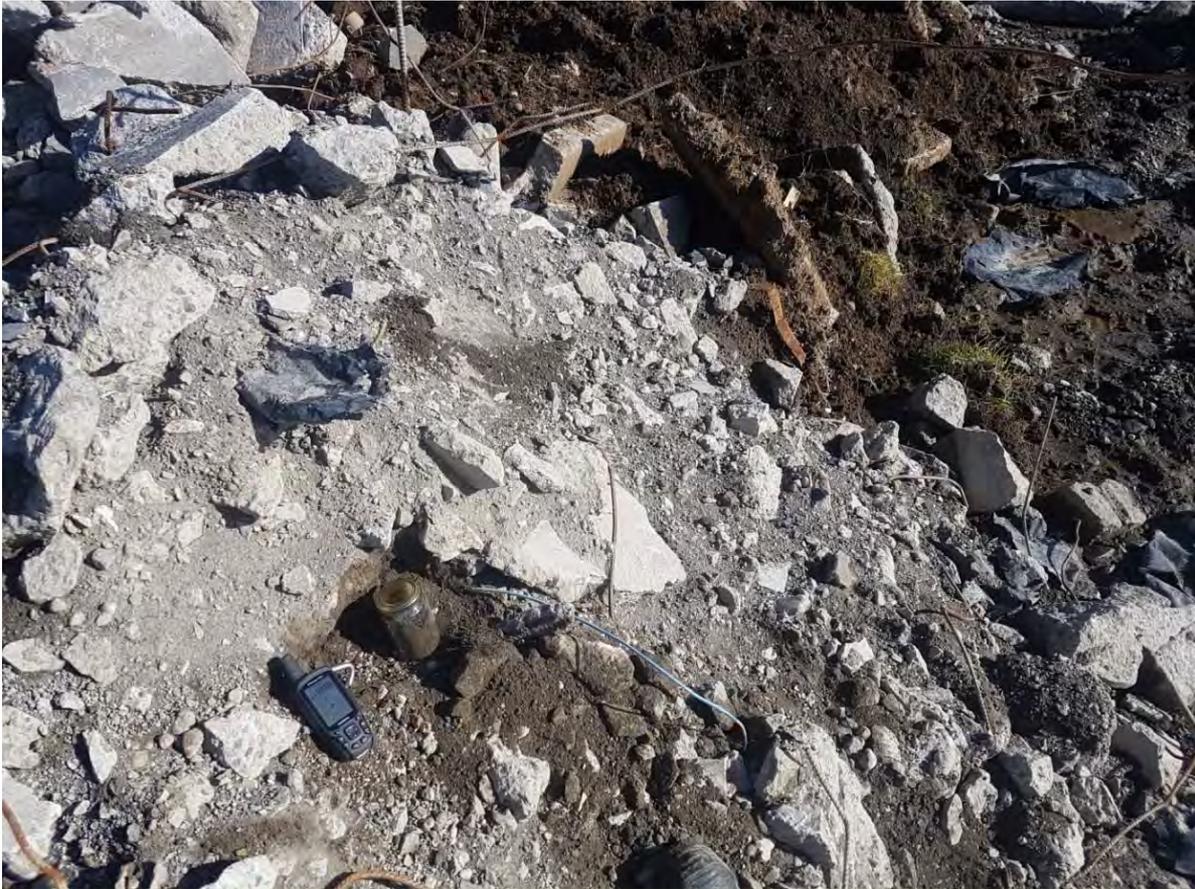
Photo 1 Contaminated material at Graham Harris (2000) Lt's cleanfill, Egmont Road

An inspection the cleanfill was undertaken as a result of concerns received regarding potentially contaminated material from the BP site in Waitara being disposed of at the cleanfill on Egmont Road, New Plymouth.

Most of the material discharged at the cleanfill looked to be inert material. However at the time of the inspection a very slight hydrocarbon odour was detected coming from the piles of concrete and shingle. Soil samples were taken from the material shown in (Photo 1) and the results are shown in Table 20.

An improvement in the Graham Harris's environmental performance is required as defined in Section 1.1.4. During the year under review contaminated material was discharged at the site, and an abatement notice was issued requiring its removal. The consent holder also failed to contact Council prior to discharge to ascertain whether this contaminated material could be discharged at the site under the conditions of the consent.

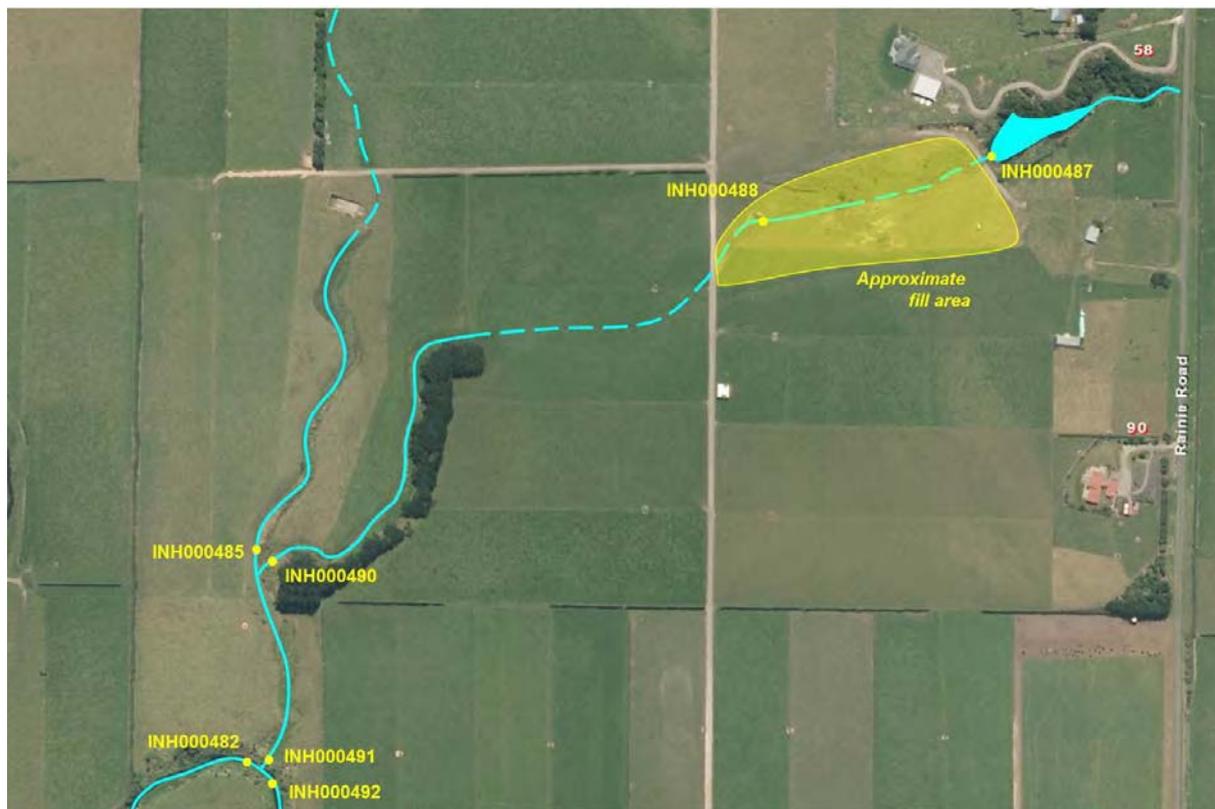
Figure 14 TPJ Partnership's cleanfill and sampling sites at Rainie Road, Hawera

The site also has a separate area for the storage of green waste, and the consent holder is currently working through site management practices and potential consenting requirements with Council. This area is bunded to prevent the movement of stormwater across the site from the surrounding land, and there is a large sediment and silt trap installed at the base of the area.

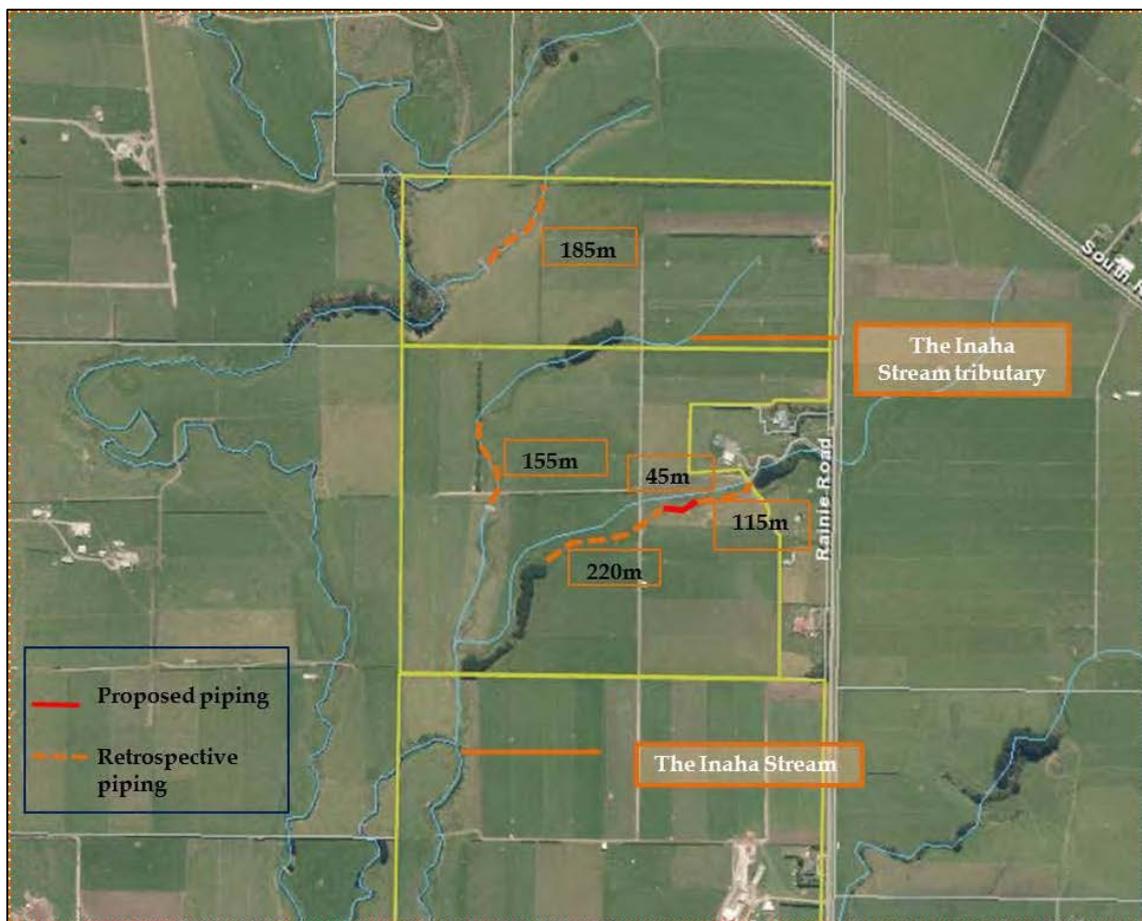
Figure 15 Map of TPJ Partnership retrospective and proposed piping – consent 10209

In terms of the piping undertaken prior to the granting of the consent, approximately 115 m of piping was undertaken about three years ago, while the remaining (approximately 600 m) was undertaken at different stages over an 18 year period. There was little, if any, information provided to Council regarding the nature of the fill used above these culvert pipes.

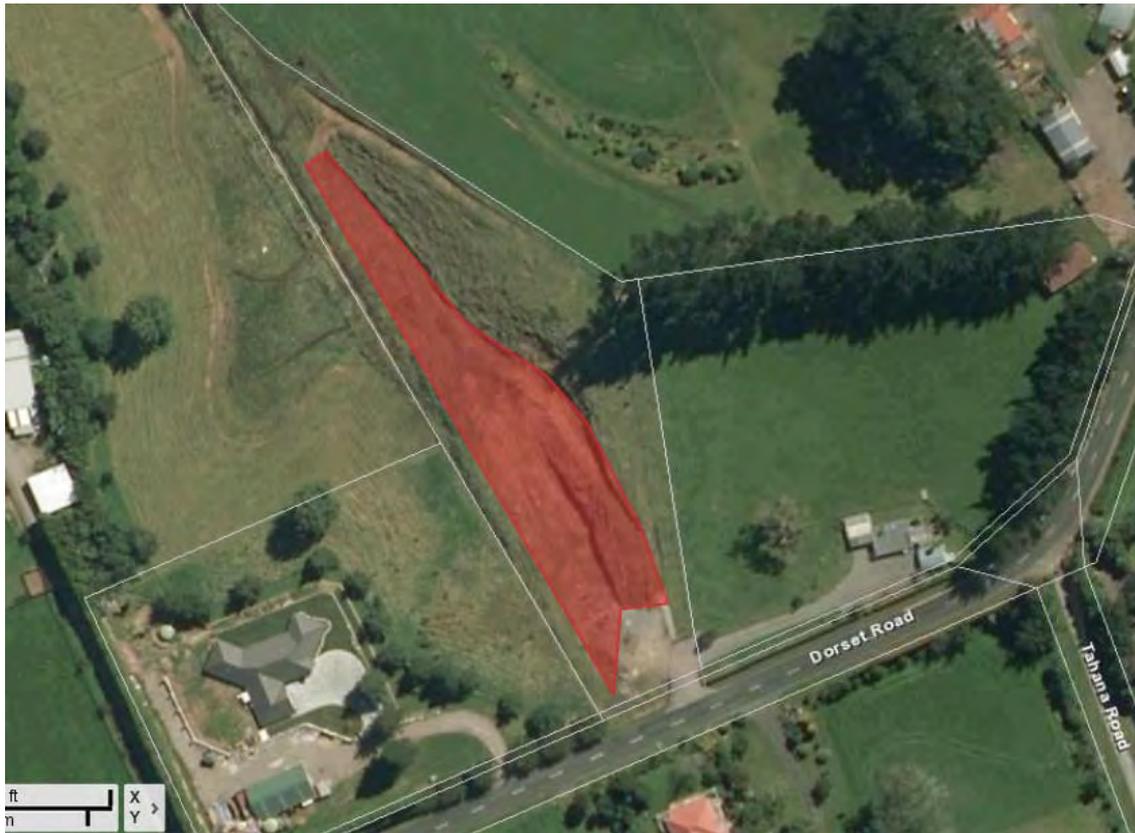
Map showing the extent of cleanfill discharge.

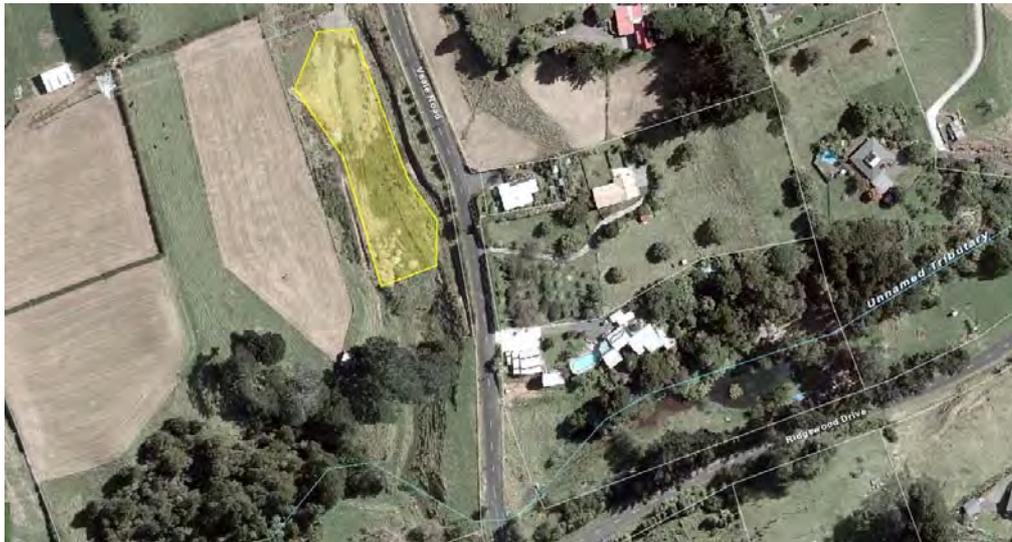
Appendix 1

Figure 2 Area where the discharge of cleanfill is permitted.
