South Taranaki District Council  
Patea Beach green waste discharge  
Monitoring Programme  
Annual Report  
2016-2017

Technical Report 2017-75

October 2017

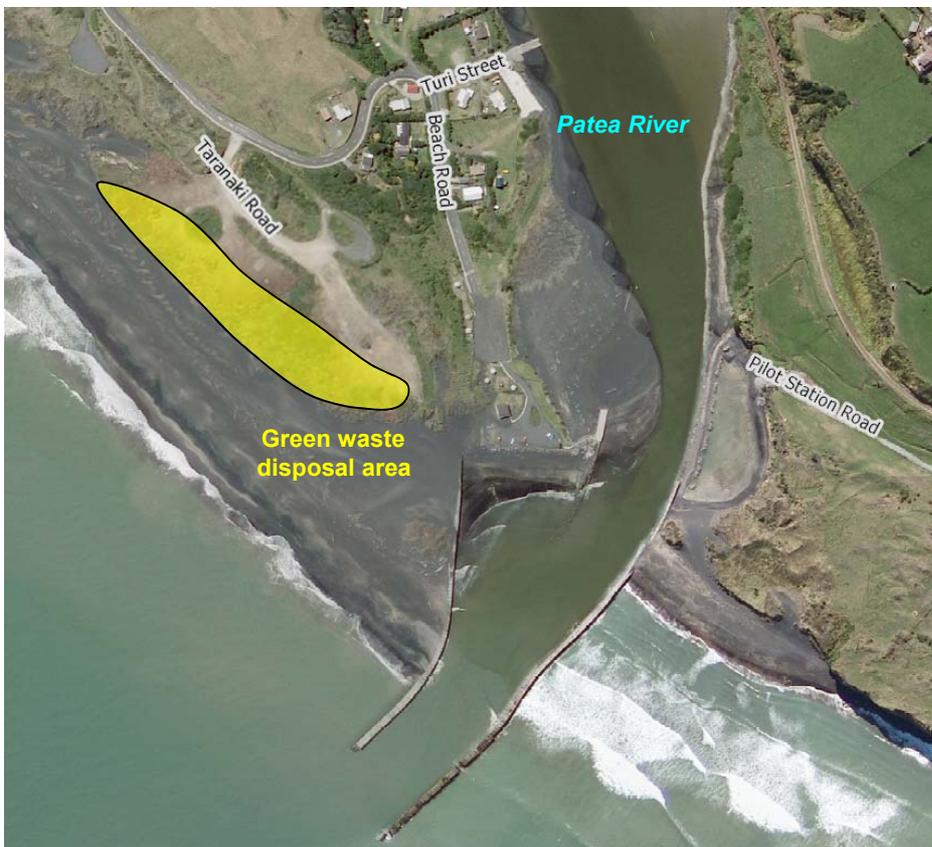
The site was established as a public facility that could accept green waste for sand dune stabilisation purposes. It is consented to accept green waste from the Patea community and from STDC. The aim of the activity is to place green waste and plant material, such as branches, along the eroding sand dune area, to act as a sand trap, facilitating the reinstatement of the dune system and aiming to prevent future erosion at the site. Members of the public are directed to specific drop off points at the beach area by means of signs. Periodically, the waste is moved from the drop off areas onto the dunes. STDC also conducts a programme of fortnightly inspections to identify and remove unacceptable wastes being dropped at the site by third party users, prior to the green waste being discharged onto the dunes. The discharge site is approximately 120 metres long and 25 metres wide, and is shown in Figure 2.

Figure 2 Aerial view of the Patea Beach green waste disposal area

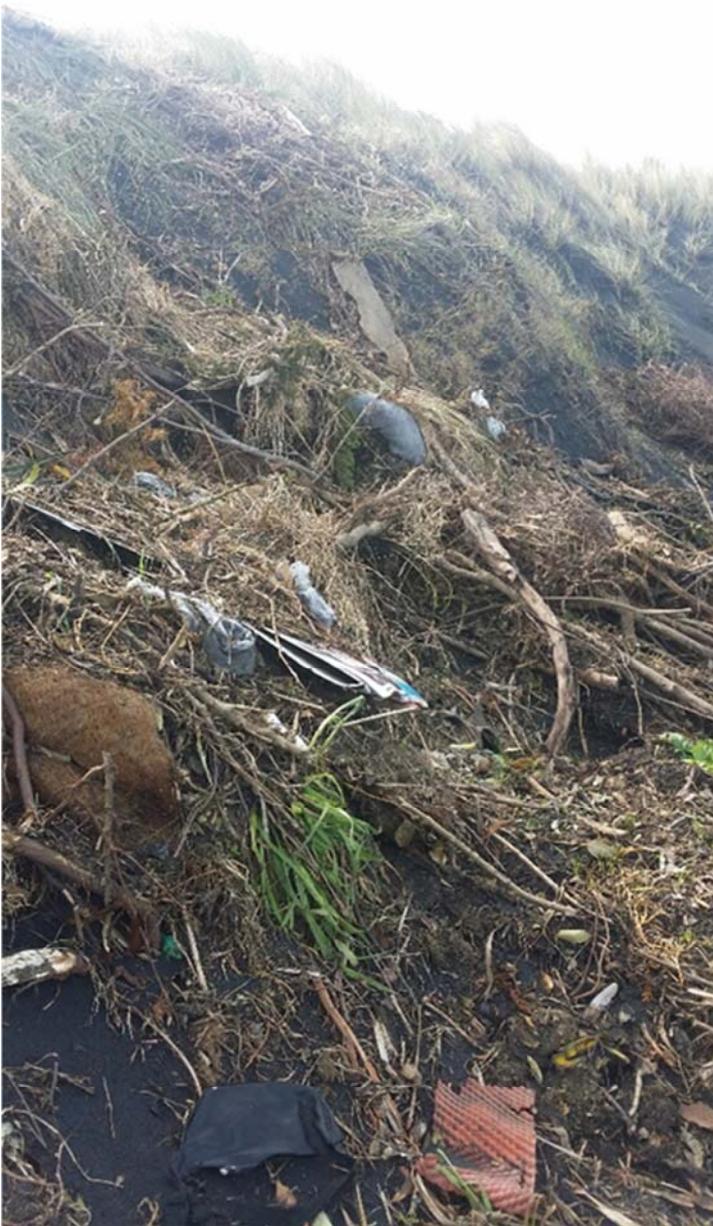
After having being found cleared of inorganic material at inspection on 5 September 2016, it was found that small pockets of inorganic material had been exposed by eroding sand dunes due to recent high tides.

Photograph 1 Previously discharged material exposed by erosion

The following action was to be taken:

- Continue to remove any inorganic material at and along the coast on a regular basis.
