Value Timber Limited
Monitoring Programme
Annual Report
2016-2017

Technical Report 2017-37

Value Timber Ltd (the Company) operates an untreated wood waste landfill located on Bristol Road at Inglewood, in the Waitara catchment. The sole source of the wood waste is from the Company's sawmilling operation in Inglewood. The Company sells most of its woodchip and sawdust as calf litter. The remaining material consisting of bark, soil and soiled woodchip/sawdust is sent to the Bristol Road site for disposal.

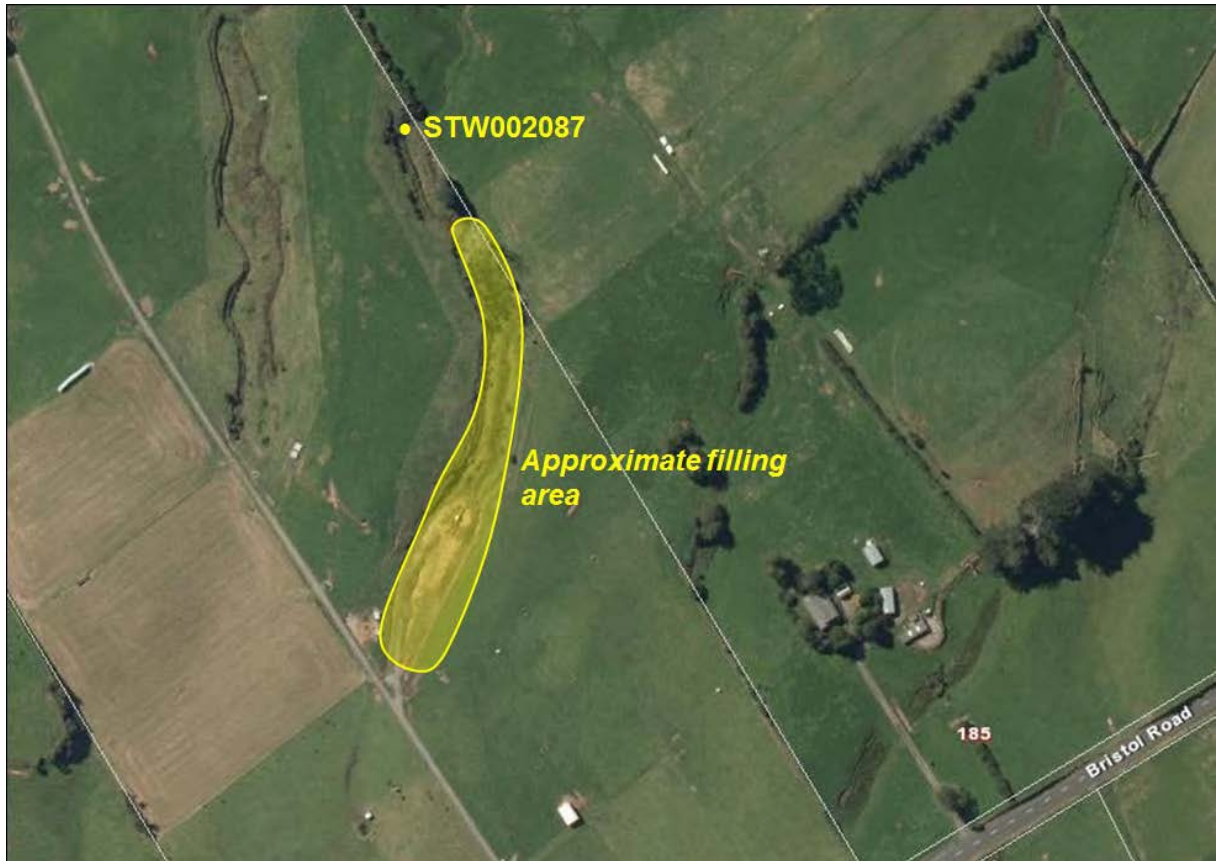
Figure 1 Aerial image of the Bristol Road site and sampling site

The site is located between two unnamed tributaries of the Kurapete Stream system. The site where the wood waste is discharged is a gully that directs stormwater and spring water from the surrounding pastureland to the headwater of the unnamed tributary of the Kurapete Stream. The previous owner of the property was in the process of filling the gully when the property was sold to the current owner. The current operation will continue to fill in the gully with untreated woodchip and sawdust to create more flat pasture land. Stormwater run-off from the land surrounding the fill area is intercepted and diverted by two lateral channels on each side of the fill area. Piping is being progressively laid ahead of the fill to allow ground water and spring water to drain away without being in contact with the wood waste. The final cap will consist of at least 300 mm of compacted clay and 100 mm of topsoil. The capping will be done progressively as the gully is filled.

The samples were taken from site STW002087, which is in the receiving drain downstream of the fill area, just upstream of the property's boundary fence (Figure 1).

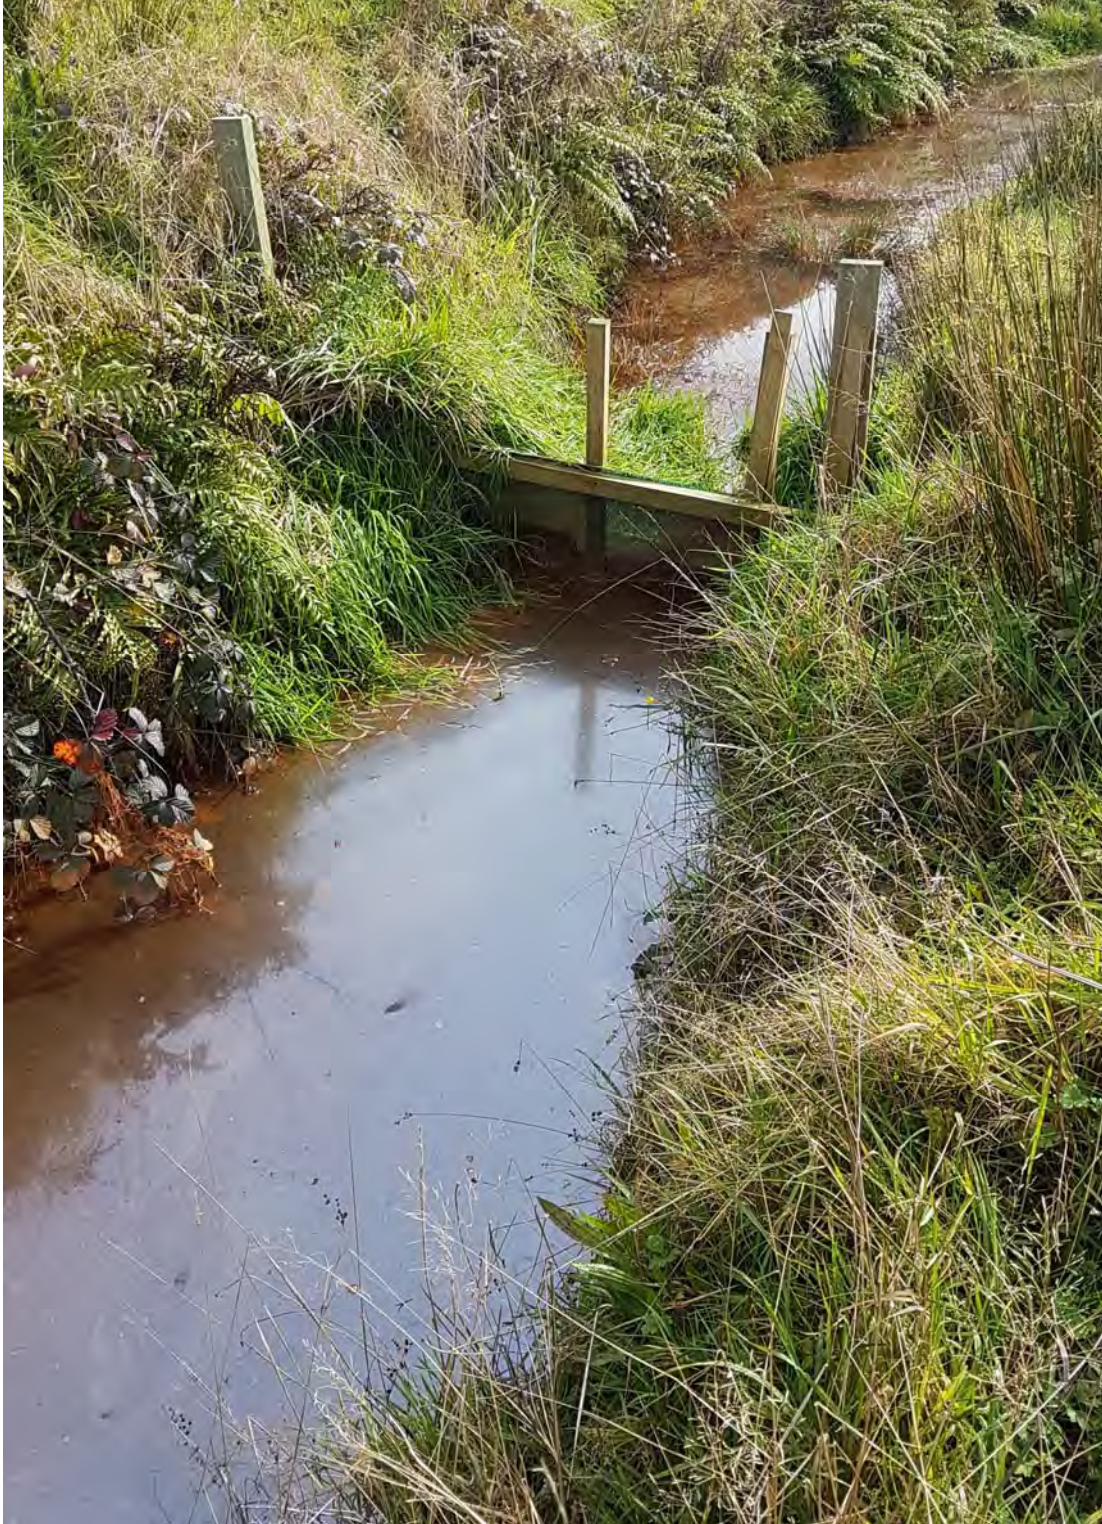
Silt controls were in place and had been upgraded to a high standard (Photo 1). Silt cloth had been fully extended to each side of the channel and was held in place with a robust, rigid framing. The appearance of the stream below the silt controls was improved compared to upstream, with less iron oxide sheen and turbidity. A sample was collected from the surface water monitoring site.

Photo 1 Upgraded in-drain silt control fence

The site was found to be well managed during the period under review. The silt control was much improved over the previous monitoring period. The grass cover in the pre-fill gully was maintained appropriately and the silt control fencing in the stormwater drain/tributary was upgraded to a more substantive and effective system.
