New Plymouth District Council
Inglewood, Okato,
and Marfell Park Landfills
Monitoring Programme
Annual Report
2017-2018

Technical Report 2018-38

Taranaki Regional Council
Private Bag 713
STRATFORD
October 2018

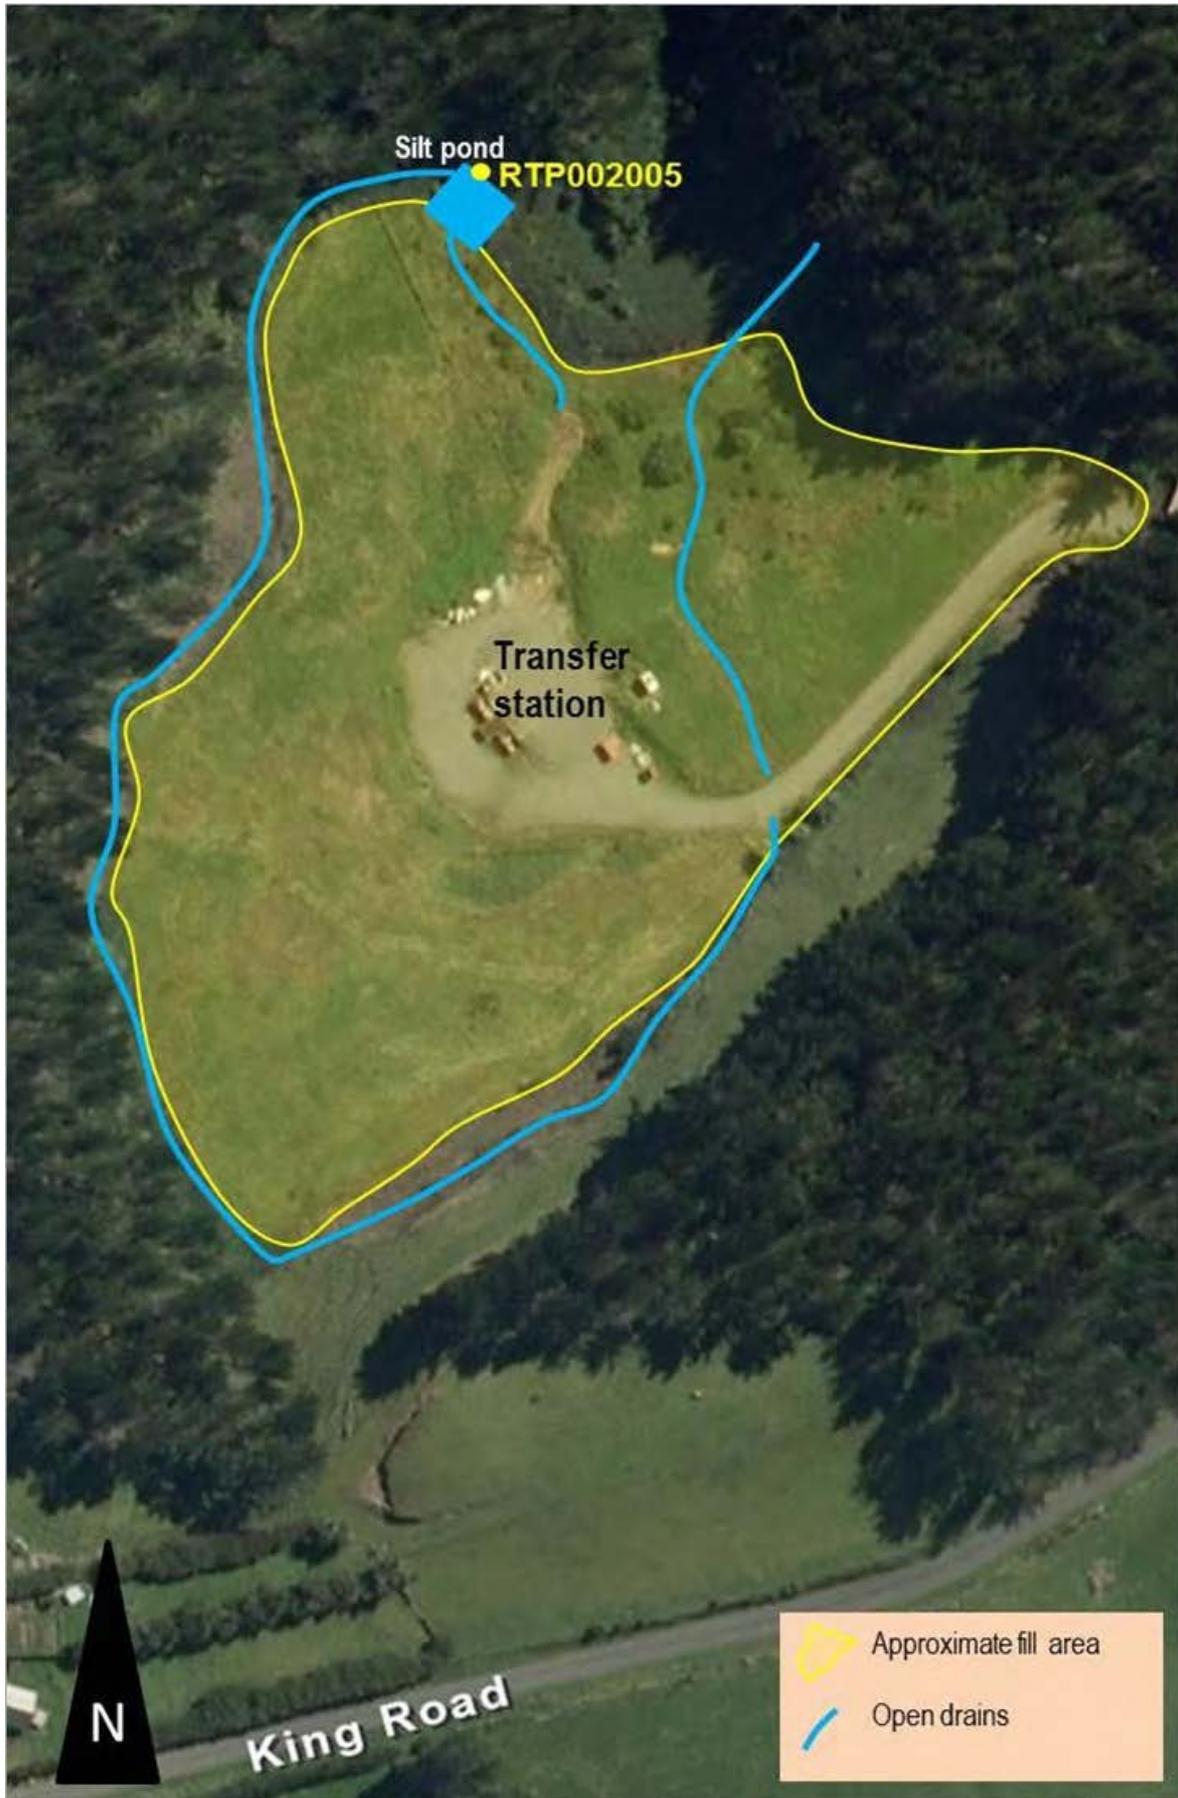
Figure 1 Site layout at Inglewood contingency landfill

Figure 1 shows the approximate extent of the fill and the general layout of the Inglewood landfill site. The discharge and receiving water monitoring site locations are shown in Figure 2.

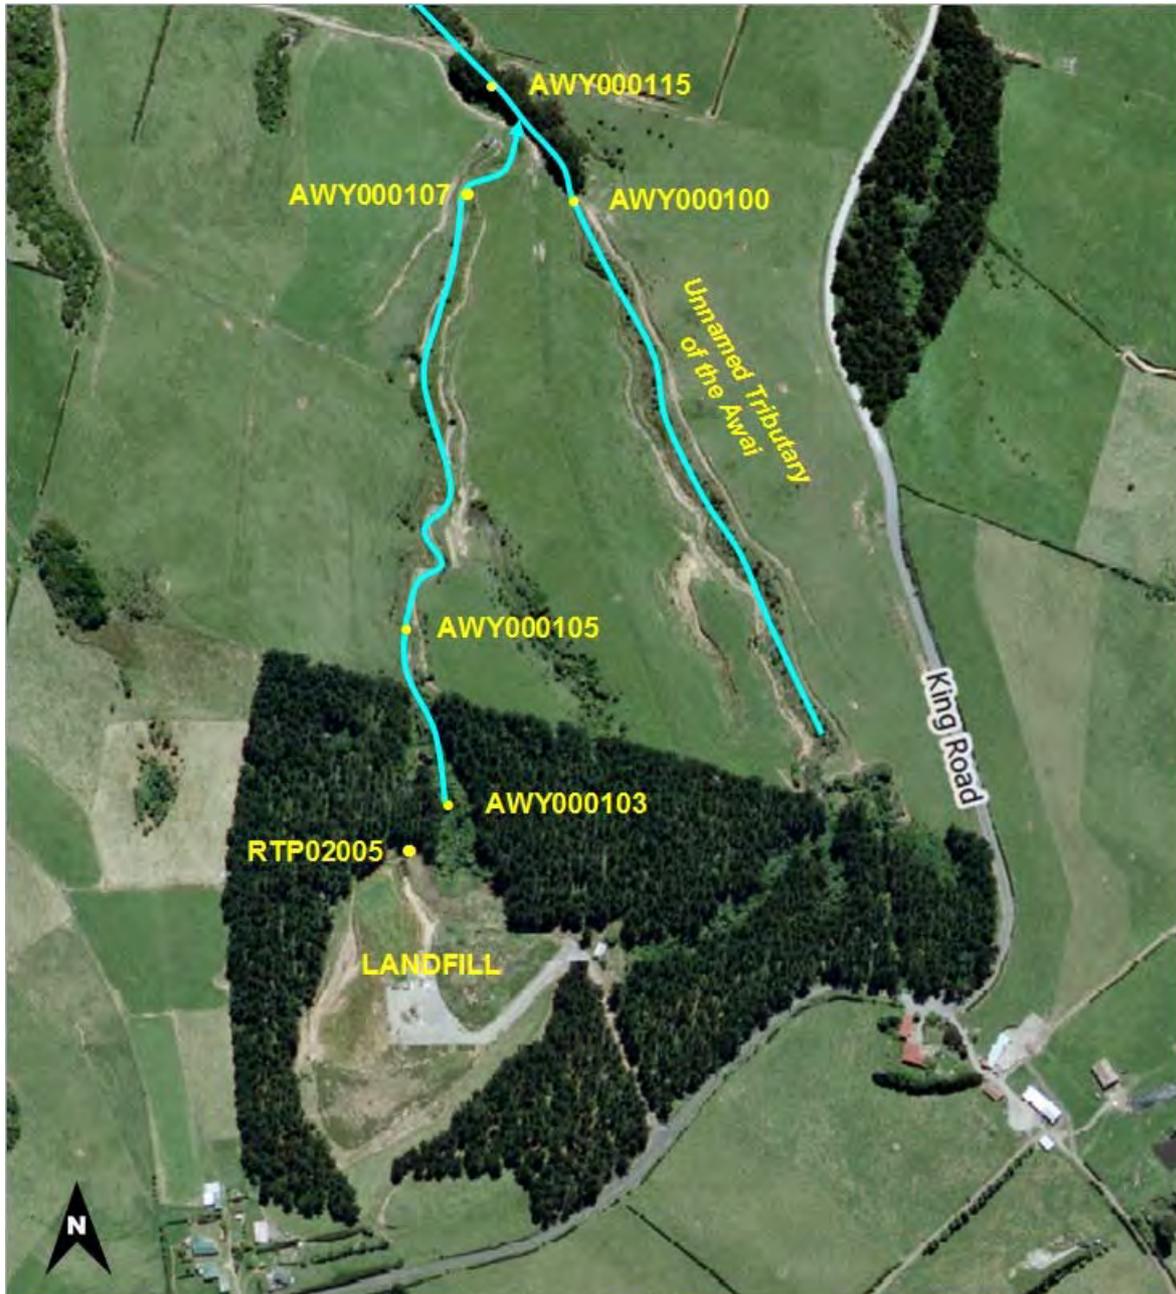
Figure 2 Inglewood landfill and receiving water sampling sites

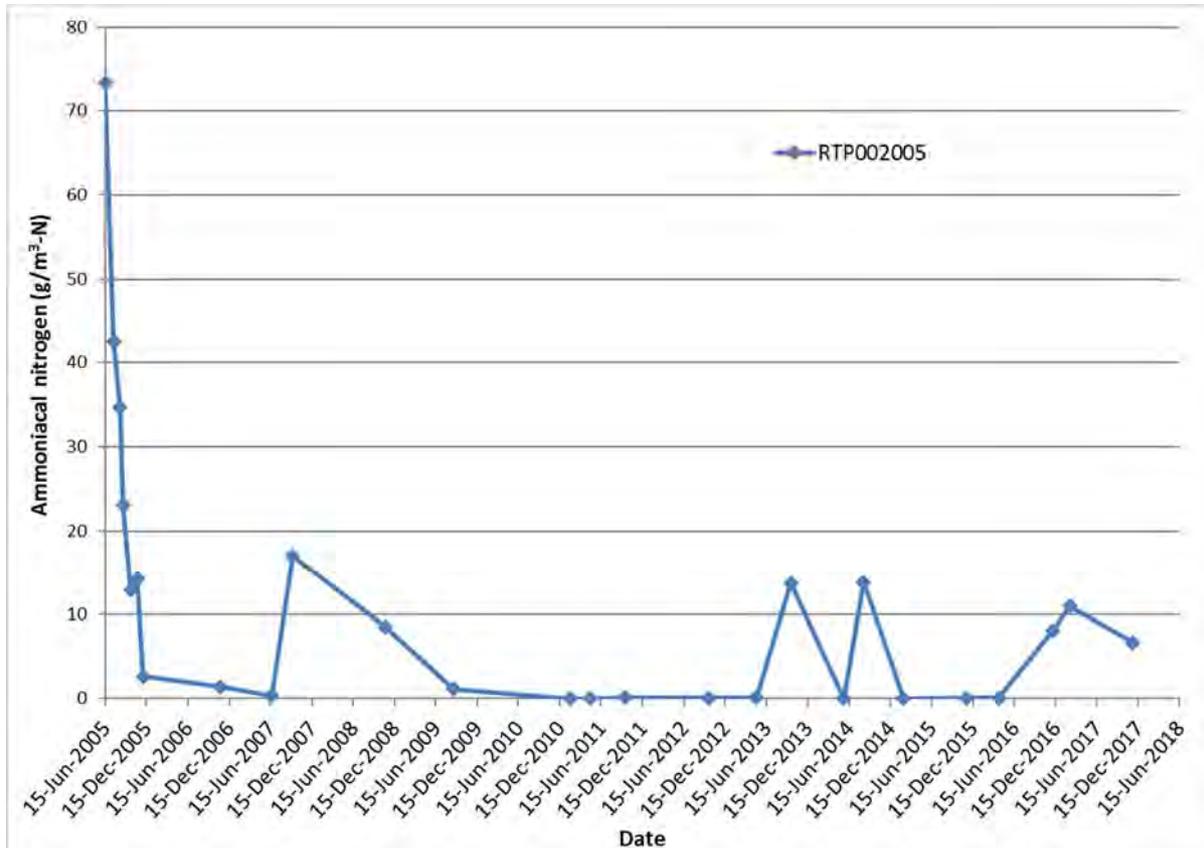
The autumn samples were collected after heavy rainfall in the 2013-2014, 2014-2015 and 2015-2016 years resulting in the ammoniacal nitrogen concentrations of the samples collected being elevated when compared the 2009-2012 years. During the year under review, ammoniacal nitrogen concentration continued to be elevated, (Figure 3), but to a slightly lesser extent due to the lower rainfall in the month preceding this survey.

Figure 3 Ammoniacal nitrogen concentration of the Inglewood landfill stormwater/leachate (RTP002005) for monitoring to date

The higher values obtained may have been the result of one or more of a number of factors including: the surrounding area, recent grazing, and/or additional stormwater infiltration causing increased leachate generation. Increased leachate generation is considered to be an unlikely cause as the cap was remediated during the 2014-2015 year, and was found to be intact and well vegetated during the year under review.

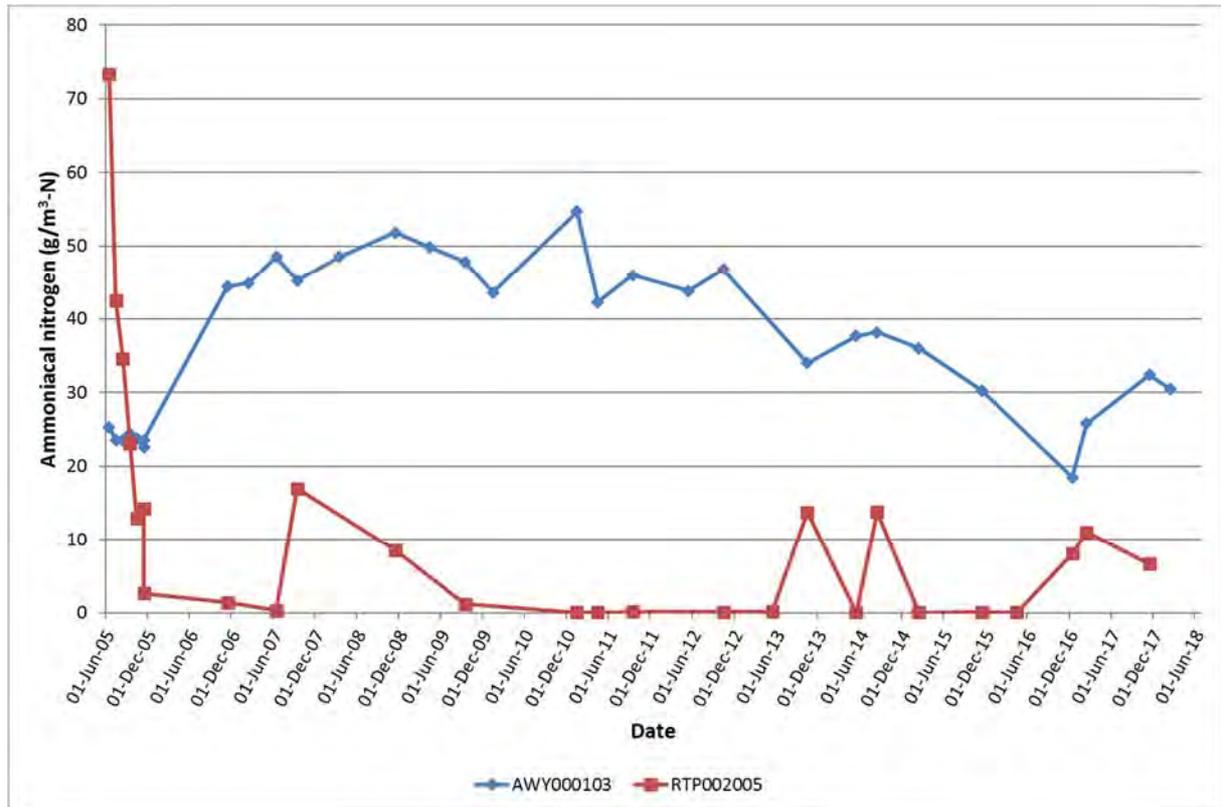
Figure 4 shows the ammoniacal nitrogen results for the stormwater/leachate pond (RTP002005) and the landfill tributary below the culvert outlet (AWY000103). During the year under review there was no discharge occurring at the time of either survey, but it is noted that the concentration was much lower in the pond than in the tributary. This has been a consistent finding since September 2005, and continues to indicate that ammoniacal nitrogen is entering the landfill tributary via another route, potentially via shallow groundwater.

Figure 4 Ammoniacal nitrogen concentration between the Inglewood landfill stormwater/leachate (RTP002005) and the tributary below the culvert outlet (AWY000103)

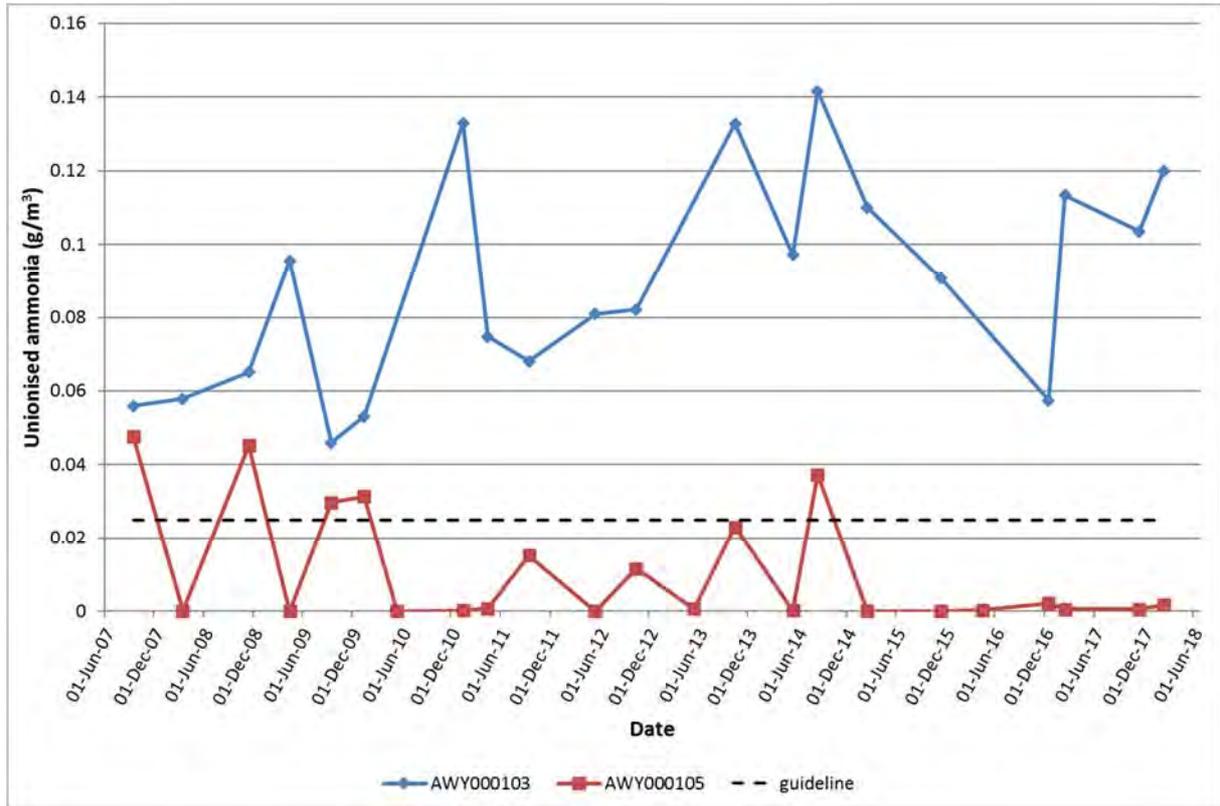
It is also noted that at the culvert outlet the unionised ammoniacal nitrogen concentration has been consistently above the 0.025 g/m³ guideline adopted by the Council to protect aquatic organisms from chronic effects. From a review of the historical results, it appears that there has been an emerging trend of increasing levels of this contaminant at this site. It is however noted that, for the most part, this is generally assimilated in the wetland area, and the concentrations found at the lower end of the landfill tributary (site AWY000105) are normally well below this guideline value (Figure 5).

The concentration range above which acute toxic effects may be seen for New Zealand native fish, for example a fish kill, is 0.75 to 2.35 g/m³, and the levels of unionised ammonia found at all monitoring sites during the year under review were well below this concentration range. Although the unionised ammonia concentration was found to be above the 0.025 g/m³ guideline at the lower end of the tributary on occasion, this has not happened in recent years.

Figure 5 Unionised ammonia concentration in the landfill tributary below Inglewood landfill

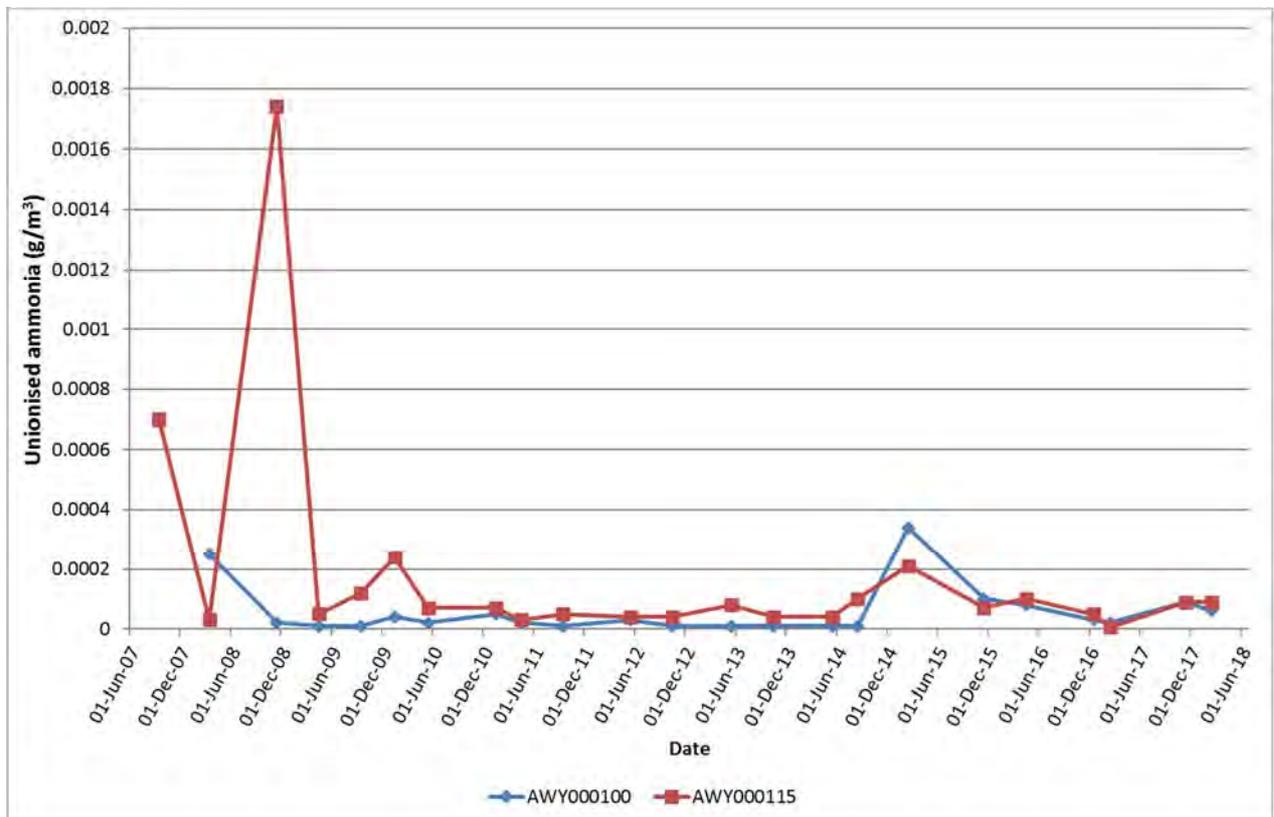
Figure 6 shows that there has generally been little, if any, effect found on the unionised ammonia concentration of the larger (main) tributary (site AWY000115). Any changes that have been found have not been of environmental significance.

Figure 6 Unionised ammonia concentration in the main tributary below Inglewood landfill

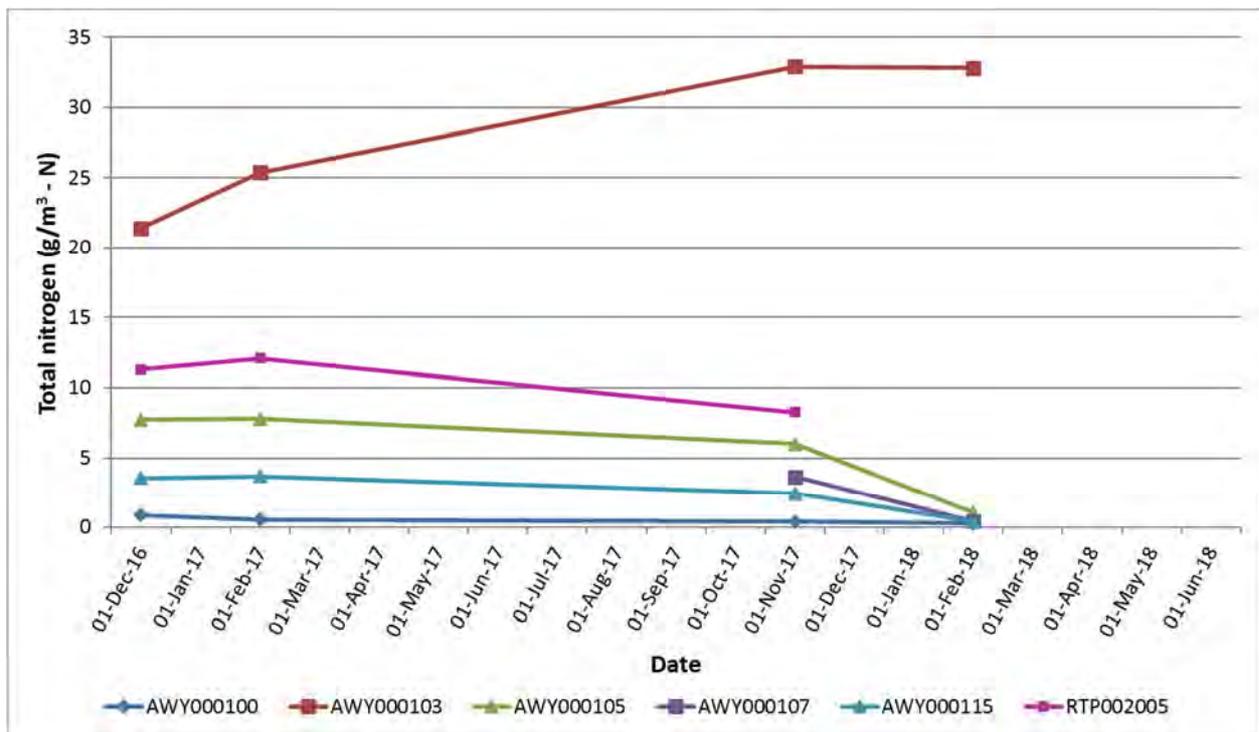
Due to the changes observed in recent years in the ammoniacal nitrogen and nitrate/nitrite concentrations at the various sites, total nitrogen has recently been included in the suite of analyses performed. The results obtained since this analysis was initiated in the 2016-2017 year are depicted in Figure 7, and show that:

- the nitrogen contained in the leachate/stormwater pond is significantly lower than at site AWY000103;
- the wetland below the culvert is effective at decreasing the total nitrogen loading in the landfill tributary, and that this continues to decrease prior to the confluence with the main tributary; and
- with the exception of the February 2018 survey, there is a notable increase in the total nitrogen concentration of the main tributary that mirrors the increases observed in the nitrate/nitrogen at these sites (Figure 8).

Figure 7 Total nitrogen concentration in the surface waters below the landfill

The nitrate/nitrite nitrogen concentration is well below the National Objectives Framework (NOF) bottom line of 9.8 g/ m³ (annual 95 percentile) at all sites. At the end of the 2014-2015 year, it was noted that the ammoniacal nitrogen and unionised ammonia concentrations in the landfill tributary at the culvert appeared to be increasing and the difference in the nitrate/nitrogen concentrations between the upstream and downstream sites in the main tributary also appeared to be increasing. It was thought possible that the condition of the cap as found in the 2014-2015 year, with its increased permeability, may have contributed to the increasing trends seen in the nitrogen containing species in recent years. Although the long term trend now appears to be decreasing and this may have resolved with the remediation work undertaken on the cap during the 2014-2015 year, the limited total nitrogen data available (four surveys) still potentially indicated increasing concentrations of nitrogen containing species at the culvert outlet (Figure 7).

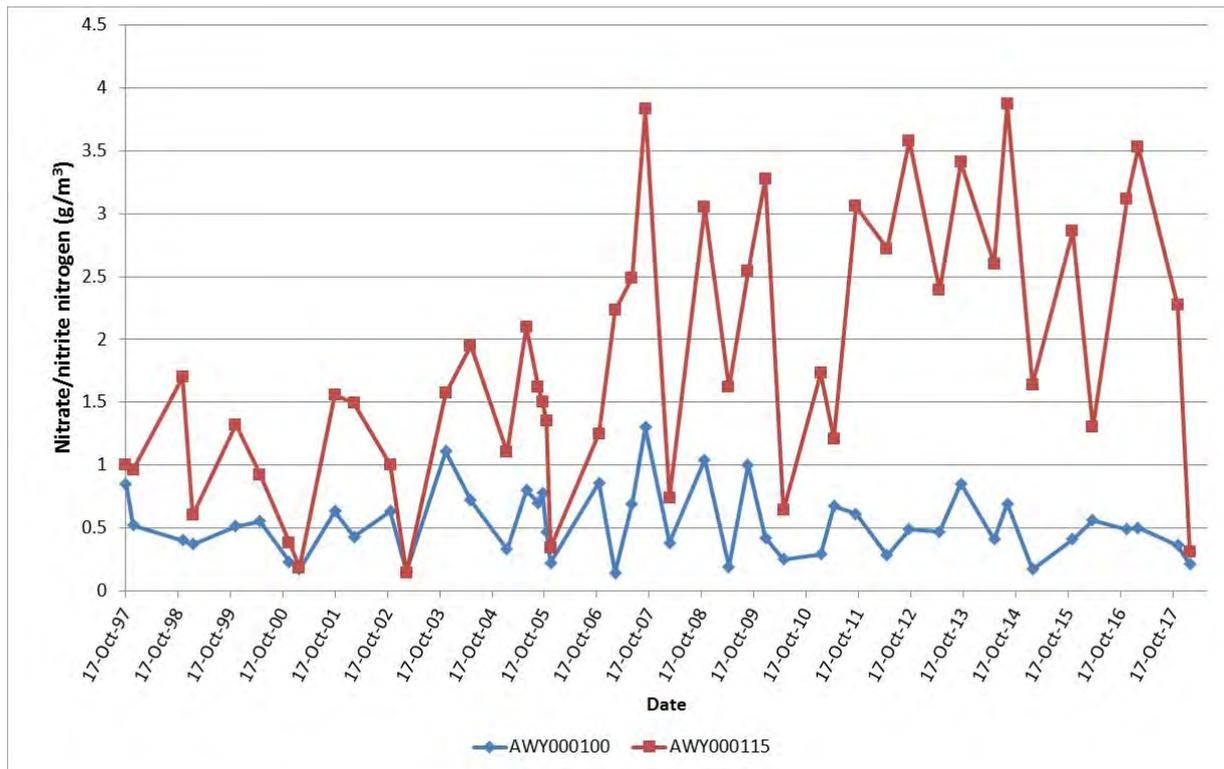
Figure 8 Nitrate/nitrite nitrogen results in the main tributary upstream and downstream of the Inglewood landfill tributary discharge

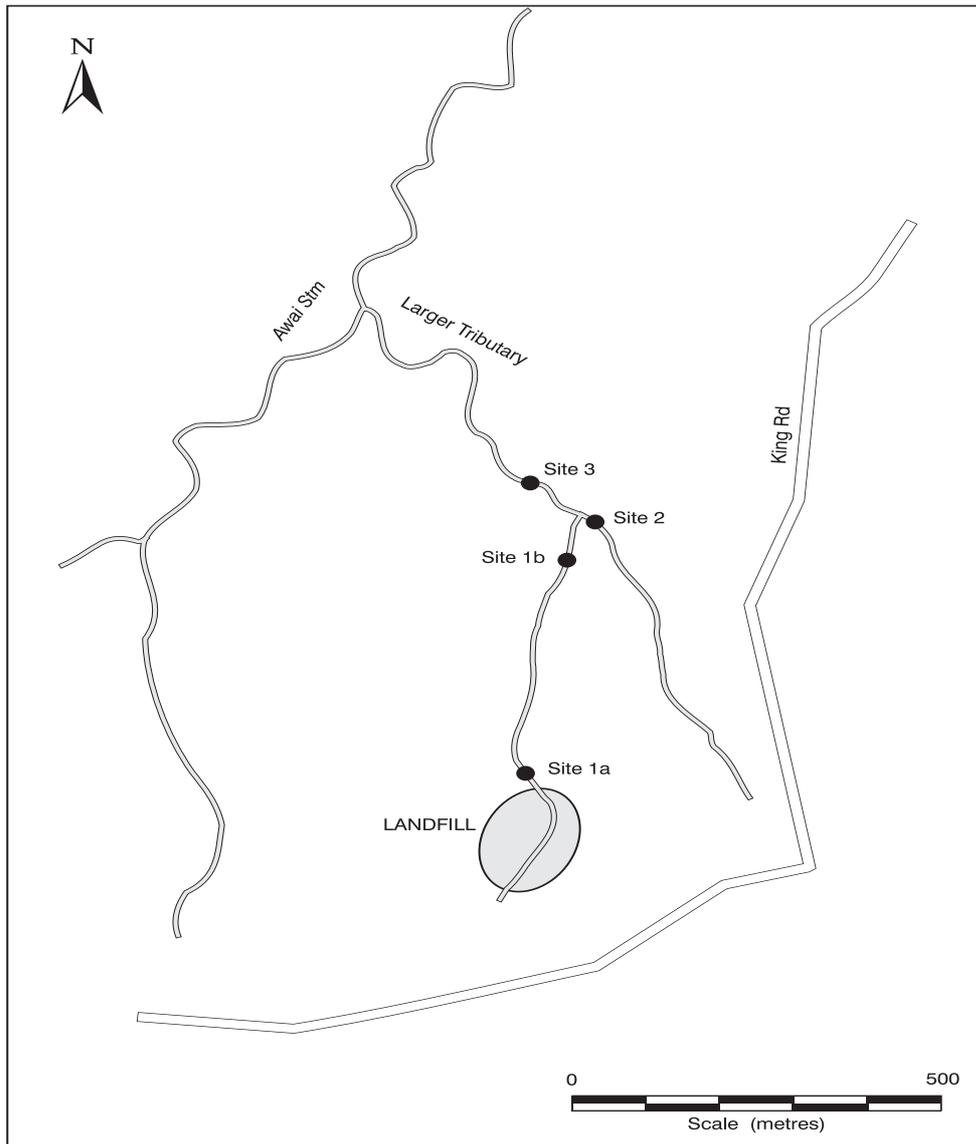
Figure 9 Biomonitoring sites in tributaries of the Awai Stream relative to the Inglewood landfill

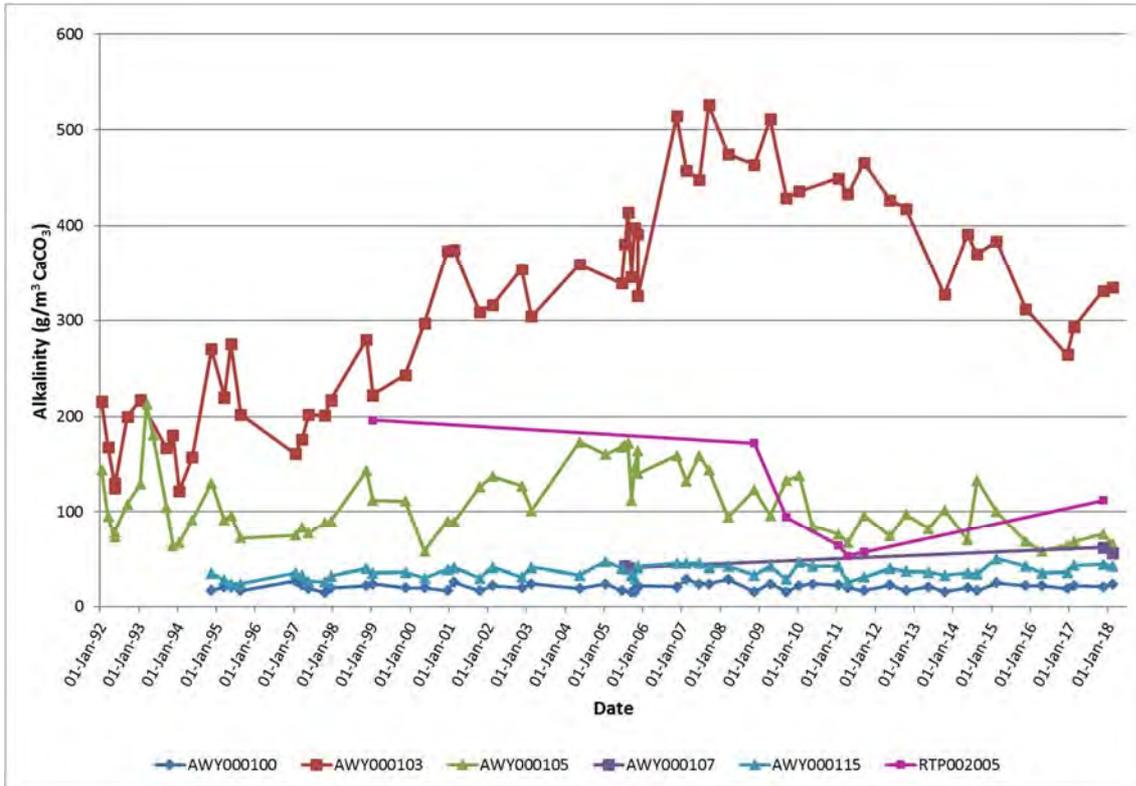
When viewing the long term data, alkalinity, ammoniacal nitrogen and nitrate/nitrite nitrogen concentrations in the discharge from the culvert (AWY000103) all appear to be declining from the peak that was reached following the use of this site for the three months of contingency filling in 2005 and closure of the site to general waste on 1 September 2006 (Figure 10, Figure 11 and Figure 12).

Figure 10 Alkalinity in the surface waters below the Inglewood landfill (1992 to date)

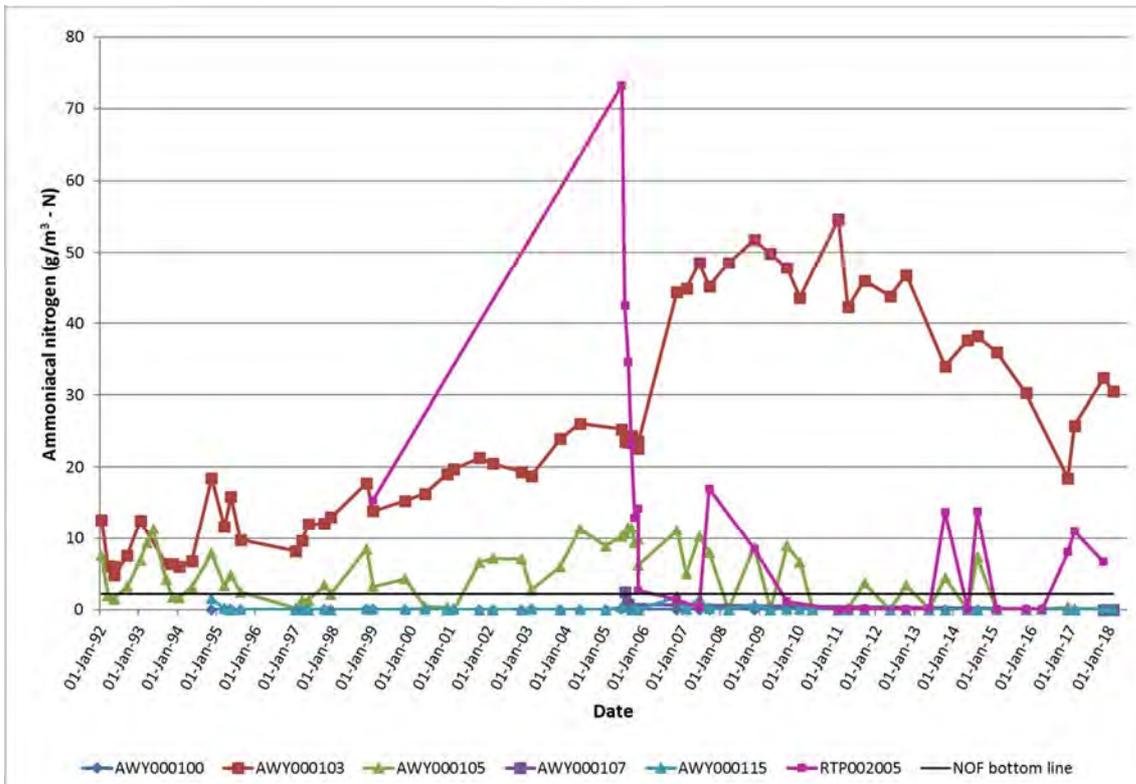
Figure 11 Ammoniacal nitrogen in the surface waters below the Inglewood landfill (1992 to date)

Although the ammoniacal nitrogen concentration is consistently above the National Objectives Framework (NOF) bottom line of 2.2 g/ m³ (annual 95 percentile)¹ at the culvert outlet (AWY000103), the concentration at the wetland is decreasing, and the concentrations found in the main tributary are well below this level.

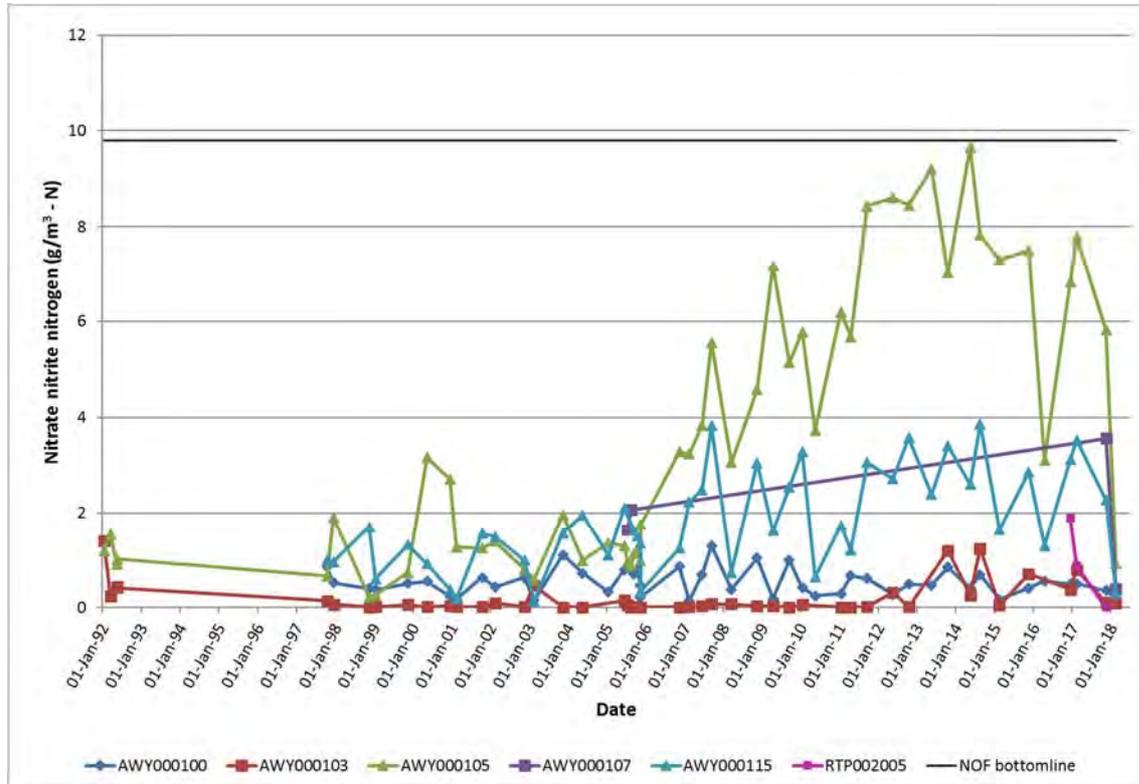
Figure 12 Nitrate/nitrite nitrogen in the surface waters below the Inglewood landfill (1992 to date)

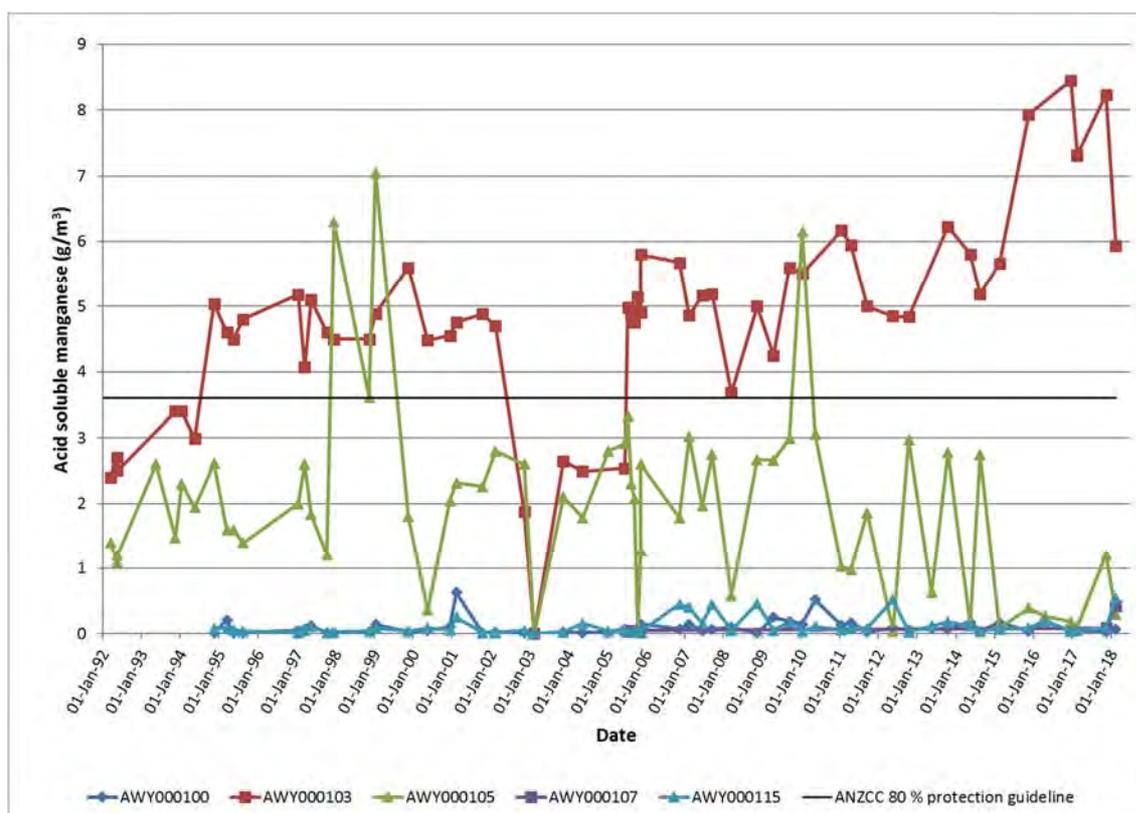
Historical data is also indicating a trend of increasing acid soluble manganese in the discharges from the site. However currently, with a few exceptions at site AWY000105, the tributaries beyond the wetland treatment system are below the ANZECC guideline for the protection of 80 % of species (3.6 g/m³), with the landfill tributary well below the guideline for the protection of 99 % of species (1.2 g/m³).

Figure 13 Acid soluble manganese in the surface waters below the Inglewood landfill (1992 to date)

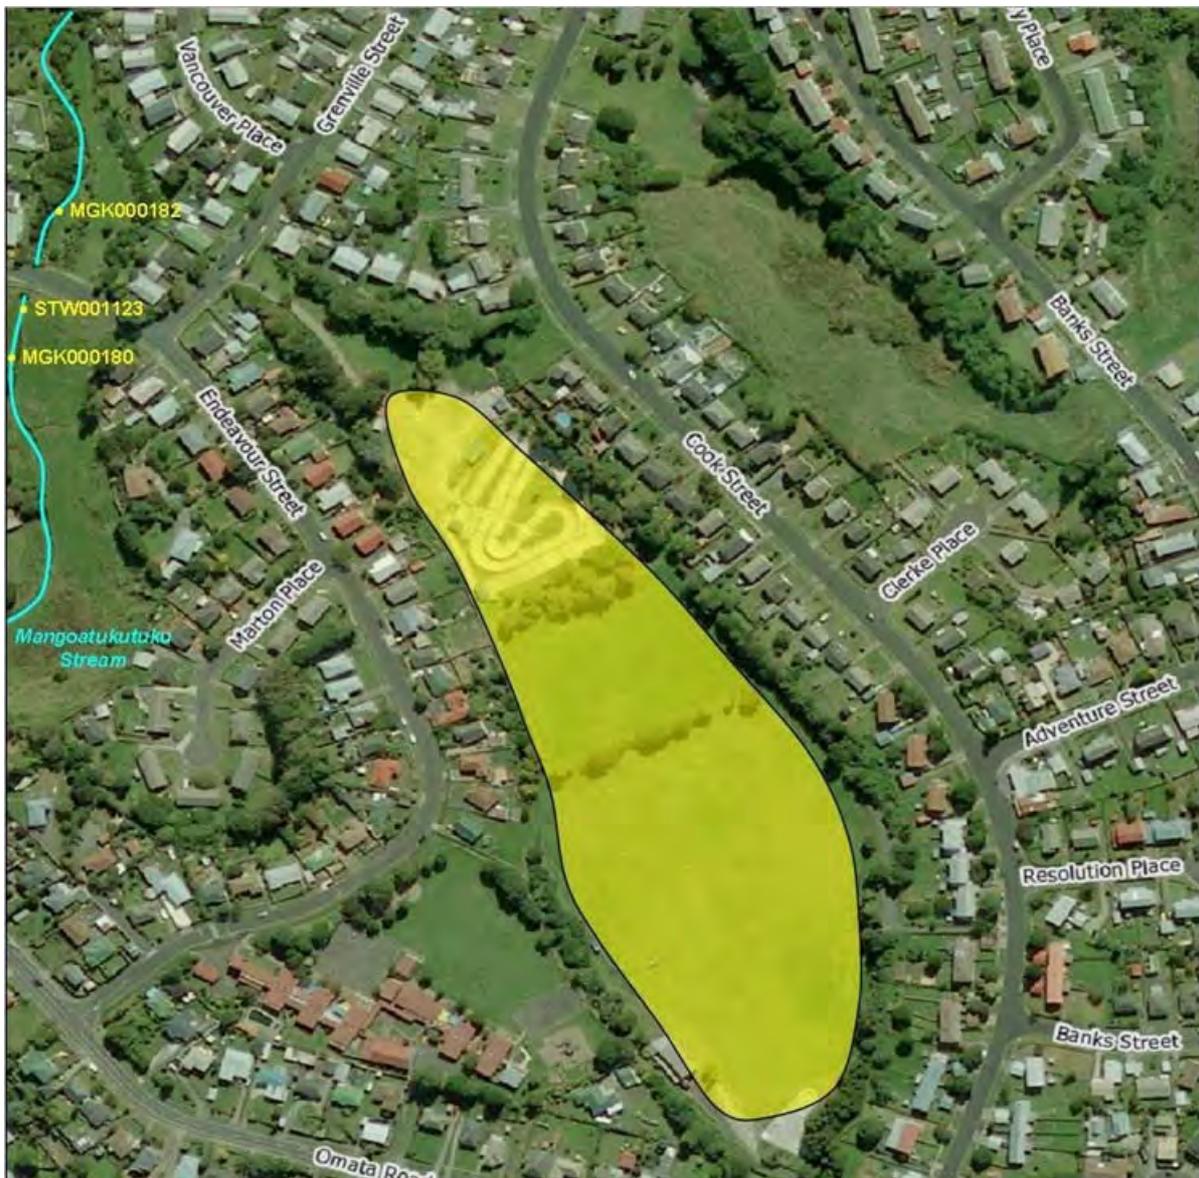
Figure 14 An aerial view showing the former landfill at Marfell Park and associated sampling sites

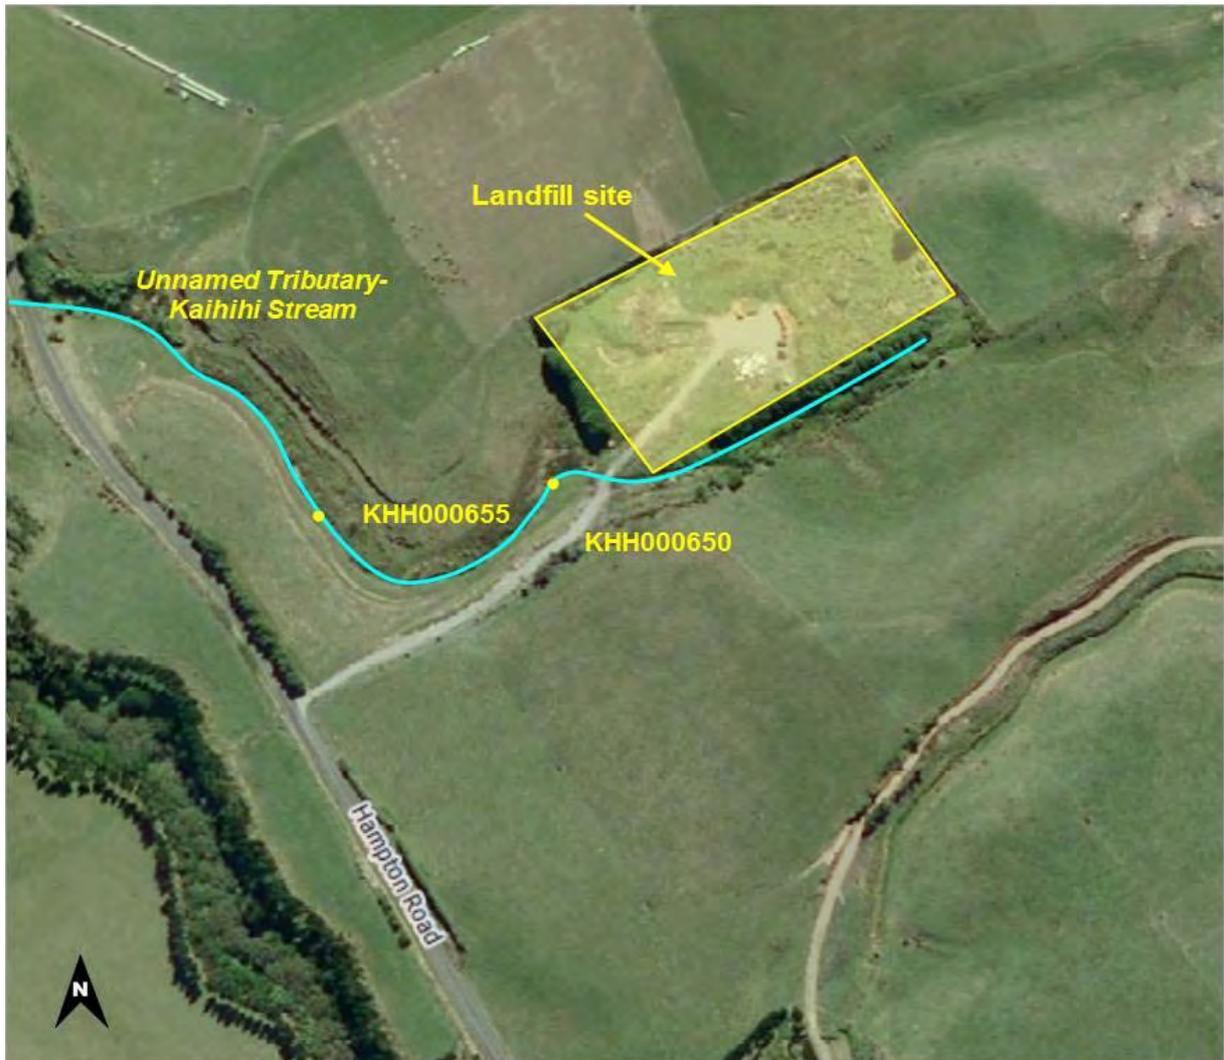
Figure 15 Okato landfill and sampling sites

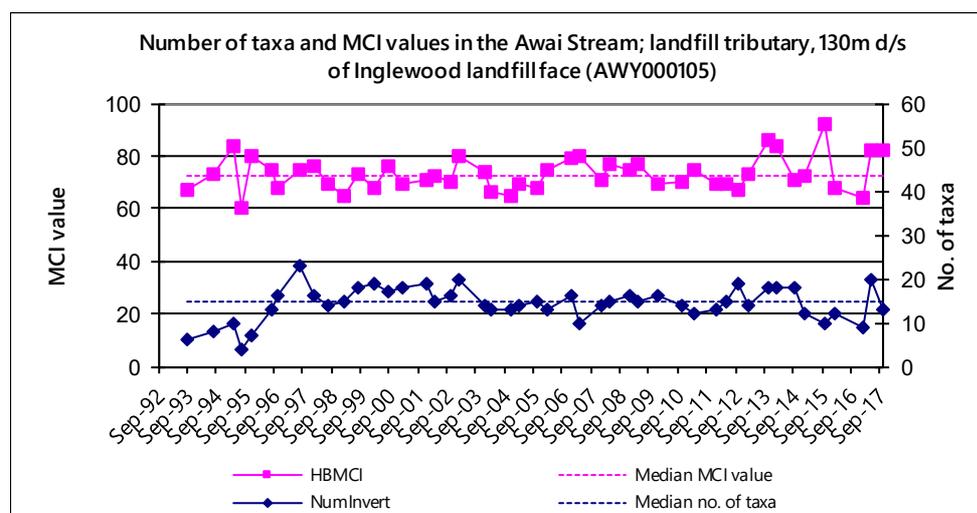
A low taxa richness of 13 taxa was recorded. This is a substantial eight taxa fewer than recorded in the preceding survey, but only two taxa less than the median richness for this site (Table 4, Figure 2). The macroinvertebrate community was characterised by two 'moderately sensitive' taxa [amphipod (Paraleptamphopidae) and midge larvae (Tanypodinae)] and three 'tolerant' taxa [oligochaete worms, seed shrimps (Ostracoda) and midge larvae (*Polypedilum*)].

A MCI score of 87 was recorded, categorising the site as having 'fair' macroinvertebrate community health. This score is a non-significant (Stark 1998) ten units higher than the median score for this site and equal to the score recorded in the preceding survey (Figure 2). A SQMCI₅ score of 3.3 units was recorded, not significantly (Stark 1998) higher than the median score for this site (median SQMCI₅ score 2.6 units; Table 4) and significantly higher (Stark 1998) the score of 1.6 units recorded in the preceding survey.

Figure 2 Number of taxa and MCI values at site 1a in a tributary of the Awai Stream

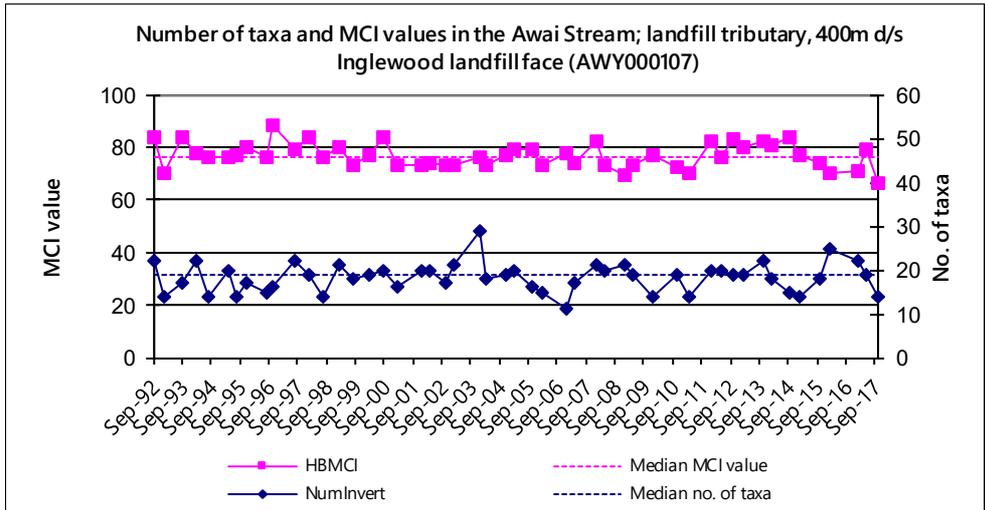
A MCI score of 66 units was recorded, categorising the site as having 'poor' macroinvertebrate community health. This score is significantly lower (Stark 1998) than both the median score for this site and the score recorded in the preceding survey (Table 4, Figure 3). A SQMCI₅ score of 3.3 units was recorded, which is not significantly different to the score of 3.9 units recorded in the preceding survey or to the median score for this site (median SQMCI₅ score 3.4 units; Table 4).

Figure 3 Number of taxa and MCI values at site 1b in a tributary of the Awai Stream

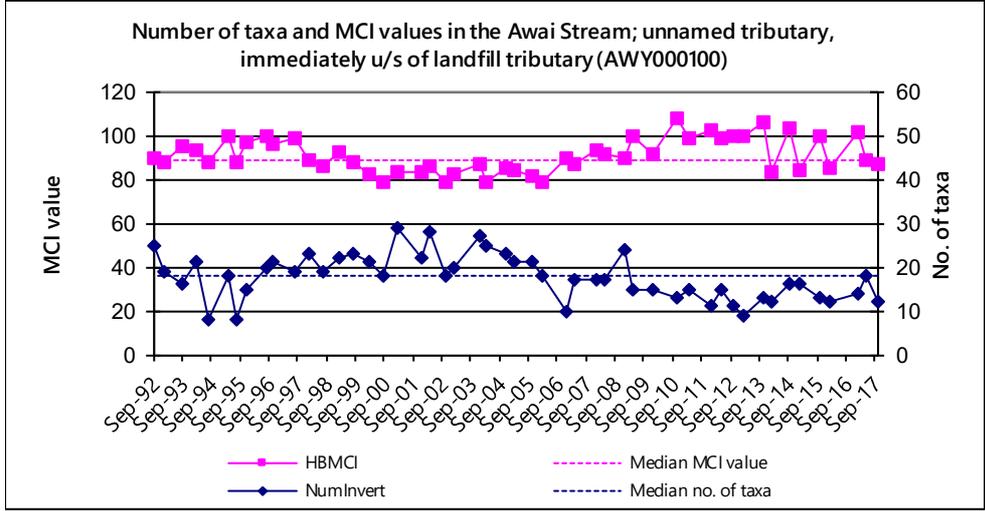
A MCI score of 87 units was recorded at this site, categorising the site as having 'fair' macroinvertebrate community health. This score is not significantly lower (Stark 1998) than either the median score for this site (median MCI score 90 units; Table 4) or the score recorded in the preceding survey (Figure 4). A SQMCI₅ score of 4.1 units was recorded, significantly lower (Stark 1998) than the score of 5.5 units recorded in the preceding survey but equal to the median score for this site (Table 4).

Figure 4 Number of taxa and MCI values at site 2 in a tributary of the Awai Stream

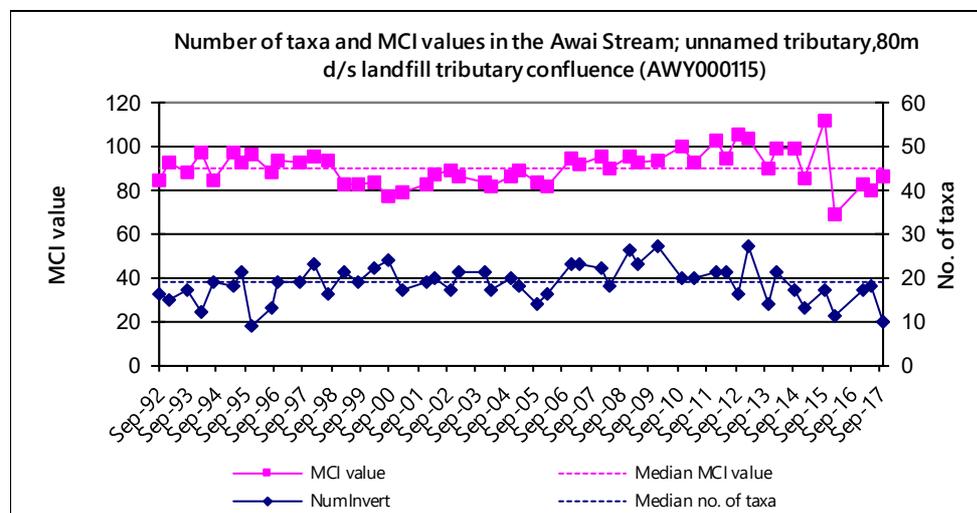
A MCI score of 86 units was recorded, categorising the site as having 'fair' macroinvertebrate community health. This score is not significantly different from either the median score for this site (median MCI score 90 units; Table 4, Figure 5) or the score recorded in the preceding survey (Figure 5). A SQMCI_s score of 1.7 units was recorded, significantly lower (Stark 1998) than the median score for this site (median SQMCI_s score 3.3 units; Table 4) but similar to the score of 1.9 units recorded in the preceding survey.

Figure 5 Number of taxa and MCI values at site 3 in a tributary of the Awai Stream

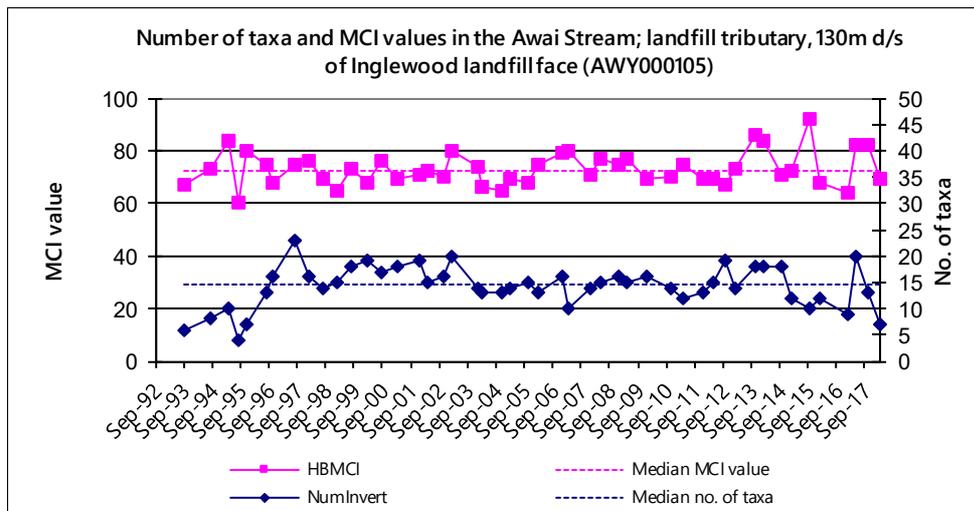
A MCI score of 69 was recorded, categorising the site as having 'poor' macroinvertebrate community health. This score is a non-significant (Stark 1998) three units lower than the median score for this site and a significant 18 units lower than recorded in the preceding survey (Figure 2). A SQMCI₅ score of 2.5 units was recorded, not significantly (Stark 1998) lower than the median score for this site (median SQMCI₅ score 2.6 units; Table 4) or the score of 3.3 units recorded in the preceding survey.

Figure 2 Number of taxa and MCI values at site 1a in a tributary of the Awai Stream
