New Plymouth District Council
Inglewood, Okato,
and Marfell Park Landfills
Monitoring Programme
Annual Report
2017-2018

Technical Report 2018-38

Taranaki Regional Council
Private Bag 713
STRATFORD
October 2018

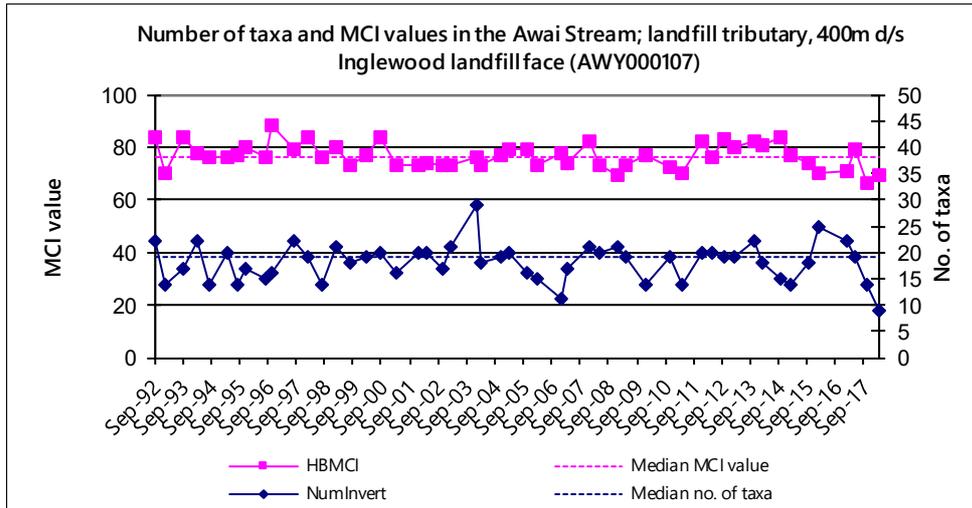
A MCI score of 69 units was recorded, categorising the site as having 'poor' macroinvertebrate community health. This score is non-significantly lower (Stark 1998) than the median score for this site but is a non-significant (Stark 1998) three units higher than that recorded in the preceding survey (Table 4, Figure 3). A SQMCI₅ score of 3.5 units was recorded, which is not significantly different to the score of 3.4 units recorded in the preceding survey or to the median score for this site (median SQMCI₅ score 3.3 units; Table 4).

Figure 3 Number of taxa and MCI values at site 1b in a tributary of the Awai Stream

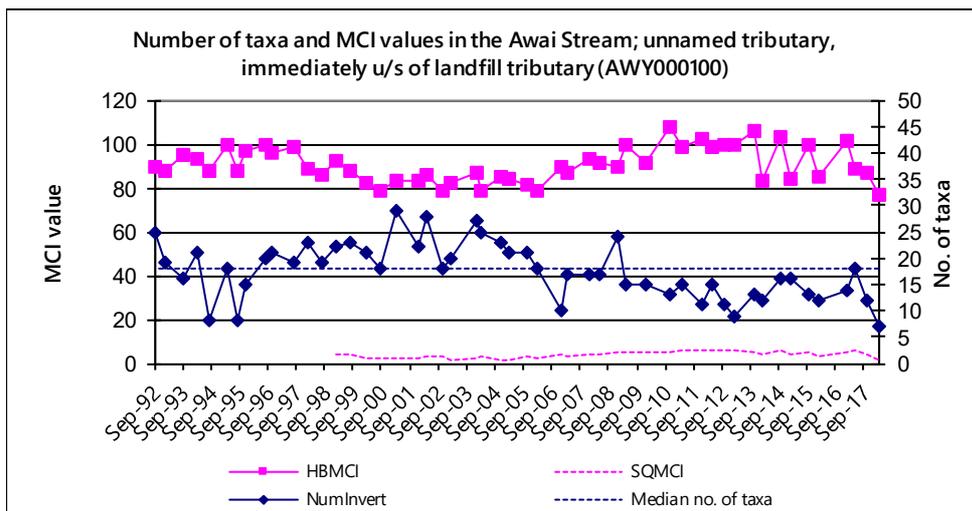
A MCI score of 77 units was recorded at this site, categorising the site as having 'poor' macroinvertebrate community health. This score is significantly lower (Stark 1998) than the median score for this site (median MCI score 89 units; Table 4) but is not significantly lower than the score recorded in the preceding survey (Figure 4). This MCI score is the lowest score recorded at this site to date, by 2 units (Table 4, Figure 4). A SQMCI₅ score of 1.2 units was recorded, significantly lower (Stark 1998) than the score of 4.1 units recorded in the preceding survey and the median score for this site (Table 4). This is also the lowest SQMCI₅ score recorded at this site to date, by 0.2 unit (Table 4).

Figure 4 Number of taxa and MCI values at site 2 in a tributary of the Awai Stream

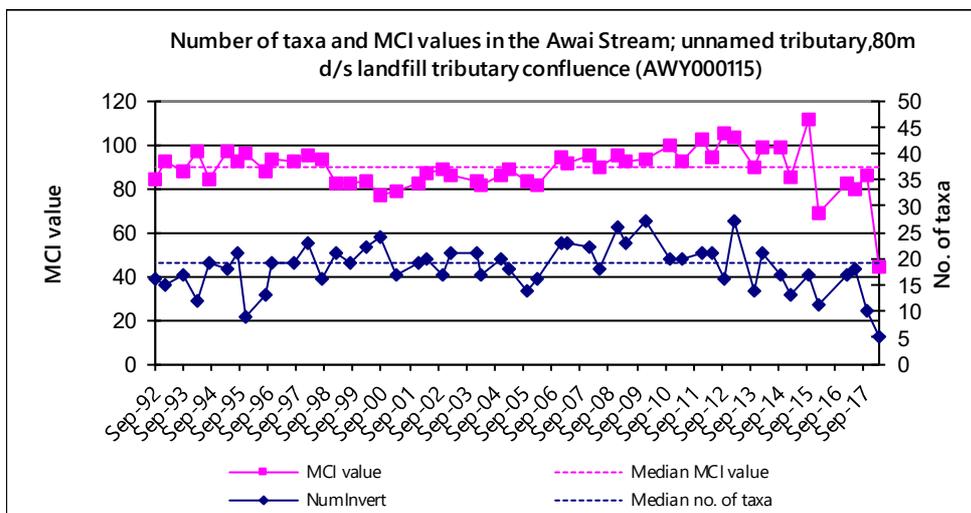
A MCI score of 44 units was recorded, categorising the site as having 'very poor' macroinvertebrate community health. This score is a significant (Stark 1998) 46 units lower than the median score for this site (median MCI score 90 units; Table 4, Figure 5) and 42 units lower than the score recorded in the preceding survey (Figure 5). A SQMCI_s score of 1.0 units was recorded, significantly lower (Stark 1998) than the median score for this site (median SQMCI_s score 3.3 units; Table 4) and non-significantly lower than the score of 1.7 units recorded in the preceding survey. The MCI and SQMCI_s scores are the lowest recorded at this site to date, by 25 units and 0.3 unit respectively (Table 4, Figure 5).

Figure 5 Number of taxa and MCI values at site 3 in a tributary of the Awai Stream
