Stratford District Council Landfills
Monitoring Programme
Annual Report
2017-2018

Technical Report 2018-68

Taranaki Regional Council
Private Bag 713
STRATFORD
November 2018

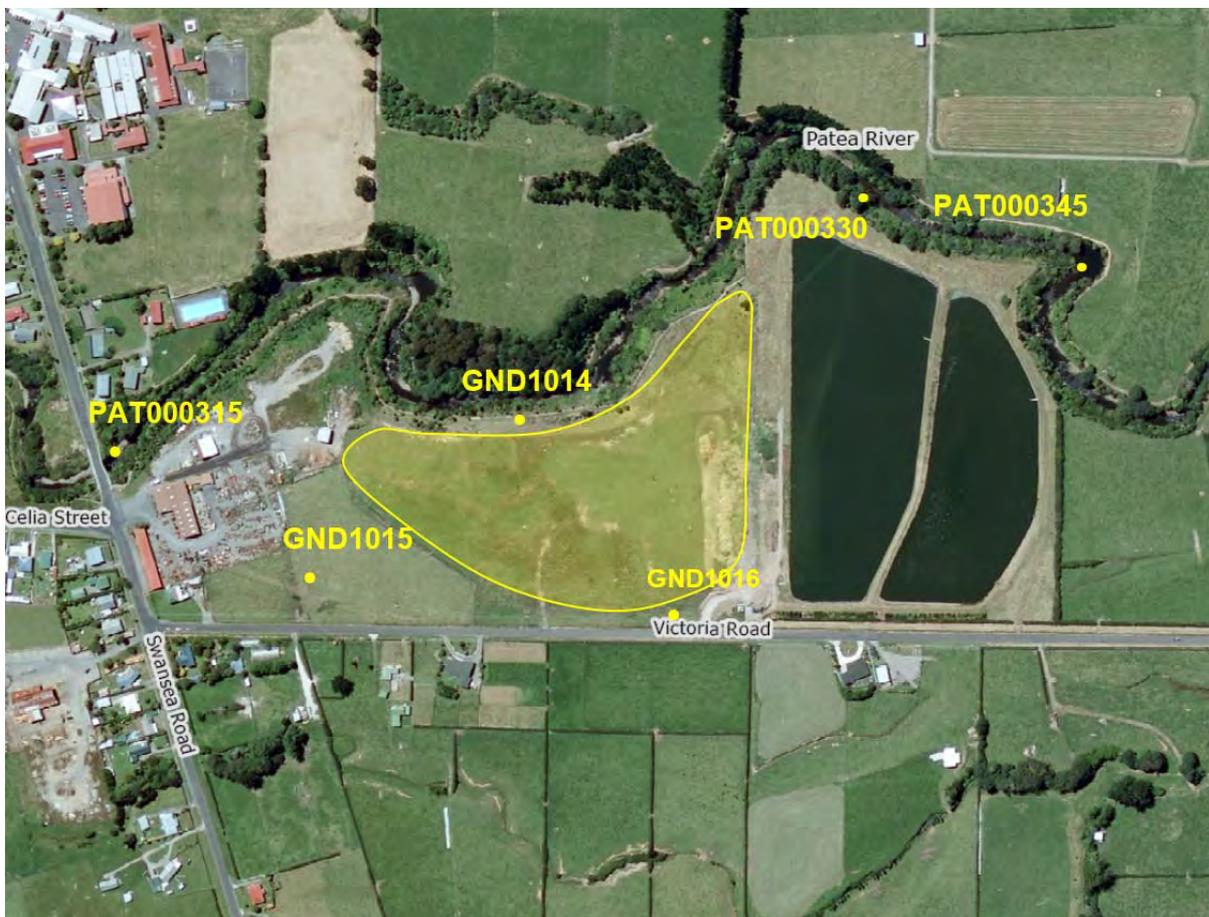
Figure 2 Stratford landfill (shaded in yellow) and sampling locations

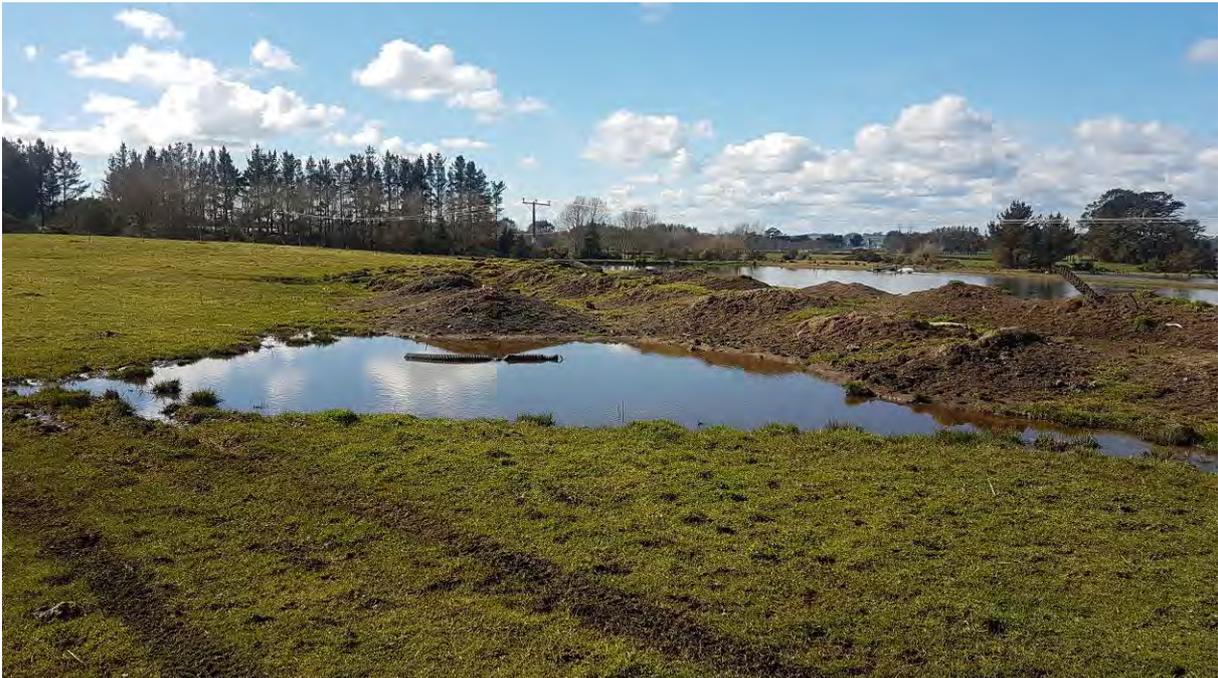
This inspection was conducted in fine weather with a light northerly wind. The cap was very damp, with minor ponding in multiple areas following heavy rain during the previous weeks. The most significant ponding was on the eastern border of the cap, approximately 5 m² in size, and up to 10 cm deep. The lack of vegetation in this area indicated that the ponding had been occurring for some time. Widespread minor vehicle and stock damage was noted on the cap and batters, but was mainly concentrated in the gateways. No slumping, cracking or exposed refuse was noted on either the cap or batters.

An inspection of a closed landfill at Swansea Road, Stratford found noncompliance with special conditions of resource consent 3889-3, in that ponding of stormwater (Photo 1) and trough water (Photo 2) was observed in contravention of consent conditions. The ponding was significant in some areas, which was contributed to by the stormwater drains not being well constructed. It was noted that the northern leachate drain was overflowing onto the public walkway (Photo 3) and there was widespread minor damage to the cap (Photo 4 and Photo 5). SDC were given the opportunity to write in explaining the circumstances surrounding the breaches of consent, and why further enforcement action should not be undertaken by the Council.

Photo 1 Area of ponding on the cap at Stratford landfill

- to clean up the overflowing leachate and re-establish the walkway drains where necessary;
- carry out preliminary repairs to define the stormwater drains;
- carry out preliminary repairs to the areas of ponding on the western edge of the cap;
- carry out preliminary reinstatement to all stock damaged areas of the caps and batters.

By April 2018, SDC undertook to review the contour plan and reinstate the capped areas in stages ensuring that the undefined stormwater drains were defined and remediate/fill all areas affected by ponding to ensure compliance with special condition 3.

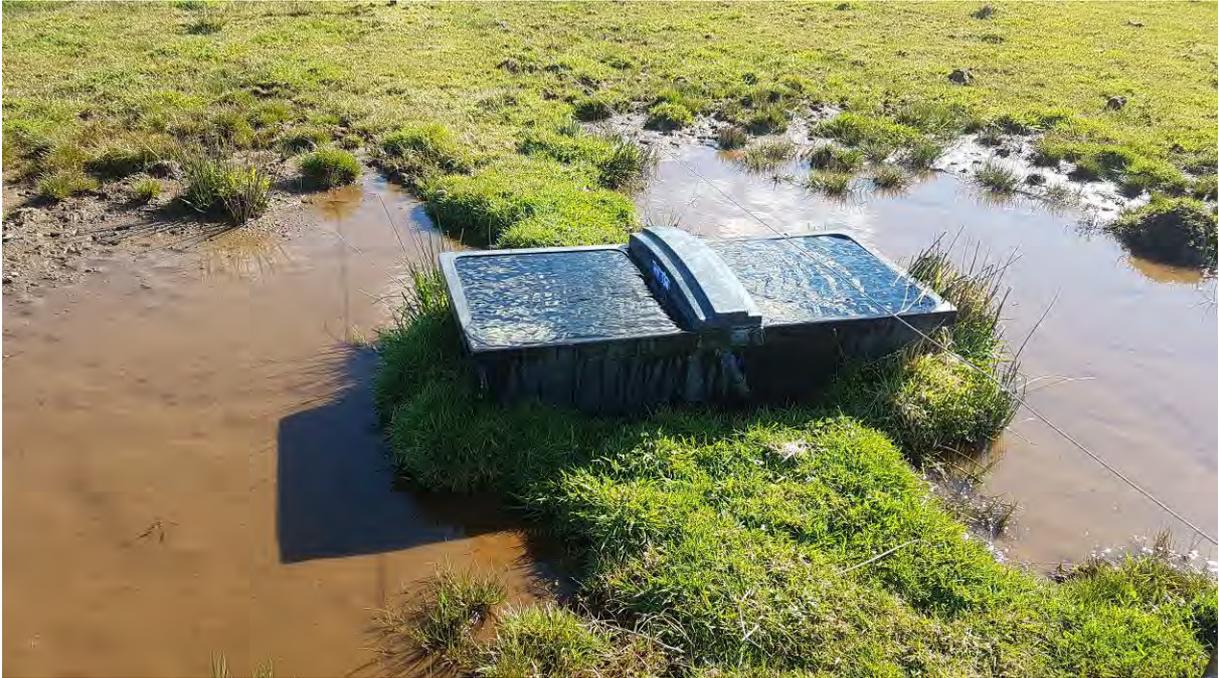
Fencing was intact and permanent. The cap was being grazed by a small number of young stock. Three of the four water troughs on the cap were full, and one was overflowing and causing localised ponding around the trough. The site was unoccupied, and no odour or dust issues were noted.

Photo 2 Overflowing water trough and surrounding ponding at Stratford landfill

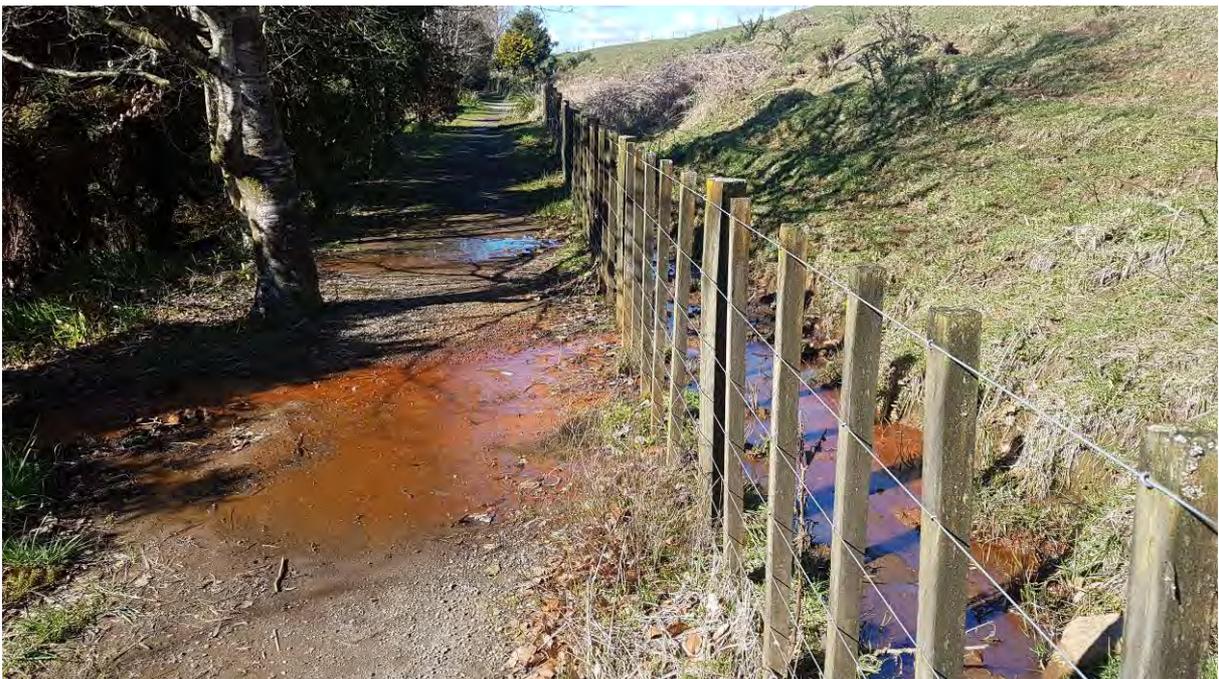
Photo 3 Stormwater/leachate/groundwater overflow from Stratford landfill across public walkway

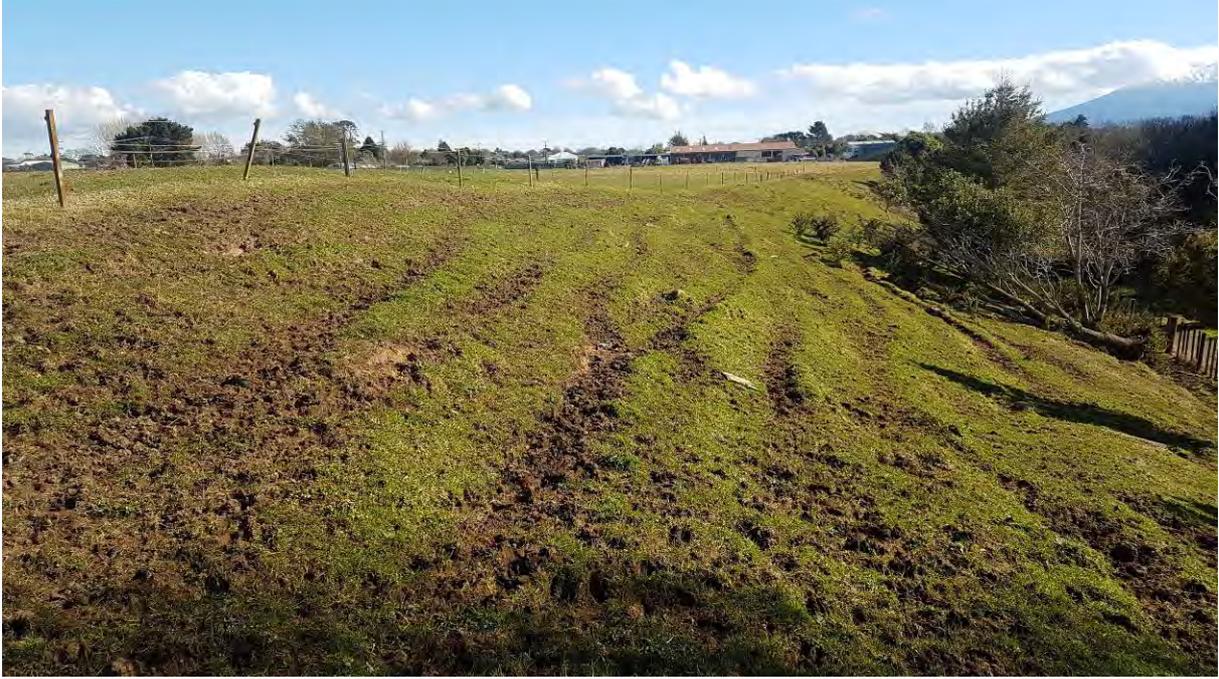
Due to the poor stock management that had resulted in widespread damage to the cap and batter, the overflowing water trough and significant ponding on the western edge of the cap, the consent holder was informed of the non-compliances with conditions 1 (best practicable option) and 3 (adherence to the management plan). This is discussed further in section 2.3.5.

Photo 4 Example of stock damage to the batter at Stratford landfill

The poor stock management and widespread damage to the cap and batters was addressed by requiring the lessee to remove and thereafter exclude all 'heavy' stock from the affected area and restrict the grazing of a defined area to sheep only. The leaky troughs were repaired. Weather permitting, SDC undertook to take the following actions by the end of November 2017:

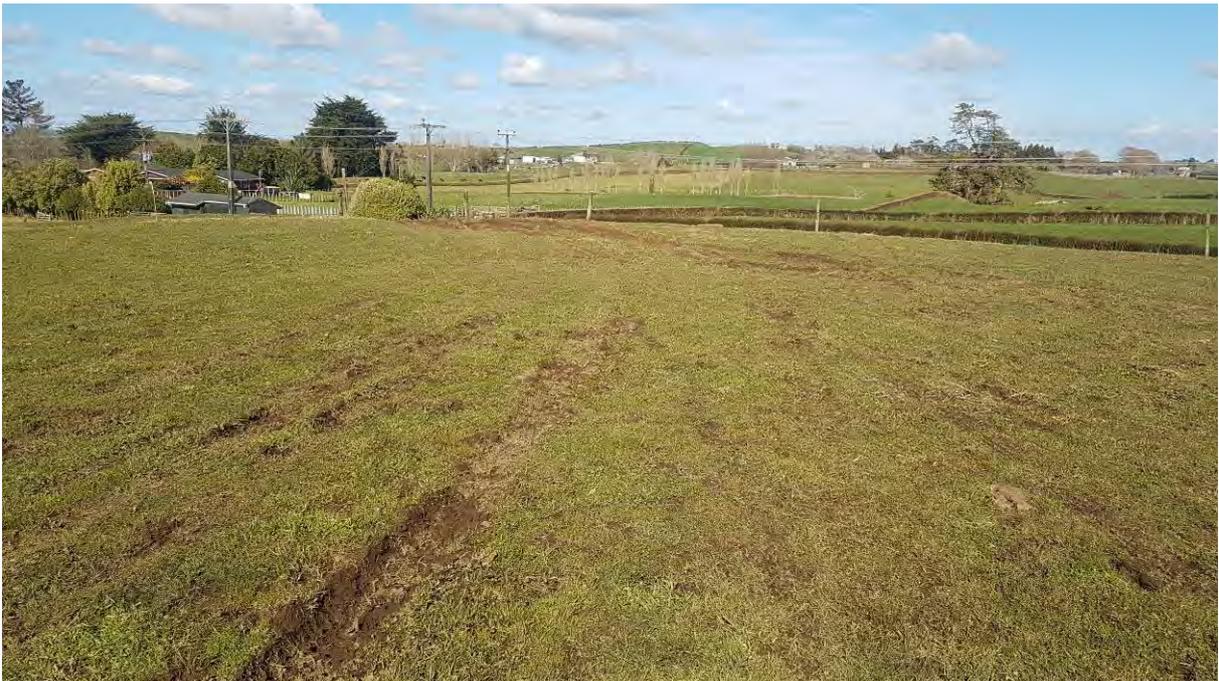
Photo 5 Example of vehicle and stock damage to the cap at Stratford landfill

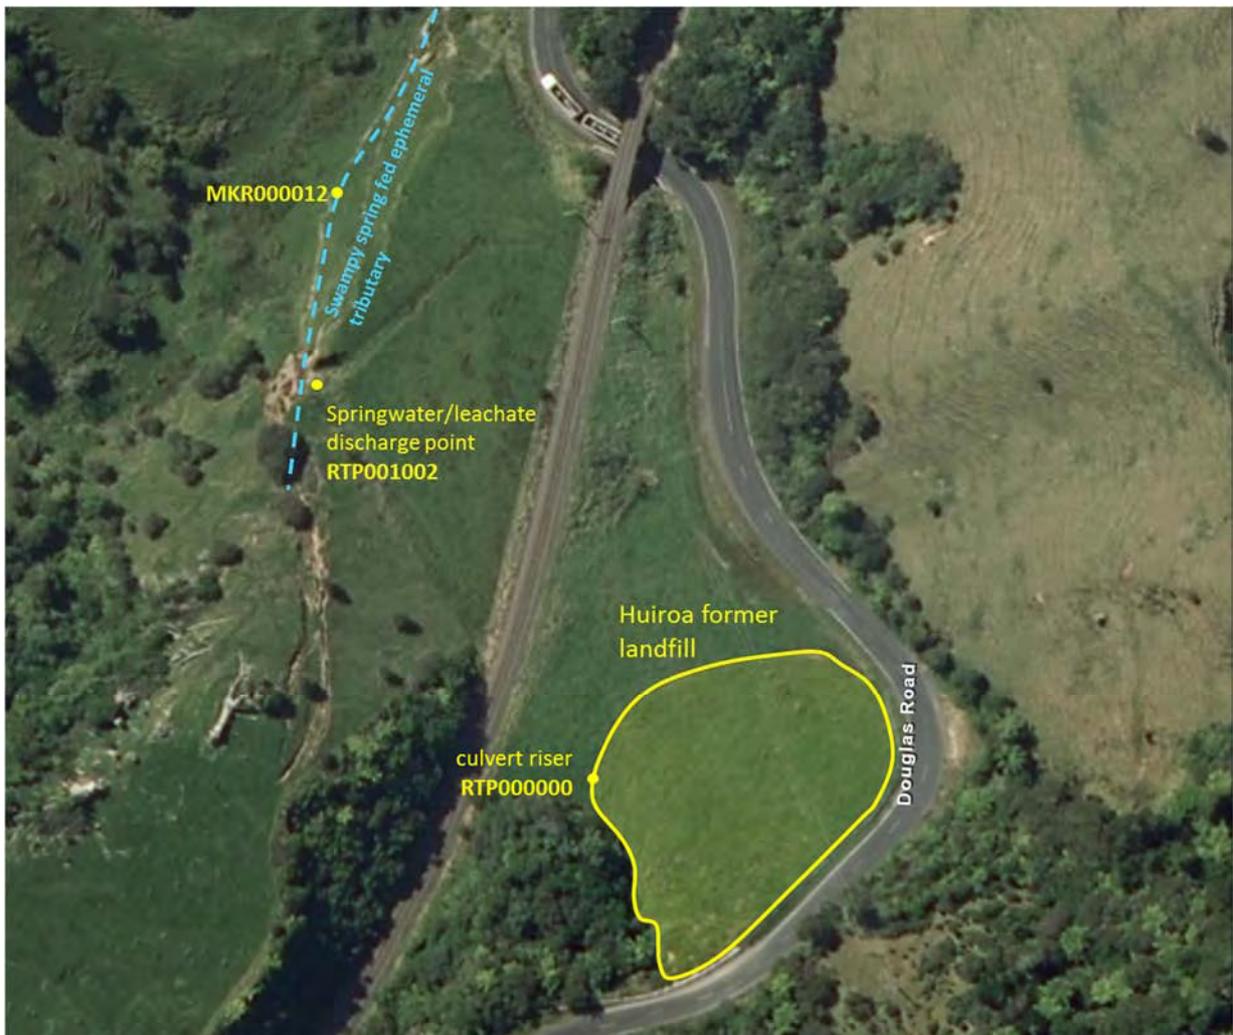
This closed landfill is monitored on a triennial basis, with inspections and sampling carried out as scheduled in 2017-2018. The location of the landfill and monitoring sites are shown in Figure 7.

Figure 7 Huiroa landfill and approximate sampling locations
