South Taranaki District Council
Eltham, Hawera, Kaponga, Manaia, Patea, Opunake
and Otakeho Landfills
Monitoring Programme
Annual Report
2017-2018

Technical Report 2018-30

Taranaki Regional Council
Private Bag 713
STRATFORD
October 2018

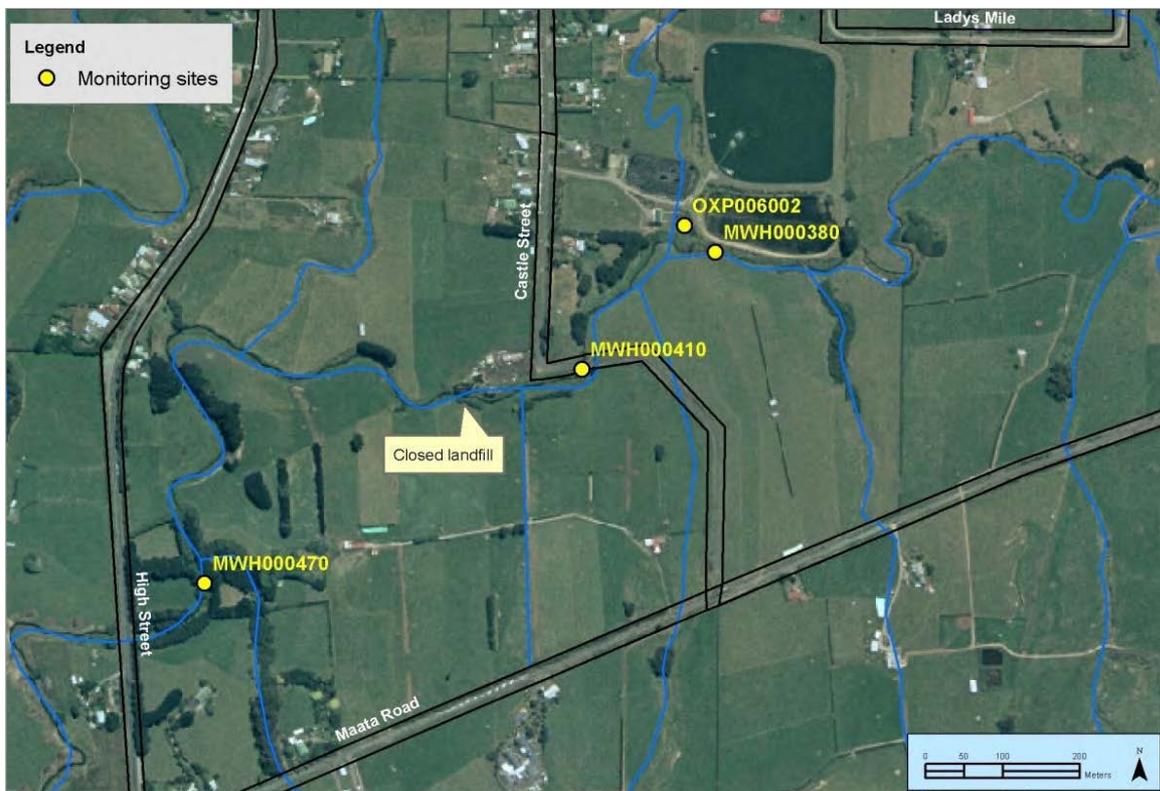
Figure 2 Eltham landfill and sampling sites

This landfill used to service the township of Eltham and surrounding rural areas but was closed in 1992 due to exhaustion of landfill capacity. The 0.71 ha site is located on Castle Street, just downstream of the Eltham oxidation ponds (Figure 2). The area is generally well rehabilitated, with the majority of the area grassed. The landfill is monitored by the Council under the Eltham wastewater treatment plant/Eltham landfill combined monitoring programme.

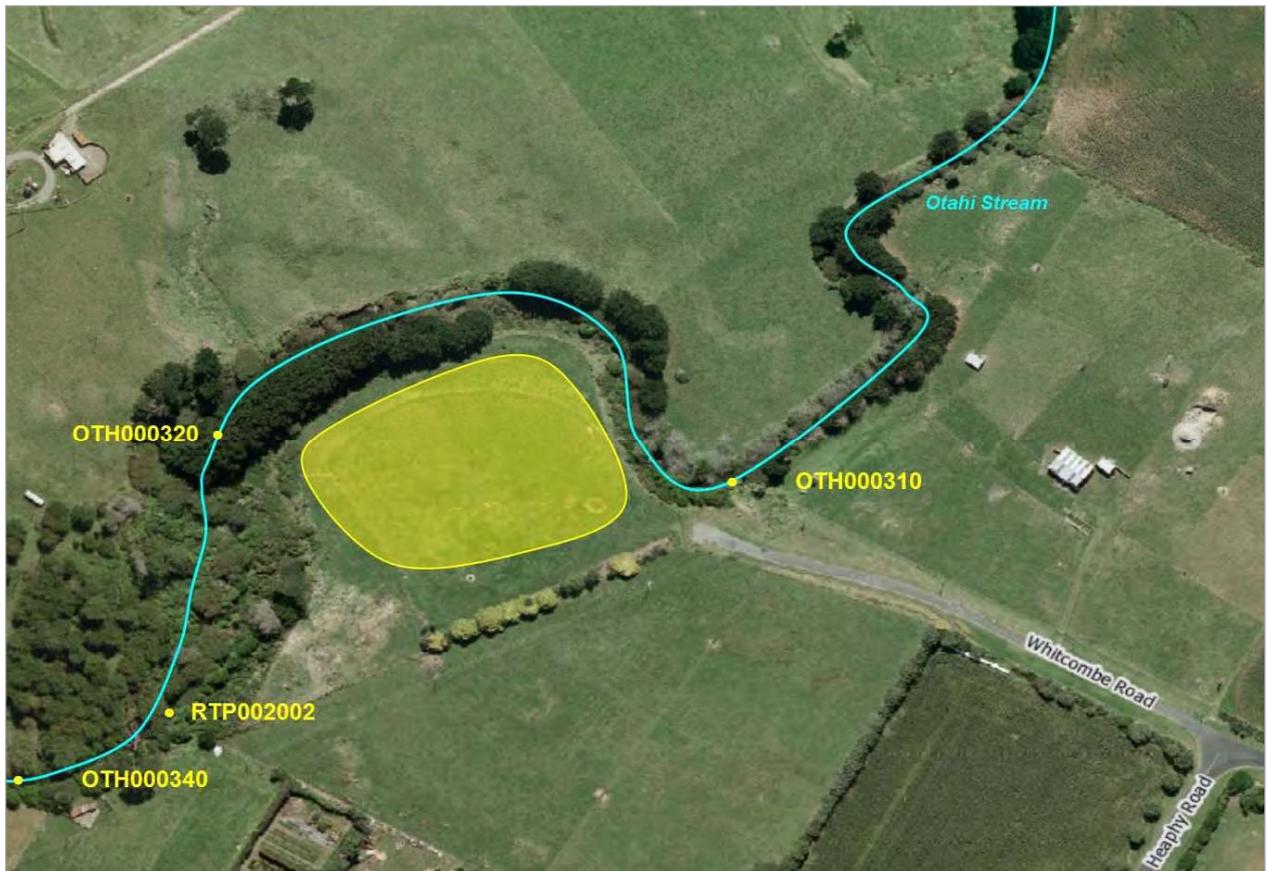
Figure 12 Aerial view of Opunake landfill footprint and sampling sites

The Opunake landfill was operational from 1979, closing in 1999 with the expiry of the 20 year lease of the land. The landfill site is located on Whitcombe Road, and was used to service the township of Opunake and the surrounding rural areas. Waste from Rahotu and Pungarehu was also disposed of at the landfill. The 4.73 ha site was initially operated in an uncontrolled manner for many years with a significant amount of rubbish being burnt. In 1990 a ban on fires was imposed and the site began to operate under restricted hours. In 1999 STDC submitted a landfill closure plan and had the site reinstated.

Samples were collected from the leachate drain, and the Otahi Stream at sites above, below and adjacent to the landfill on 30 August 2017 (Figure 12). The results are presented in Table 13.

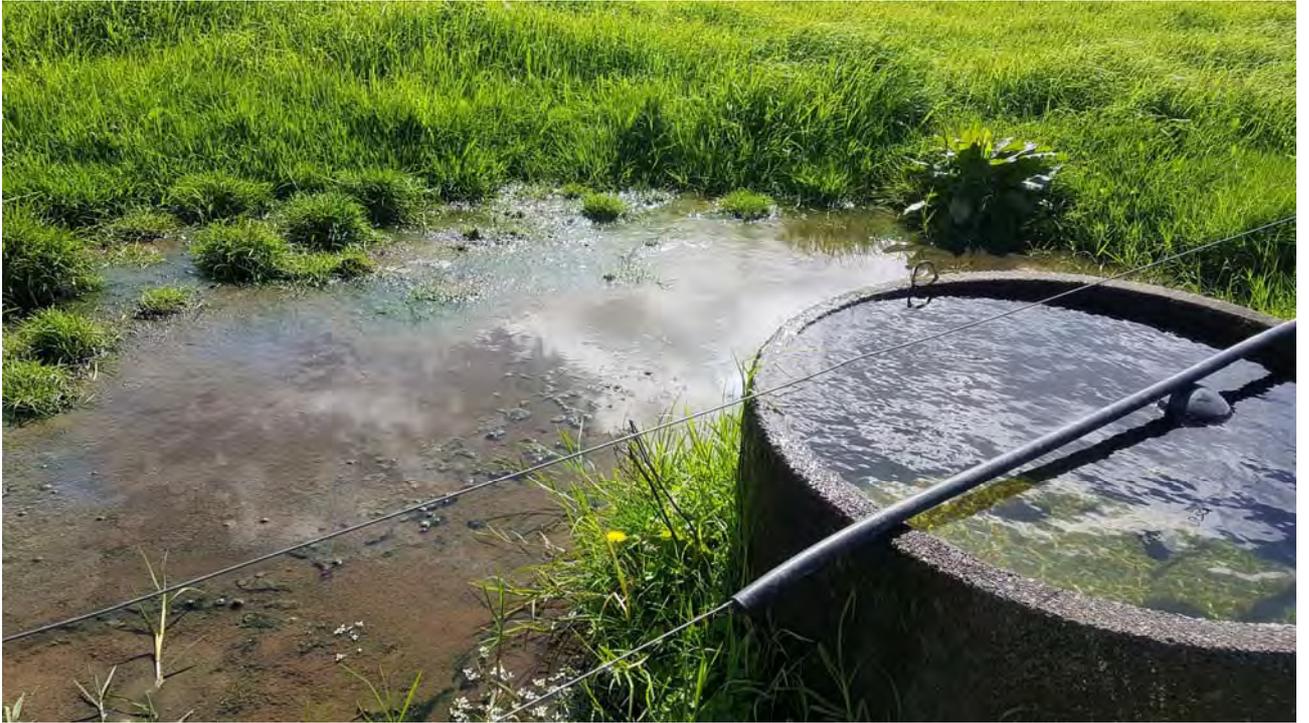
Photo 1 North water trough overflowing, Opunake landfill

This was determined to be a non-compliance under condition 5 of consent 0526-3. The discharge of contaminant, namely leachate from a closed landfill, onto or into land in circumstances that may have resulted in that contaminant entering water, namely the Otahi Stream, when the discharge was not expressly allowed by a rule in a resource consent.

STDC were contacted and advised of the contravention. They undertook repairs and the subsequent re-inspection on 3 May 2018 found that repairs had been undertaken and the consent was being complied with.

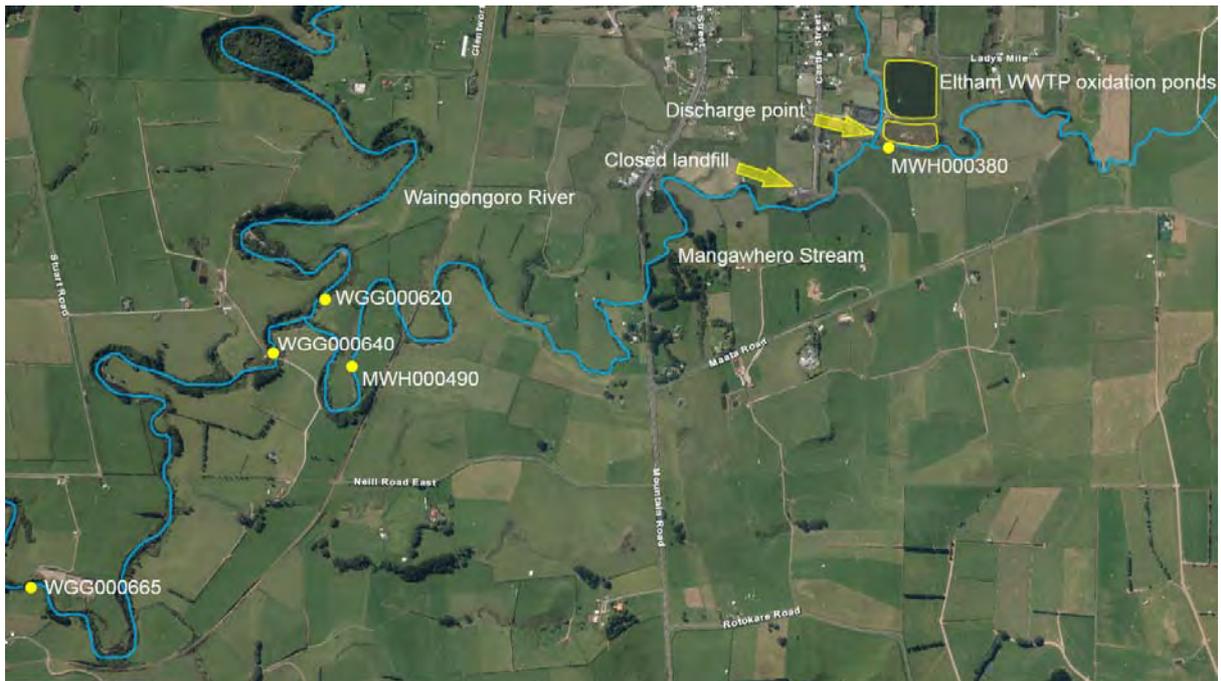
Figure 1 Aerial location map of biomonitoring site locations in the Mangawhero Stream and Waingongoro River in relation to Eltham WWTP and landfill

The standard 400 ml 'kick sampling' technique was used for site 1 and site 5 in the Mangawhero Stream and site 8 in the Waingongoro River (illustrated in Figure 1) on 6 November 2017.

Site No	Site code	Grid reference	Location
1	MWH000380	E1712475 N5633431	Mangawhero Stream: upstream of wastewater treatment plant's discharge
5	MWH000490	E1710795 N5632738	Mangawhero Stream: approximately 200 m downstream of rail bridge
8	WGG000665	E1709784 N5632049	Waingongoro River: approx 2 km downstream of Mangawhero S. confluence (off Stuart Road)

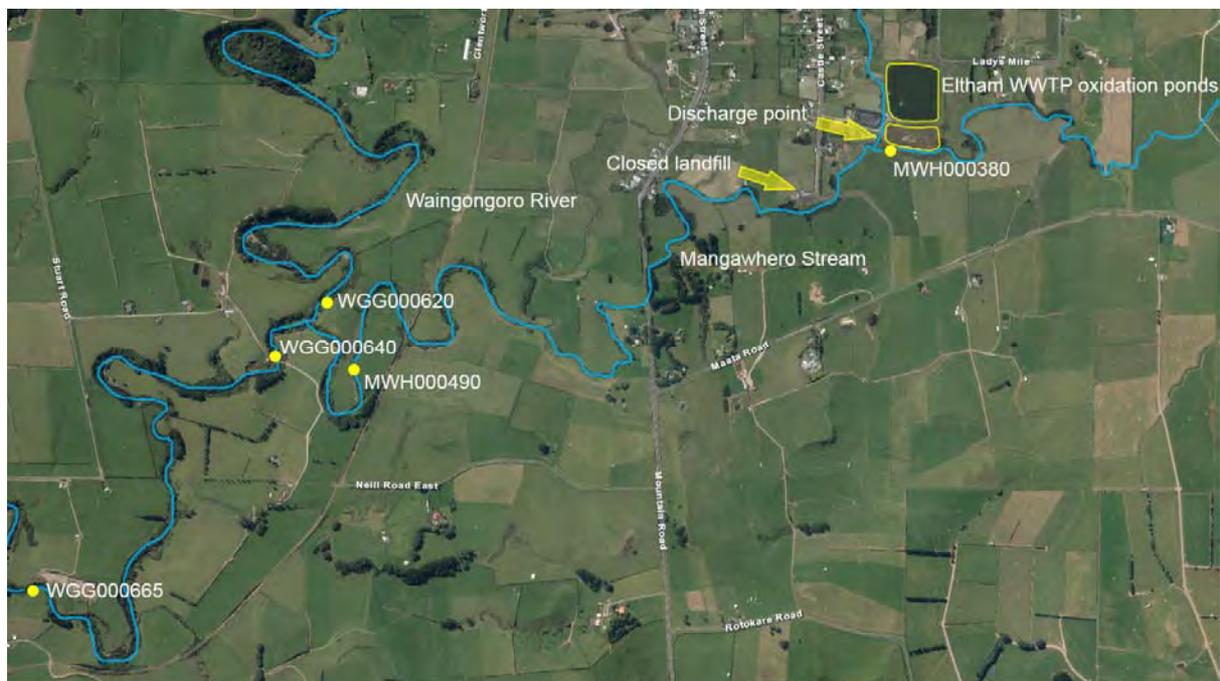
Figure 1 Aerial location map of biomonitoring site locations in the Mangawhero Stream and Waingongoro River in relation to Eltham WWTP and landfill

Site No	Site code	Grid reference	Location
1	MWH000380	E1712475 N5633431	Mangawhero Stream: upstream of wastewater treatment plant discharge
5	MWH000490	E1710795 N5632738	Mangawhero Stream: approximately 200 m downstream of rail bridge
6	WGG000620	E1710708 N5632961	Waingongoro River: approx 150 m upstream of Mangawhero S. confluence
7	WGG000640	E1710554 N5632790	Waingongoro River: approx 200 m downstream of Mangawhero S. confluence
8	WGG000665	E1709784 N5632049	Waingongoro River: approx 2 km downstream of Mangawhero S. confluence (off Stuart Road)
