Waverley Sawmills Ltd  
Monitoring Programme  
Annual Report  
2017-2018

Technical Report 2018-81

Taranaki Regional Council  
Private Bag 713  
STRATFORD  
March 2019

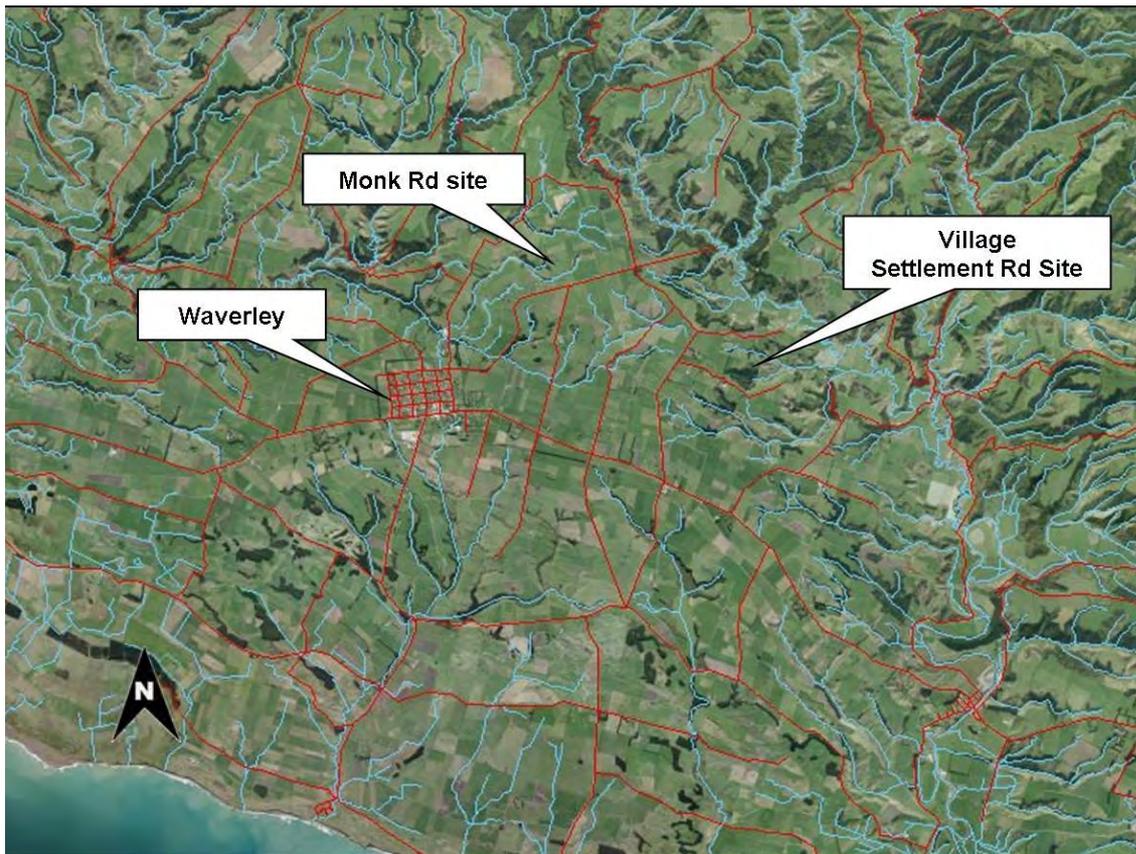
Figure 1 Waverley Sawmills Ltd discharge sites

The discharge site on Village Settlement Road was chosen because it is elevated and therefore dry. The site is small in size compared to the Monk Road site and while it is situated close to an unnamed tributary at the north west end of the site, the surface gradient and contours ensure that surface water from the site flows in a south easterly direction, away from the water body. The Company is now at the point that it produces no treated wood waste as all machining is done prior to treatment. As a result, the Company's Village

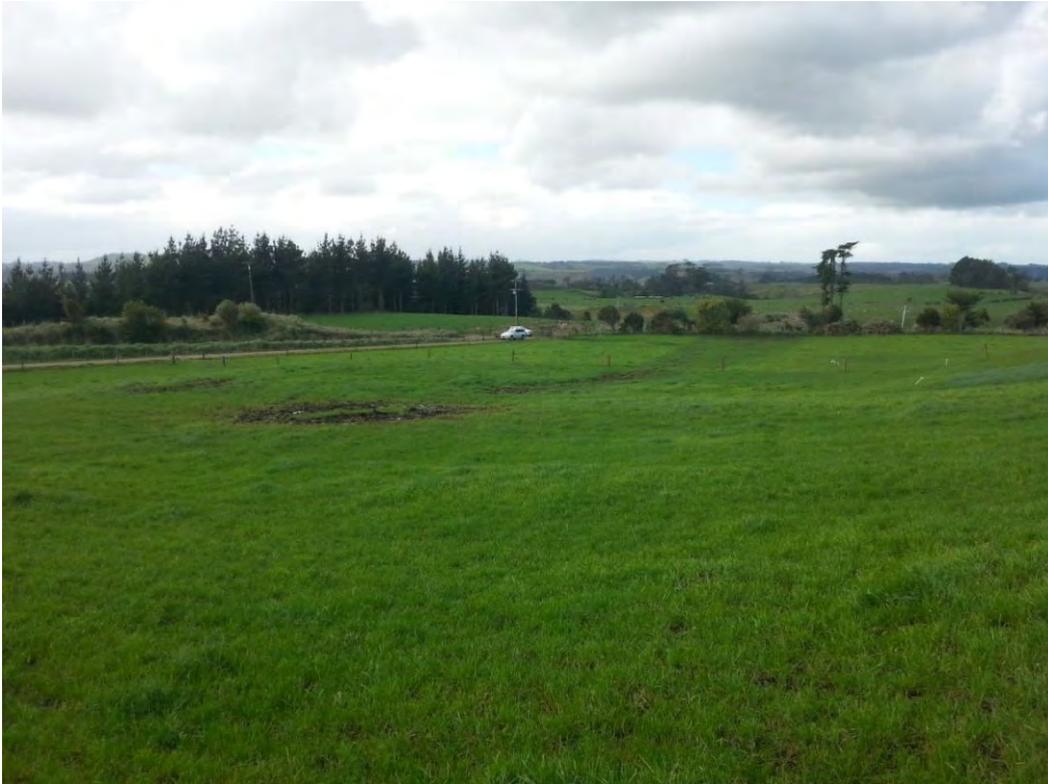
Settlement Road site was closed in June 2014. Site remediation work was undertaken in the 2013-2014 year to ensure that the consent soil component concentrations for the cap and surface soils down gradient of the fill area were met. This was discussed in the 2013-2014 Annual Report.

Photo 1 Waverley Sawmills Ltd discharge site at Village Settlement Road, Waverley – post closure

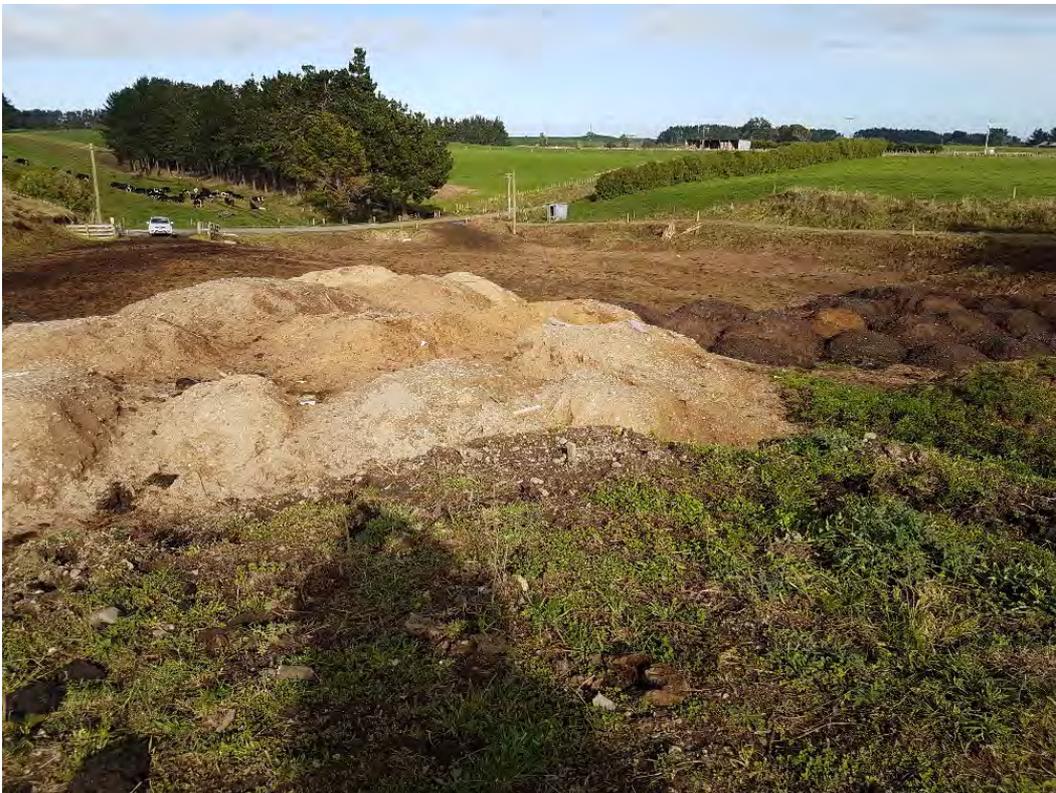
Photo 2 Waverley Sawmills Ltd discharge site at Monk Road, Waverley

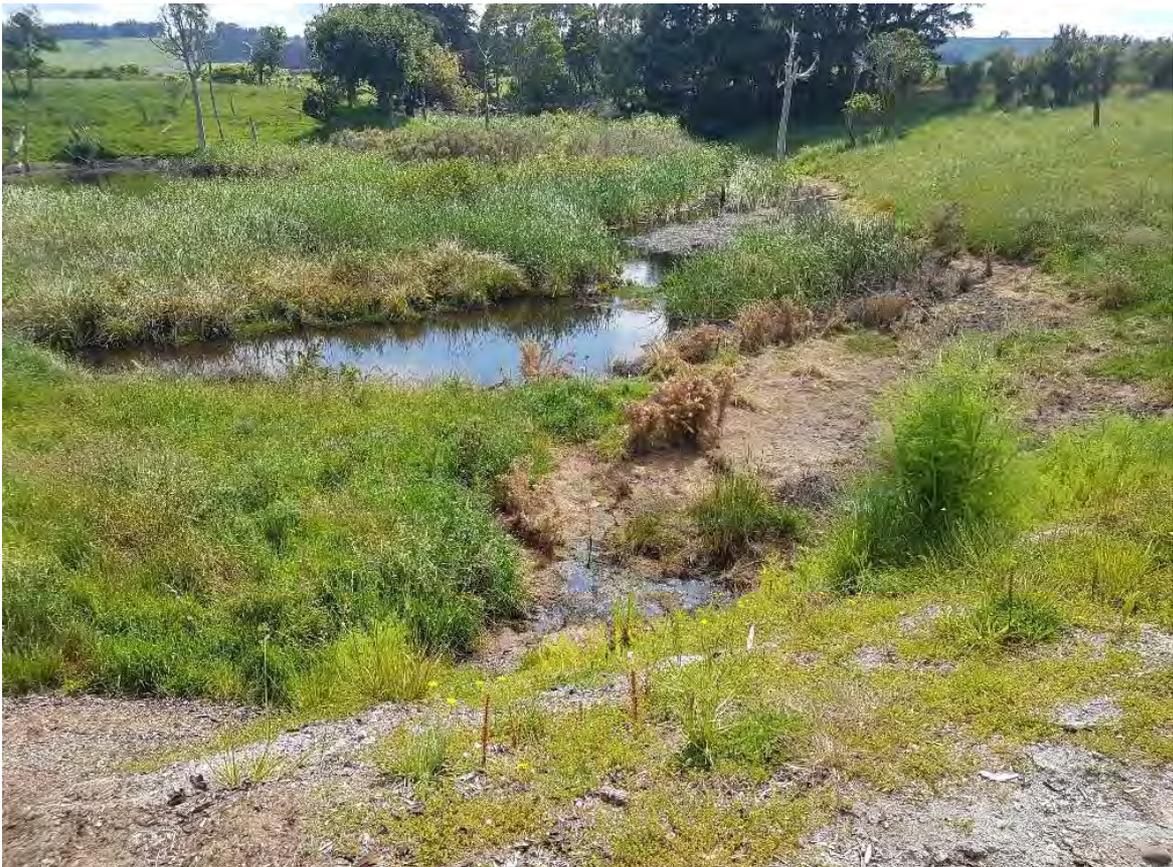
At the time of inspection the upstream tributary was discharging via the weir. The downstream leachate flow was found to be slightly turbid, slightly brackish brown in colour with a slight organic type odour. The tributary bypass discharge was light brown in colour with no distinguishable odour. In light of the high biochemical oxygen demand found in the sample collected at KOI000130 at the previous inspection (18 May 2017), the Kohi Stream was checked approximately 200 m downstream that sampling site. No heterotopic growths (sewerage fungus) were noted on the stream bed. No water quality samples were collected at this location on this occasion as the stream appeared to be flowing relatively clear. The Company was informed that a further investigation may be warranted in the future. At the fill site it was found that there had been no recent deliveries of sawdust to the site. The sawdust area appeared to be free of treated sawdust and other unauthorised materials. The most northern area of the site had been partially capped, with some vegetation establishing. This was noted to be mainly weed growth. The inspecting officer contacted one of the Company Directors regarding leachate seepage from the sawdust pile along the northern face (Photo 3 and Photo 4).

Photo 3 Leachate seepage from the northern side of the wood waste disposal area, 28 November 2017

The inspecting officer was informed that this was a direct result of a blockage in the pipe causing the water in the tributary on the upstream side of the fill to back up (approximately 0.5 m above the level of the weir). It was stated that the high water level covered the toe of the sawdust pile and when the water receded, leachate seeped from the sawdust but did not enter the stream. The blockage was found approximately

80 m upstream of the manhole and it took 10 days to complete repairs. The Company was asked to provide the programme manager with the explanation and findings in relation to this occurrence, and the matter was recorded as a non-compliance on the incident register, which is discussed further in section 2.3.

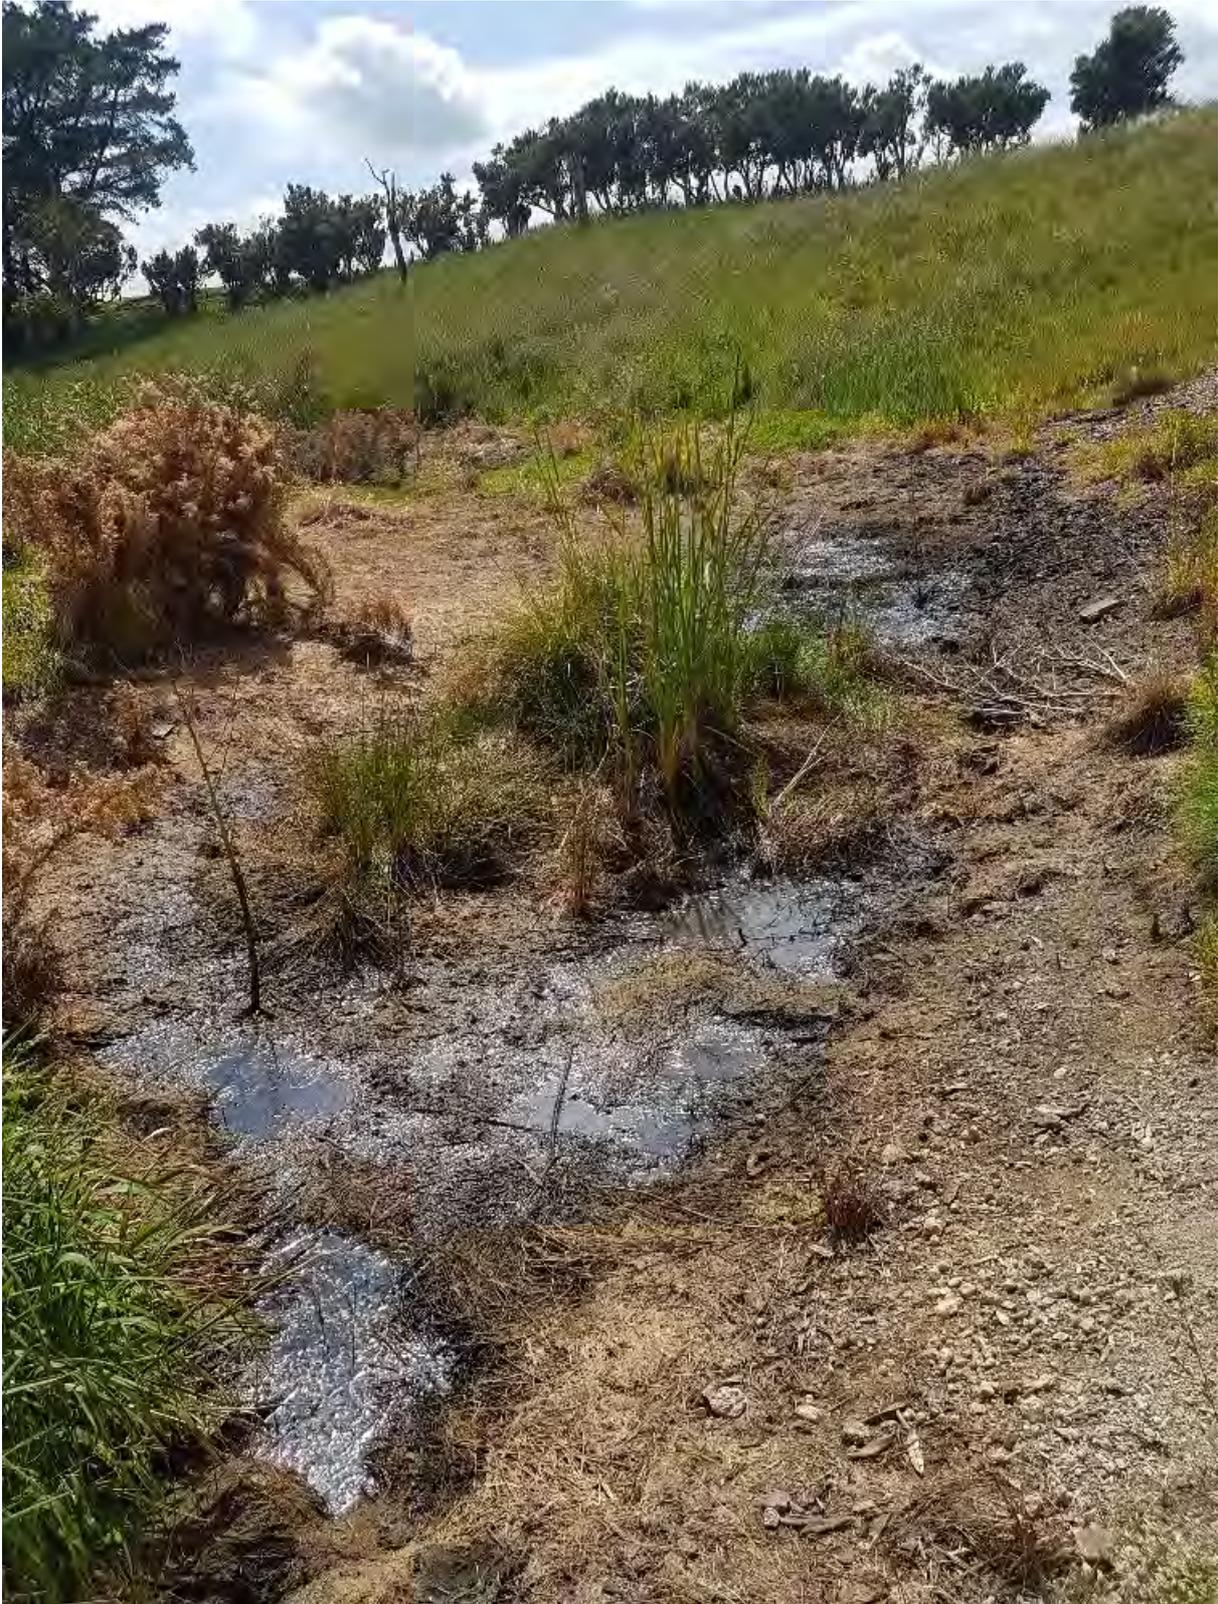
Photo 4 Ponded leachate seepage from the northern side of the wood waste disposal area, 28 November 2017

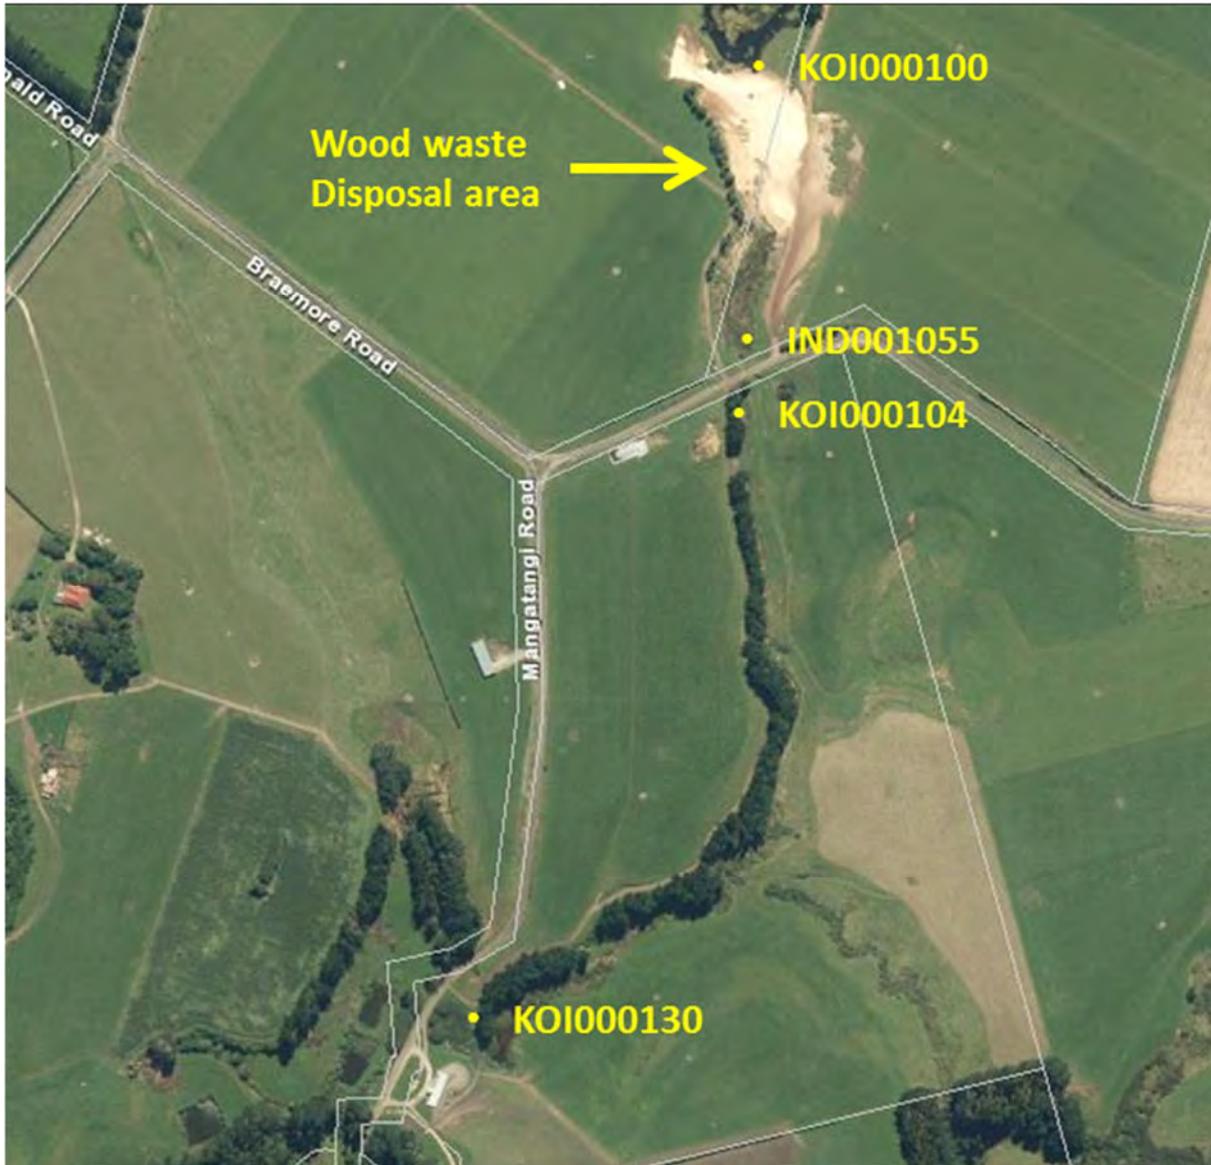
IND001055 was previously located in an open drain below the fill site, which is fed by a spring that originates (and is culverted) under the fill. At the inspection on 20 September 2017, it was found that the remainder of the drain had been piped, with a manhole installed downstream of the remaining area to be filled. Three samples of the discharge were collected during the monitoring period, two of which were obtained from the pipe outlet within the manhole, and one of which was obtained from the Monk Road culvert outlet. The results of this sampling are presented in Table 2.

Figure 2 Monk Road sampling sites, Waverley

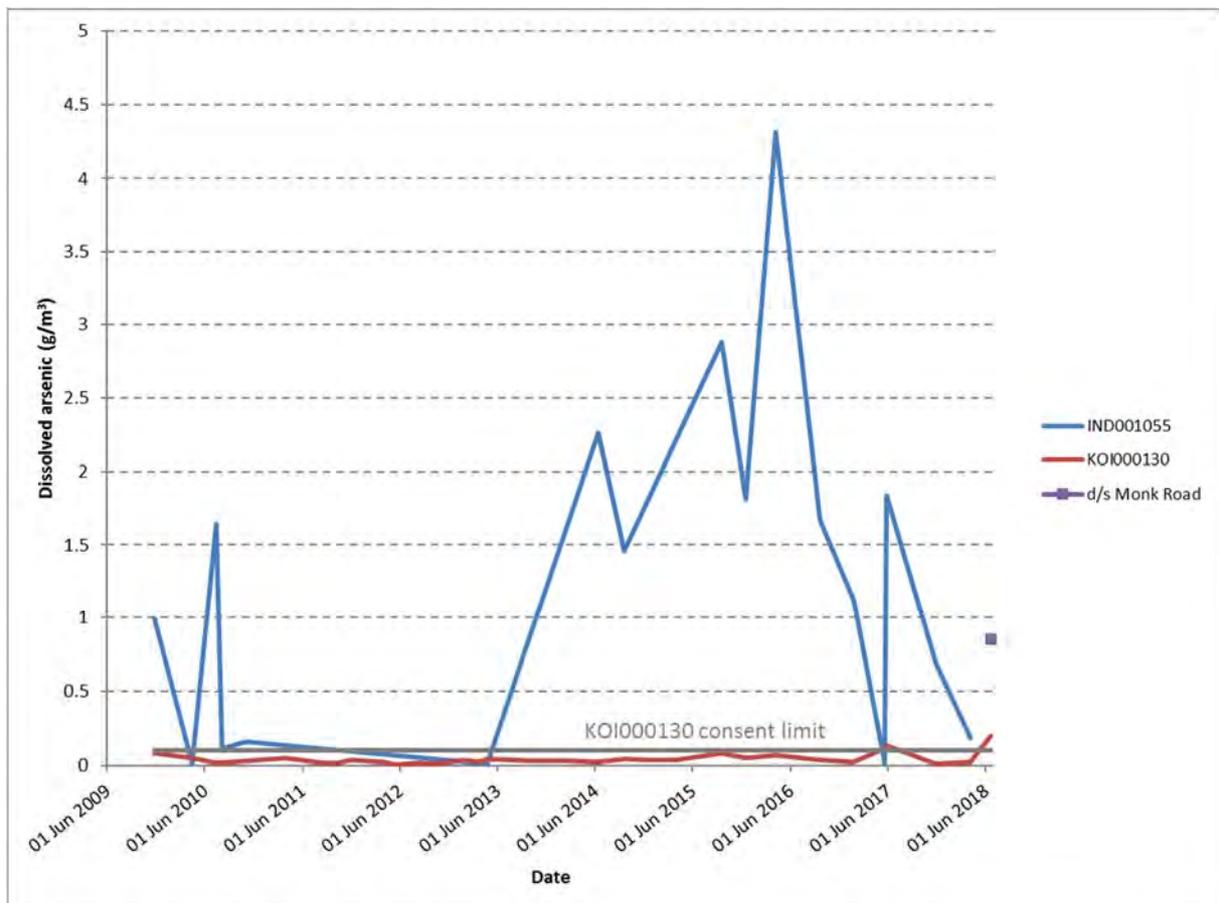
During the period under review it was found that the spring water at the source (site IND001055) continued to show higher than usual levels of dissolved arsenic and BODCF when compared to 2008 to 2013, whereas the chromium and copper levels appear to have returned to the earlier levels, as shown in Figure 3, Figure 4, Figure 5, and Figure 6.

Figure 3 Graph showing trends in dissolved arsenic at site IND001055 and KOI000130

Since the massive spike in contaminant loads in 2007 was noted in the leachate/spring water discharge, the levels of contaminants in this spring water had reduced and remain relatively consistent. This trend came to an end in the 2013-2014 year, when levels of BOD, copper, chrome and arsenic all increased. Since then, and during the period under review the BOD and arsenic have remained elevated to varying degrees, although the copper and chromium concentrations appeared to return to the former levels during the year under review. These changes indicate that the nature of the discharge has changed and should continue to be monitored.

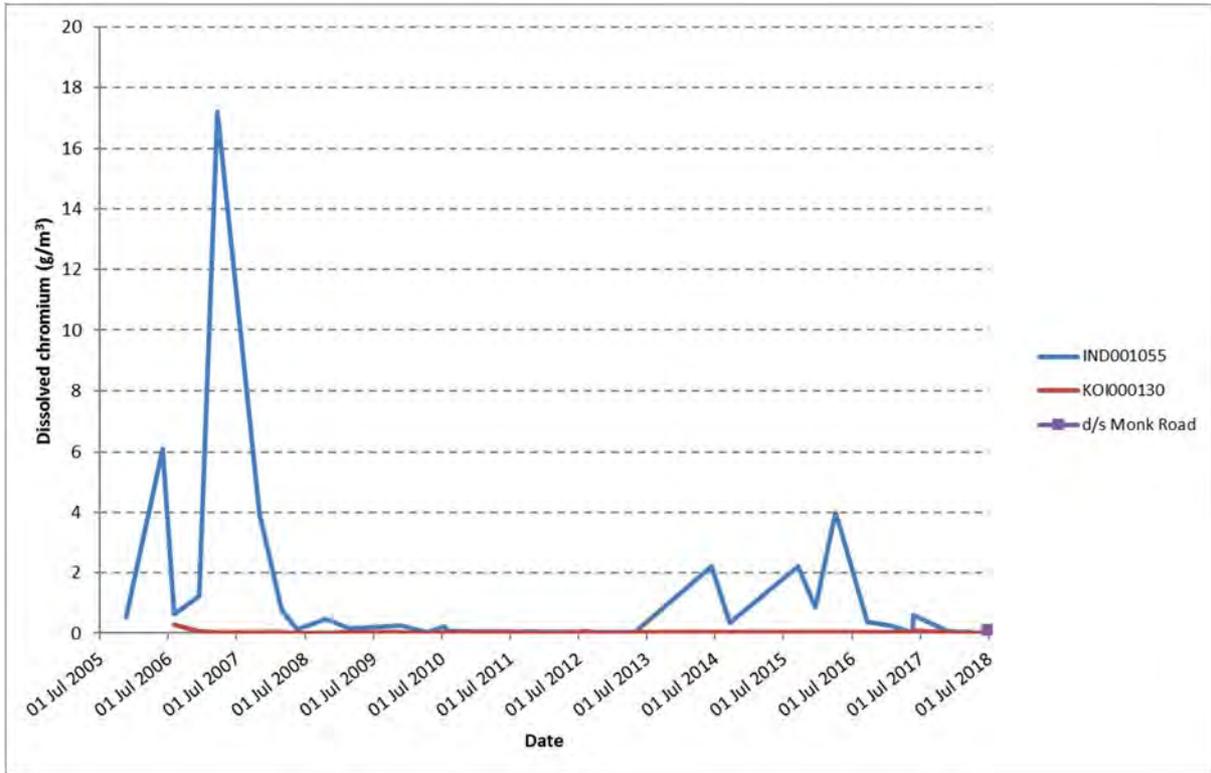
Figure 4 Graph showing trends in dissolved chromium at site IND001055

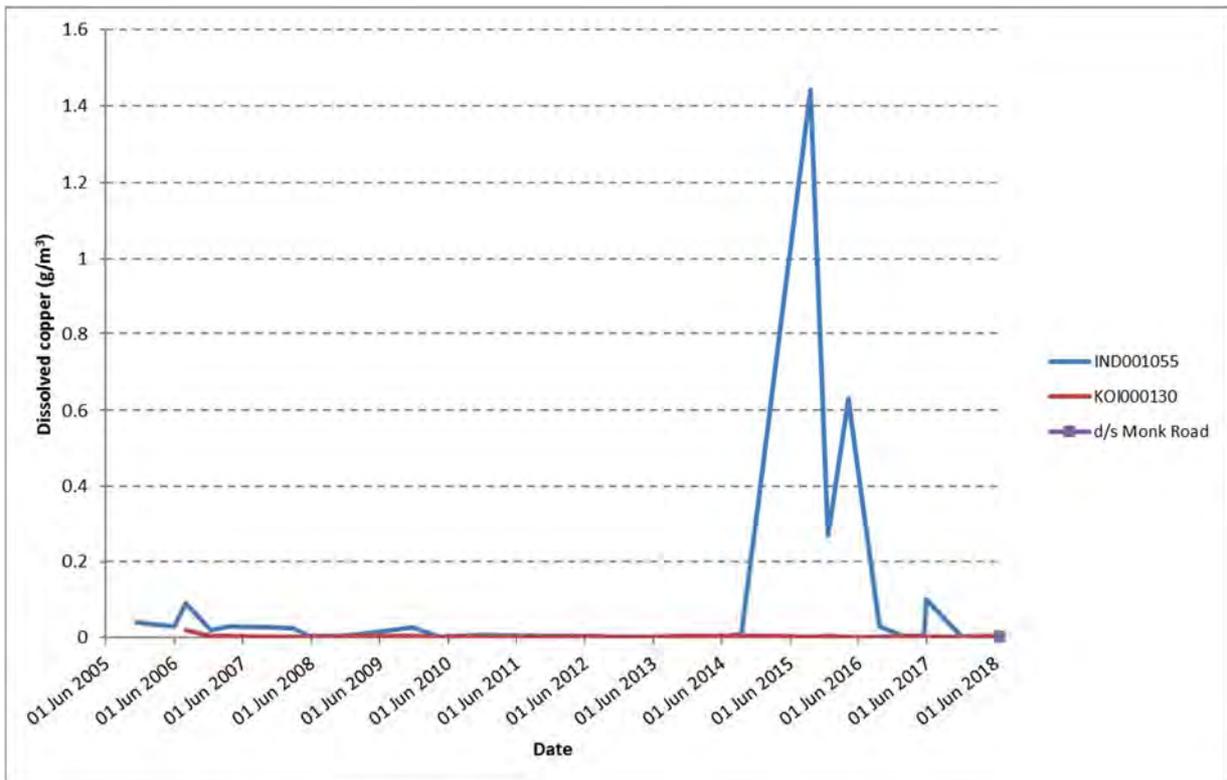
Figure 5 Graph showing trends in dissolved copper at site IND001055

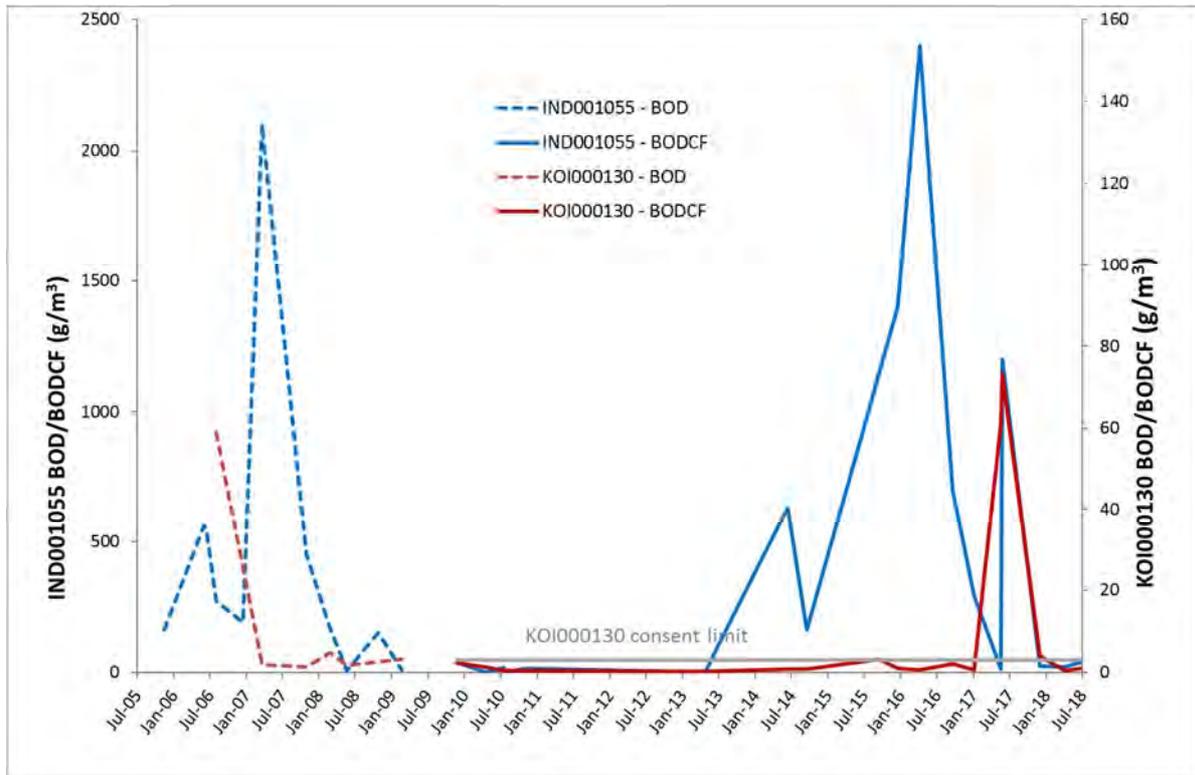
Figure 6 Graph showing trends in BOD at site IND001055 and KOI000130

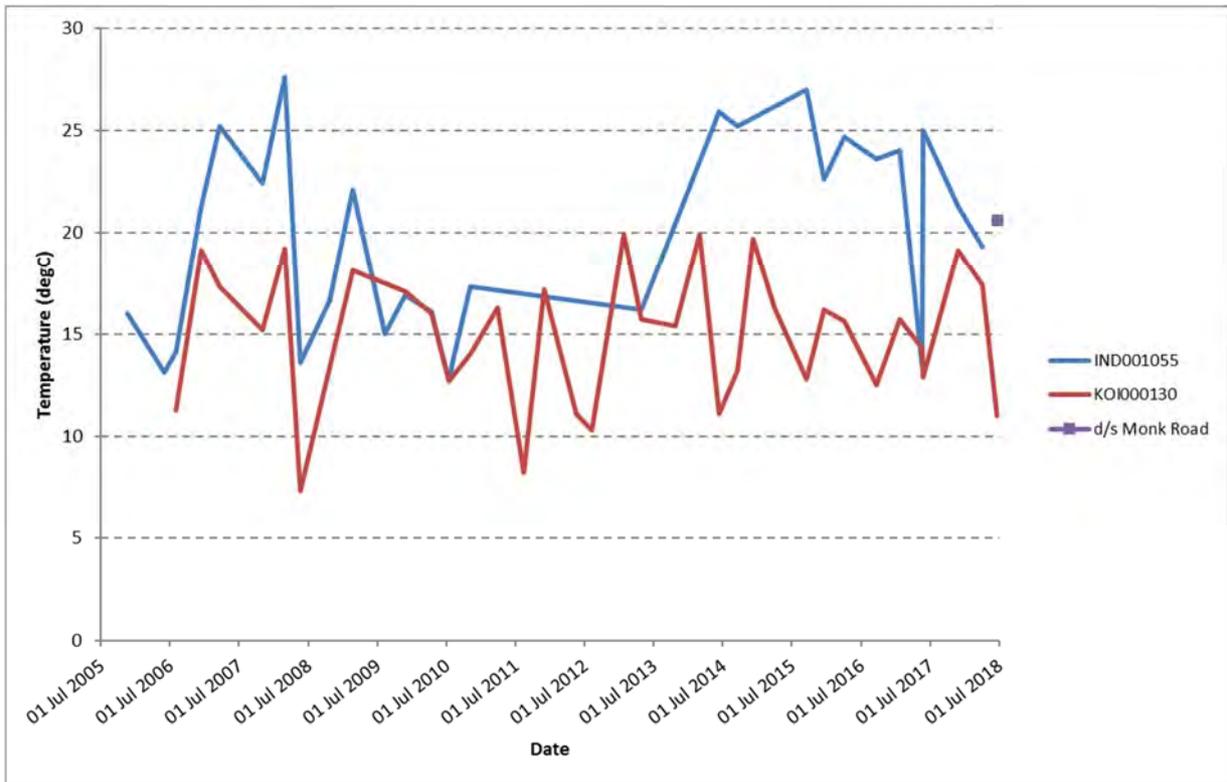
It is also noted that the pH of the discharge from the wood waste disposal area has decreased, resulting in the discharge/spring water sampled at IND001055 becoming more acidic. The combination of the elevated temperature at this site (Figure 7) and its more acidic pH is likely to be the cause of the mobilisation of metals from treated timber wood waste that was thought to have been disposed of at the site under previous management. This was prior to consent being sought by the current consent holder. The apparent pH dependence is shown in Figure 8 and Figure 9, but is noted that the effect observed at the downstream site will also depend on the relative flow rates of the tributary and the leachate/spring water at the time that the grab samples were collected.

Figure 7 Graph showing the temperatures at site IND001055

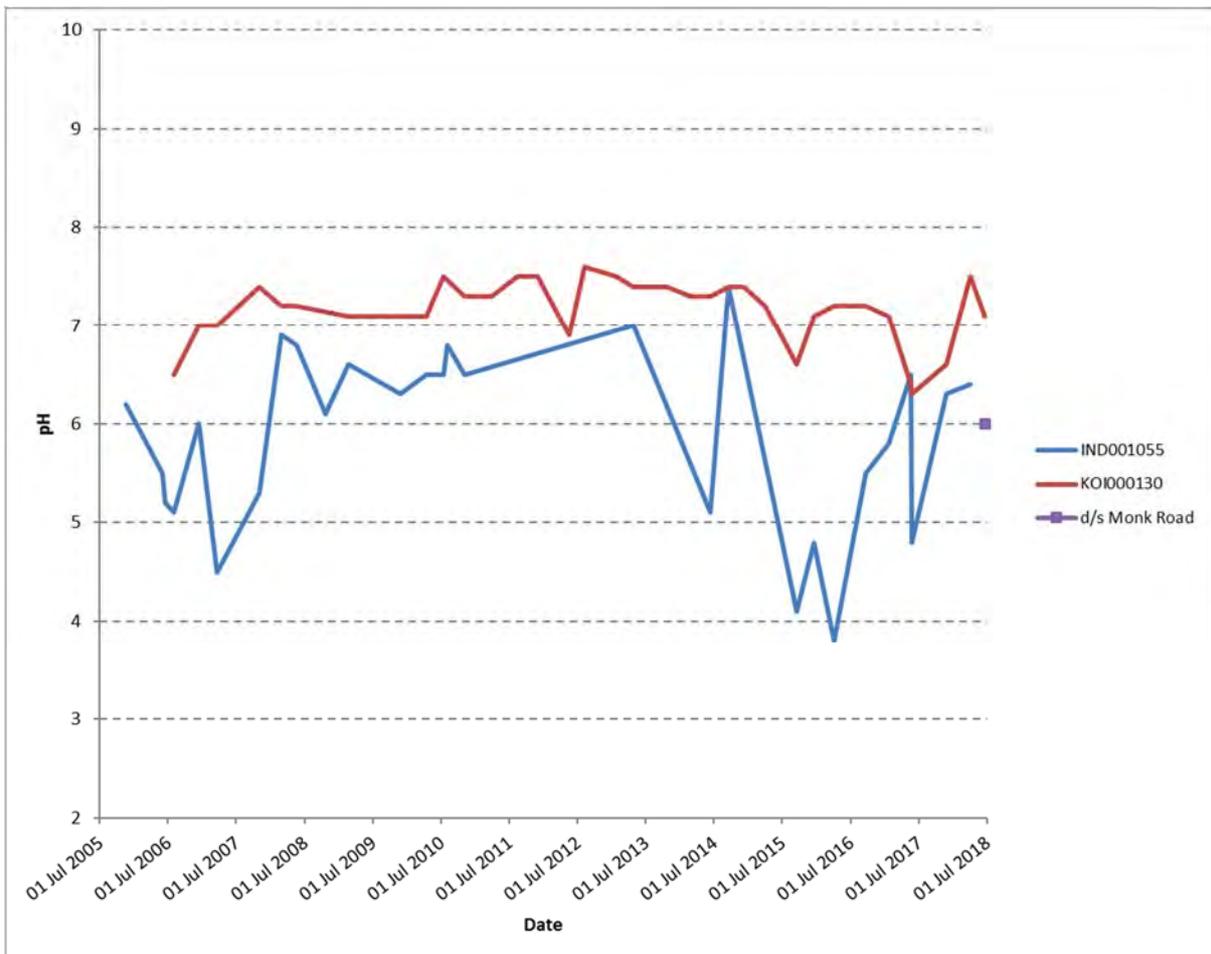
Figure 8 Graph showing pH and arsenic of the discharge at site IND001055

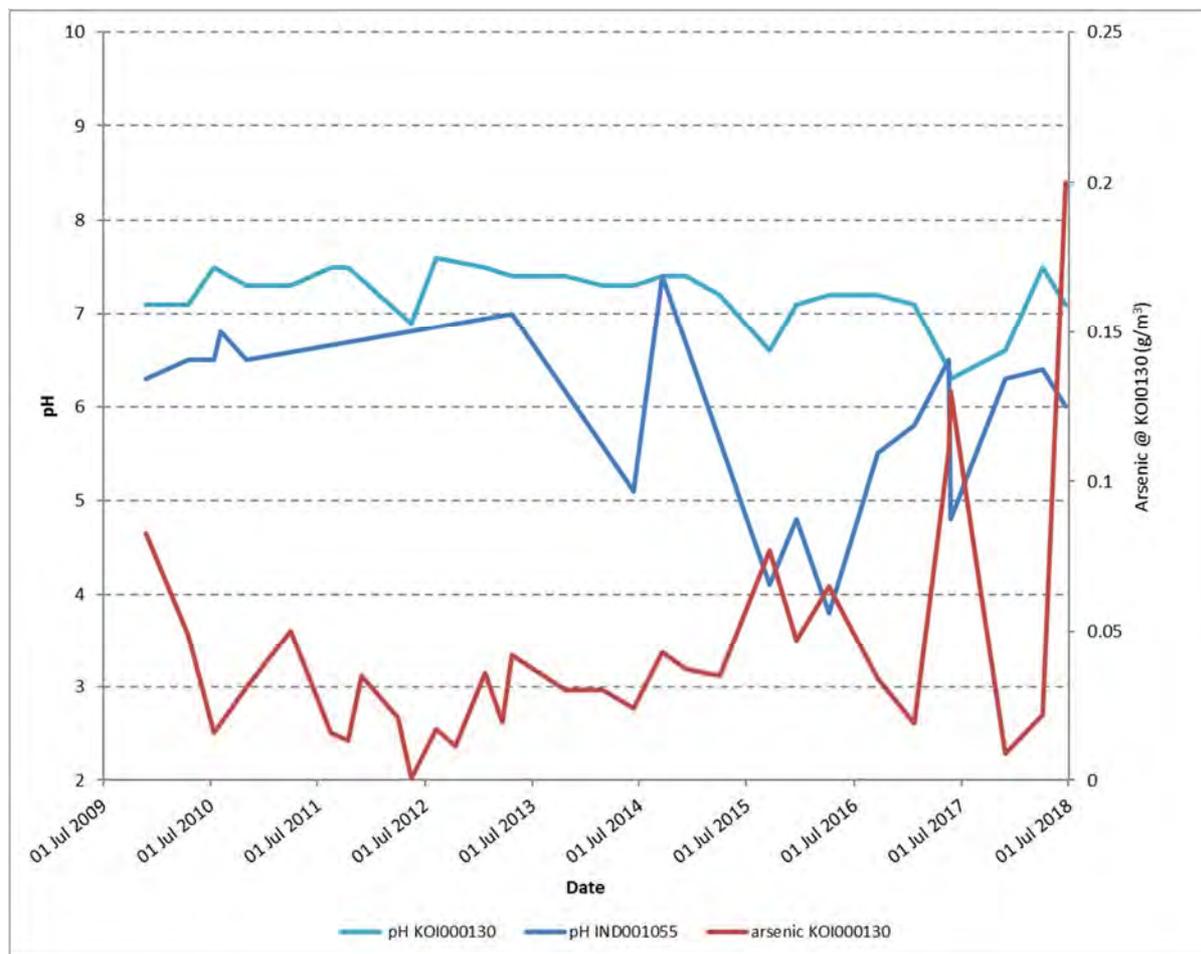
Figure 9 Graph showing pH at sites IND001055 and KOI000130 and arsenic of the receiving water site KOI000130

Notwithstanding the increases in contaminant loads within the discharge, after mixing with the unnamed tributary downstream of the sampling site and passage through the wetland, the discharge at the compliance point (site KOI000130), was generally within the specified limits given in the consent conditions. The exceptions to this were a minor exceedance of BODCF on 28 November 2017 and of the dissolved arsenic in the sample collected on 21 June 2018.

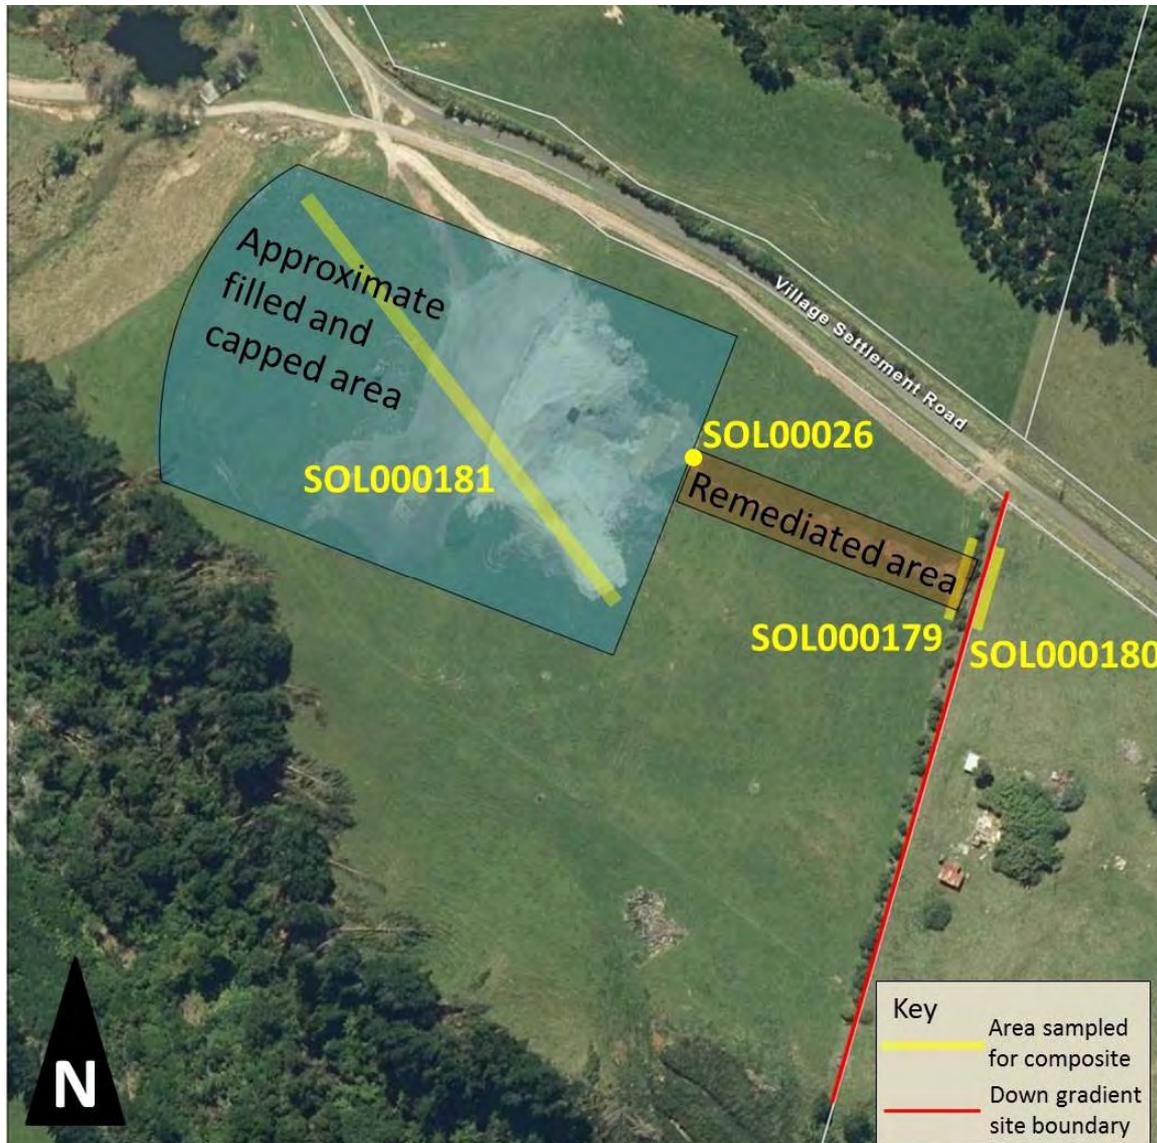
Soil samples were taken from the capped areas, on virgin ground down-gradient of the landfill footprint and from the neighbouring property. The sampling sites are shown in Figure 10 and the results of the soil analysis are given in the following tables.

Figure 10 Aerial view of the discharge site and sampling sites at Waverley Sawmills Ltd's Village Settlement Road site
