Stratford District Council Landfills  
Monitoring Programme  
Annual Report  
2018-2019

Technical Report 2019-22

Taranaki Regional Council  
Private Bag 713  
STRATFORD  
November 2019

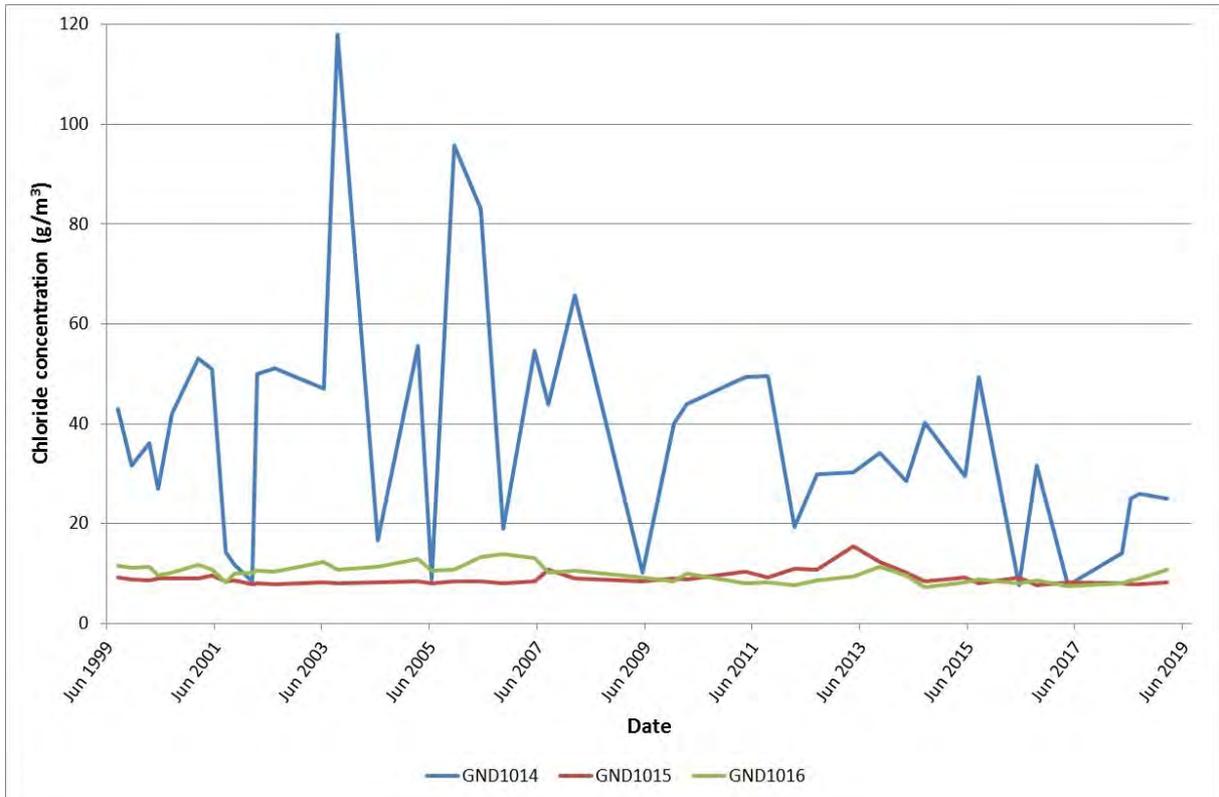
Figure 3 Graph showing chloride levels in the groundwater at the Stratford landfill

As with the results from previous samples taken from these monitoring bores, the groundwater down gradient of the landfill (as represented by bore GND1014), shows some evidence of contamination from the landfill. The graphs of historical data given in Figures 3, 4 and 5 show how bore GND1014 is affected by landfill indicator species; ammoniacal nitrogen, chloride, and zinc. The graphs also show how the levels of chloride and ammonia are apt to fluctuate against the more stable background levels found in the two bores mid and up gradient from the filled area (more so in the case of chloride and ammoniacal nitrogen).

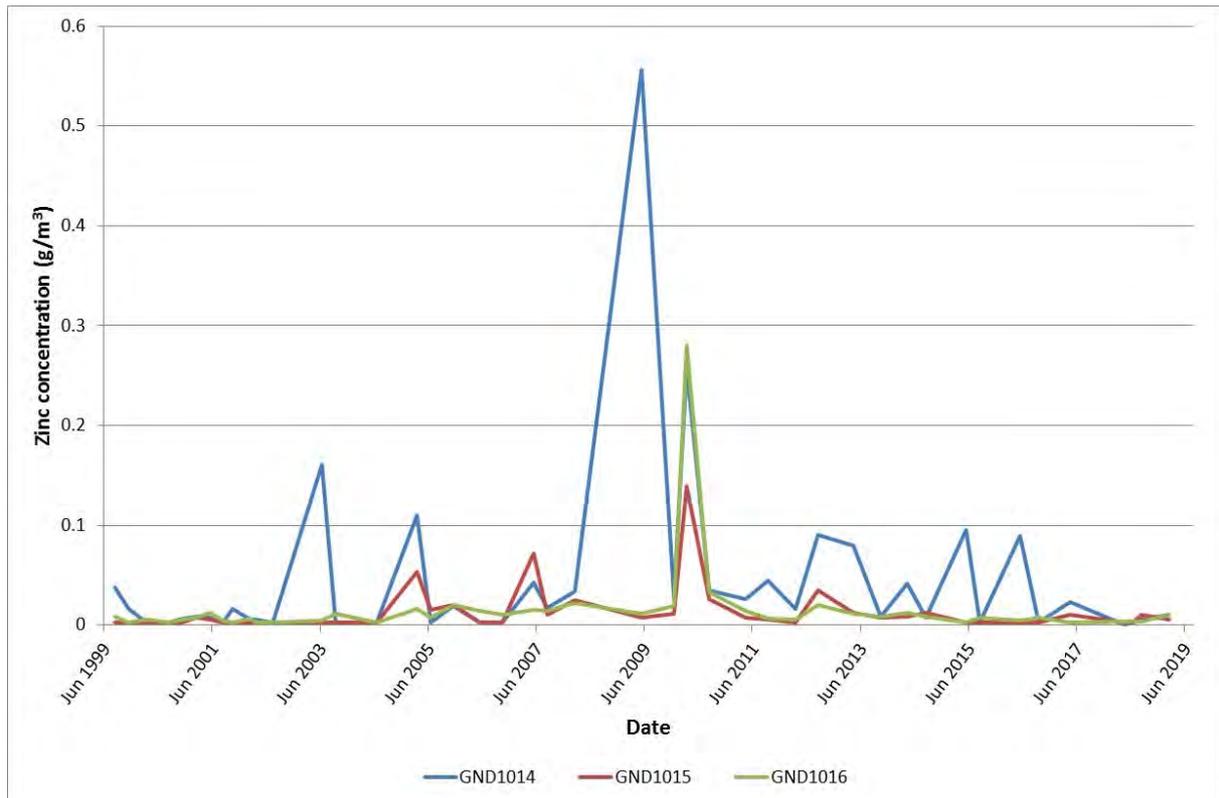
Figure 5 Graph showing dissolved zinc levels in the groundwater at the Stratford landfill

Zinc is found to be higher in the down gradient bore but is also seen to fluctuate in the up gradient bores as well, which may indicate other local effects in the groundwater.

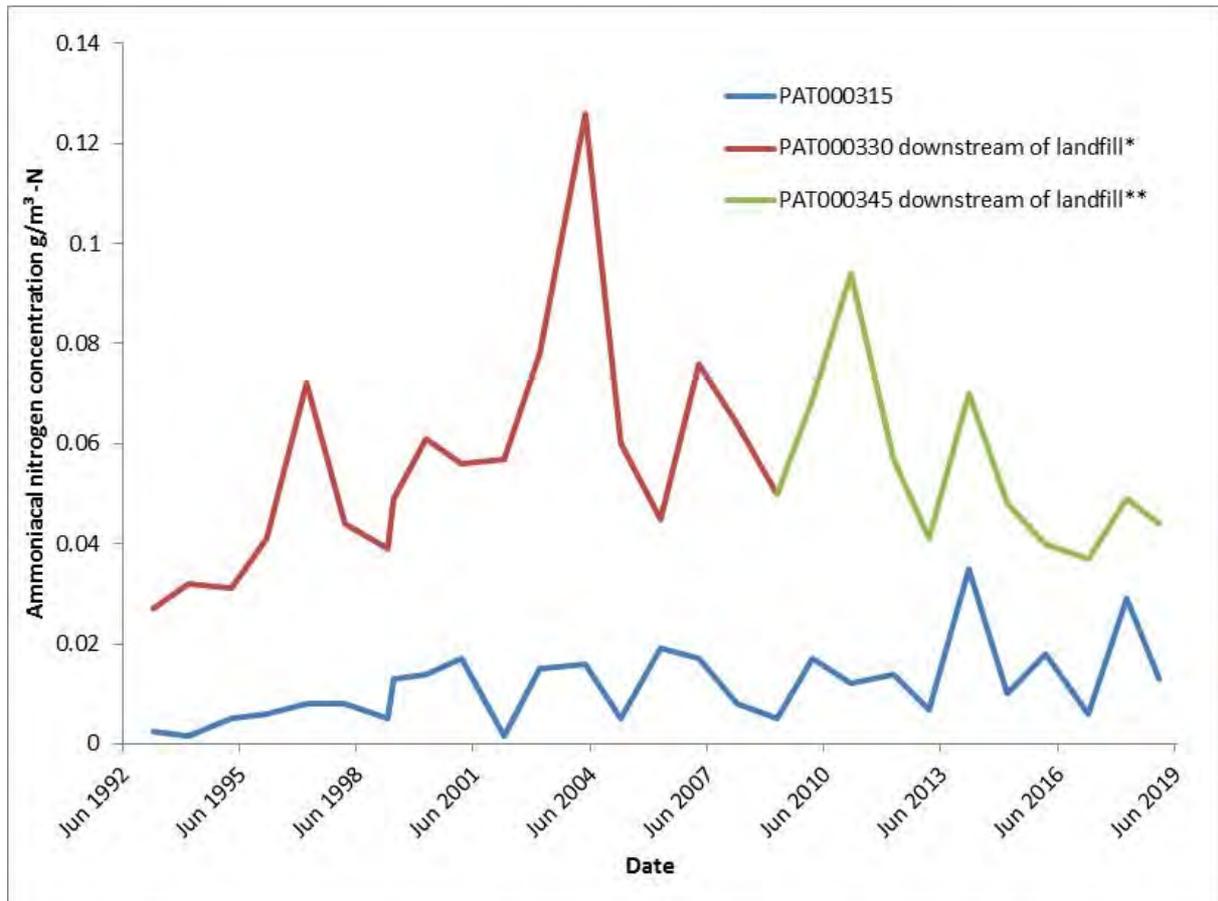
Figure 6 Graph showing ammoniacal nitrogen levels in the Patea Stream up and downstream of the landfill (where comparative data is available)

Figure 6 shows the ammoniacal nitrogen data gathered over the past 25 years. It is noted that, as the Stratford WWTP had an upgrade in 2009, the discharge point of the WWTP was moved and the sites used to monitor the downstream effects of the landfill have also changed. Monitoring at site PAT000330 ceased in March 2009, with monitoring continuing at site PAT000345, further downstream.

Whilst there is some separation between the site's locations, the graph indicates that a similar, stable, and modest rise in ammoniacal nitrogen has occurred in the Patea River as result of the landfill's presence. The highest level of ammoniacal nitrogen found downstream of the landfill since monitoring began was  $0.87 \text{ g/m}^3$  at site PAT000345, on 16 March 2005 (prior to the WWTP upgrade and not plotted in Figure 6). Under the pH and temperature conditions prevailing at the time of sampling, this ammoniacal nitrogen concentration would have resulted in an unionised ammonia concentration of  $0.014 \text{ g/m}^3$ , well below the  $0.025 \text{ g/m}^3$  unionised ammonia guideline used for the long term protection of aquatic ecosystems.

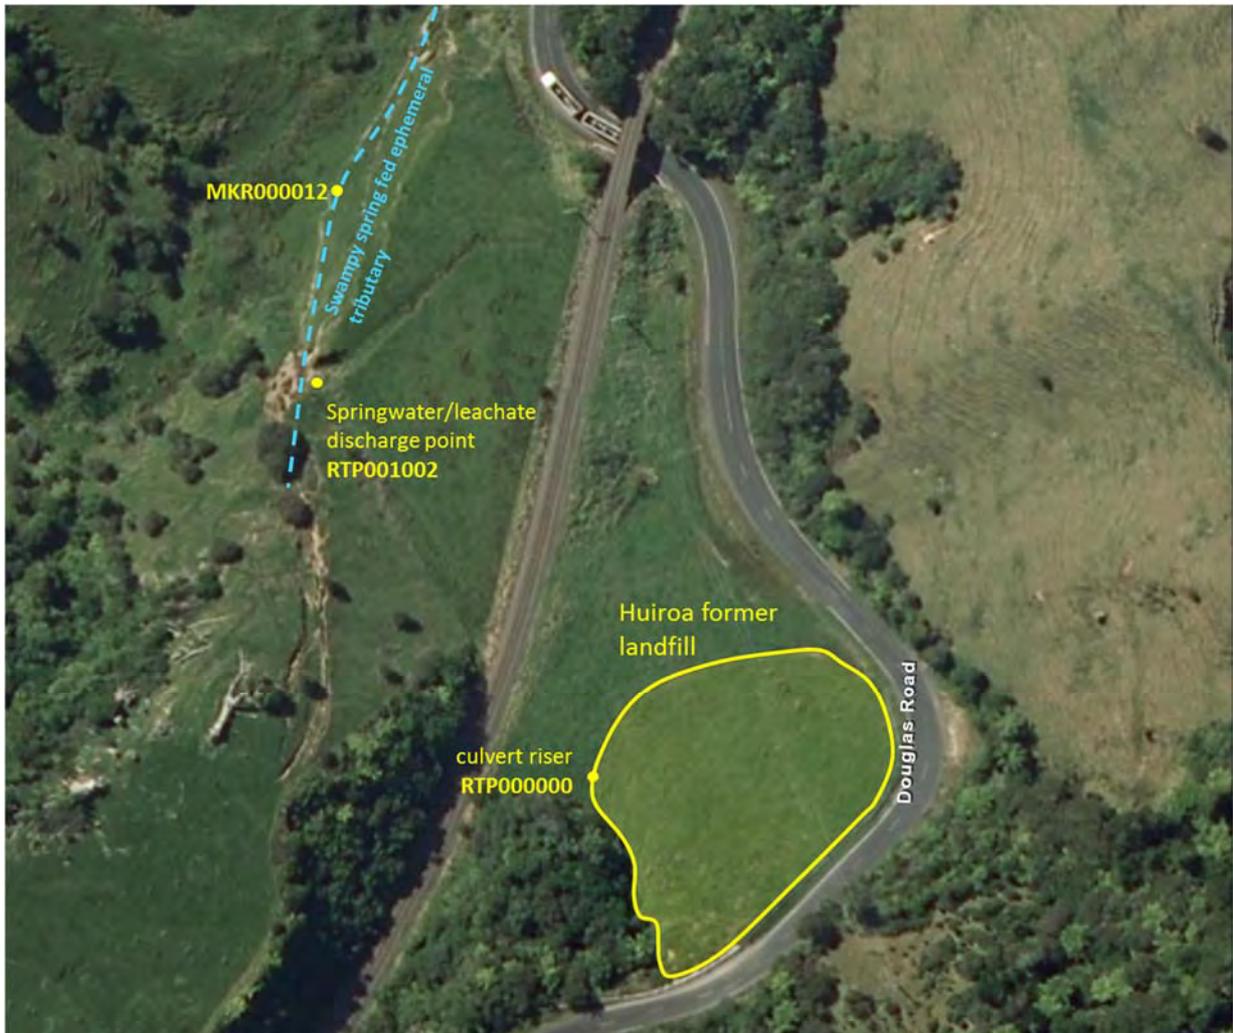
Figure 7 Huiroa landfill and approximate sampling locations

The Huiroa landfill is sited within an elbow of Douglas Road. The dump was an uncontrolled roadside landfill used by local residents to dispose of domestic waste. The site was closed in 1991 and reinstated by SDC.

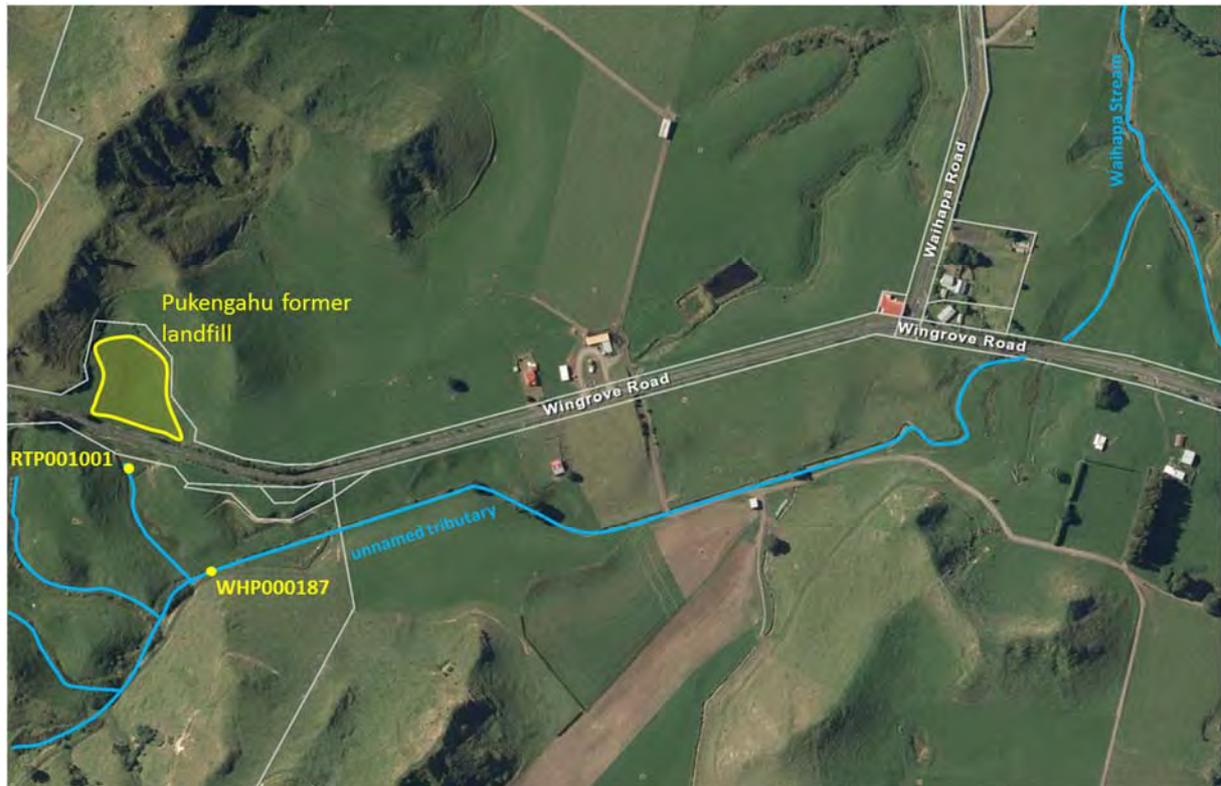
Figure 8 Pukengahu landfill and approximate sampling locations

The site is situated in a small gully off Wingrove Road (Figure 8). At the base of the gully is a small wetland area, which is fed by a spring that is culverted beneath the road and feeds into a small unnamed stream. The dump was unmanaged but was mostly used for the discharge of domestic waste by local residents. The landfill closed in 1991 and the site was reinstated by SDC. It is monitored on a triennial basis, with inspections and sampling next scheduled to be undertaken during the 2020-2021 monitoring year.
