Todd Energy Limited
Mangahewa-D Wellsite
Monitoring Programme Report
2014-2015

Technical Report 2015-115

May 2016

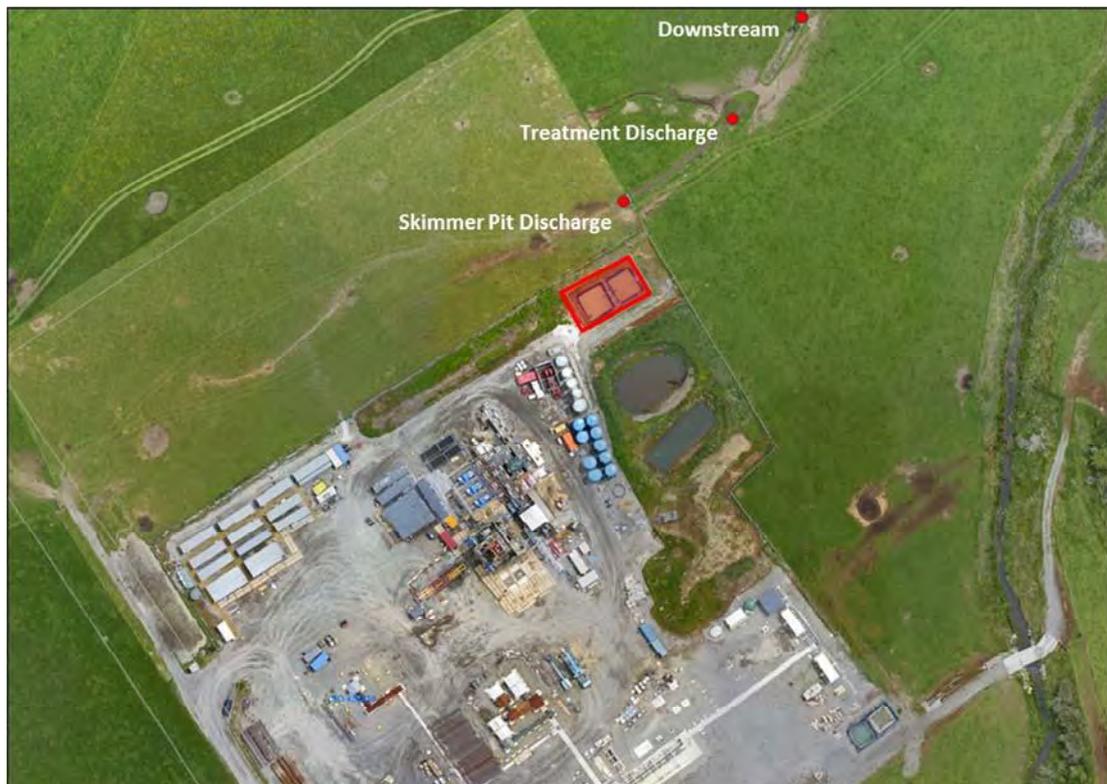
Figure 2 Aerial view of the Mangahewa-D wellsite showing the location of the skimmer pits (in red) and the discharge and downstream sampling locations.

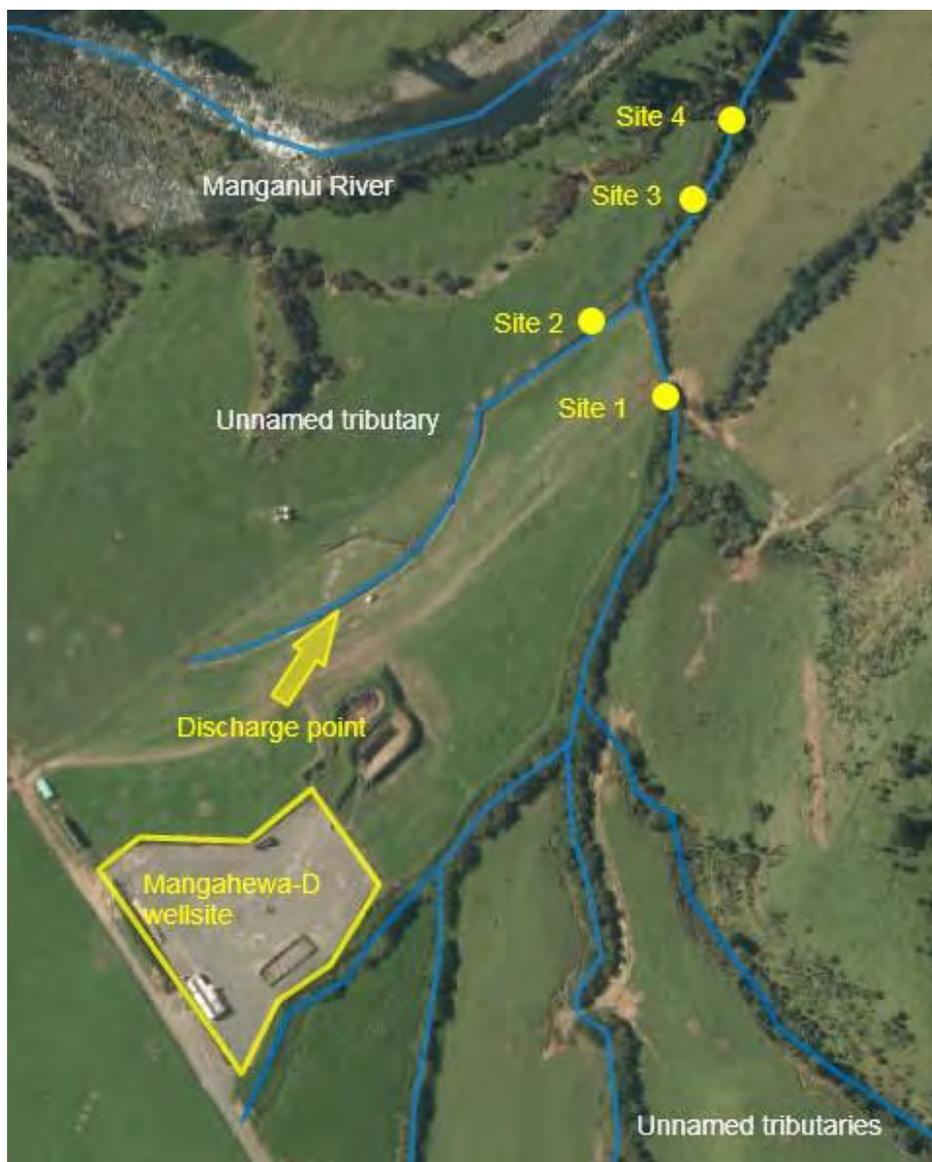
Table 1 Biomonitoring sites in two unnamed tributaries of the Manganui River in relation to the Mangahewa-D wellsite.

Figure 1 Biomonitoring sites in two unnamed tributaries of the Manganui River in relation to the Mangahewa-D wellsite
