Todd Energy Limited  
Mangahewa-E Wellsite  
Monitoring Programme Report  
2013-2015

Technical Report 2015–54

February 2016

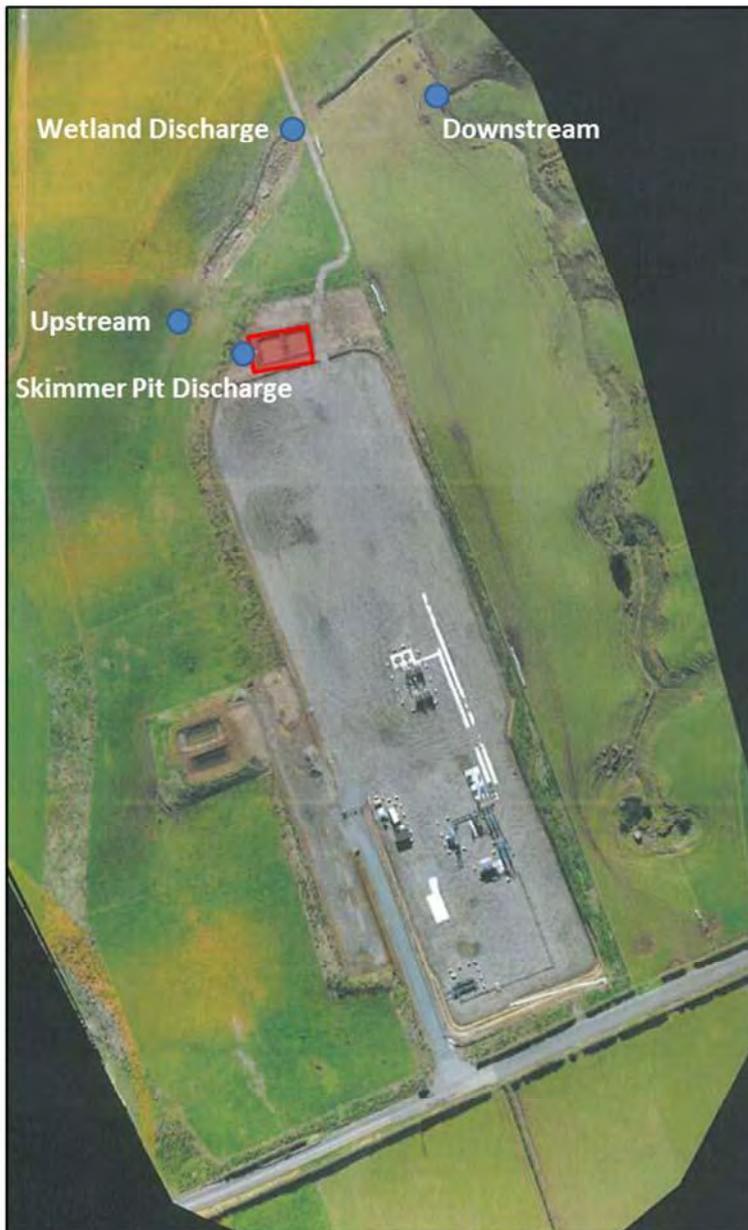
**Figure 2** Stormwater and surface water sampling locations at the Mangahewa-E wellsite.

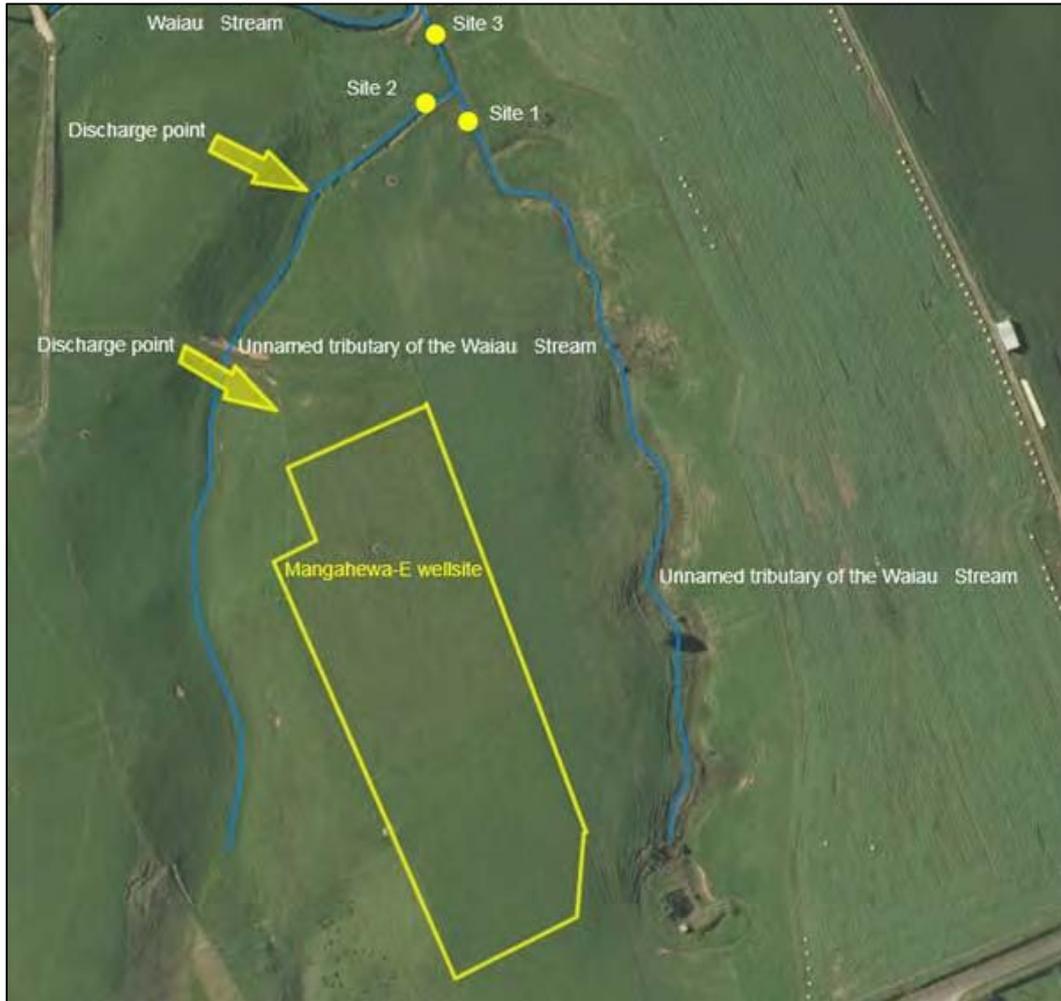
The biomonitoring surveys were undertaken at three established sites; a control site 10 m upstream of the tributary confluence (site 1), a primary impacted site 15 m upstream of the tributary confluence and 40 m downstream of the wetland treatment system (site 2) and a secondary impacted site 15 m downstream of the tributary confluence (site 3), as seen in Figure 3.

**Figure 3** Biomonitoring sites in the two unnamed tributaries of the Waiiau Stream in relation to the Mangahewa-E wellsite.

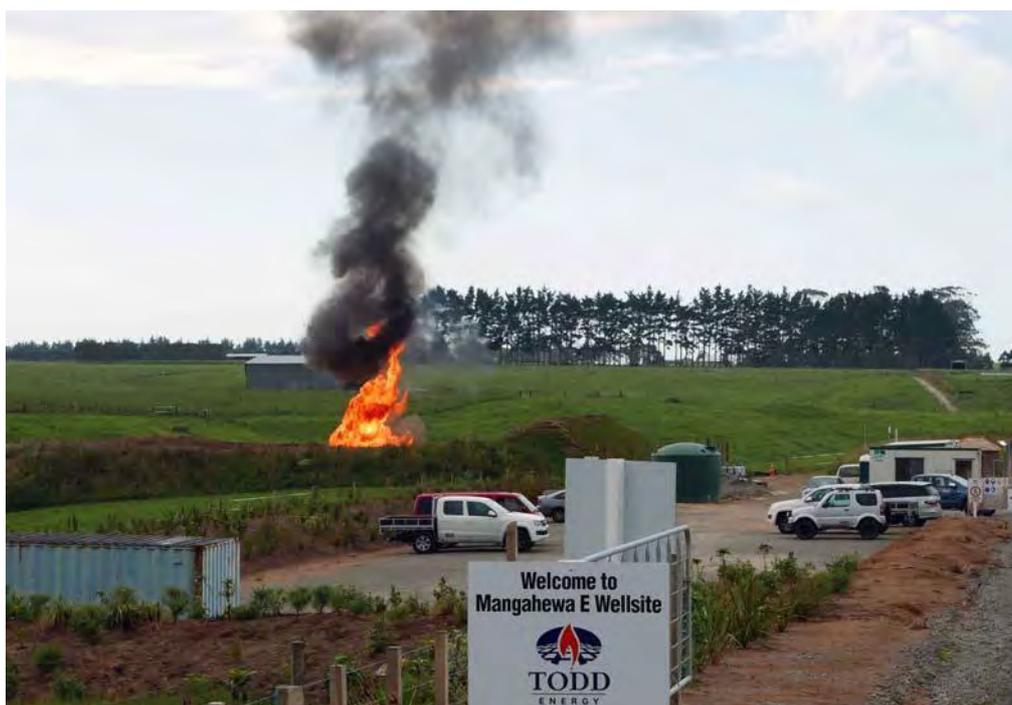
On 29 December 2014, notification was received concerning black smoke at the Mangahewa-E site. Investigation found that the relatively short duration 'black smoke' event was the consequence of following an incorrect procedure - reducing the separator pressure rather than increasing it, allowing more liquids to 'carry over' into the flare pit. The ignition of the liquid had caused the black smoke which contravened Section 15(1)(b) of the RMA and special conditions 6 and 7 of resource consent 9454-1. It was deemed that the reduction of separator pressure causing the carry over of liquids to the flare pit, resulting in discharges of black smoke, was not beyond the consent holder's control, and was not unavoidable. Infringement notice EAC-20709 was issued to Todd Energy Limited.

**Figure 4** Black smoke event at Mangahewa-E wellsite, 29 December 2014.

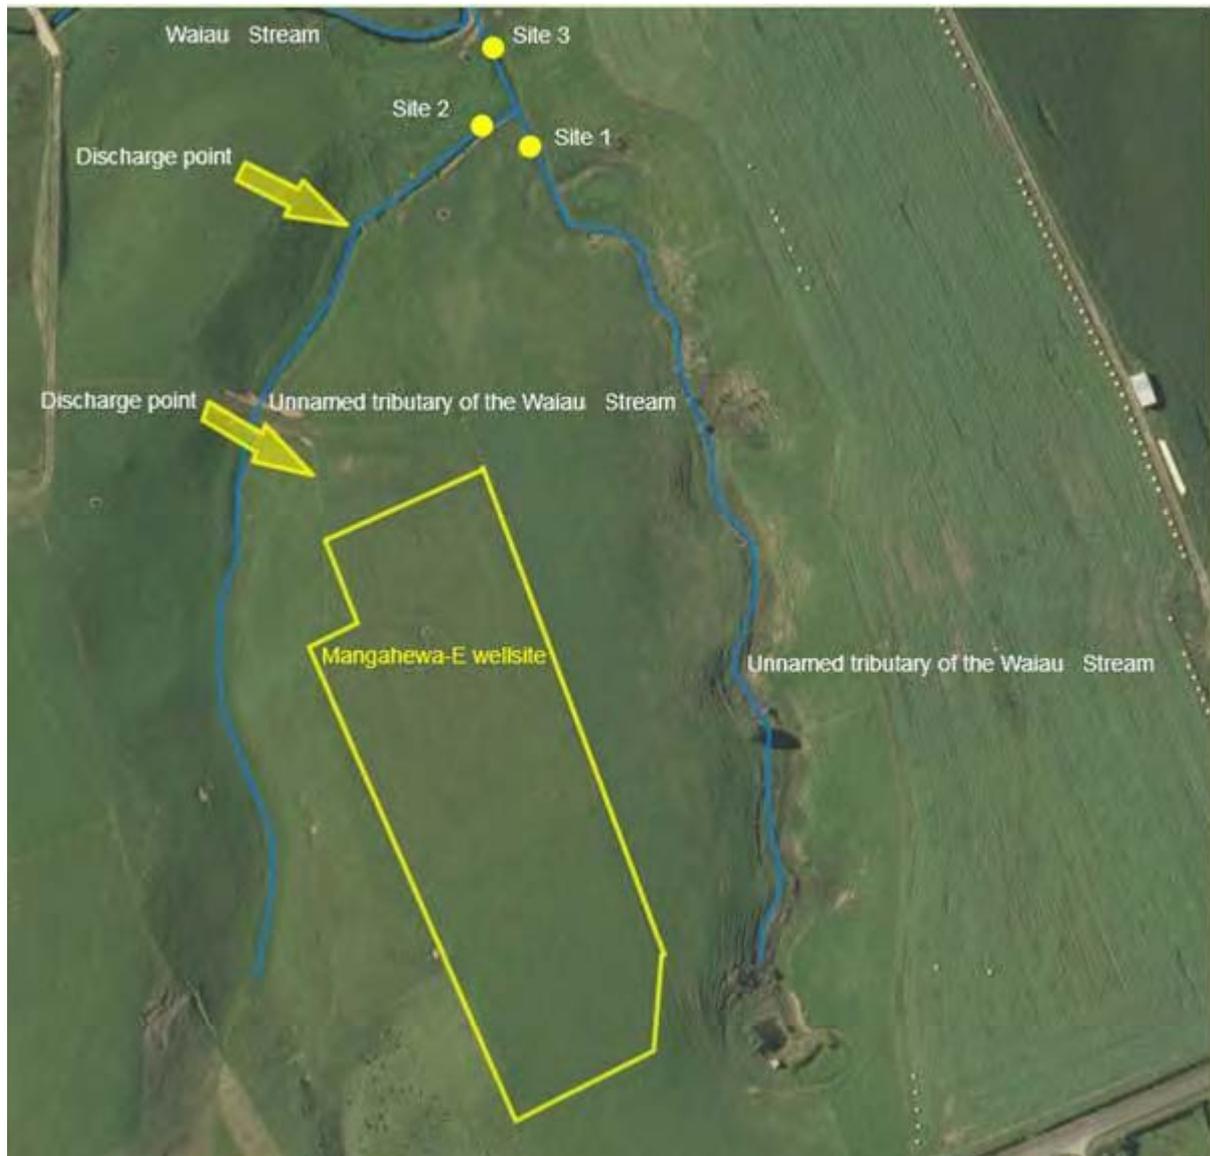
**Figure 1** Biomonitoring sites in the two unnamed tributaries of the Waiiau Stream in relation to the Mangahewa-E wellsite
