Waste Remediation Service Ltd  
Waikaikai Landfarm  
Monitoring Programme  
Annual Report  
2018-2019

Technical Report 2019-70

Taranaki Regional Council  
Private Bag 713  
STRATFORD  
February 2020

Waste Remediation Services Ltd (the Company) operates a drilling waste landfarm (Waikaikai Landfarm) located off Lower Manutahi Road at Manutahi, South Taranaki, in the Mangaroa catchment.

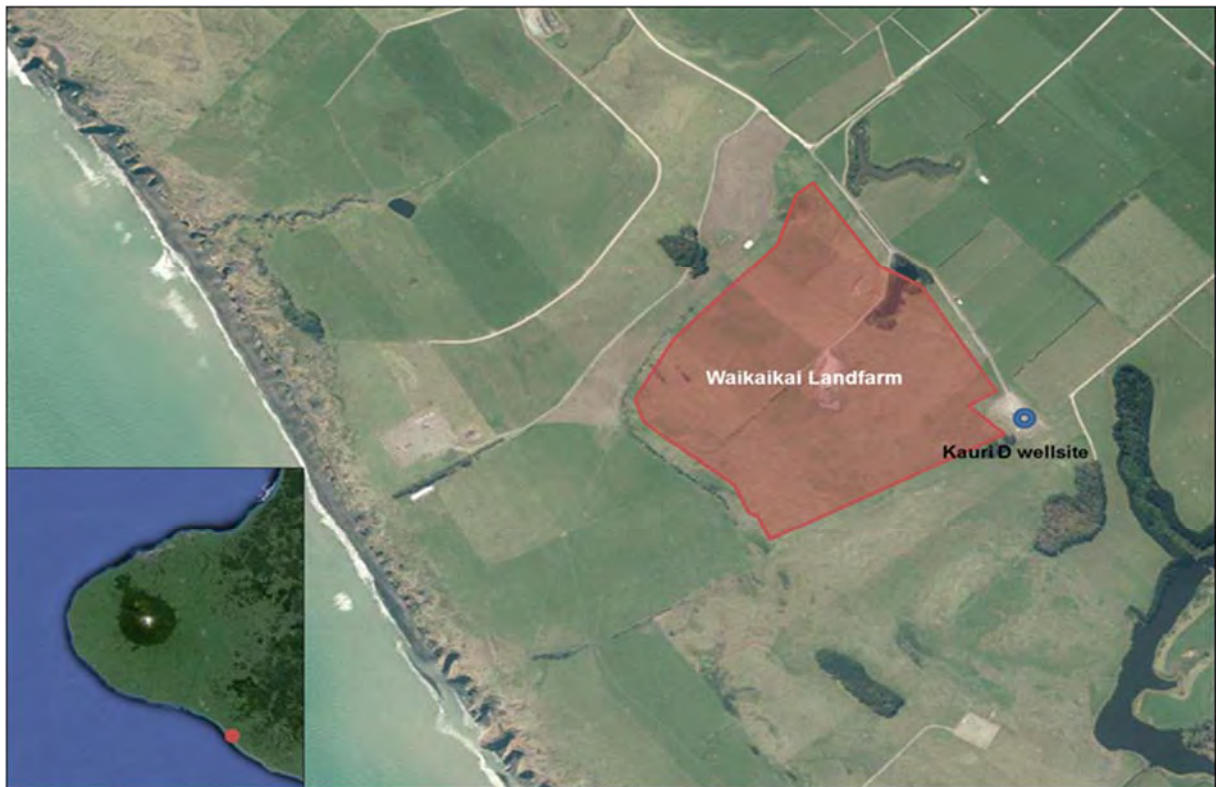
Figure 1 WRS Waikaikai Landfarm and regional insert

Origin Energy Ltd's Kauri D wellsite is situated in the eastern corner of the site, and there is a small coastal lake inland and to the northeast (up gradient) of the storage pit area. Both of these features are presented in Figure 1.

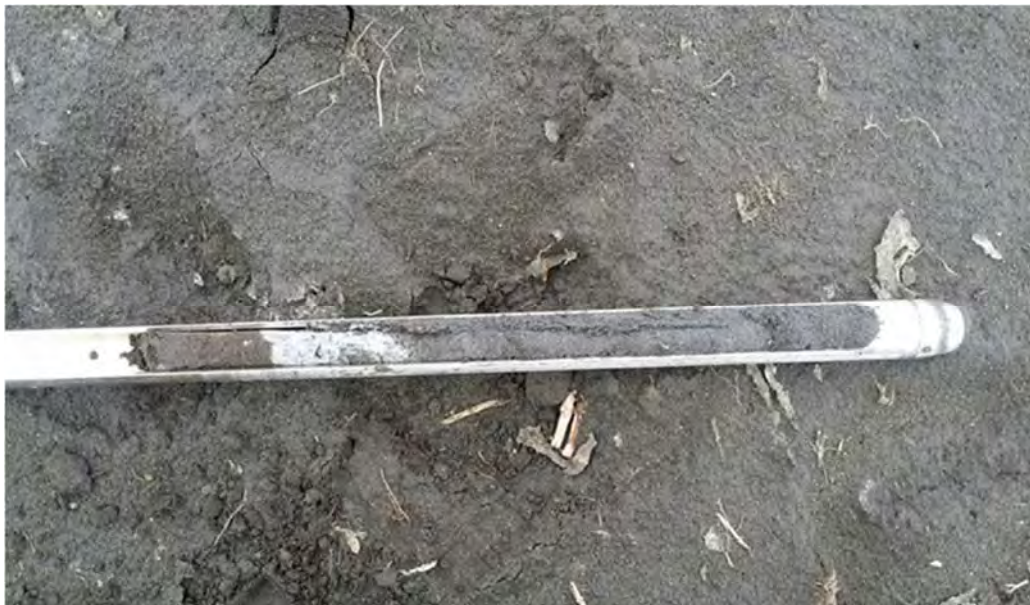
Photo 1 An example of an extracted soil core

To collect the sample, a soil corer is inserted to a depth of 400 mm +/- to encompass the zone of application. Ten soil cores are collected, spaced 10 meters apart. These ten soil cores are then composited to gain one representative soil sample of an application area. An example of an extracted soil core is provided in Photo 1.

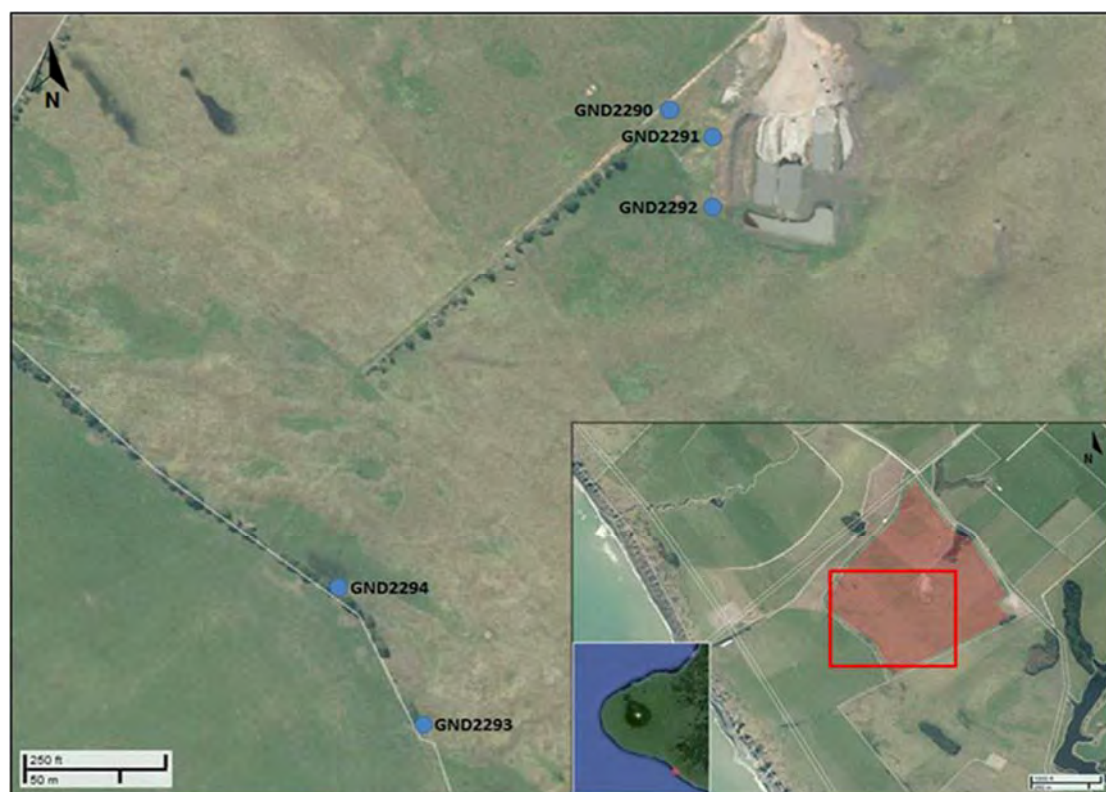
Figure 2 WRS Waikaikai Landfarm groundwater monitoring well locations

The results of the groundwater monitoring of Waikaikai Landfarm is provided in the following Tables 2-6.

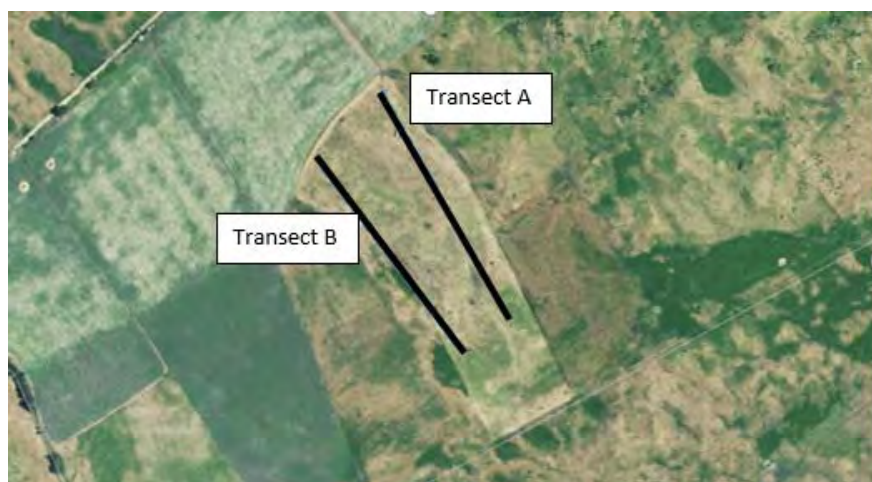
Figure 3 Soil sample transects 2018-2019 monitoring period

The Council collected two composite soil samples this monitoring period from the landfarmed location W1810 (Figure 3). This location was landfarmed between the 01/04/2018 and 31/10/2018. This area (W1810) constituted the second most recently landfarmed area at the Waikaikai Landfarm. The most recently landfarmed (W1911) is yet to be completed but will be assessed in the upcoming monitoring period.

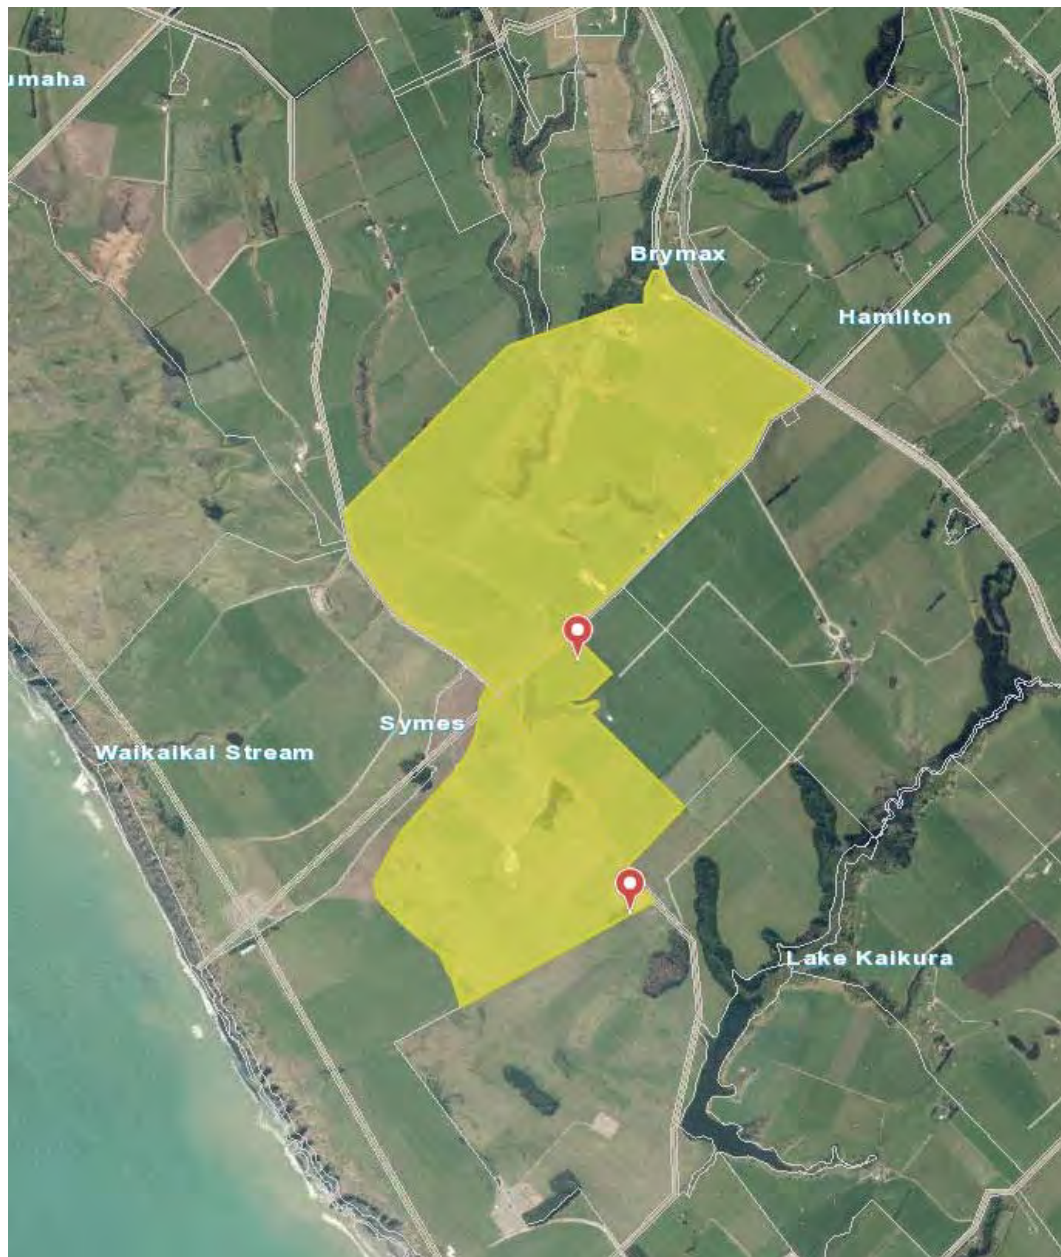
Total consented area for Waikaikai Landfarm (in yellow) as authorised by consent 5956-2.0

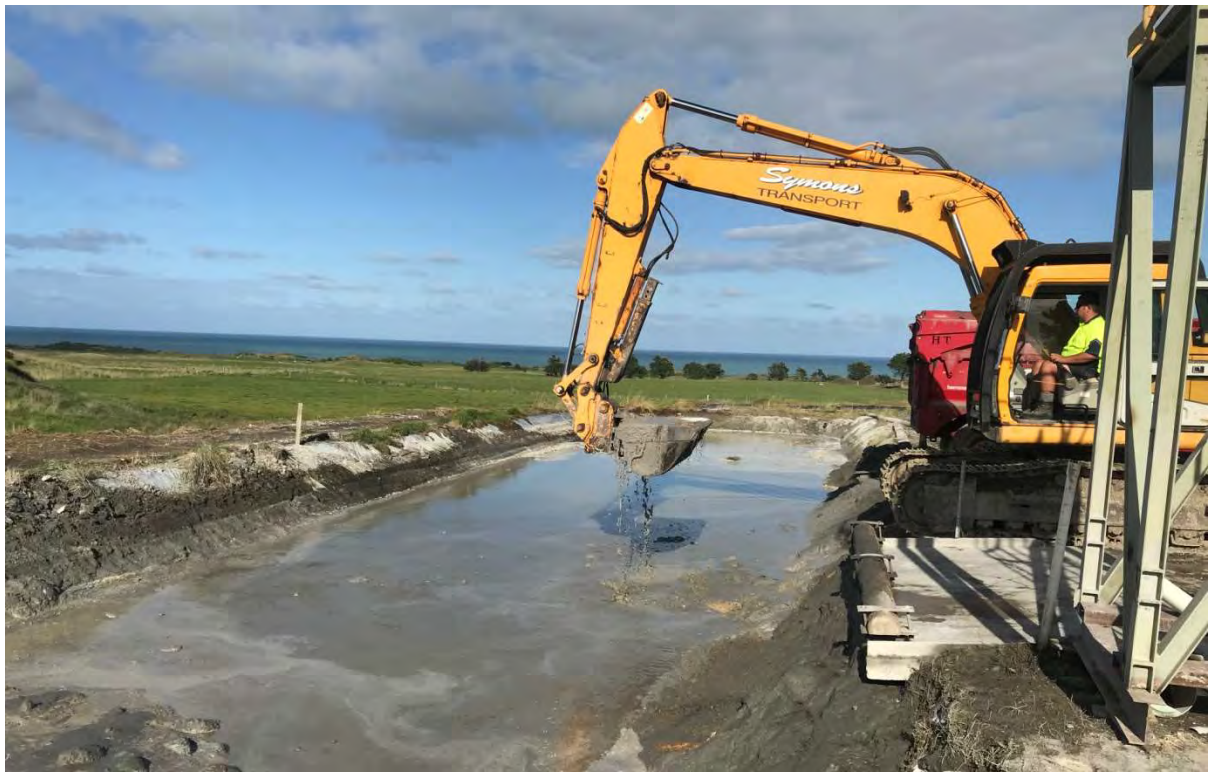
Photograph 1      Cleaning out of pit 1

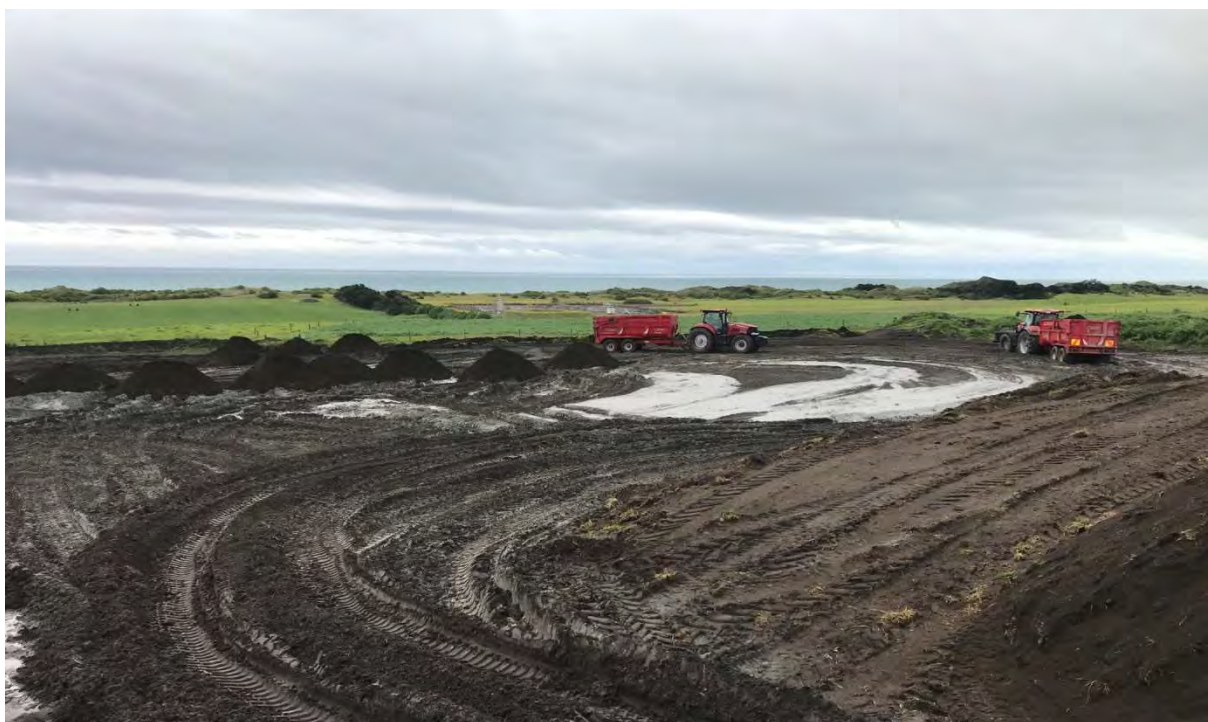
Photograph 2      Spreading operations W1911

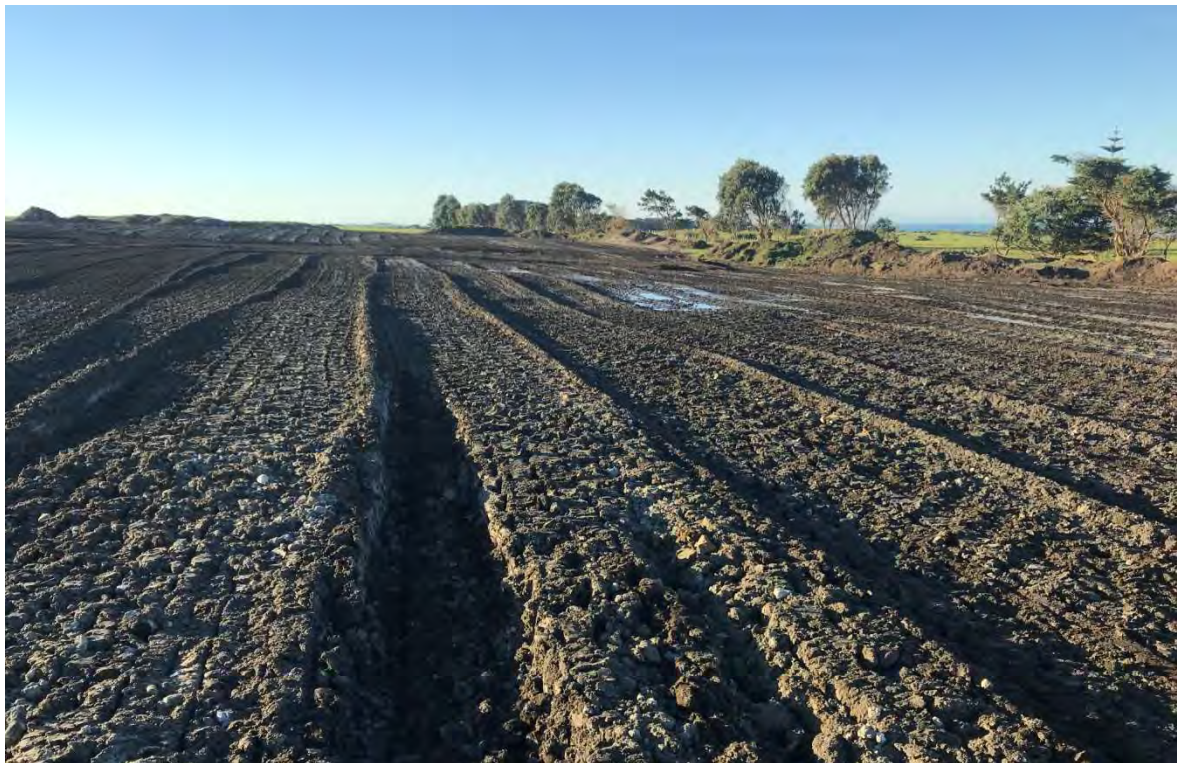
Photograph 3 Spread area W1911 post incorporation of waste

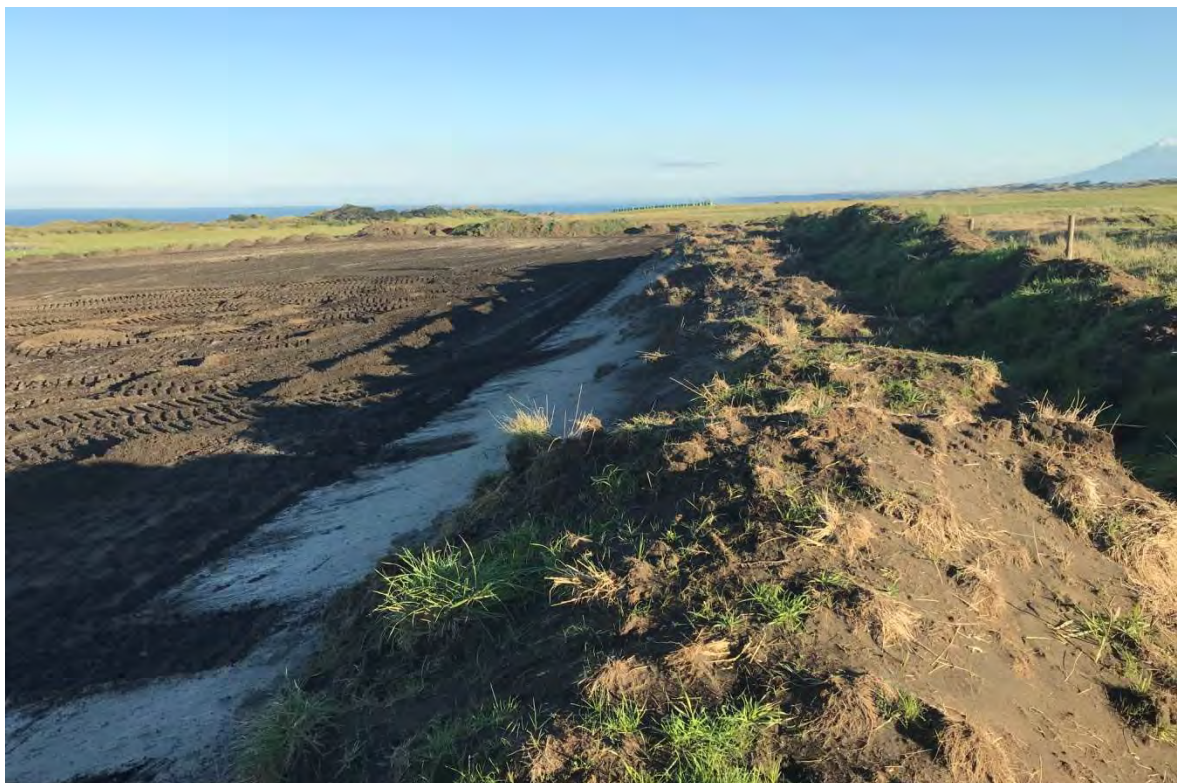
Photograph 4 Spreading area W1911 showing stockpiled topsoil bund

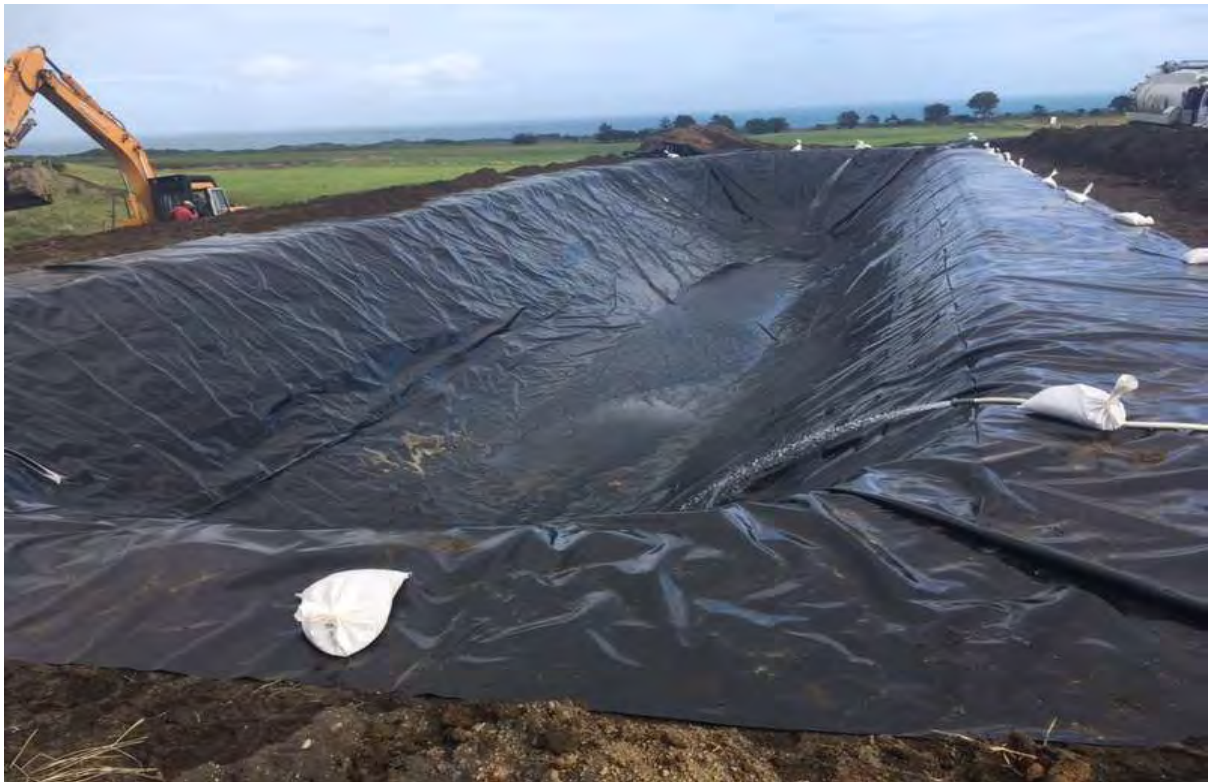
Photograph 5 Pit 1 new liner as installed

In this monitoring period the consent holder assessed the integrity of the storage cell liners. This is a consent requirement that must be undertaken within a 24 month period. No repairs were required to be undertaken. However, during normal operations the liner of pit 1 was compromised, which resulted in a new liner being sourced and installed. Similarly, pit 2's liner was damaged during loading operations which resulted in the pit being decommissioned. This pit currently remains out of action until it is required in future, whereby a new storage liner will be sourced. Noting that all landfarms within the region are required to install fit for purpose synthetic liners or equivalents, which hold fluid without leakage.

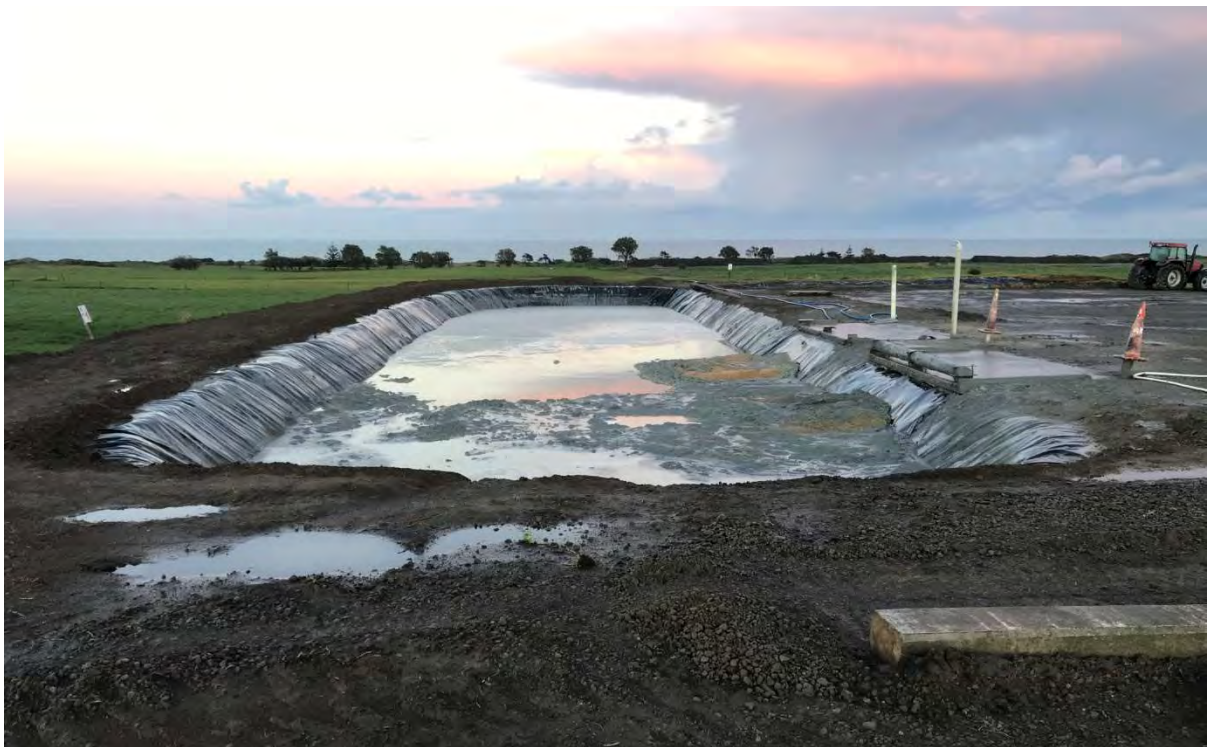
Photograph 6 Pit 1 in use post liner replacement
